**From:** [REDACTED]  
**To:** [REDACTED]  
**Subject:** Email Materials Laboratory Report--ERA20LA326  
**Date:** Wednesday, November 18, 2020 4:10:50 PM  
**Attachments:** [ERA20LA326 Fractured Head Stud Evaluation.pptx](#)

Place: Honea Path, South Carolina  
Date: September 21, 2020  
Vehicle: Boeing Model E75 Stearman Kaydet (N1524M)  
NTSB No.: ERA20LA326

Examination of fractured cylinder studs through photographs only. A summary of observations is included in the attached file.

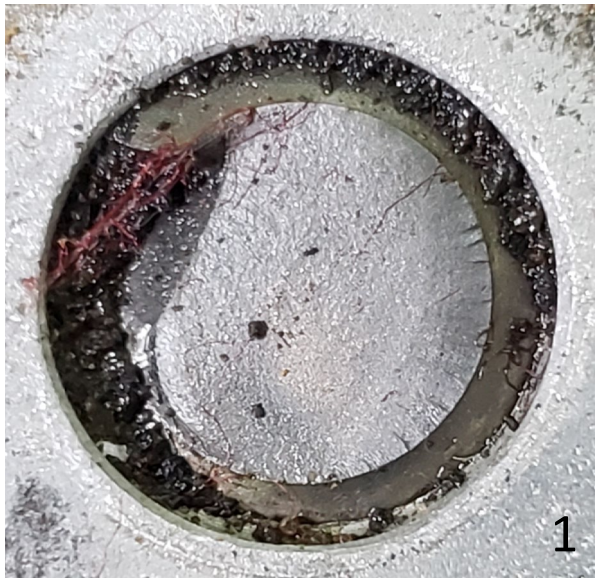
| Stud number | Fractographic observation |
|---|---|
| 1 | Features consistent with fatigue fracture |

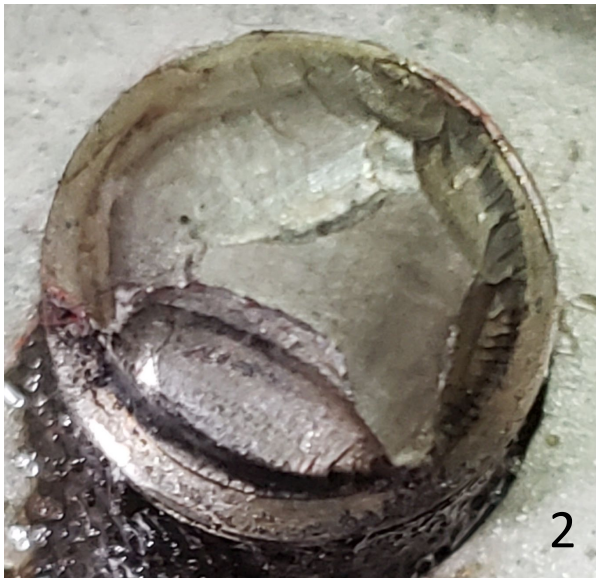
| Stud number | Fractographic observation |
|---|---|
| 2 | Mechanically damaged / image out of focus |

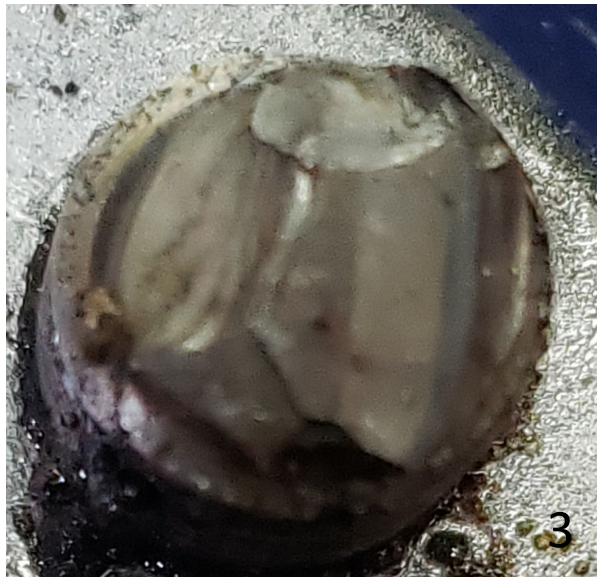
| Stud number | Fractographic observation |
|---|---|
| 3 | Mechanically damaged / image out of focus |

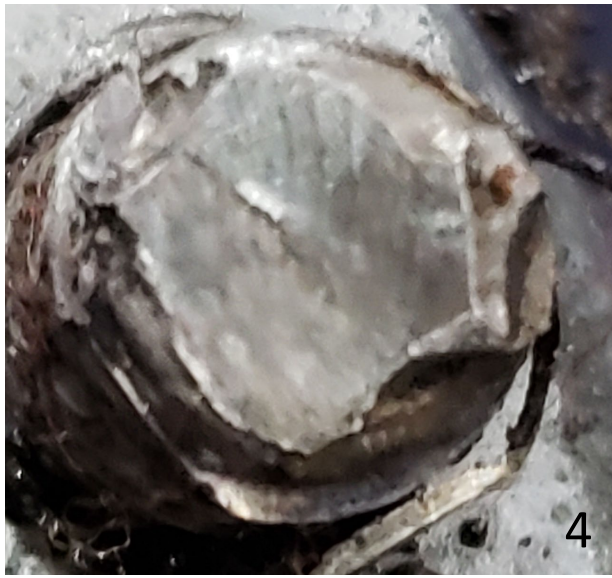
| Stud number | Fractographic observation |
|---|---|
| 4 | Mechanically damaged / image out of focus |
