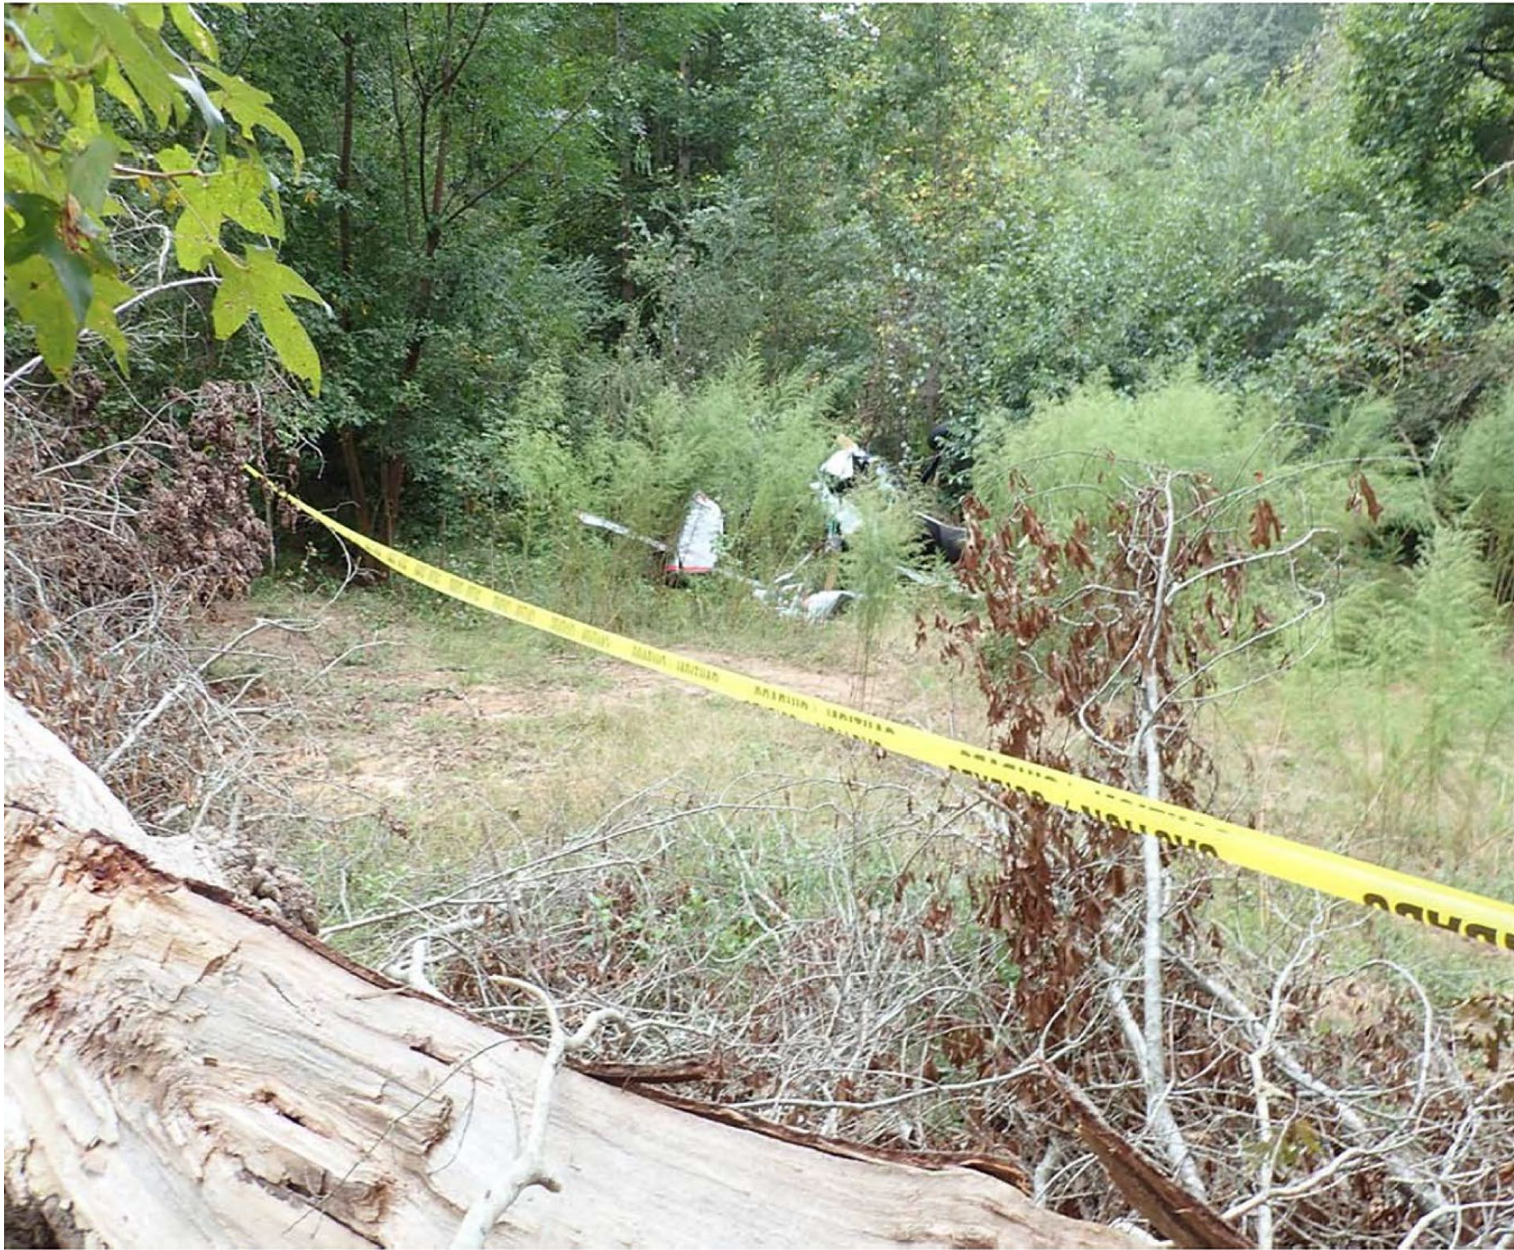
**Photo 1 – View of Main Wreckage as Found (FAA)**

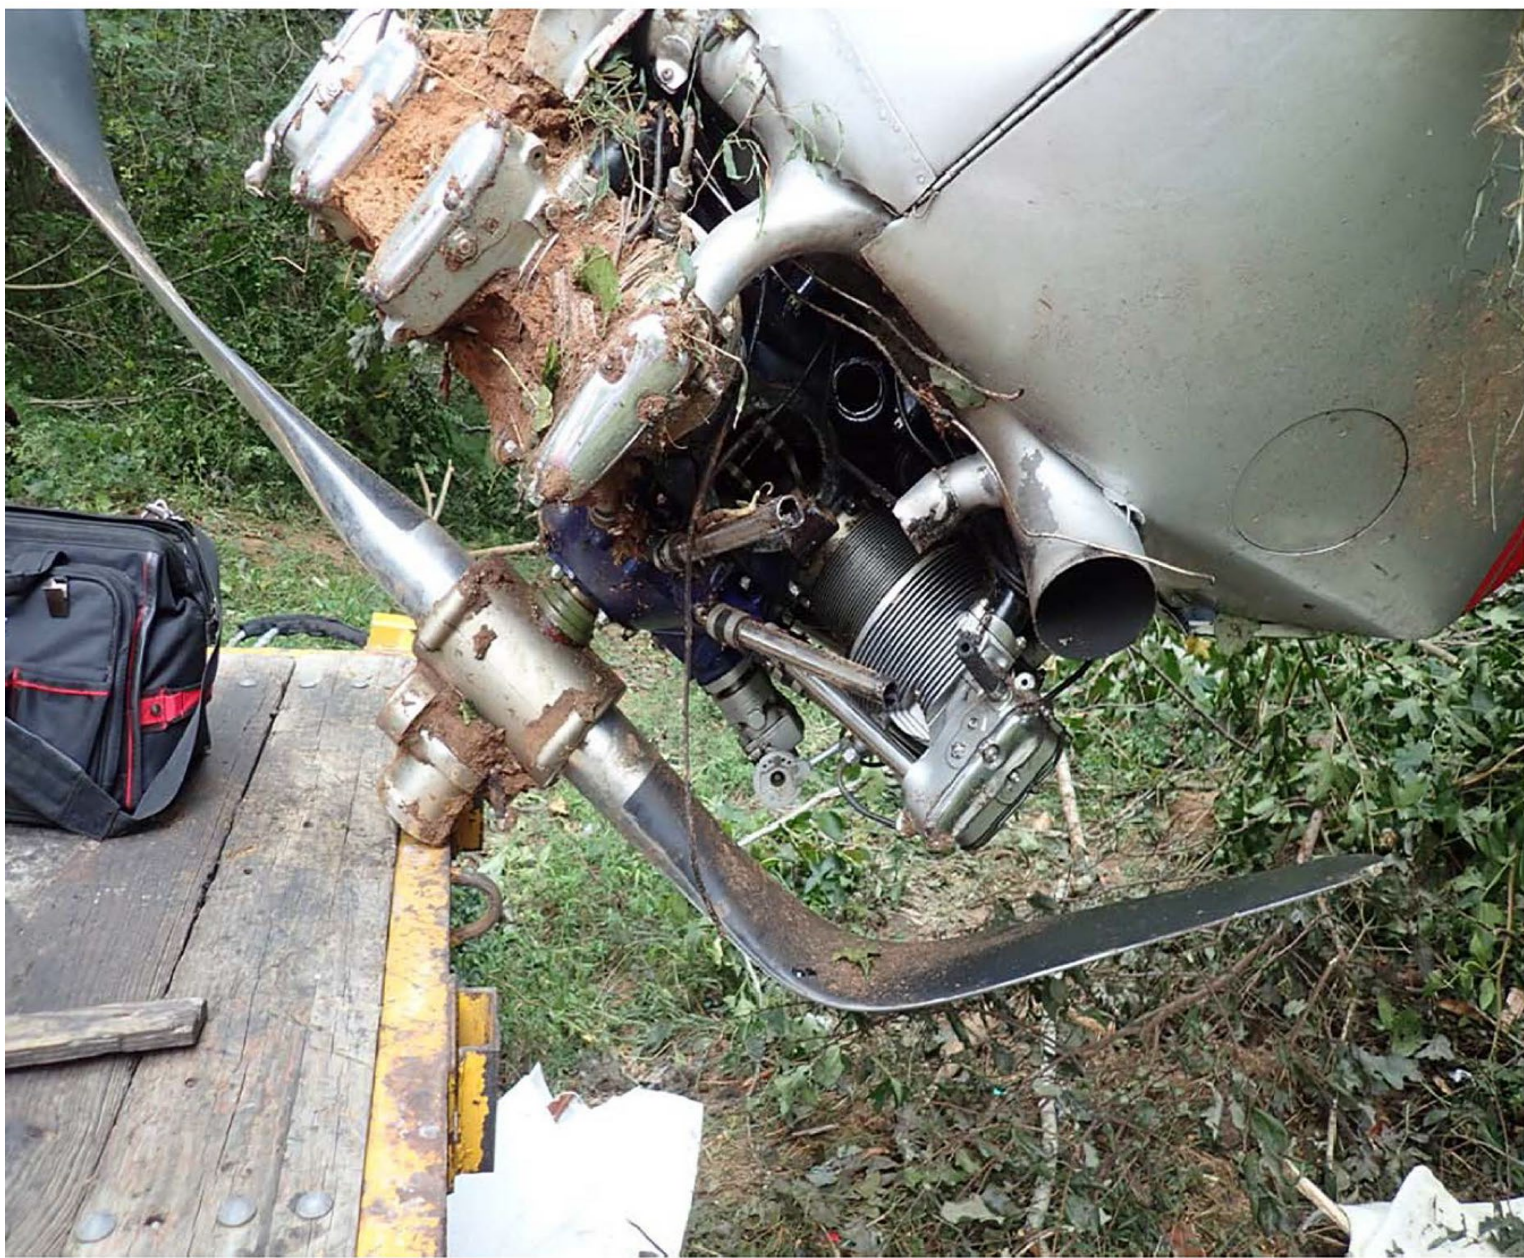
**Photo 2 – View of Engine During Recovery (FAA)**

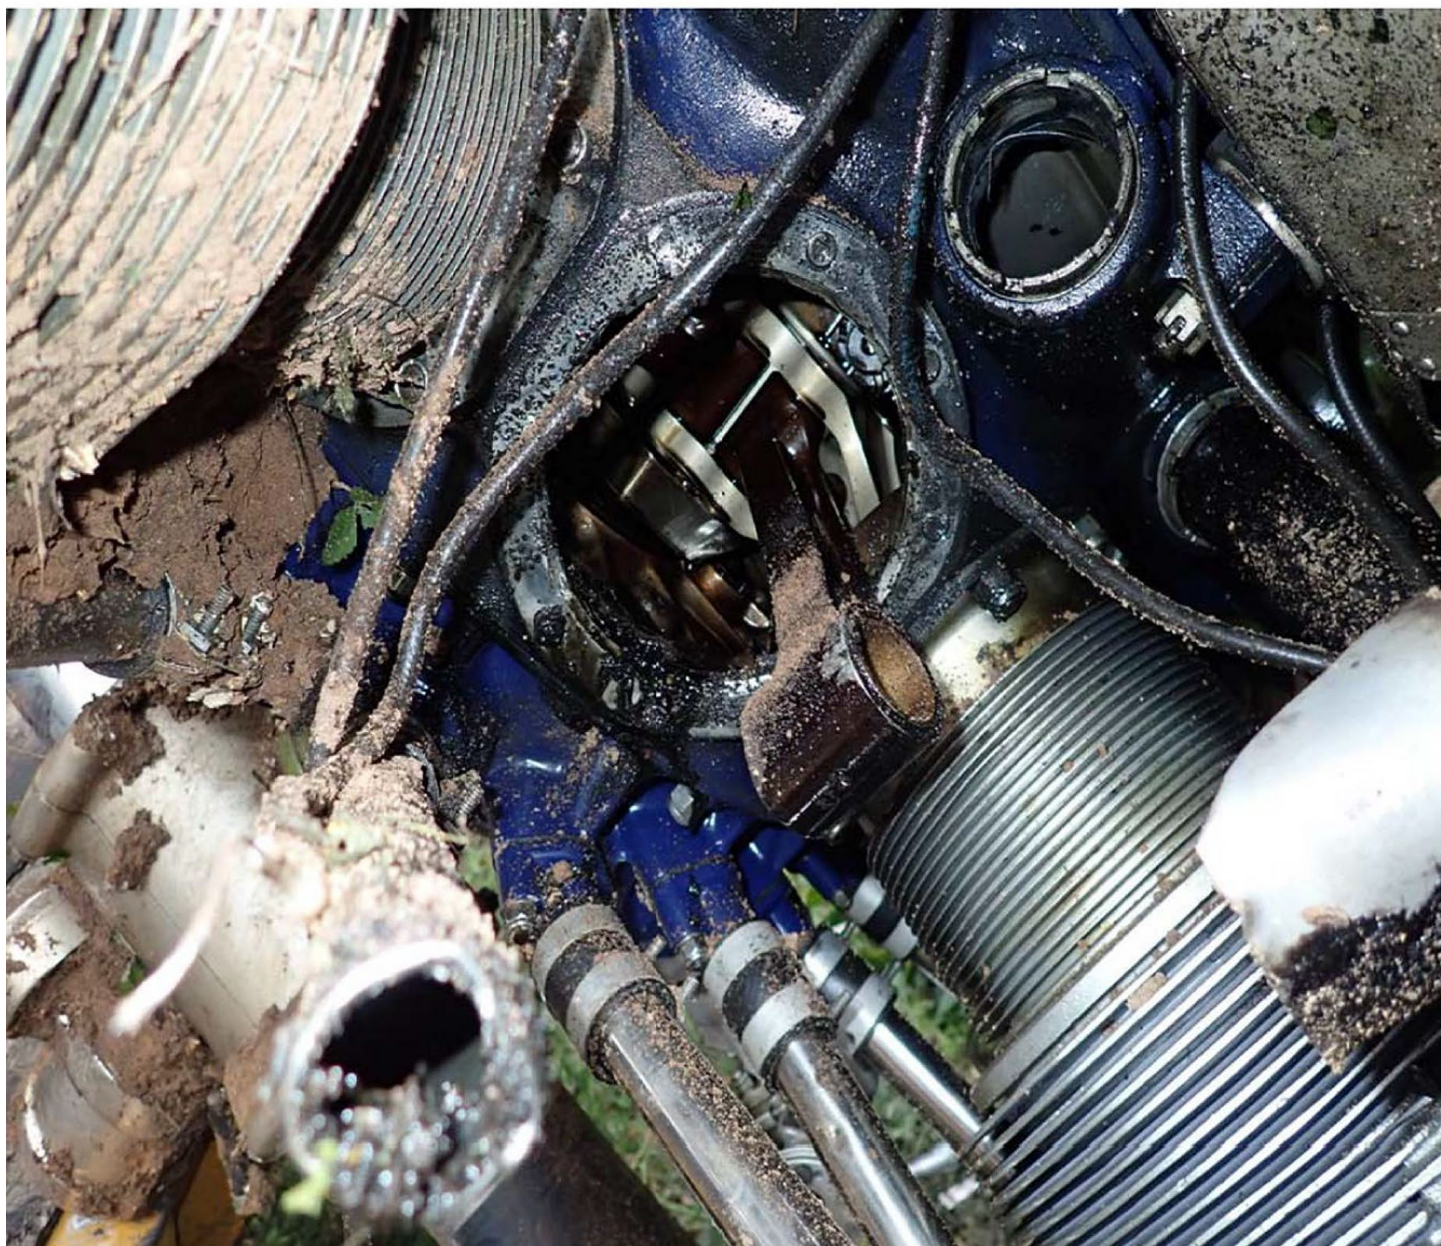
**Photo 3 – View of Connecting Rod (FAA)**

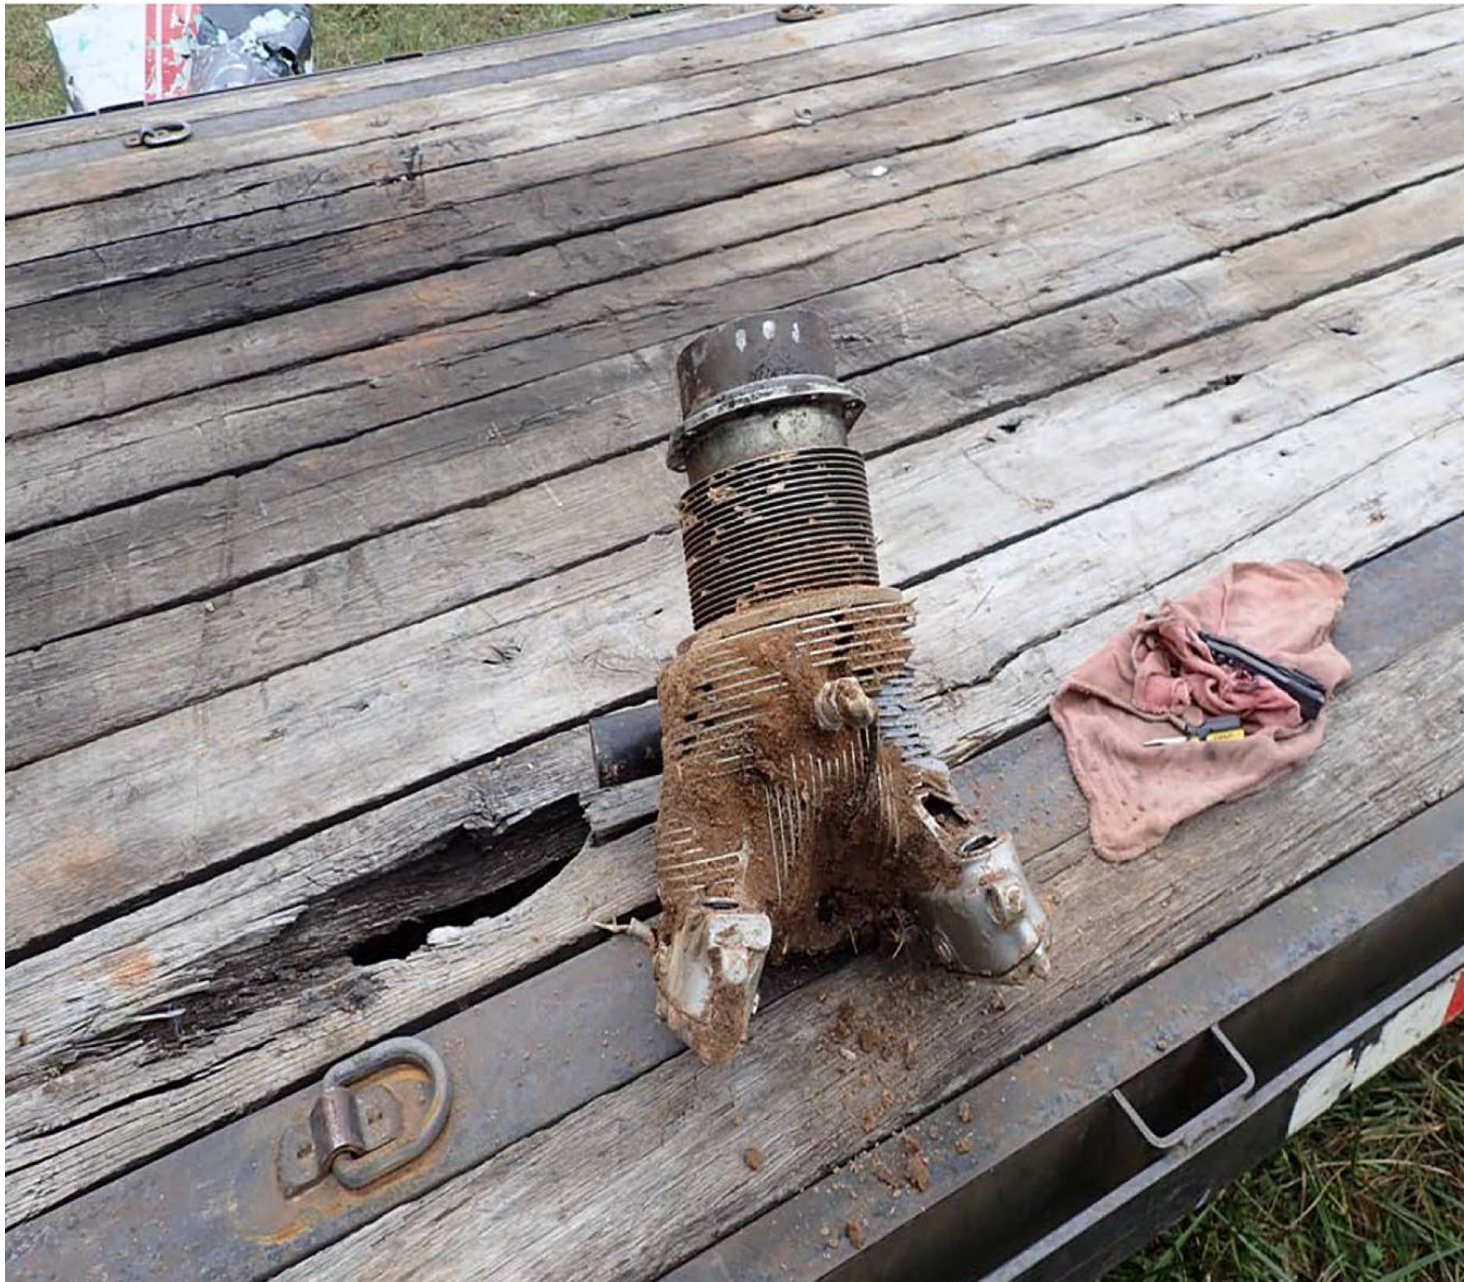
**Photo 4 – View of Separated Cylinder after Recovery (FAA)**

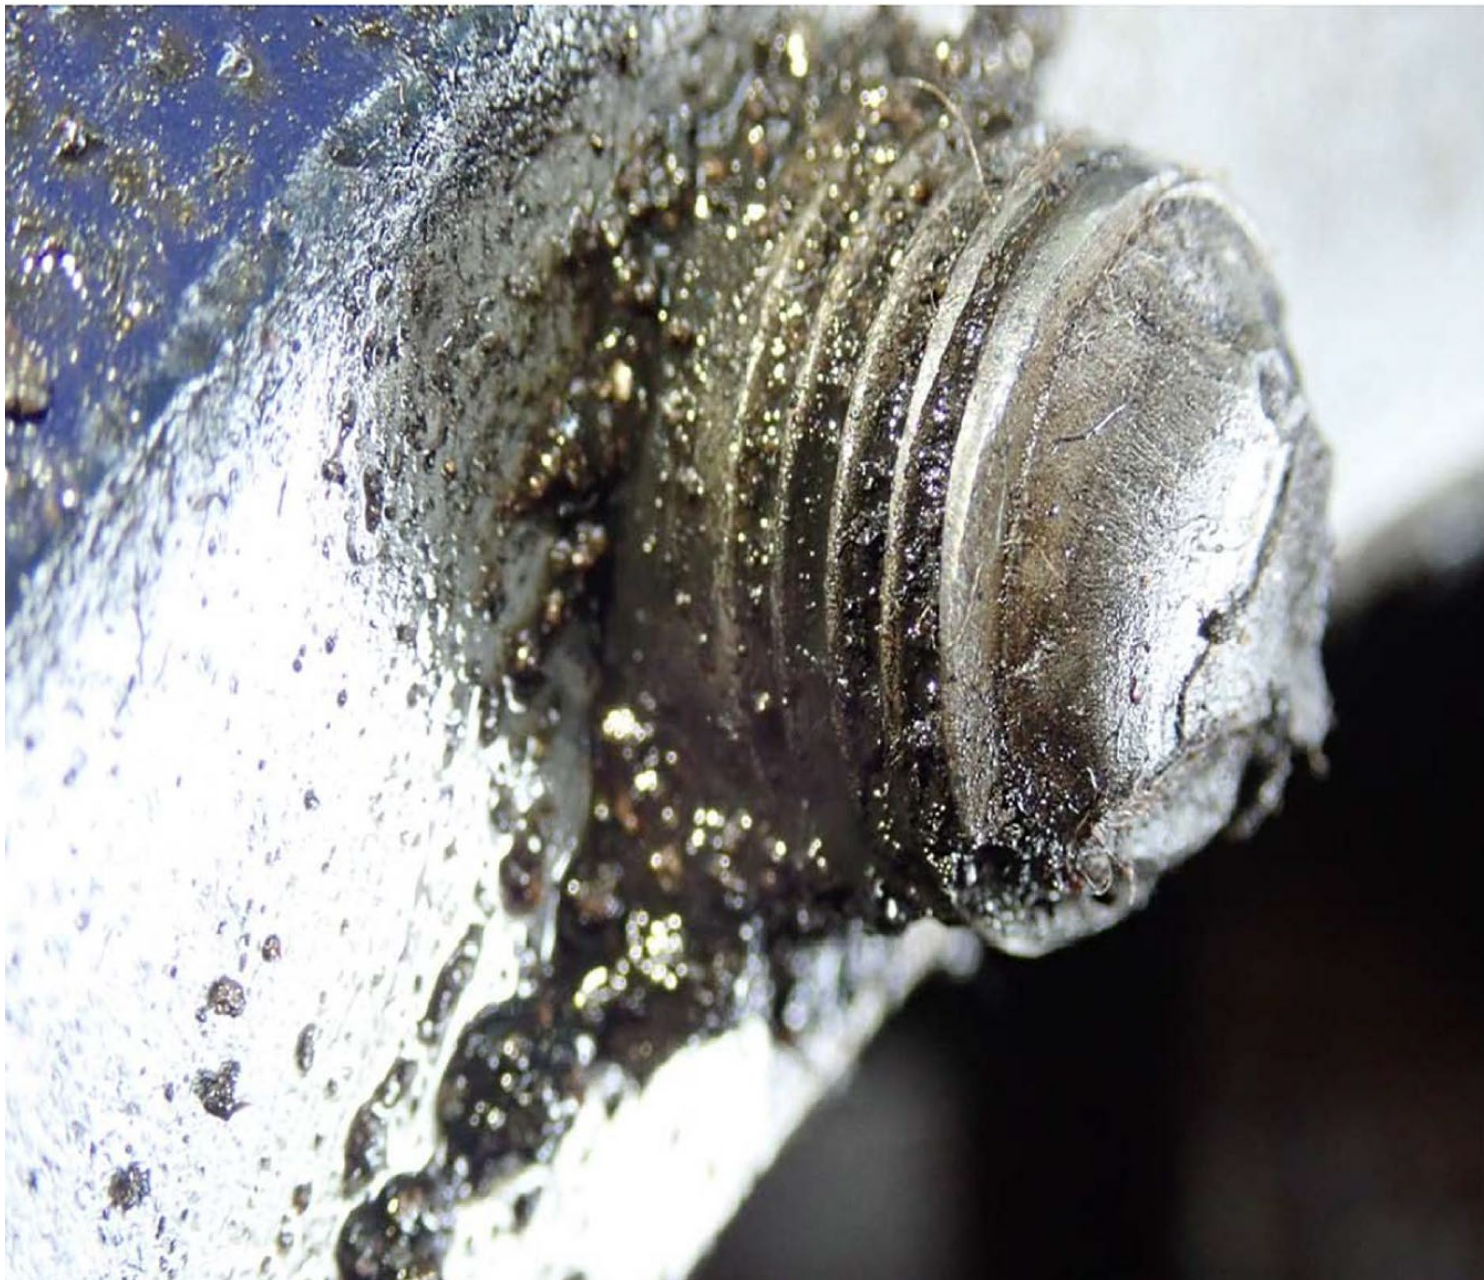
**Photo 5 – View of Fractured Cylinder Mount Stud (FAA)**
