# NTSB Investigation: ERA20LA330

Photo Array

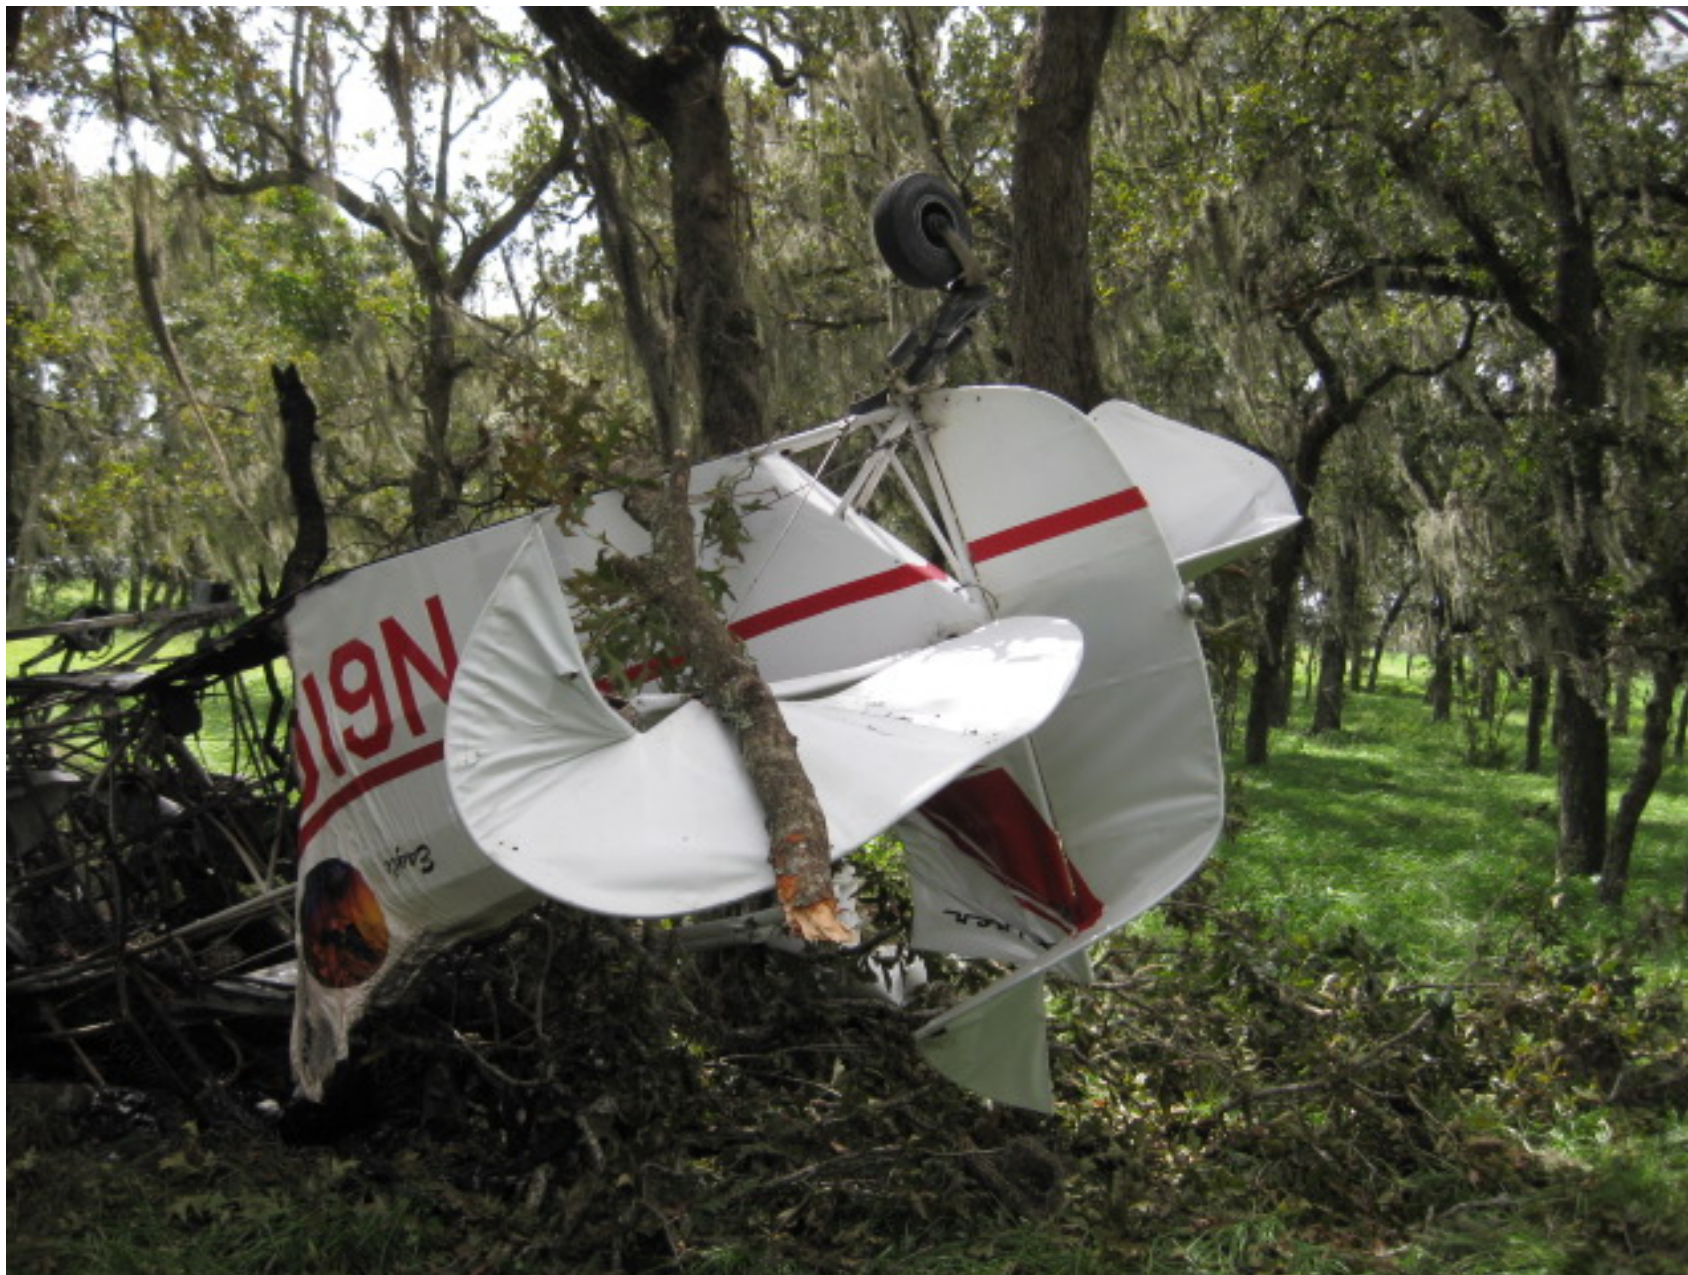
Photo 1 – View of the airplane inverted at the accident site (Photo Courtesy of FAA)

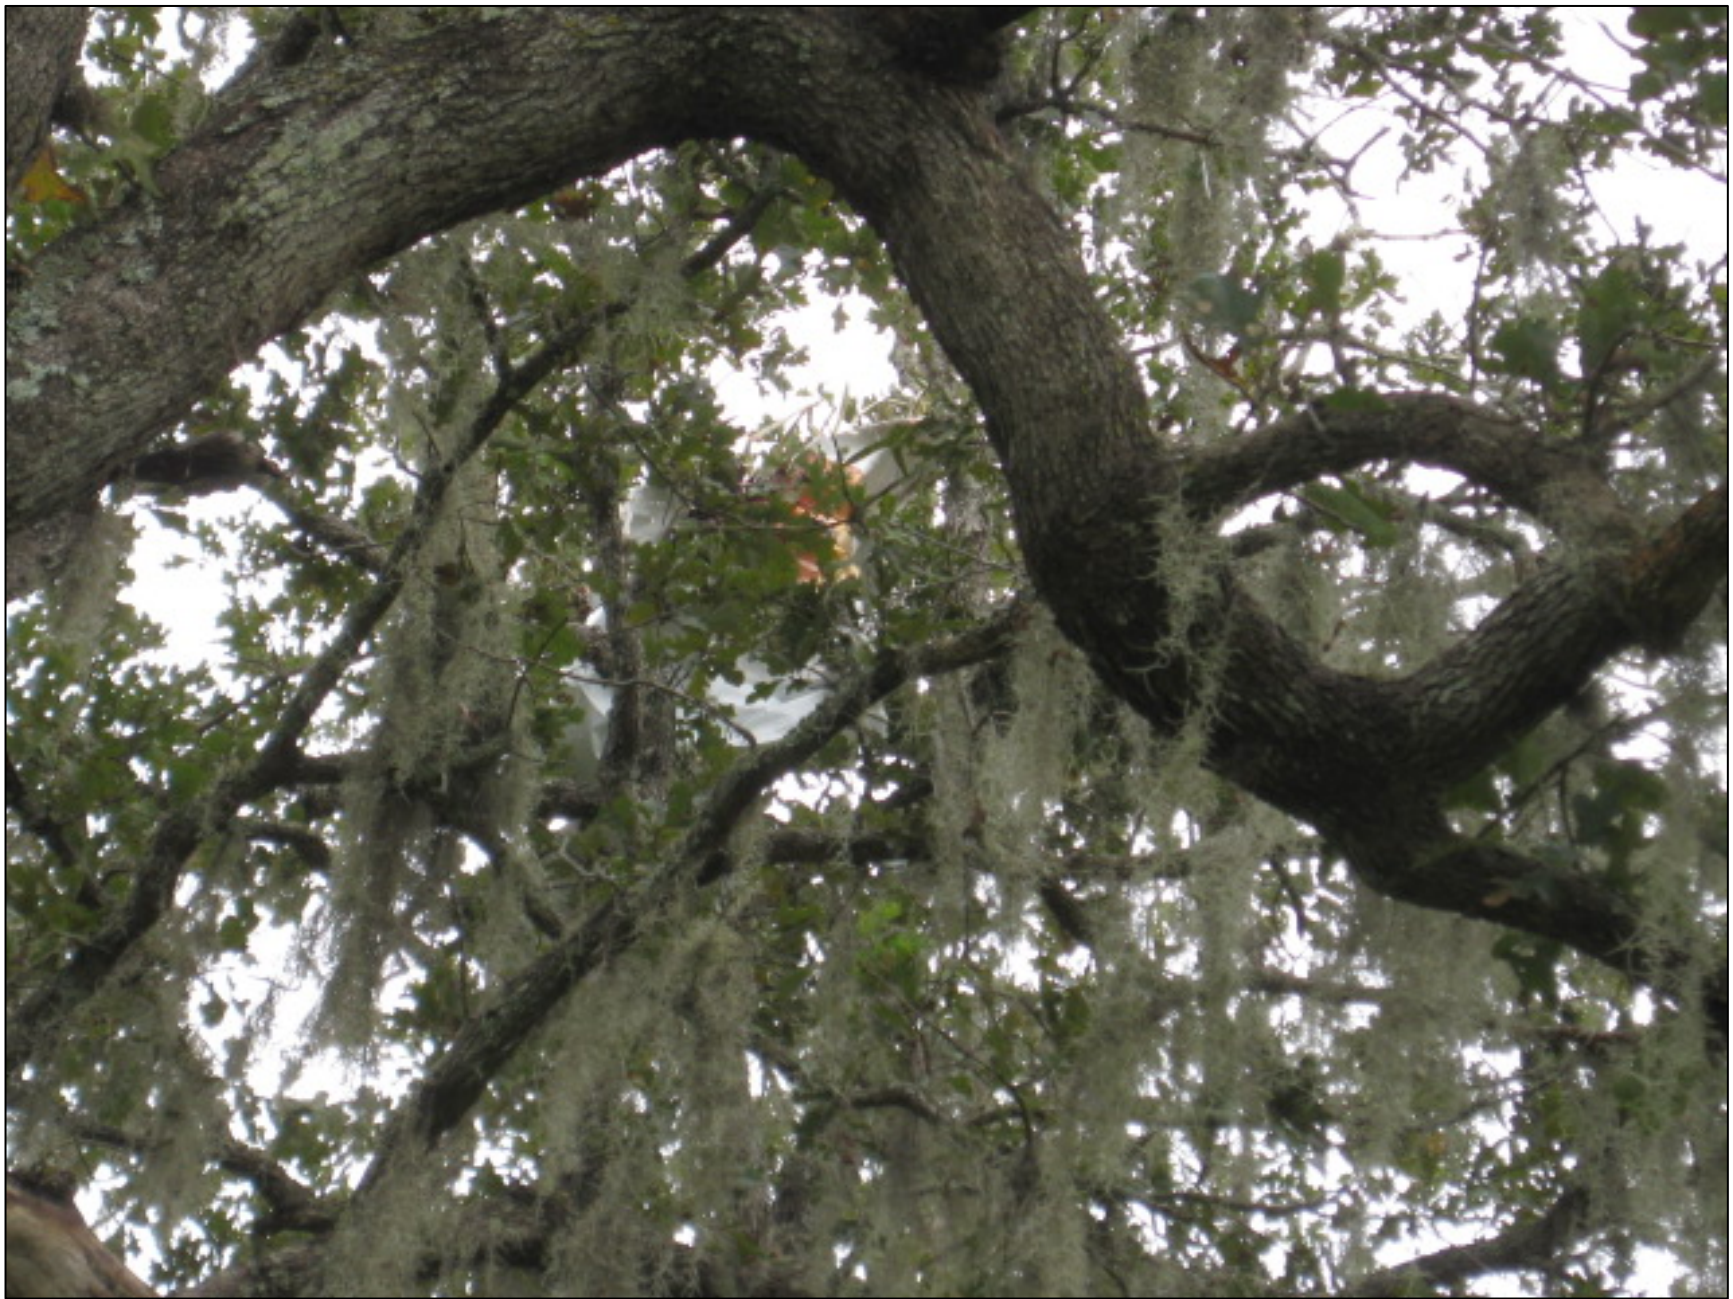
Photo 2 – Fragment of right wing in tree (Photo Courtesy of FAA)

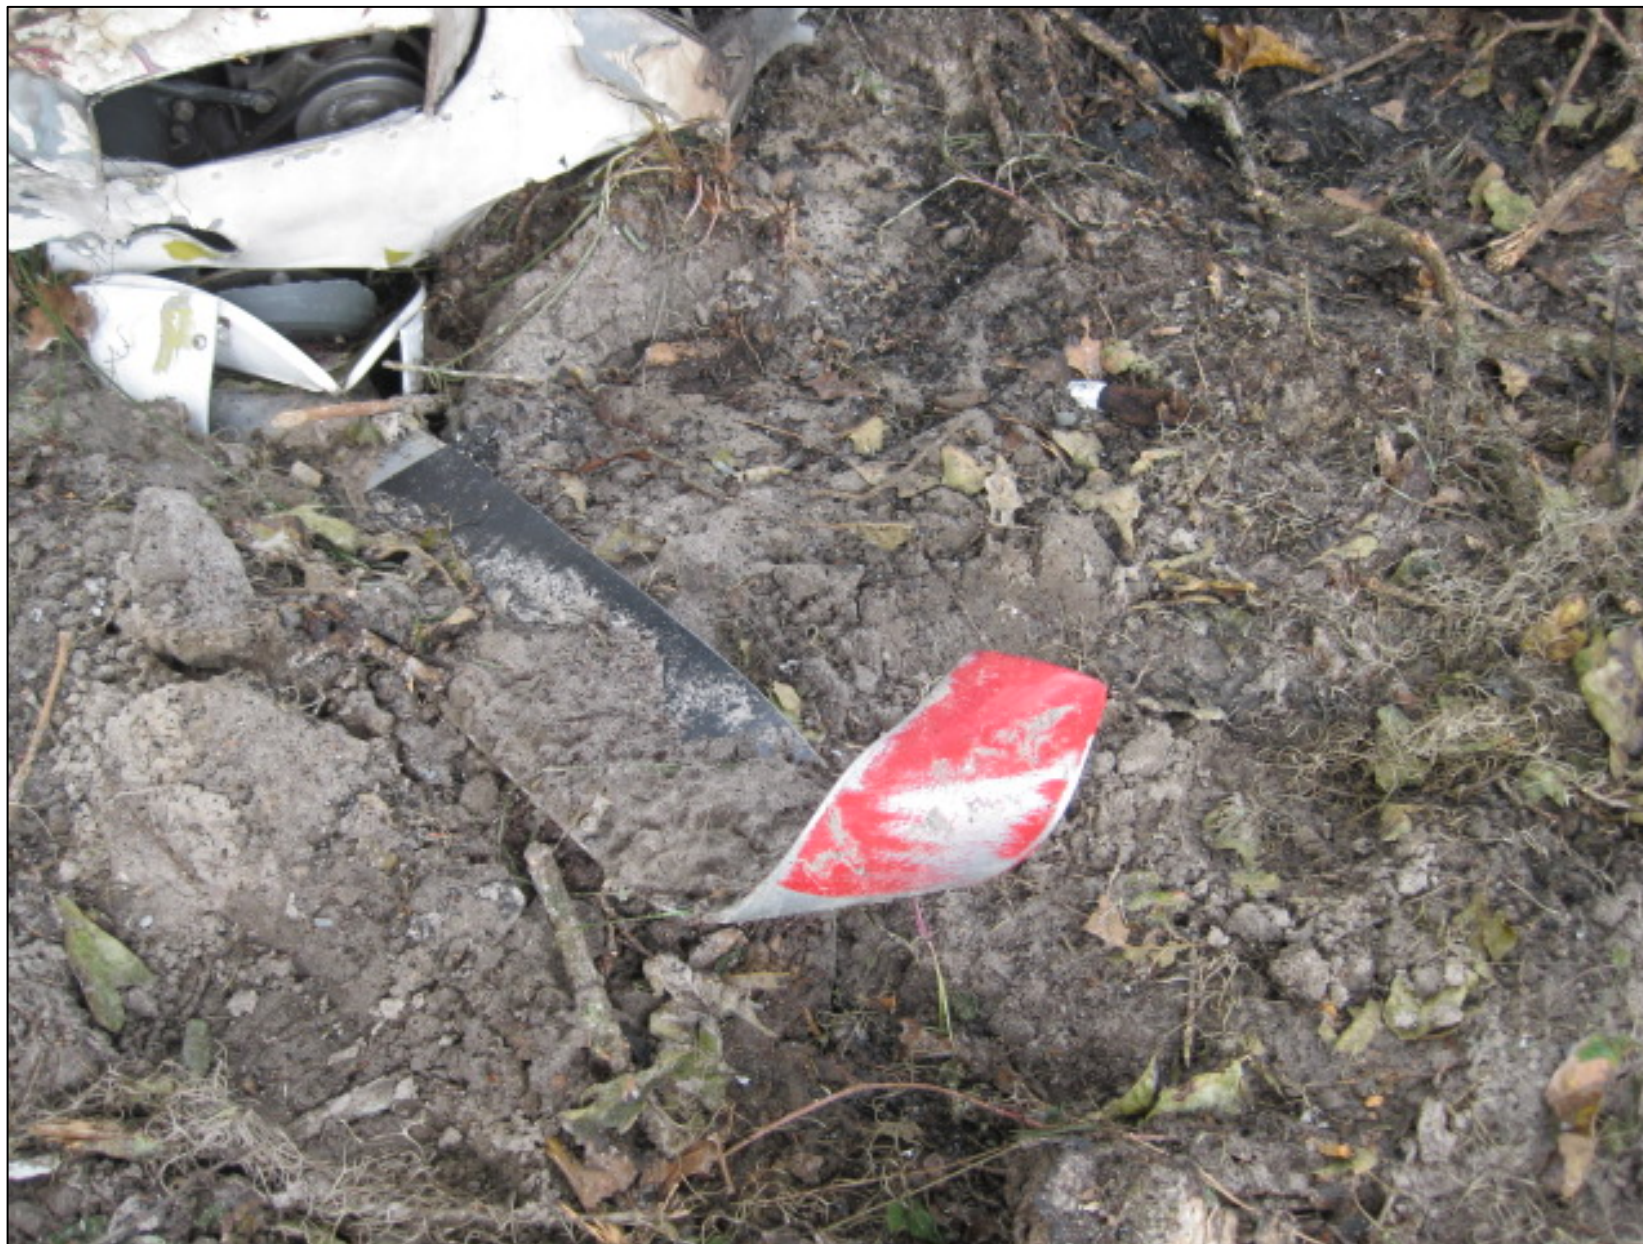
Photo 3 – Curled tip of propeller blade (Photo Courtesy of FAA)

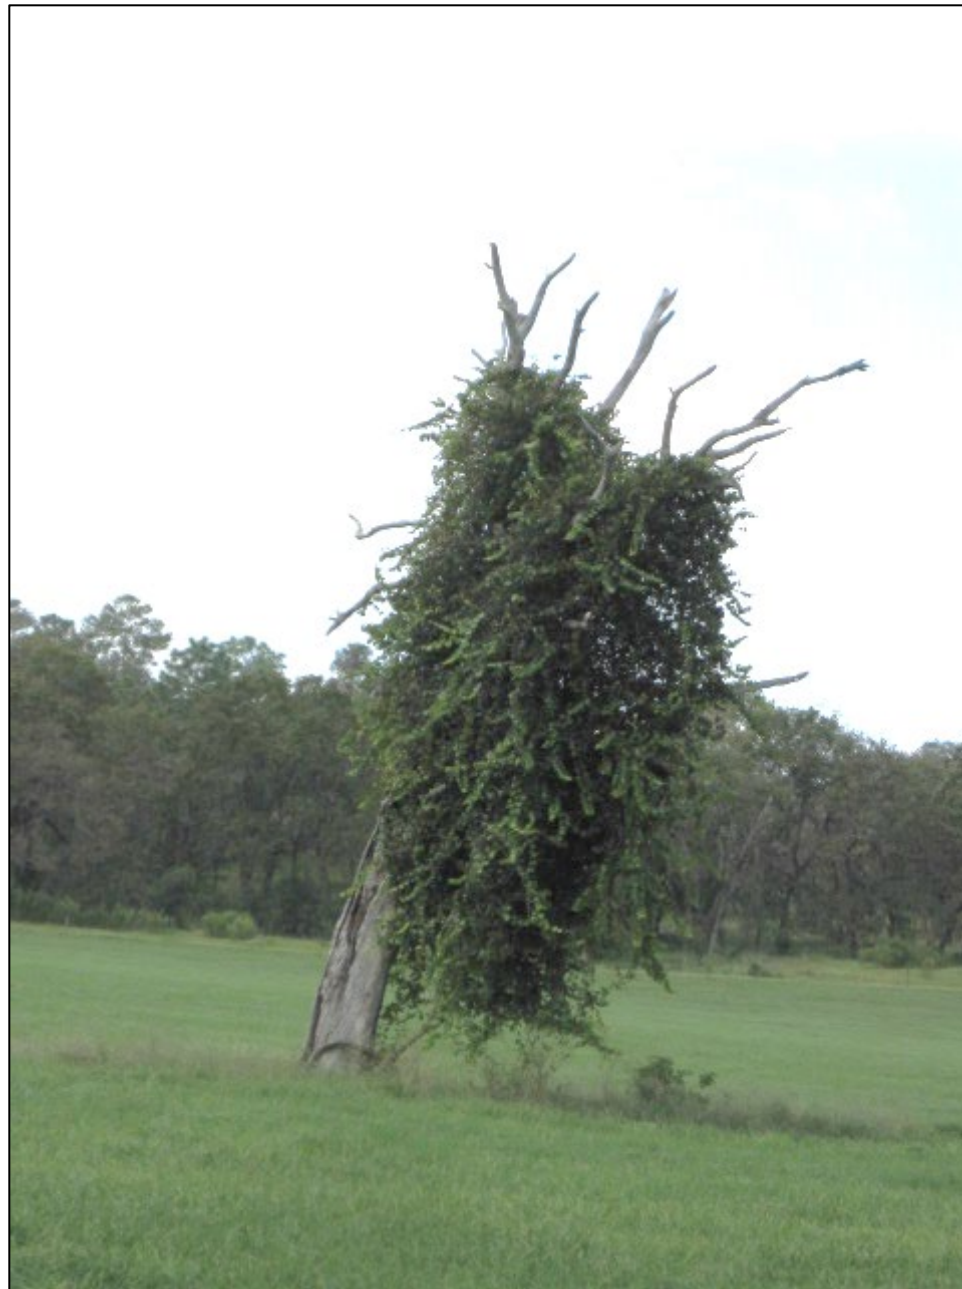
Photo 4 – View of tree in field being sprayed (Photo Courtesy of FAA)

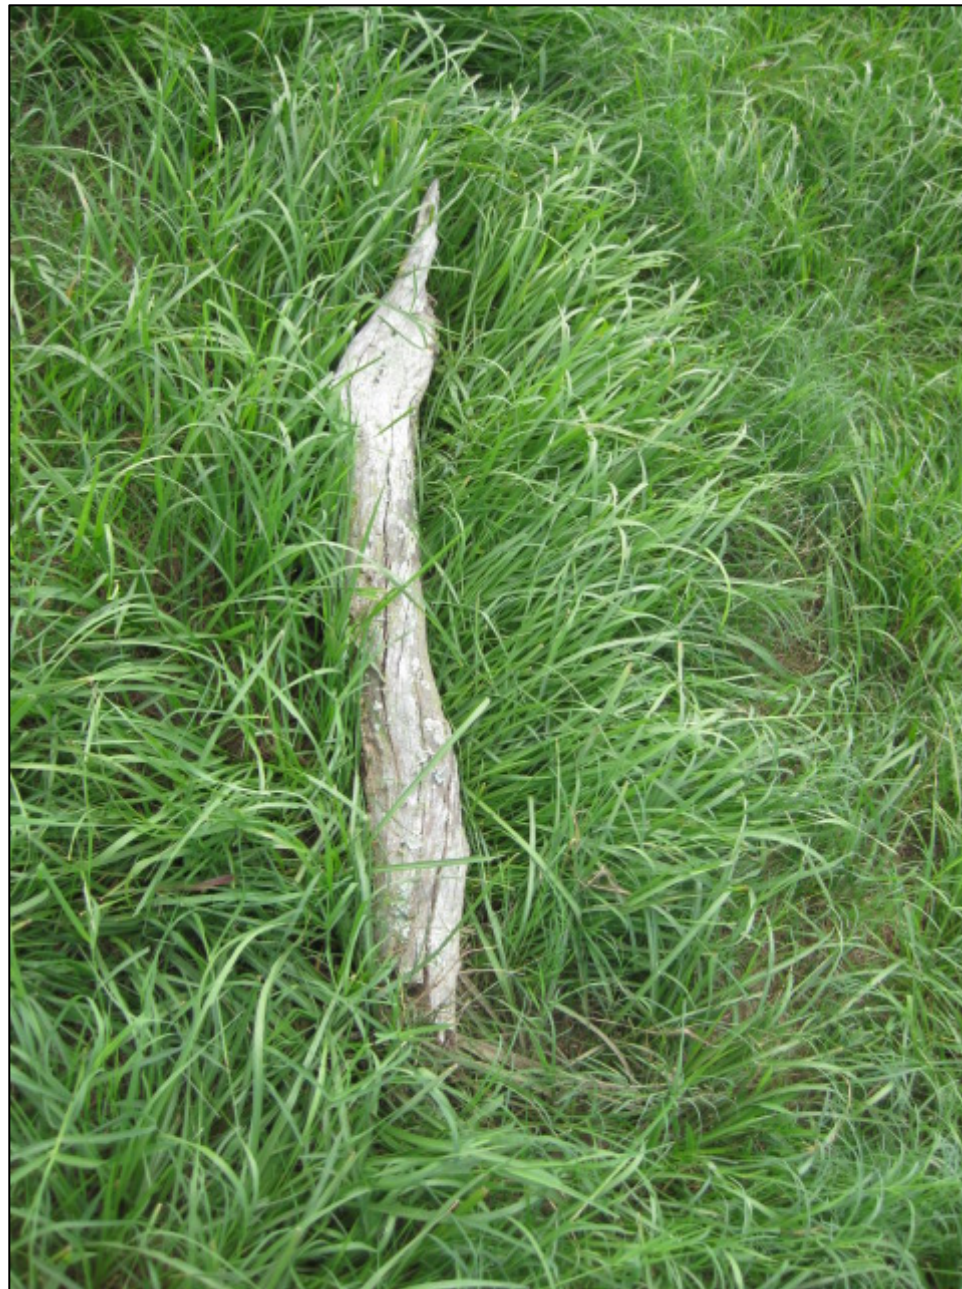
Photo 5 – Broken branch near dead tree in field (Photo Courtesy FAA)

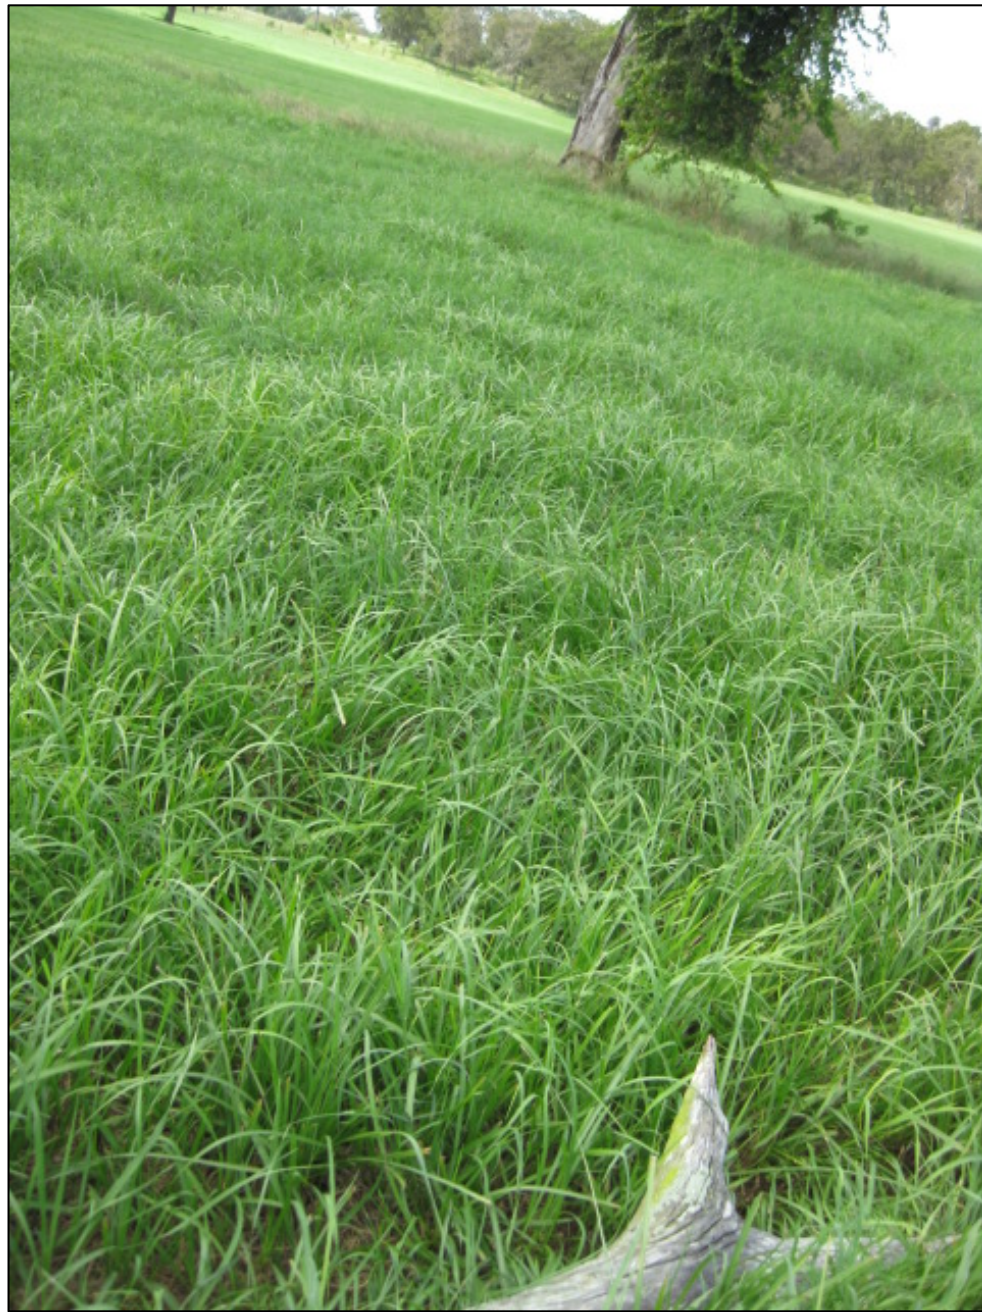
Photo 6 – Additional broken branch near dead tree in field (Photo Courtesy FAA)

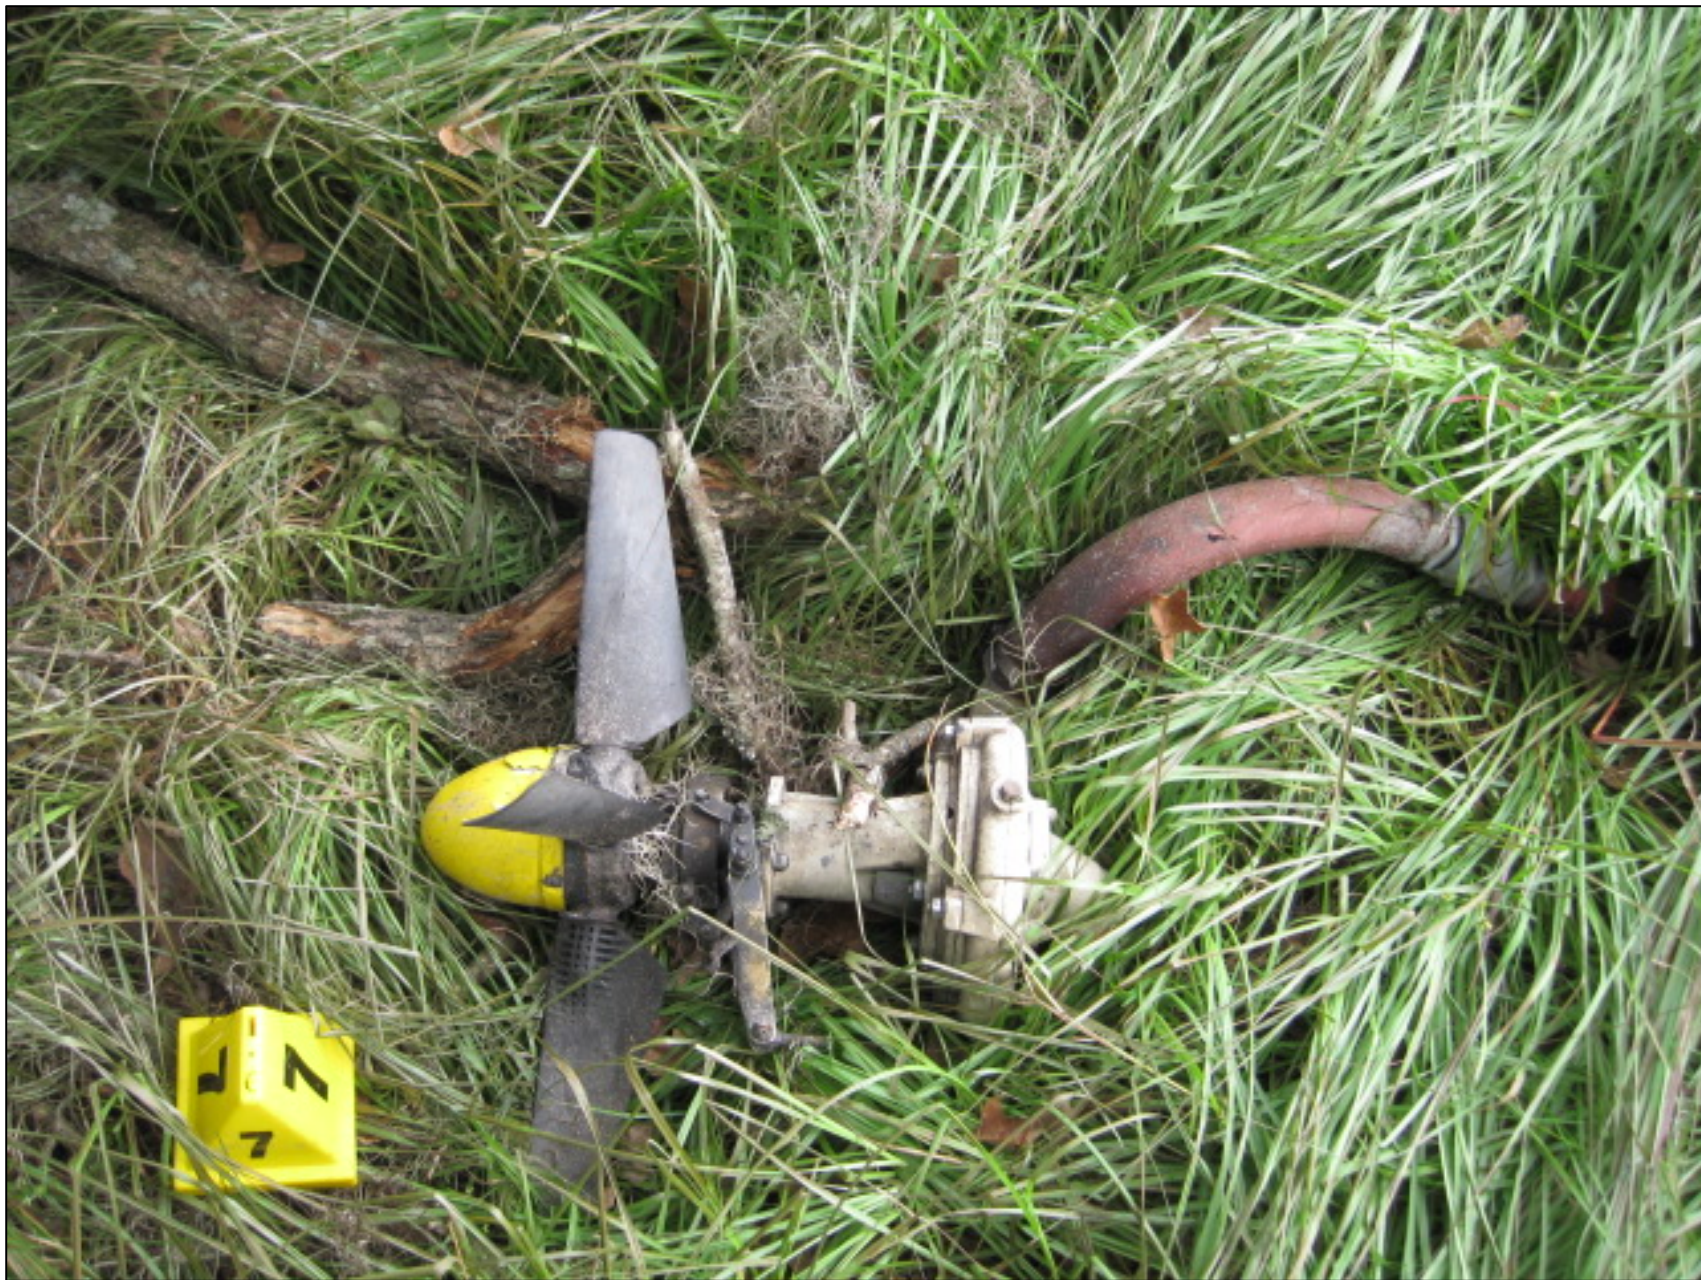
Photo 7 – Separated agriculture spraying fan and piping found near dead tree (Photo Courtesy FAA)
