# AIRFRAME AND ENGINE EXAMINATION

**ERA20LA330, N6106Z**

Examination of wreckage at Florida Air Recovery (Jacksonville, FL)  
September 29, 2020

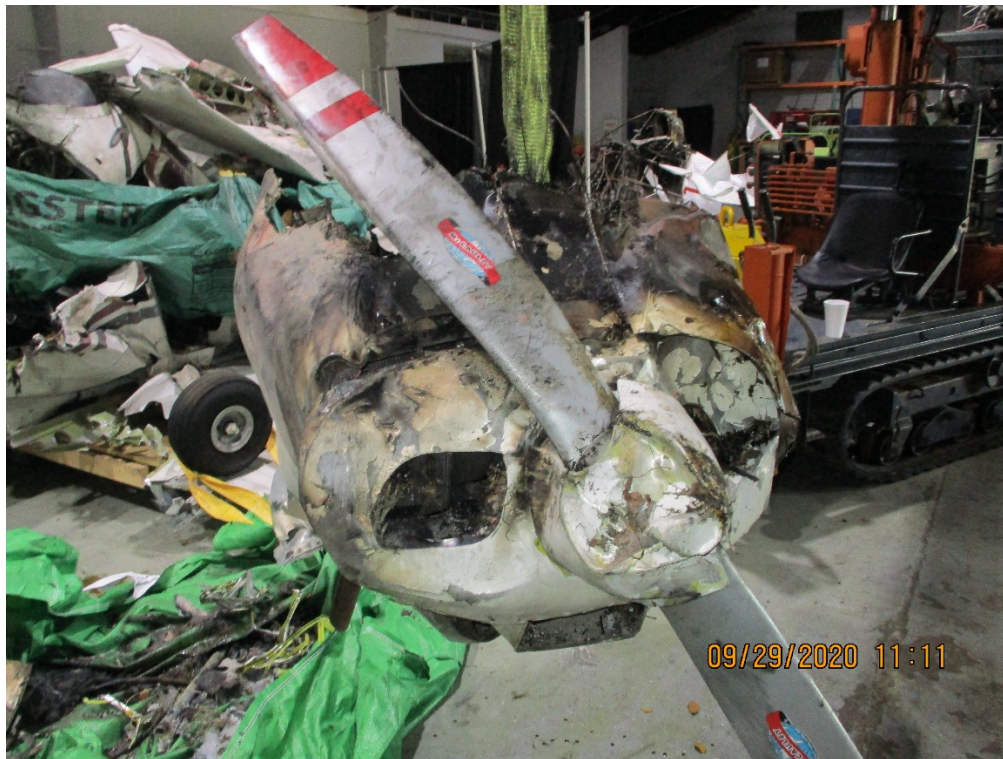
The engine was consumed by fire. The accessory case was melted, and the metal was drooping. The magnetos were completely melted away along with all the other components. Only the gears of the magnetos remained. The top spark plugs were removed and showed normal wear. The propeller blades were bent aft, the tip of one blade showed "S" bending. The propeller was removed to facilitate engine rotation. The engine was rotated by the propeller flange. Engine continuity was established through the engine. The crank, valves, pistons and camshaft all rotated normally.

Photo 1: View of the propeller and nose of airplane

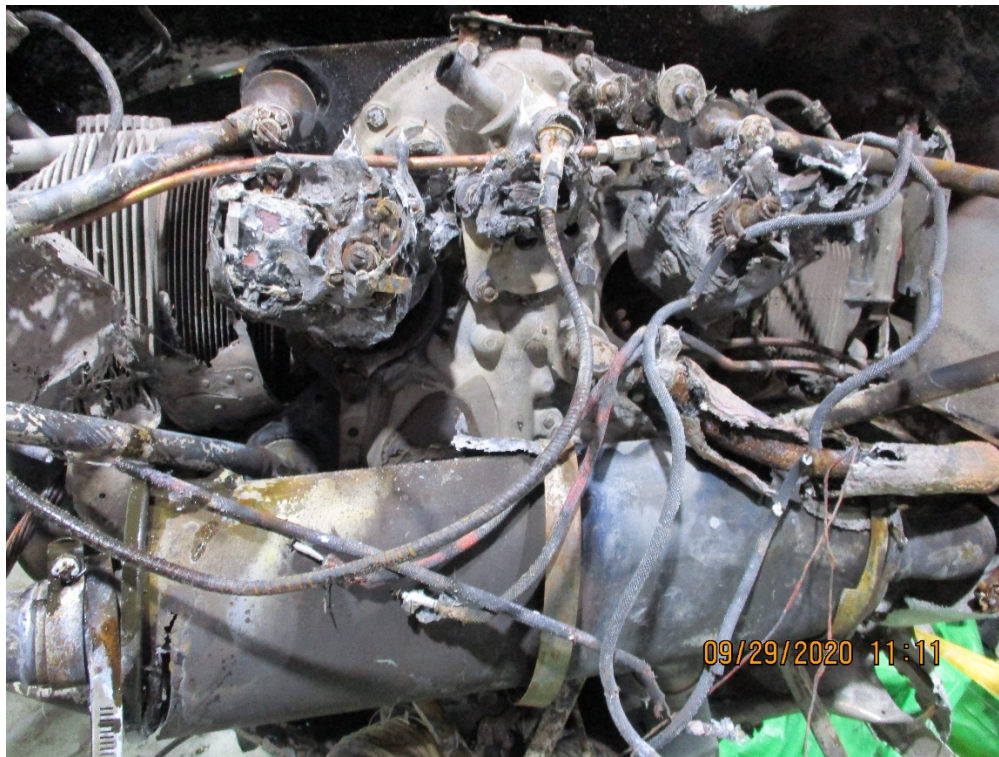
Photo 2: View of the rear section of the engine

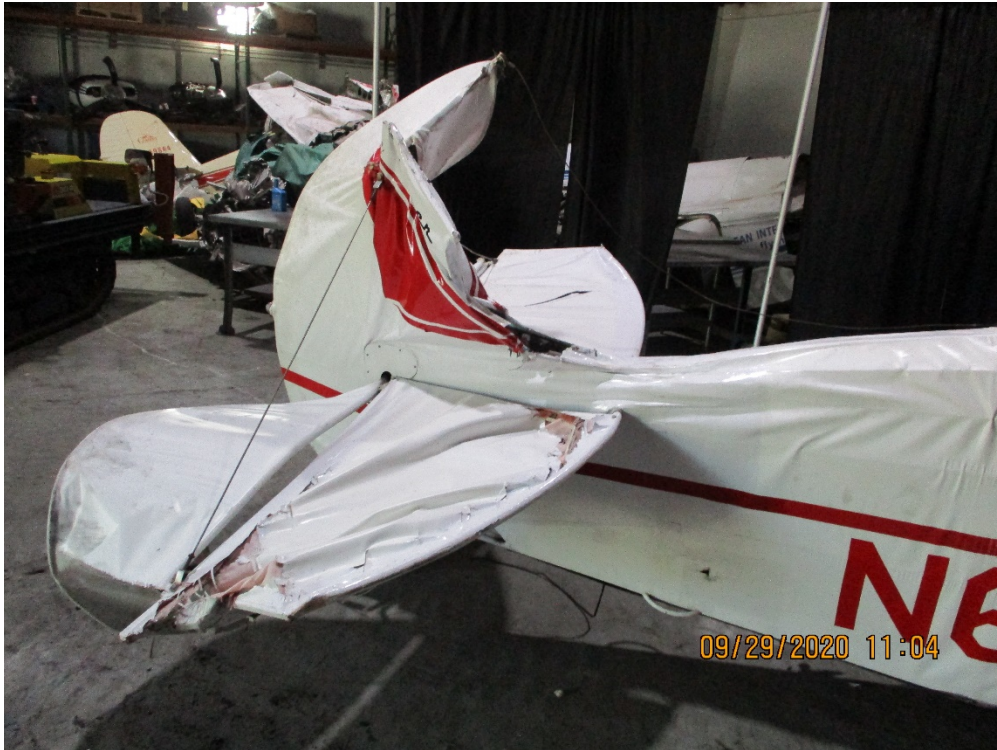
The fuselage was consumed by fire. Only the tail section had some fabric remaining, the wings were destroyed by impact forces with the trees and terrain. The inside structure of both wings were fractured into many small pieces. The fabric was shredded on both wings.

Photo 3: View of the empennage

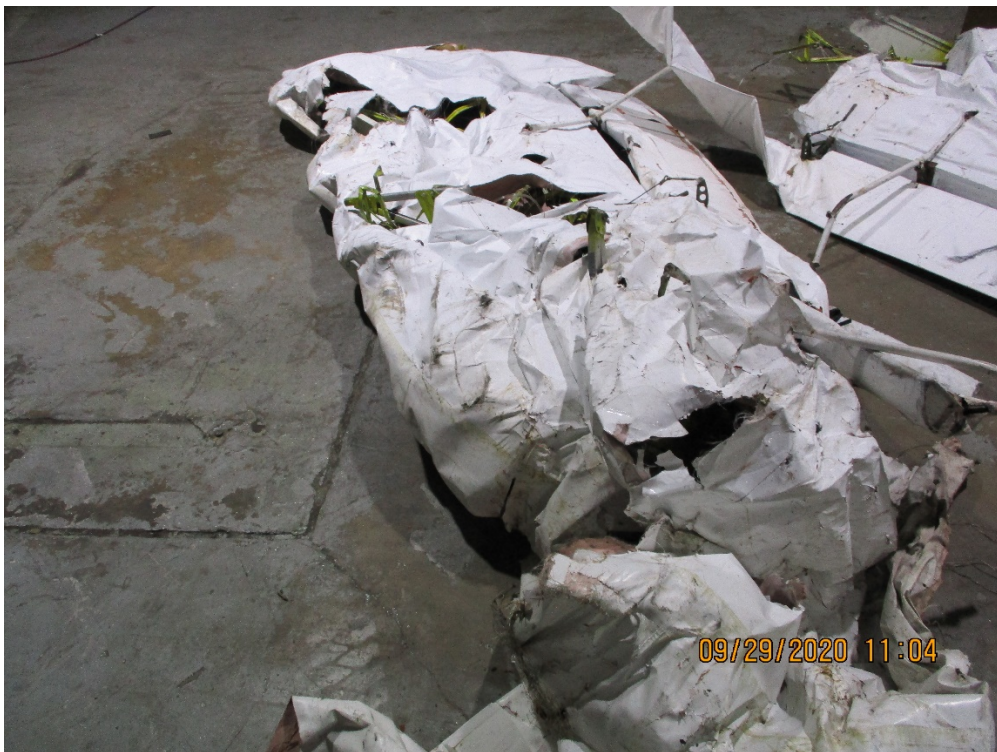
Photo 4: View of crumpled wing

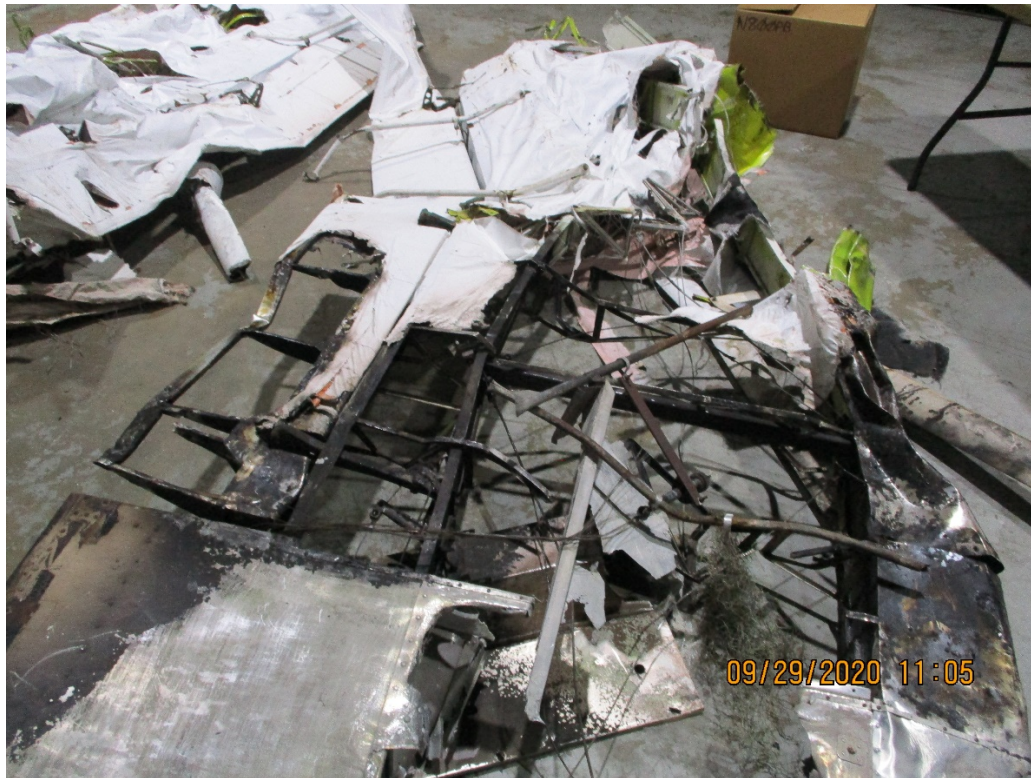
Photo 5: Additional view of fire damaged and impact damaged wing

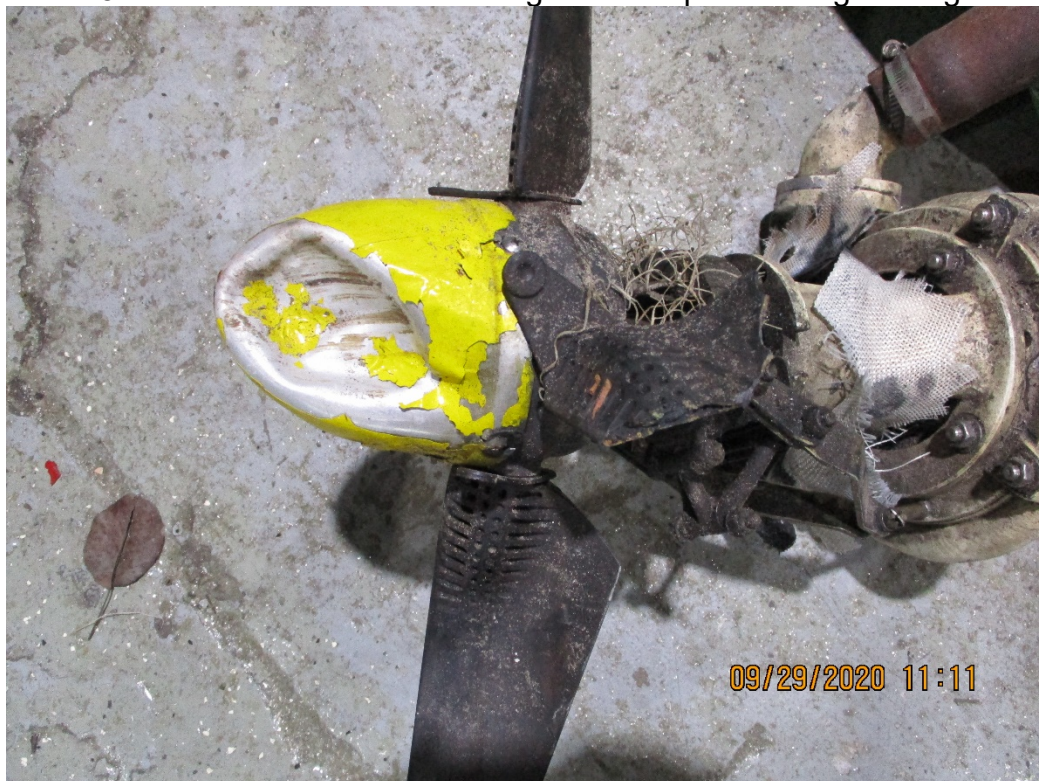
Flight control continuity was established to all flight controls through cables to/from that were cut by recovery personnel. The instrument panel was completely consumed by fire and could not be located. The agriculture spraying fan displayed a large impact damage witness signature on its nose cone.

Photo 6: View of impact damaged agriculture fan spraying equipment
