**NATIONAL TRANSPORTATION SAFETY BOARD**  
Office of Aviation Safety

**Engine Examination**

**A. ACCIDENT      ERA20LA332**

Location:            Hagerstown, MD  
Date:                September 23, 2020  
Time:                1145 Eastern Daylight Time (EDT)  
Operator/Pilot:    Matthew Johnson  
Aircraft:            Glasair 1RG  
Engine:             Lycoming O-320-E2A sn SH 583  
Registration:       N324DJ

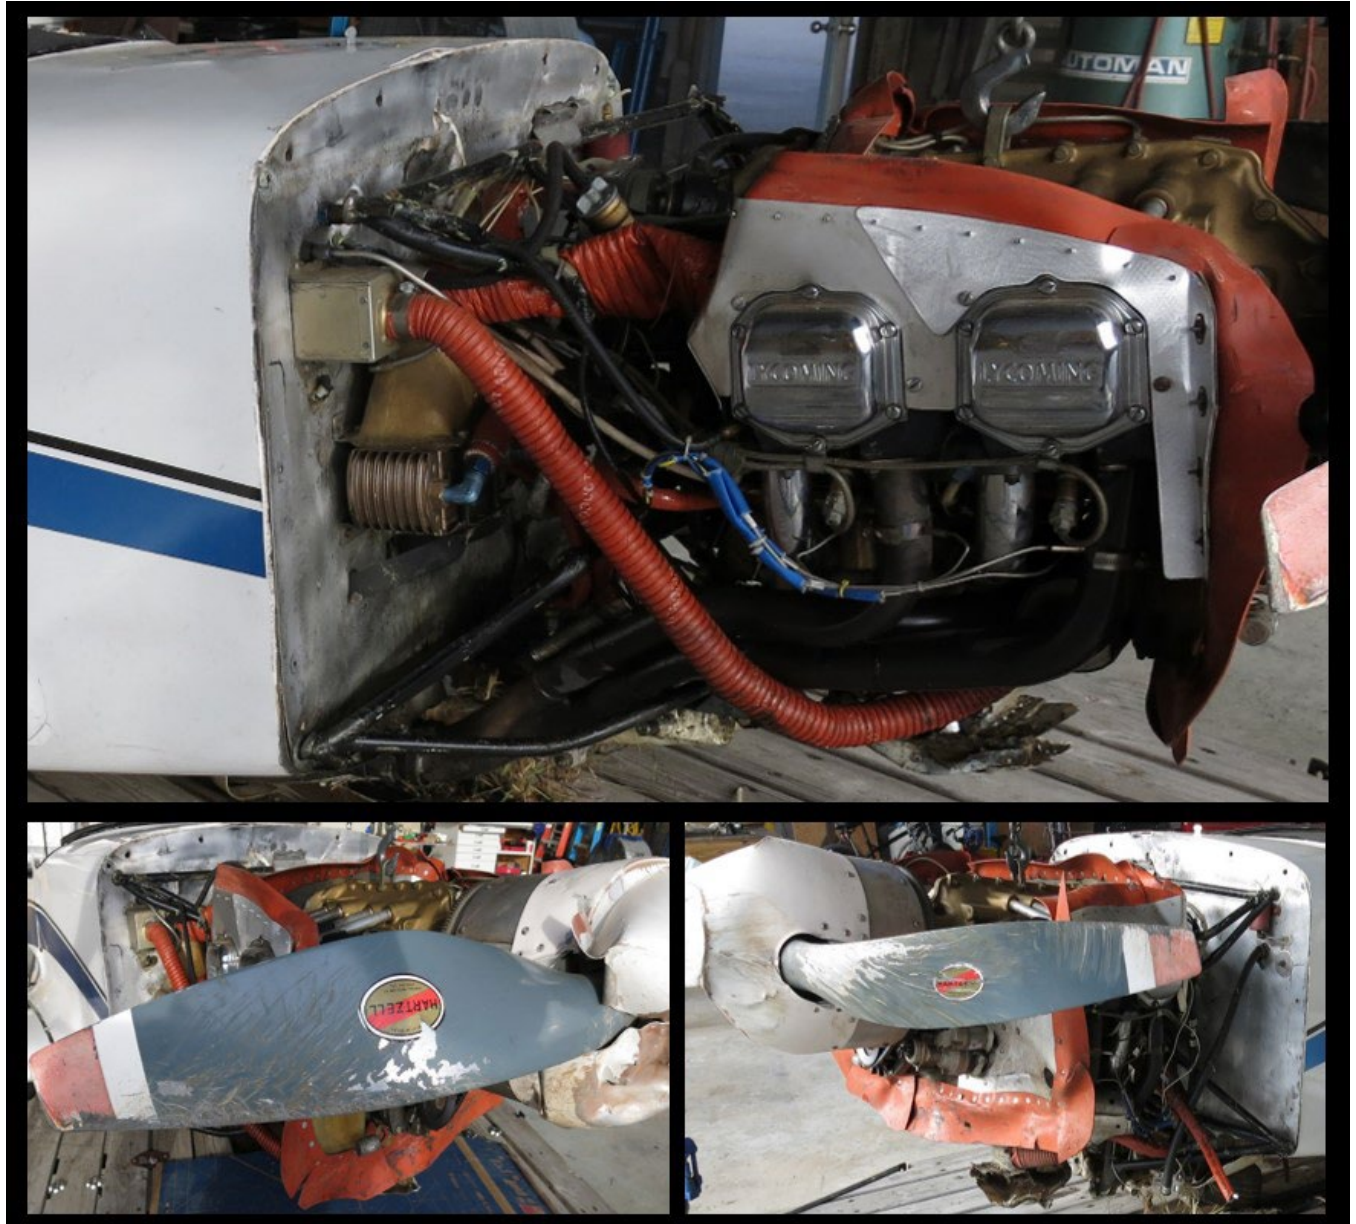
*Photograph 1 – Accident airplane engine at recovery facility.*

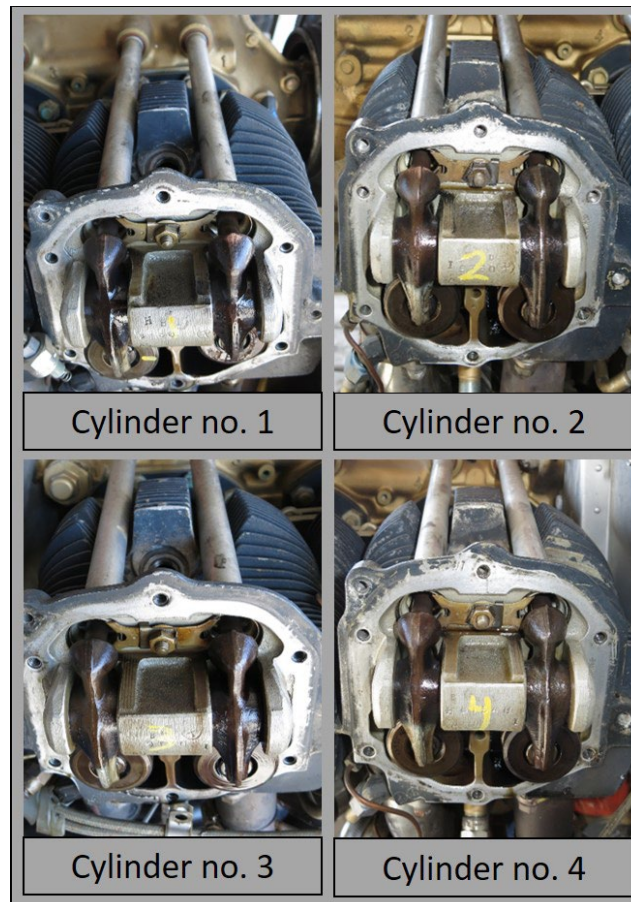
The accident airplane engine was a Lycoming, O-320-E2A sn SH 583. The engine was attached to the motor mounts on the airframe during the examination. The engine crankshaft and valvetrain continuity were confirmed by rotating the propeller by hand. All valve push rods, and rocker arms were undamaged and operated as expected. The top spark plugs were removed, and all (1-4) spark plugs appeared normal. Both magnetos produced spark on all leads when the engine was rotated by hand and each plug wire was ground to the engine. The airplane was equipped with 3 fuel tanks, (two wing tanks and a header tank). The carburetor was removed and when manually operated; the accelerator pump ejected a small trace of fuel. The carburetor (Precision Model MA-4SP) was disassembled, and a small trace of fuel was present, the fuel was tested using Kolor Kut (water finding paste) and found no water present. The float was tested by passing air thru the system, then the float was moved to a closed position and the air stopped. The engine driven fuel pump was removed and operated, all parts moved without resistance, A crack was witnessed on the fuel intake port from impact forces. The pump was disassembled and examined, no tears in the diaphragm were observed. The accessory port on the back of the engine was opened the gear moved freely when the propeller was manually turned. There were trace amounts of fuel found in both the carburetor and fuel pump, but no fuel noted in any of the three fuel tanks or fuel lines.

*Photograph 2 –Cylinders*

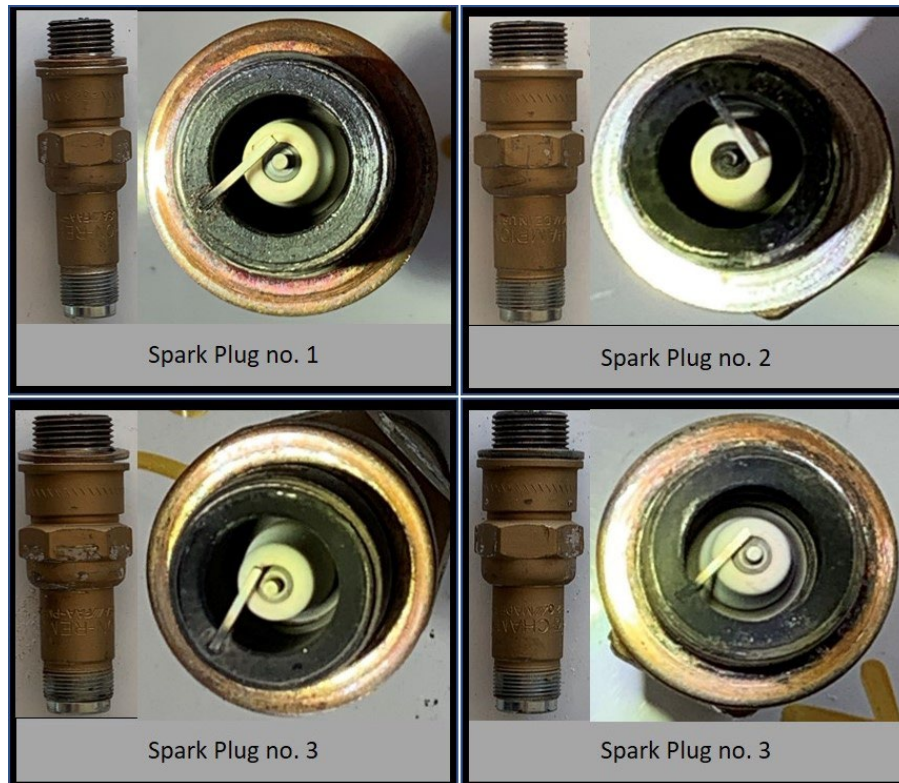
The top spark plugs were removed from each cylinder head for examination. The spark plugs were manufactured by Champion.

*Photograph 3 –Champion top spark plugs removed from the accident engine.*

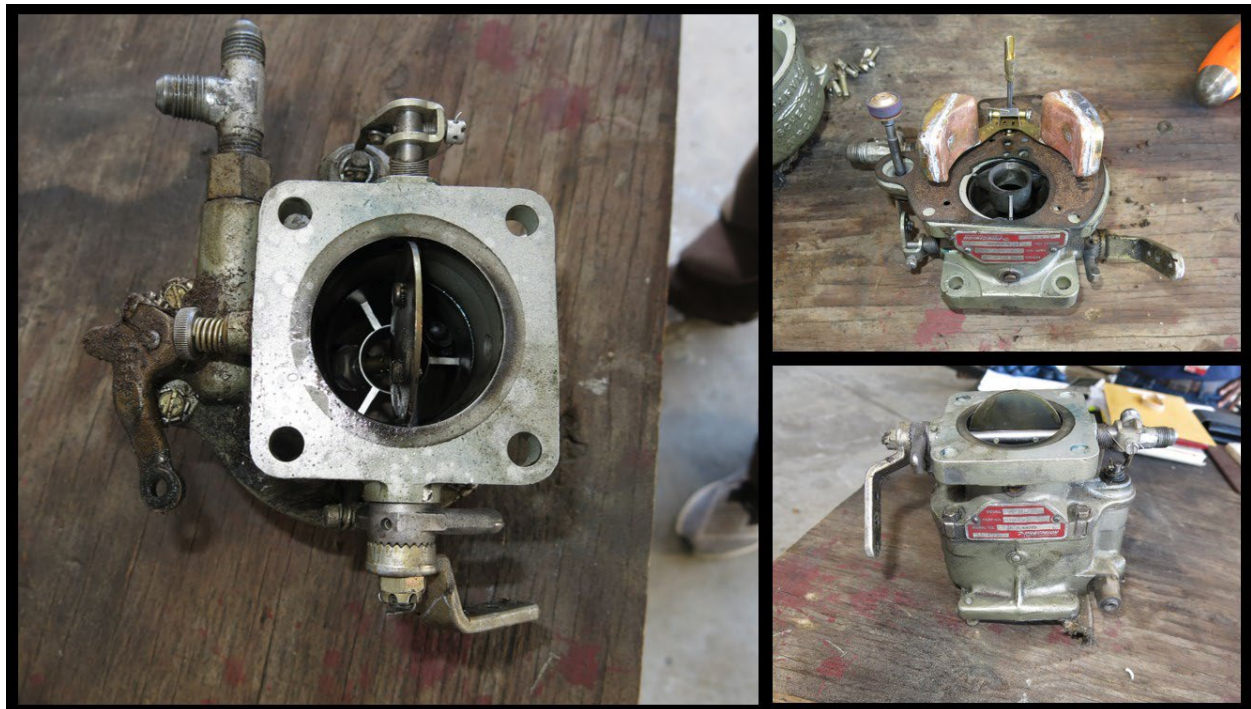
*Photograph 4 –Precision Model MA-4SPA Carburetor.*

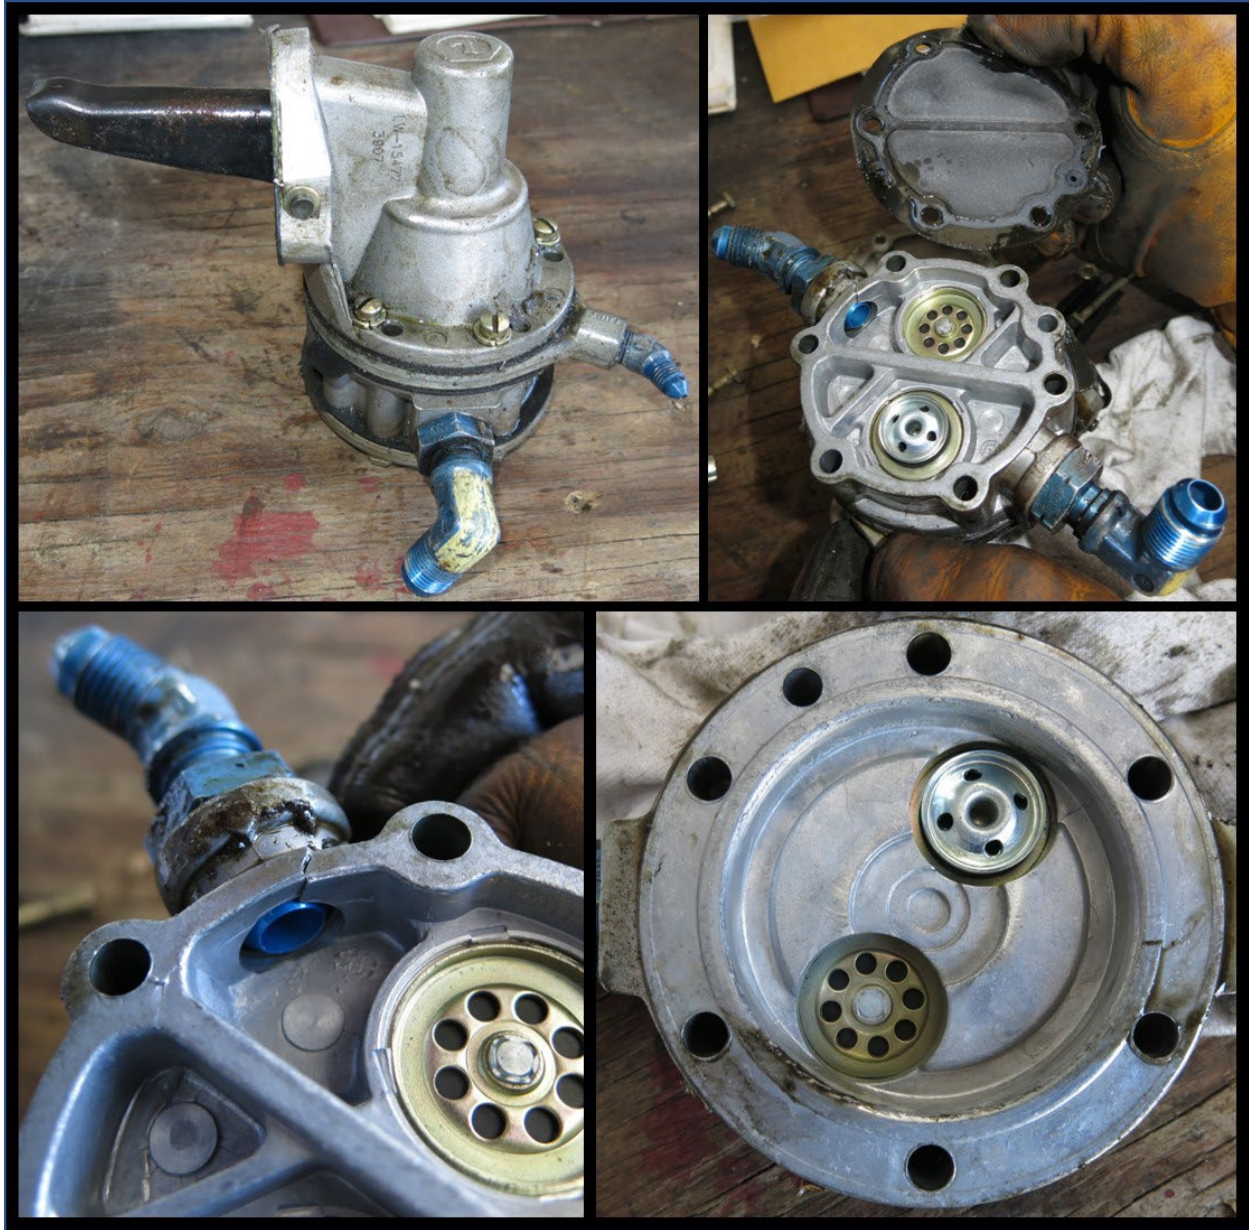
*Photograph 5 –Engine driven fuel pump*

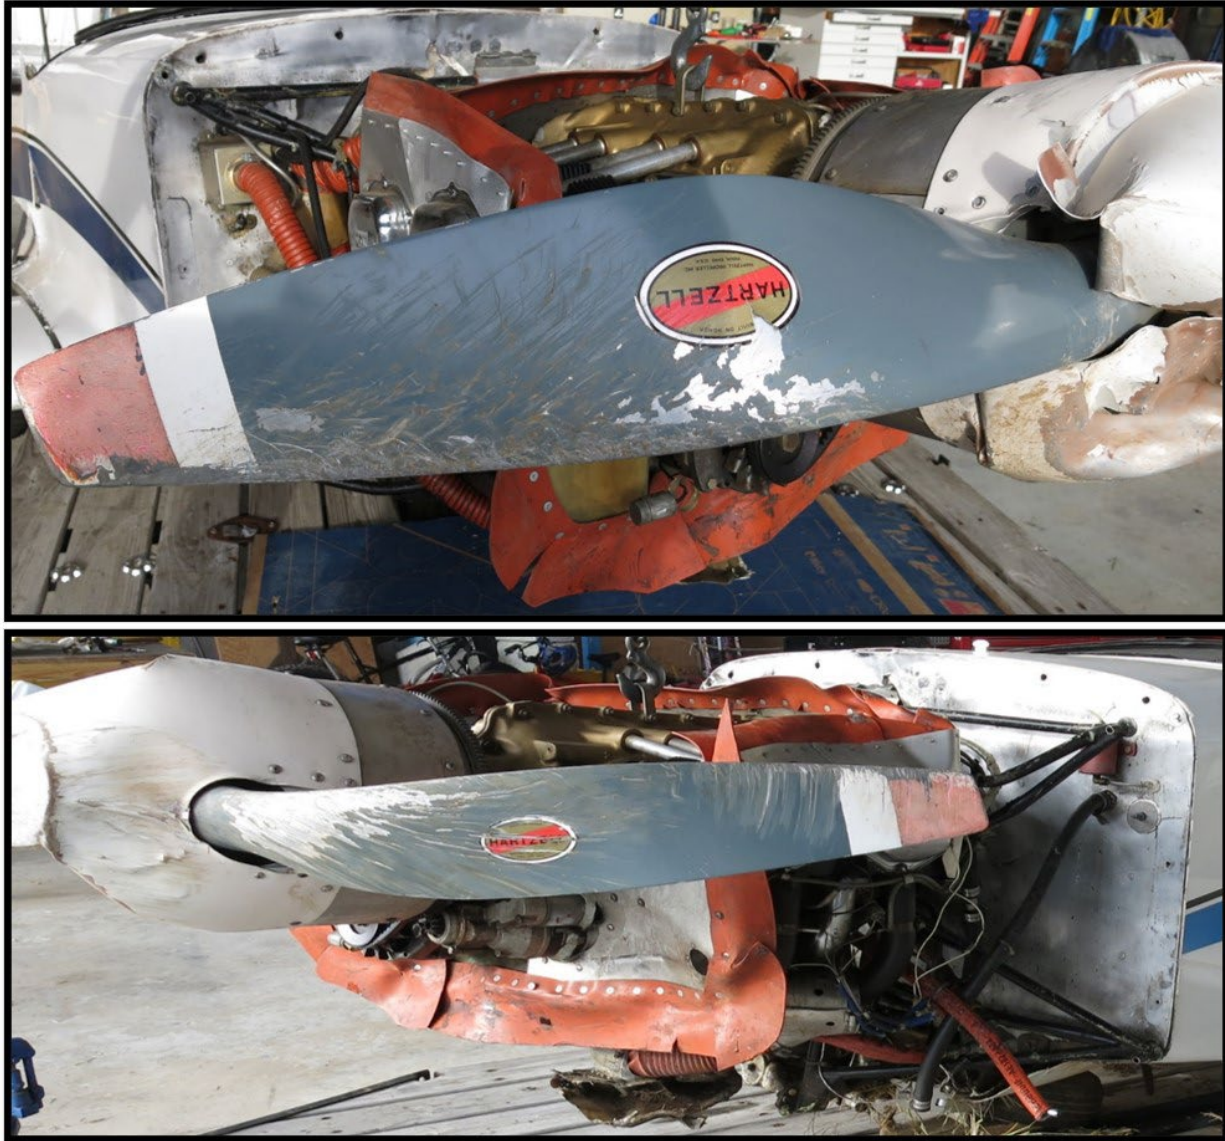
*Photograph 6 –Hartzell two bladed propeller*
