**NATIONAL TRANSPORTATION SAFETY BOARD**

**Photo Array**

**ERA20LA337**

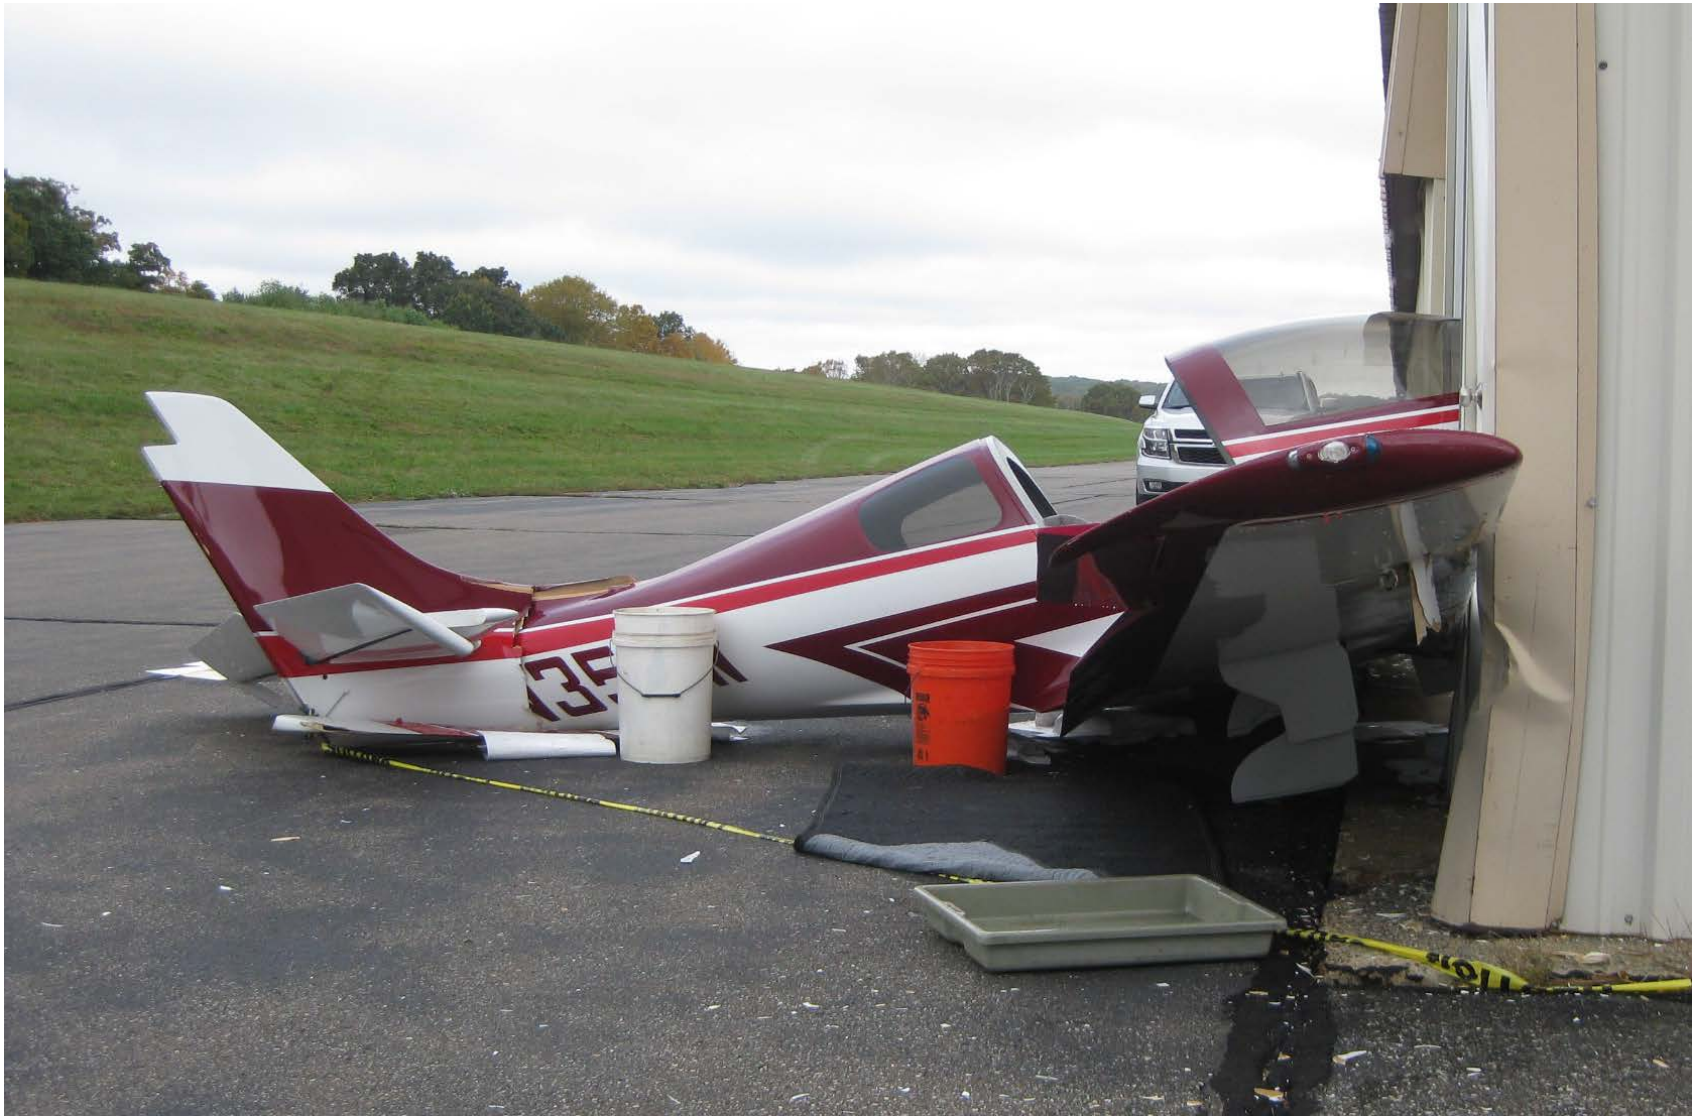
**Photo 1 – View of Airplane from Right Wing (Photo Courtesy of FAA)**

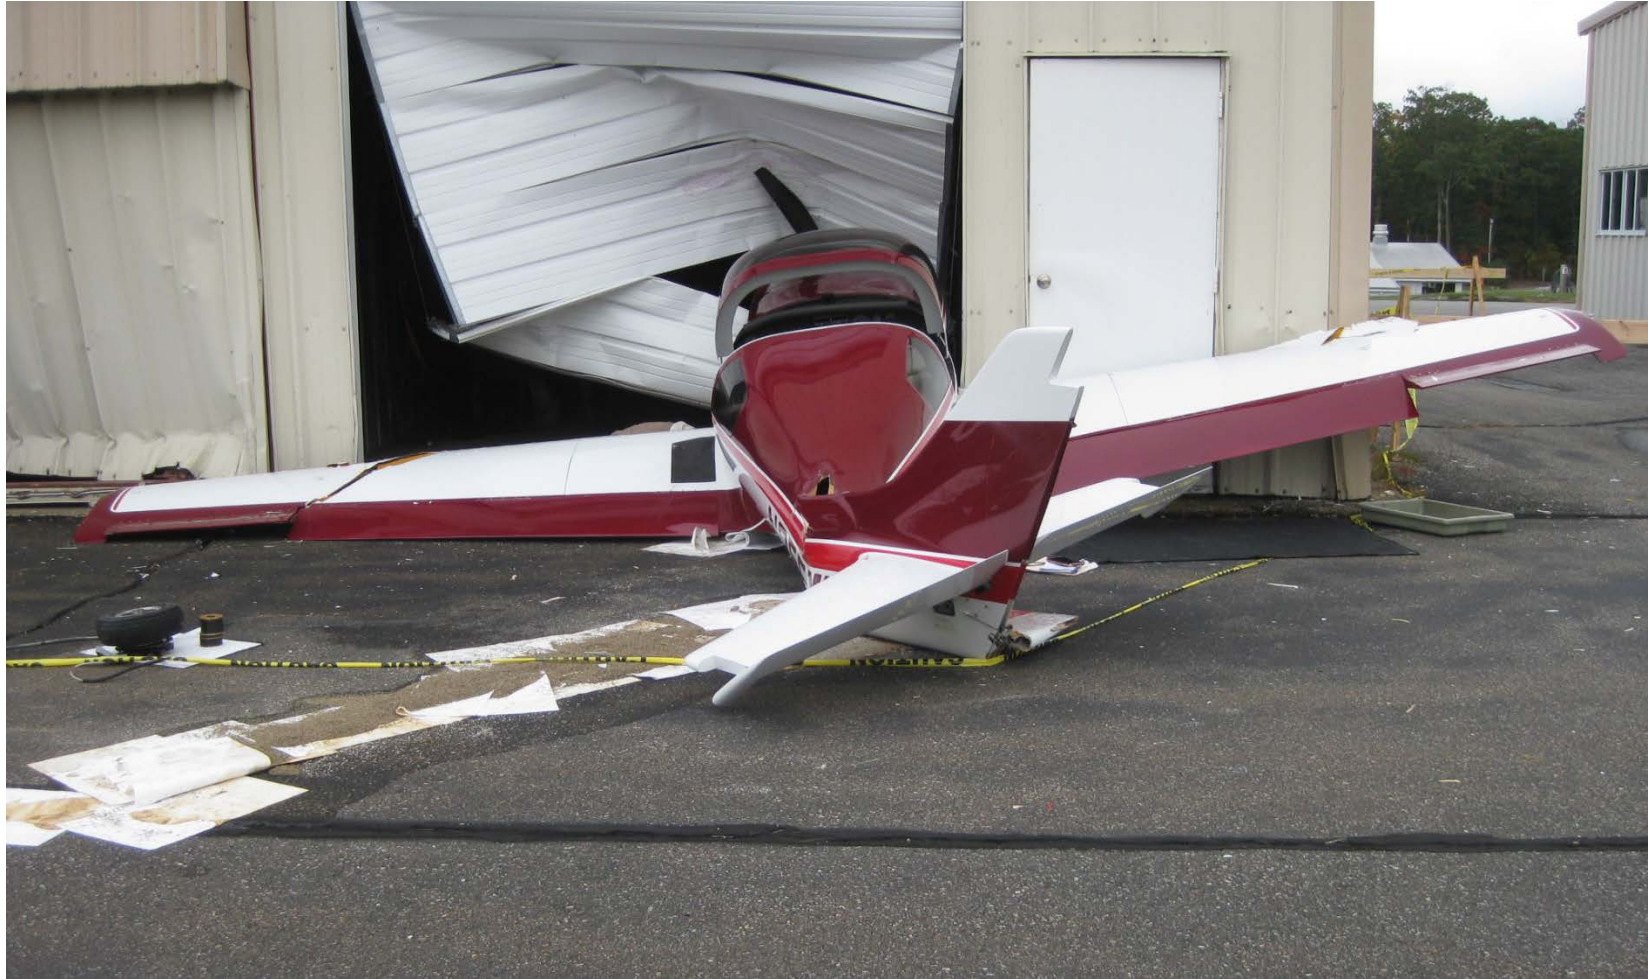
**Photo 2 – View of Airplane from Rear (Photo Courtesy of FAA)**

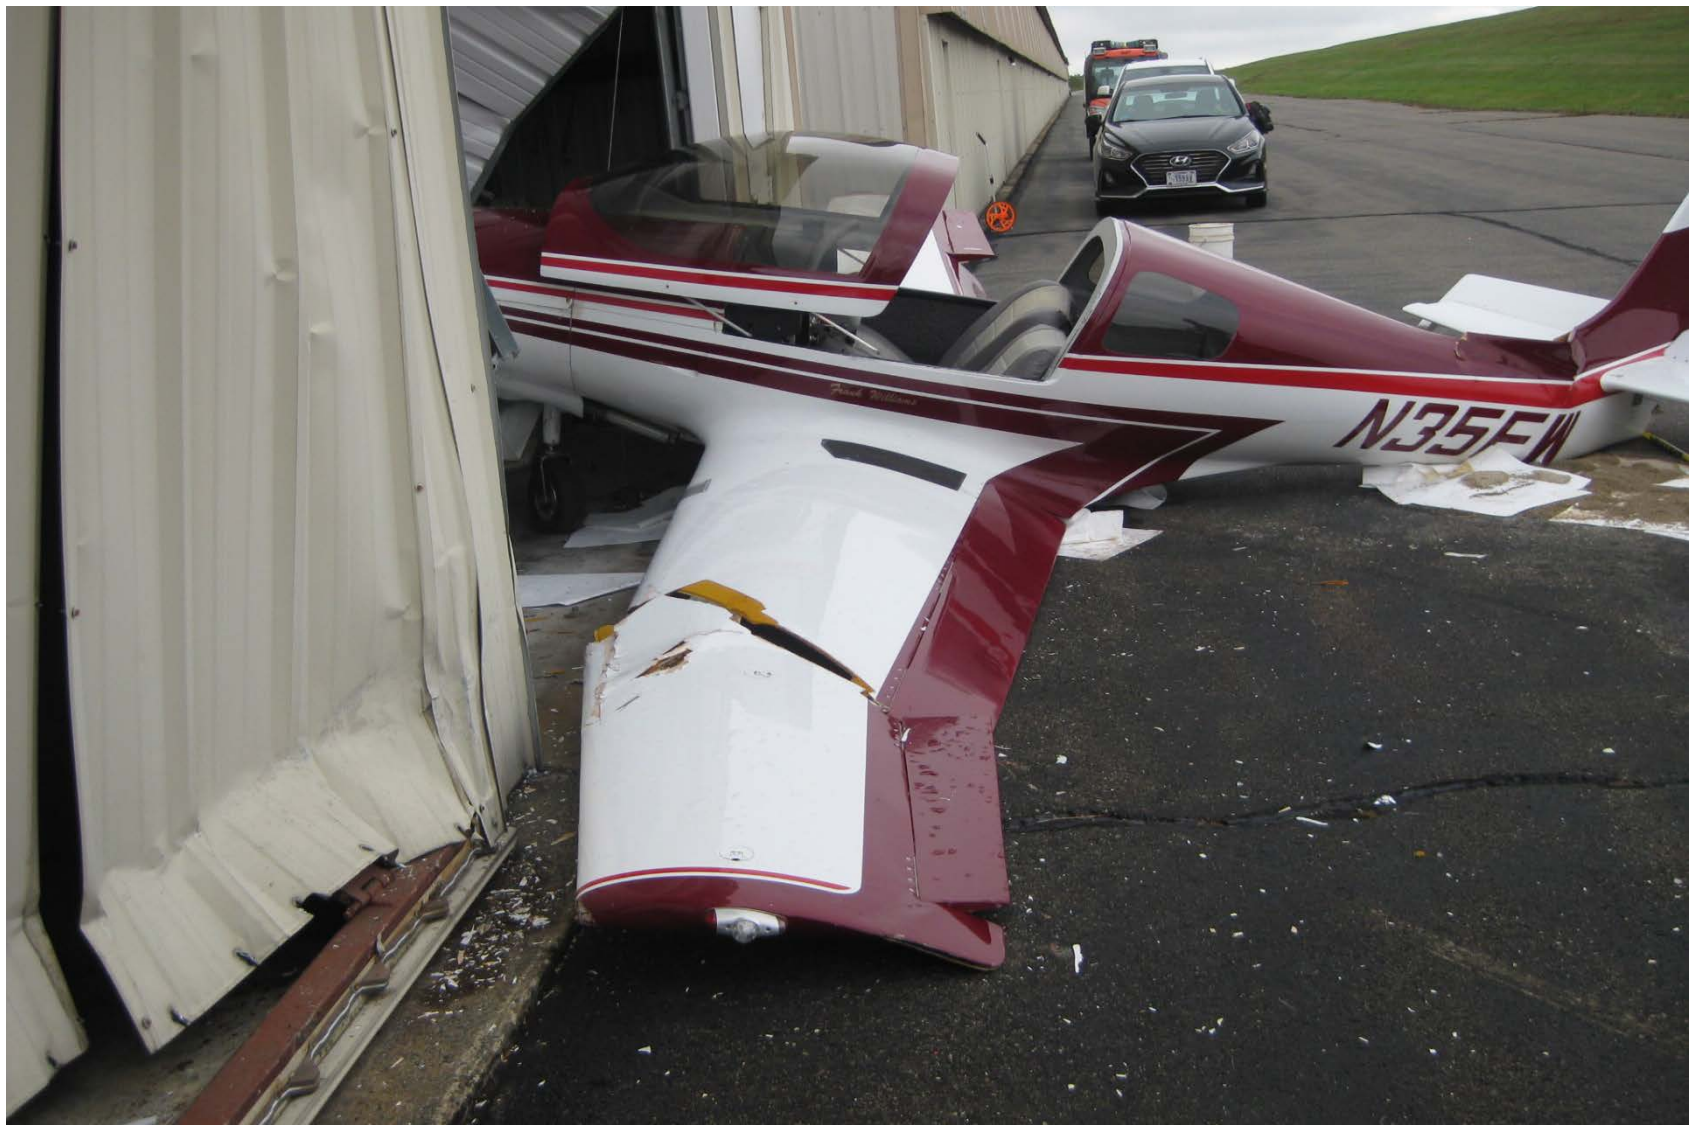
**Photo 3 – View of Airplane from Left Wing (Photo Courtesy of FAA)**

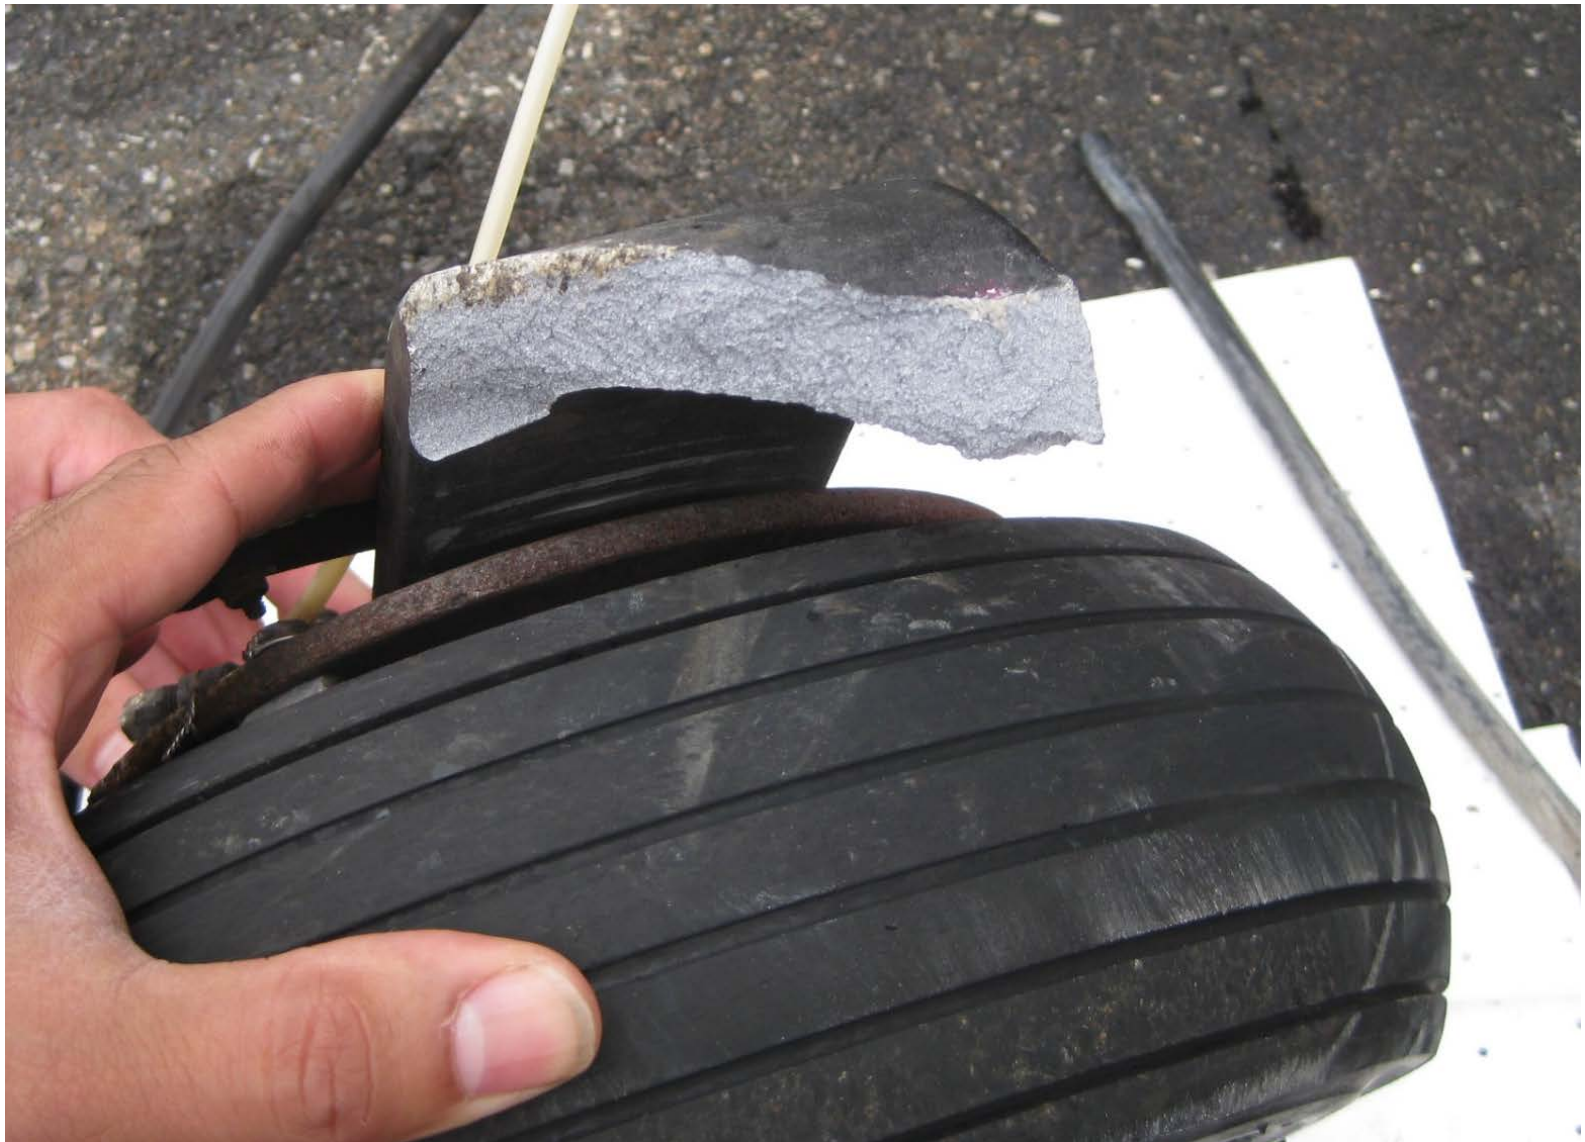
**Photo 4 – View of Fractured Left Landing Gear (Photo Courtesy of FAA)**

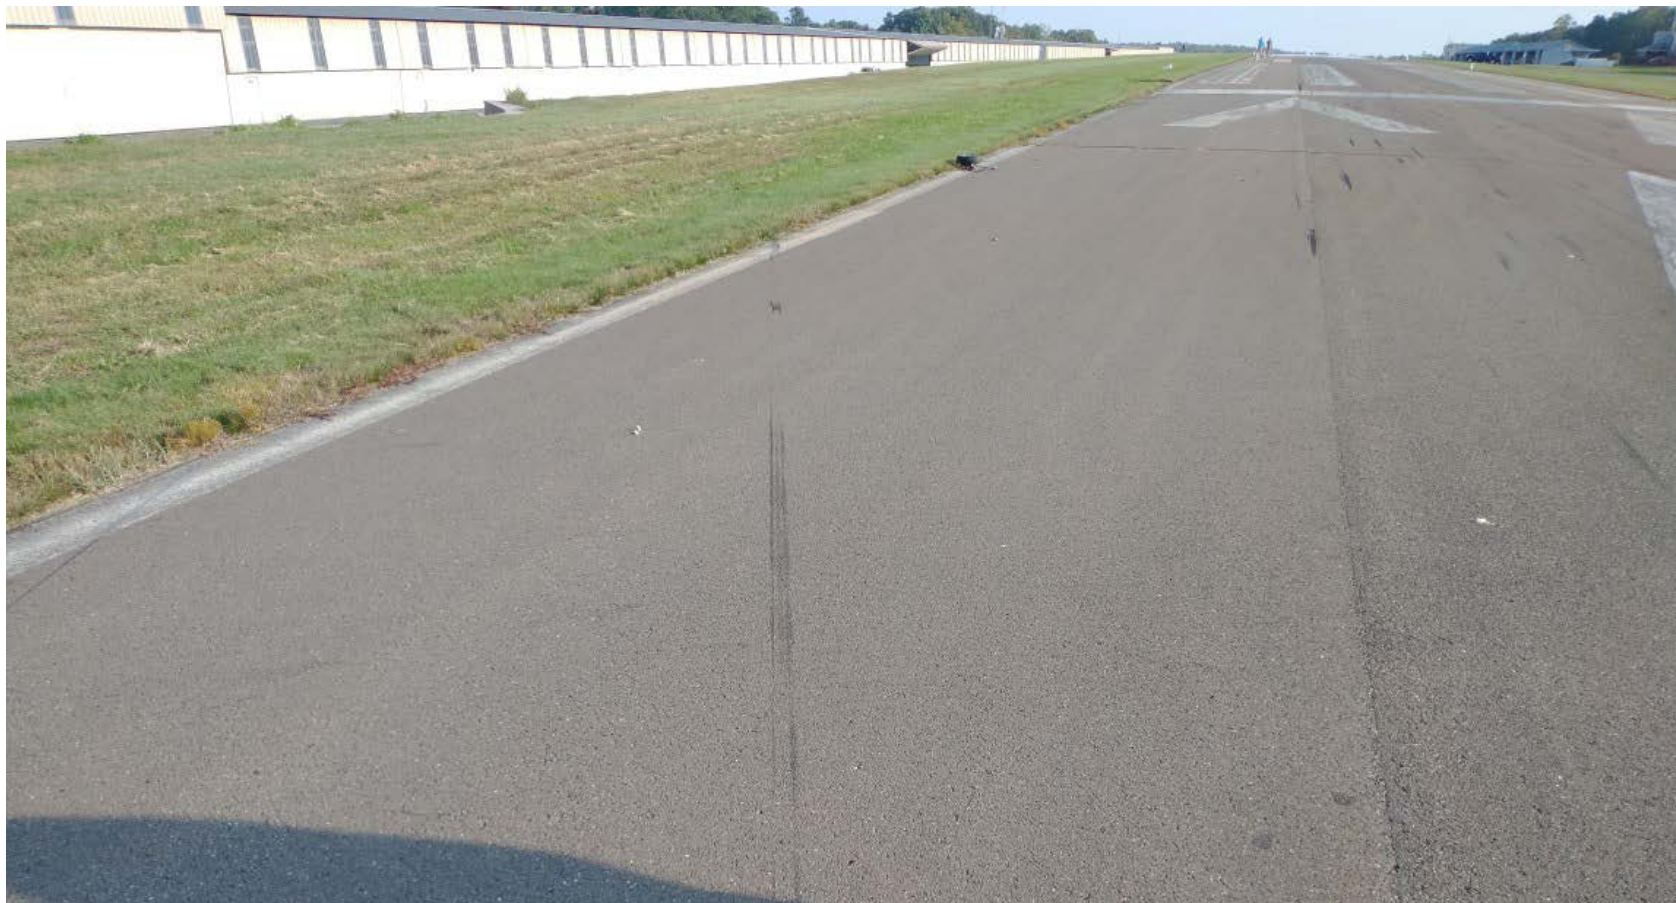
**Photo 5 – View of Skid Mark, Left Landing Gear and Displaced Threshold (Photo Courtesy of FAA)**
