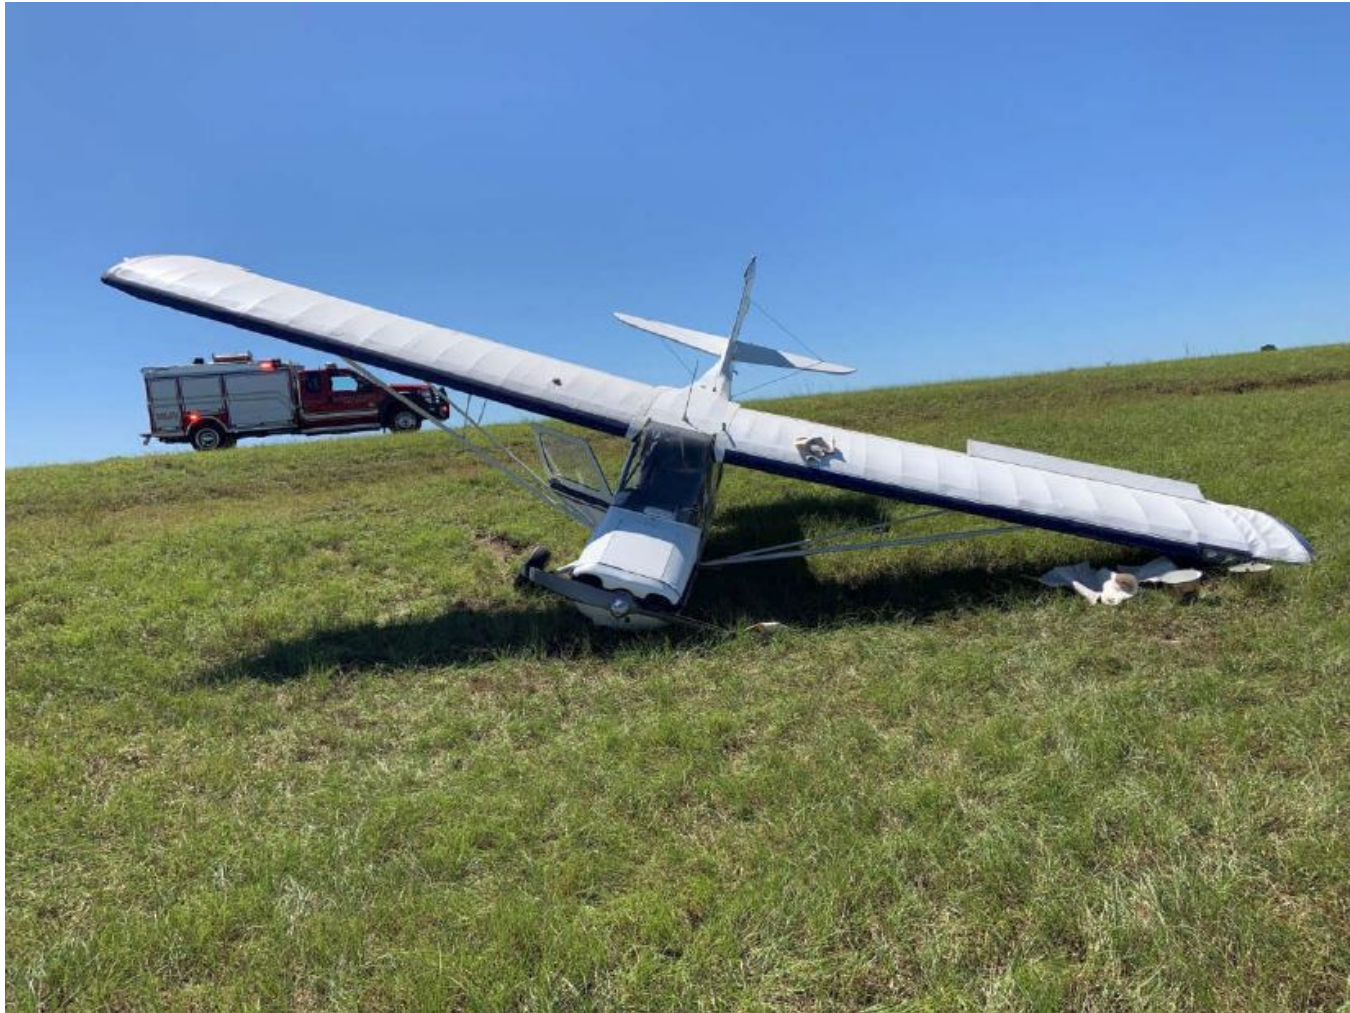
**Photo 1 – View of the accident airplane at the accident site (Photo Courtesy of FAA)**

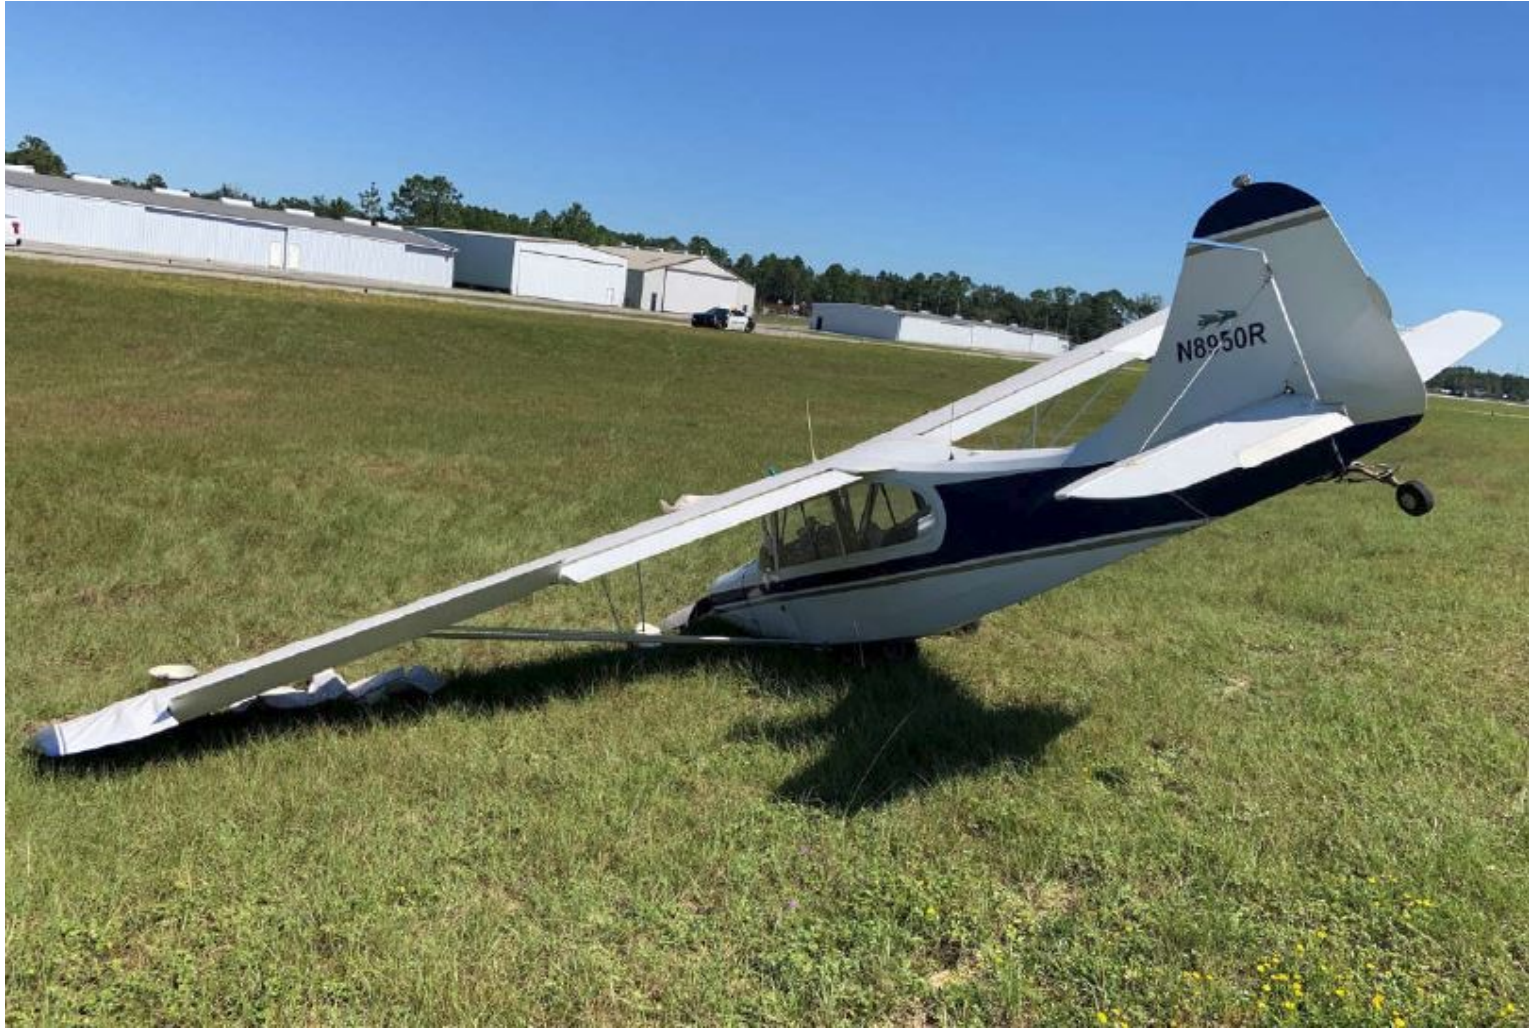
**Photo 2 - View of the left main landing gear collapsed under the fuselage (Photo Courtesy of FAA)**

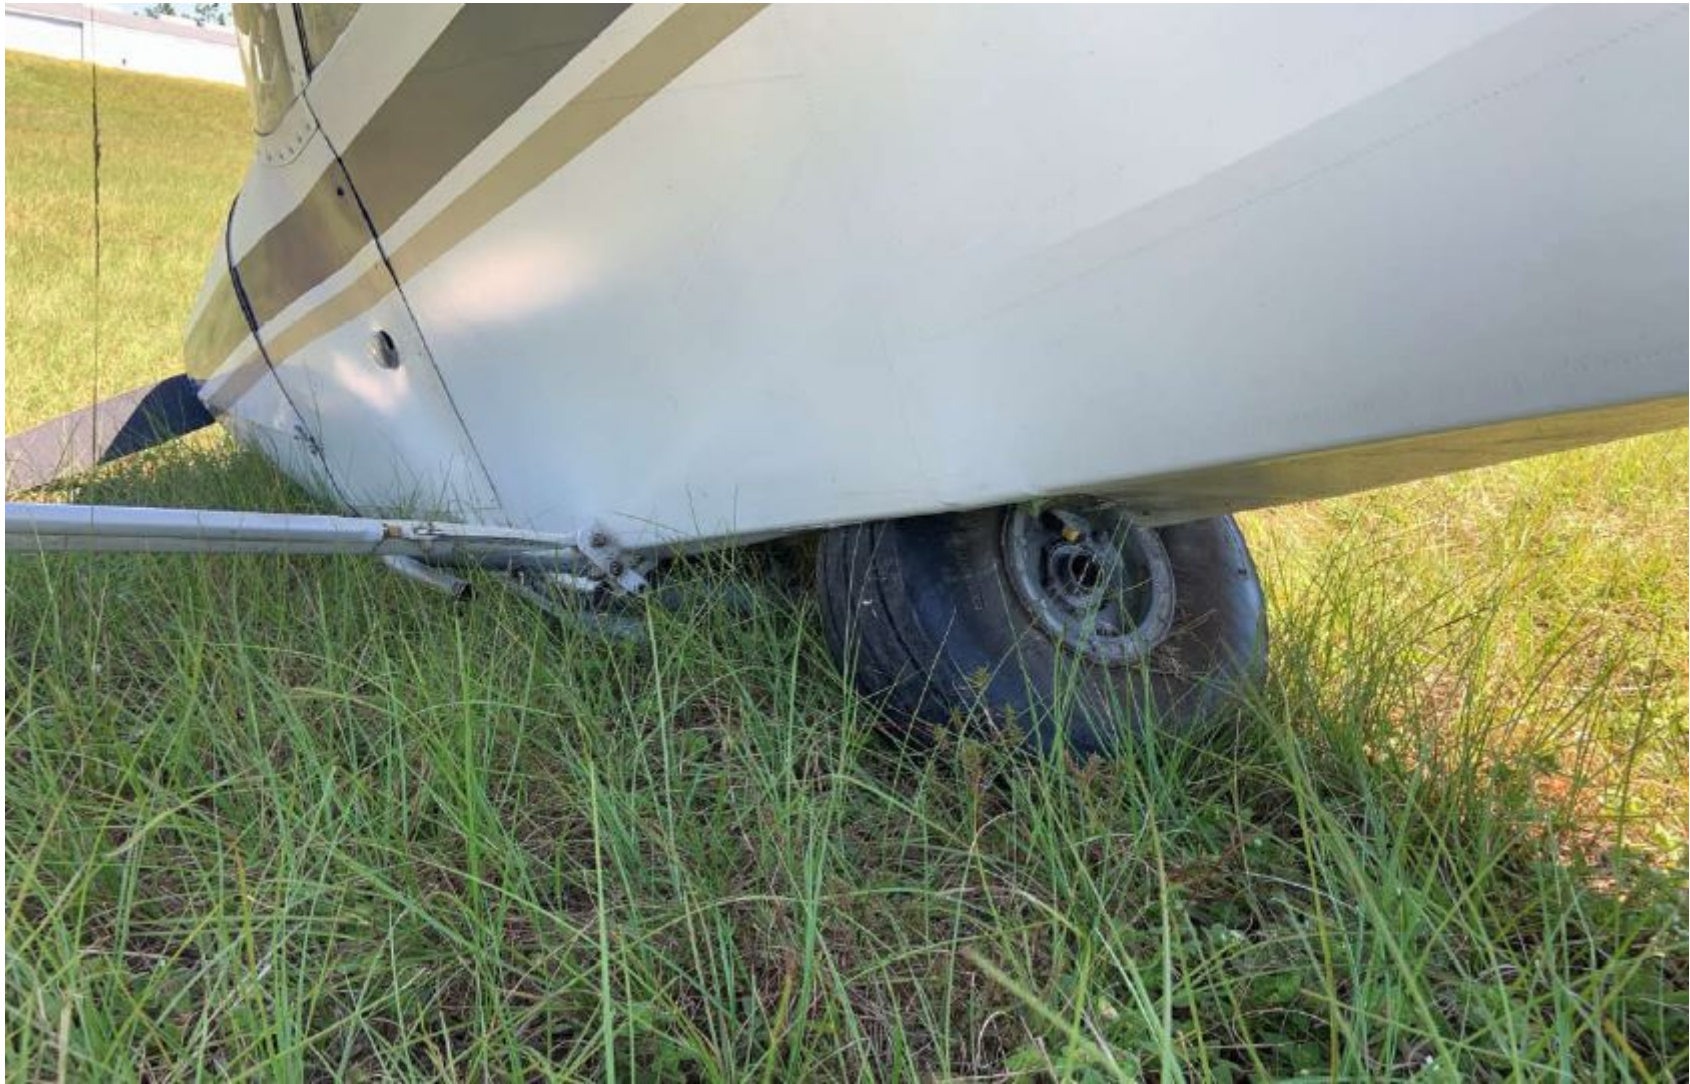
**Photo 3 – Closer view of the left main landing gear collapsed under the fuselage (Photo Courtesy of FAA)**

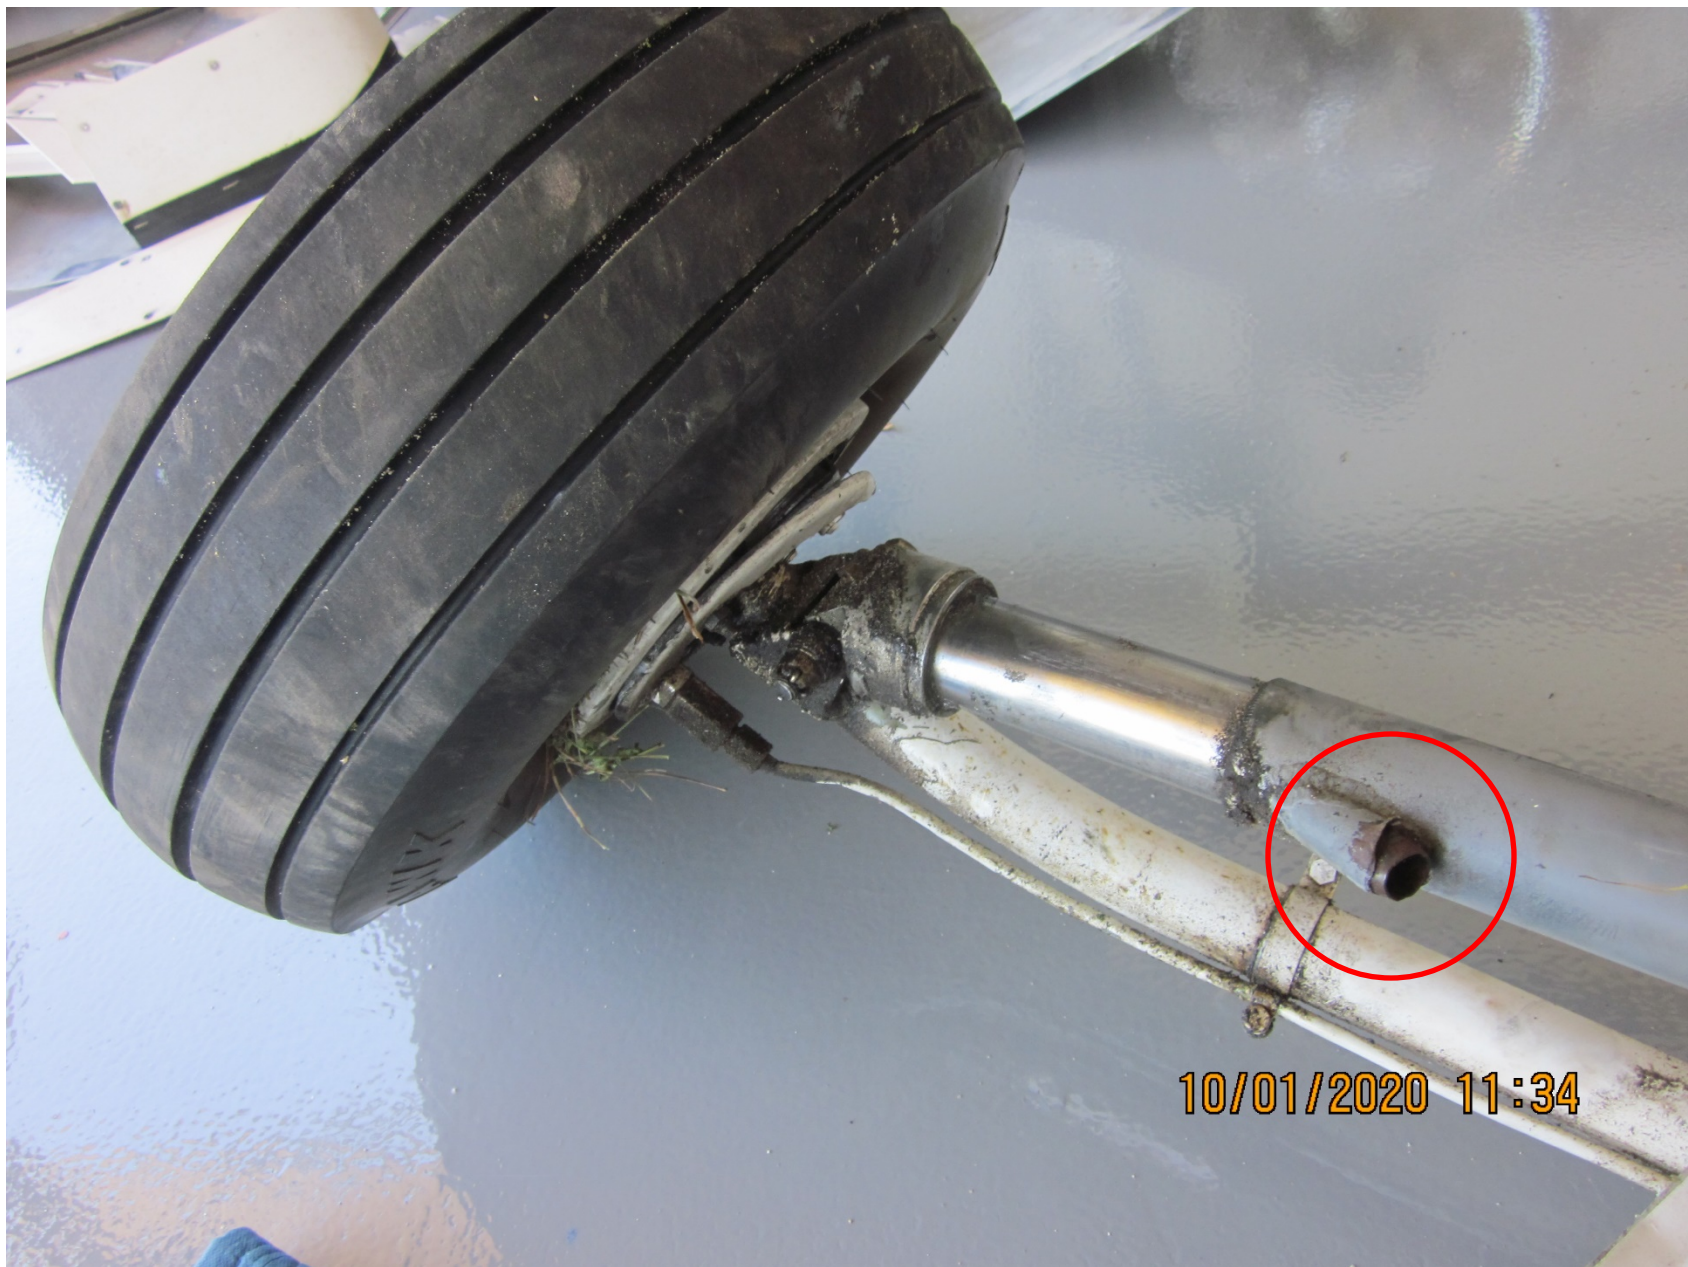
**Figure 1 – View of the corrosion visible on the left landing gear airframe cross tube (Photo Courtesy of FAA)**

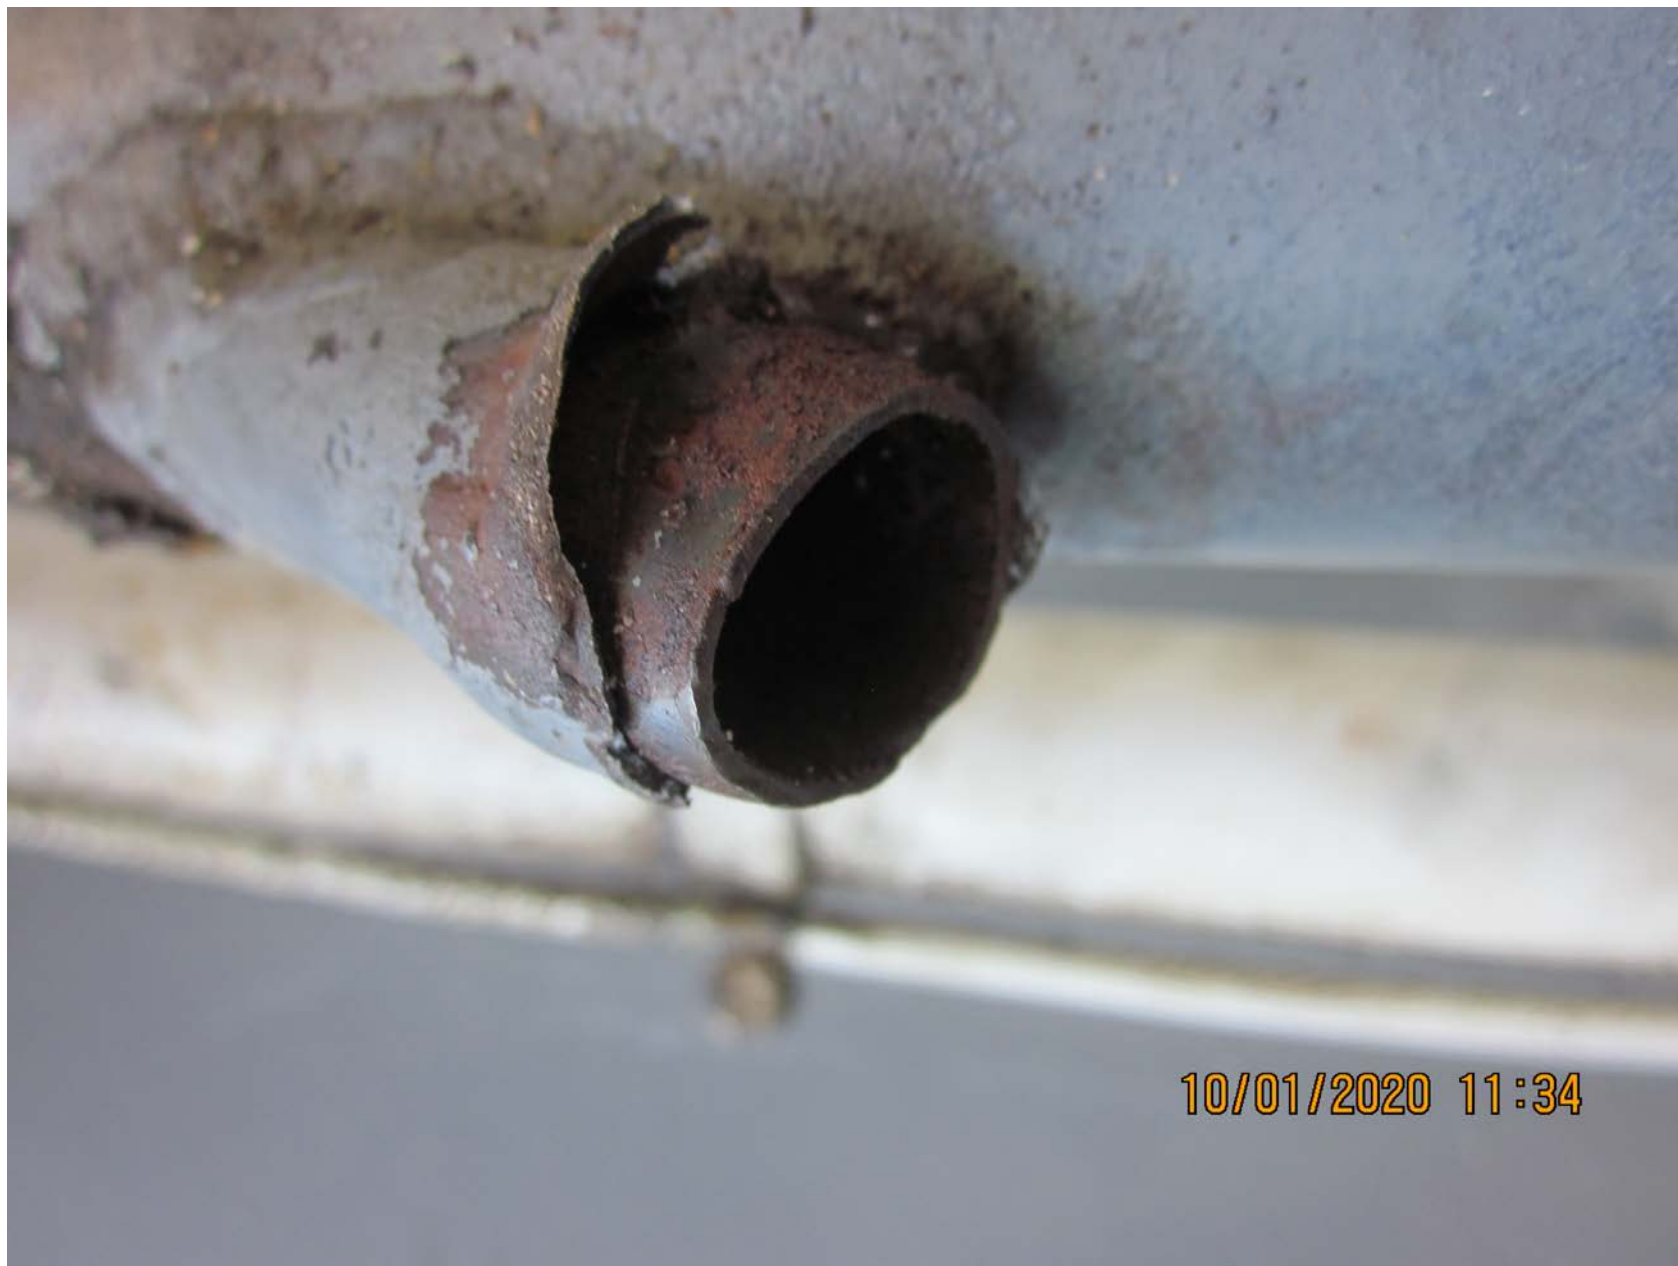
**Photo 4 – Closer view of the corrosion visible on the left landing gear airframe cross tube (Photo Courtesy of FAA)**
