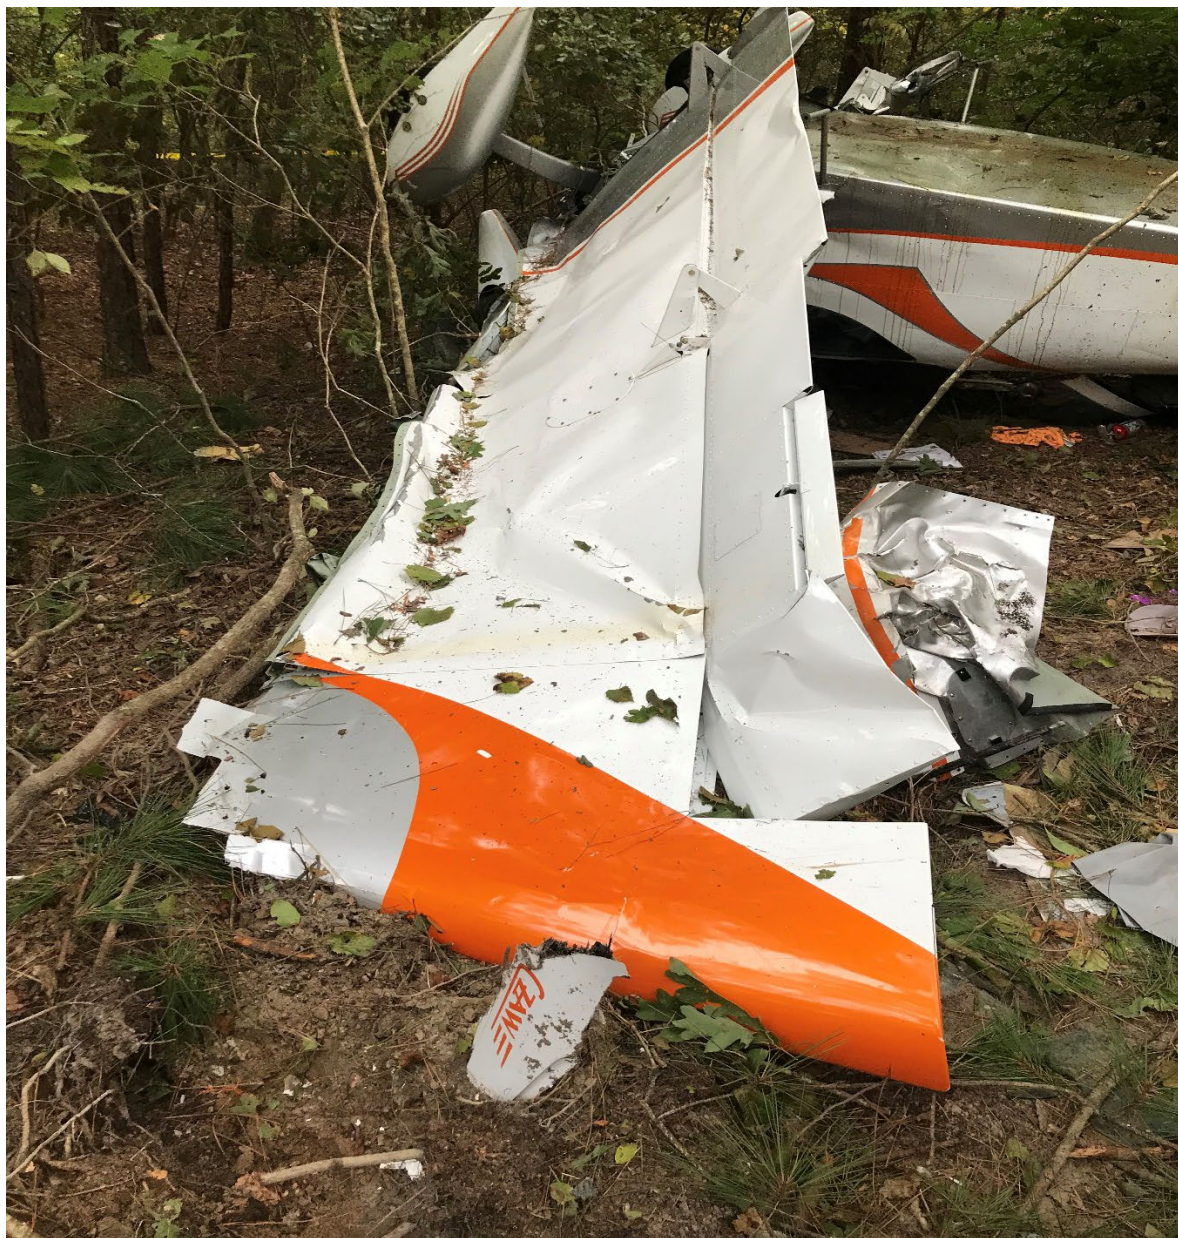
**Photo 1 – View of airplane at wreckage site**

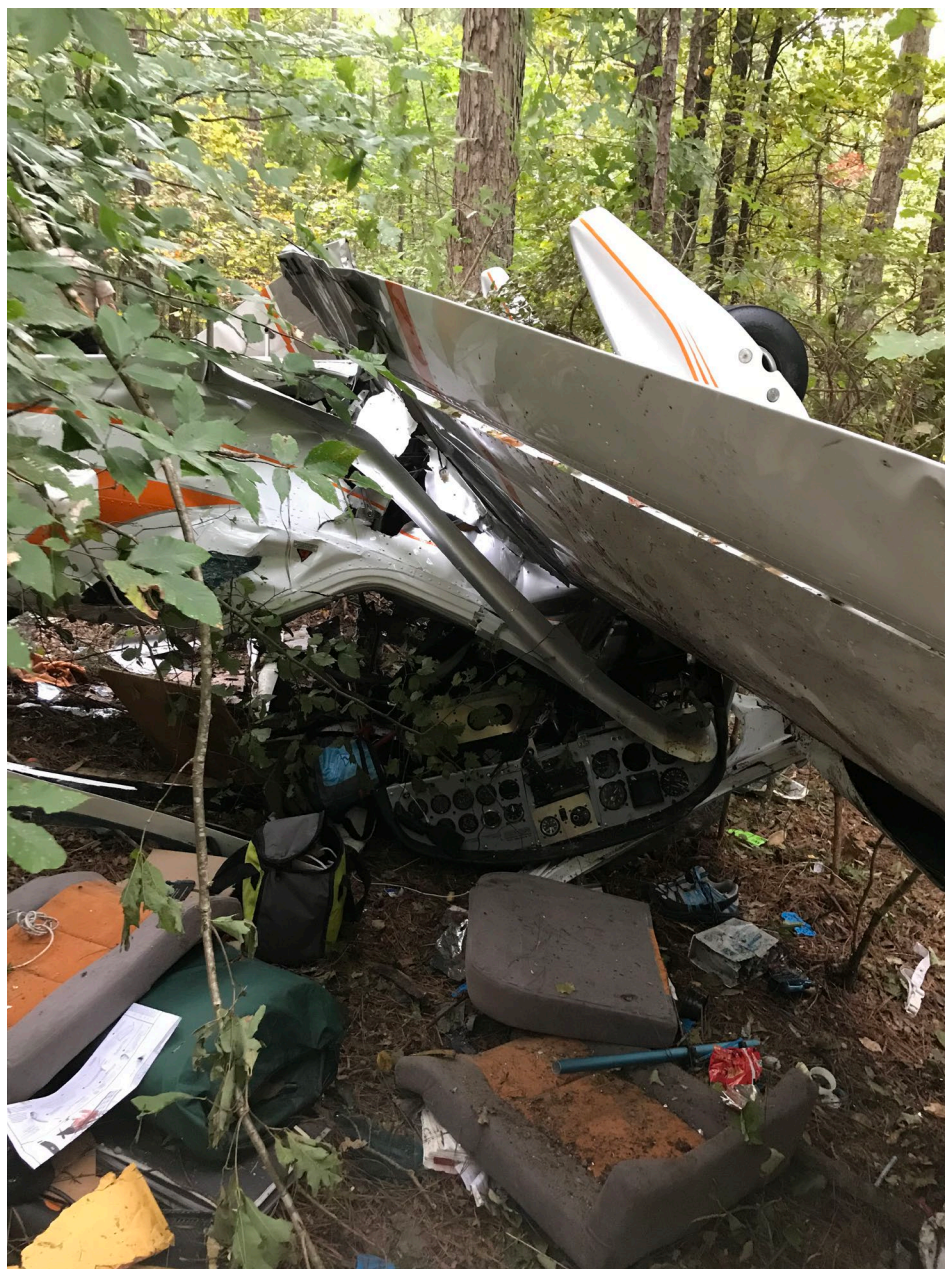
**Photo 2 – View of cockpit at wreckage site**

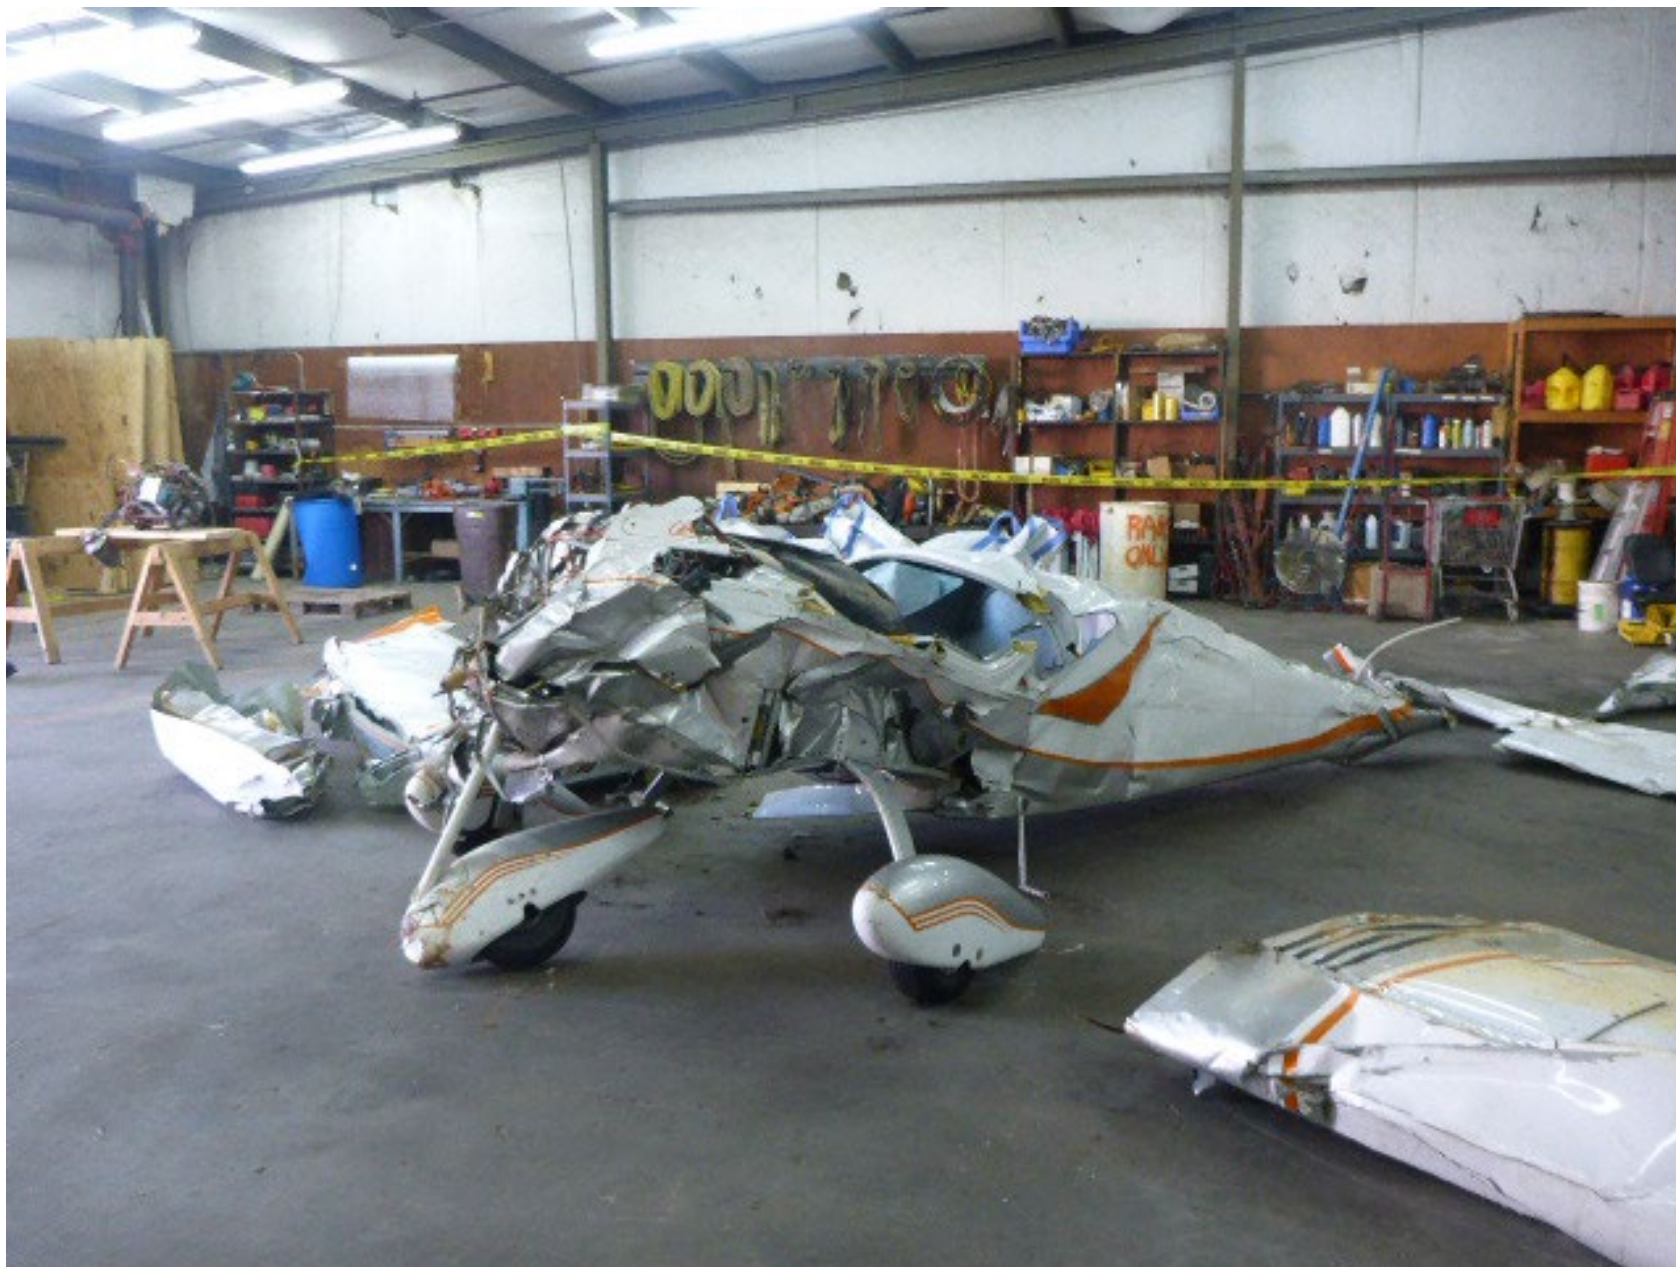
**Photo 3 – View of wreckage layout after recovery**

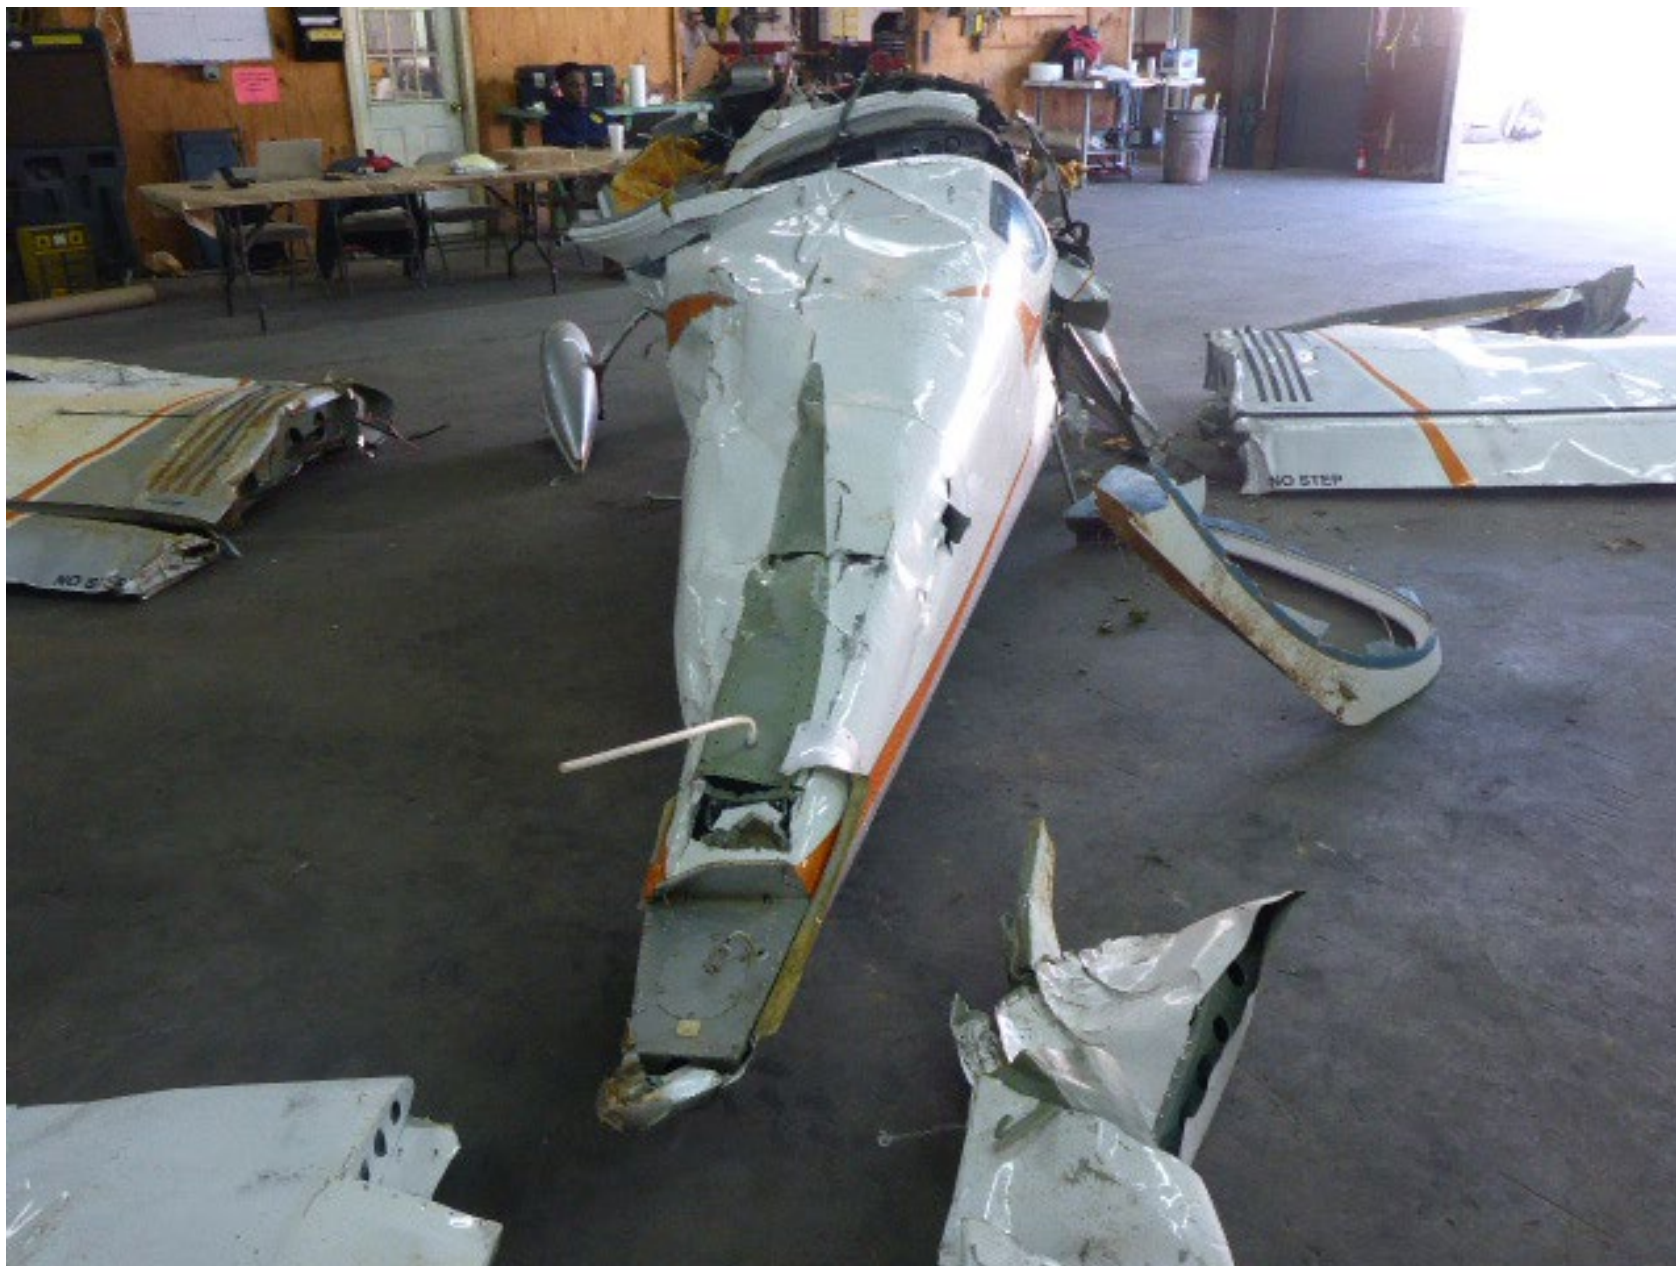
**Photo 4 – Aft view of layout after recovery**

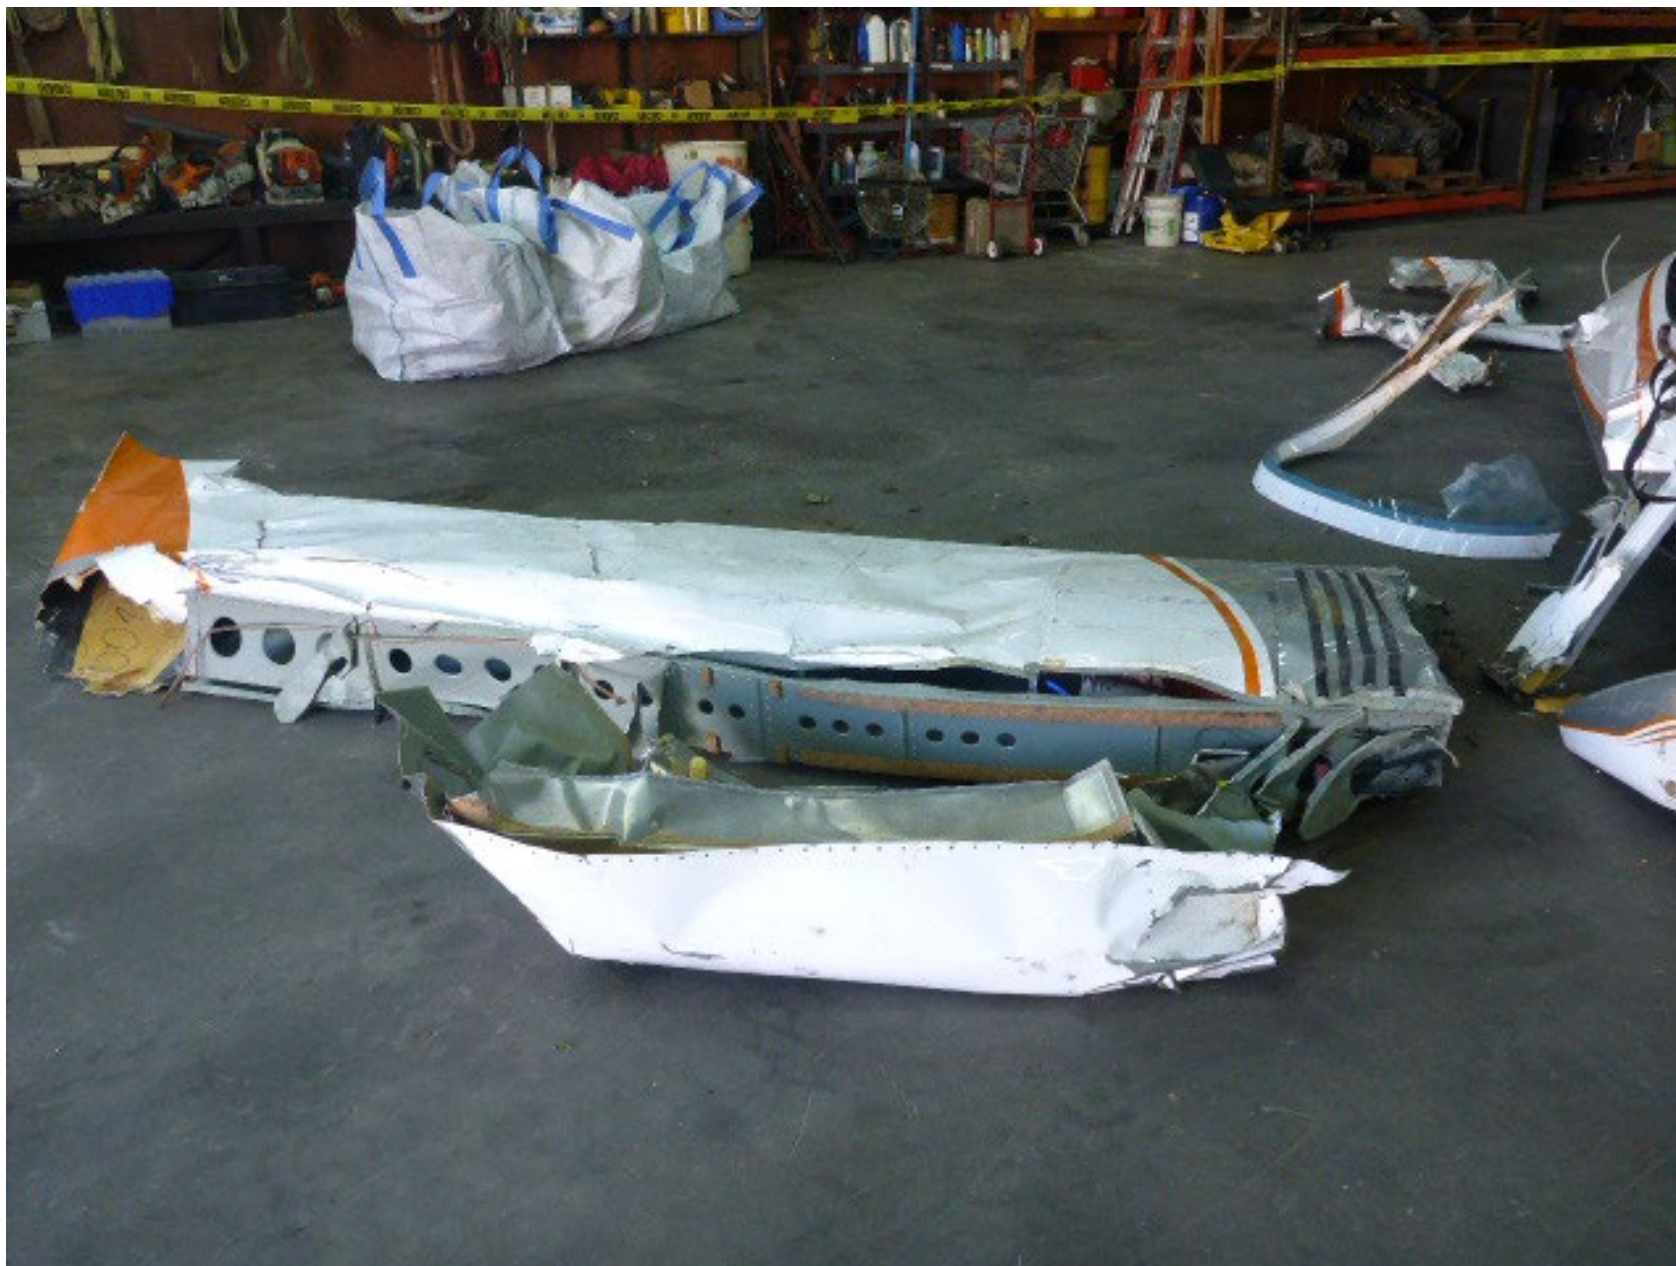
**Photo 5 – Right wing view after recovery**

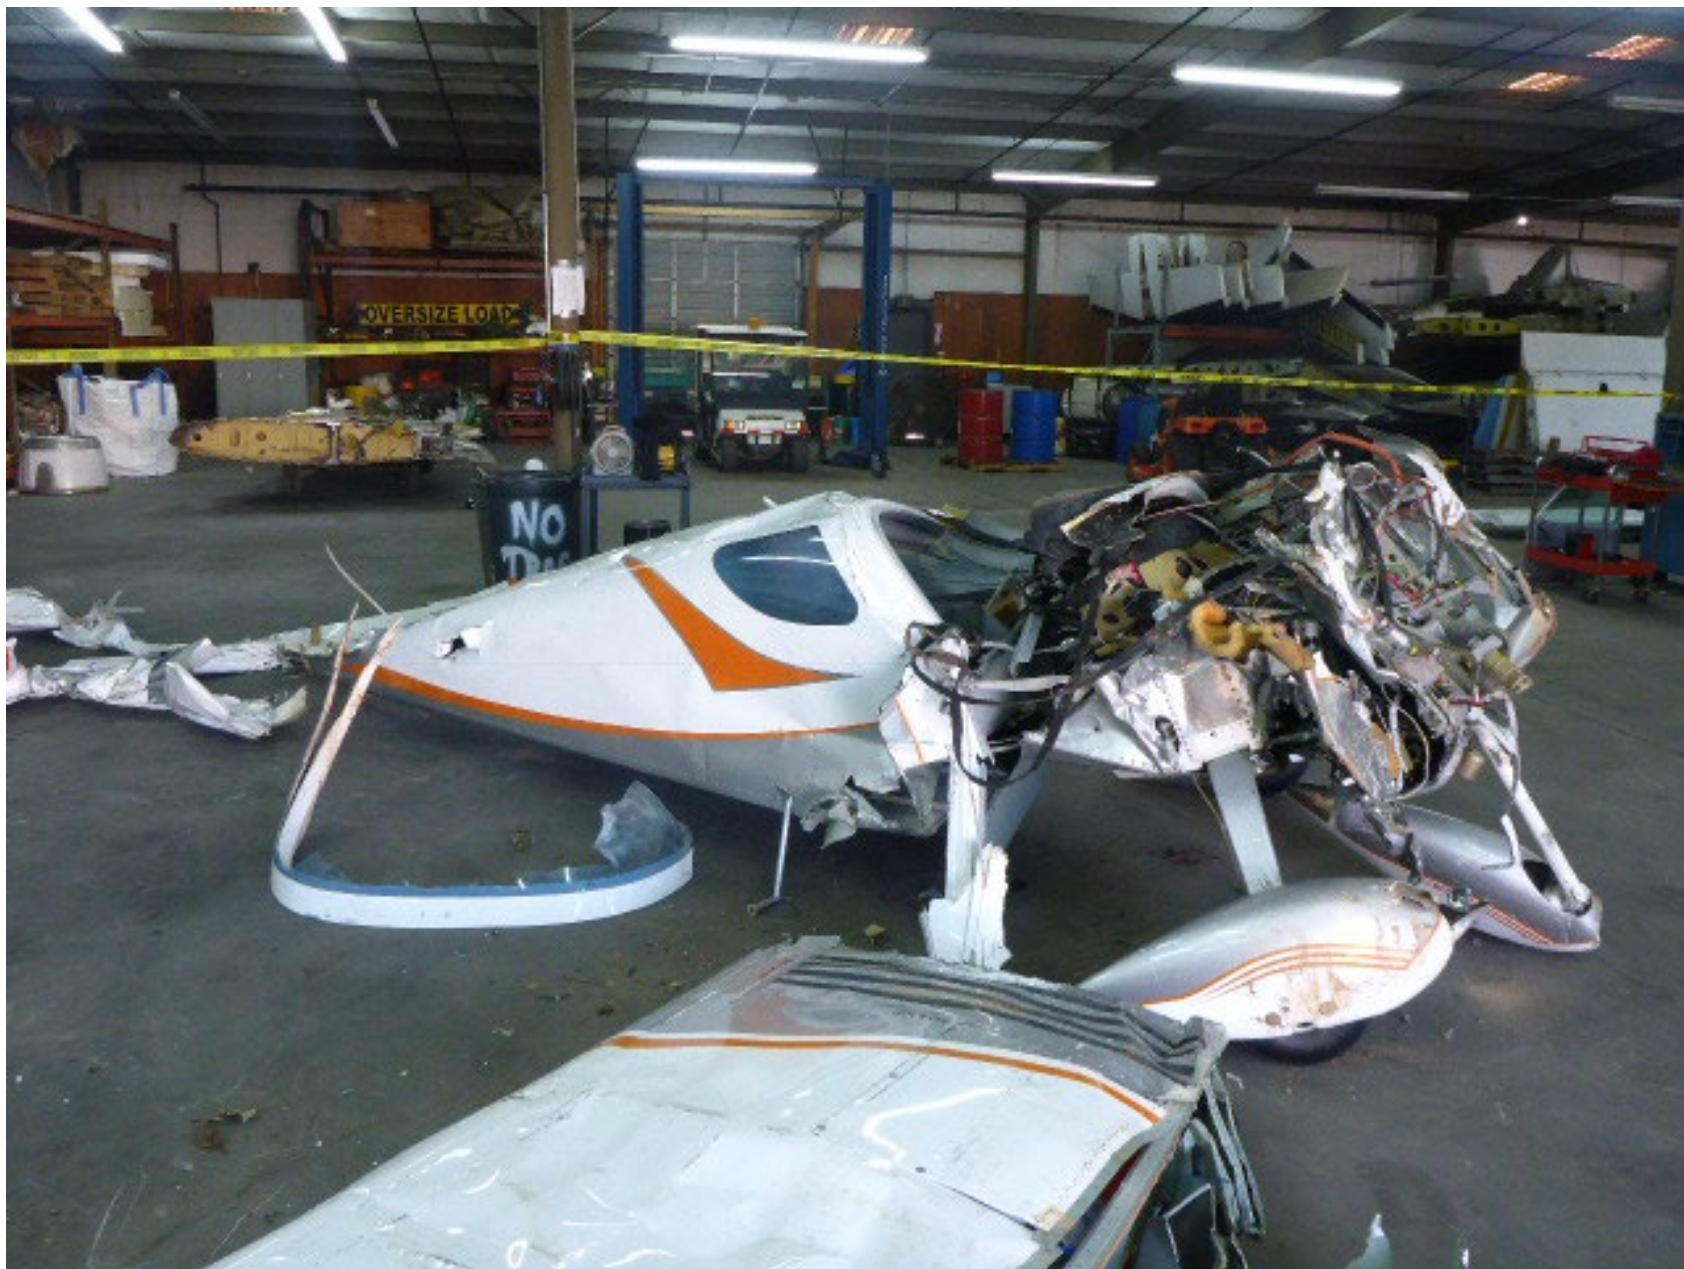
**Photo 6 – Right side of fuselage after recovery**

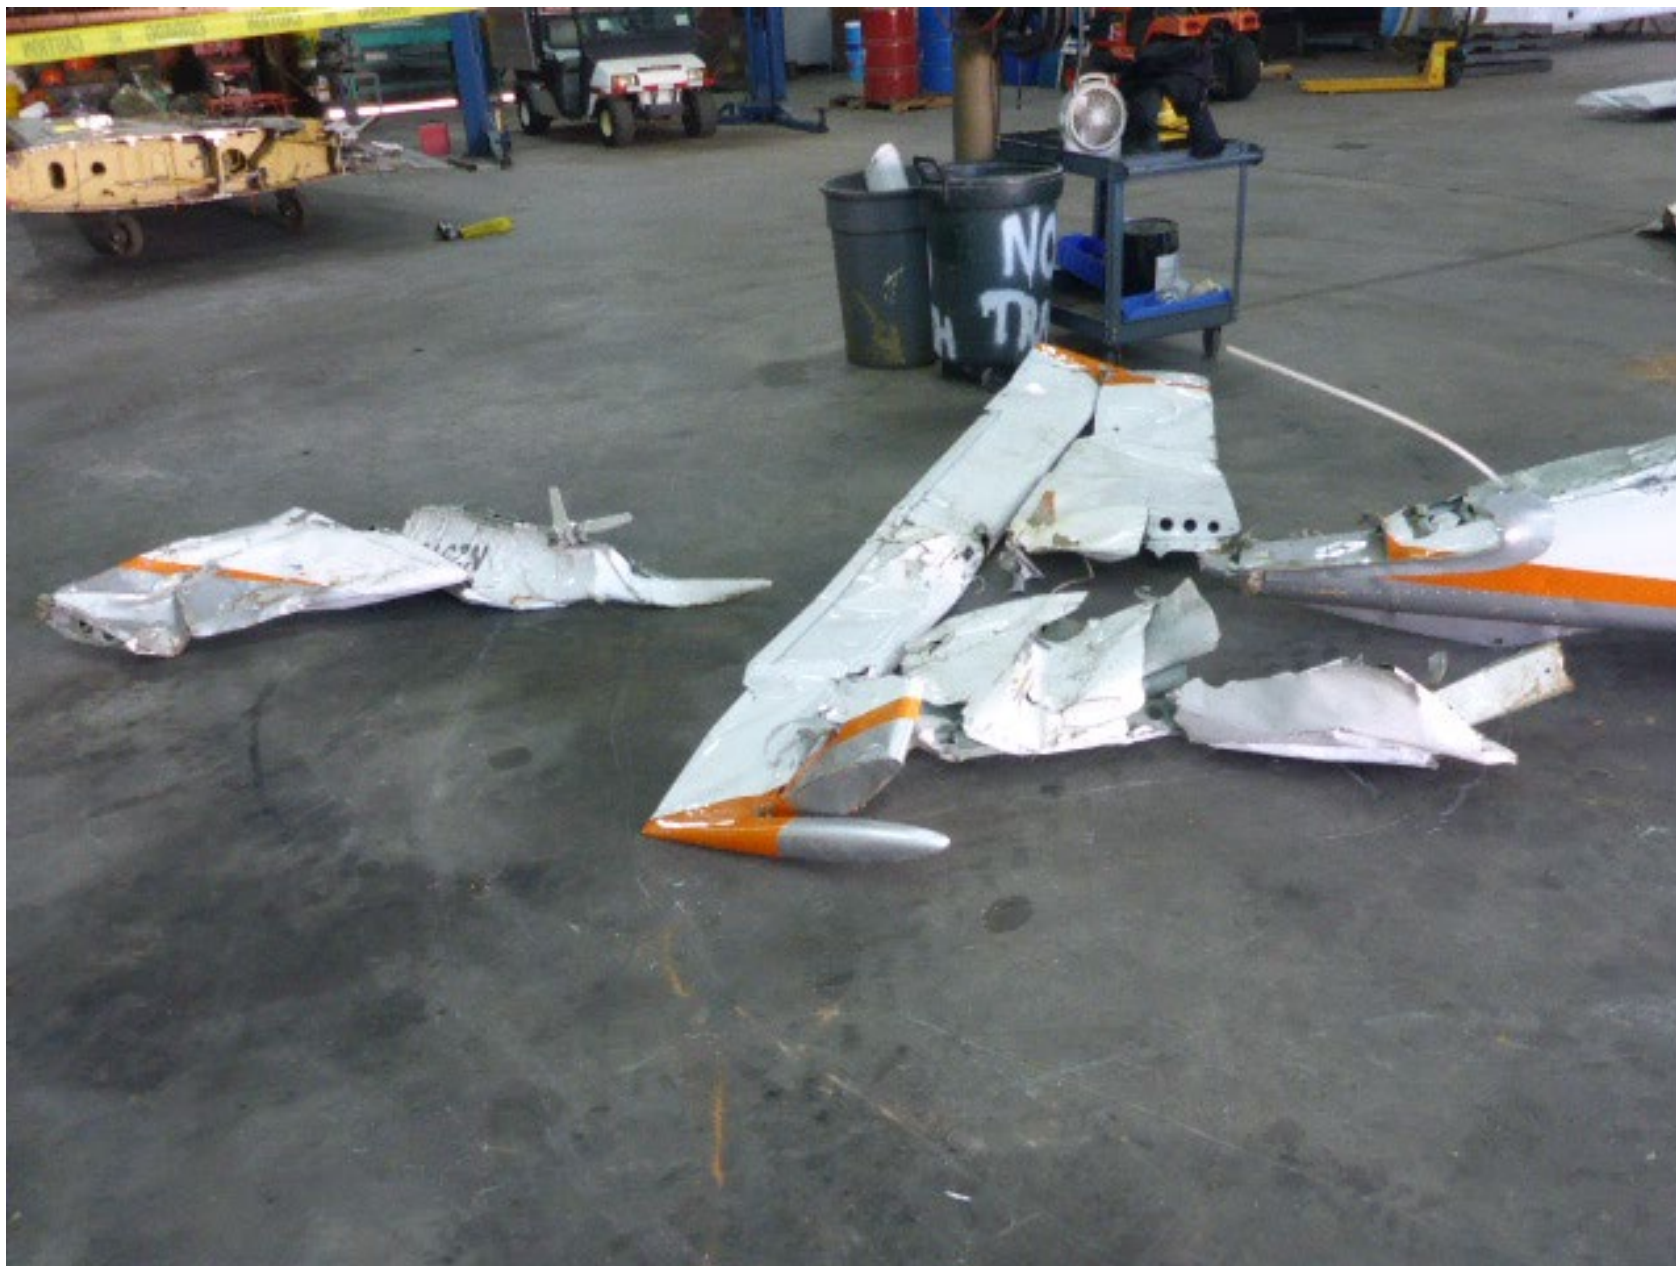
**Photo 7 – Empennage section after recovery**

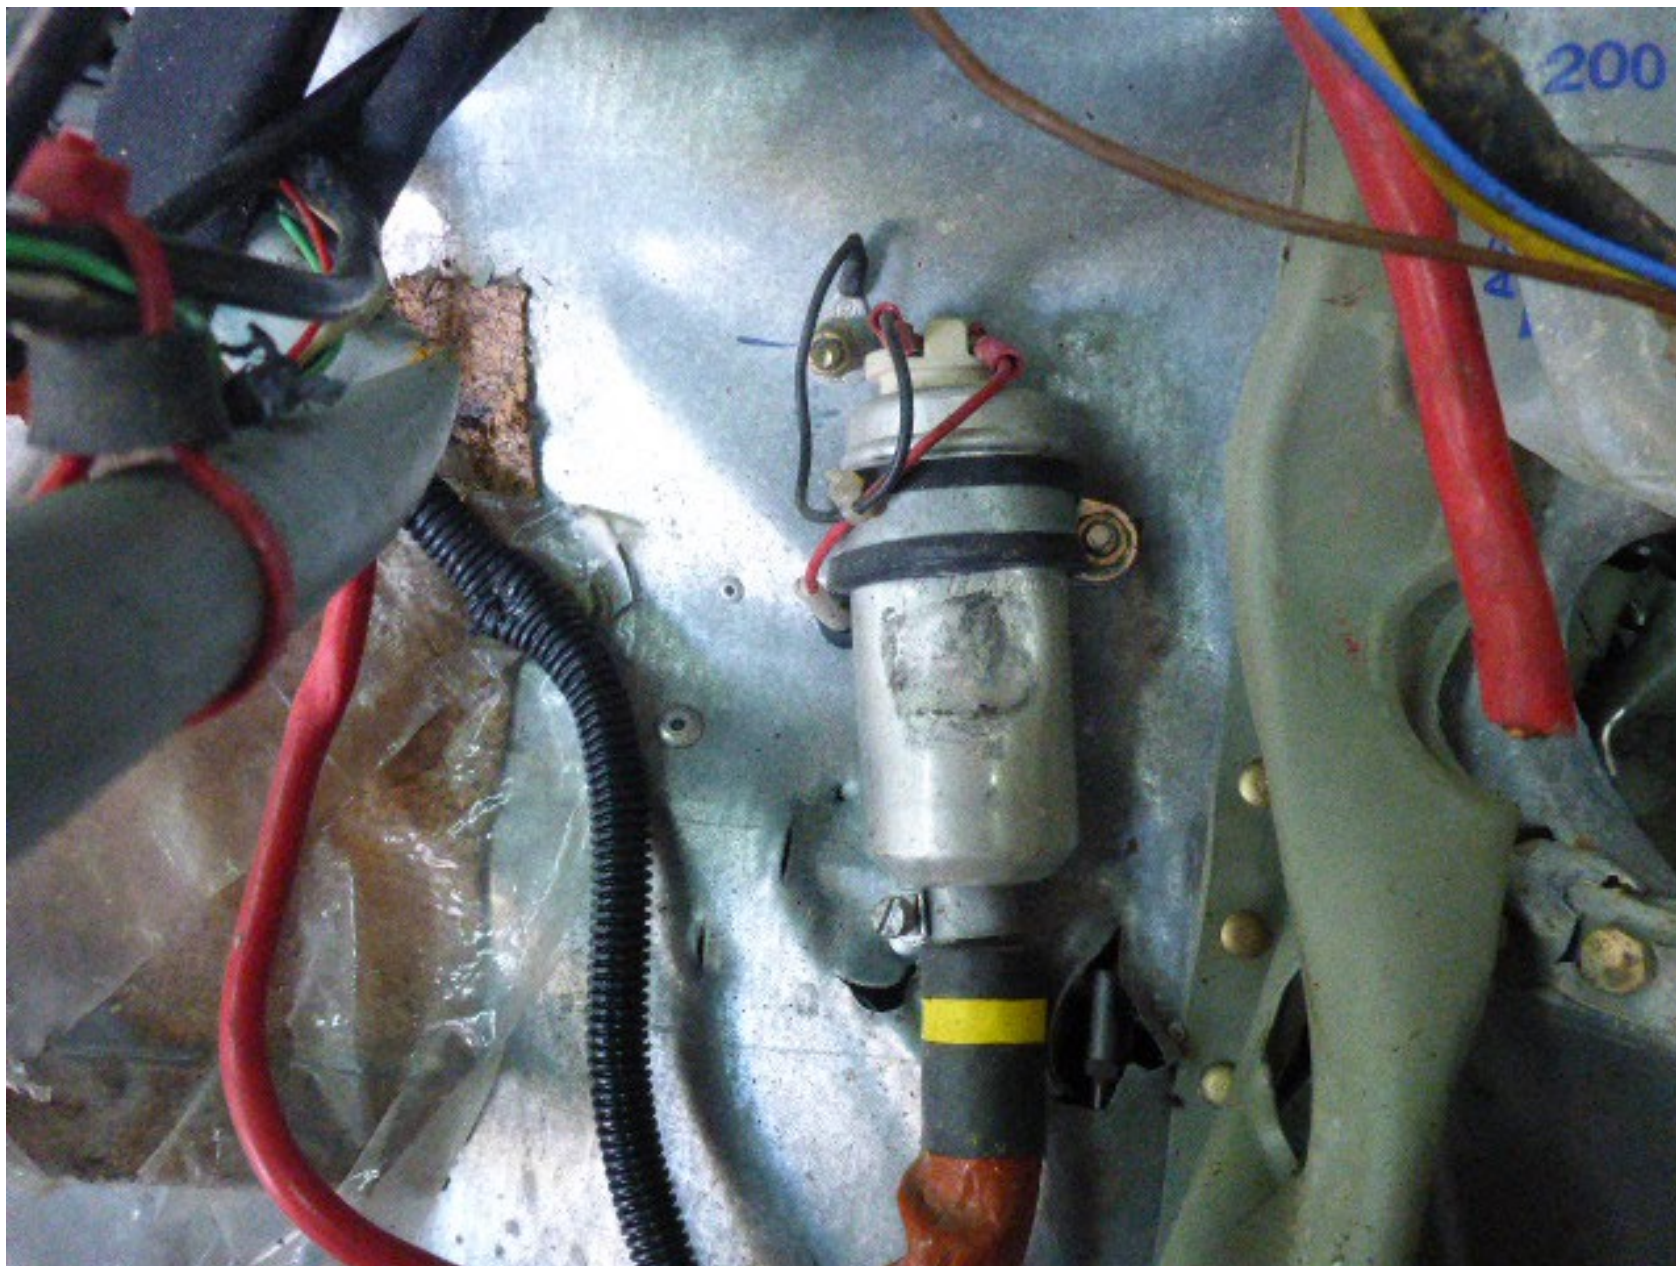
**Photo 8 – Automotive installed fuel pump**

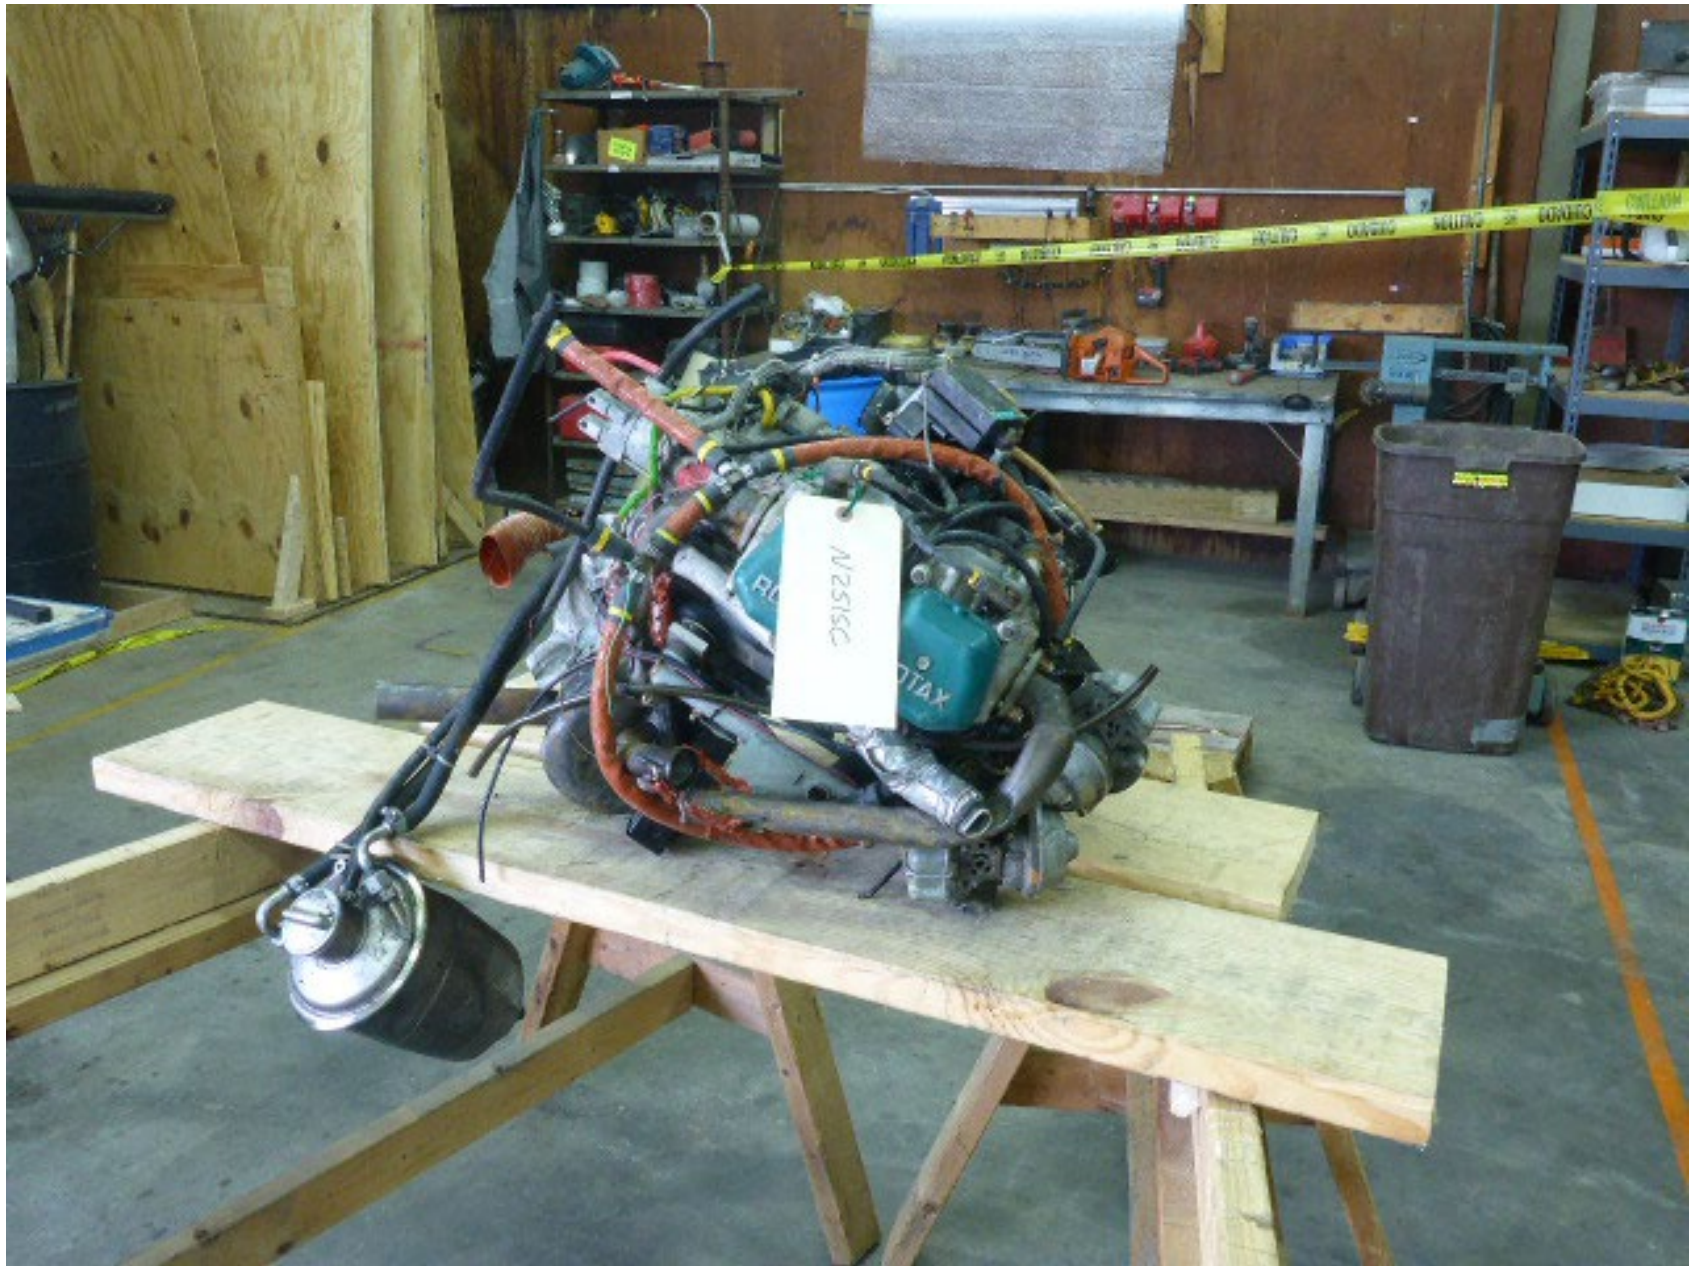
**Photo 9 – Rotax 912 ULS engine**
