**NATIONAL TRANSPORTATION SAFETY BOARD**  
**Office of Aviation Safety**  
**Washington, D.C. 20594**

**AIRWORTHINESS GROUP CHAIRMAN'S FACTUAL REPORT**

**NTSB No: ERA21FA130**

Operator: Caribbean Buzz  
Aircraft: Bell 206B-III, registration N13AT  
Location: Saint Thomas, United States Virgin Islands  
Date: February 15, 2021  
Time: 15:14 Atlantic standard time

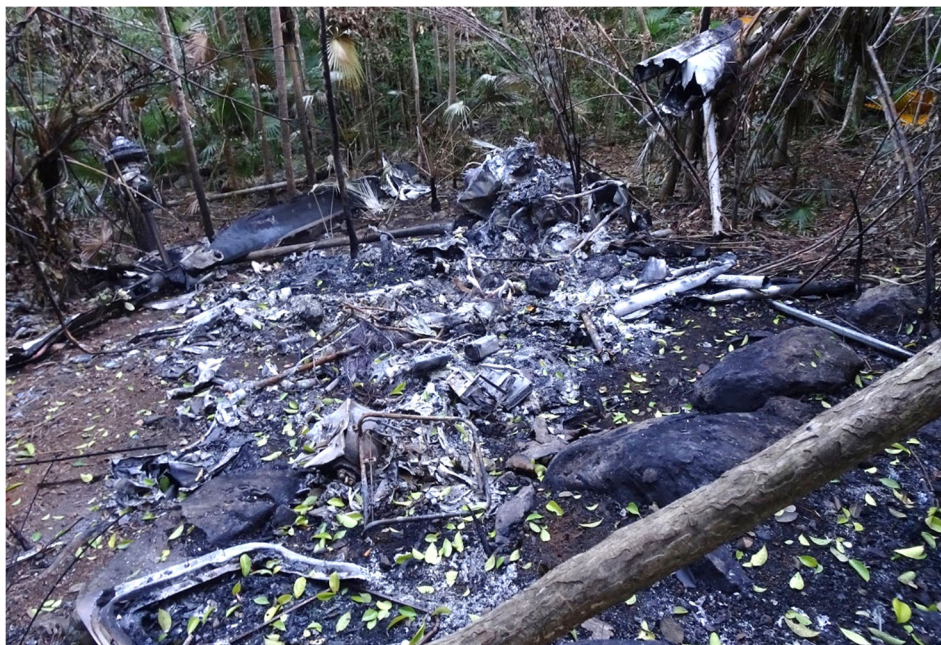
On February 18-19, 2021, National Transportation Safety Board (NTSB) investigators examined the wreckage at the accident site. The helicopter came to rest upright on a heading of about 200° magnetic. The wreckage location was 18°21'18" North by 65°1'40" West and an elevation of about 376 feet above mean sea level. The majority of the wreckage exhibited thermal damage due to exposure from the postcrash fire (**Figure 1**).

**Figure 1. The accident site.**

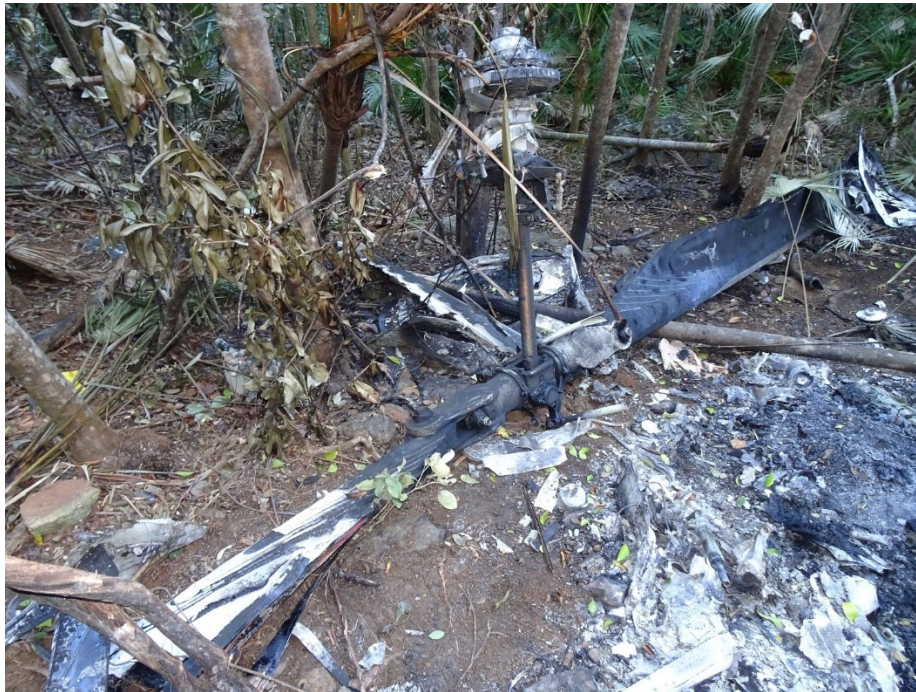
Both main rotor blades remained attached to their respective grips, and both main rotor blade grips remained attached to the main rotor hub (**Figure 2**). One main rotor blade span was continuous from root to tip. The second main rotor blade was fractured about 41 inches outboard of its [inboard] blade attachment bolt. A 100-inch section of the second main rotor blade was found on the ground adjacent to the main rotor hub and the tip weight for this blade was found within the fuselage wreckage. The main rotor hub remained attached to the main rotor mast. The mast nut and adjacent installation hardware remained installed.

**Figure 2. The main rotor, main rotor mast, and a portion of the main rotor gearbox found as an assembly at the accident site.**

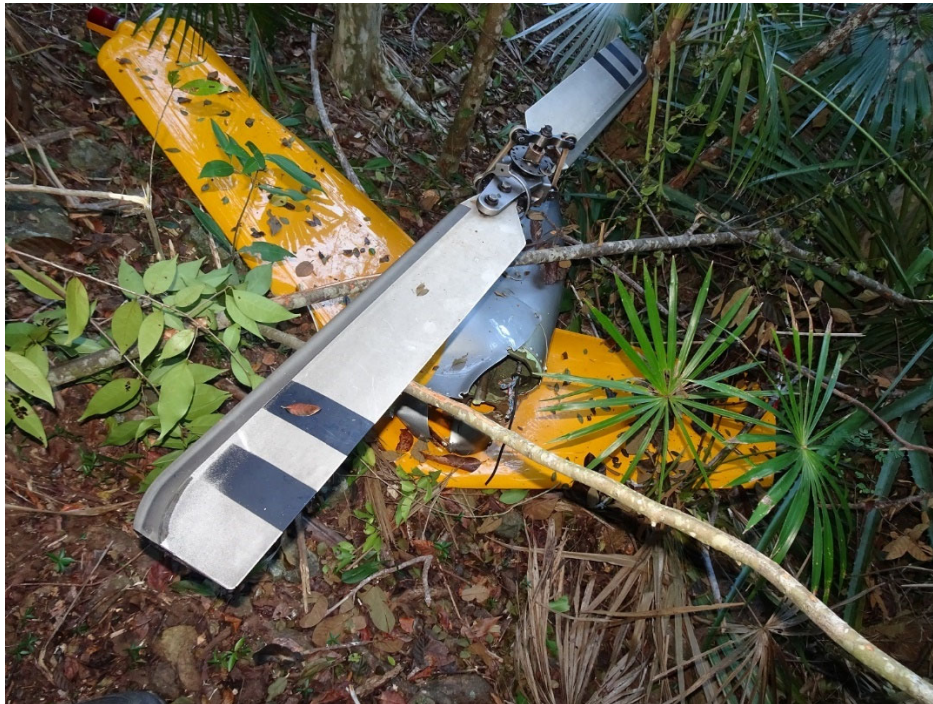
The tail rotor assembly remained attached to the tail rotor gearbox output shaft (**Figure 3**). The crosshead, pitch links, pitch horns, and yoke assembly did not exhibit evidence of preimpact fractures or separation. The two tail rotor blades remained attached to the yoke and were whole with no significant damage to its leading edge and afterbody. Manual manipulation of tail rotor blade pitch revealed no evidence of restriction or anomalous damage to the pitch change mechanism.

**Figure 3. The tail rotor, tail rotor gearbox, and vertical stabilizer at the accident site.**

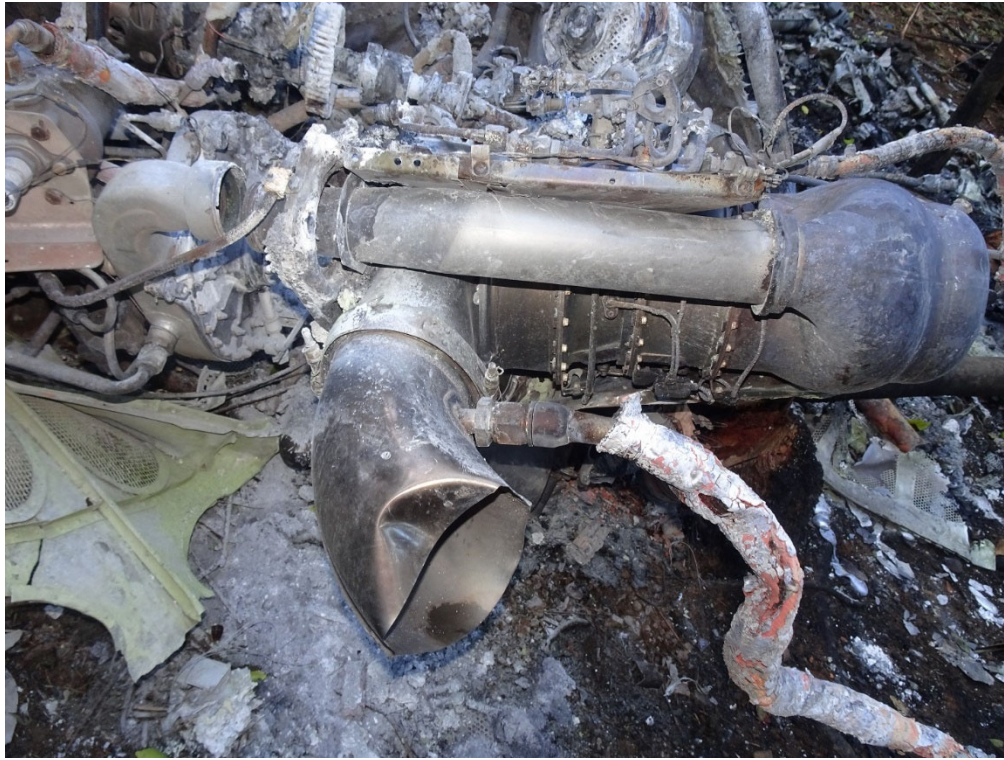
The engine was present on the engine deck, but the accessory gearbox housing was consumed by the postcrash fire (**Figure 4**). The engine case showed no evidence of uncontained failure. The compressor discharge tubes were separated from the compressor module but remained attached to the combustor. All first stage compressor blades were present with no evidence of foreign object debris (FOD) ingestion (**Figure 5**). The compressor section data plate showed it was S/N CAC-36783.

**Figure 4. The engine assembly at the accident site.**

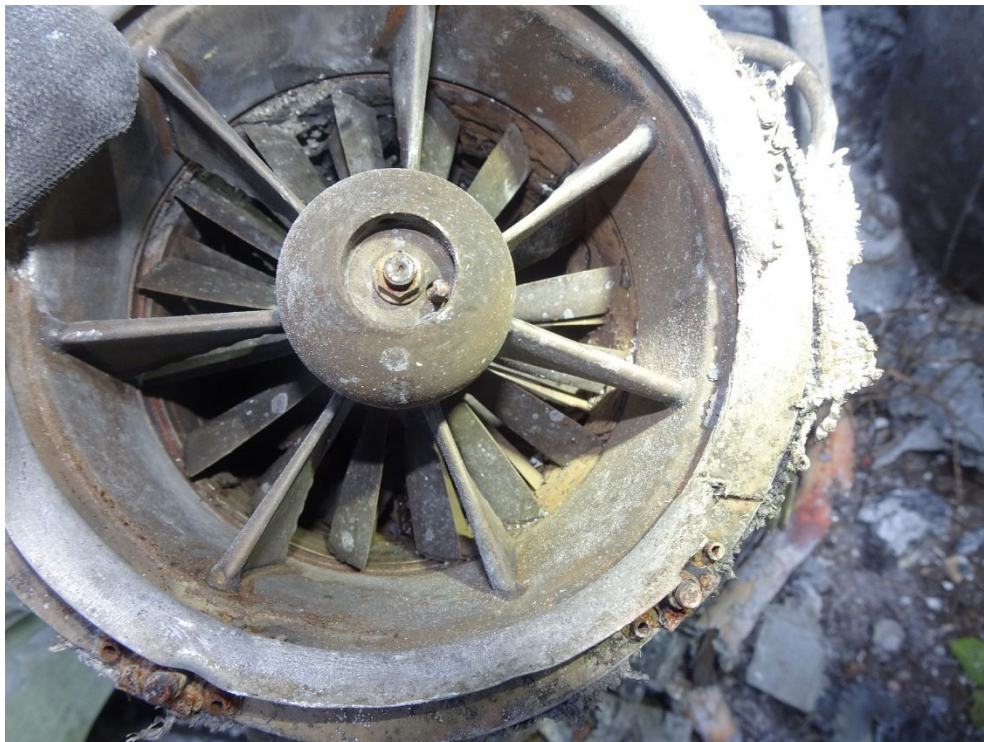
**Figure 5. A view of the first stage compressor blades through the engine inlet.**

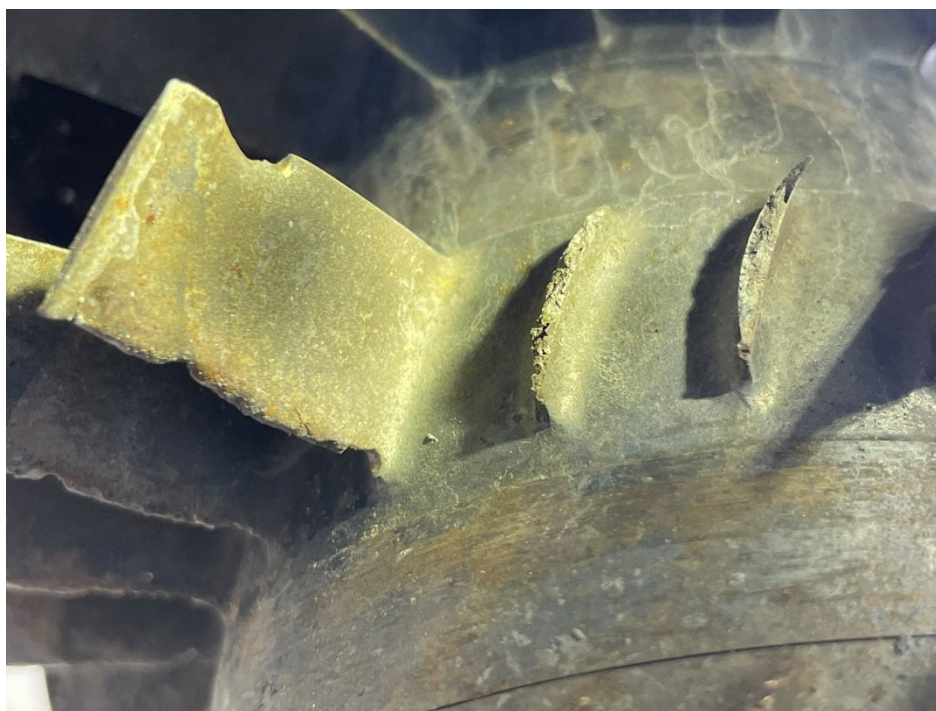
**Figure 6. Two fractured stage 3 compressor blades.**

Both fractured stage 3 compressor blades exhibited signatures consistent with fatigue. Both fractures originated near the pressure side of their trailing edge but the area of fatigue origins were impact damaged, precluding further analysis of the fatigue origins. There was no evidence of pitting corrosion on the remaining blades. On one blade, the fatigue progressed about 0.31 inches toward the leading edge with the remainder of the fracture surface exhibiting signatures of overload. On the second blade, the fatigue fracture progressed about 0.023 inches toward the leading edge with the remainder of the fracture surface exhibiting signatures of overload. Analysis of a cross-section of the stage 2-3 compressor wheel found it met material requirements, including chemistry for material type as well as hardness.

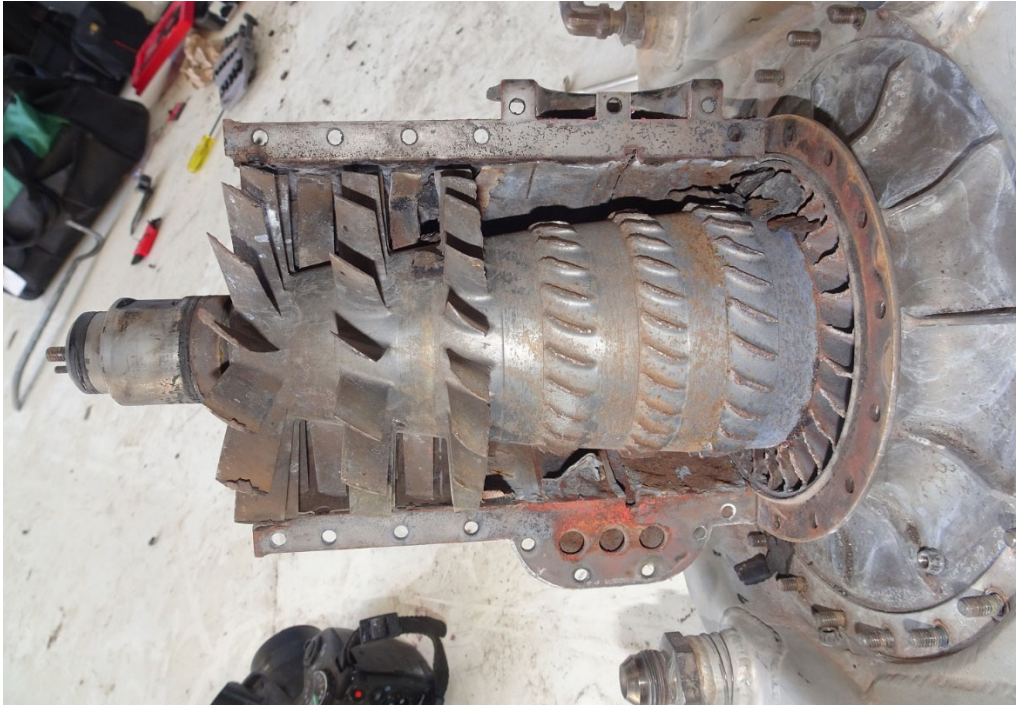
The wreckage was recovered to a hangar at Cyril E. King Airport in Charlotte Amalie, Saint Thomas for further examination on February 20, 2021. The compressor section was separated from the remainder of the engine. Subsequently, the compressor case halves were separated. All blades on compressor stages 1 and 2 were present and did not exhibit anomalous damage. Two of the stage 3 blades were fractured and separated from the wheel (**Figure 6**). The remainder of the stage 3 blades were present and the majority of them had impact damage on their trailing edges. All blades from compressor stages 4, 5, and 6 were fractured and separated from their wheels (**Figure 7**). Remnant pieces of axial compressor blades were found within the axial compressor section as well as the impeller inducer. The impeller inducer exhibited damage consistent with hard body FOD ingestion.<sup>2</sup> The impeller exducer did not exhibit evidence of FOD ingestion. Remnant pieces of [axial] compressor blades were found within the impeller vane assembly. The inner surfaces of the impeller shroud exhibited circular scoring marks. The part numbers and S/Ns for the compressor wheels are listed in **Table 1**.

**Figure 7. The axial compressor after removal of a case half.**

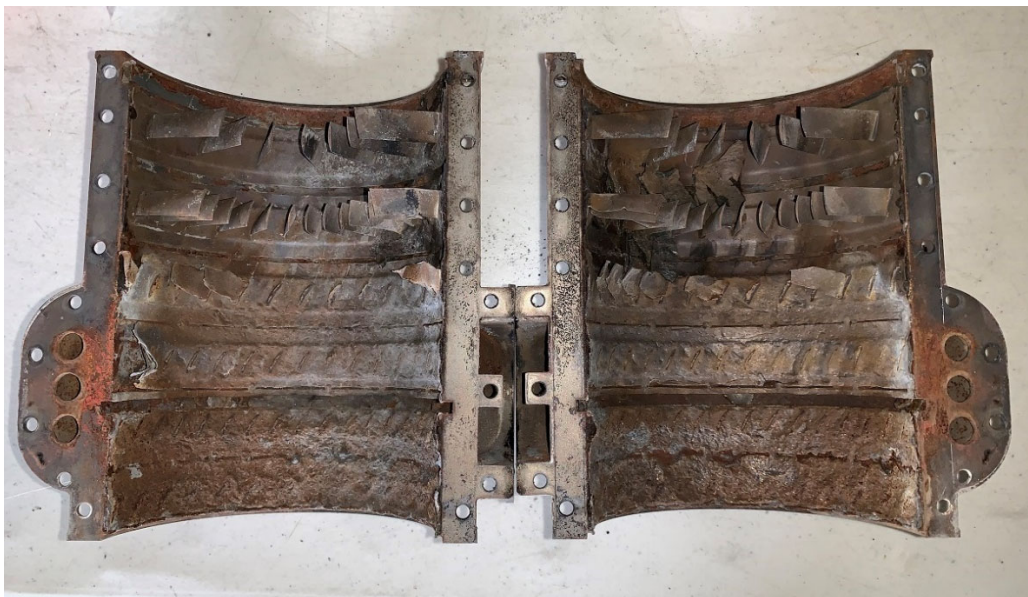
All [axial] compressor stators were present between the stages 1 and 2 wheel as well as the stages 2 and 3 wheels, though several vanes on the latter exhibited damage on their downstream edges (**Figure 8**). All but 11 stator vanes were fractured and separated between the stages 3 and 4 wheels. The 11 remaining stator vanes exhibited deformation and were bent in the direction of normal axial compressor rotation. All stator vanes between stages 4 and 5; 5 and 6; and 6 and impeller stages were fractured and separated. The plastic coating within the compressor case halves exhibited thermal degradation from exposure to the postcrash fire.

**Figure 8. The two compressor case halves showing the damaged liner.**
