## **AIRWORTHINESS GROUP FACTUAL REPORT**

**NTSB No. ERA21FA130**

**Rolls-Royce Materials Evaluation Report No. 21FAE-025-PR  
(111 pages)**

| <b>TITLE</b><br><br><b>METALLURGICAL INVESTIGATION OF COMPRESSOR COMPONENTS REMOVED FROM AN M250-C20B, ENGINE S/N CAE833459, OPERATED BY CARIBBEAN BUZZ HELICOPTER</b> | | <b>PREPARED</b><br>Signatures on File | | |

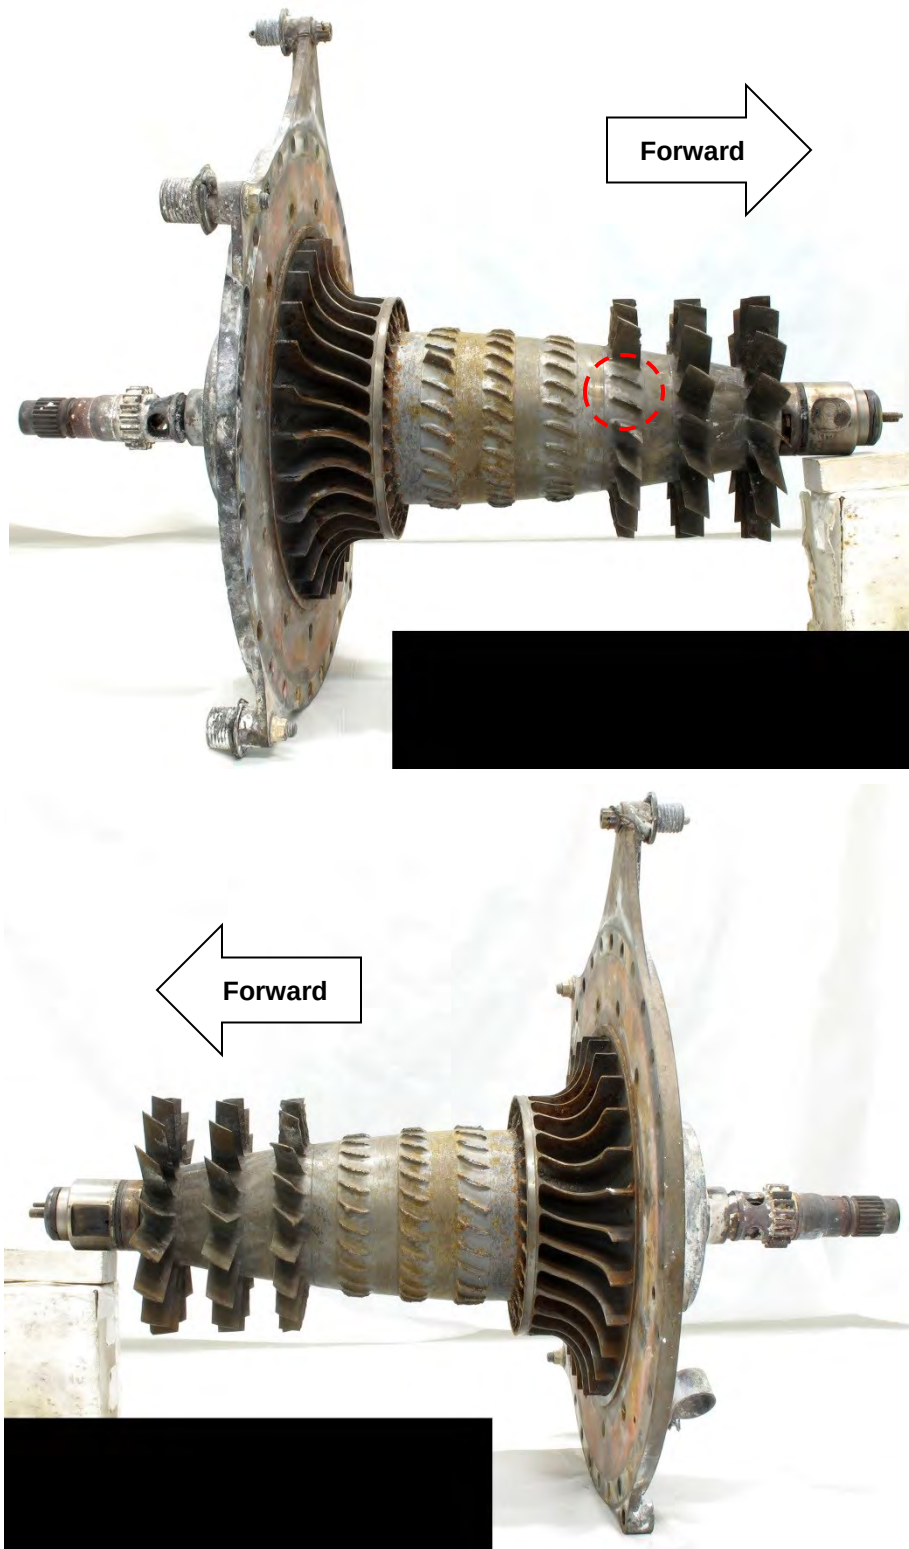
Figure 1 shows the as-received condition of the compressor section. The entire compressor rotor including the impeller, the compressor tie bolt, the No. 1 bearing and sump, compressor rear diffuser, No. 2 bearing and spanner nut, compressor splined adaptor, and the spur adaptor gearshaft were all assembled together when received by the lab. The No. 2 bearing spanner nut was fused to the impeller stub shaft and cutting was required to remove it. The rest of the assembled compressor was able to be disassembled via standard disassembly procedures, except for the stages 1 through 6 compressor rotors (see Figure 2 and Figure 3). All the blades on the stage 4 through 6 compressor wheels were liberated near the root. Two adjacent stage 3 compressor blades from the stage 2-3 compressor wheel were liberated near the root. The compressor rotor was subsequently cut through the gap between blades to separate all the wheels. Table 1 lists the components documented below.

**Figure 1.** As-received condition of the compressor rotor. The red dashed circle indicates the two stage 3 blades that liberated near the root.

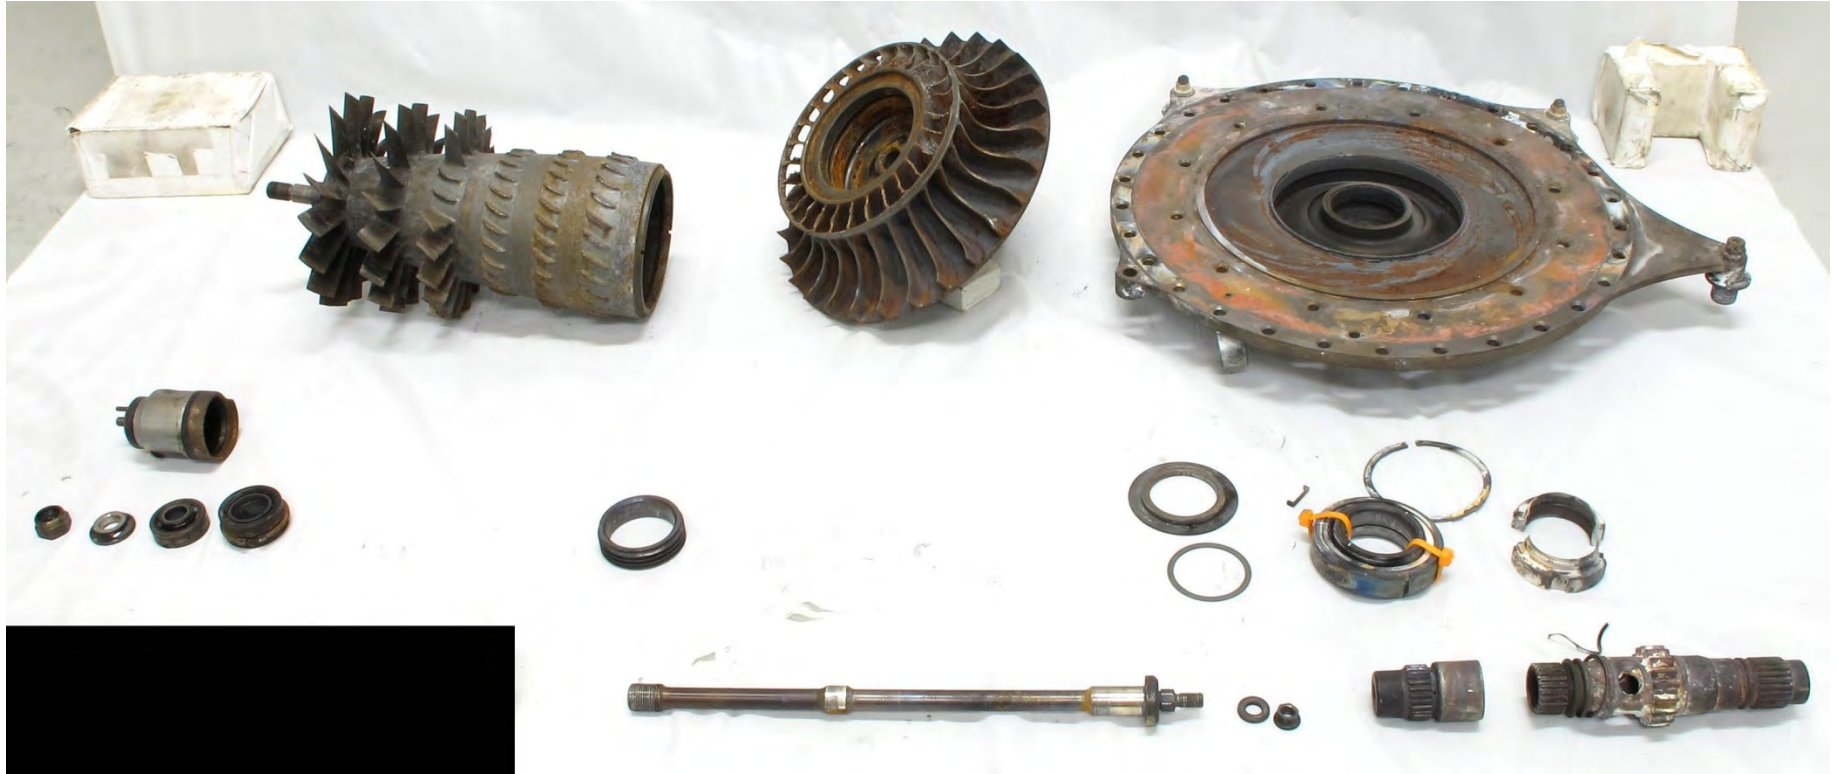
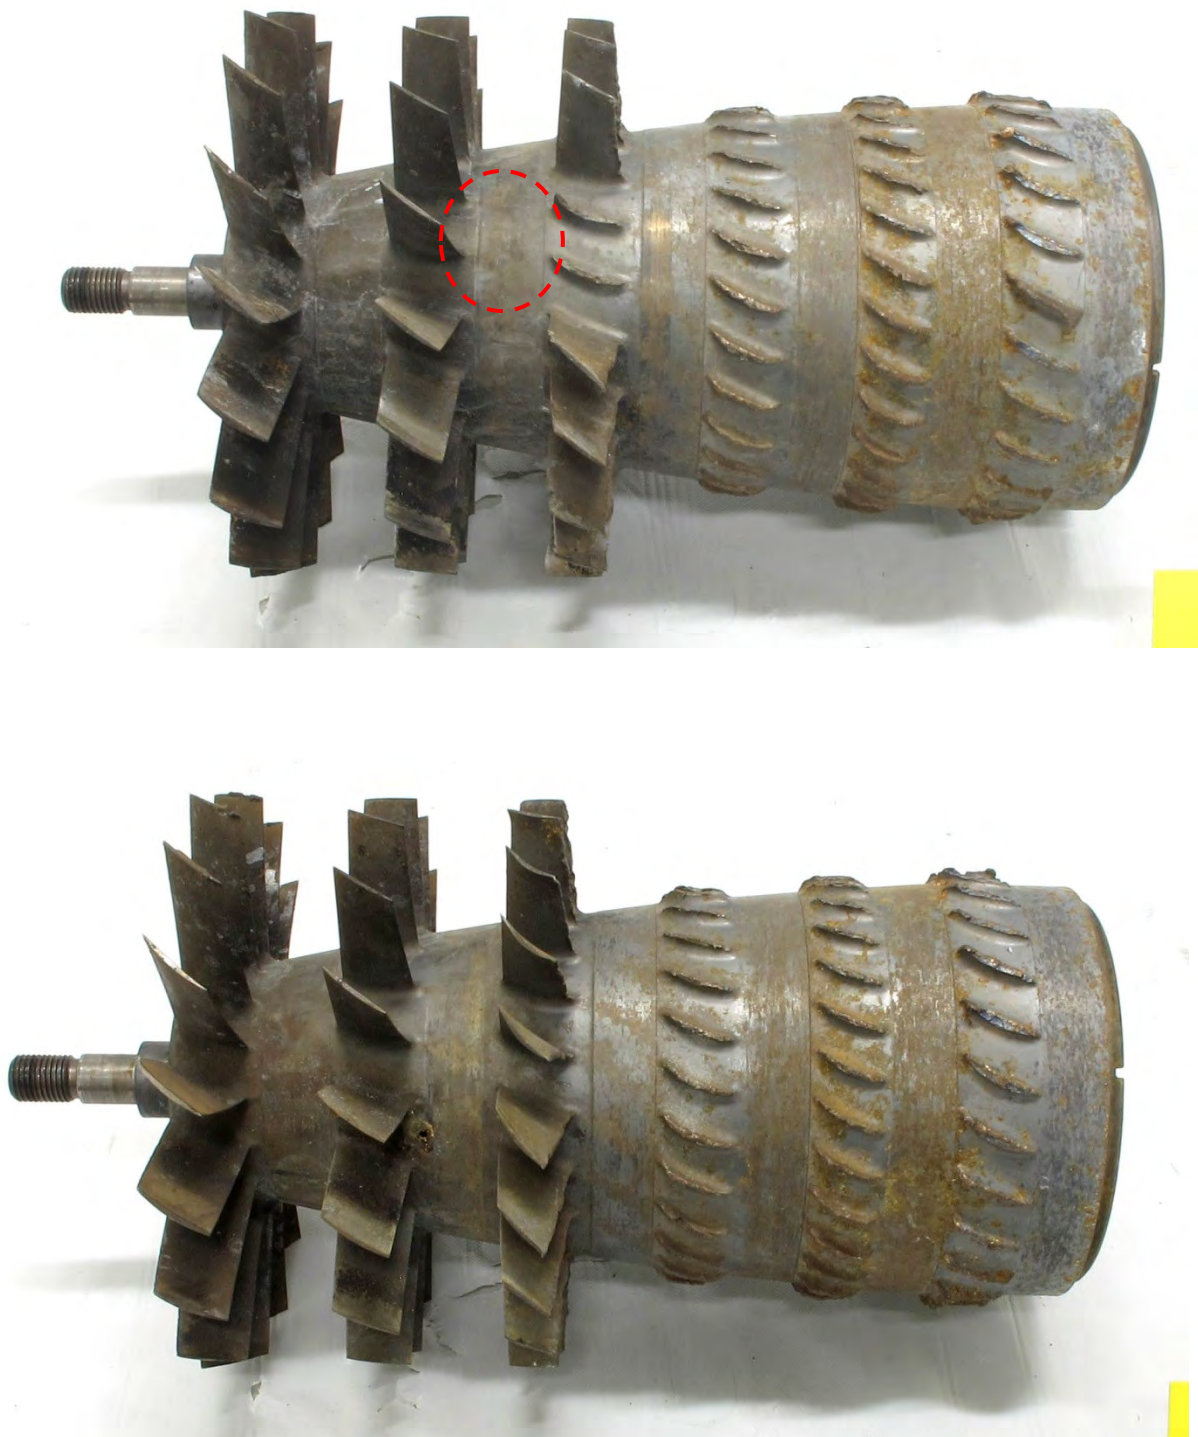
**Figure 3.** Stage 1 through stage 6 compressor wheels. The red dashed circle indicates the two stage 3 blades that liberated near the root. The bottom image shows the rotor rotated approximately 180° relative to the top image.

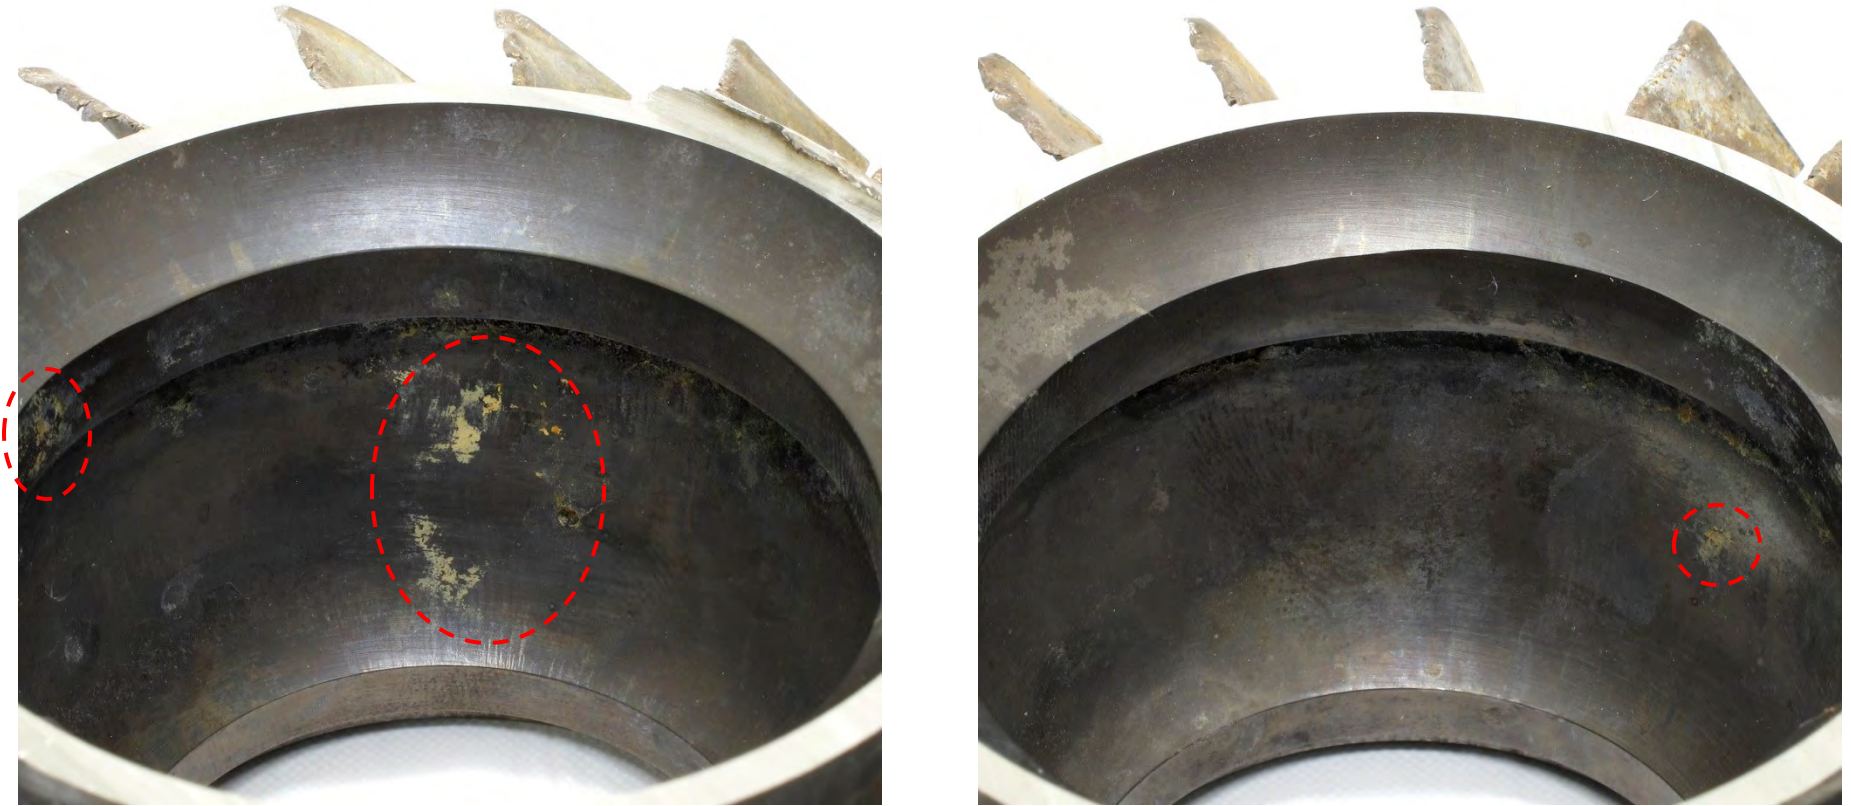
The compressor wheel exhibited generalized corrosion over the entire gas path surface. There were isolated areas on the inner diameter that also exhibited corrosion (see Figure 6). Figures 7 through 11 show detailed views of the trailing edge root areas of all the non-liberated stage 3 compressor blades. No corrosion pitting was noted on any of the blades. There was impact damage on every stage 3 blade trailing edge area, which obfuscated any visually detectable cracking on other blades; however, magnetic particle inspection (MPI) was performed by the Rolls-Royce Test Department to see if any other stage 3 blades exhibited crack-like indications. One blade (blade 16) had an MPI indication on the trailing edge, suction side radius; however, scanning electron microscope (SEM) examination of the area revealed that the indication was in an area of damage from the cutting process (see Figure 12). No other blades exhibited MPI indications.

**Figure 6.** Inner diameter of the stage 2-3 compressor wheel. The red circles indicate areas of corrosion damage. Not all corrosion damage is indicated. Each image shows the component rotated approximately 180° from the previous.

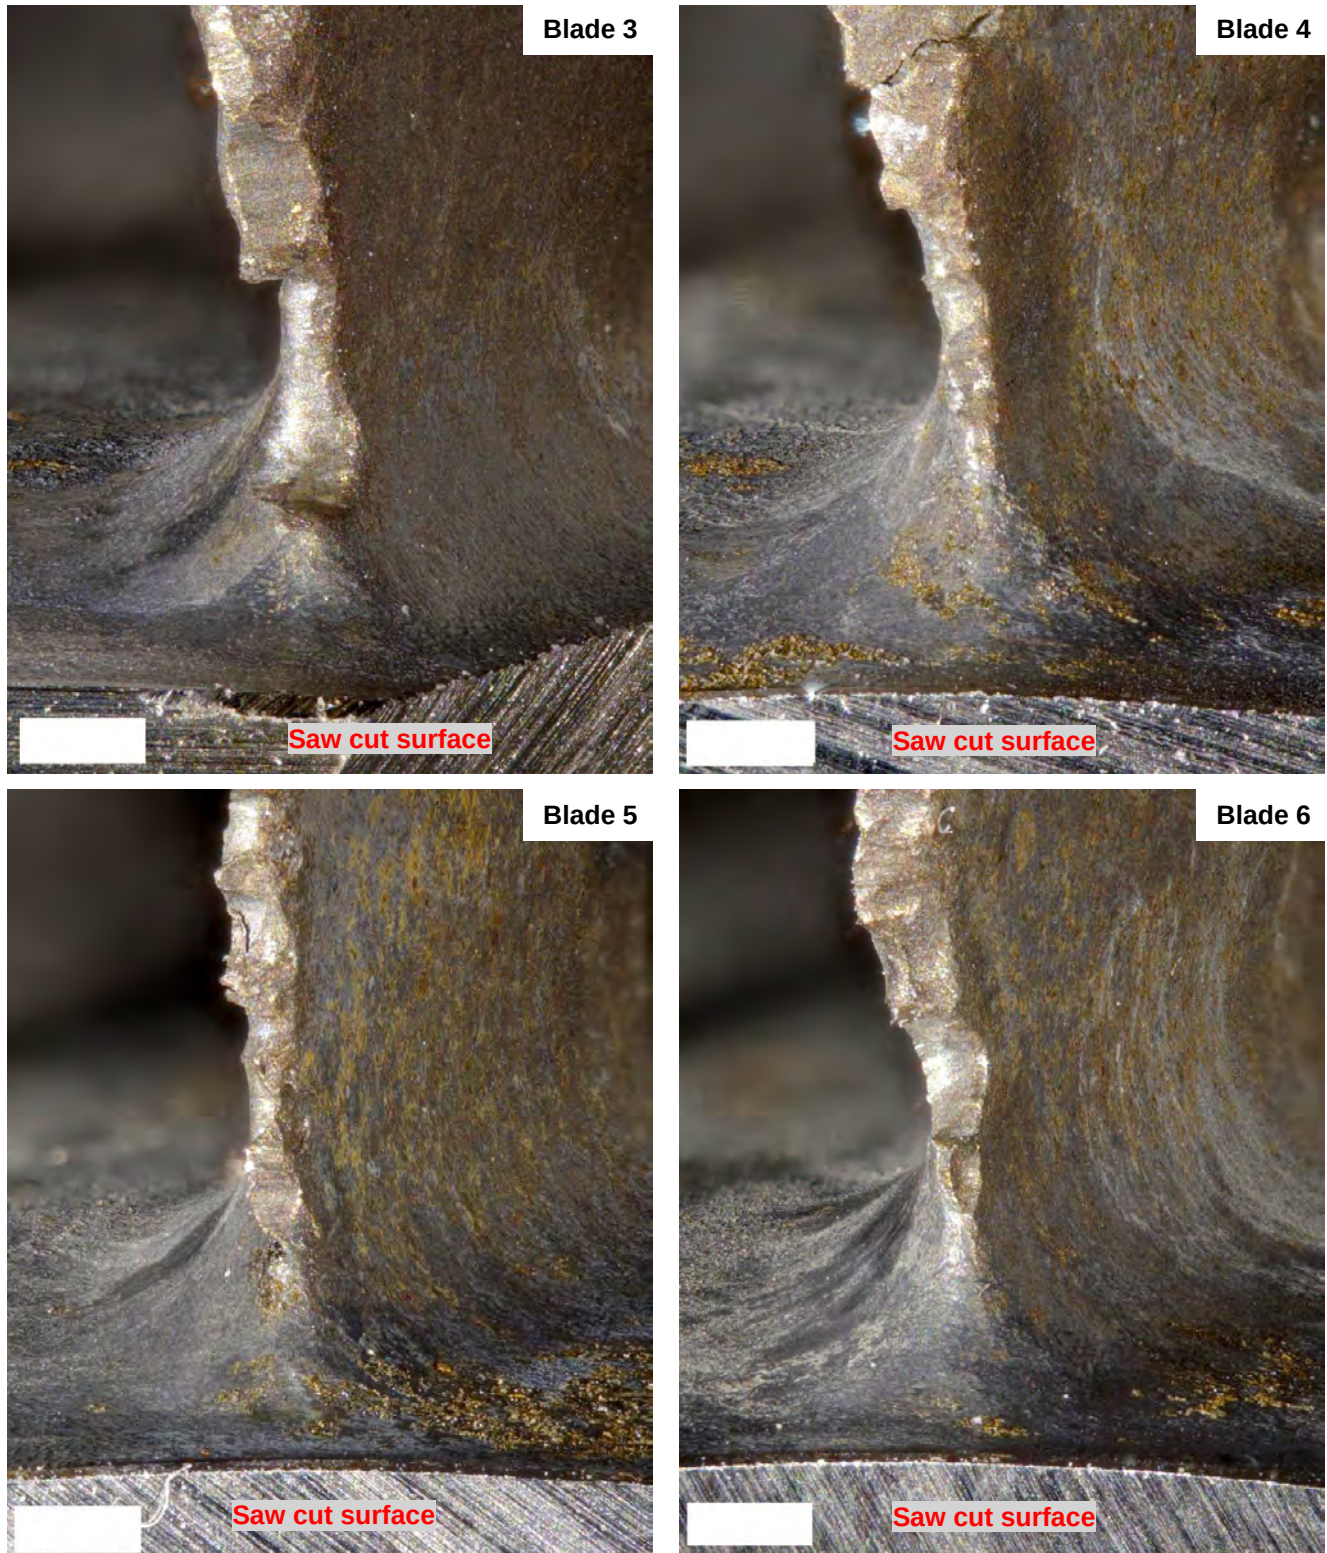
**Figure 7.** Detailed images of the trailing edge root area of stage 3 compressor blades 3 through 6.

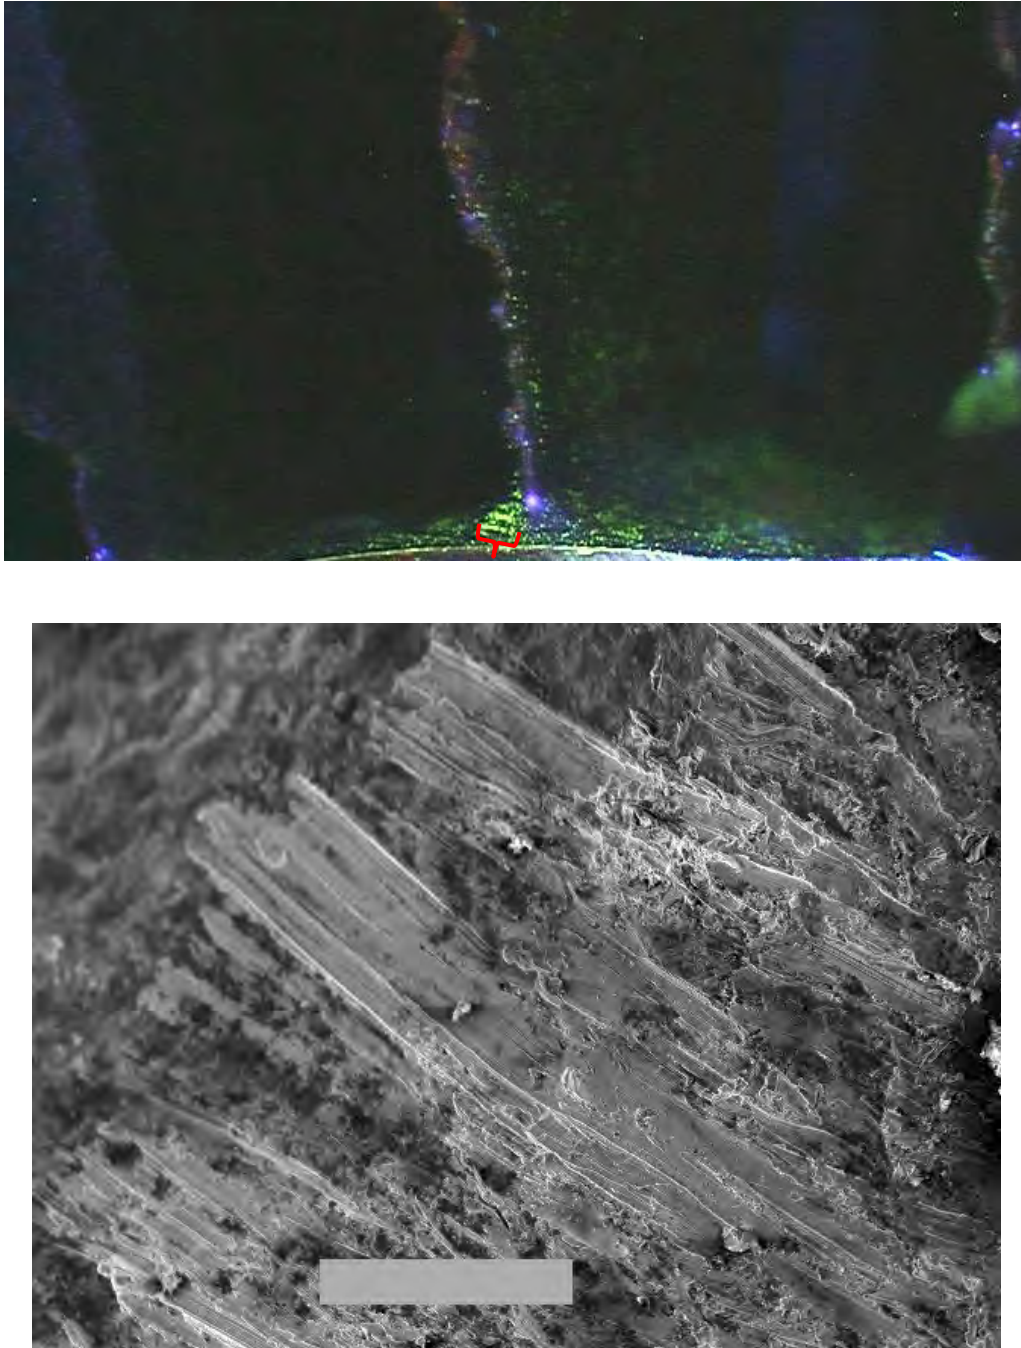
**Figure 12.** Top: Blacklight MPI photo of the trailing edge of blade 16. The red brace indicates an MPI indication. Image provided by the Rolls-Royce Test Department.  
Bottom: Secondary electron SEM image of the area of the MPI indication, which exhibited cutting damage.

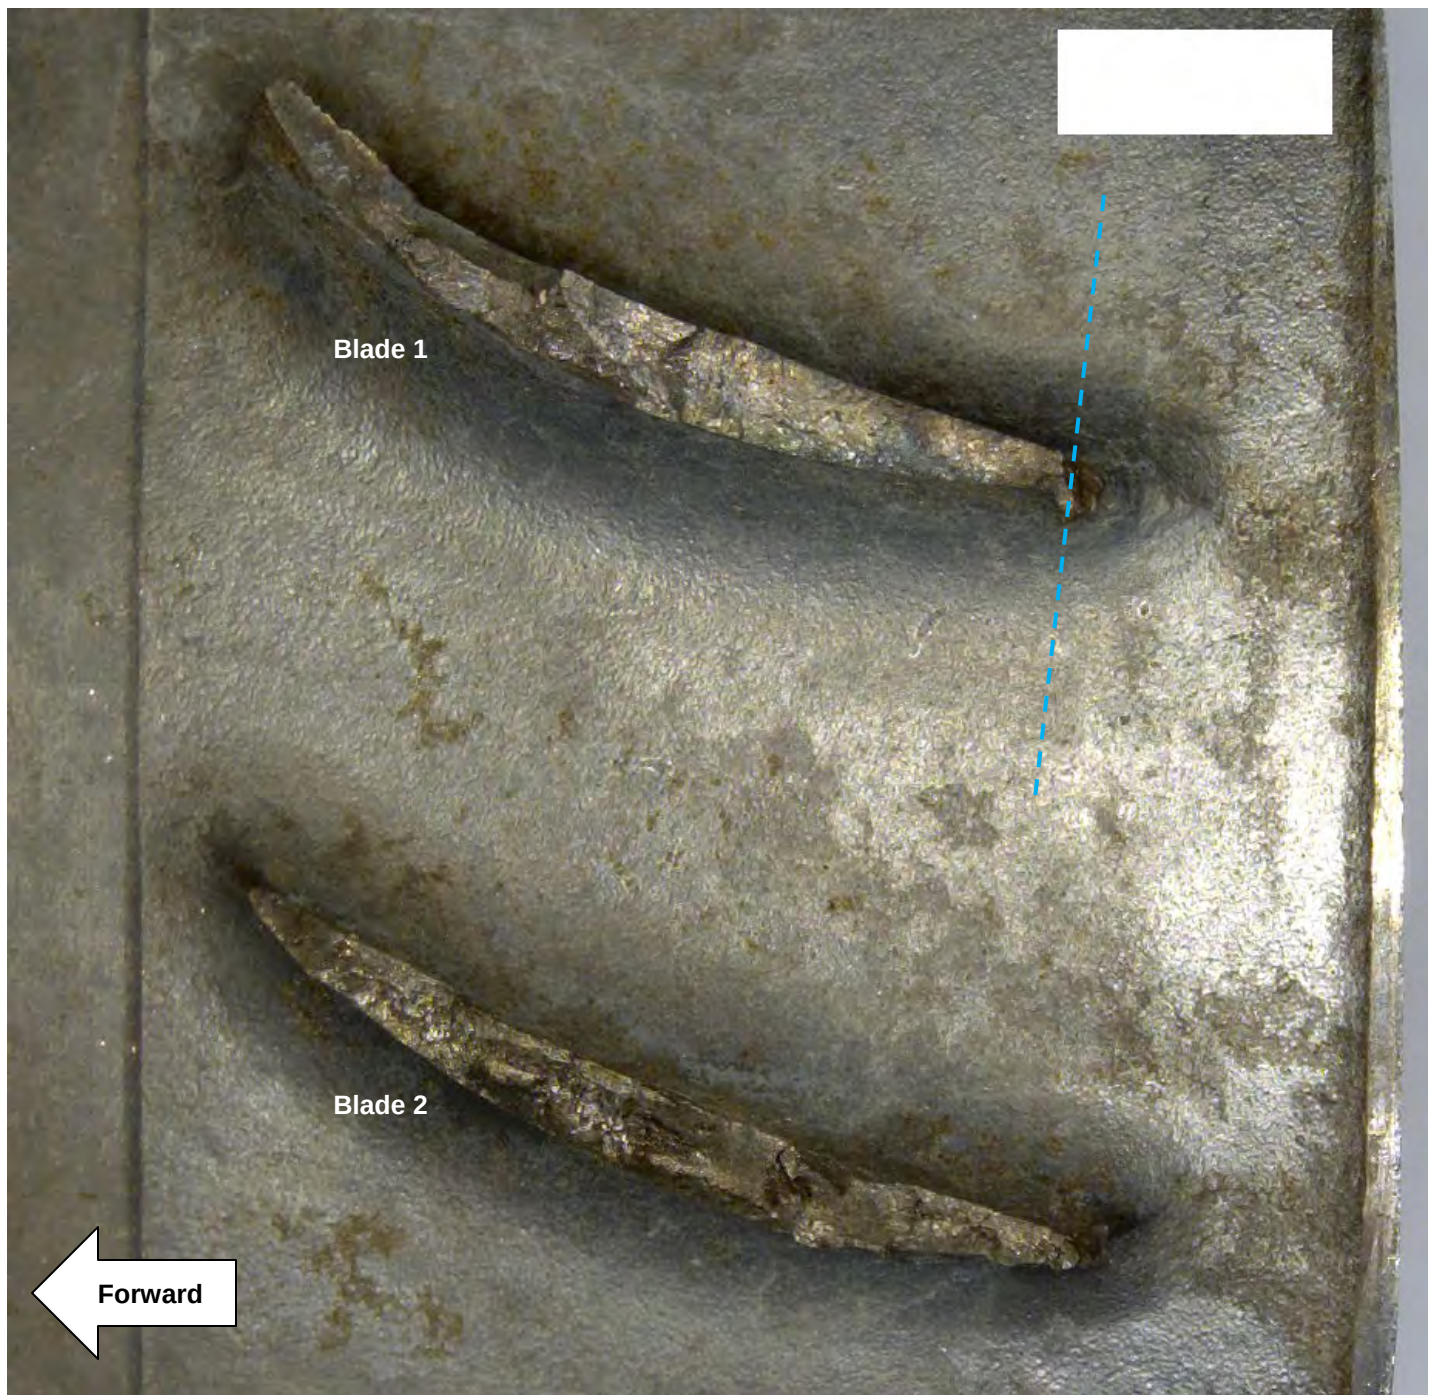
Figure 13 shows the fracture surfaces from stage 3 compressor blades 1 and 2. Figure 14 shows detailed views of the trailing edge area of blade 1, which exhibited fatigue fracture initiating near the trailing edge, pressure side. The fatigue fracture surface extended approximately 0.31 inch from the trailing edge along the pressure side surface. The trailing edge area was impact damaged on both the radius and pressure side corner.

**Figure 13. Detailed radial views of the fracture surfaces of the two liberated stage 3 compressor blades. The blue dashed line shows the approximate plane of metallographic cross section shown in Figure 23.**

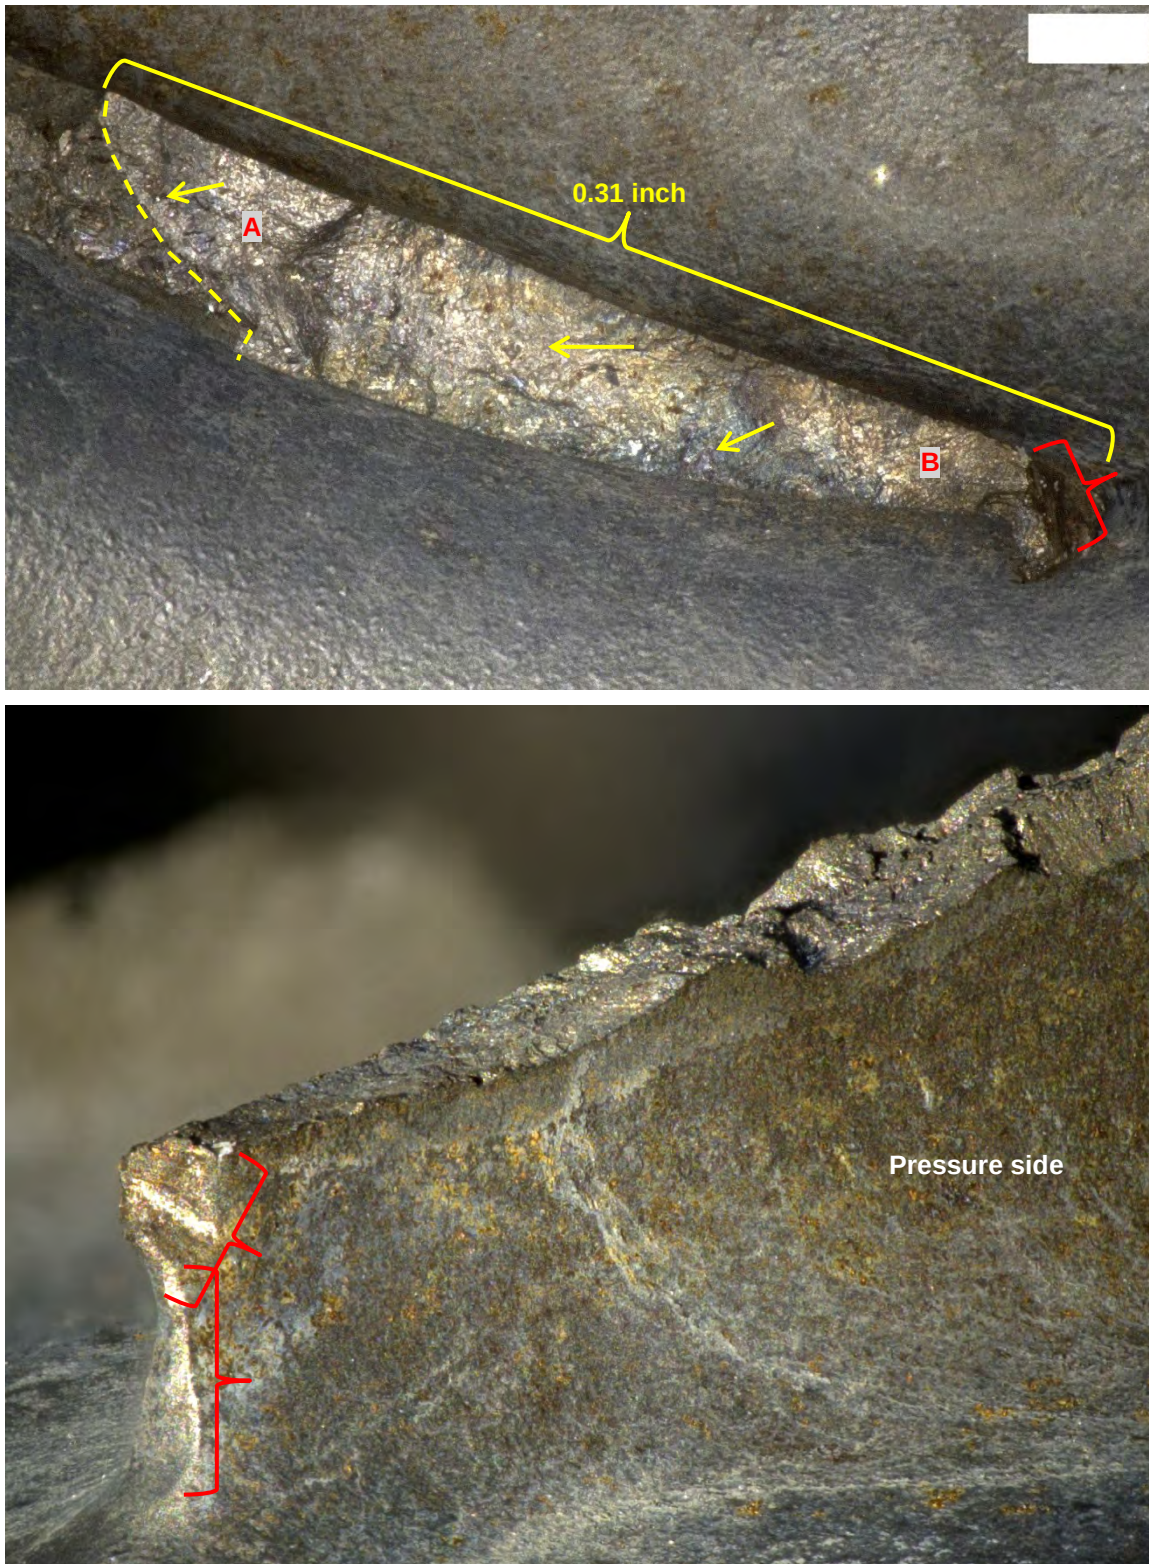
- 2.1 One stage 3 compressor blade fractured in fatigue initiating from the trailing edge area near the pressure side, approximately 0.12 inch above the rim. The fatigue progressed approximately 0.31 inch toward the leading edge before the airfoil liberated in overload. Impact damage at the trailing edge obliterated the origin area.

**Figure 14.** Detailed views of the trailing edge area of blade 1. The yellow dashed line indicates the approximate transition from fatigue to overload. The yellow arrows indicate the local direction of fatigue progression. The red braces indicate impact damage at the trailing edge. Areas A and B are shown in the following figure.

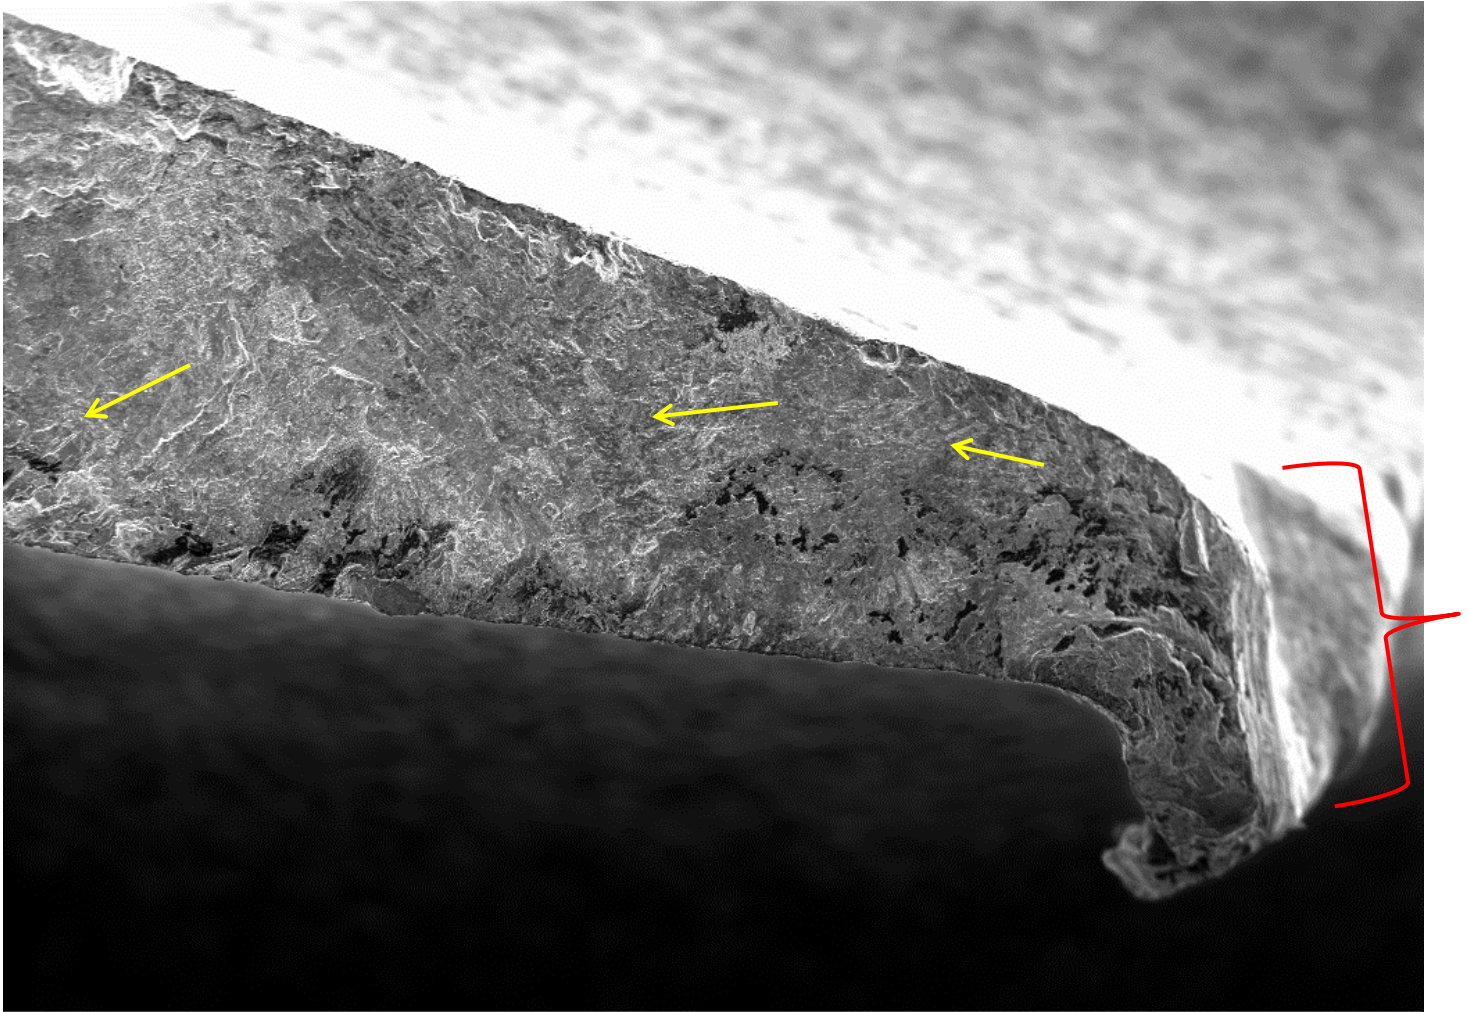
SEM examination of the fracture surface revealed fatigue progression from the impact damaged area on the trailing edge pressure side corner (see Figures 15 and 16). Figure 17 shows representative ductile fracture features from the overload region. Figure 18 shows the trailing edge of blade 1, which did not exhibit any geometric or material anomalies other than the aforementioned impact damage.

**Figure 15. Detailed SEM image of the trailing edge of blade 1. The red brace indicates the impact damage. The yellow arrows indicate the direction of fatigue progression.**

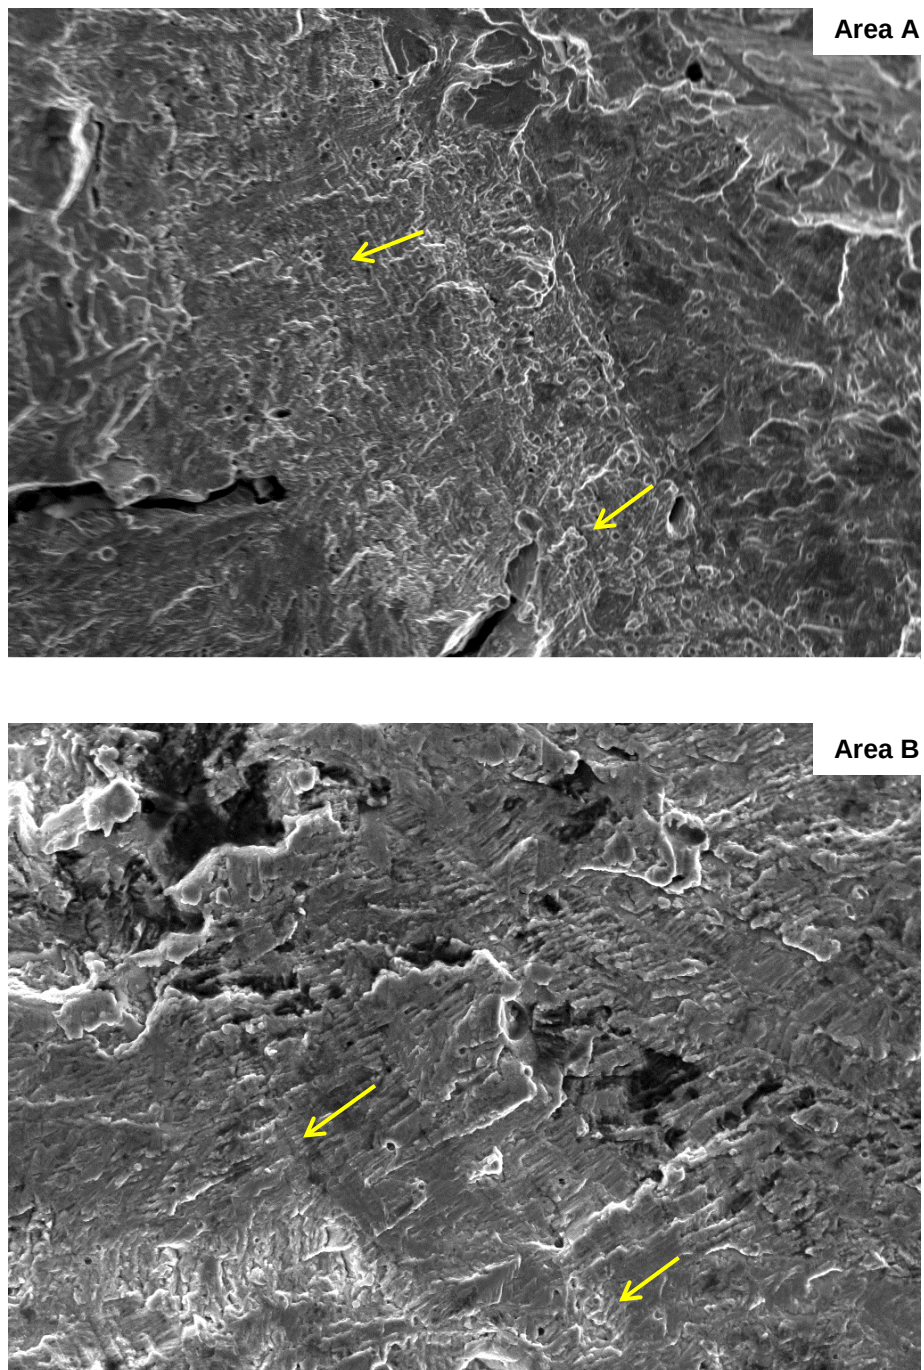
**Figure 16. Detailed secondary electron SEM images of fatigue fracture features from blade 1 (see Figure 14).**

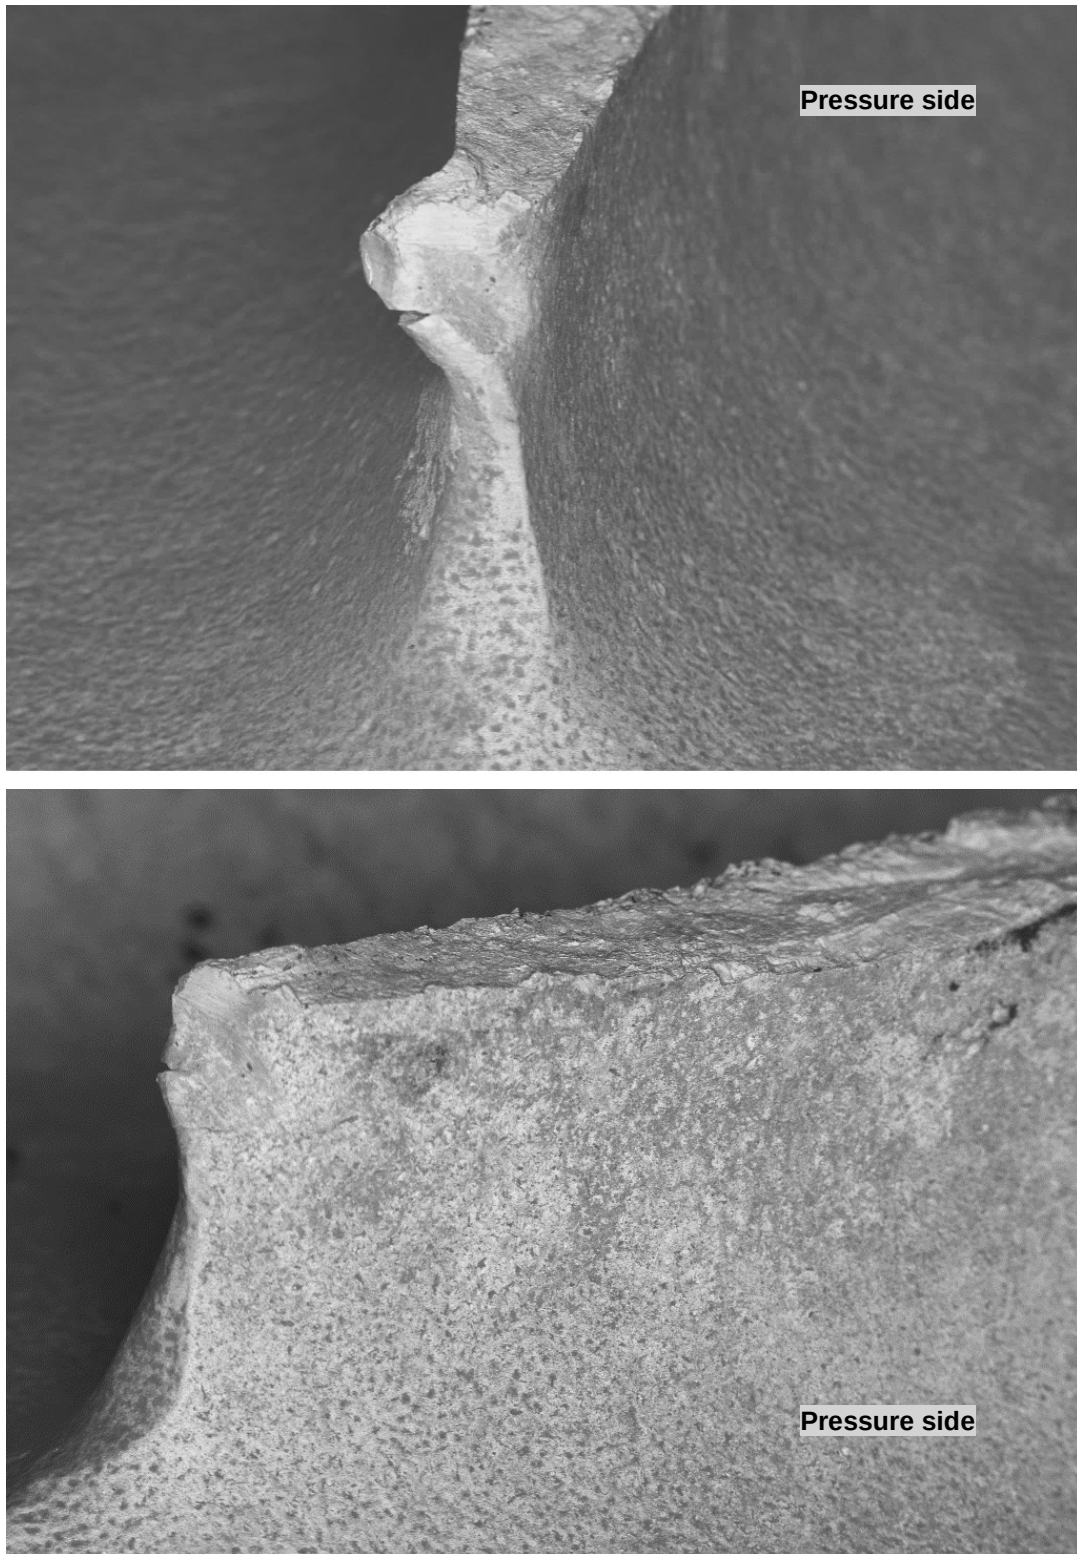
**Figure 18. Detailed backscattered electron SEM images of the trailing edge area of blade 1.**

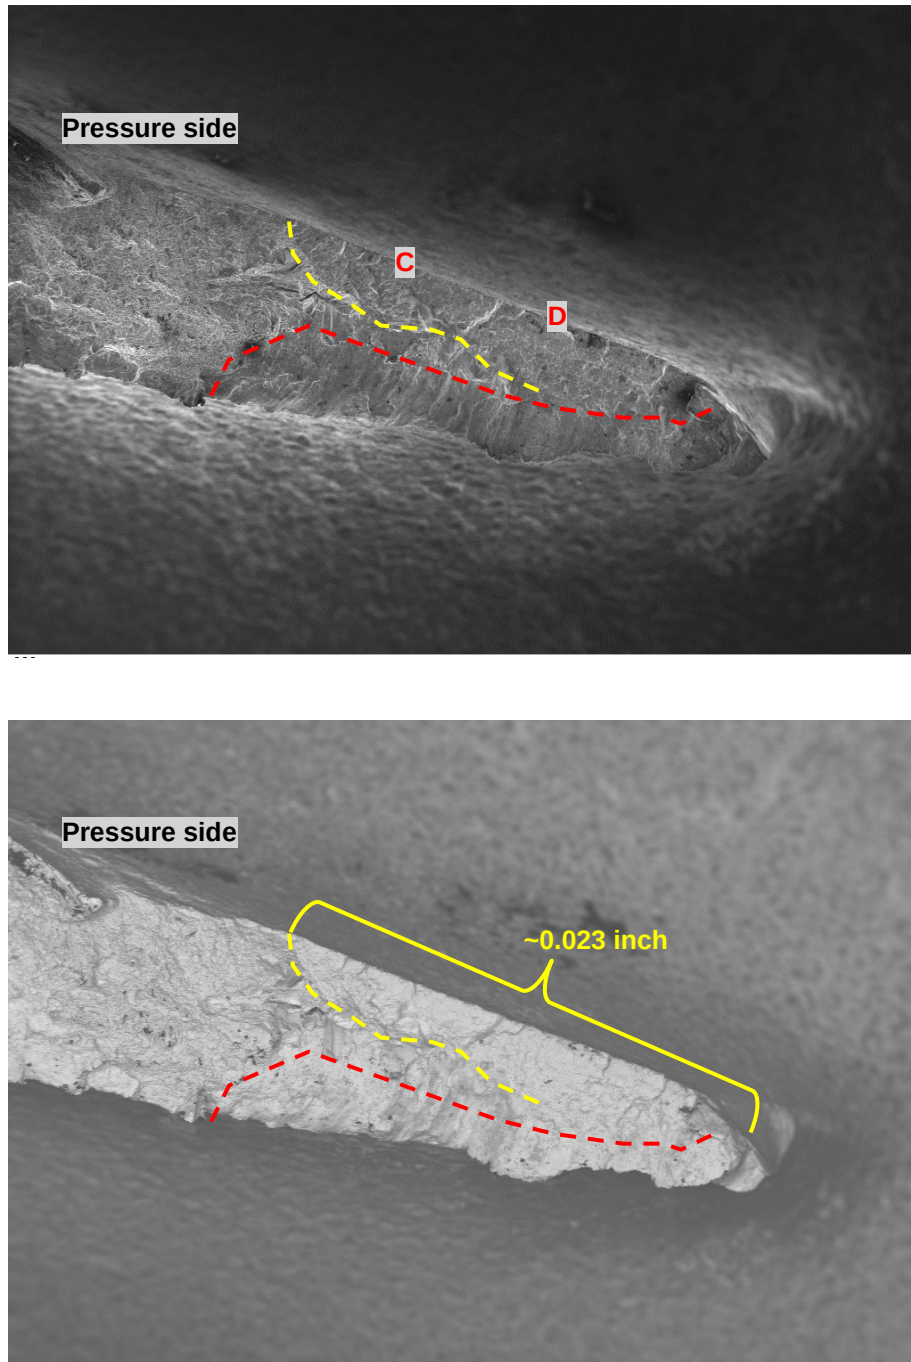
- 2.2 The stage 3 blade following the primary fractured blade in the direction of engine rotation also exhibited a fatigue fracture on the pressure side surface near the trailing edge. This fatigue surface extended approximately 0.023 inch from the trailing edge.

Figure 19 shows SEM images of the trailing edge of blade 2, which revealed two fatigue fractures initiating from multiple origins on the pressure side near the trailing edge. The total length of the fatigue crack was approximately 0.023 inch along the pressure side surface, extending from the trailing edge. Figures 20 and 21 show detailed SEM images of fatigue fracture features from multiple initiations on the pressure side surface of

**Figure 19.** Secondary (top) and backscattered (bottom) electron SEM images of the trailing edge area of the blade 2 fracture surface. The red dashed line outlines an area of smearing consistent with secondary impact damage. The yellow dashed line indicates the approximate boundary of the fatigue region at the pressure side. Areas C and D are shown in greater detail in Figures 20 and 21, respectively.

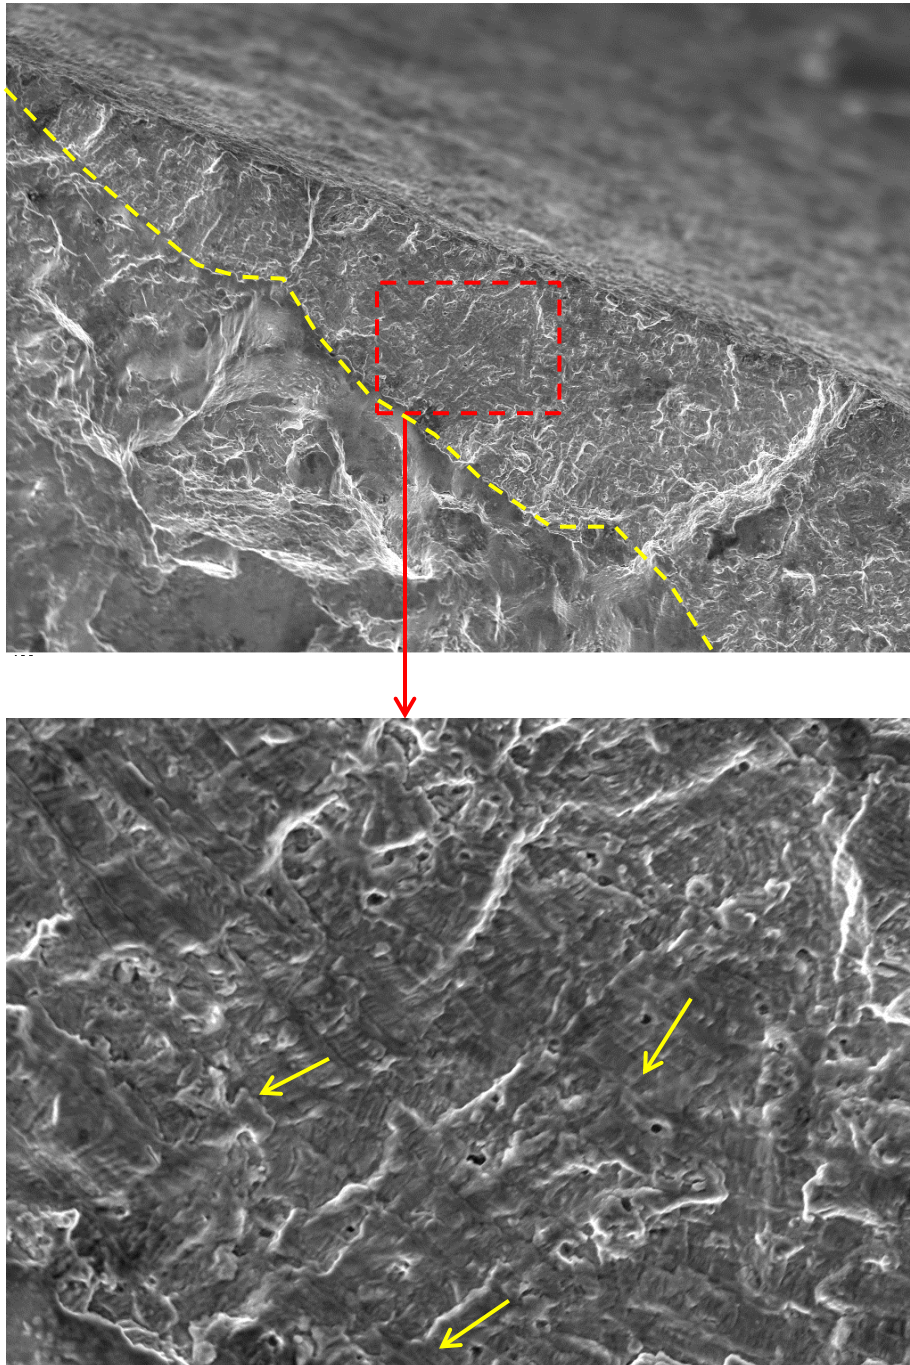
**Figure 20.** Secondary electron SEM images of area C from Figure 19. The yellow dashed line indicates the approximate boundary of the fatigue region. The yellow arrows indicate the local direction of fatigue progression.
