## **AIRWORTHINESS GROUP FACTUAL REPORT**

**NTSB No. ERA21FA130**

**Rolls-Royce Materials Evaluation Report No. 21FAE-025-PR  
(111 pages)**

| <b>TITLE</b><br><br><b>METALLURGICAL INVESTIGATION OF COMPRESSOR COMPONENTS REMOVED FROM AN M250-C20B, ENGINE S/N CAE833459, OPERATED BY CARIBBEAN BUZZ HELICOPTER</b> | | <b>PREPARED</b><br>Signatures on File | | |

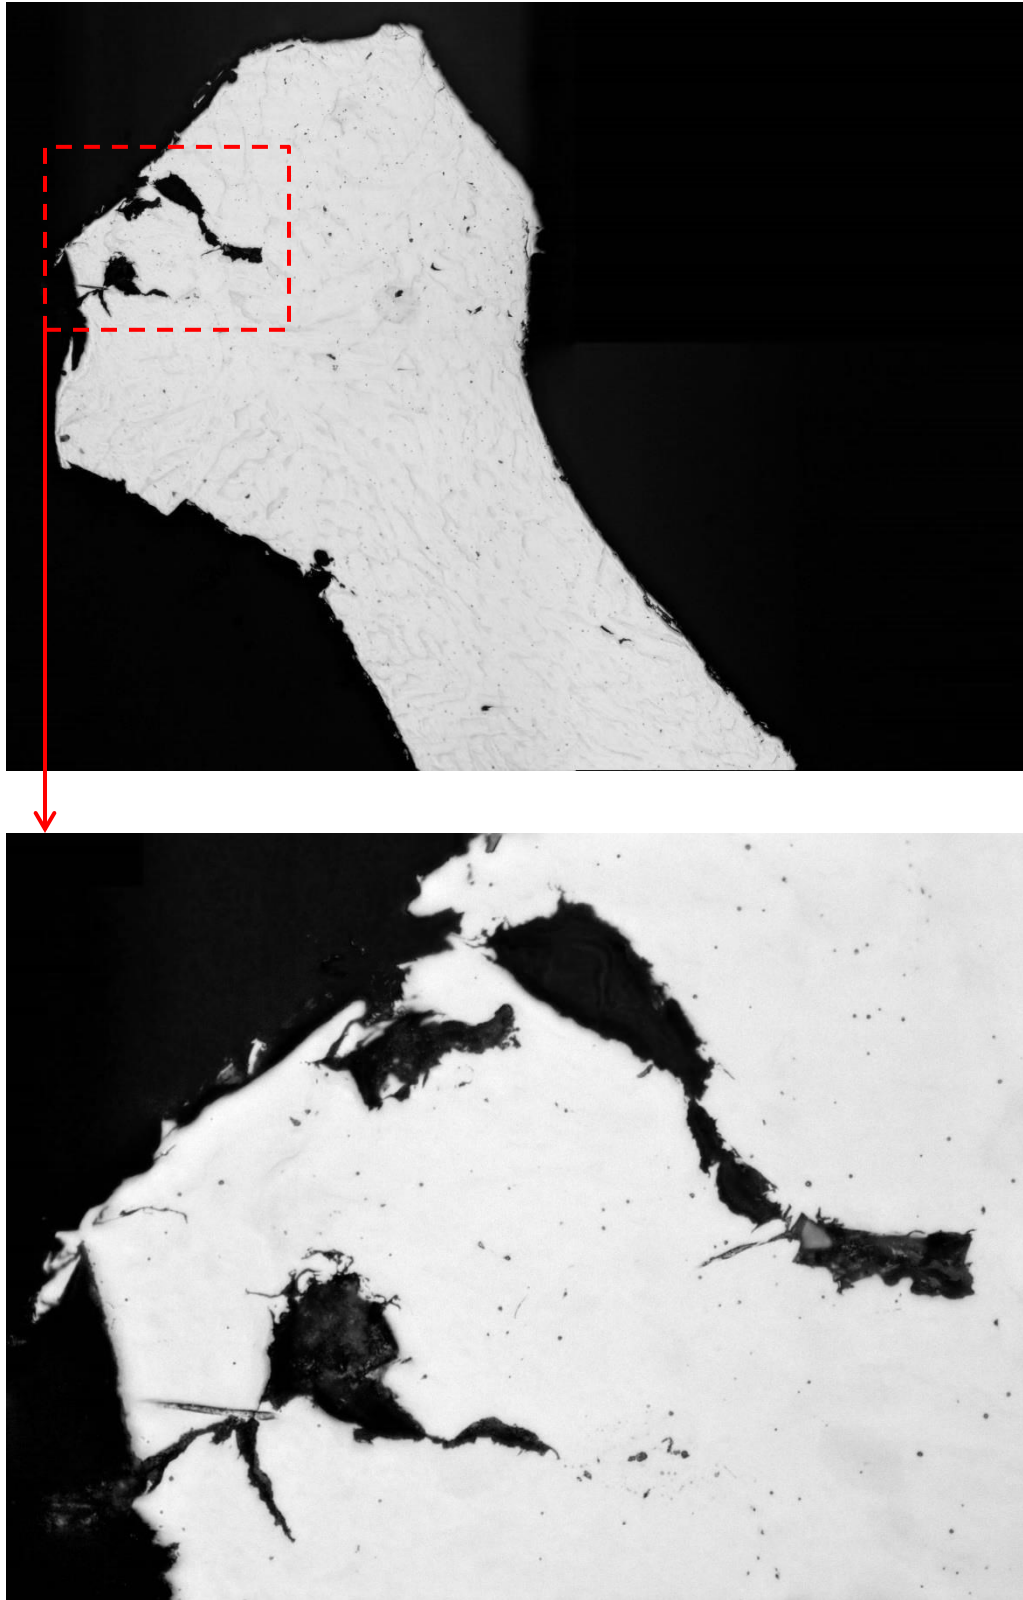
**Figure 24. Detailed views of the area near the fracture surface from the cross section in Figure 23. Unetched.**

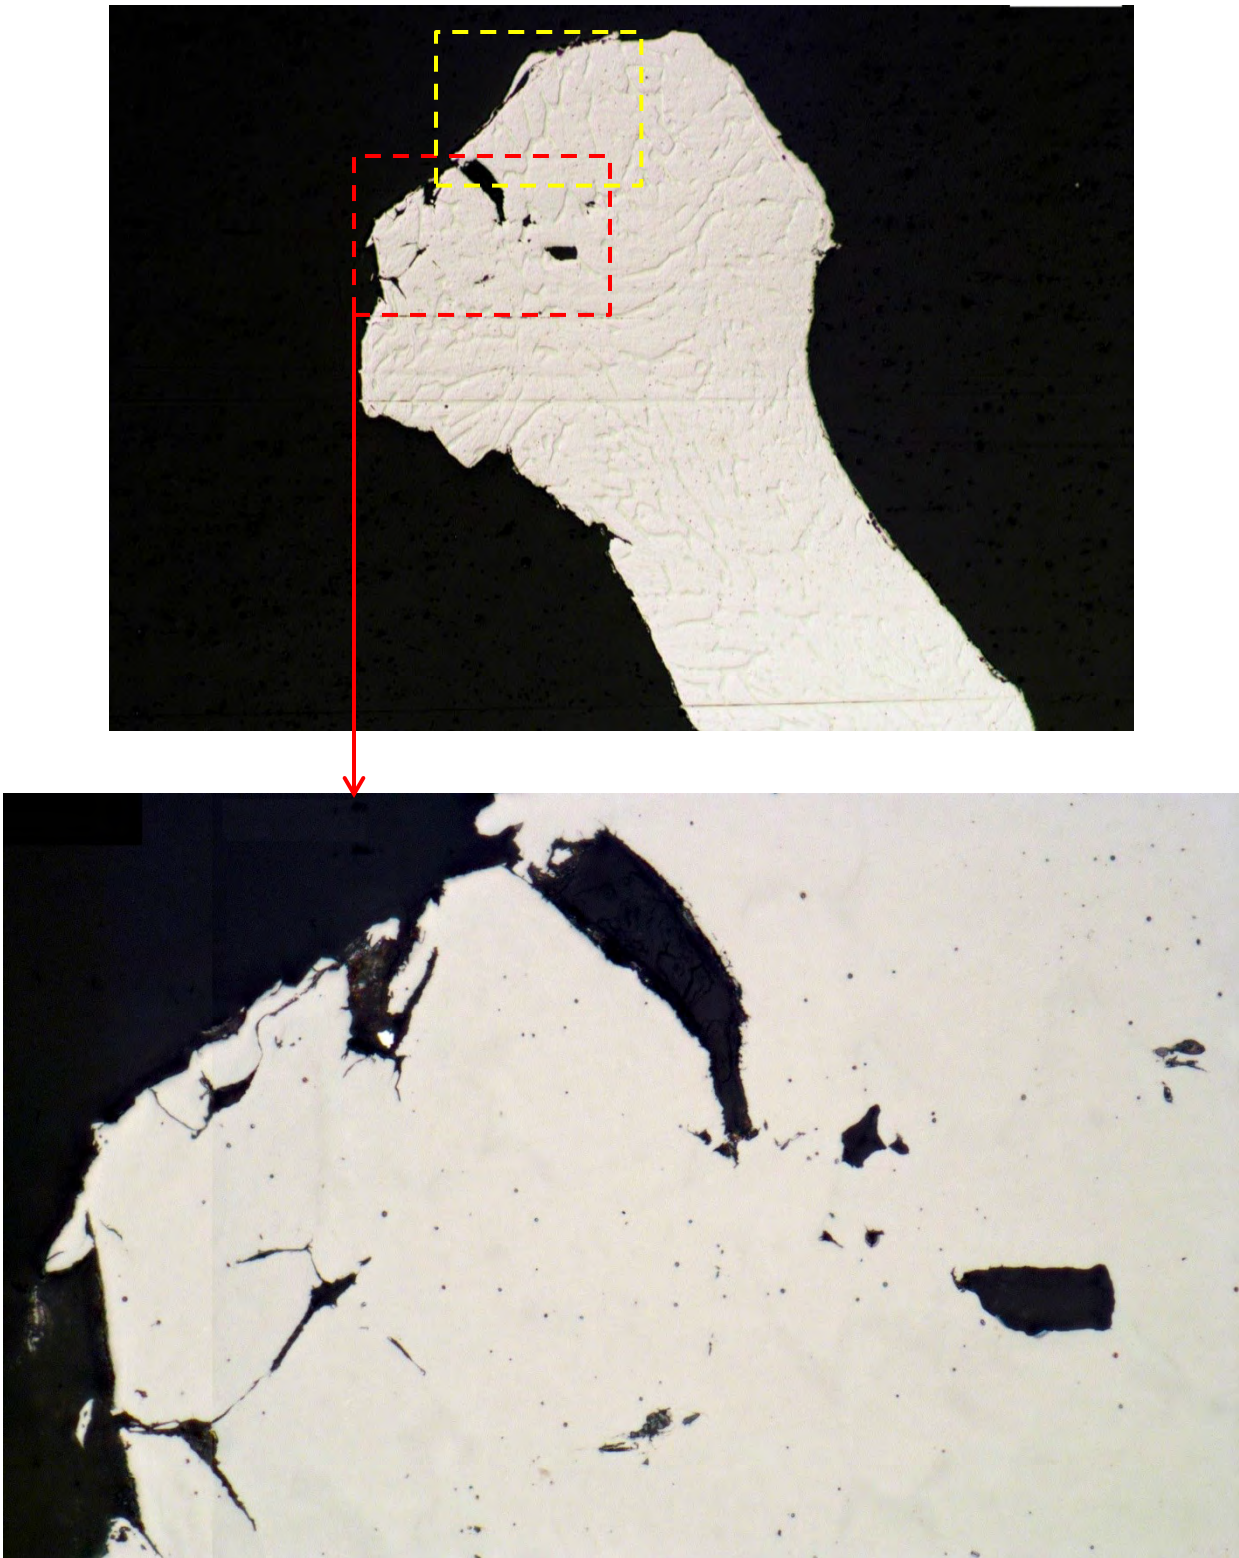
**Figure 25. Detailed views of the origin area from the cross section in Figure 23 after removing approximately 0.02 inch of material to move the plane farther from the trailing edge. The area in the yellow dashed box is shown in greater detail in the following figure. Unetched.**

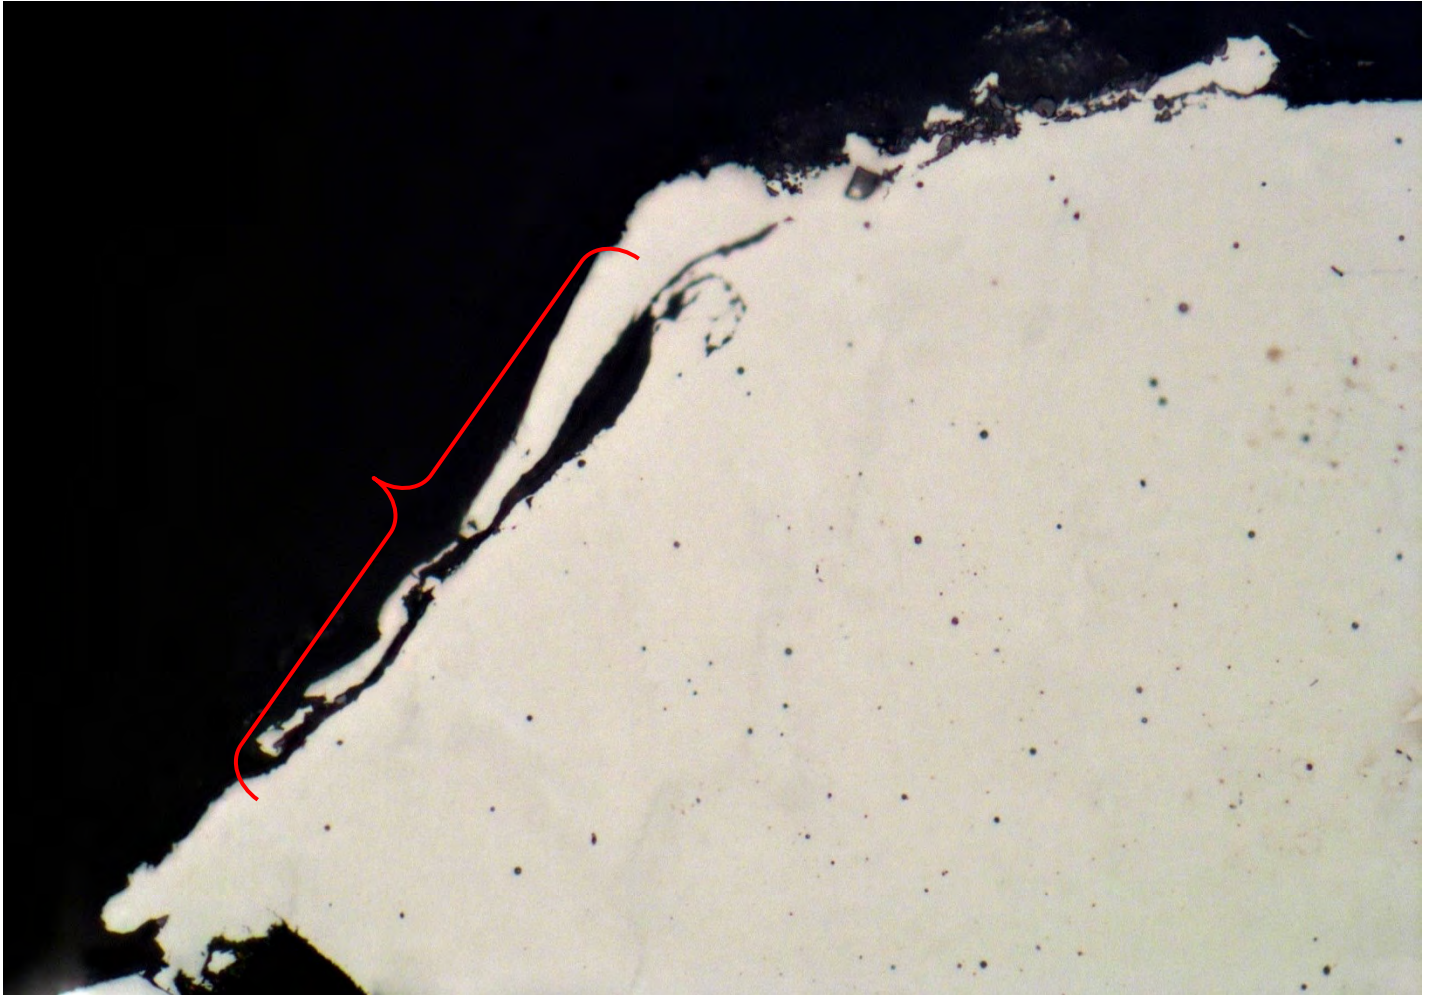
**Figure 26. Deformed and folded over material (red brace) near the origin area consistent with secondary impact damage (see Figure 25). Unetched.**

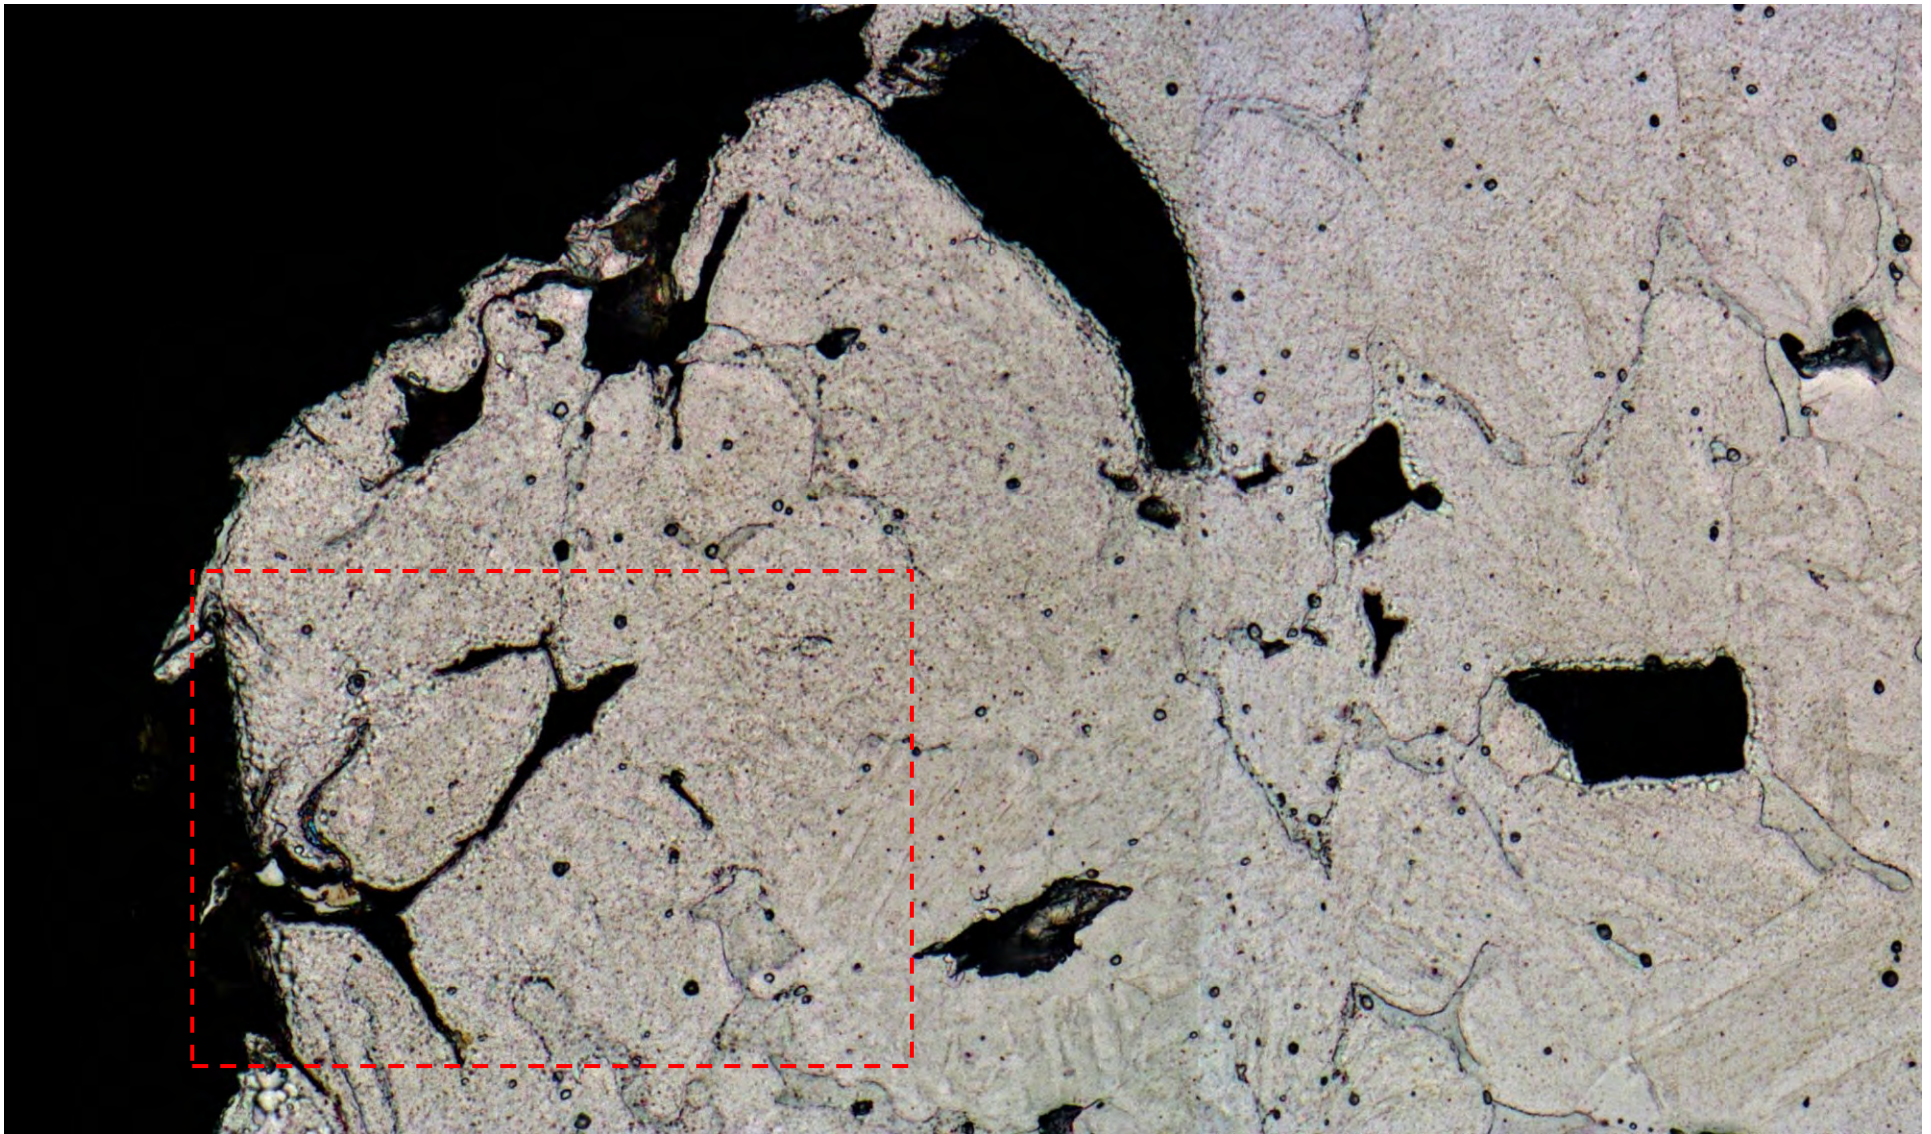
**Figure 27. Montage of etched metallographic images of the area of the cross section in Figure 25 that exhibited subsurface voids. The area in the red dashed box is shown in Figure 28.**

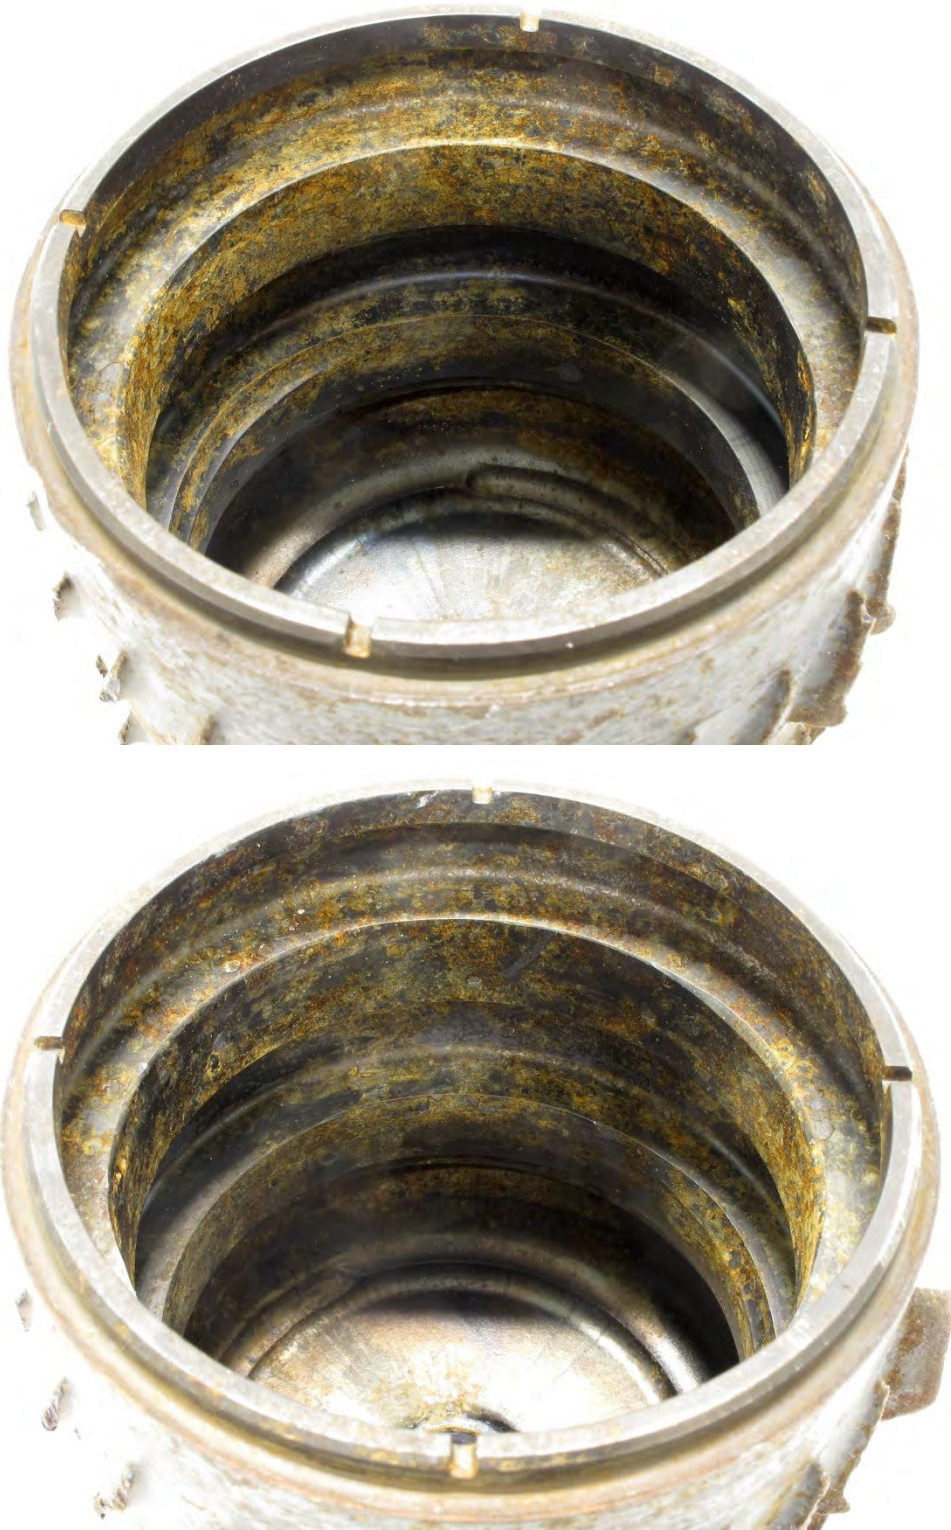
**Figure 34. Inner diameter of the stage 4 through 6 compressor wheels after separation from the stage 1 through 3 compressor wheels. Each image shows the component rotated approximately 180° from the previous. Generalized corrosion was present on the majority of the inner diameter.**

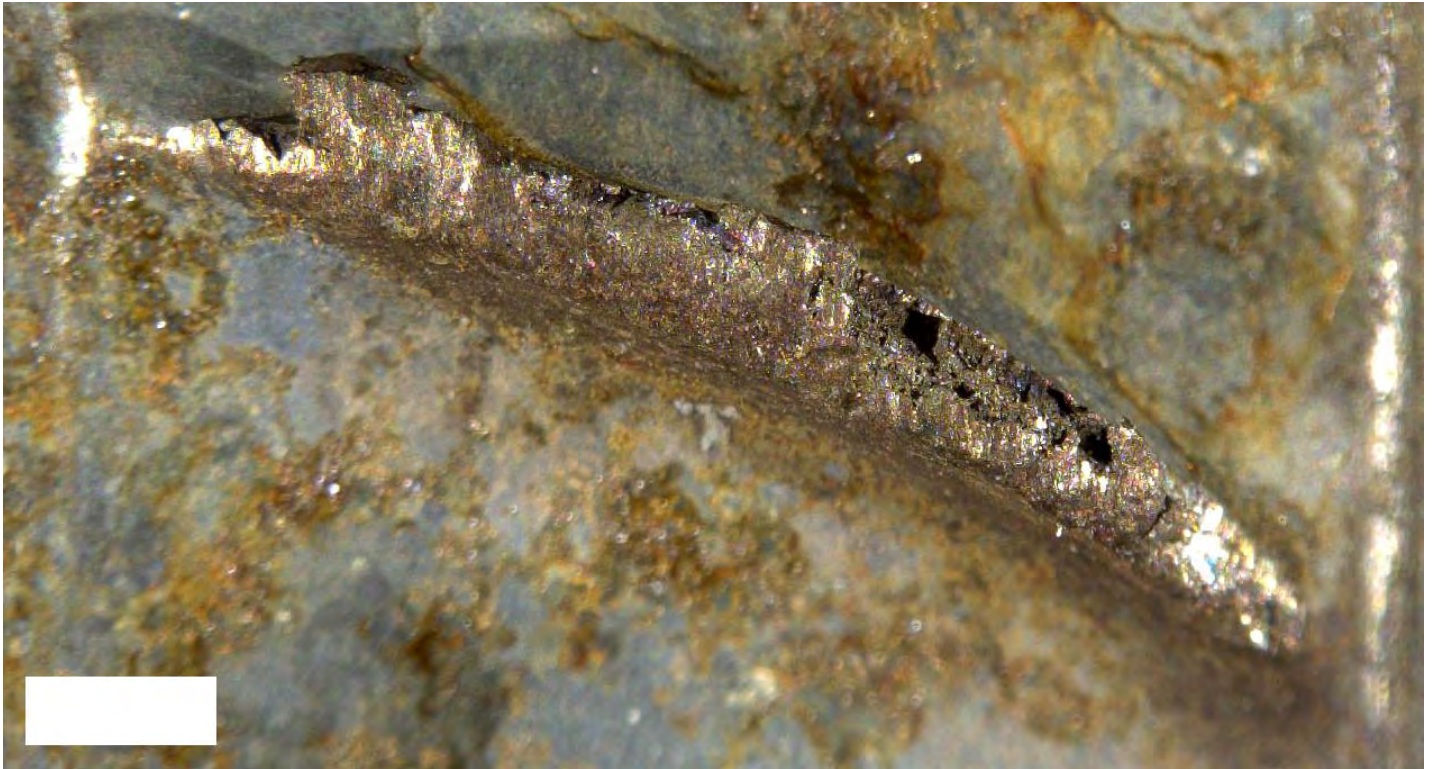
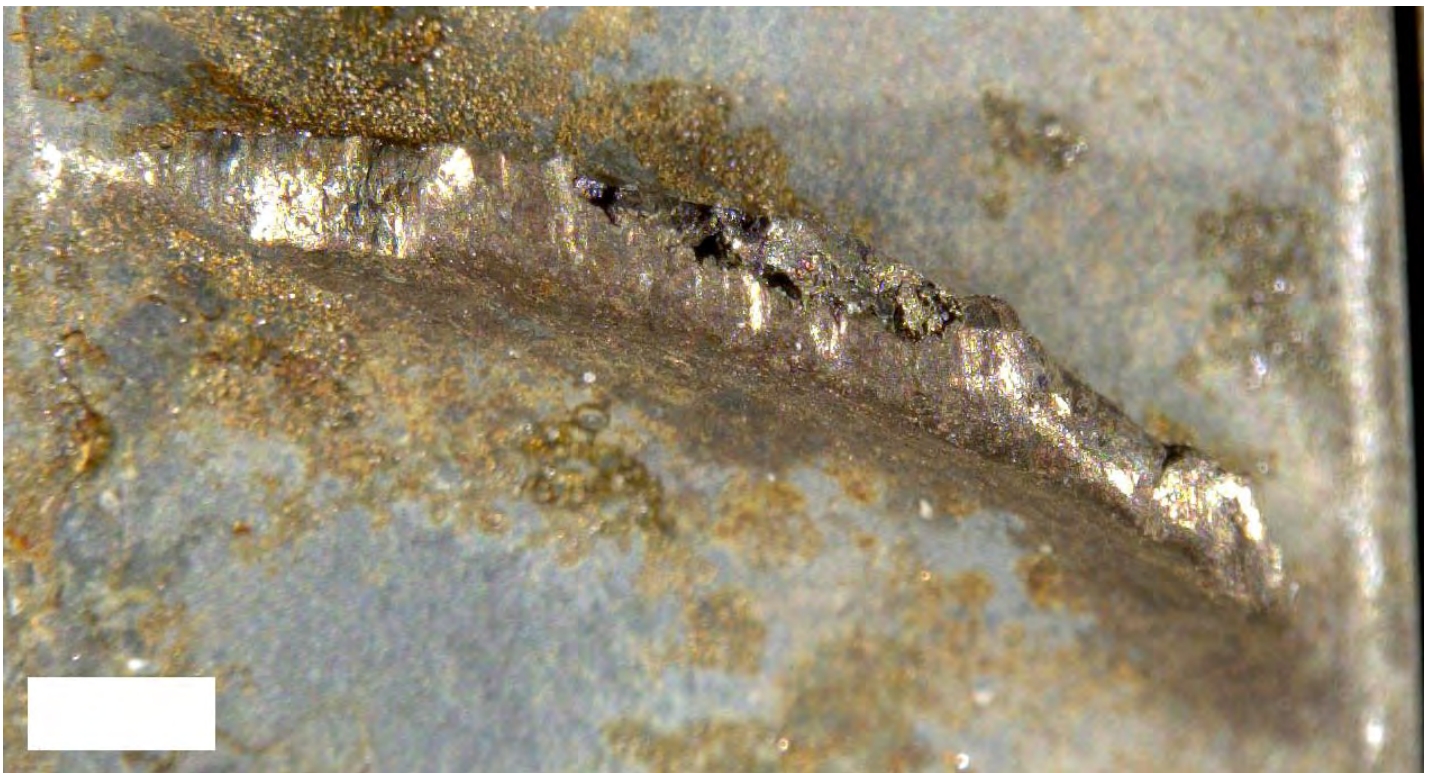
**Figure 48. Detailed views of two stage 5 blade fracture surfaces. No fatigue fracture features were present on either of the fracture surfaces.**

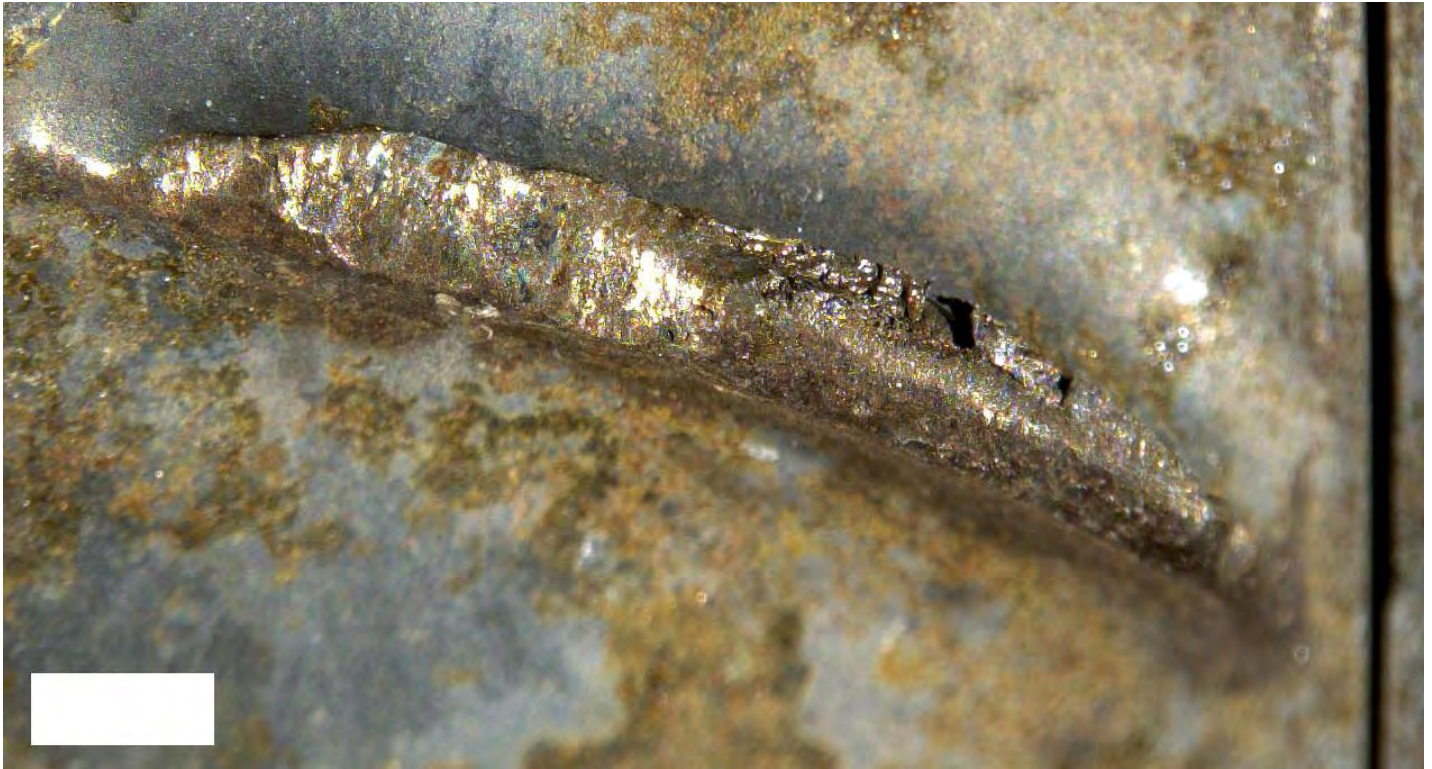
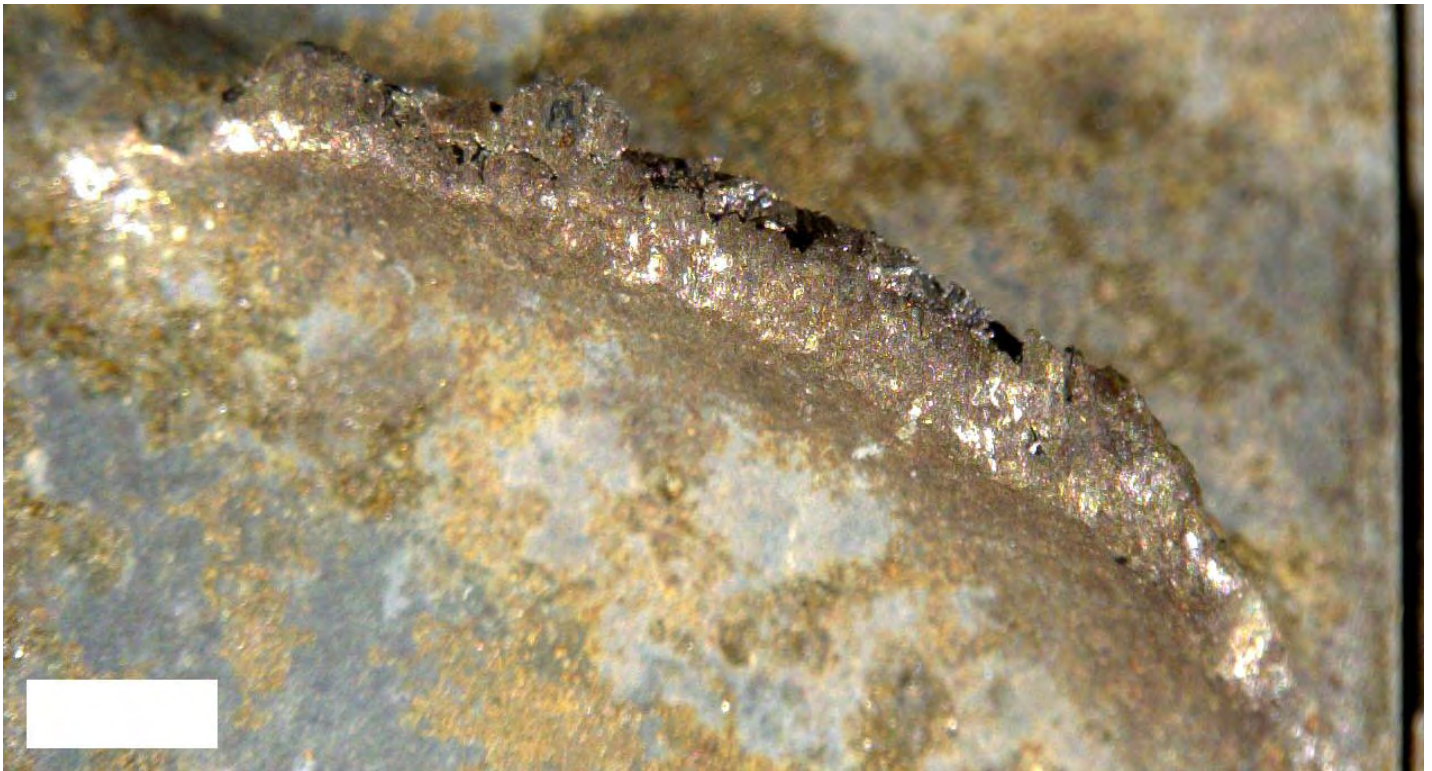
**Figure 49. Detailed views of two stage 5 blade fracture surfaces. No fatigue fracture features were present on either of the fracture surfaces.**

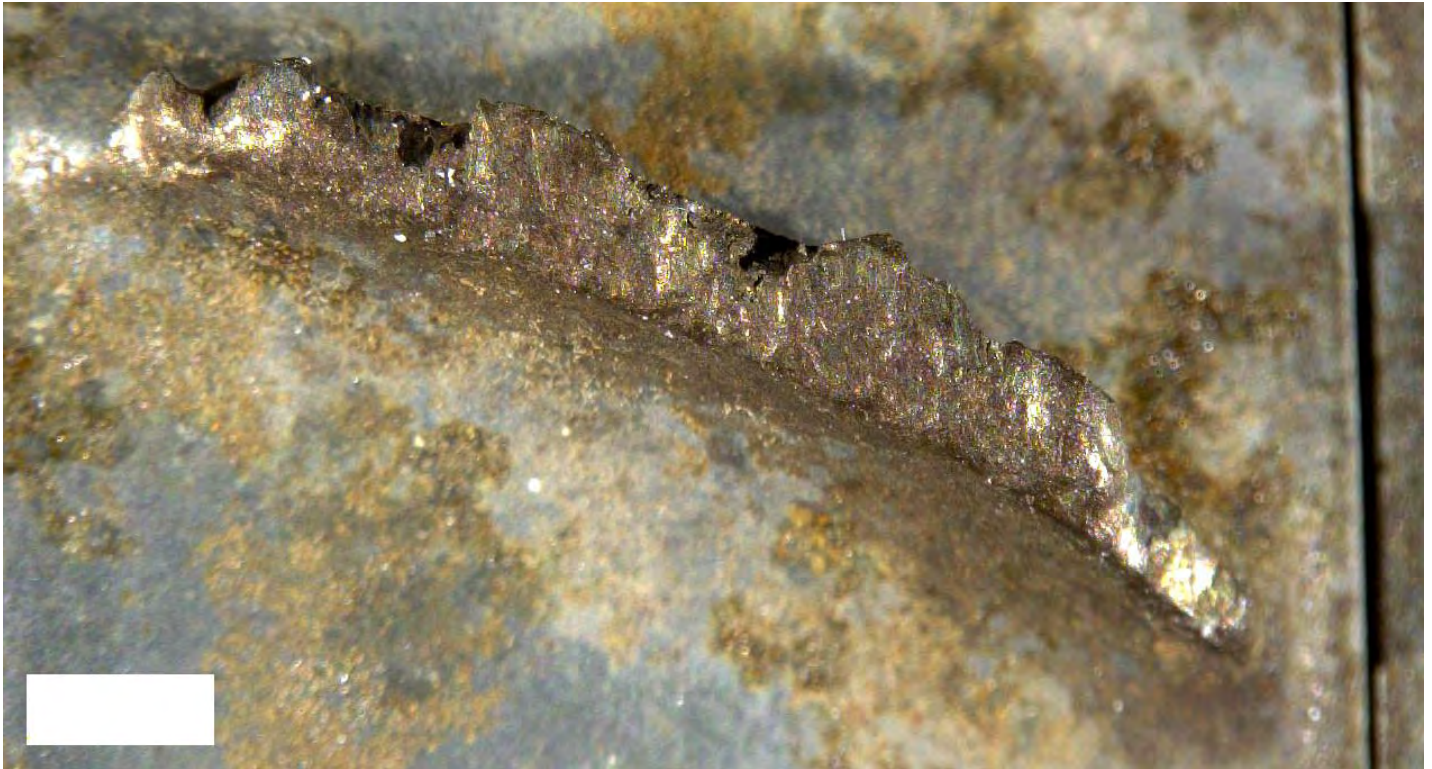
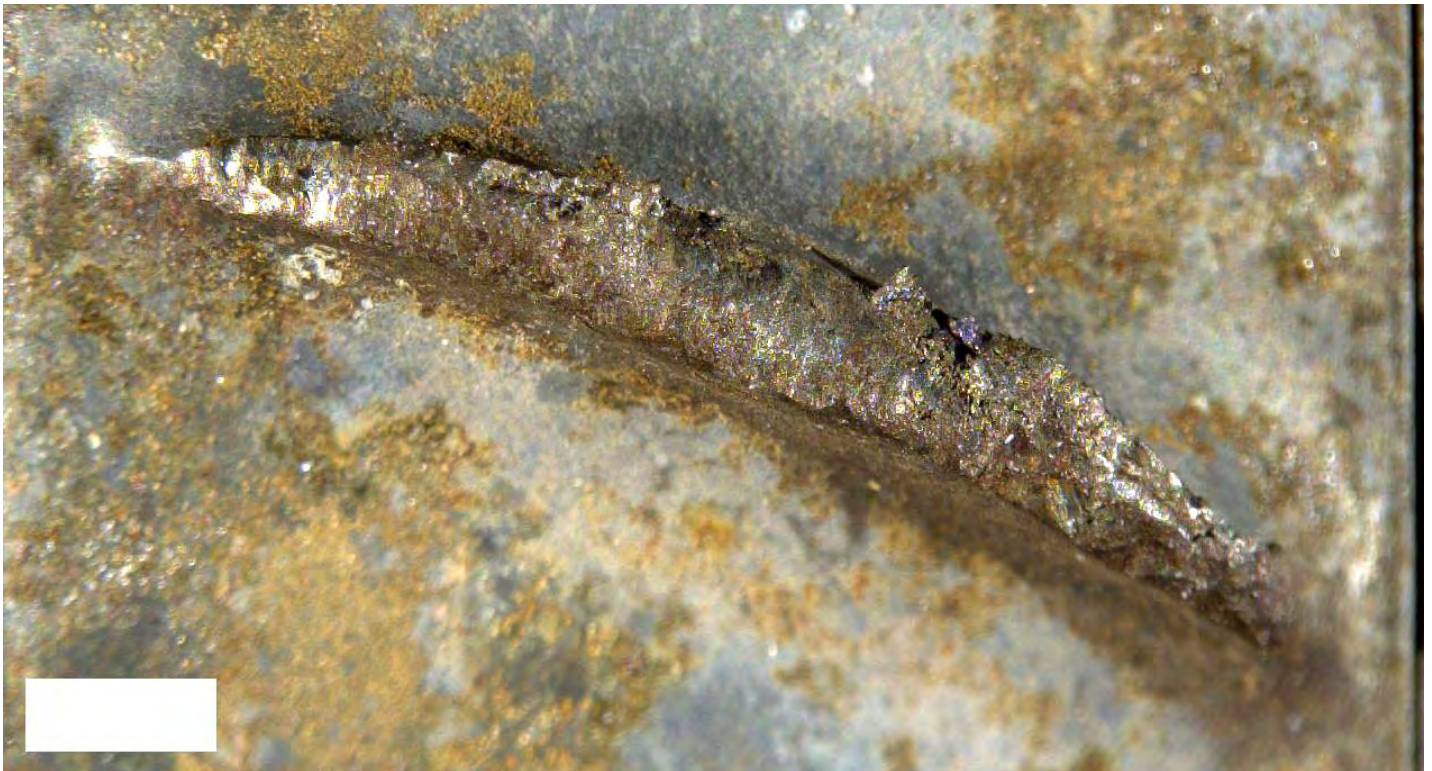
**Figure 50. Detailed views of two stage 5 blade fracture surfaces. No fatigue fracture features were present on either of the fracture surfaces.**

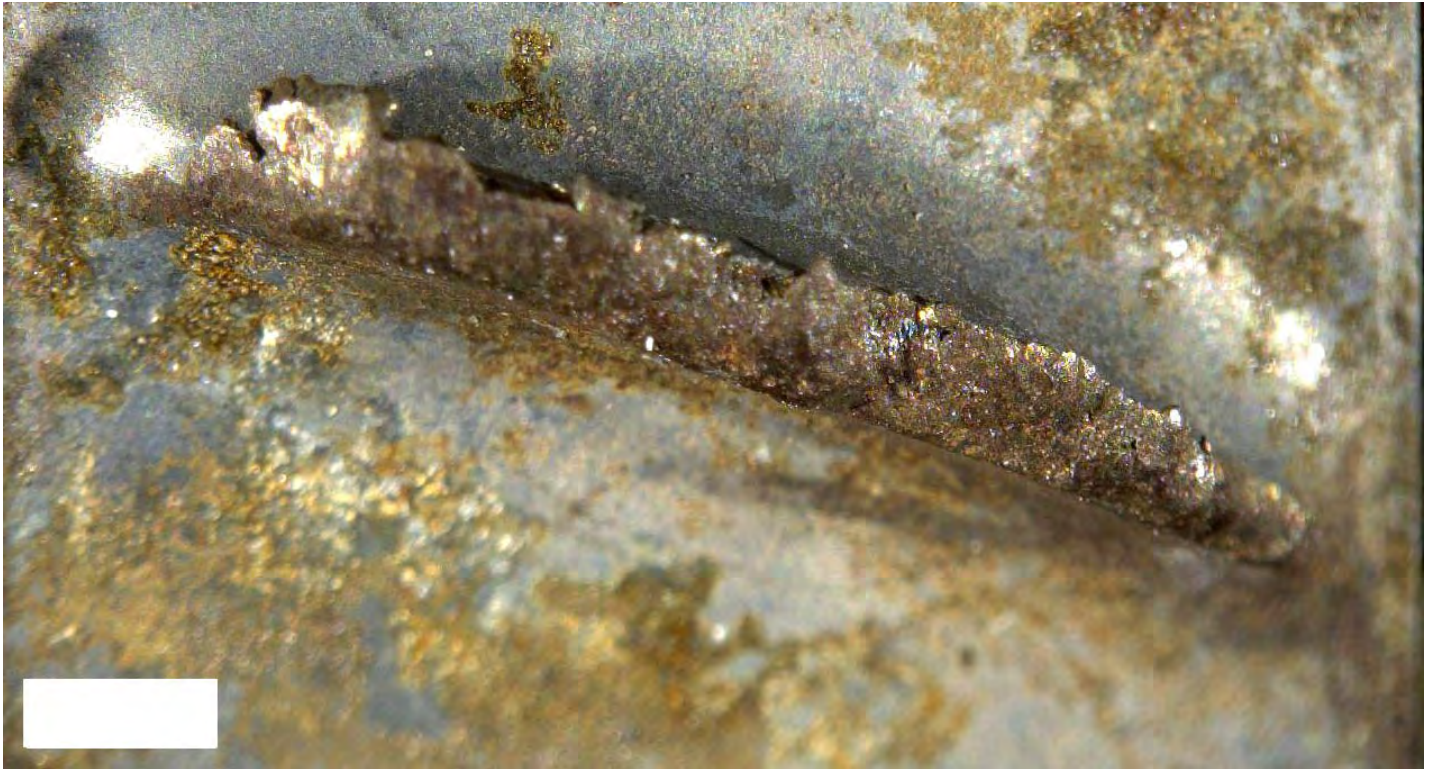
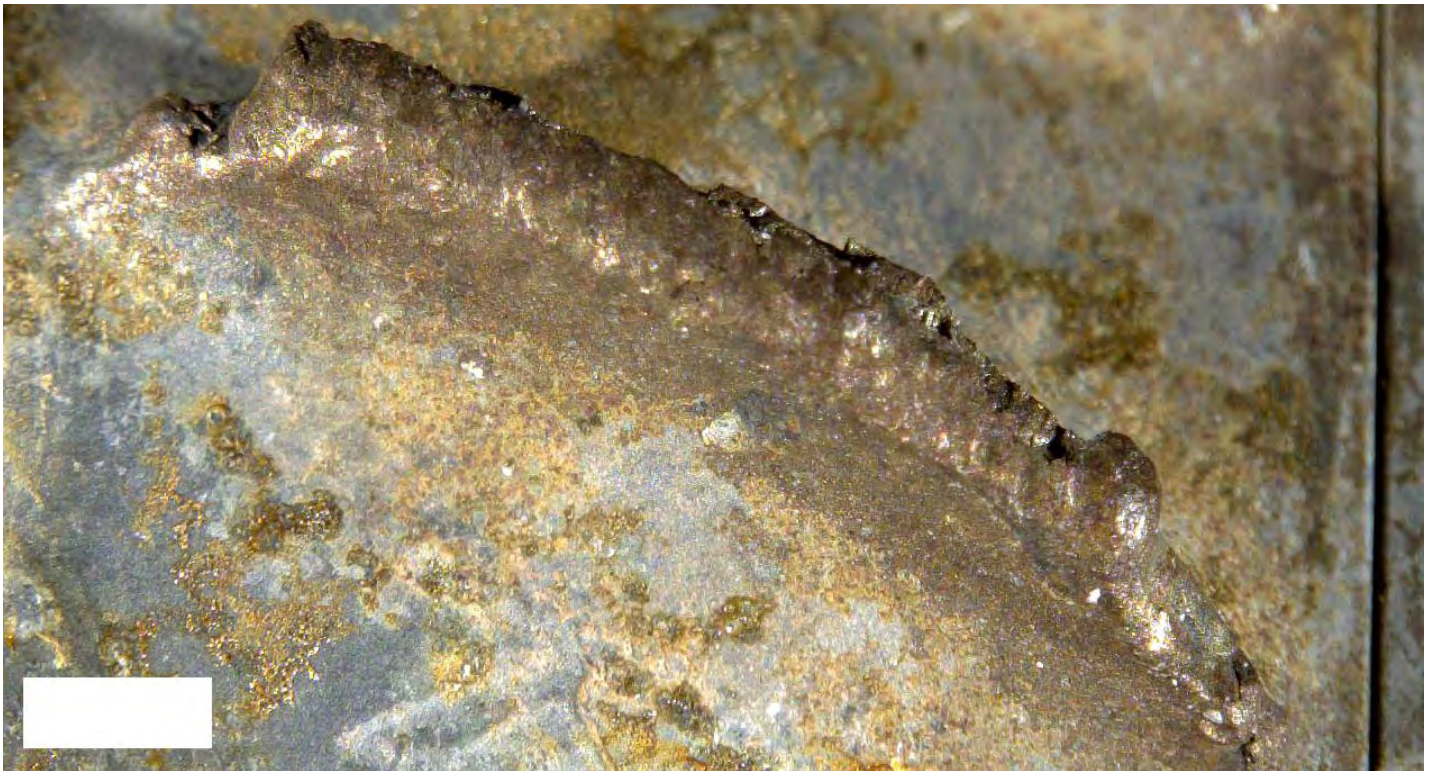
**Figure 51. Detailed views of two stage 5 blade fracture surfaces. No fatigue fracture features were present on either of the fracture surfaces.**

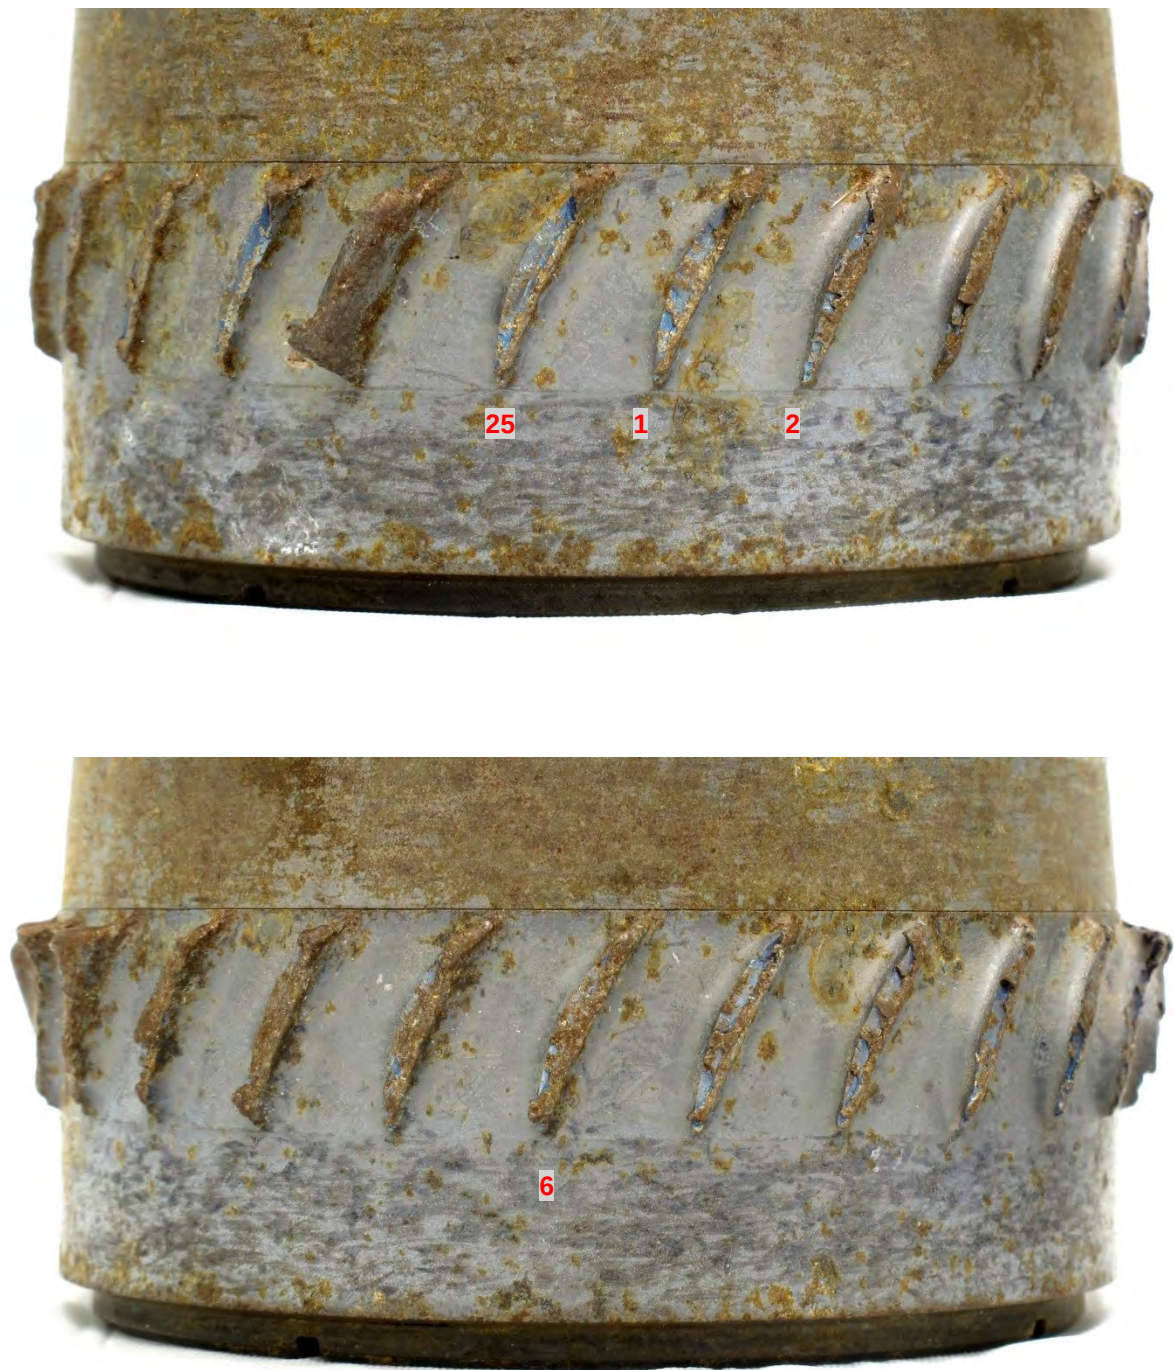
Figures 62 and 63 show the stage 6 compressor wheel before it was cut from the rest of the rotor. All the compressor blades were fractured near the root. The wheel also exhibited generalized corrosion on both the outer and inner diameter (see Figures 33 and 34).

Figure 62. Detailed radial views of the stage 6 compressor wheel while still in the rotor stack. Each image shows the rotor rotated approximately 90° from the previous.

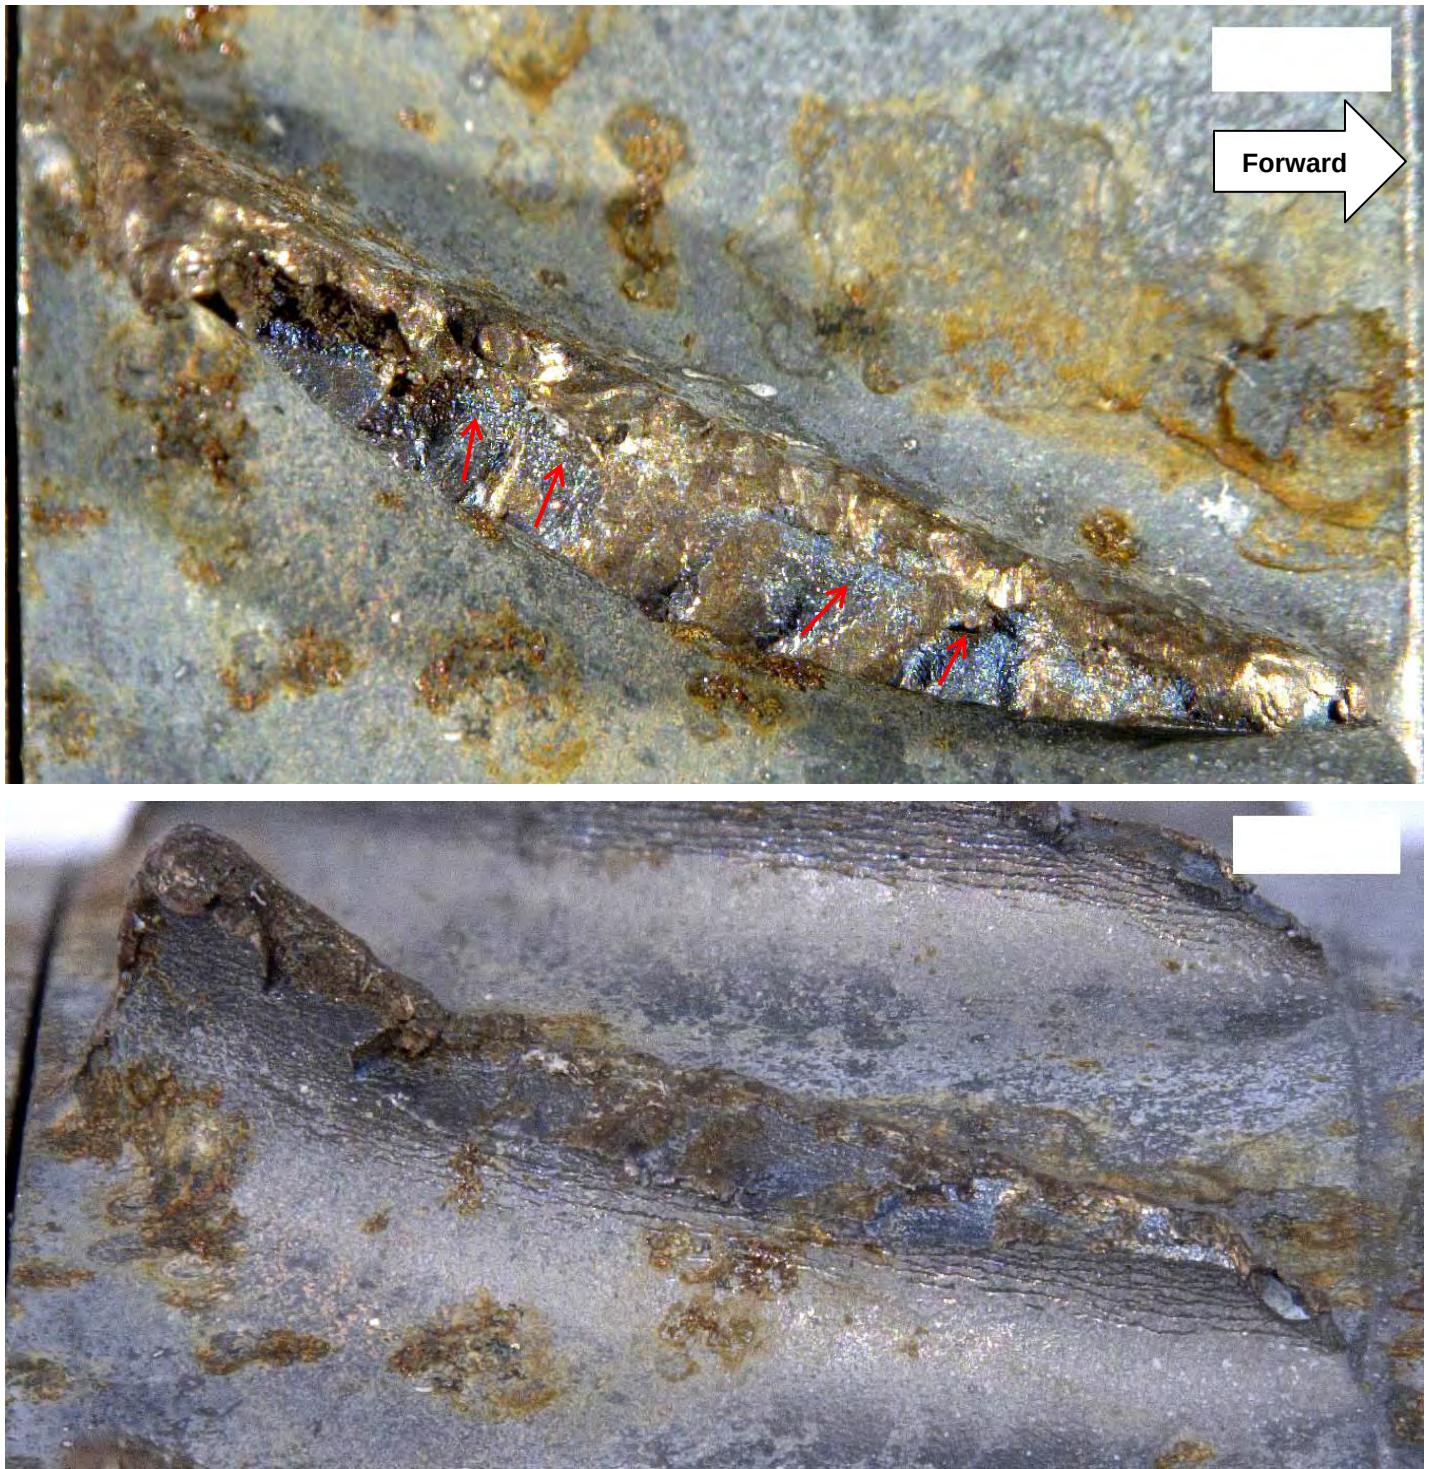
**Figure 64. Detailed views of the fracture surface (top) and suction side surface (bottom) of stage 6 compressor blade 1 (see Figures 62 and 63). The red arrows indicate the local direction of fatigue progression.**

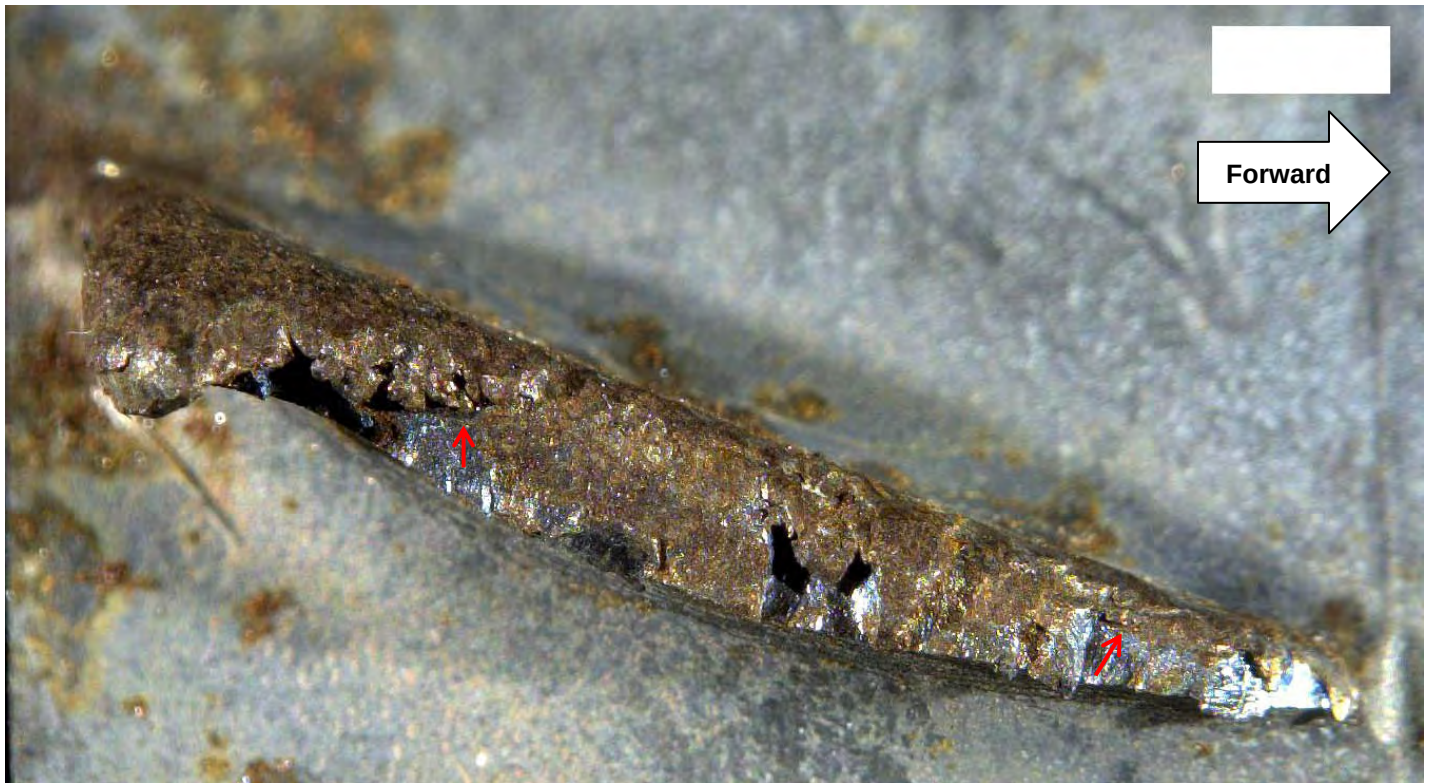
**Figure 65. Detailed views of the fracture surface (top) and suction side surface (bottom) of stage 6 compressor blade 2 (see Figures 62 and 63). The red arrows indicate the local direction of fatigue progression. The yellow line indicates the plane of metallographic cross section in Figure 91.**
