## **AIRWORTHINESS GROUP FACTUAL REPORT**

**NTSB No. ERA21FA130**

**Rolls-Royce Materials Evaluation Report No. 21FAE-025-PR  
(111 pages)**

| <b>TITLE</b><br><br><b>METALLURGICAL INVESTIGATION OF COMPRESSOR COMPONENTS REMOVED FROM AN M250-C20B, ENGINE S/N CAE833459, OPERATED BY CARIBBEAN BUZZ HELICOPTER</b> | | <b>PREPARED</b><br>Signatures on File | | |

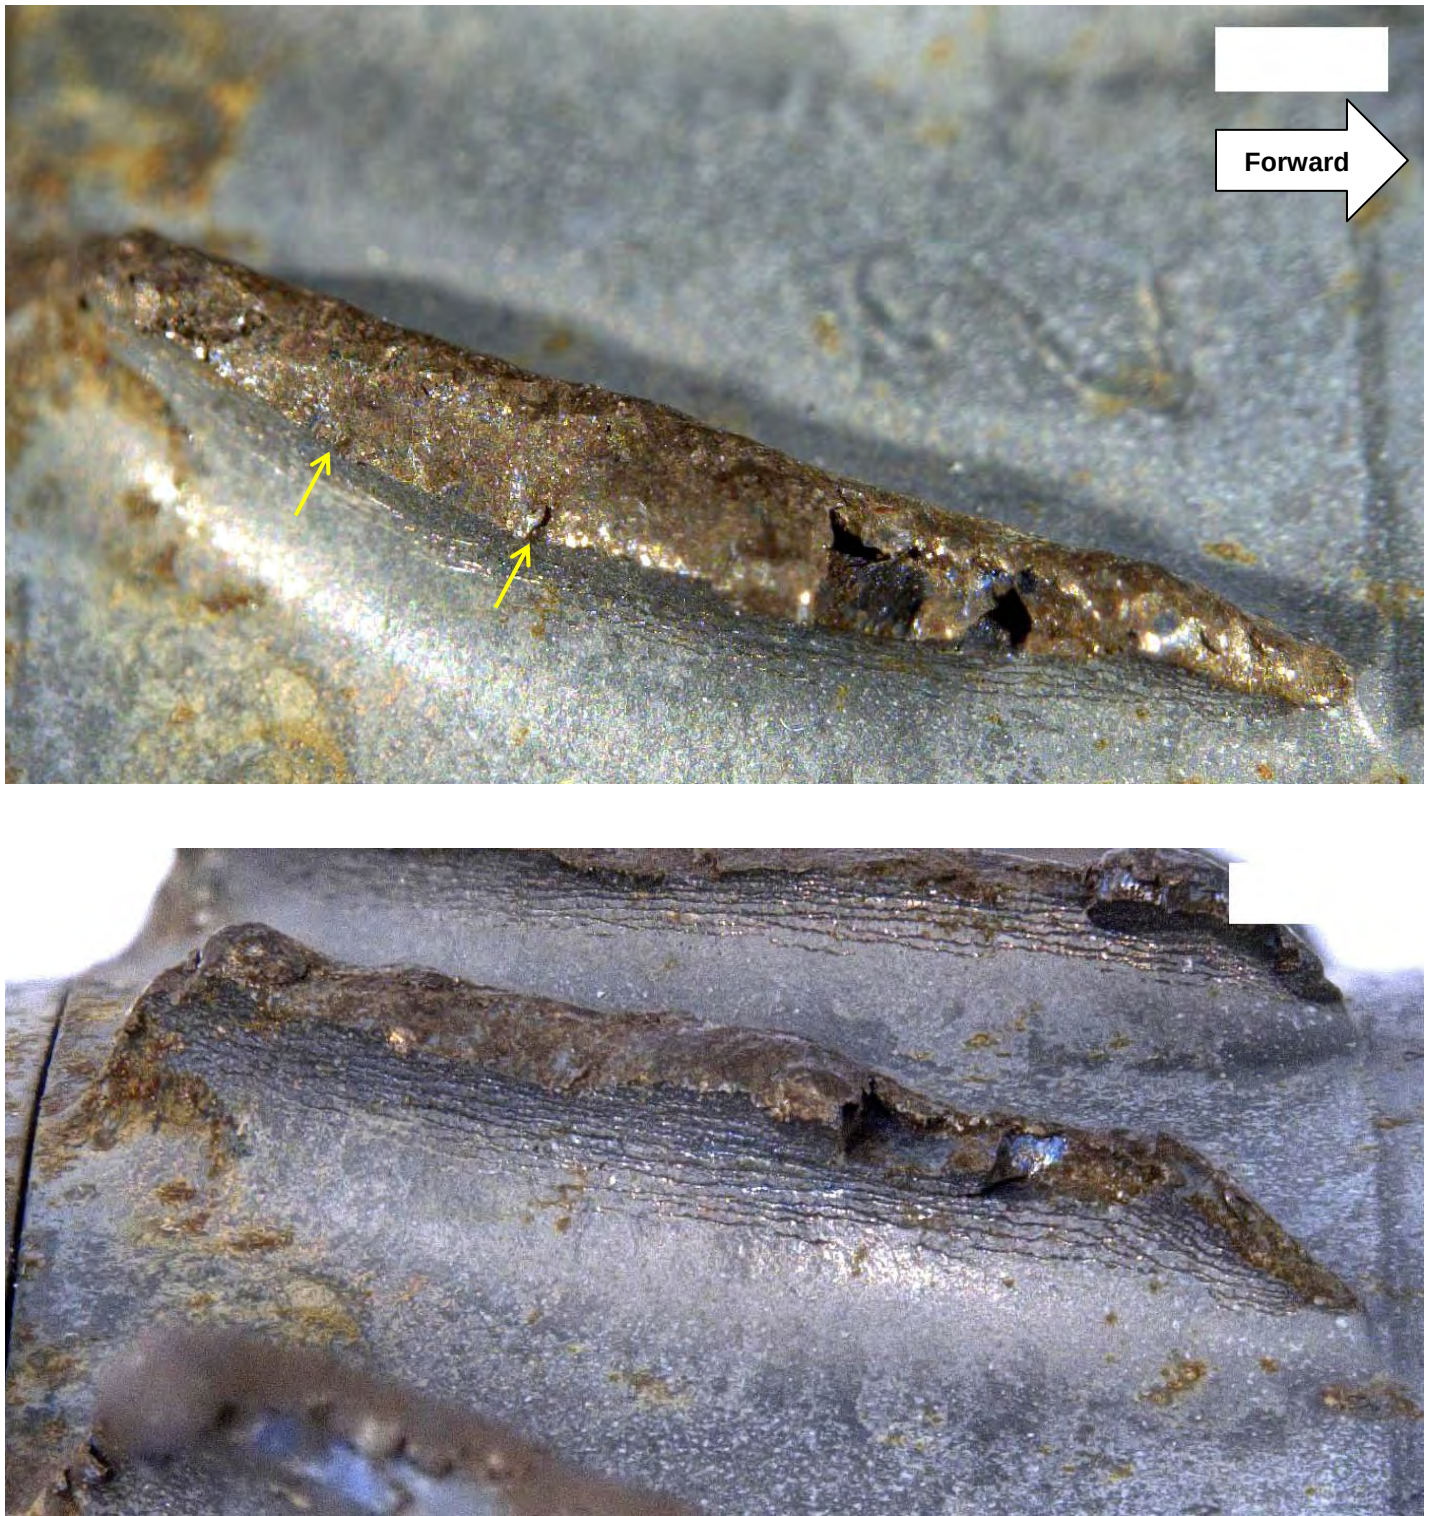
**Figure 66.** Detailed views of the fracture surface (top) and suction side surface (bottom) of stage 6 compressor blade 3 (see Figures 62 and 63). The yellow arrows indicate ratchet marks consistent with fatigue initiation on the suction side surface.

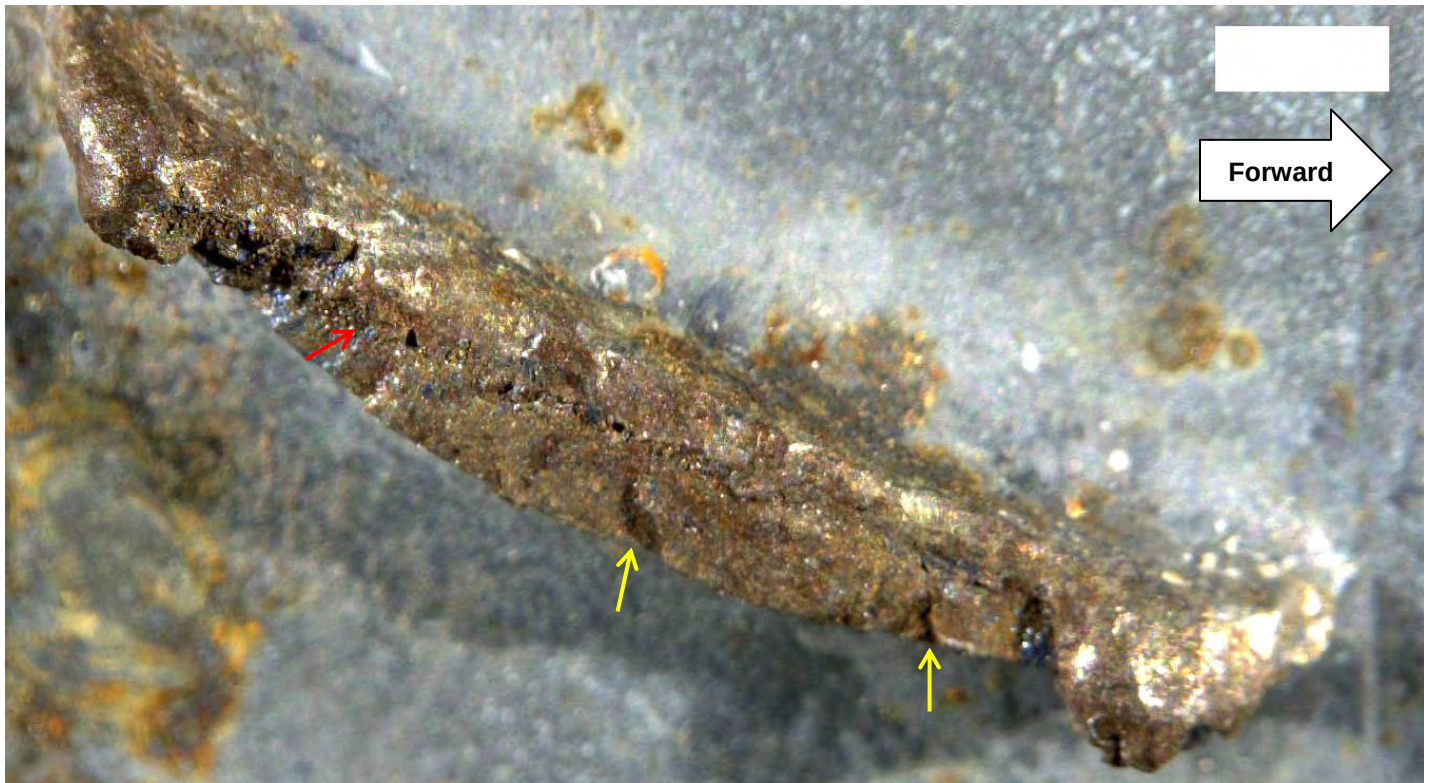
**Figure 67.** Detailed views of the fracture surface (top) and suction side surface (bottom) of stage 6 compressor blade 4 (see Figures 62 and 63). The red arrow indicates the local direction of fatigue progression. The yellow arrows indicate ratchet marks consistent with fatigue initiation on the suction side surface.

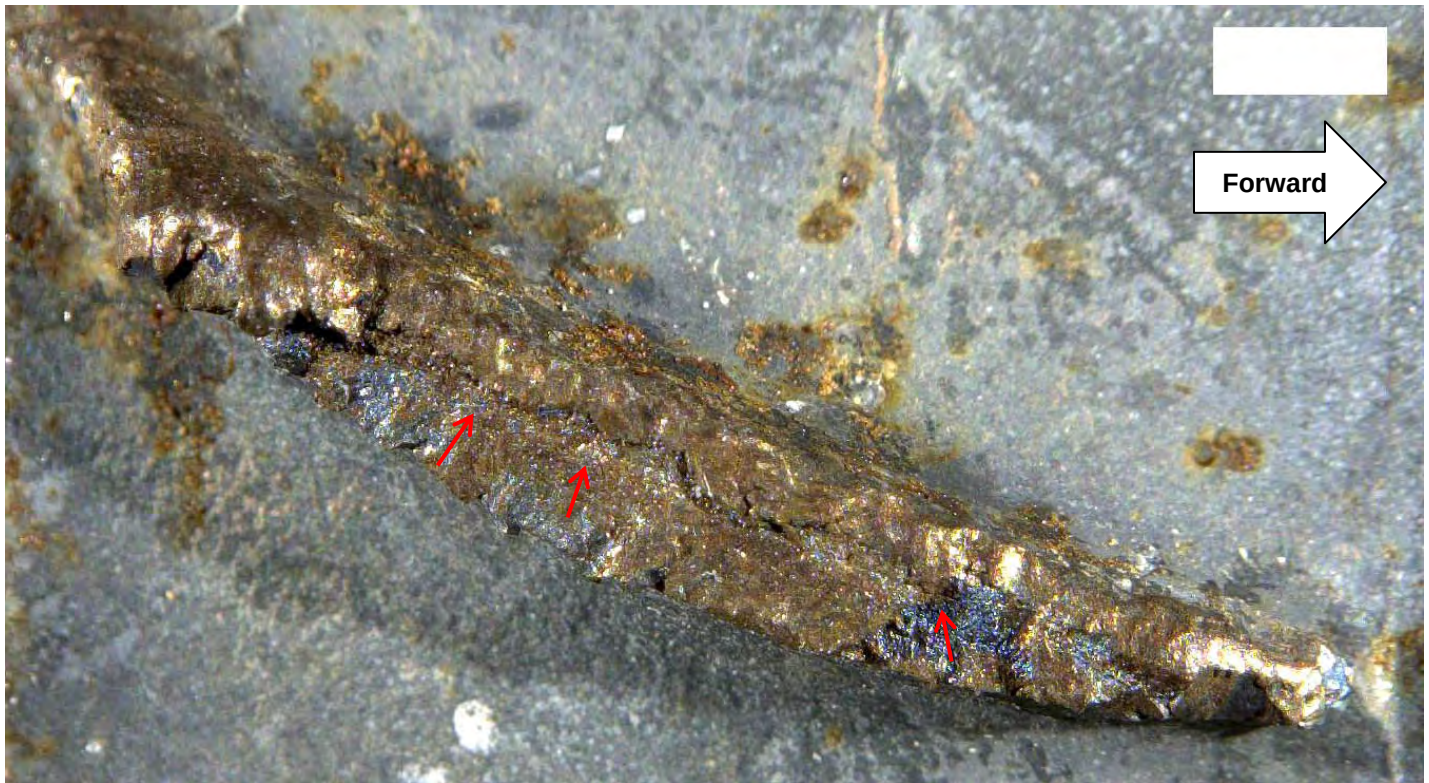
**Figure 68.** Detailed views of the fracture surface (top) and suction side surface (bottom) of stage 6 compressor blade 5 (see Figures 62 and 63). The red arrows indicate the direction of fatigue progression.

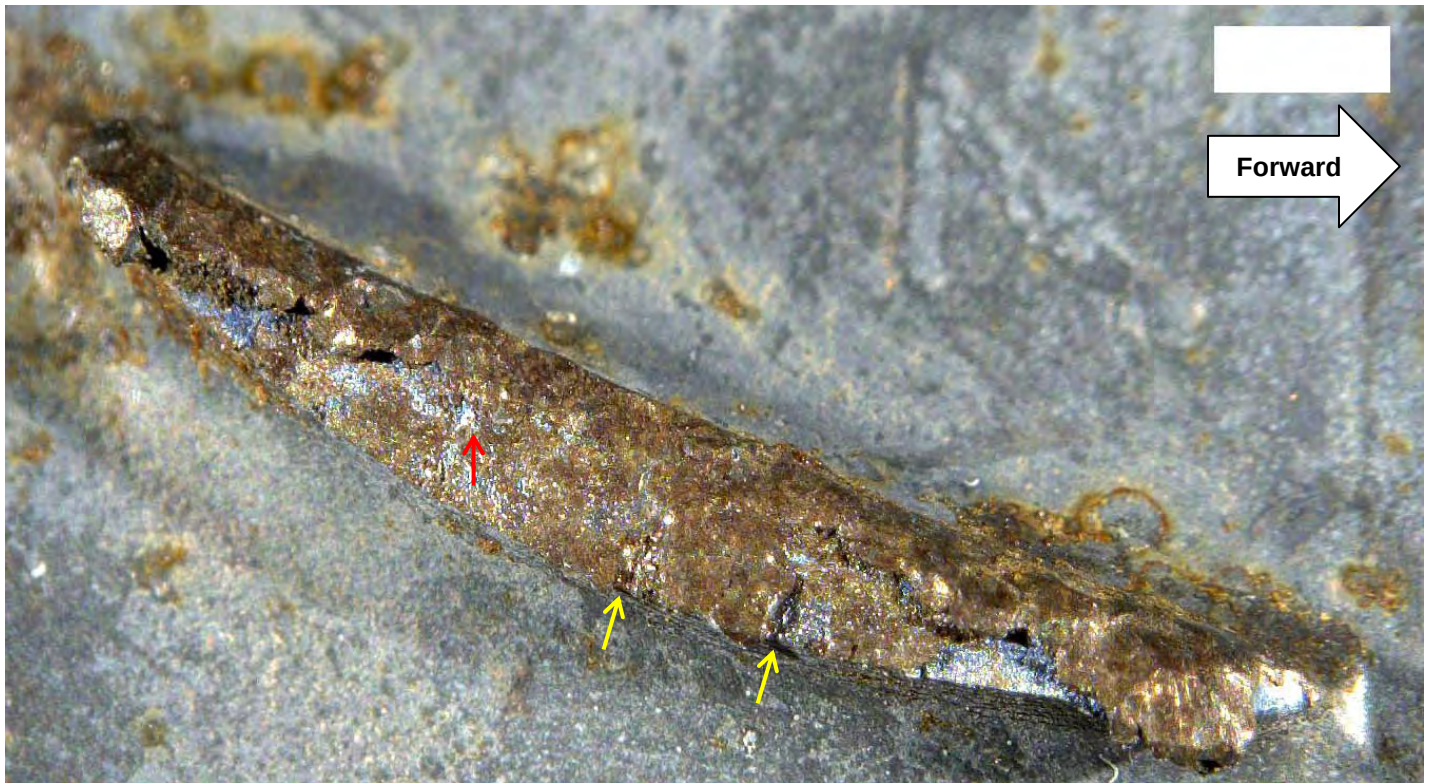
**Figure 69.** Detailed views of the fracture surface (top) and suction side surface (bottom) of stage 6 compressor blade 6 (see Figures 62 and 63). The red arrow indicates the local direction of fatigue progression. The yellow arrows indicate ratchet marks consistent with fatigue initiation on the suction side surface.

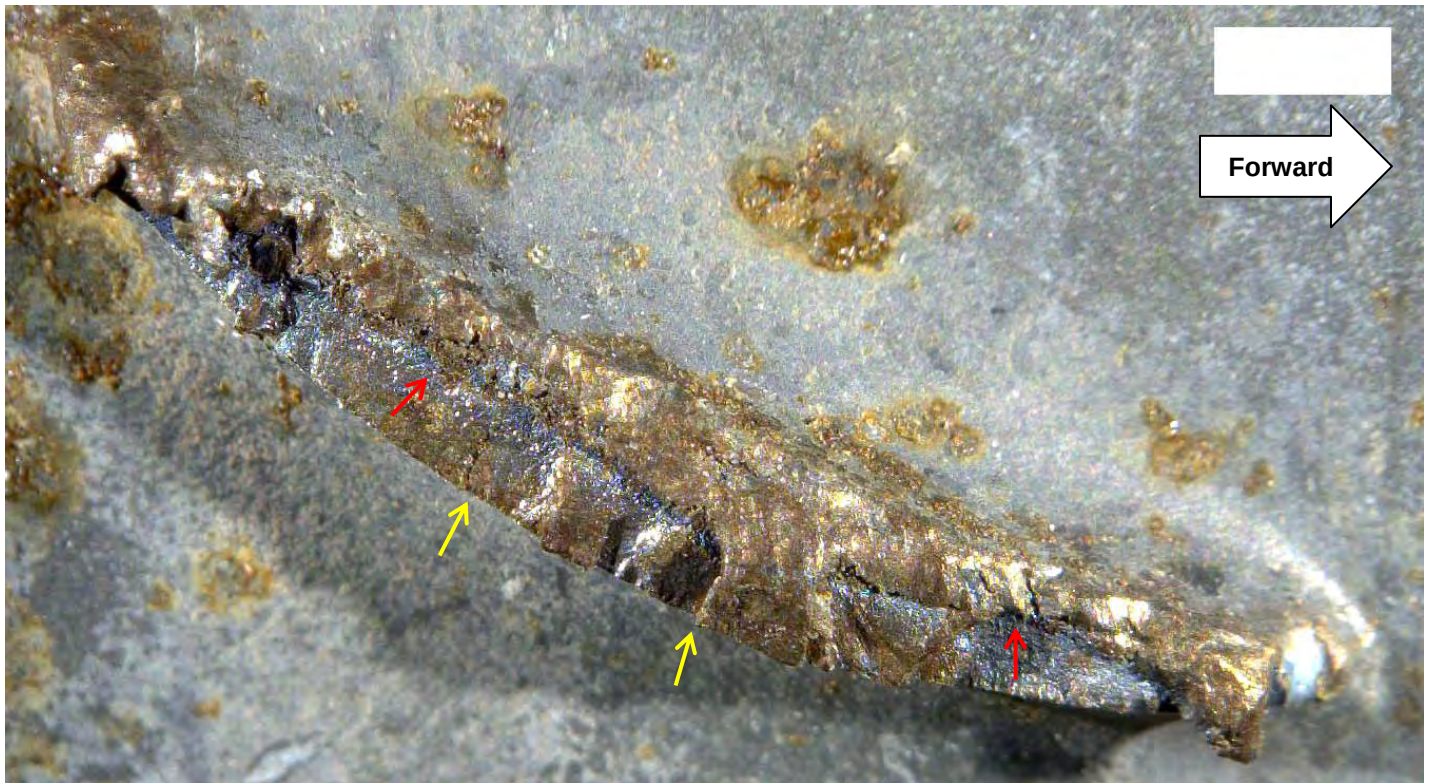
**Figure 70.** Detailed views of the fracture surface (top) and suction side surface (bottom) of stage 6 compressor blade 7 (see Figures 62 and 63). The red arrows indicate the local direction of fatigue progression. The yellow arrows indicate ratchet marks consistent with fatigue initiation on the suction side surface.

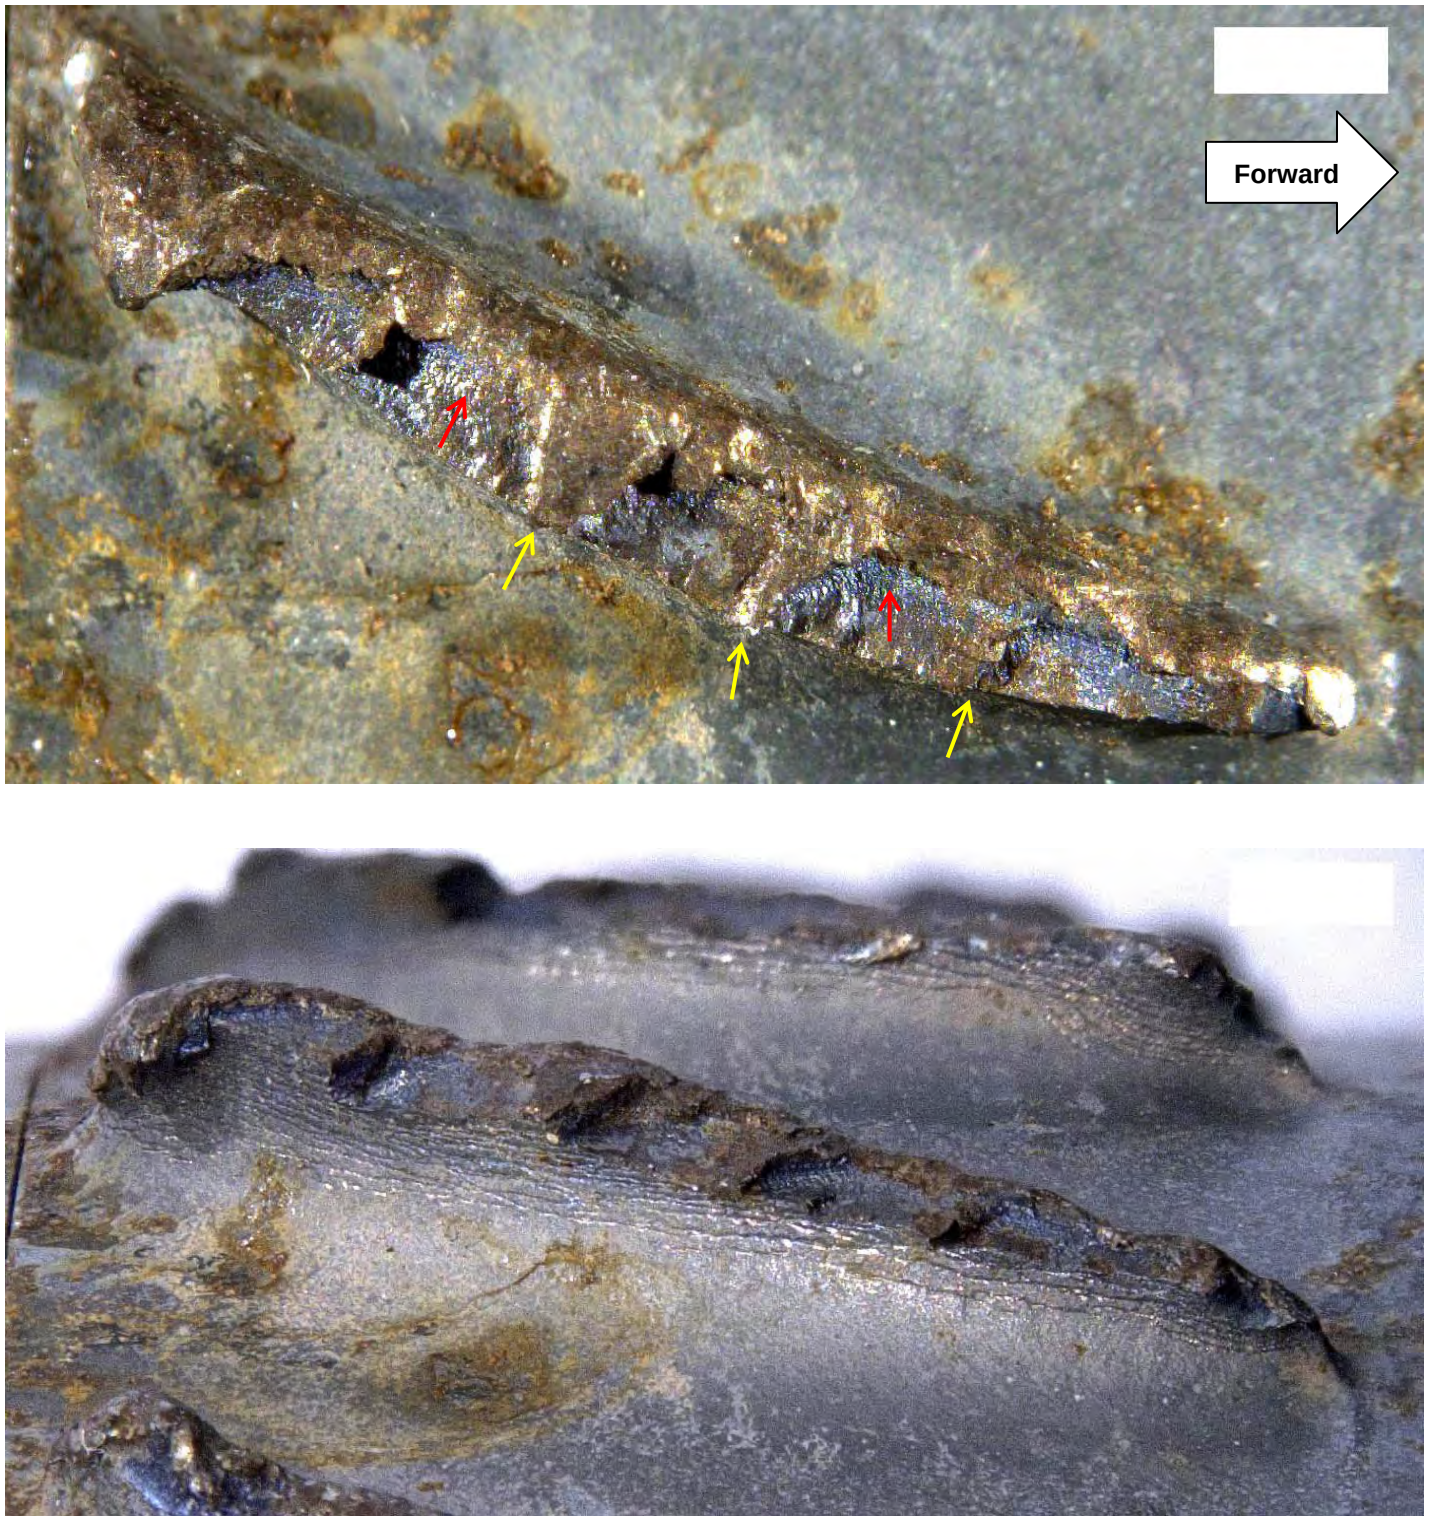
**Figure 71.** Detailed views of the fracture surface (top) and suction side surface (bottom) of stage 6 compressor blade 8 (see Figures 62 and 63). The red arrows indicate the local direction of fatigue progression. The yellow arrows indicate ratchet marks consistent with fatigue initiation on the suction side surface.

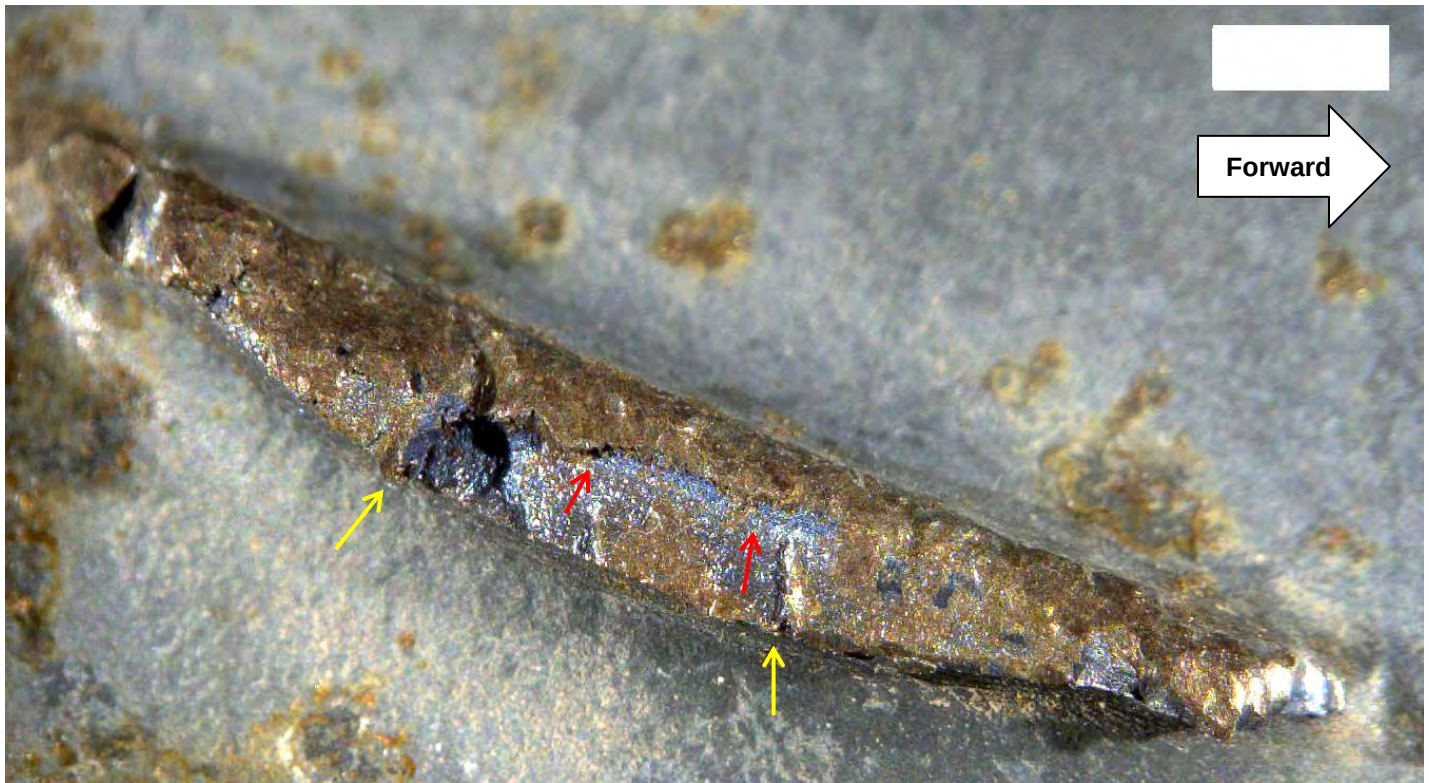
**Figure 72.** Detailed views of the fracture surface (top) and suction side surface (bottom) of stage 6 compressor blade 9 (see Figures 62 and 63). The red arrows indicate the direction of fatigue progression. The yellow arrows indicate ratchet marks consistent with fatigue initiation on the suction side surface.

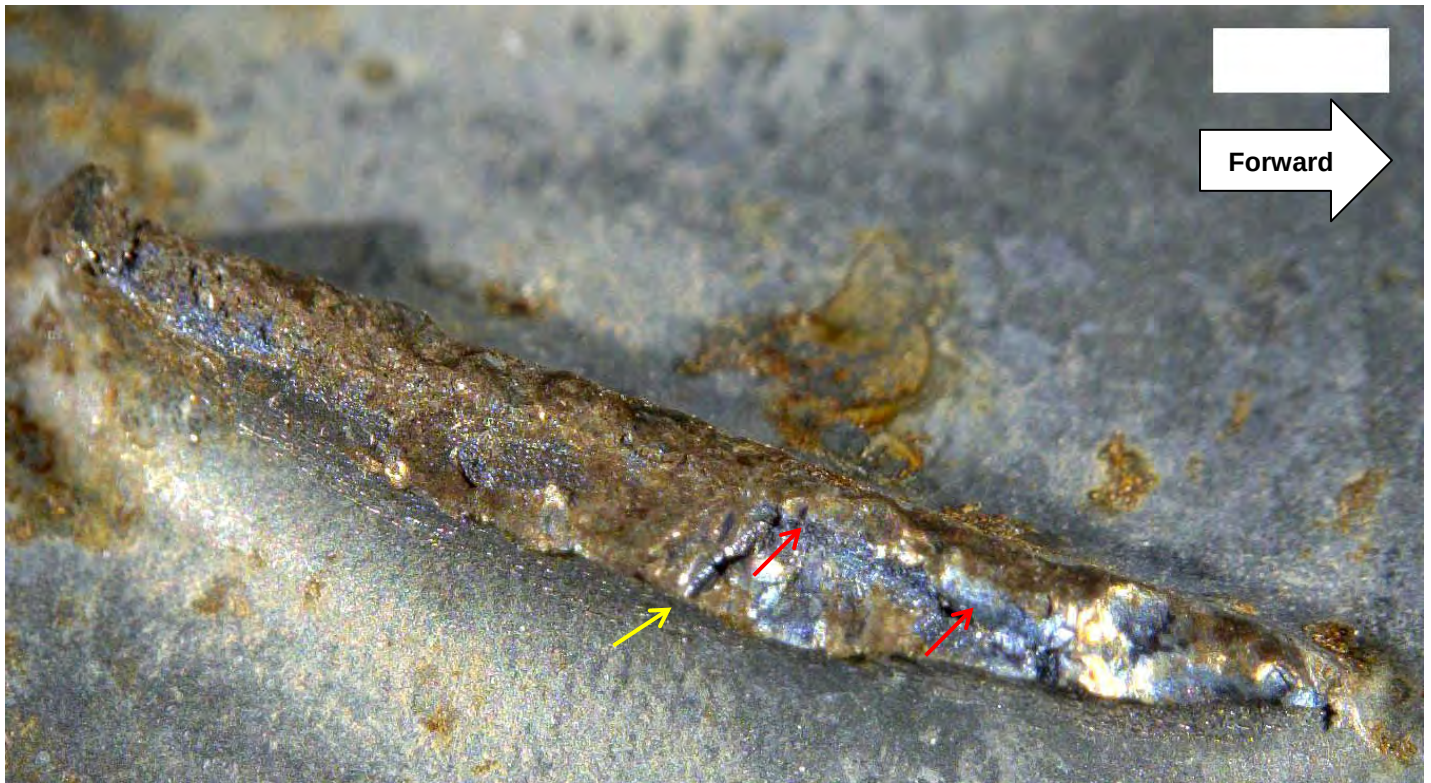
**Figure 73. Detailed views of the fracture surface (top) and suction side surface (bottom) of stage 6 compressor blade 10 (see Figures 62 and 63). The red arrows indicate the direction of fatigue progression. The yellow arrow indicates a ratchet mark consistent with fatigue initiation on the suction side surface.**

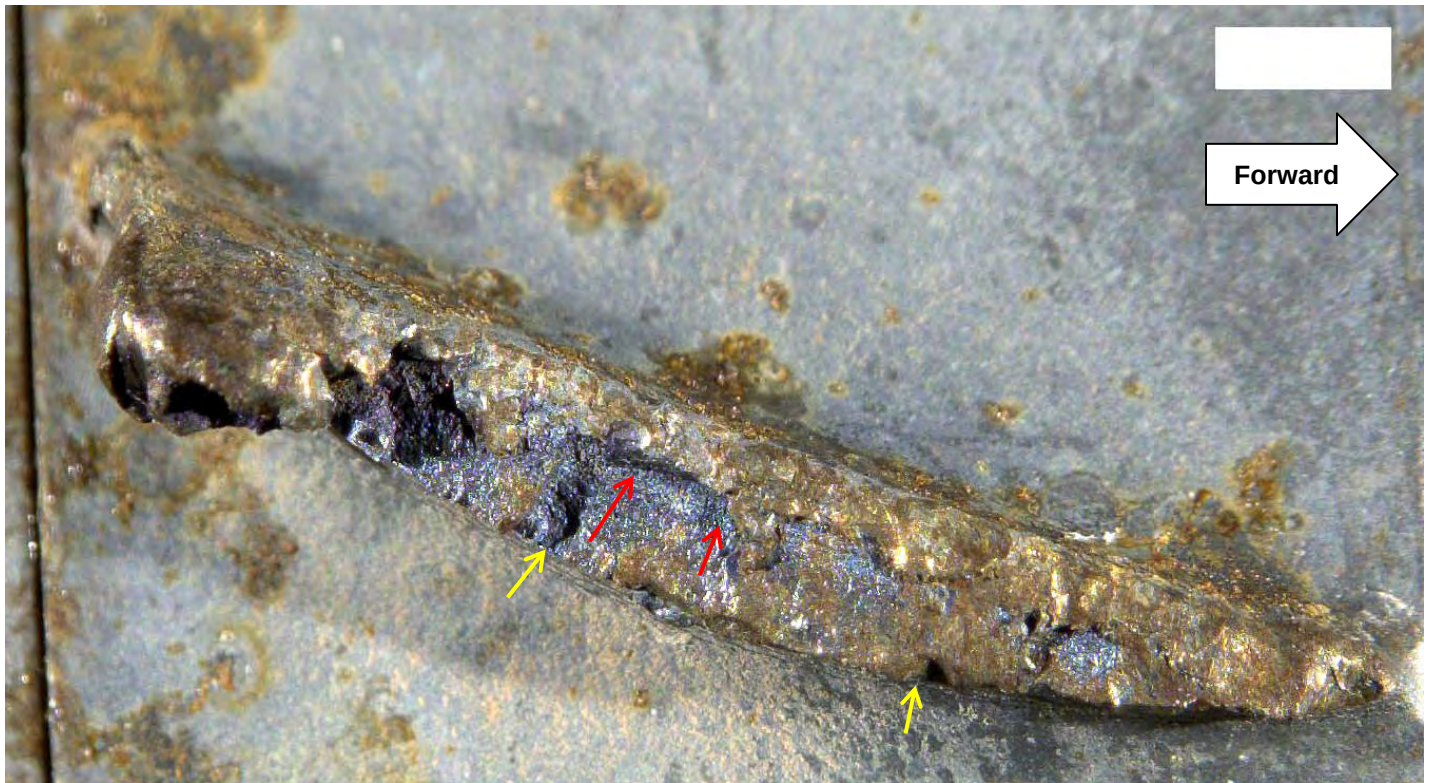
**Figure 74.** Detailed views of the fracture surface (top) and suction side surface (bottom) of stage 6 compressor blade 11 (see Figures 62 and 63). The red arrows indicate the local direction of fatigue progression. The yellow arrows indicate ratchet marks consistent with fatigue initiation on the suction side surface. The yellow line indicates the plane of metallographic cross section in Figure 94.

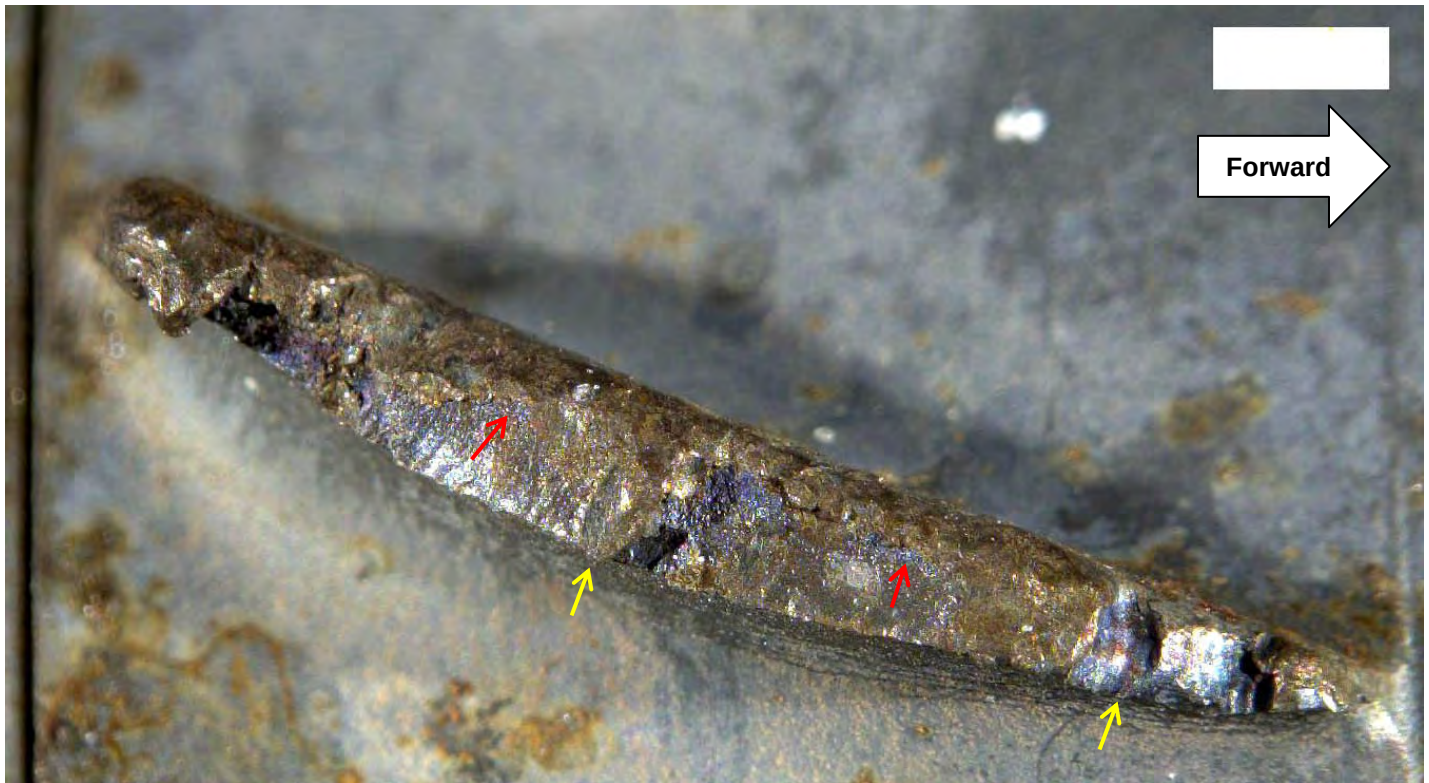
**Figure 75.** Detailed views of the fracture surface (top) and suction side surface (bottom) of stage 6 compressor blade 12 (see Figures 62 and 63). The red arrows indicate the local direction of fatigue progression. The yellow arrows indicate ratchet marks consistent with fatigue initiation on the suction side surface.

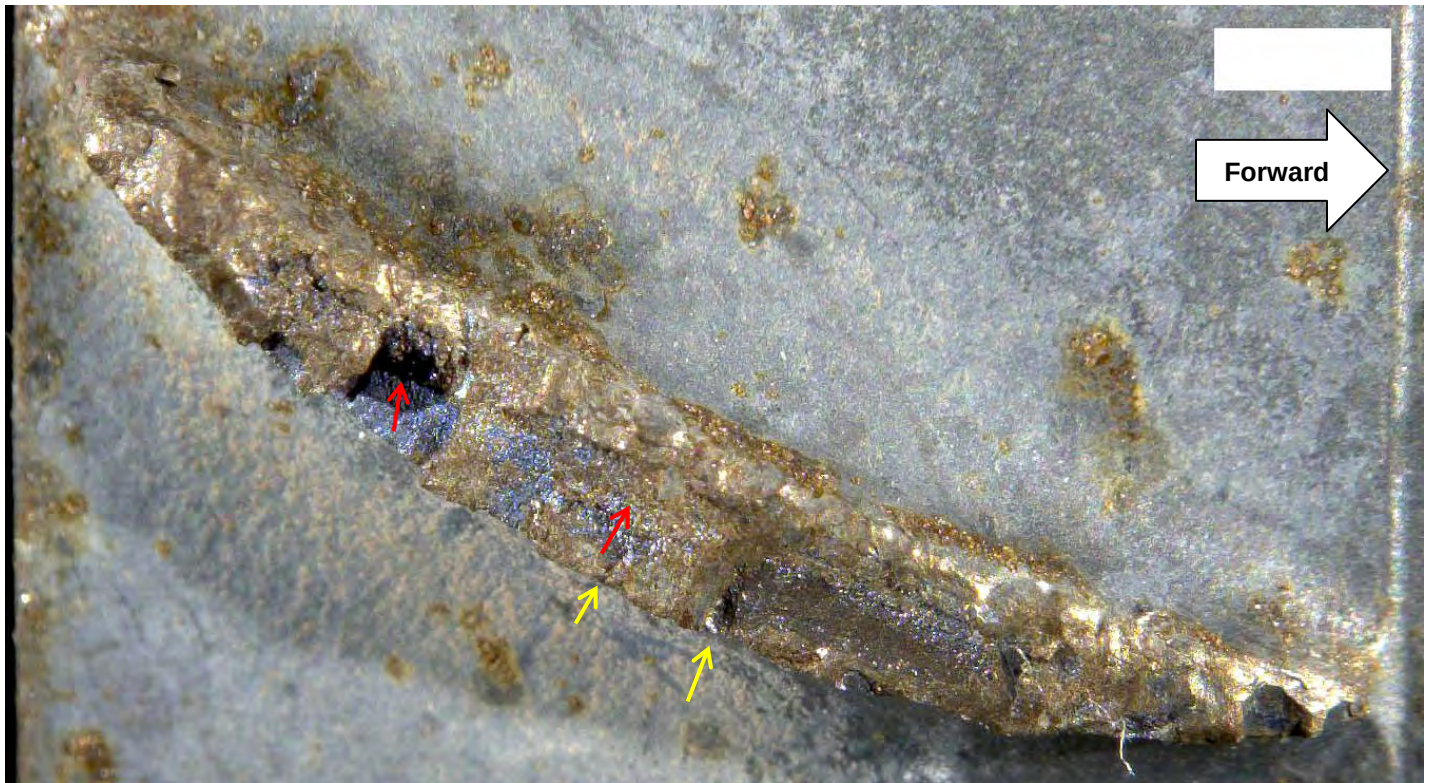
**Figure 76. Detailed views of the fracture surface (top) and suction side surface (bottom) of stage 6 compressor blade 13 (see Figures 62 and 63). The red arrows indicate the local direction of fatigue progression. The yellow arrows indicate ratchet marks consistent with fatigue initiation on the suction side surface.**

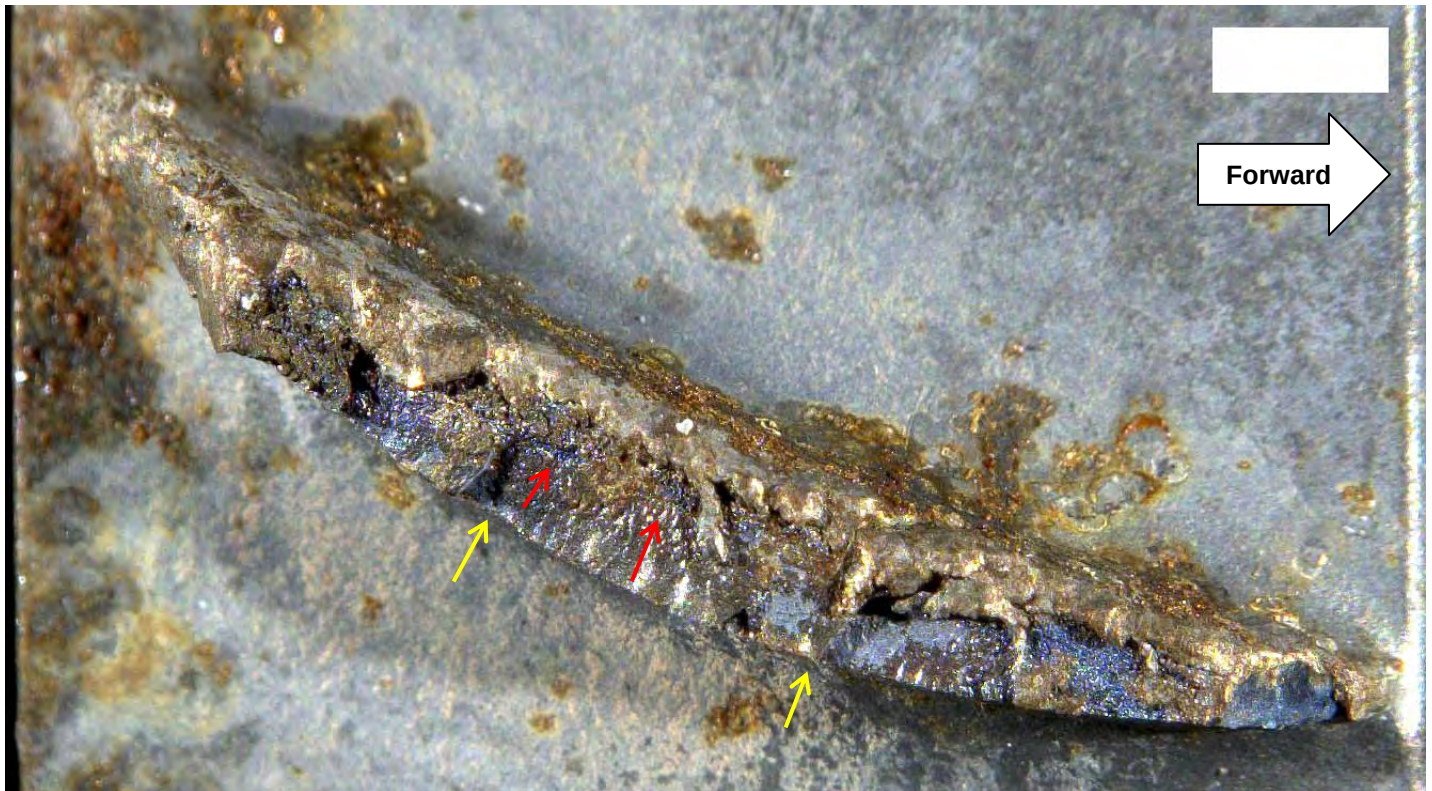
**Figure 77.** Detailed views of the fracture surface (top) and suction side surface (bottom) of stage 6 compressor blade 14 (see Figures 62 and 63). The red arrows indicate the local direction of fatigue progression. The yellow arrows indicate ratchet marks consistent with fatigue initiation on the suction side surface.

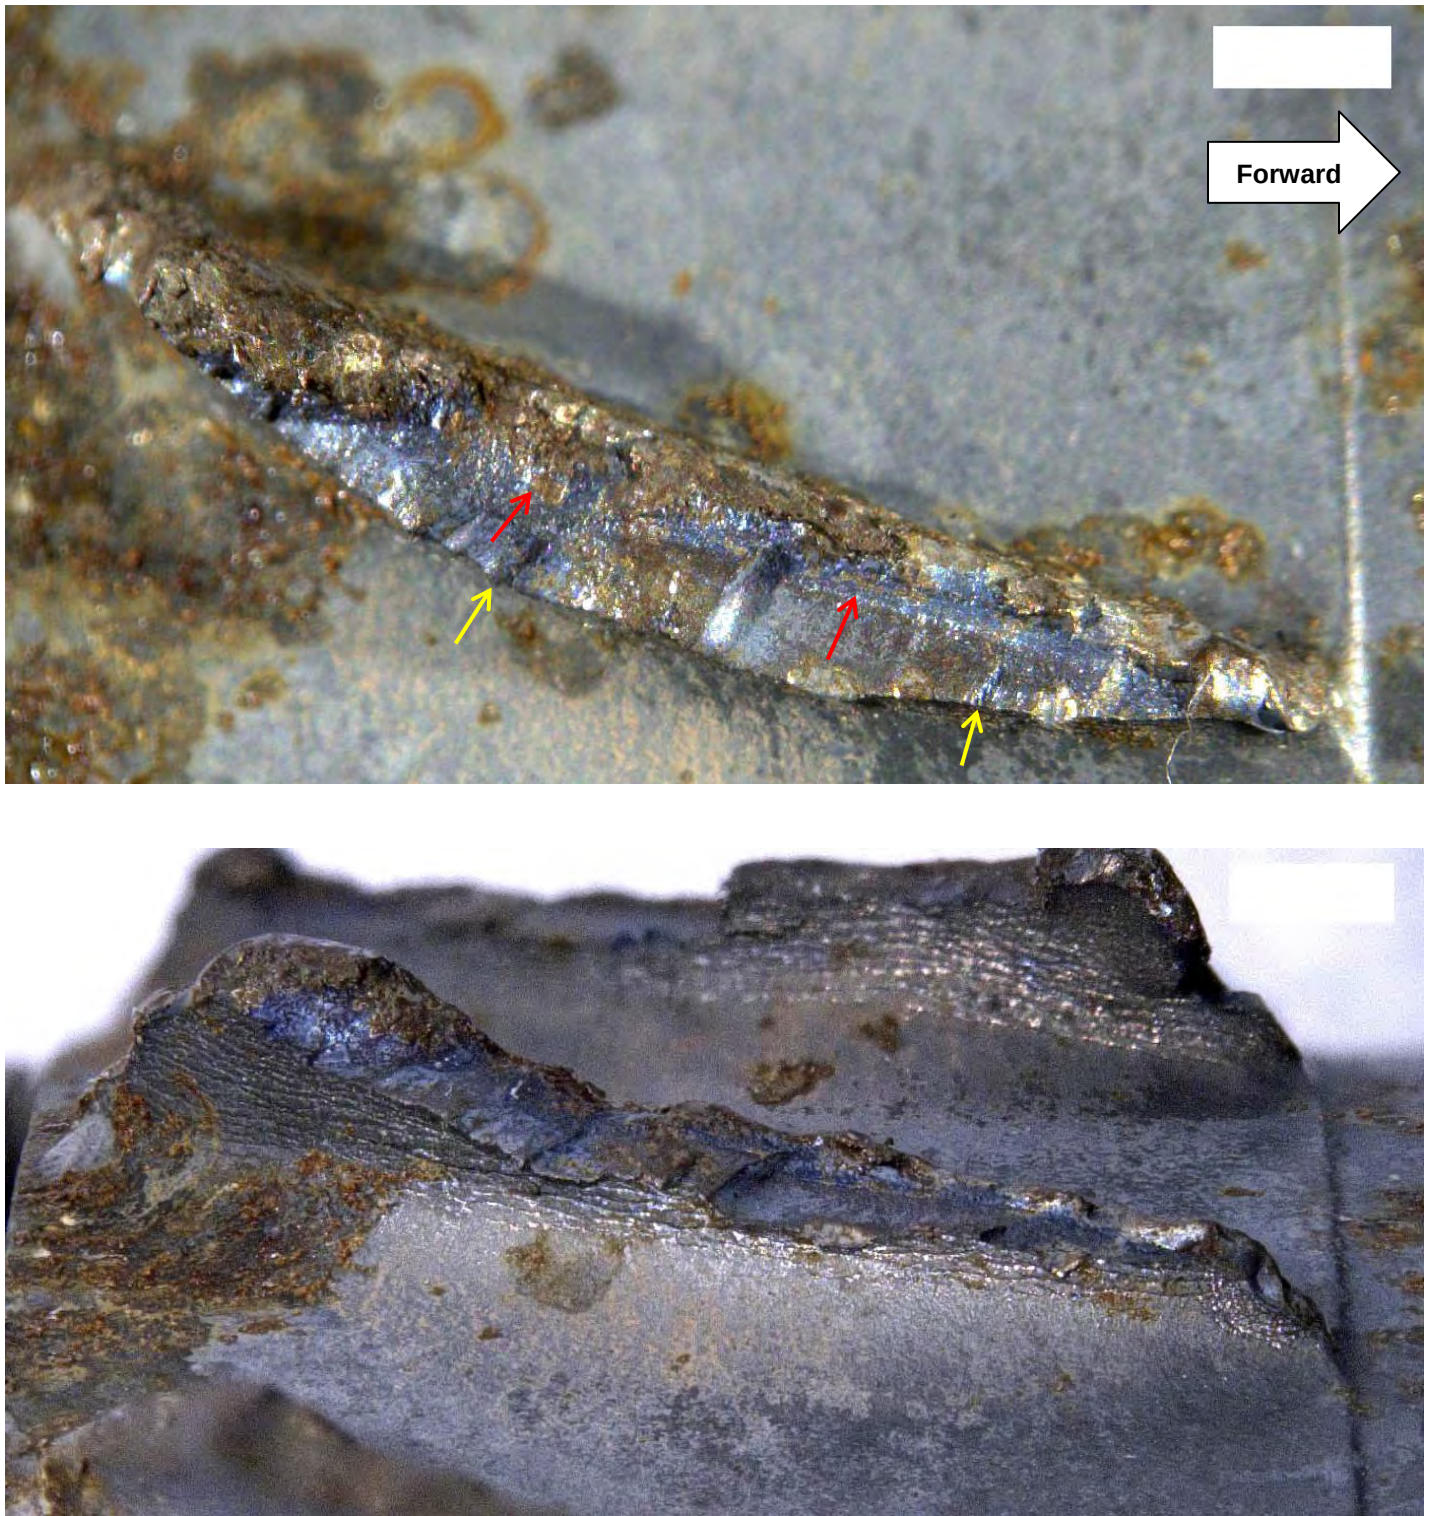
**Figure 78.** Detailed views of the fracture surface (top) and suction side surface (bottom) of stage 6 compressor blade 15 (see Figures 62 and 63). The red arrows indicate the local direction of fatigue progression. The yellow arrows indicate ratchet marks consistent with fatigue initiation on the suction side surface.

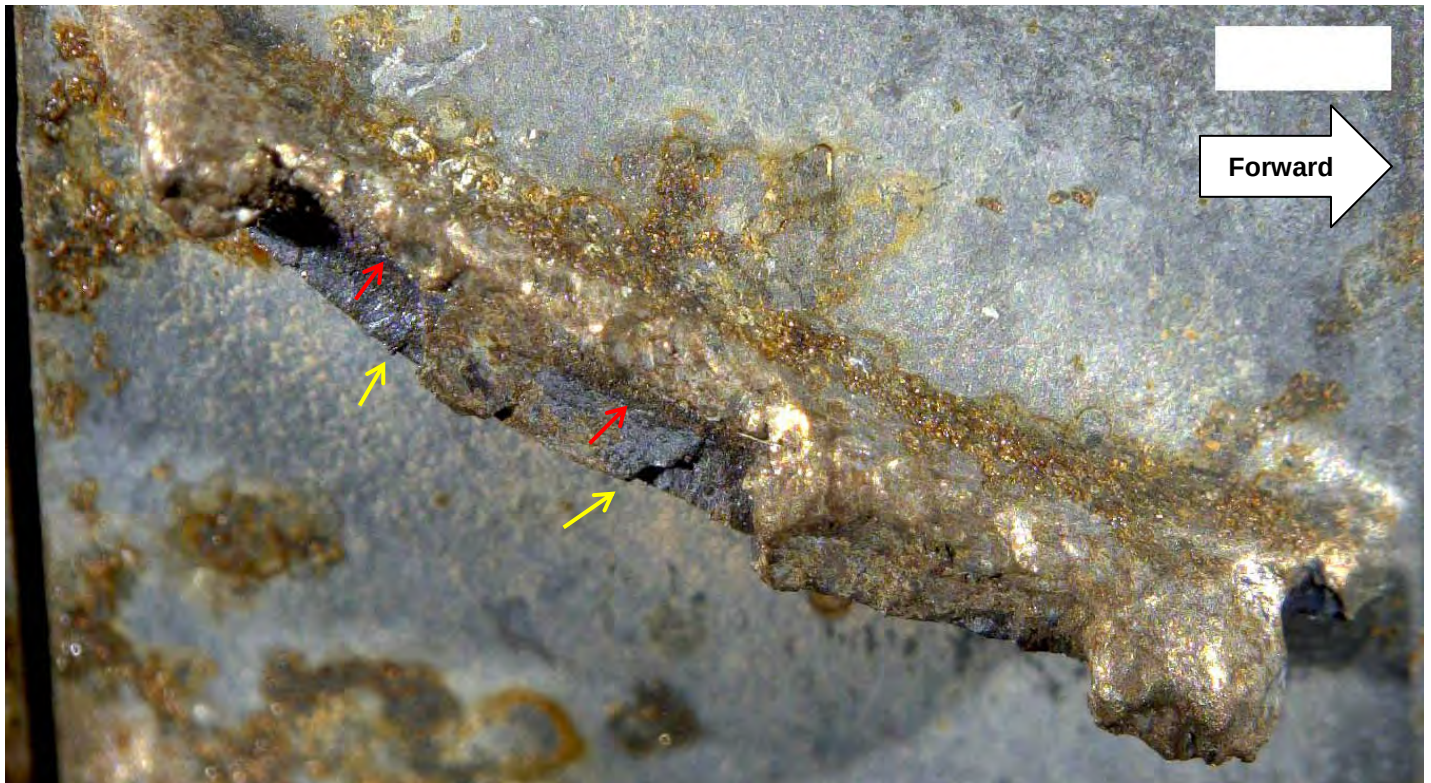
**Figure 79.** Detailed views of the fracture surface (top) and suction side surface (bottom) of stage 6 compressor blade 16 (see Figures 62 and 63). The red arrows indicate the local direction of fatigue progression. The yellow arrows indicate ratchet marks consistent with fatigue initiation on the suction side surface.

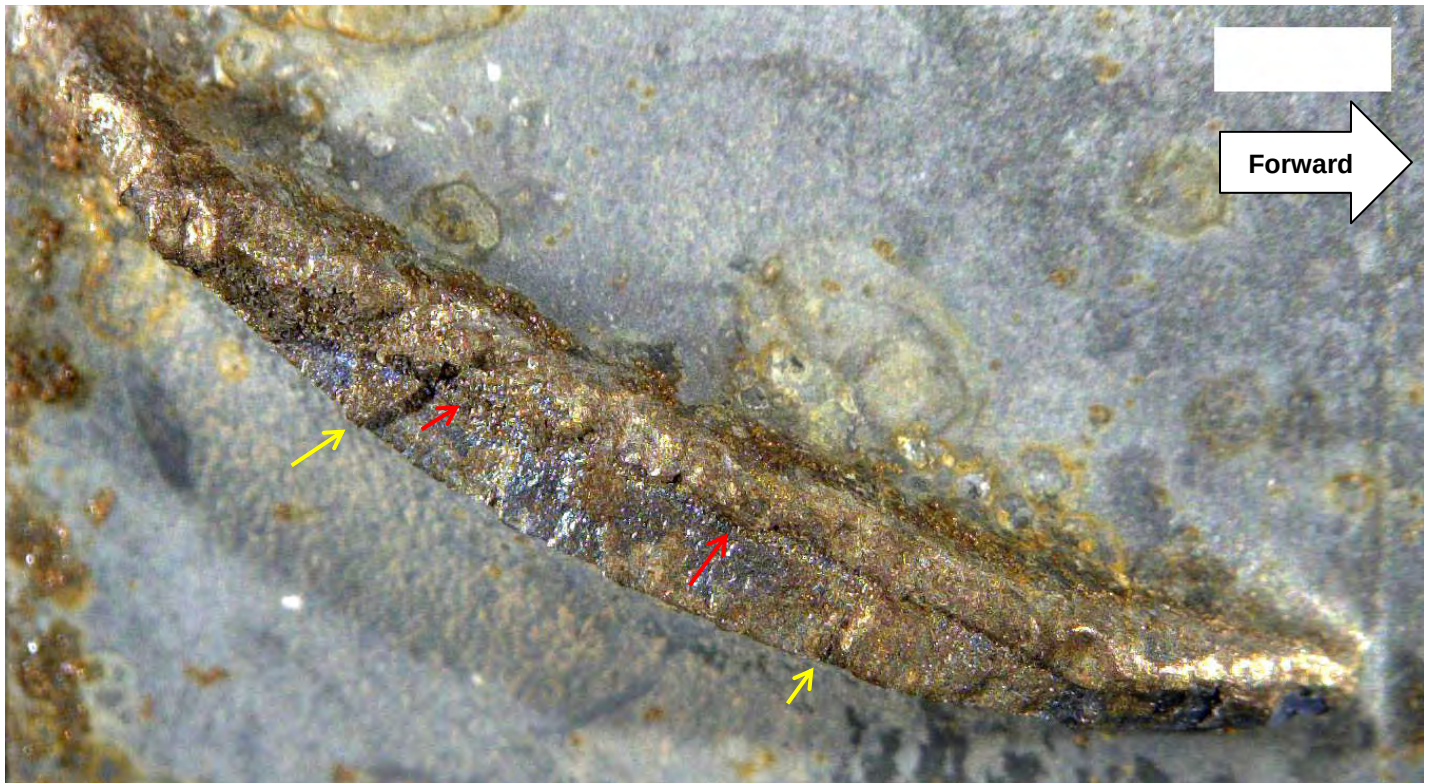
**Figure 80.** Detailed views of the fracture surface (top) and suction side surface (bottom) of stage 6 compressor blade 17 (see Figures 62 and 63). The red arrows indicate the local direction of fatigue progression. The yellow arrows indicate ratchet marks consistent with fatigue initiation on the suction side surface.

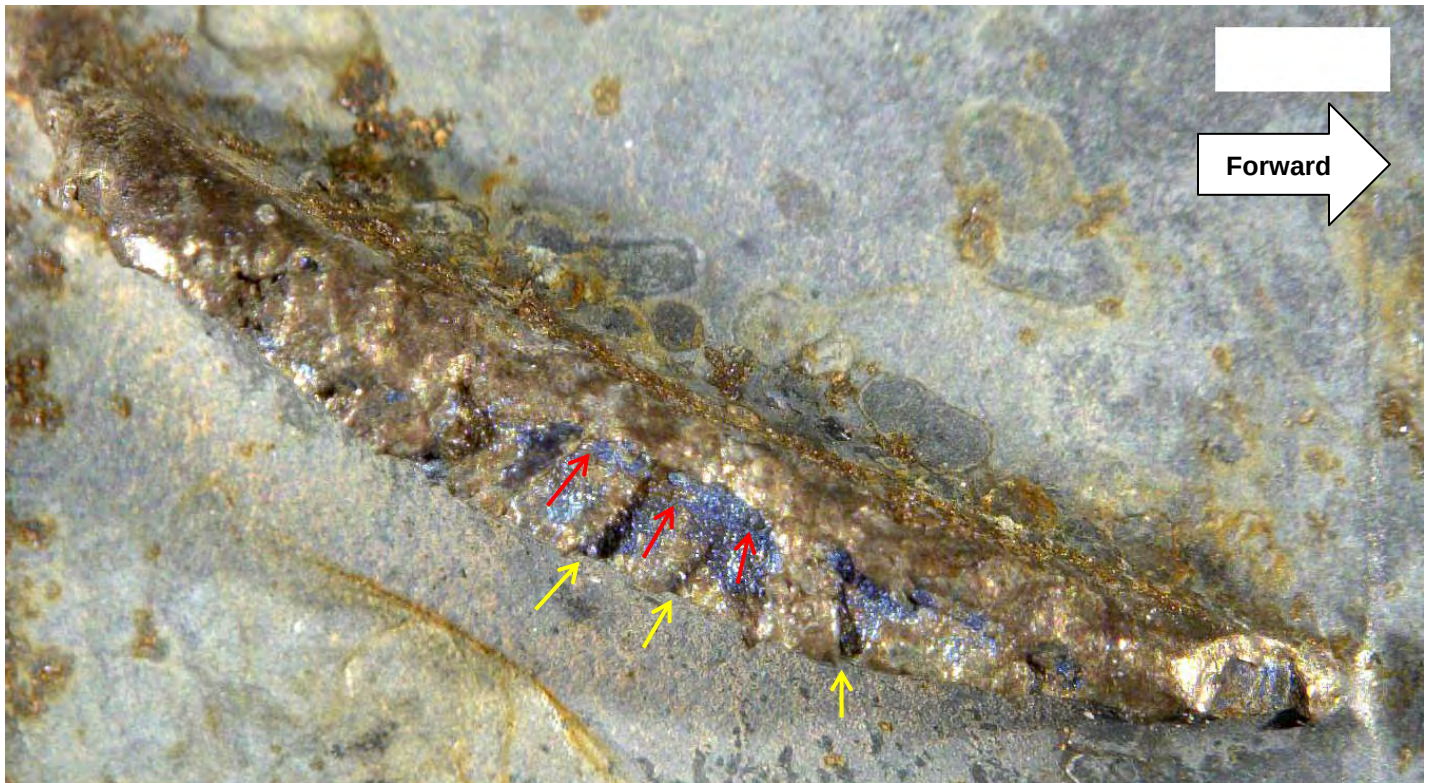
**Figure 81.** Detailed views of the fracture surface (top) and suction side surface (bottom) of stage 6 compressor blade 18 (see Figures 62 and 63). The red arrows indicate the local direction of fatigue progression. The yellow arrows indicate ratchet marks consistent with fatigue initiation on the suction side surface.
