## **AIRWORTHINESS GROUP FACTUAL REPORT**

**NTSB No. ERA21FA130**

**Rolls-Royce Materials Evaluation Report No. 21FAE-025-PR  
(111 pages)**

| <b>TITLE</b><br><br><b>METALLURGICAL INVESTIGATION OF COMPRESSOR COMPONENTS REMOVED FROM AN M250-C20B, ENGINE S/N CAE833459, OPERATED BY CARIBBEAN BUZZ HELICOPTER</b> | | <b>PREPARED</b><br>Signatures on File | | |

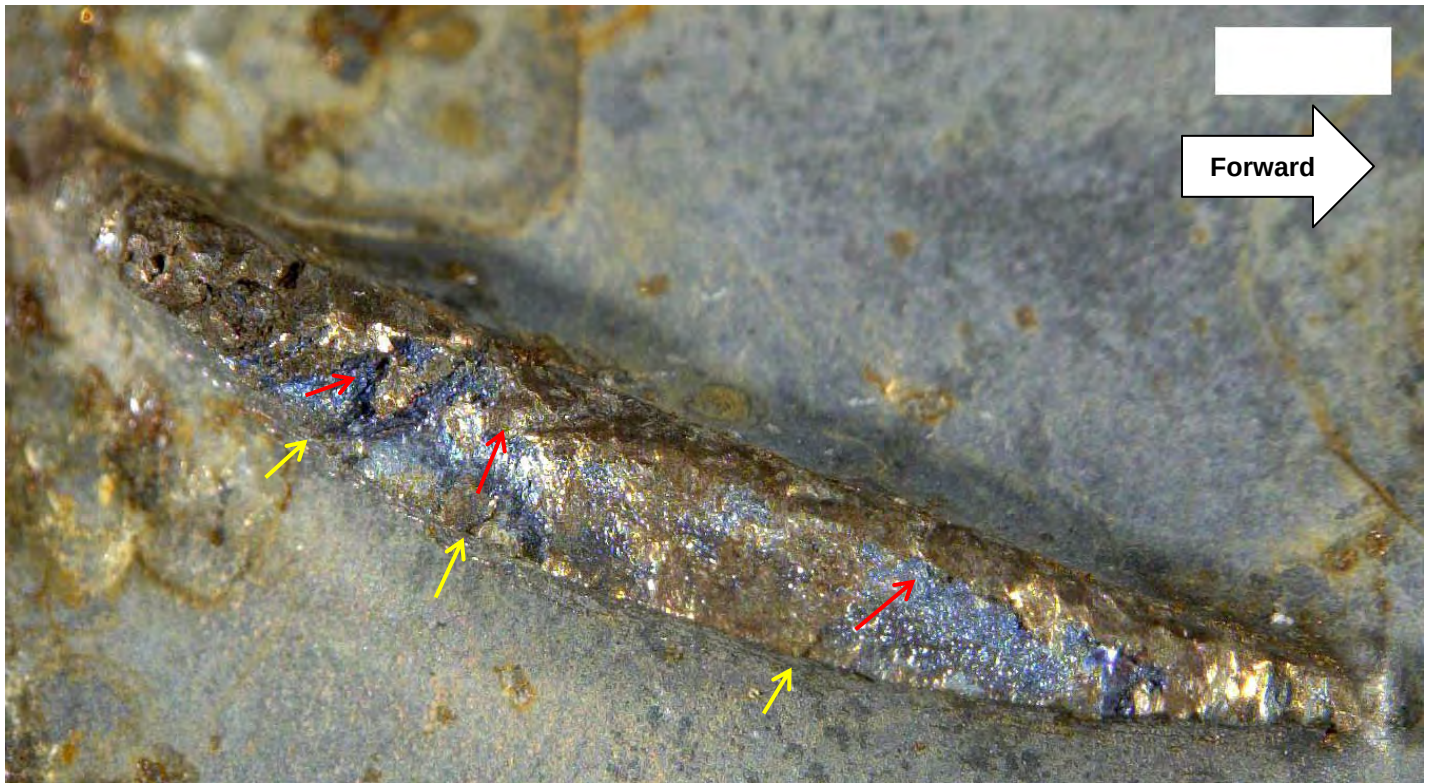
**Figure 82.** Detailed views of the fracture surface (top) and suction side surface (bottom) of stage 6 compressor blade 19 (see Figures 62 and 63). The red arrows indicate the local direction of fatigue progression. The yellow arrows indicate ratchet marks consistent with fatigue initiation on the suction side surface.

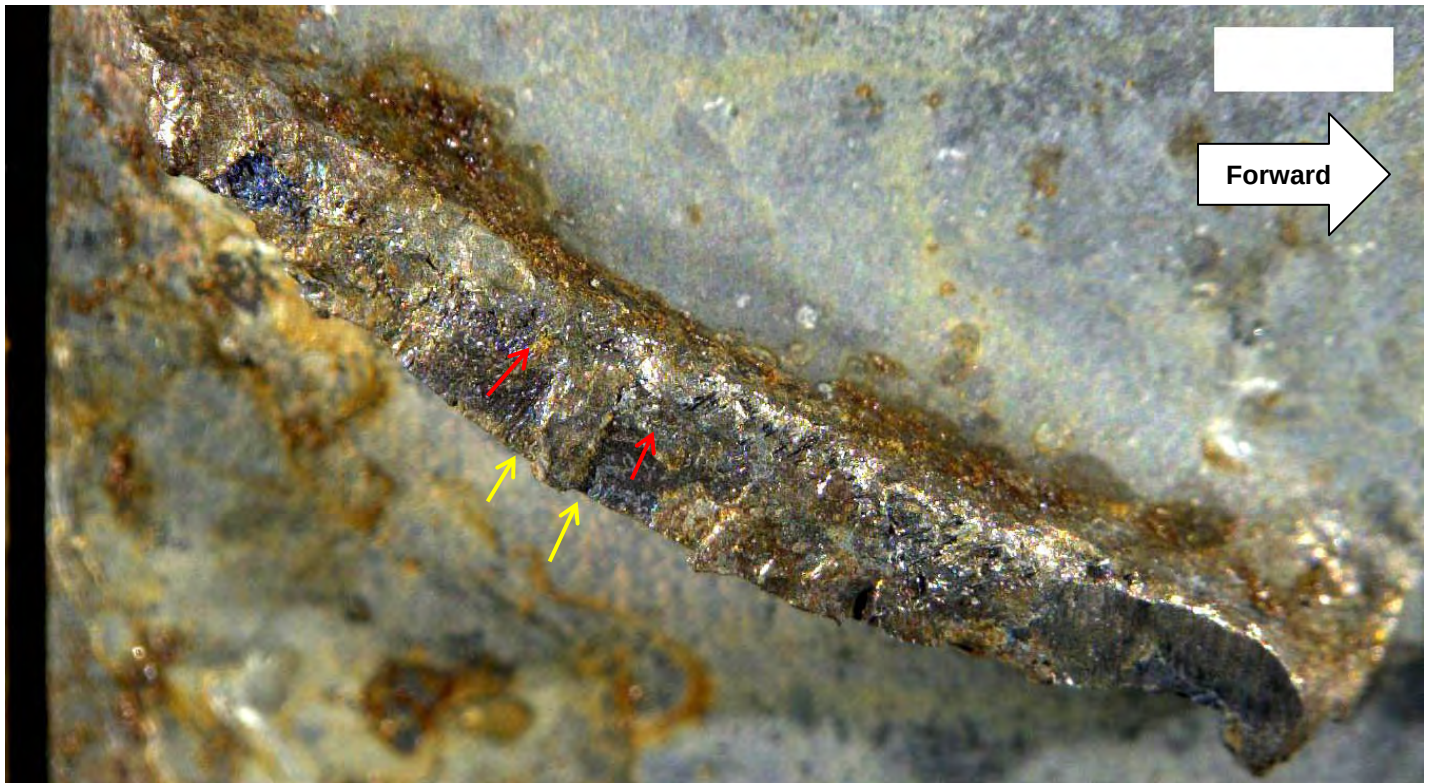
**Figure 83.** Detailed views of the fracture surface (top) and suction side surface (bottom) of stage 6 compressor blade 20 (see Figures 62 and 63). The red arrows indicate the local direction of fatigue progression. The yellow arrows indicate ratchet marks consistent with fatigue initiation on the suction side surface.

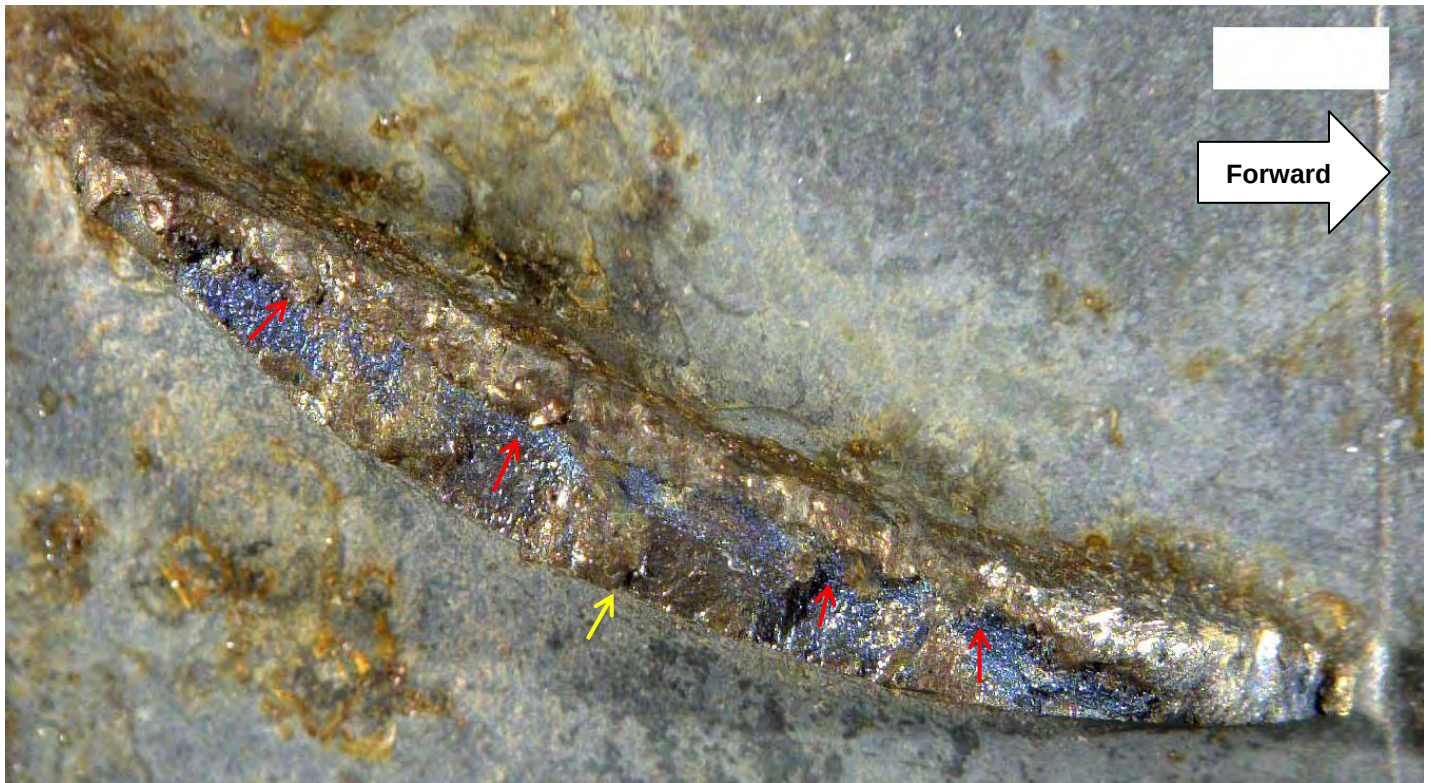
**Figure 84.** Detailed views of the fracture surface (top) and suction side surface (bottom) of stage 6 compressor blade 21 (see Figures 62 and 63). The red arrows indicate the local direction of fatigue progression. The yellow arrow indicates a ratchet mark consistent with fatigue initiation on the suction side surface.

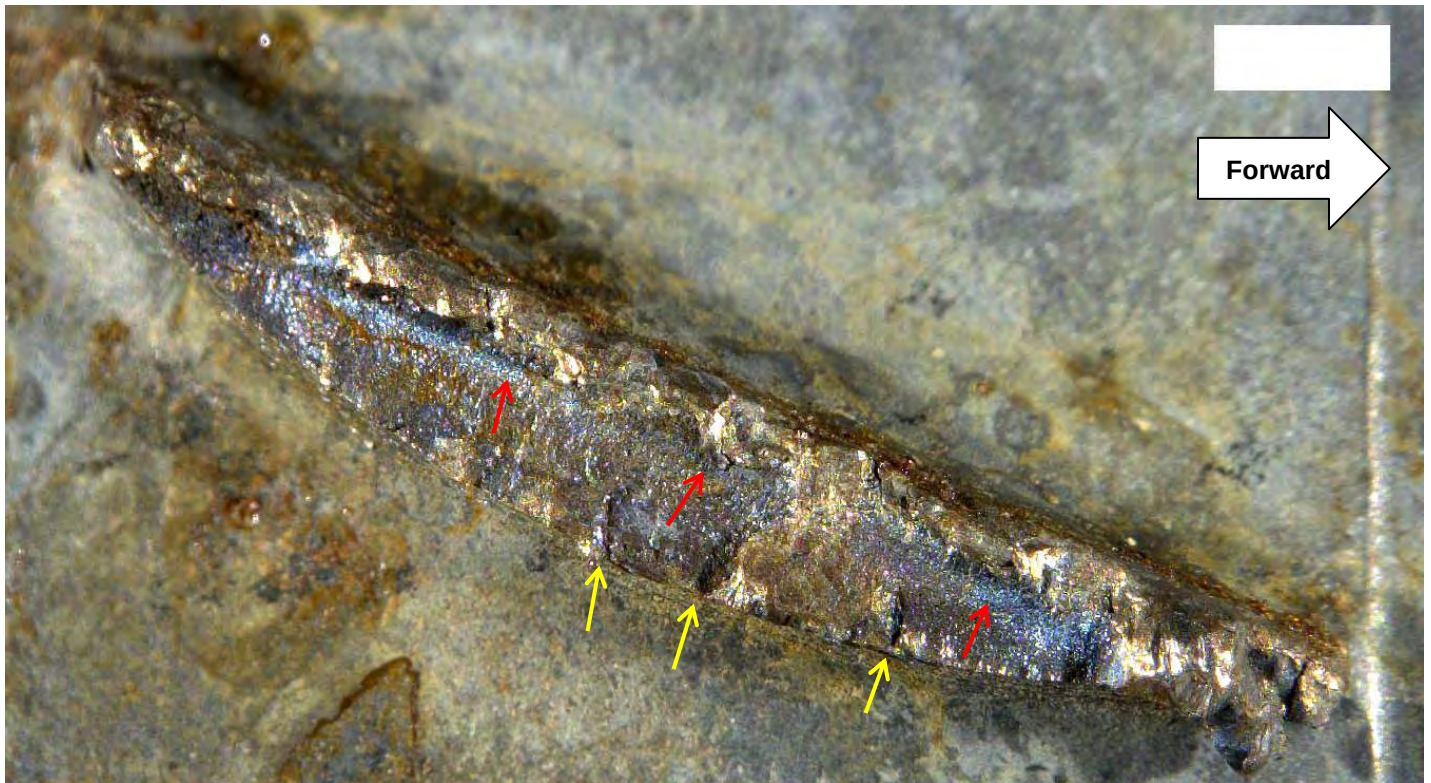
**Figure 85.** Detailed views of the fracture surface (top) and suction side surface (bottom) of stage 6 compressor blade 22 (see Figures 62 and 63). The red arrows indicate the local direction of fatigue progression. The yellow arrows indicate ratchet marks consistent with fatigue initiation on the suction side surface.

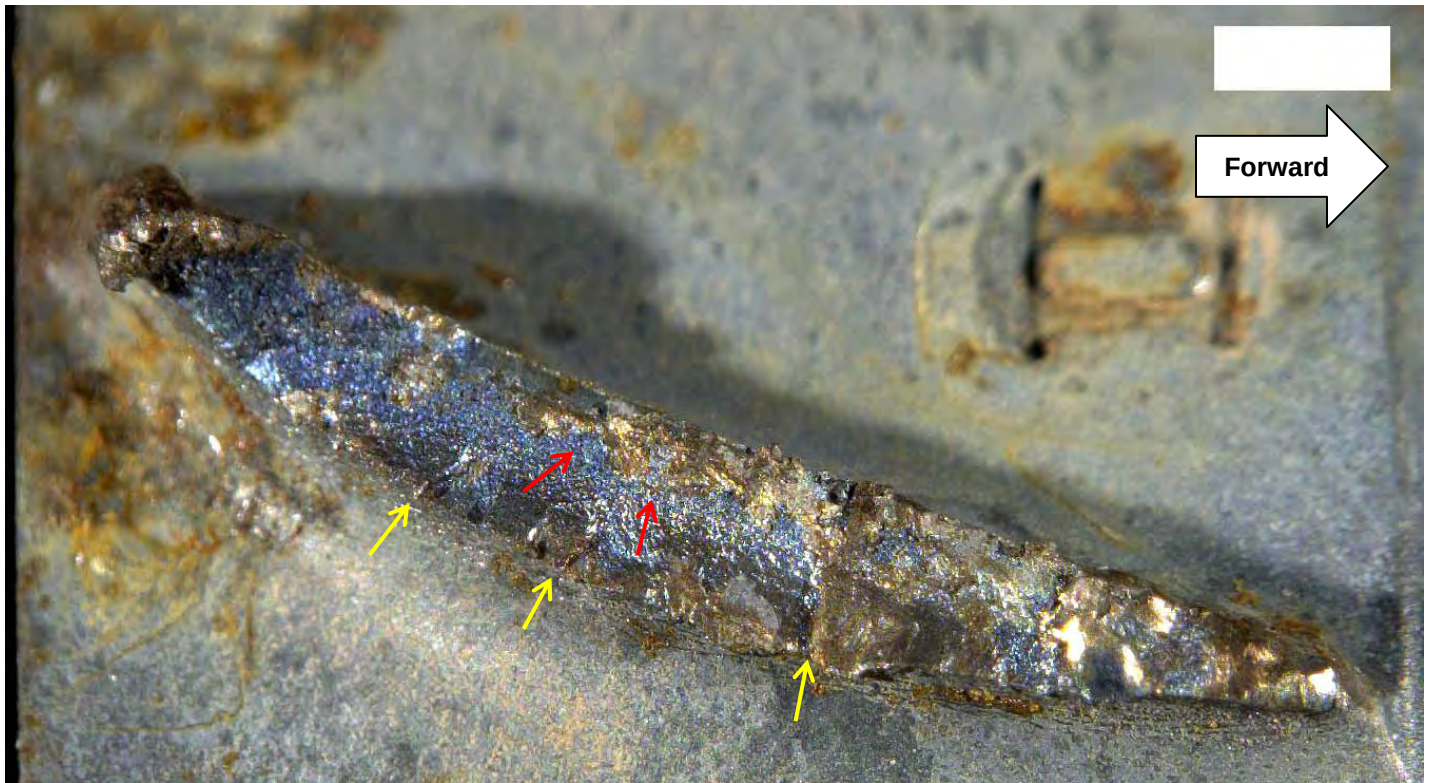
**Figure 86.** Detailed views of the fracture surface (top) and suction side surface (bottom) of stage 6 compressor blade 23 (see Figures 62 and 63). The red arrows indicate the local direction of fatigue progression. The yellow arrows indicate ratchet marks consistent with fatigue initiation on the suction side surface.

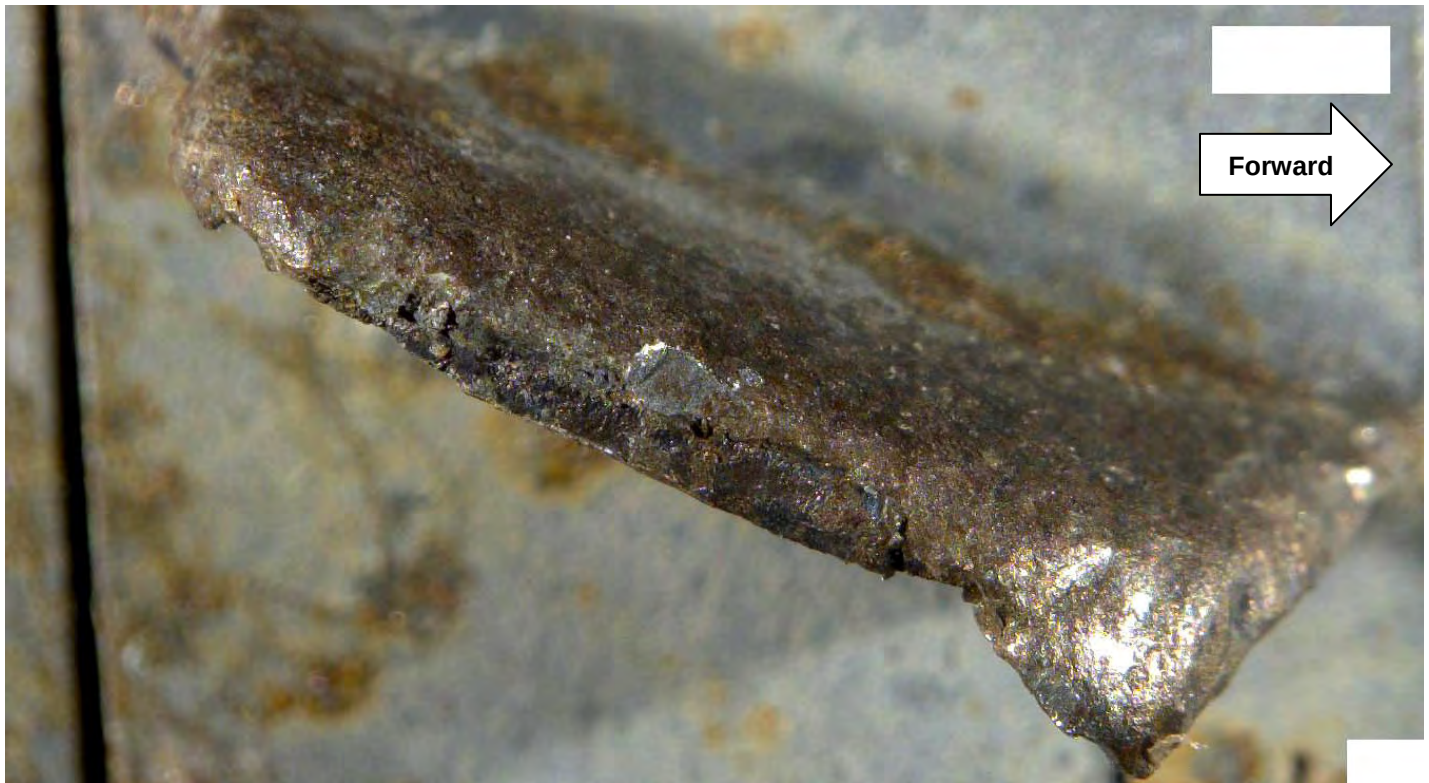
**Figure 87. Detailed views of the fracture surface (top) and suction side surface (bottom) of stage 6 compressor blade 24 (see Figures 62 and 63). There were no fatigue progression features on this fracture surface. This blade is shown in more detail in Figures 89 and 90.**

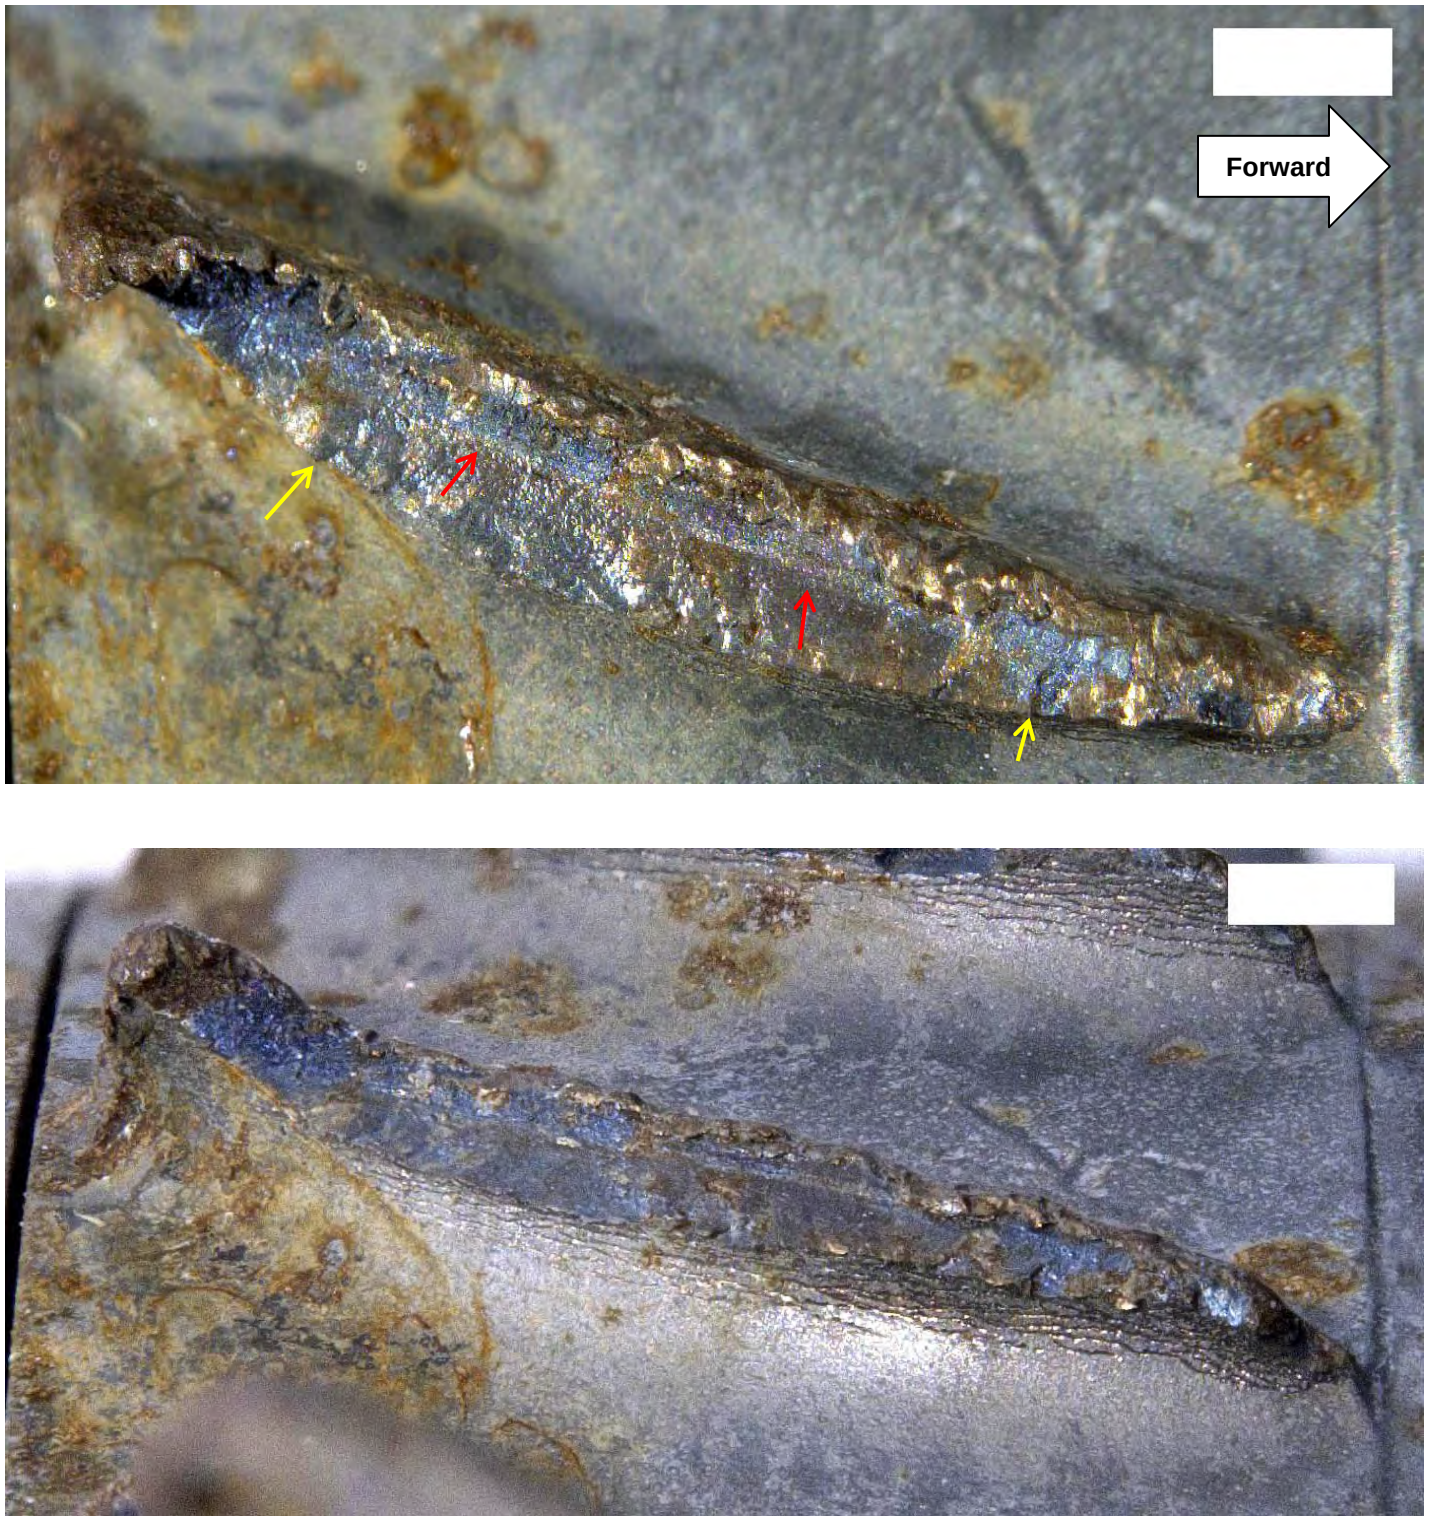
**Figure 88.** Detailed views of the fracture surface (top) and suction side surface (bottom) of stage 6 compressor blade 25 (see Figures 62 and 63). The red arrows indicate the local direction of fatigue progression. The yellow arrows indicate ratchet marks consistent with fatigue initiation on the suction side surface.
