# NATIONAL TRANSPORTATION SAFETY BOARD

## MATERIALS LABORATORY FACTUAL REPORT

Report No. 21-029

Place : Vinemont, Alabama  
Date : February 20, 2021  
Vehicle : Piper PA-32RT-300T, N10KV  
NTSB No. : ERA21FA133  
Investigator : Millicent Hill, AS-WPR

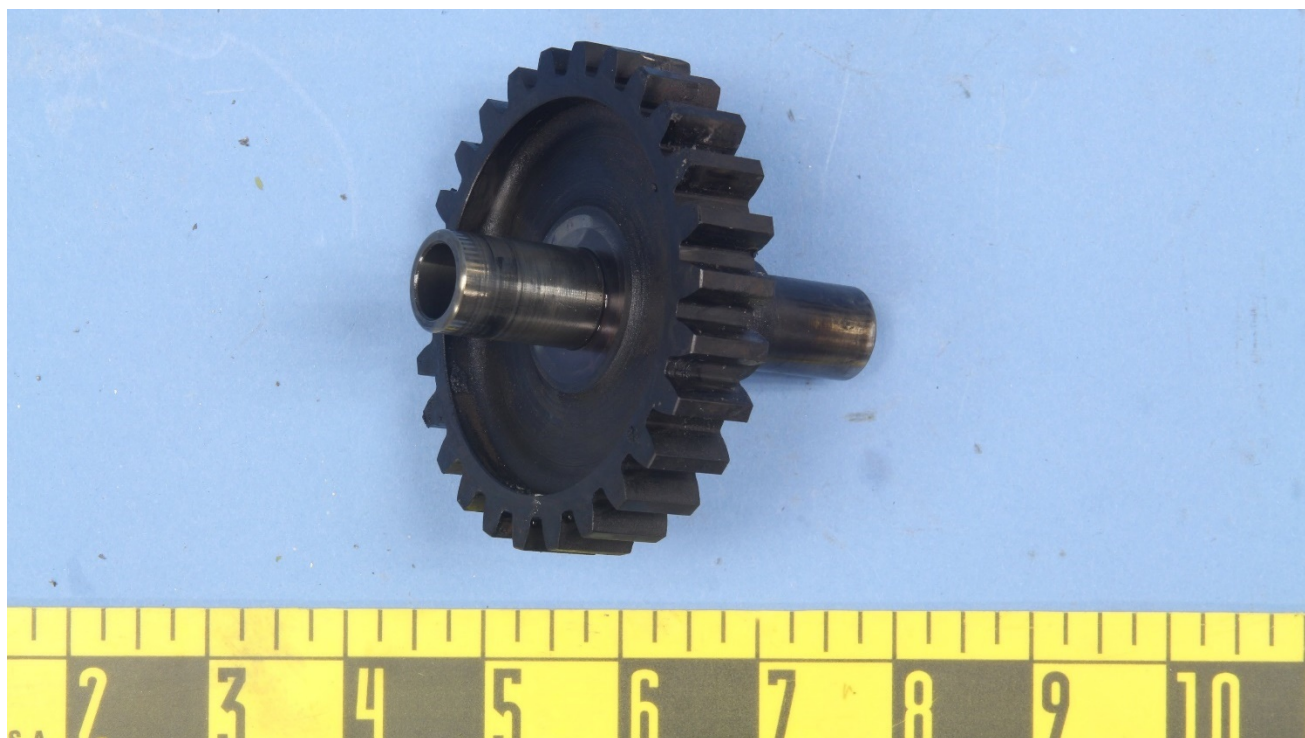
The parts received included the remnants of five gear assemblies, along with an attachment bolt and lock plate. The parts are shown in Figures 1 through 4, as received. This included the bottom right hand assembly gear (Figure 1), the top left hand assembly gear (Figure 2), and a pair of unlabeled accessory gears (Figure 3). All these gears were intact, with no clear indications of deformation or fracture. These gears did exhibit a thick surface layer of soot and oils, consistent with exposure to fire and elevated temperatures.

Figure 1 – The bottom right hand assembly gear, as received.

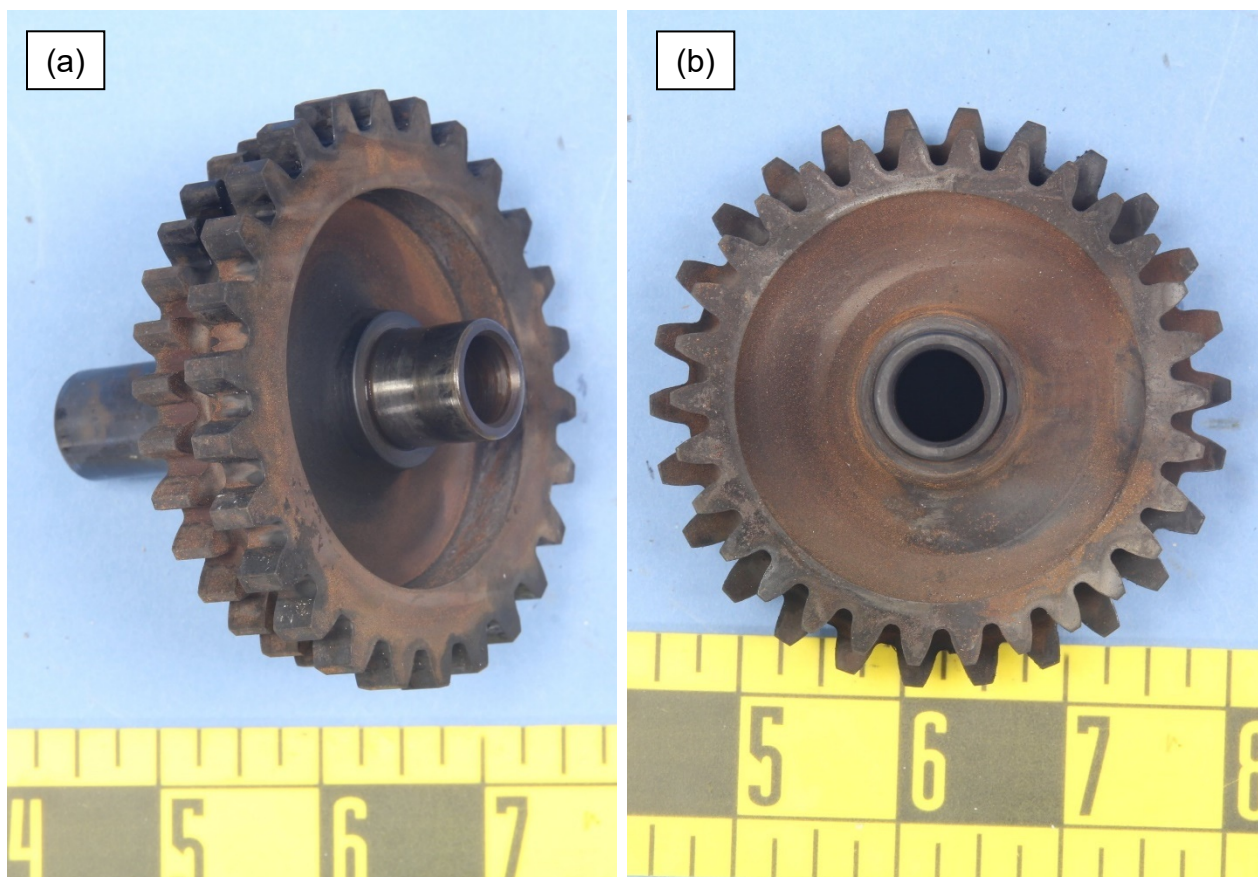
The top left hand gear also exhibited a uniform surface layer of rust. As the layer was uniform and present over wear marks, the rust was consistent with oxidation from exposure to water or air after the accident.

Figure 2 – The top left hand assembly gear, as received.

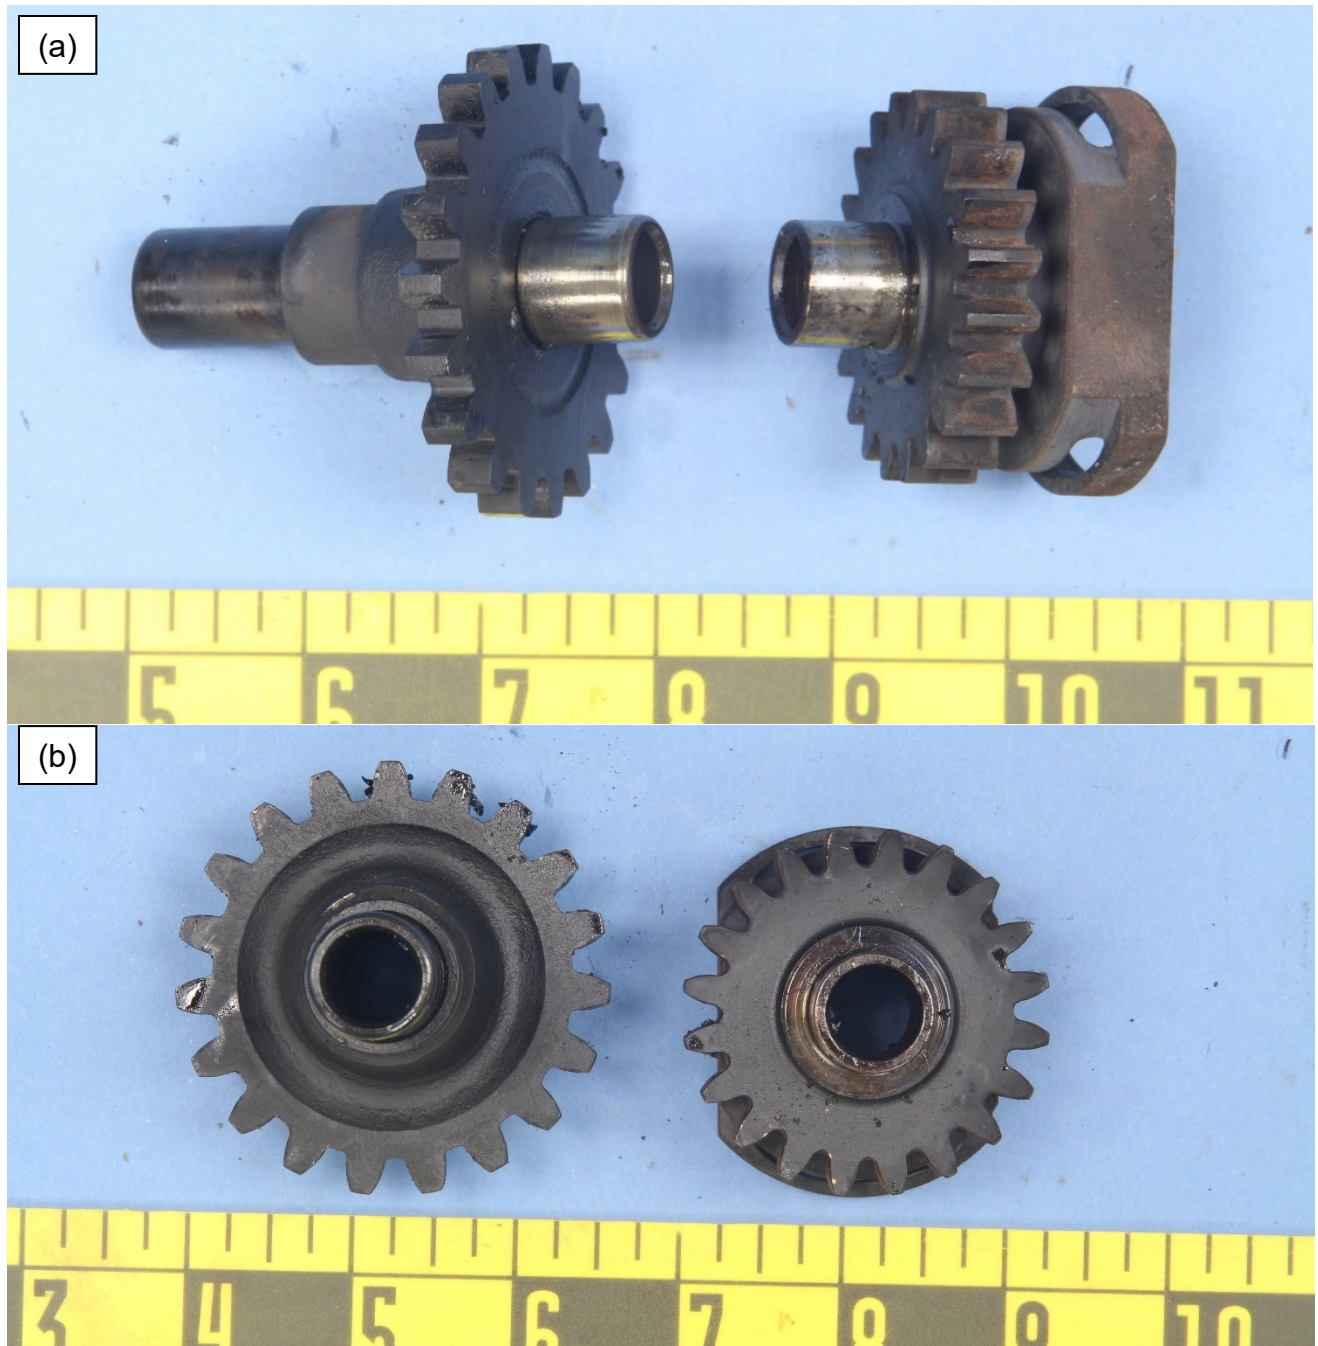
Figure 3 – The pair of accessory gears, as received; viewed from (a) the sides and (b) the gear faces.

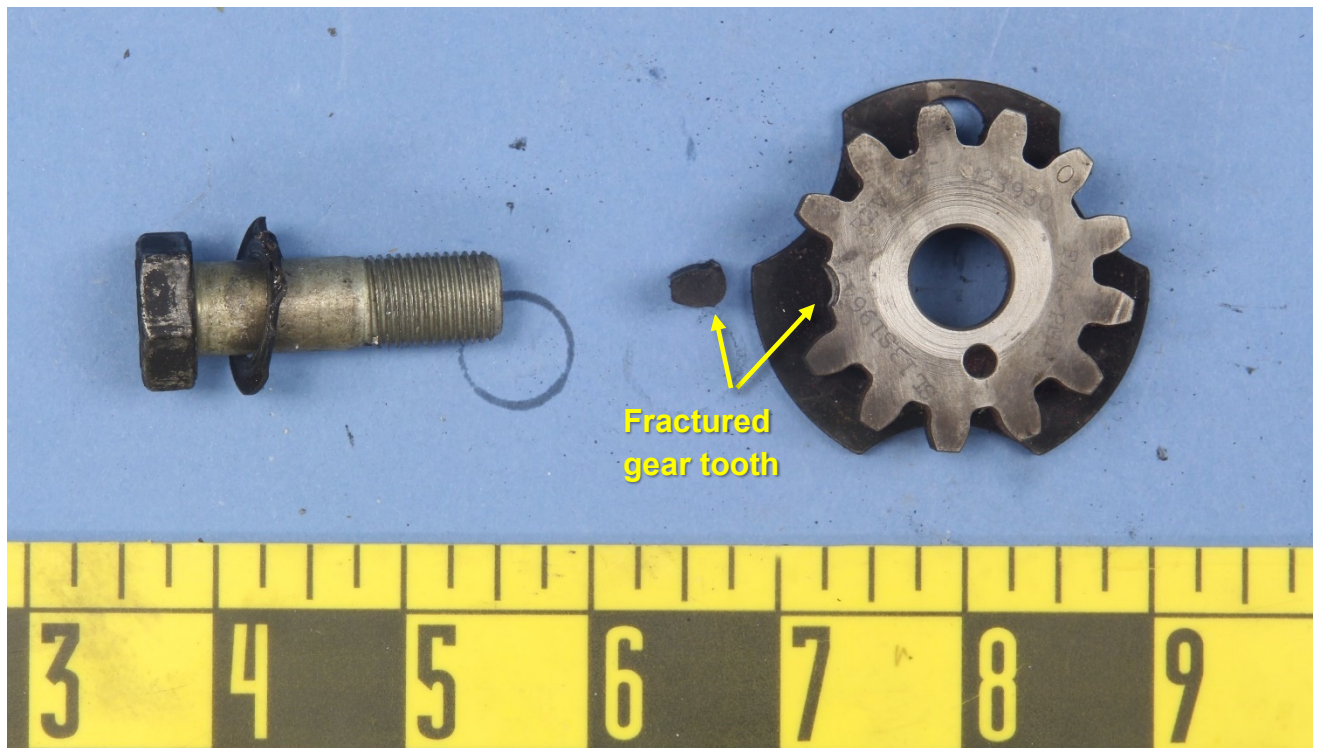
Figure 4 shows the components of the crankshaft drive gear, as received. This consisted of the remnants of the drive gear assembly, the attachment bolt, and the locking plate. The head of the bolt, the teeth of the gear, and the forward backing plate of the gear assembly exhibited a dark color, consistent with oil and soot deposits. These constituents were absent on the aft face of the gear and the threads of the bolt. Of note was one of the gear teeth had fractured and liberated from the gear assembly.

The gear exhibited the following markings on the aft face: "SL13S19649 REV B M23930 FAA-PMA". In the aft looking forward position, the fractured gear was the fifth tooth positioned counterclockwise from the aft tooth face labeled "0".

Figure 4 – The crankshaft drive gear and tooth fragment, along with the attachment bolt and locking tab remnant, as received.

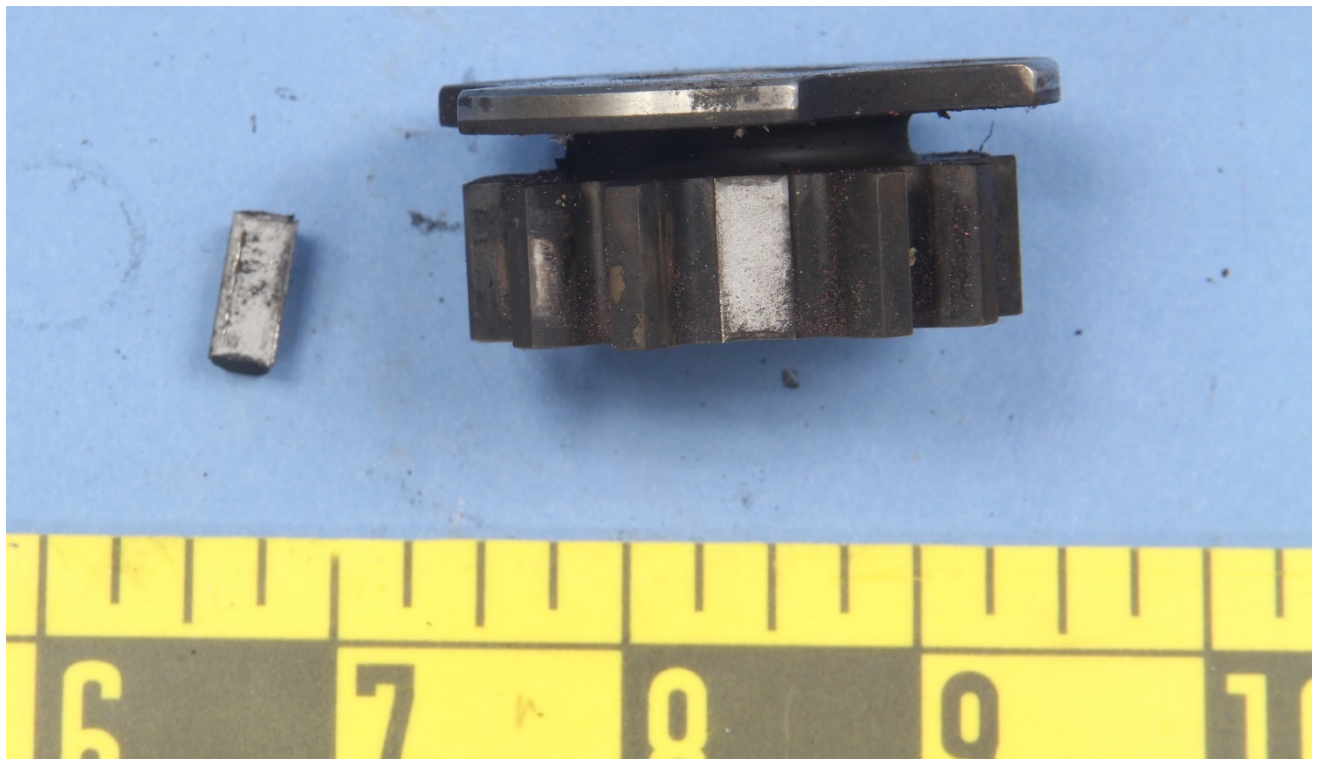
Figure 5 shows the mating fracture surfaces of the fractured tooth. For the most part, the mating fracture surfaces exhibited a dull, fibrous, light gray surface, contrasting with the surrounding darkened gear surfaces. Figure 6 shows a closer view of the fracture surface on the gear. This fracture exhibited a rough surface texture, along with a general concave orientation, particularly along the edges and periphery. The location of the fracture edges was consistent with the fillet radius between the bottom lands and the adjacent flanks. This geometry is exemplified in the angled view in Figure 7.

Figure 5 – View of the mating fracture surfaces of the drive gear and liberated tooth.

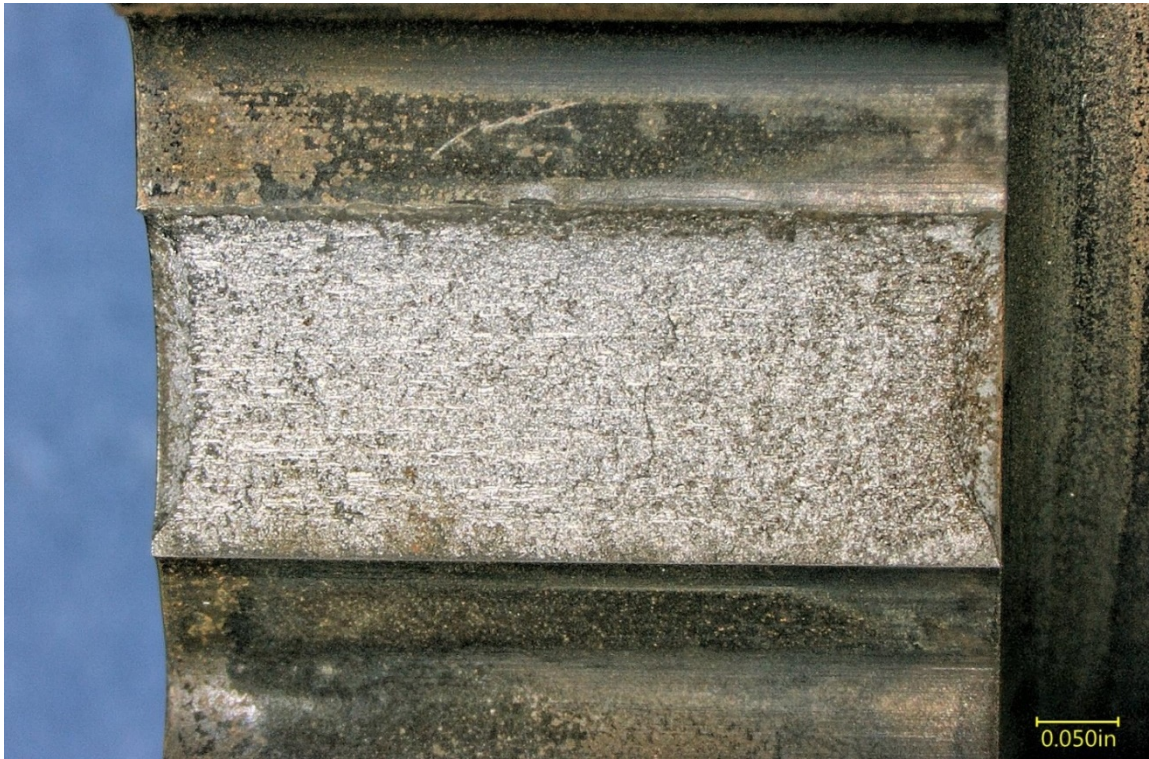
Figure 6 – The fractured tooth surface of the drive gear.

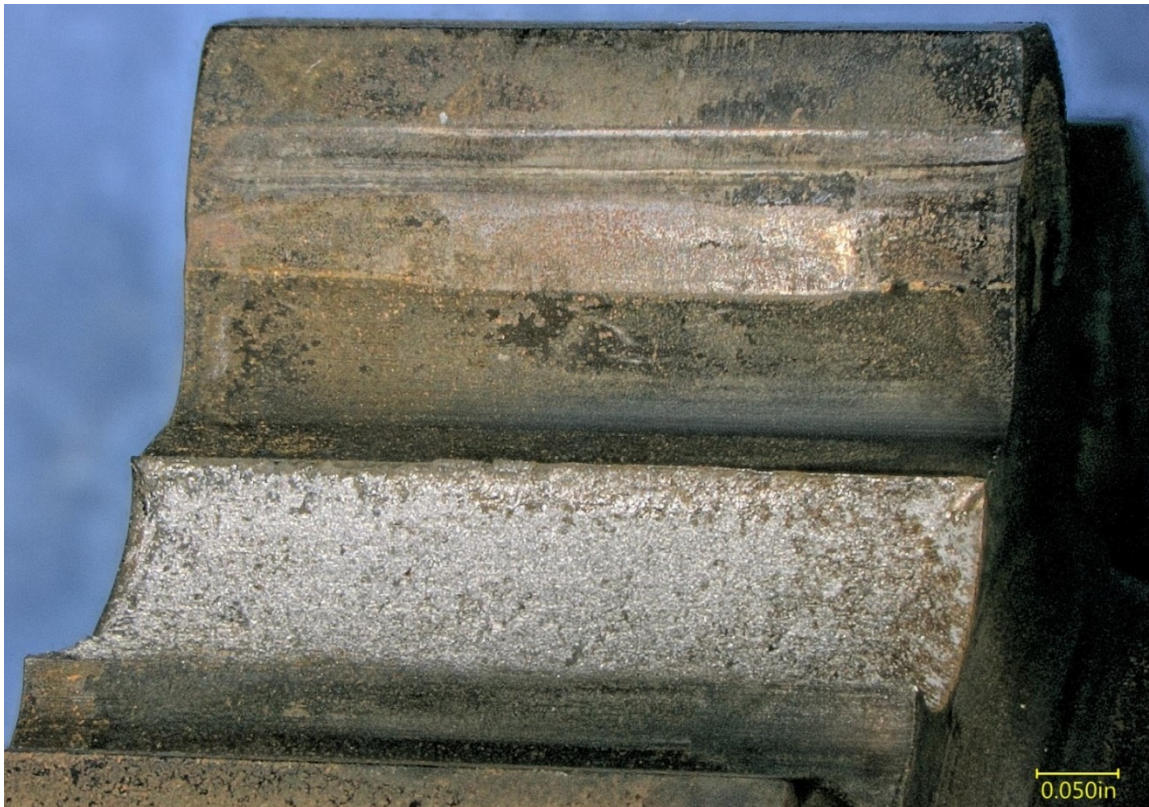
Figure 7 also shows the flank and face of an intact tooth adjacent to the fracture surface. There is a longitudinal rectangular wear mark along the width of the tooth, consistent with being the surface interacting with the adjacent gear. This wear was located along the pitch circle location in the middle of the tooth, rather than closer to the upper top land. There were no indications of cracks or fractures on this tooth.

Figure 7 – Angled view of the gear fracture surface, showing the adjacent tooth.

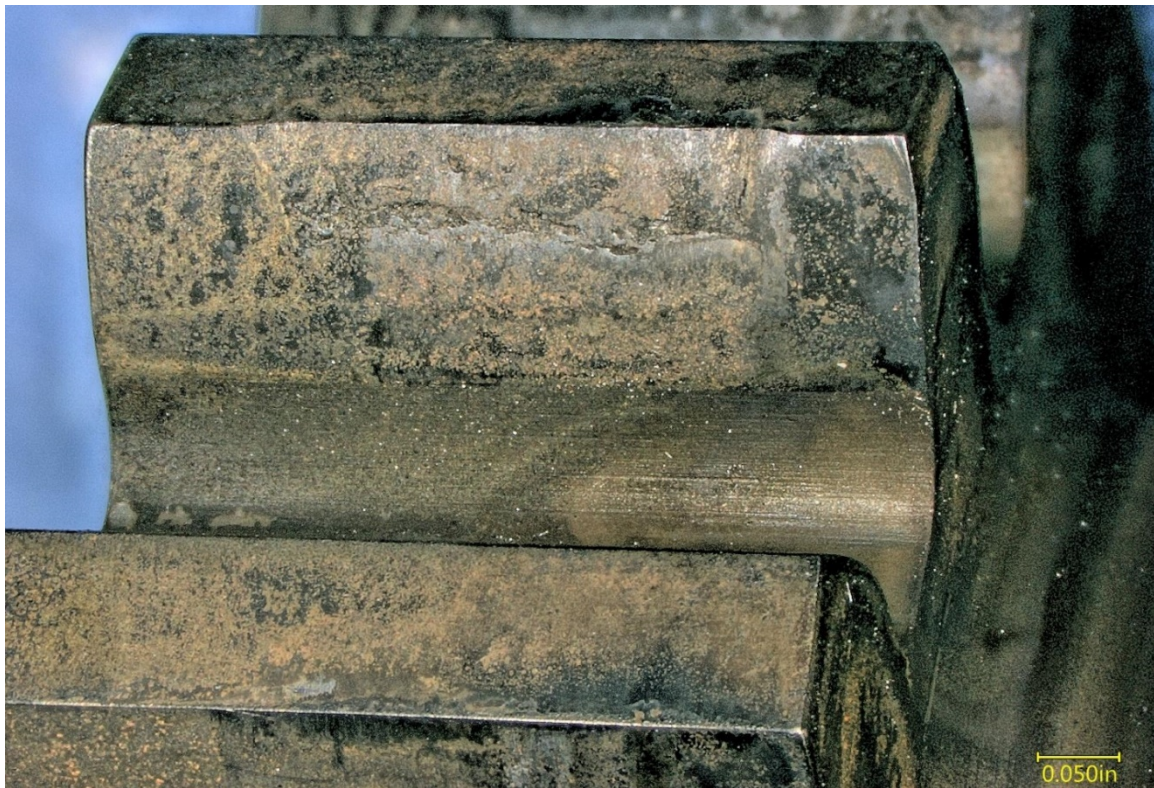
Figure 8 though shows another nearby gear tooth with a smaller rectangular impression along the tooth land. As shown in Figure 9, this impression exhibited localized plastic deformation into the tooth land around the edges. The edges of the rectangular impression exhibited some material spalling and surface cracking.

Figure 8 – View of an intact but abraded gear on the driven side.

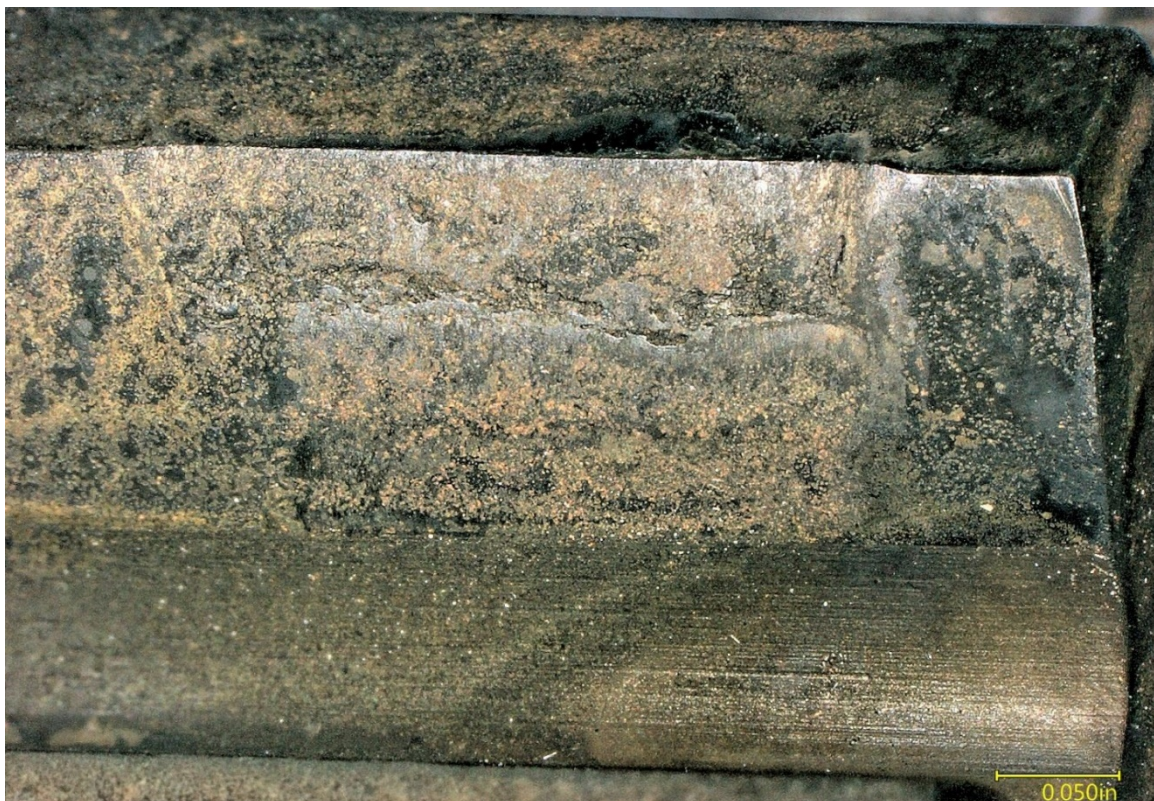
Figure 9 – Closer view of the imprint on a gear tooth flank in Figure 8.

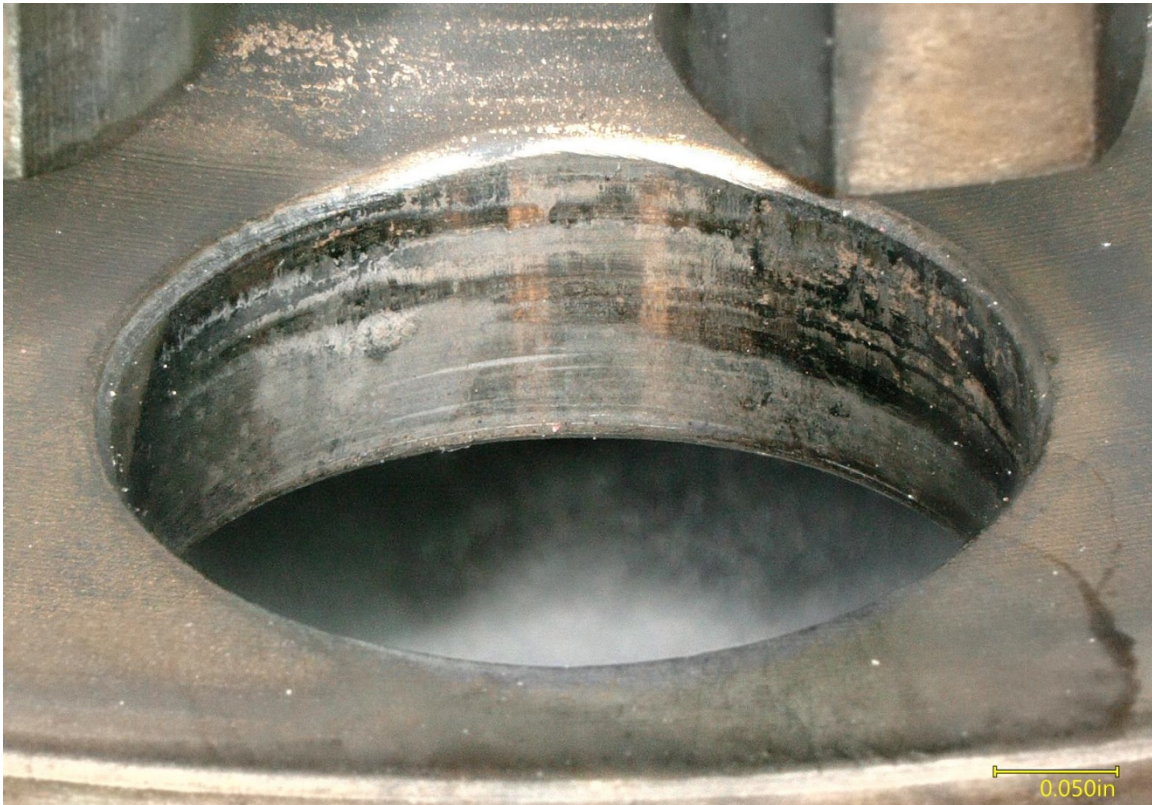
Also examined was the dowel hole on the forward backing plate of the gear assembly (see Figure 10). The interior of the hole exhibited some circumferential and longitudinal wear marks, consistent with vibration and fretting between the plate and the crankshaft dowel. There was an area on a hole edge with outward plastic deformation, manifest as an impression on the edge. This deformation was present only on the one edge location.

Figure 10 – View of the pin hole on the drive gear backing plate, showing internal wear.

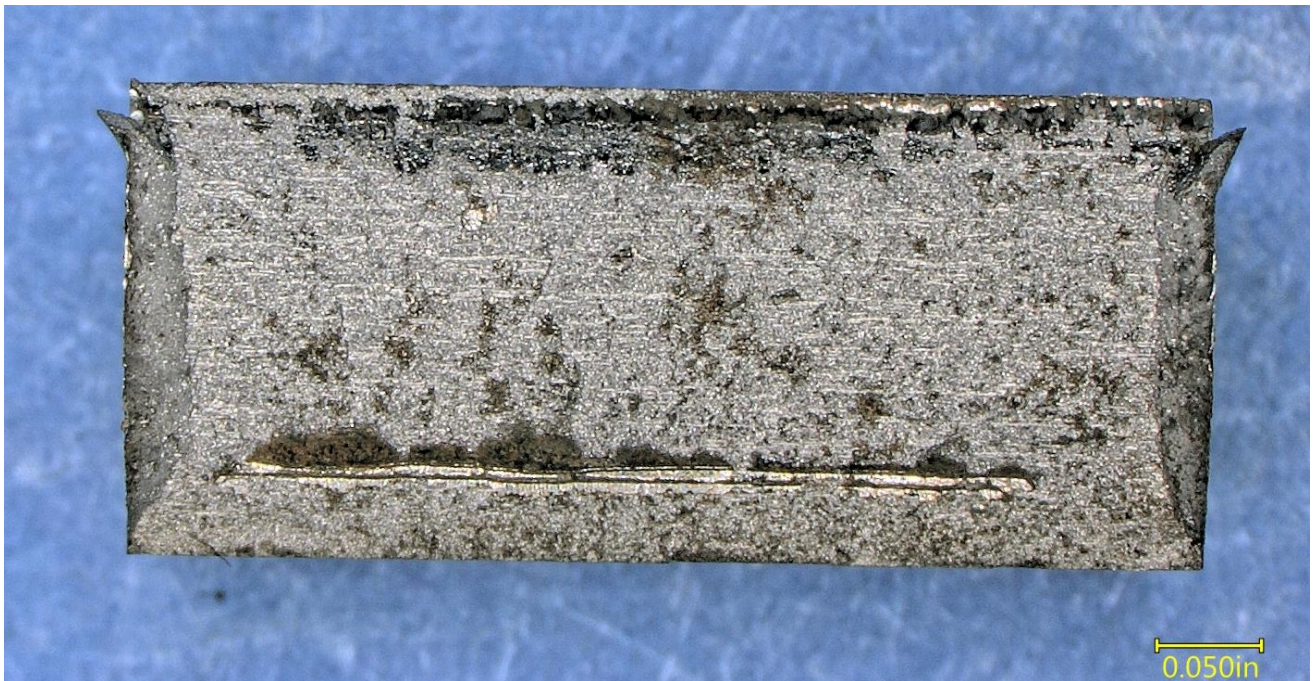
The fractured and liberated gear tooth was cleaned in acetone using an ultrasonic bath. The fracture surface is shown in Figure 11. The surface exhibited a general convex shape, consistent with having mated to the concave shape of the gear fracture. Figure 12 shows the tooth from both lands and faces, whereas Figure 13 shows the tooth from the forward and aft faces. Towards one of the edges, the fracture surface curvature was less

Figure 11 – View of the fracture surface of the fractured drive gear tooth.

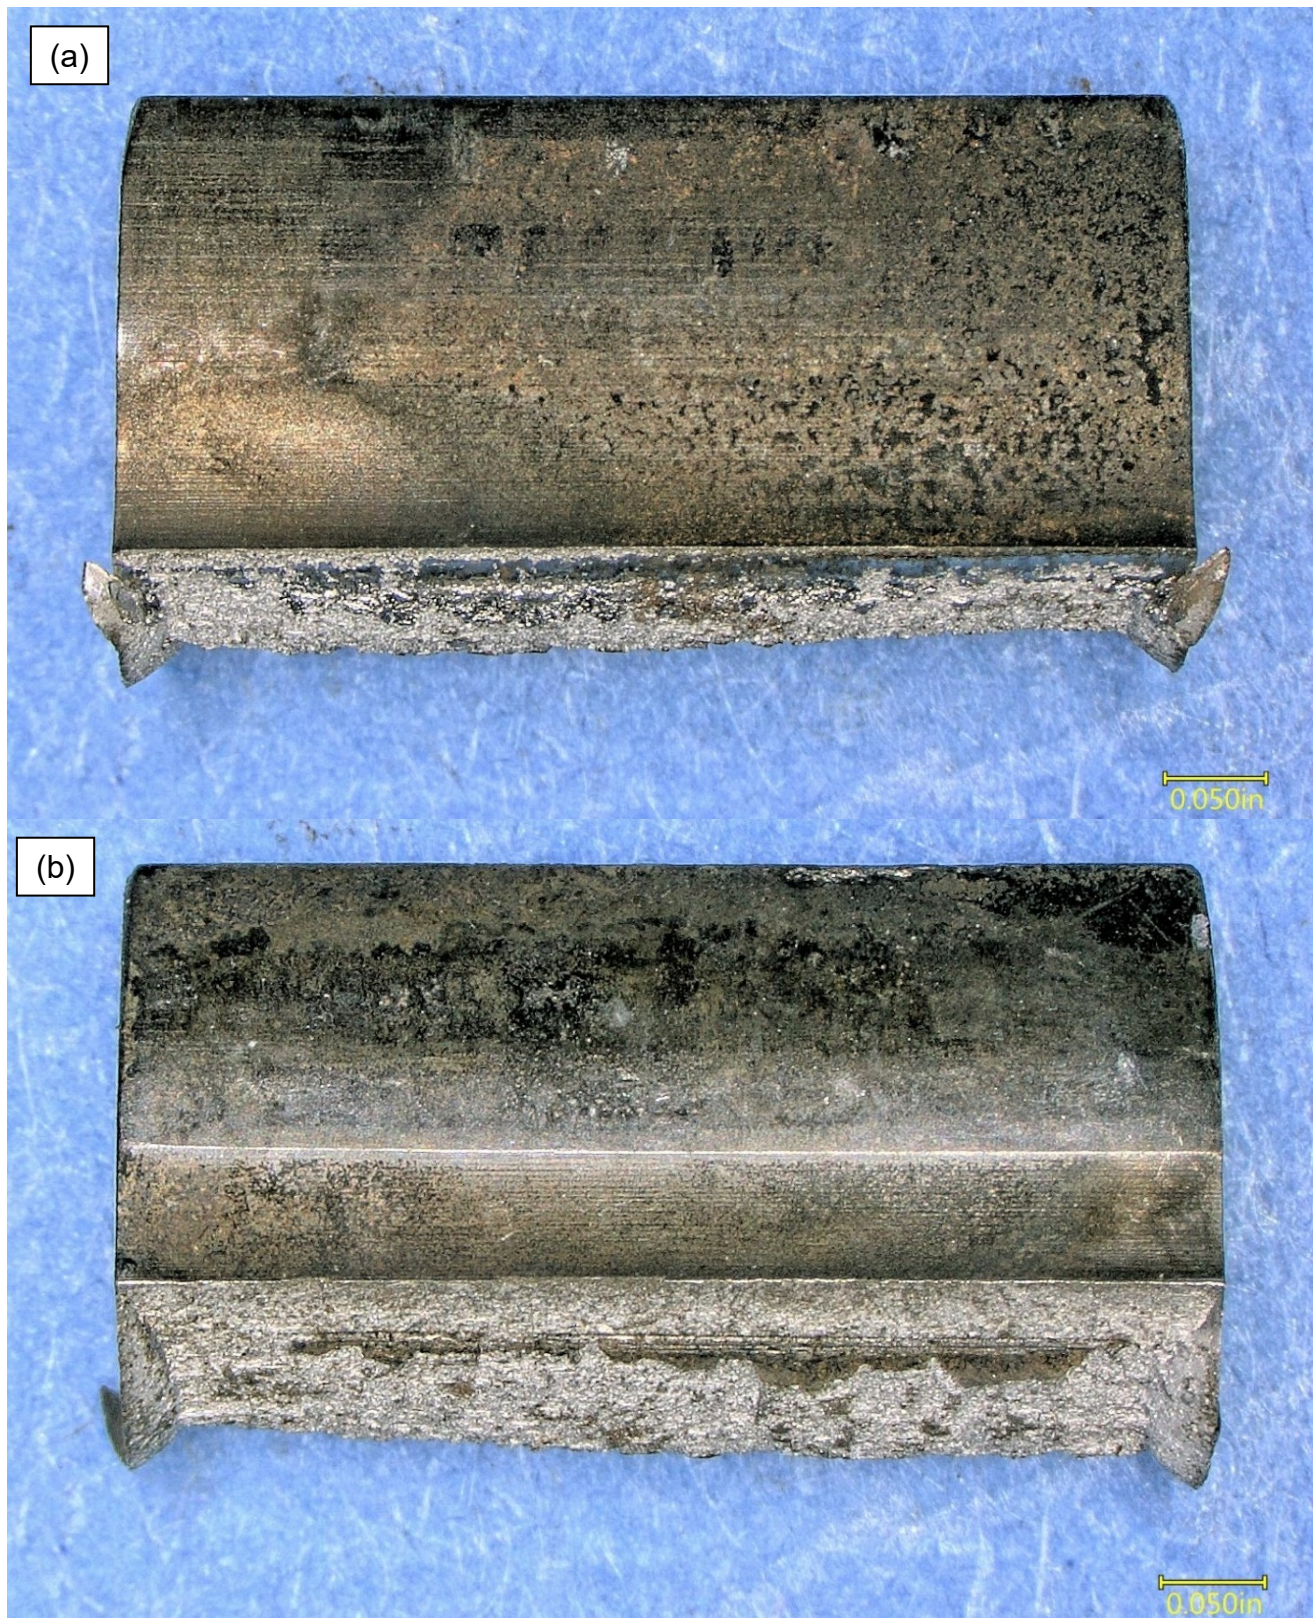
pronounced than along the opposite edge. In addition, this opposite edge exhibited a cantilever curl, along with knife-shaped points exuding outward. These features were consistent with the tooth having fractured in bending, and the bending direction was consistent with the loading and rotation direction of the gear wear marks.

Figure 12 – View of the fractured tooth from (a) the lagging face and (b) driven face.

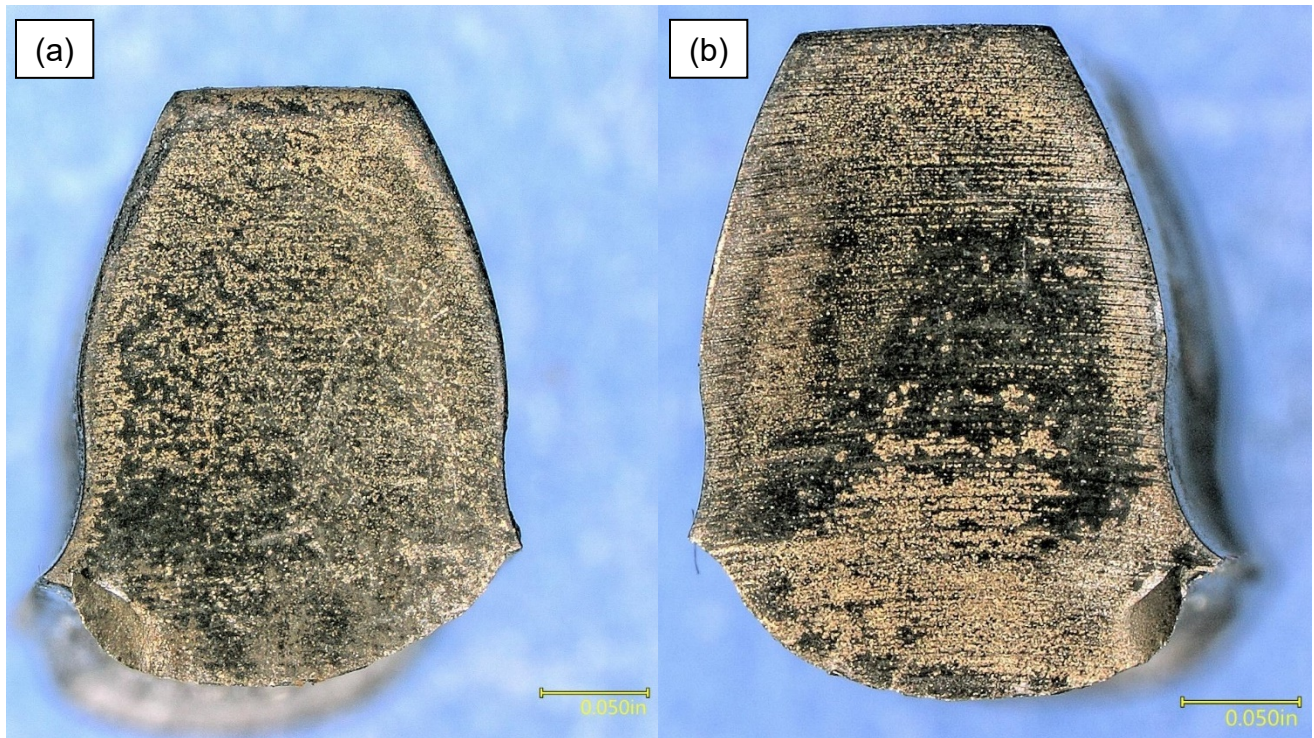
Figure 13 – The sides of the fractured gear teeth from the (a) forward face side and (b) backing plate side.

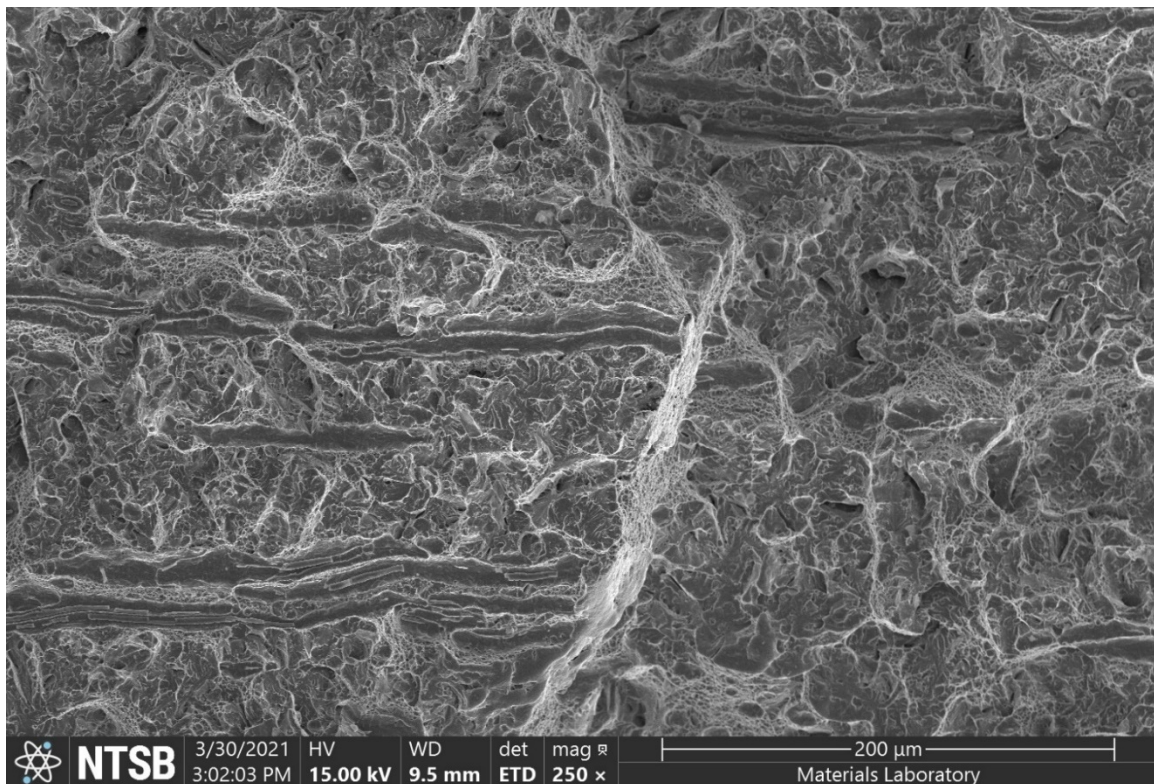
The tooth was examined using a scanning electron microscope (SEM). Figure 14 shows a typical view of the tooth fracture surface. The tooth exhibited a rough texture with parallel elongated regions of flatter surface quality. Closer examination revealed dimpled rupture, consistent with overstress fracture in both of these regions (see Figure 15).

Figure 14 – Secondary electron (SE) micrograph of a typical area of the core fracture surface of the fractured gear tooth.

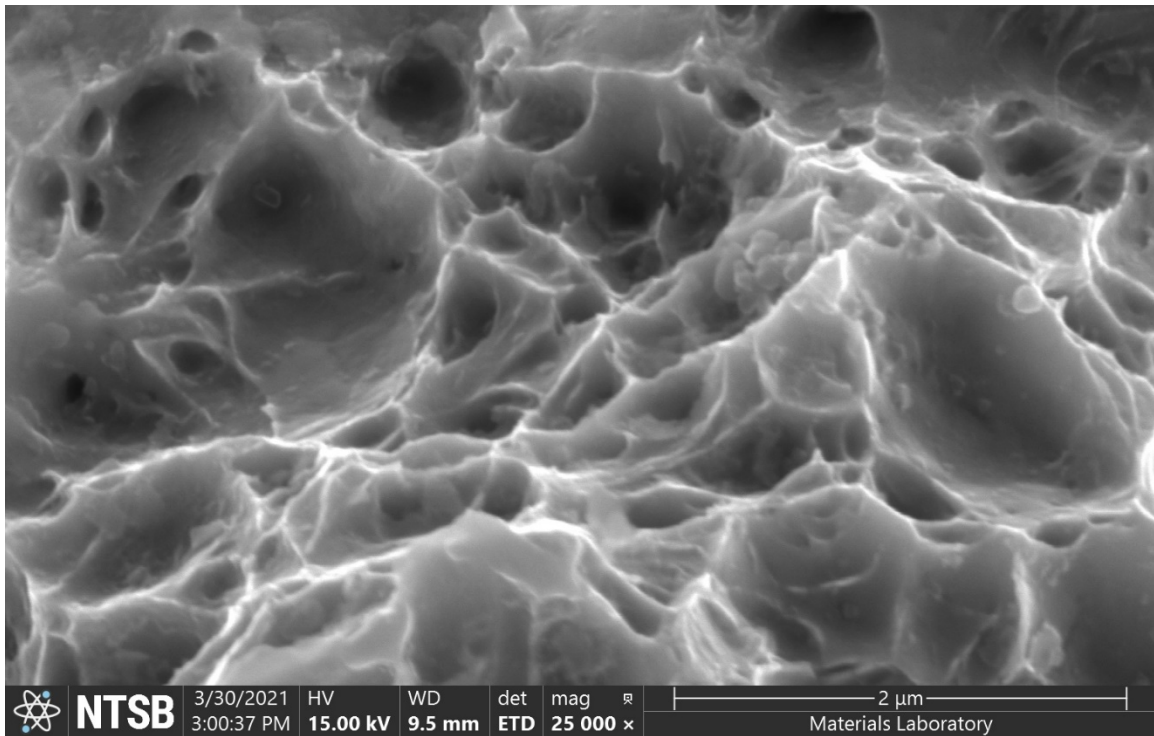
Figure 15 – Closer view of the fracture surface in Figure 14, showing dimpled rupture.

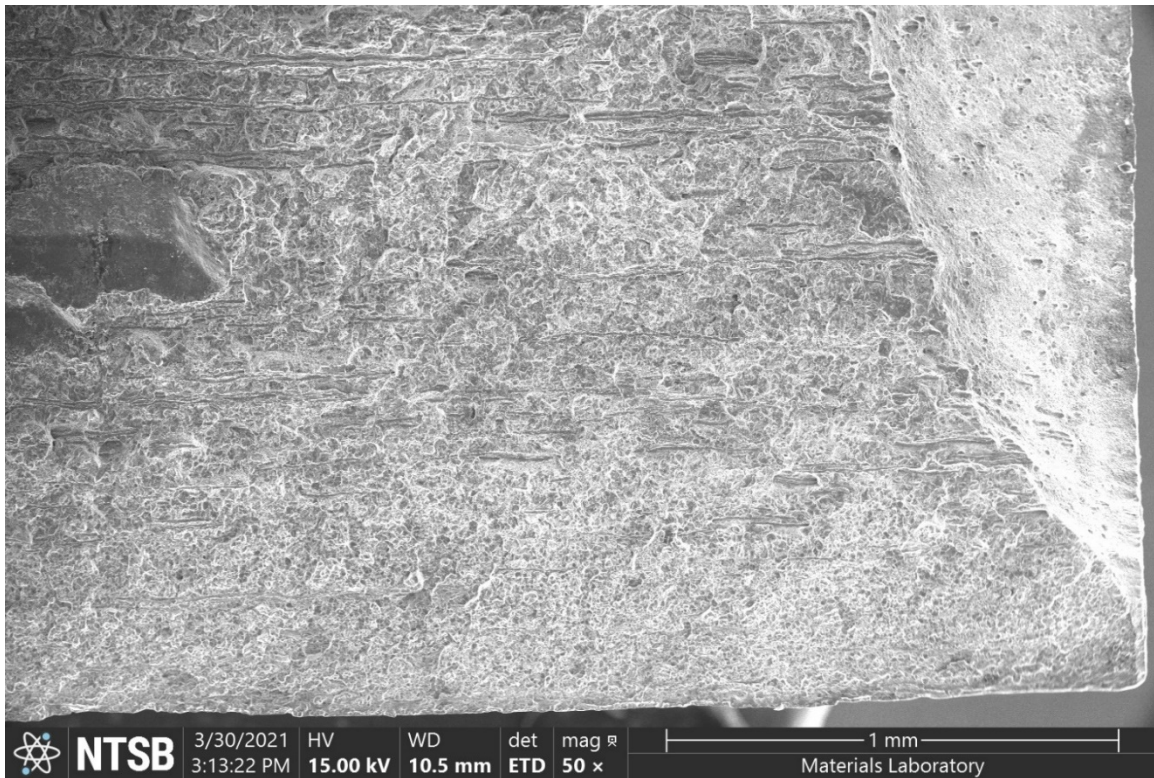
Towards the outside edge of the fracture surfaces on the tooth land and profile width, the fracture surface morphology became more faceted (Figure 16). A closer view of the outer portion of the fracture surface revealed mixed features of faceted and dimpled rupture features, consistent with an additional intergranular fracture mode (Figure 17). Figure 18 shows the local difference of dimpled rupture on one grain facet and tearing on a flatter facet. This intergranular fracture was present on the long edges of the tooth fracture, but not on the short sides, which exhibited only dimpled rupture, as typified in Figure 19.

Figure 16 – SE micrograph of the corner of the tooth fracture, showing different regions of fracture features.

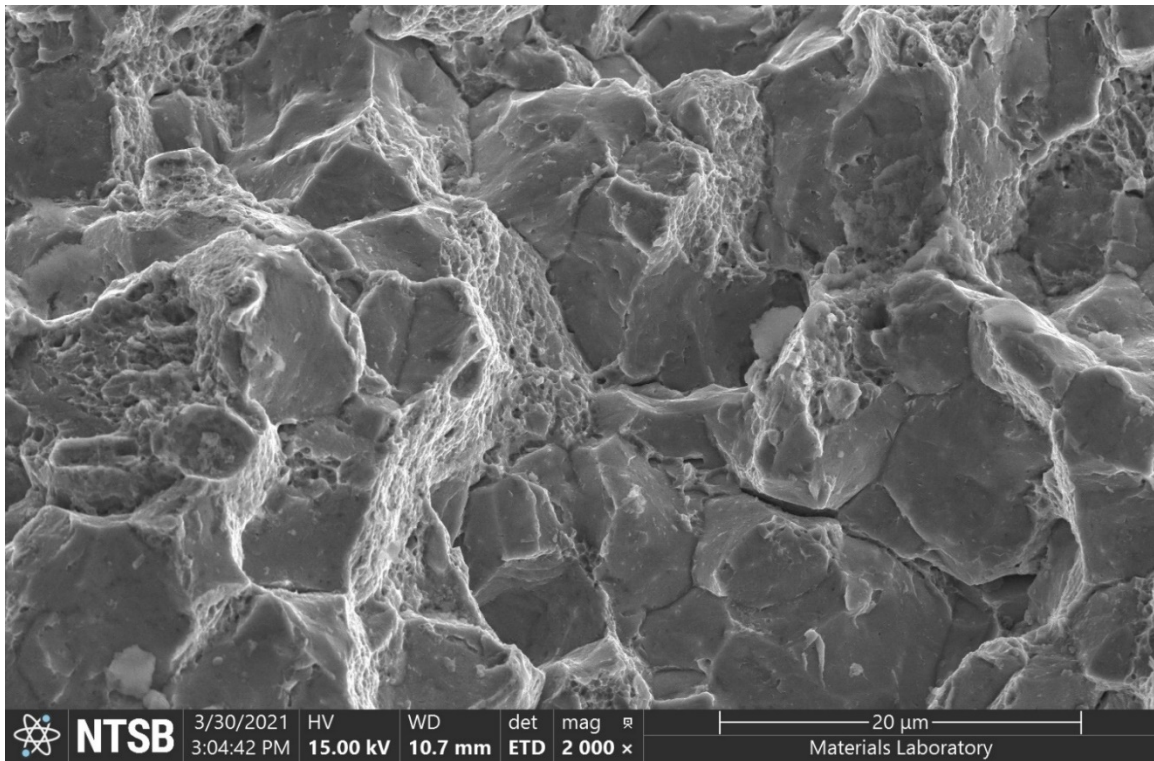
Figure 17 – SE micrograph mixed intergranular and dimpled rupture in the periphery of the tooth fracture.

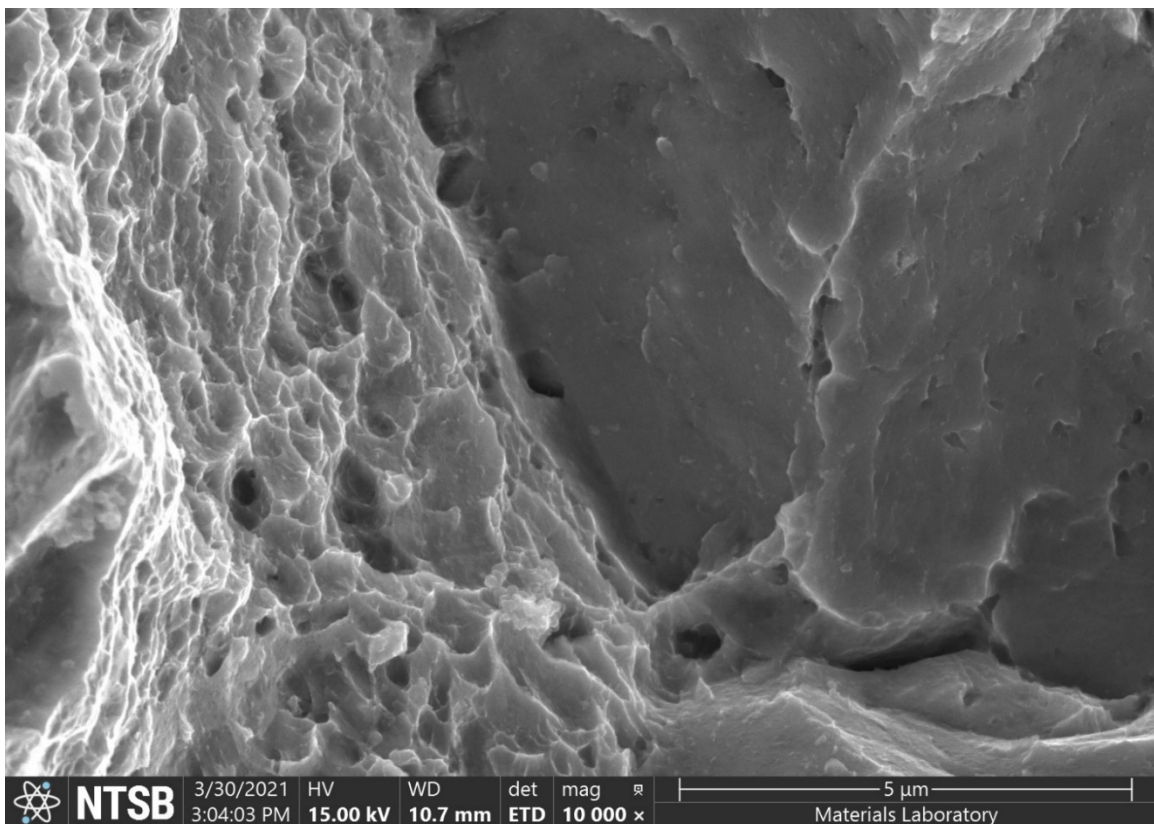
Figure 18 – SE micrograph of dimpled rupture next to a grain facet in Figure 17.

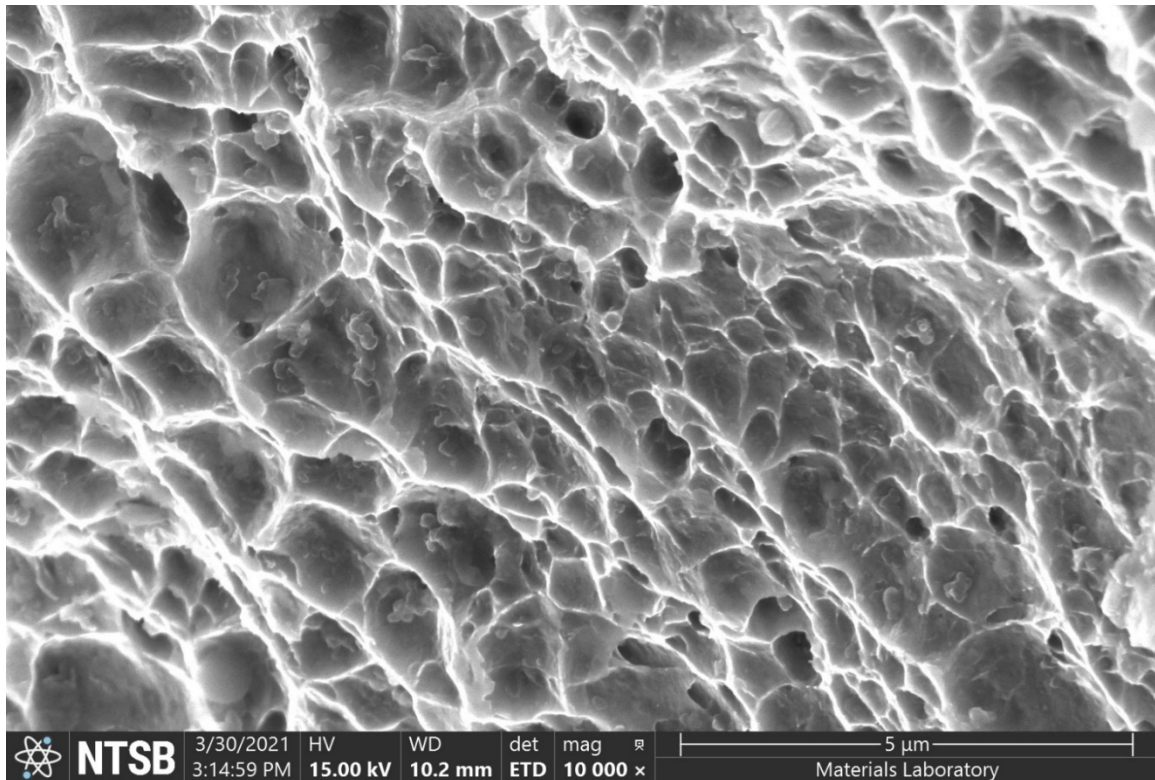
Figure 19 – SE micrograph of dimpled rupture in the shear lip in Figure 16.

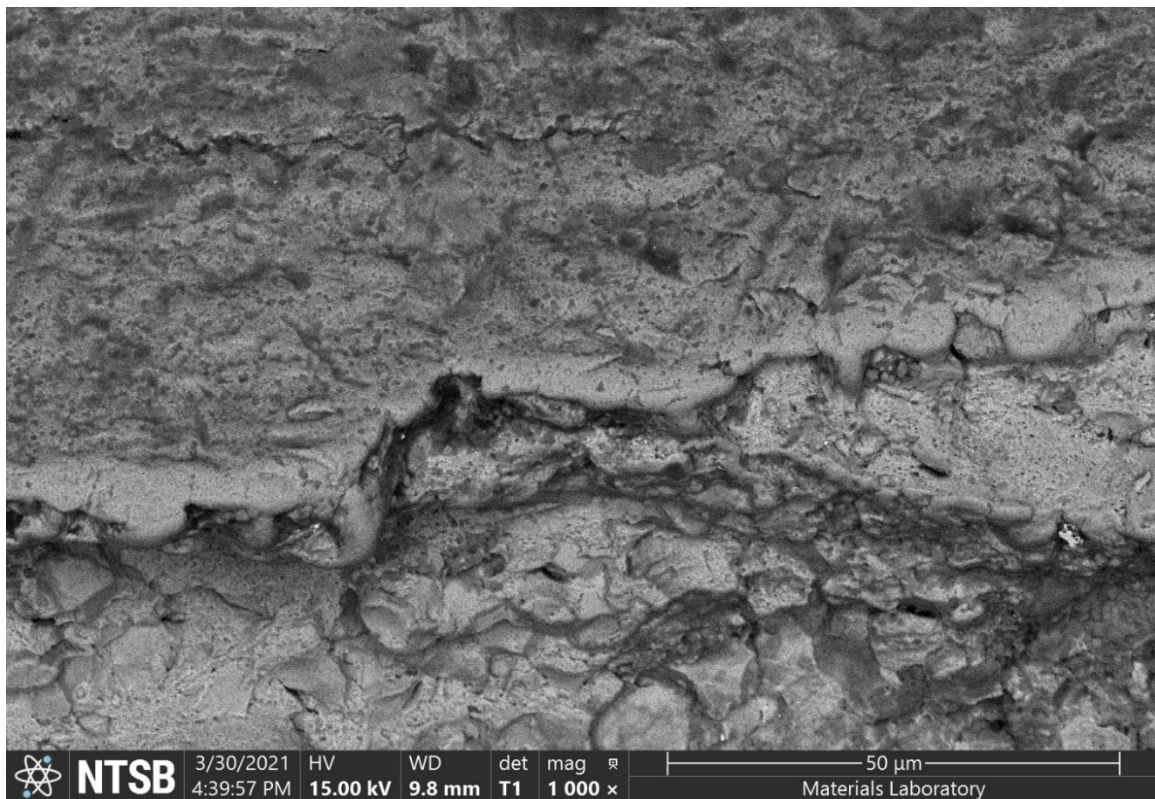
As the fracture was consistent with overstress in bending, there were no progressive fracture features or initiation sites. However, examination of the driven flank just above the fracture edge on the tensile side revealed secondary cracking above the fracture surface (Figure 20). This cracking was consistent with a partial fracture on one side of the tooth during the overstress event.

Figure 20 – Backscattered electron (BE) micrograph of the edge of the driven flank, showing secondary cracking on the flank above the fracture surface.
