# NATIONAL TRANSPORTATION SAFETY BOARD

## MATERIALS LABORATORY FACTUAL REPORT

Report No. 21-029

Place : Vinemont, Alabama  
Date : February 20, 2021  
Vehicle : Piper PA-32RT-300T, N10KV  
NTSB No. : ERA21FA133  
Investigator : Millicent Hill, AS-WPR

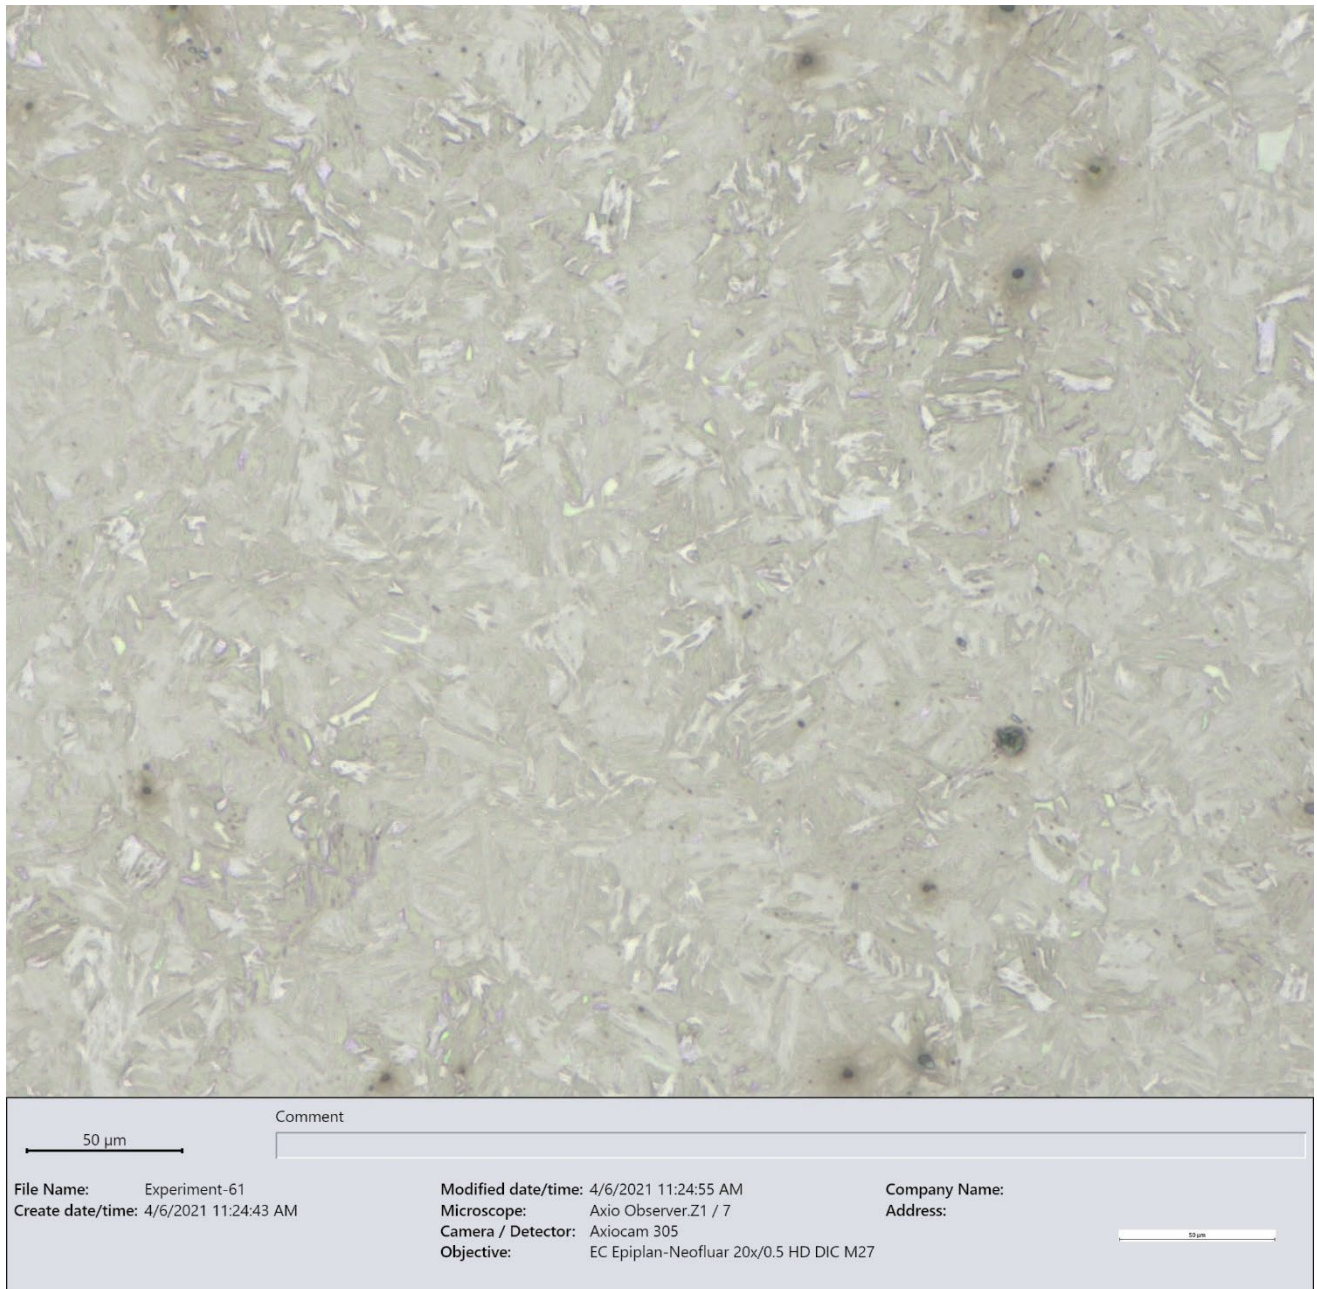
The middle of the fractured tooth was sectioned, mounted, polished, and etched using a 2% Nital solution.<sup>2</sup> A typical view of the tooth microstructure is shown in Figure 20. The microstructure exhibited a fine equiaxed grain structure with lath features, consistent with tempered martensite. Figure 21 shows the fracture edge on the compression side. Figure 22 shows the fracture edge on the tensile side. The tensile side shows additional secondary cracking in the region consistent with the observed intergranular fracture. The compressive side showed three 'spike-shaped' areas, consistent with cross-sectioning through the buckled material on the sides of the tooth fracture. These features were consistent with bending overstress for this part.

Figure 21 – Bright field (BF) optical micrograph of a typical area of the gear tooth microstructure (~500X, etched 2% Nital).

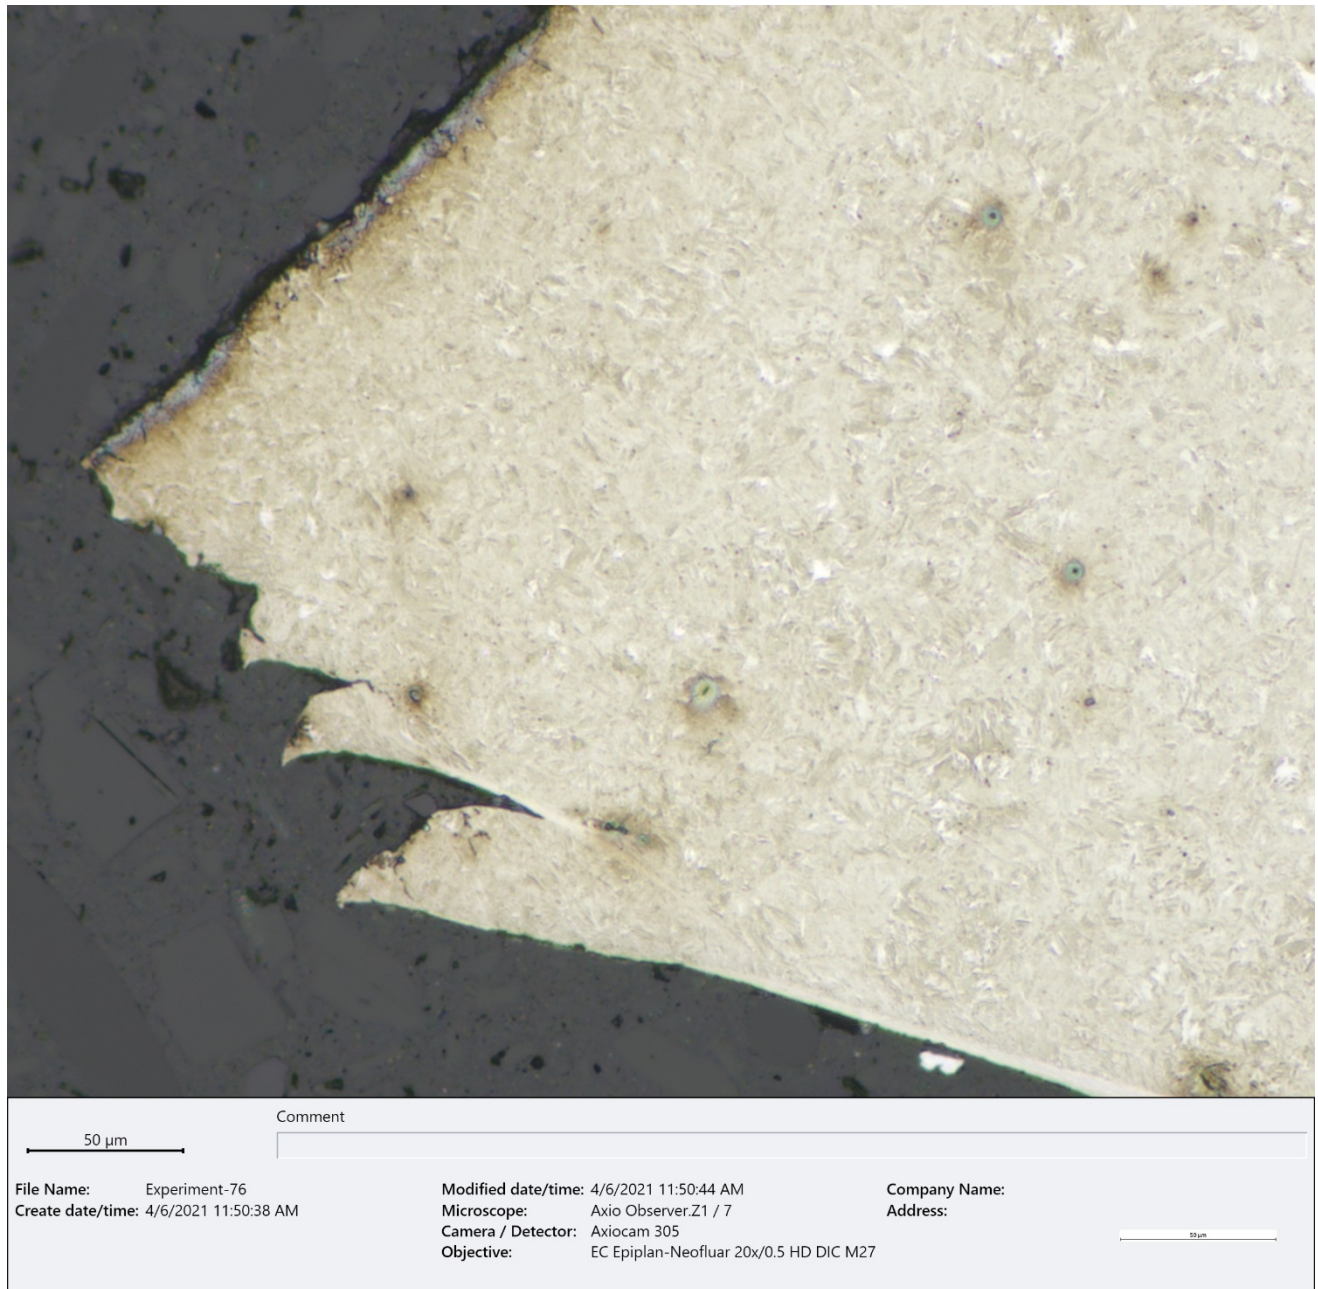
Figure 22 – BF micrograph of the edge of the fracture surface on the compression side (~500X, etched 2% Nital).

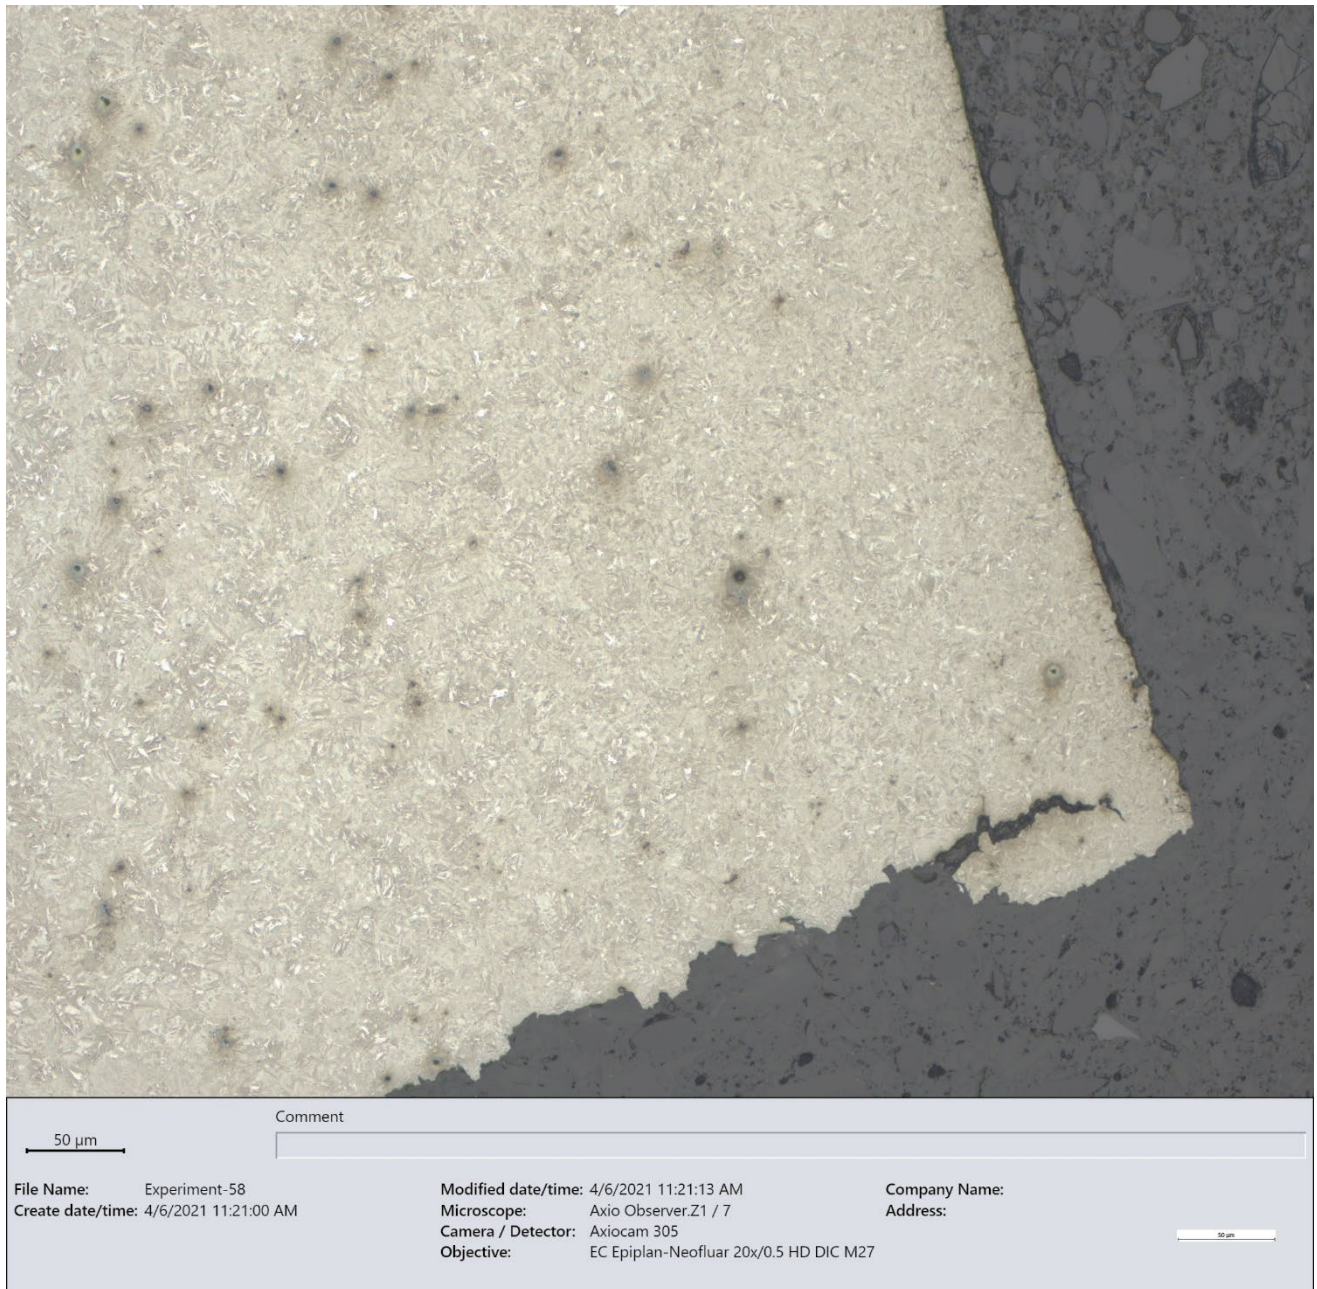
Figure 23 – BF micrograph of the edge of the fracture surface on the tension side (~500X, etched 2% Nital).

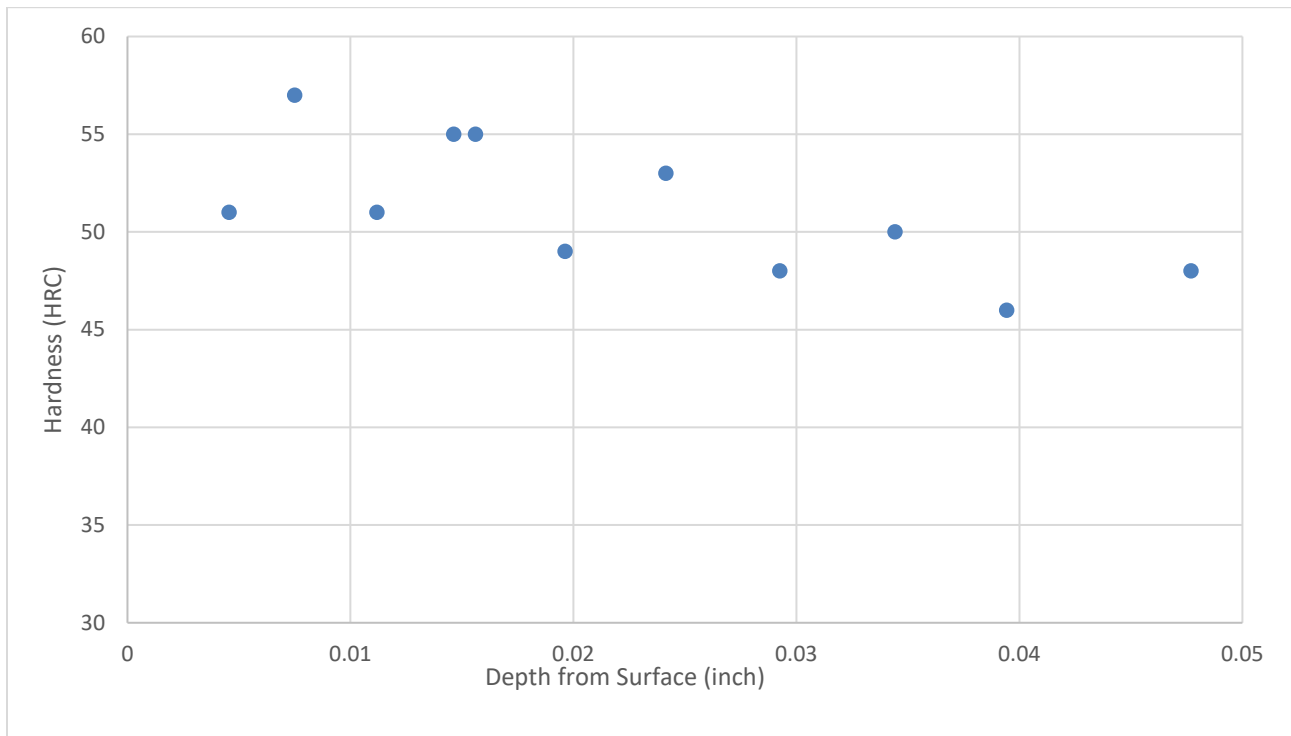
in Figure 22. The hardness of the tooth peaked at 57 HRC (670 HV<sub>500</sub>) near the surface but did not exhibit a rapid drop in hardness towards the interior, which would be typical of a case hardening surface treatment.

Rather, the hardness decreased slightly to around 47 HRC around 0.03 inches in depth, dropping below 50 HRC around 0.015 inches (0.38 mm). This was consistent with the depth of the intergranular layer on the fracture surface of the tooth, approximately 0.012 inches (0.3 mm).

Figure 24 – Microindentation hardness measurements versus depth from the surface, in HRC converted from  $HV_{500}$ .
