## **Airframe and Engine Examination Report**

NTSB ACCIDENT NUMBER: **ERA21FA133**

AIRCRAFT REGISTRATION: N10KV

AIRCRAFT TYPE: PA-32RT-300T

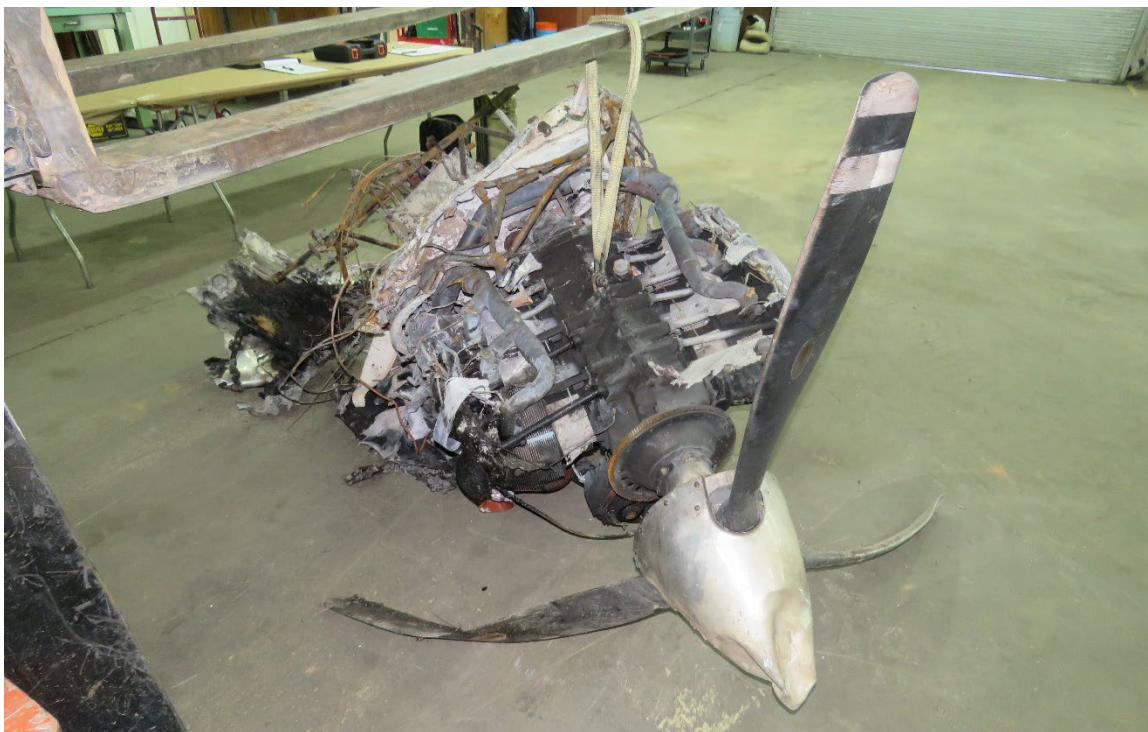
The blades of the three-bladed propeller remained attached and the propeller hub was securely mounted to the crankshaft propeller flange. Two of the blades had slight aft bending about midspan, the other blade was curled aft at the tip. The engine came to rest on its right side and sustained fire damage.

Figure 1: View of the engine and propeller before examination.

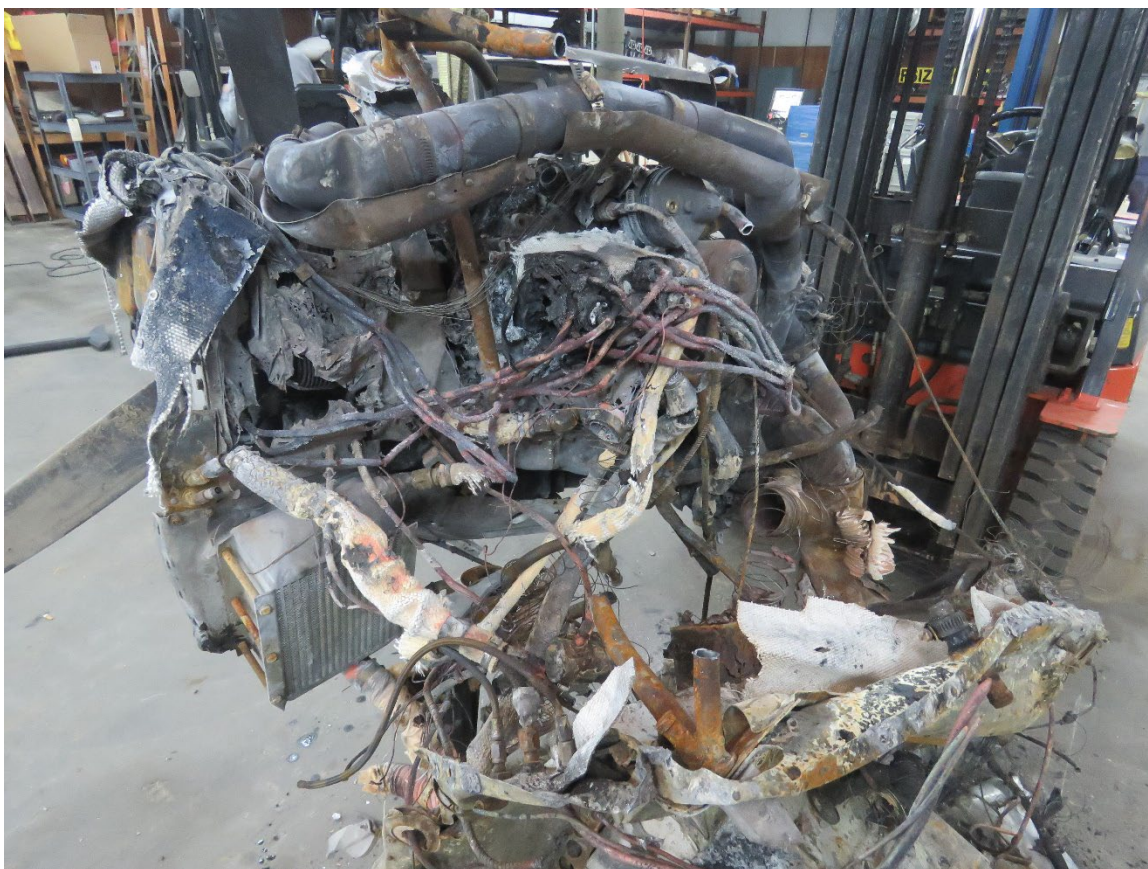
Figure 2: View of the back of the engine before examination.

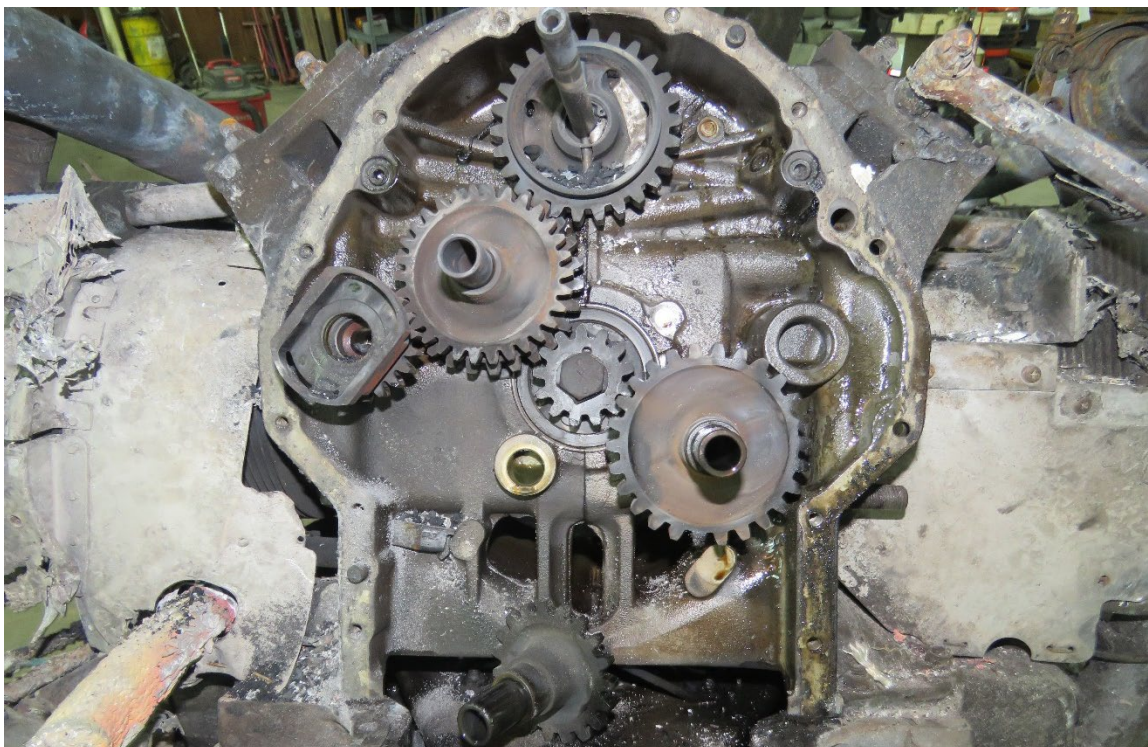
- After partially rotating the engine, a broken crankshaft gear tooth was found between the camshaft and accessory drive gear, lodged in the accessory drive gear. Removing the broken gear tooth and debris allowed the engine to be rotated a full 360°. The coloration of the fracture face is consistent with a break during the attempted engine rotation, and was not present during the postcrash fire.

Figure 3: View of the accessory case, with crankshaft gear tooth fracture.

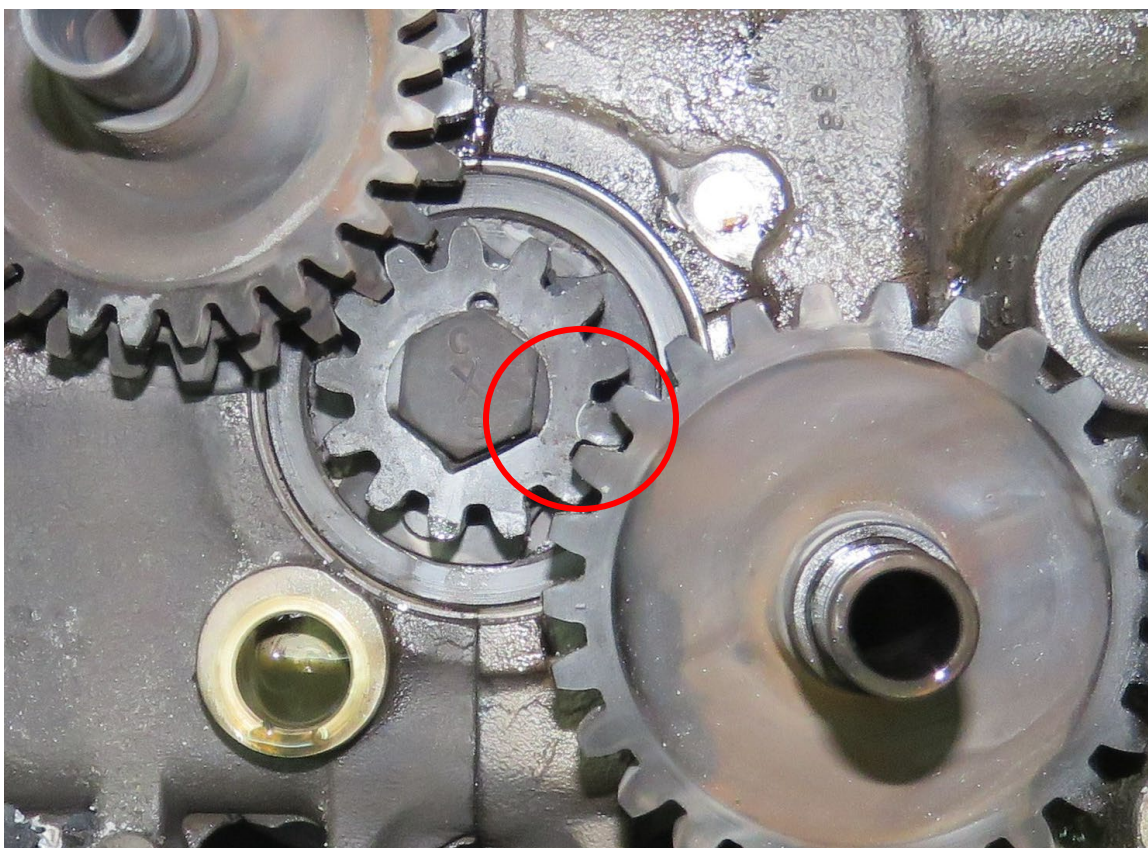
- The vacuum pump, magneto, propeller governor, turbo, were missing data plates/part numbers/serial numbers.
- The fractured gear tooth and crankshaft gear fragments were sent to the NTSB Materials Laboratory for examination.

Figure 4: Closer view of the fractured crankshaft gear tooth.
