# National Transportation Safety Board

## Performance Study

### Specialist Report

| NTSB Number: | ERA21FA142 |

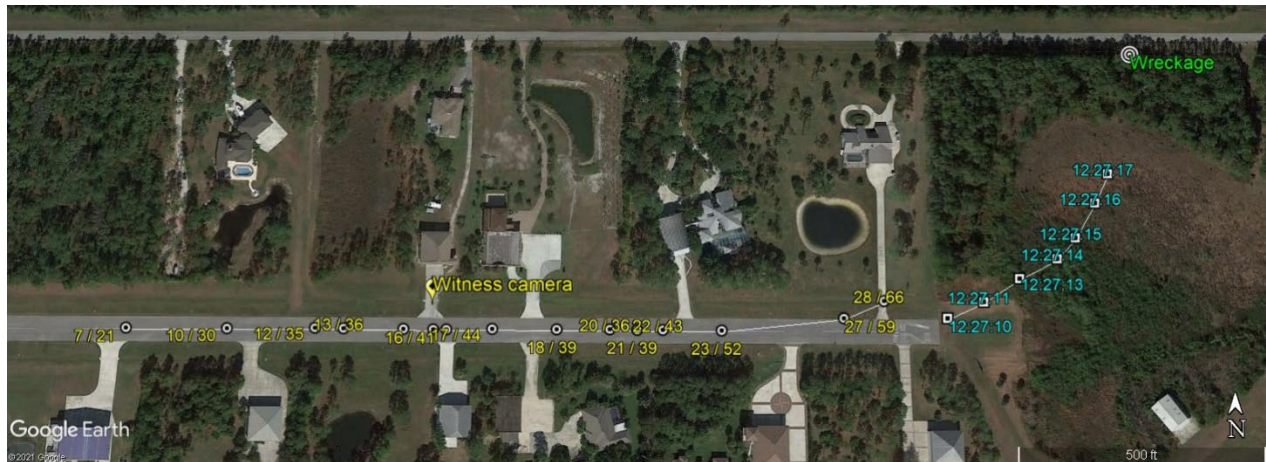
**Figure 1.** Yellow points from video study (camera location noted) with video time and height above ground in feet noted. Blue points from ADS-B data. Wreckage location in green.

Seconds 27 and 28 from the video data show the airplane turning to the left before the ADS-B data turned (Figure 1). The wreckage location was consistent with the final ADS-B flight path. When combining both sets of data, the final two video location points were shifted south to create a smoothed track between video second 23 and the first ADS-B data point, which was assigned a time of 29.5 seconds in the video timing scheme.

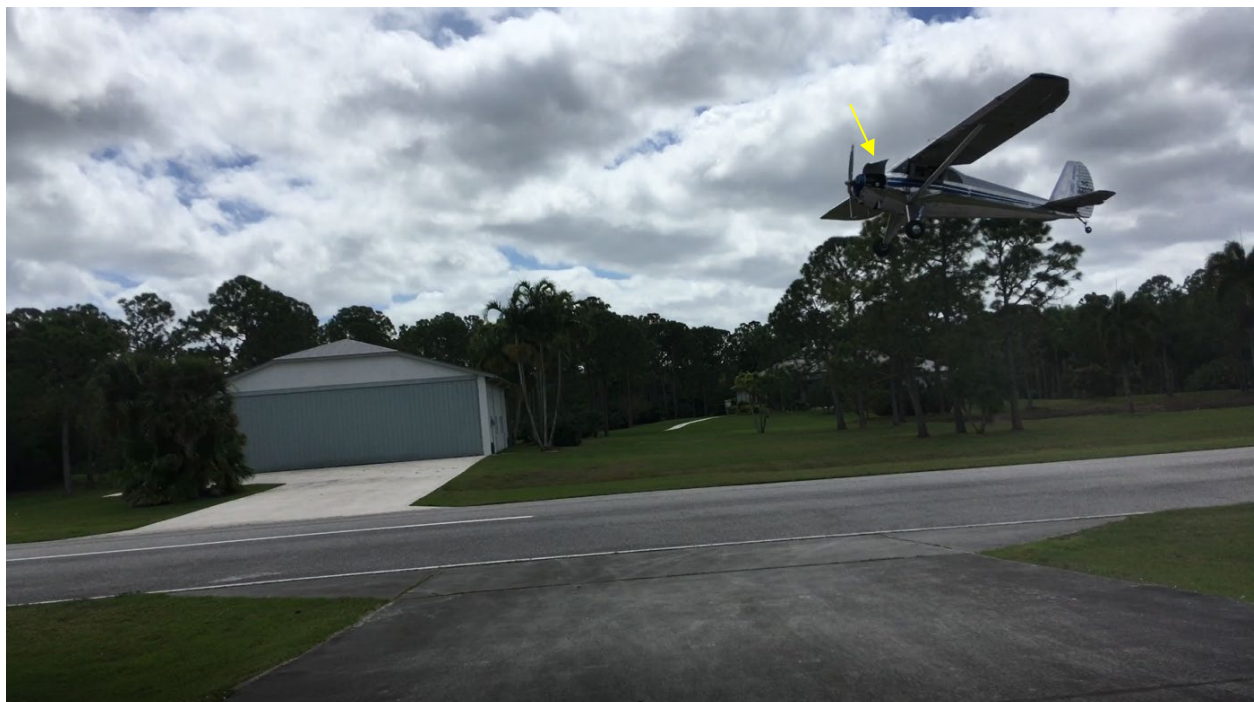
The video study also determined changes in engine RPM from the video sound. During the video, the engine cowling can be seen open and flapping (Figure 2).

**Figure 2.** Still from second 14 of video. The engine cowling (yellow arrow) is open and flapping.

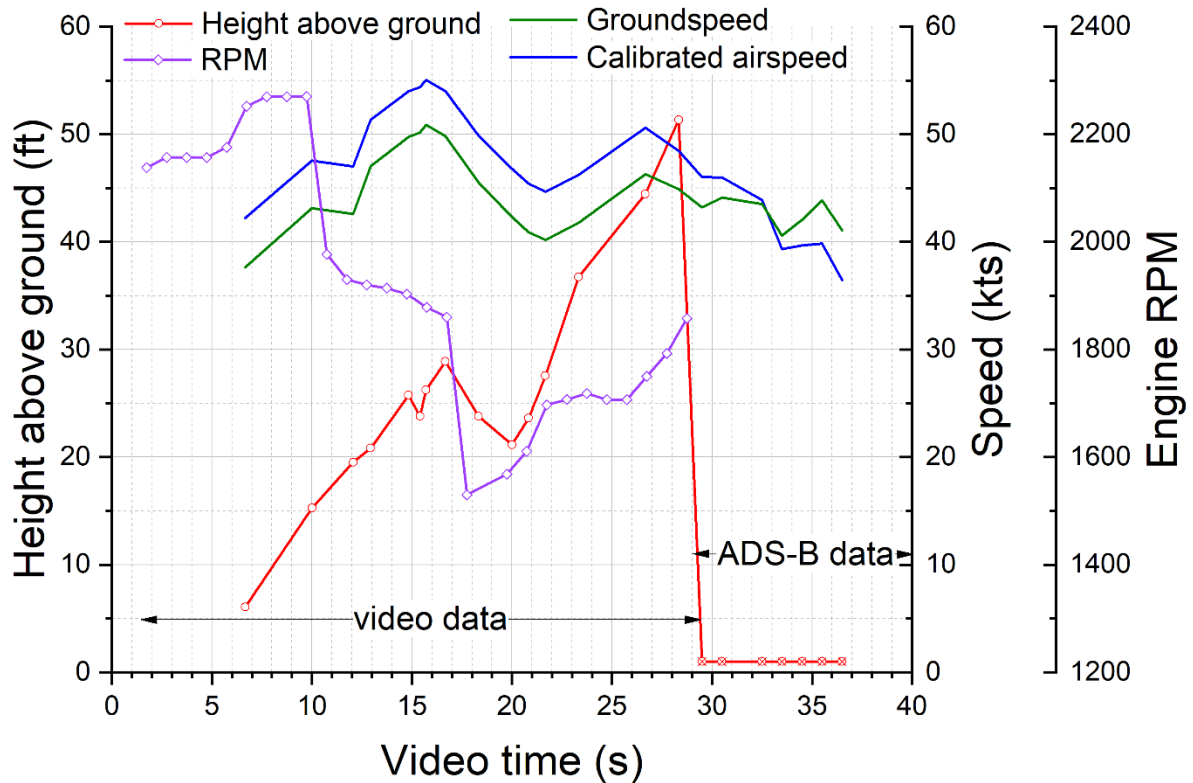
Figure 3 shows, in video time, the airplane's height above ground, calculated groundspeed and calibrated airspeed, and engine RPM. The ADS-B data did not include accurate altitude but the location data was used to calculate speed. Engine RPM dropped from near 2,300 at 10 seconds to 1,500 by 17 seconds.

**Figure 3.** Airplane altitude, calculated groundspeed and airspeed, and engine RPM in video time.

During the initial seconds of the take-off climb, the airplane gained altitude and speed. At 10 seconds the engine RPM dropped and then decreased further at 17 seconds. After the second decrease in RPM, the airplane lost altitude and the speed reduced. The airplane again climbed and was 50 ft above the ground as it flew beyond the end of the runway. It continued to lose speed, however, and had slowed to below 40 kts by the end of the ADS-B data.

The Owner's Handbook [2] reported that the airplane's stall speed is 48 mph, indicated airspeed, or 42 kts. Indicated airspeed was not corrected to calibrated airspeed, as the aircraft-specific correction table was not available, but indicated and calibrated speeds should be within a few knots. As the airplane turned left, the bank angle increased to more than 20° which would have raised the stall speed above the reported 42 kts. The increasing stall speed and decreasing airplane speed likely led to aerodynamic stall.
