**ERA21FA142**

**Jupiter, Florida**

**Luscombe, 8E, N960K**

**WRECKAGE/SITE EXAMINATION**

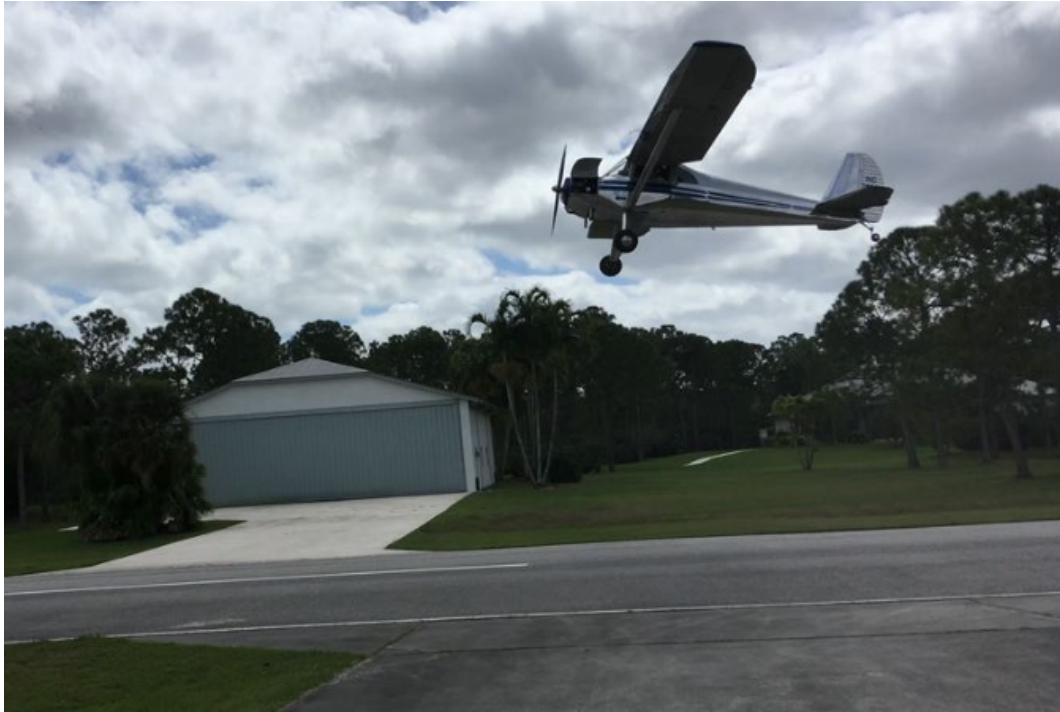
On February 28, 2021, at 1230 eastern daylight time, a Luscombe, 8E, N2601T, was substantially damaged when it was involved in an accident near Tailwinds Airport (FD15) Jupiter, Florida. The private pilot sustained fatal injuries and the pilot rated passenger was seriously injured. The airplane was operated as a Title 14 Code of Federal Regulations (CFR) Part 91 personal flight. The pilot/owner and pilot rated passenger (copilot) were father and son. Witnesses reported observing the airplane during takeoff. Their observations of the flight were inconsistent; the engine sounded strong to one witness, but another witness stated that the engine didn't sound right. The takeoff was recorded by a witness, and after takeoff, during initial climb, the left engine cowl was flapping violently in the wind. There was a decrease in engine power level off and descent followed by an increase in engine power and a gradual climb. As the airplane climbed out, the wings were rocking; gusty conditions existed at the time. The airplane entered a shallow left bank then disappeared out of view and impacted trees.

*Figure 1 Airplane during takeoff showing open engine cowl.*

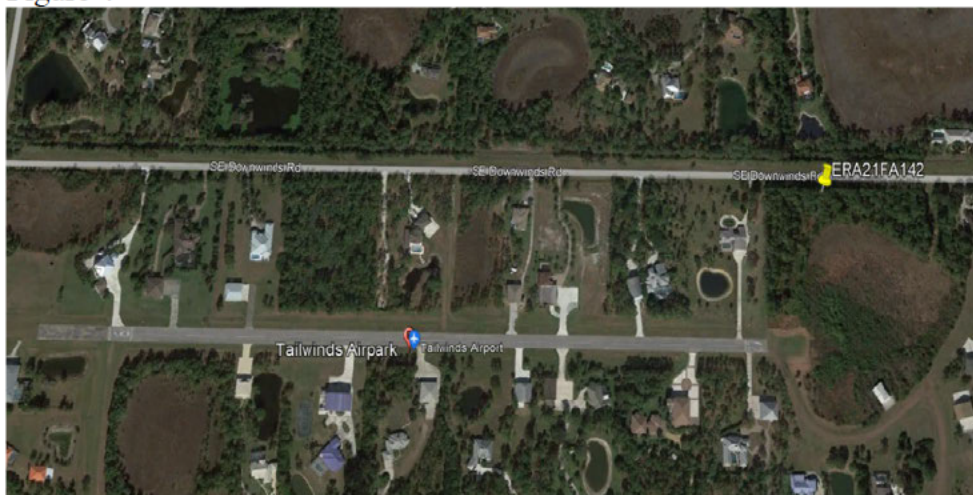
The airplane impacted dense woods and terrain about 700 feet northeast of the airport on a heading of about 030° from the departure end of runway 09 at an elevation of 20 ft above mean sea level. Figure 4

Figure 4 Overhead view of accident site and airport

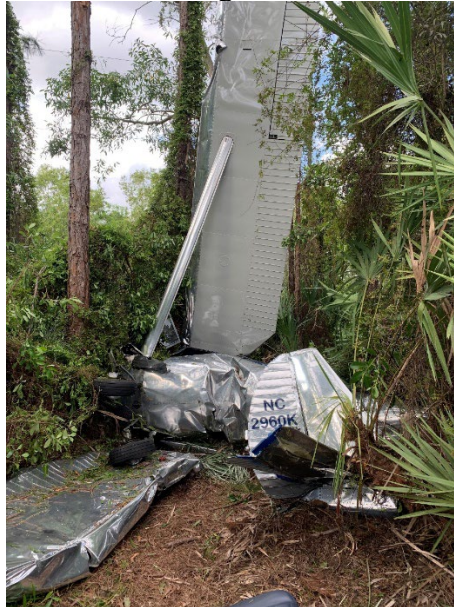
50 The right wing impacted a tree midspan as indicated by a 16-inch half-moon shape impact mark  
51 and subsequently separated from the fuselage at the wing root. The right wing strut sheared off  
52 from the wing and the fuselage and was discovered about 75 ft from the wreckage. The airplane  
53 came to rest on its right side, with the left wing pointing up in a near vertical 90-degree position  
54 (Figure 5) The left wing had outboard leading-edge compression damage. Police, fire rescue  
55 reported the strong odor of fuel at the site during their rescue and recovery.

Figure 5 Airplane wreckage

58 The wing was repositioned, and the ground underneath was saturated with fuel.

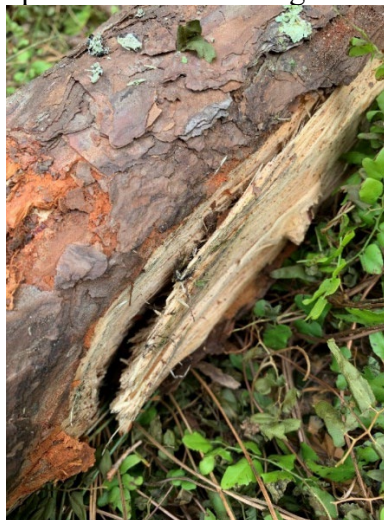
61 Damage signatures on nearby trees, including several tree branches near the wreckage that have  
62 propeller cuts and scalping impact signatures. (Figure 6) There were numerous branches on the  
63 ground with fresh breaks leading up to the main wreckage.

Figure 6 Propeller signatures on tree

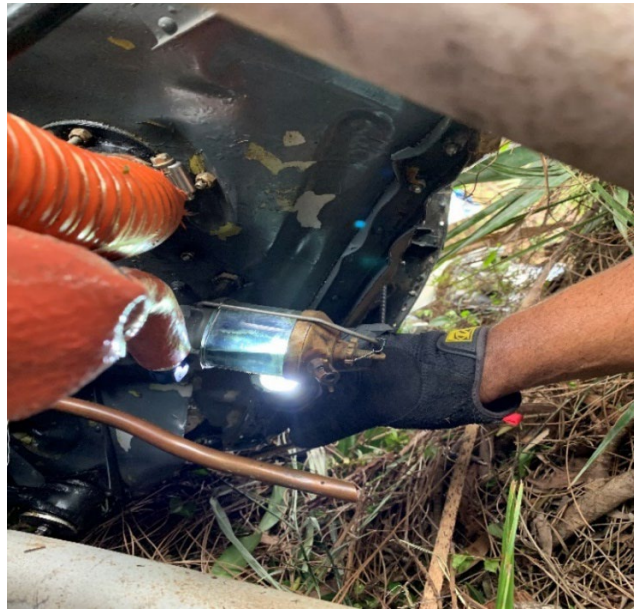
66 The gascolator was about 1/2 full of fuel (Figure 7) and there was fuel in the lines leading from  
67 the fuel tanks into the engine. About 1 gallon of fuel recovered from both tanks. The fuel lines  
68 were dripping and the gascolator filled up once the wreckage was repositioned. Fuel had the  
69 appearance and smell of aviation fuel (AVGAS); it was light blue, clear, and free of any water or  
70 debris.

Figure 7 Gascolator 1/2 full of fuel

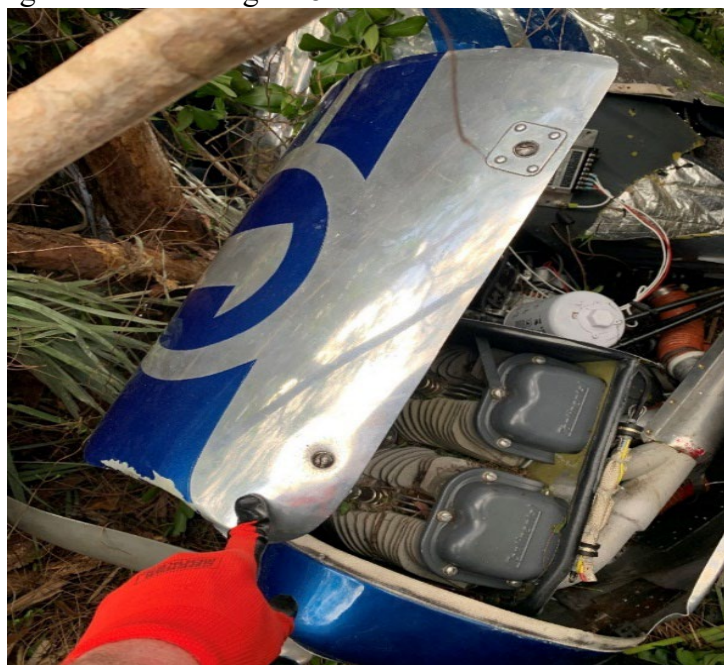
74 The engine cowl remained attached on the right side and the wing nuts were secured in place.  
75 The left side, which had flush mounted screw fasteners (Dzus fasteners.) The cowl was unlatched  
76 and there was no damage to the fasteners or receptacle. The cowl was unsecured. There was  
77 minor buckling damage to the cowl. Figure 8.

Figure 8 Damaged engine cowl showing fasteners

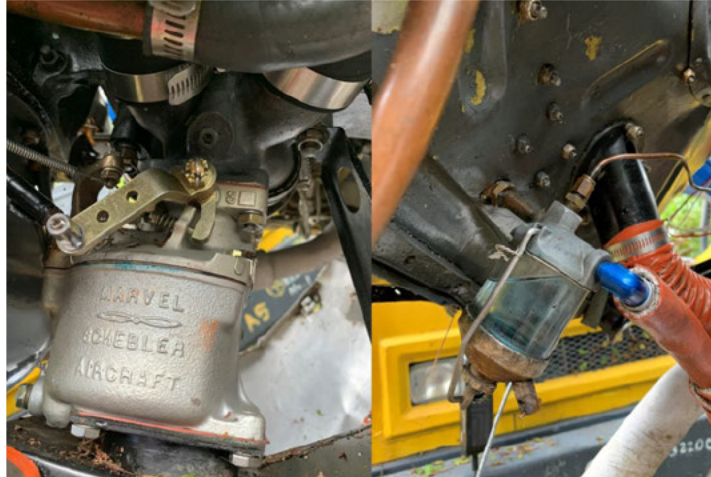
The carburetor and gascolator were undamaged. The carburetor has fuel in the bowl and the floats functioned smoothly and were undamaged. The needle valve and screen are free of obstructions and the action of the valves were smooth. There were no mechanical irregularities or other anomalous behaviors discovered with the carburetor. The carburetor appeared clean and new. Figure 9.

Figure 9 Carburetor and Gascolator side by side view. Carb appears brand new. Gascolator filled back up with fuel once wreckage was up righted.

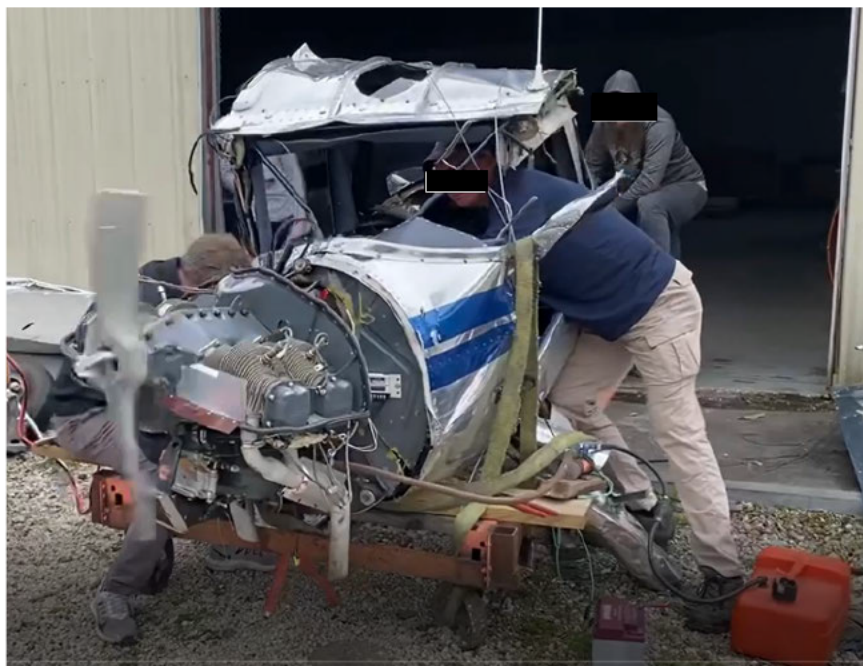
New leads were installed on the right magneto and the top spark plugs (damaged during impact) were replaced with serviceable units to facilitate engine start and operation. The propeller was measured and cut about 18 inches out from the central hub; the cuts were made before the bend in the blades equally on both sides to facilitate engine operation and limit vibrations. The mechanic operated the throttle assembly from the engine compartment as the throttle lever in the cockpit was not functional due to impact damage. The engine was successfully started while the IIC was partially inside the cockpit giving hand gestures to the mechanic. The engine was operated from idle to about 75% power briefly for safety reasons. Operated the engine for about 90 seconds with no anomalous behavior observed; the engine and associated components functioned normally. Figure 10.

Figure 10 Engine start and runup screen capture.

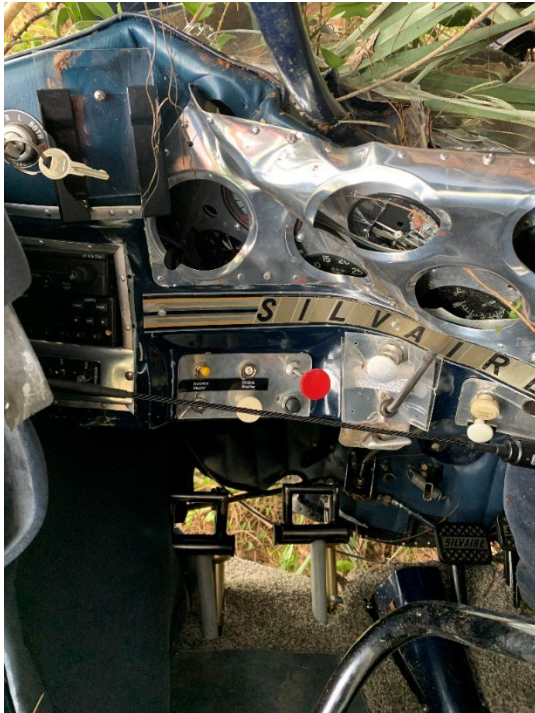
131 **Cockpit documentation (Day After Accident)**  
132 Primer\_ In and Locked  
133 Mixture- Full Rich  
134 Throttle- 3/4 out (aft) and bent 45 degrees.  
135 Fuel Switch on Left Tank  
136 Nav Lights-Off  
137 Avionics Master-On  
138 Magnetos- Off (Fire rescue turned it off from both)  
139 Fresh Air-On  
140 Landing Lights-Off  
141  
142 **Instrument Panel (Figure 10)**  
143 Oil Pressure and Temp –Unreadable  
144 Vertical Speed- Negative 1,100 feet per minute  
145 RPM – Zero  
146 Fuel – Empty left and right through sight gauge.  
147 Knots – Zero  
148 Altimeter – 90 ft  
149 Altimeter Setting - 30.00  
150 AFTT: 973.67  
151 Tach Time: 973.67  
152

154 *Figure 11 Cockpit instrument panel photograph*
