**NATIONAL TRANSPORTATION SAFETY BOARD**  
Office of Aviation Safety

**Wreckage Examination Summary**

**A. ACCIDENT      ERA21FA148**

Location:      Purcellville, Virginia  
Date:      March 4, 2021  
Time:      1510 Eastern Standard Time (EST)  
Operator:      Private  
Aircraft:      Beech C-23  
Registration:      N67013

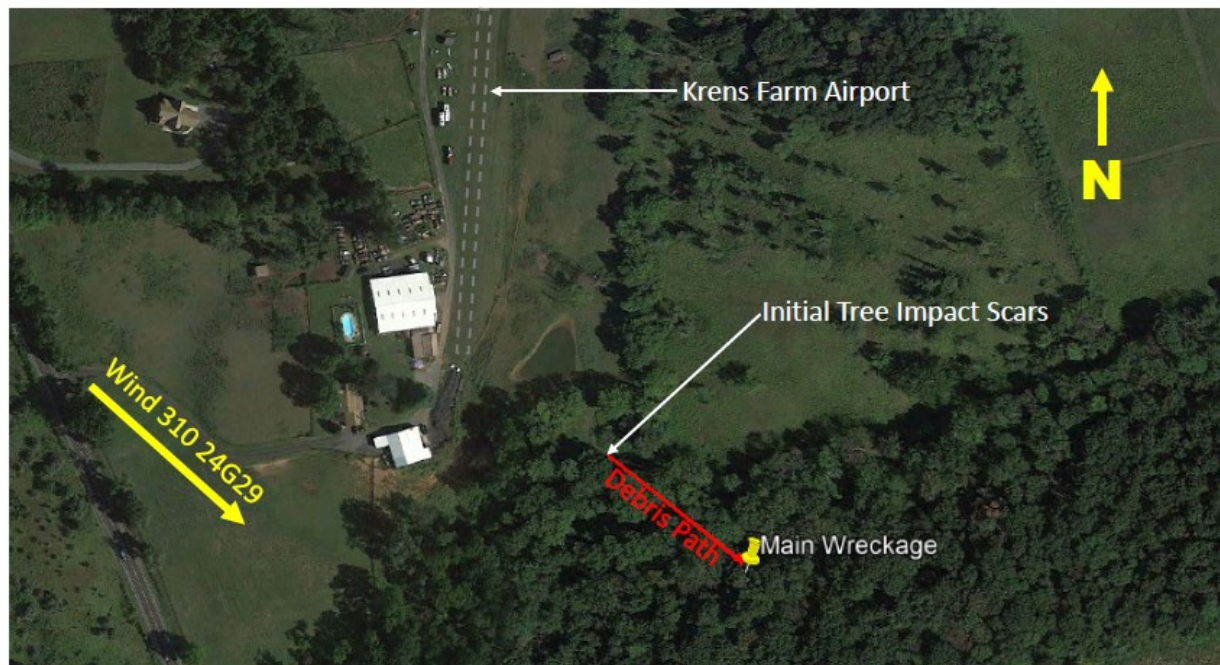
Figure 1. Accident Site Diagram

The initial tree impact scars were located about 326 ft and 124° from the departure end of runway 19 at Krens Farm Airport (14VA). From the initial tree scars, the debris field extended 306 ft and 128°. The right wingtip was located 68 ft beyond the tree, followed by the right) main landing gear at a distance of 244 ft, the left wing at 262 ft (displaced 25 ft to the left of the debris line), the vertical stabilizer and rudder at 281 ft and the main wreckage at 306 ft.

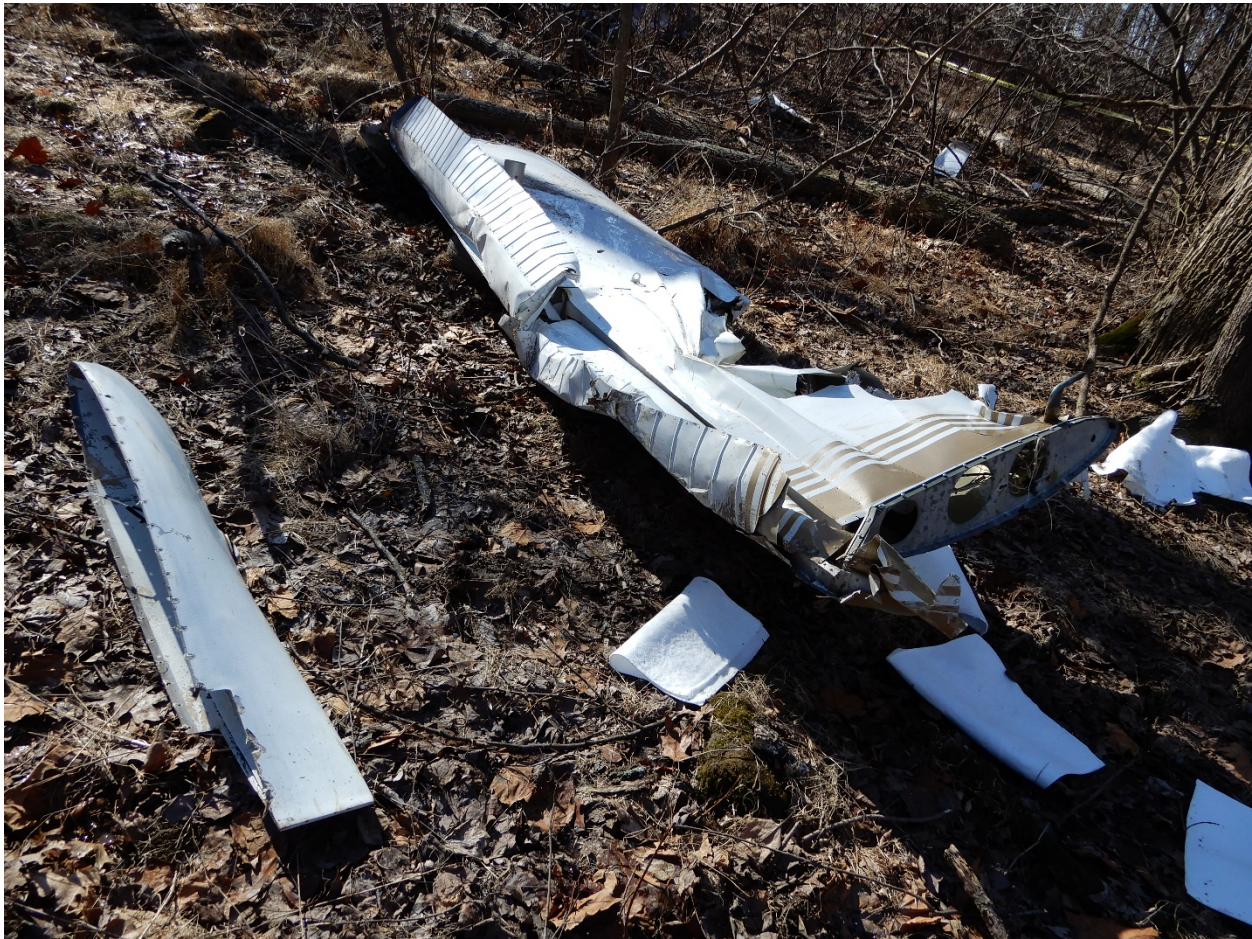
*Figure 2. Left Wing*

The left wing was impact separated at the wing root and located about 40 ft prior to the main wreckage. The outboard approximate 5 ft leading edge of the left wing was impact damaged and crushed aft. The wing tip was impact separated and located along the debris path. The pitot tube remained attached to the wing and was free of debris. The left main landing gear was impact separated and located along the debris path. The left flap remained attached to the wing at the outboard attach points, was bent outboard, and the trailing edge was impact damaged. The left aileron remained attached to the left wing through all attached points and the trailing edge was impact damaged. The left wing fuel cap remained seated and locked. The left wing fuel tank was breached. Control cable continuity was confirmed from aileron to the fuselage through overload fractures. The stall warning horn tab could be moved without issue.

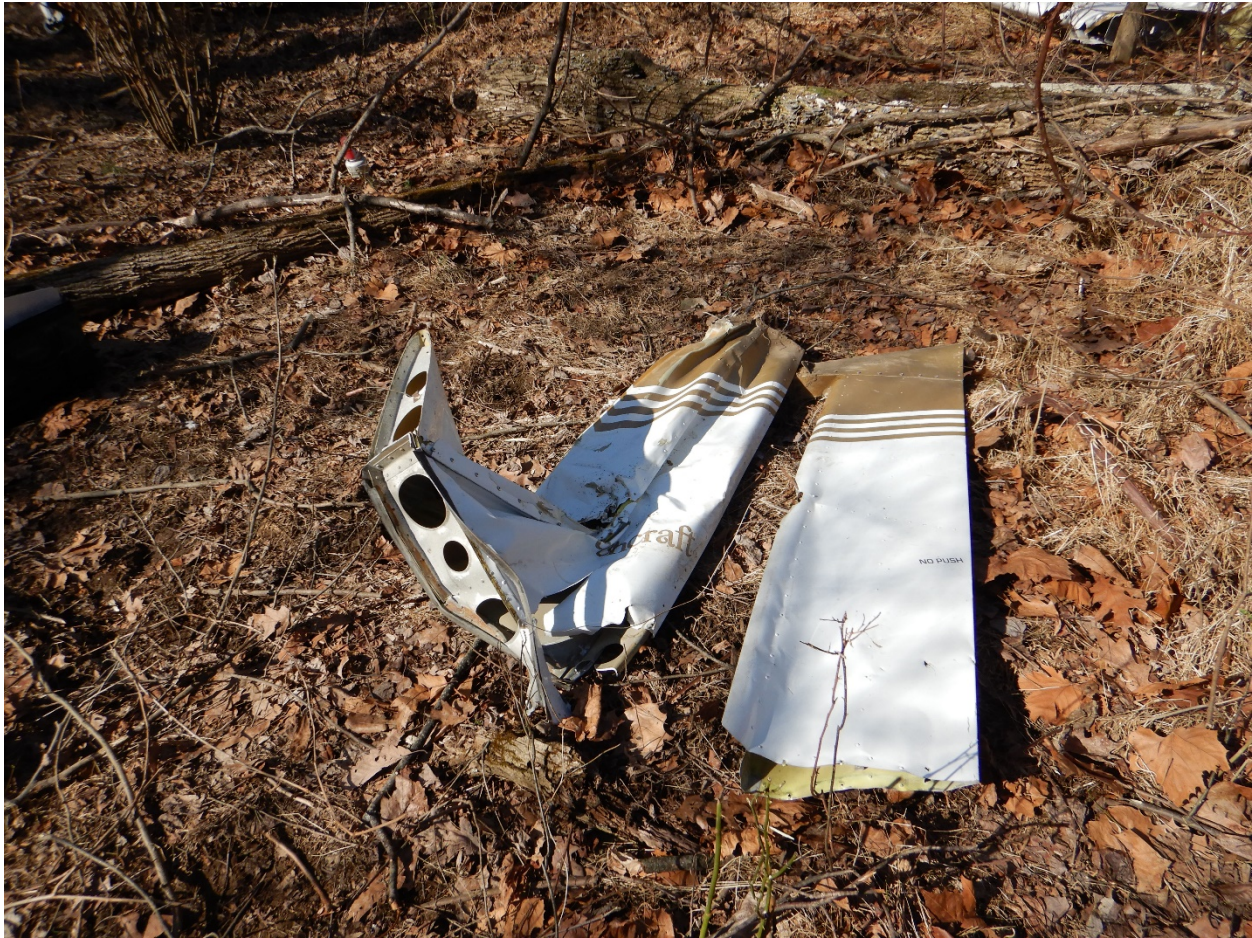
*Figure 3. Rudder and Vertical Stabilizer*

The rudder was impact separated from the vertical stabilizer and the vertical stabilizer was impact separated from the empennage and located about 20 ft prior to the main wreckage. The leading edge of the vertical stabilizer exhibited impact damage.

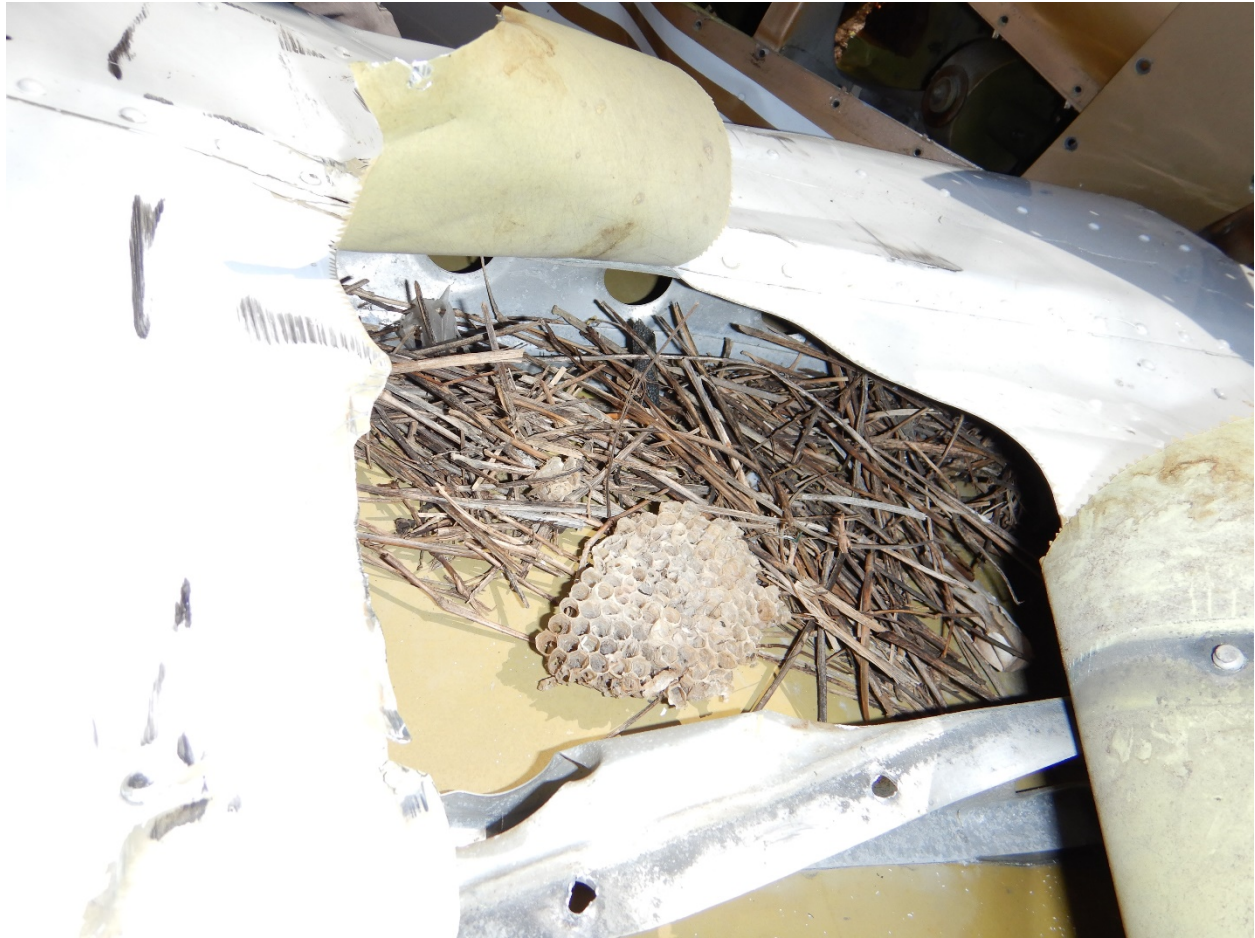
The horizontal stabilator remained attached to the empennage. The horizontal stabilator tips were impact separated. The trim tab remained attached to the horizontal stabilator. The left side of the horizontal stabilator was impact bent aft about 60°. The right horizontal stabilator had a nest located inside of the structure. Control cable continuity of the stabilator was confirmed to the cockpit. The trim actuator was measured and measured about 1.47 inches, which corresponded to about a -1° trailing edge down.

*Figure 4. Nest inside right side of horizontal stabilator.*

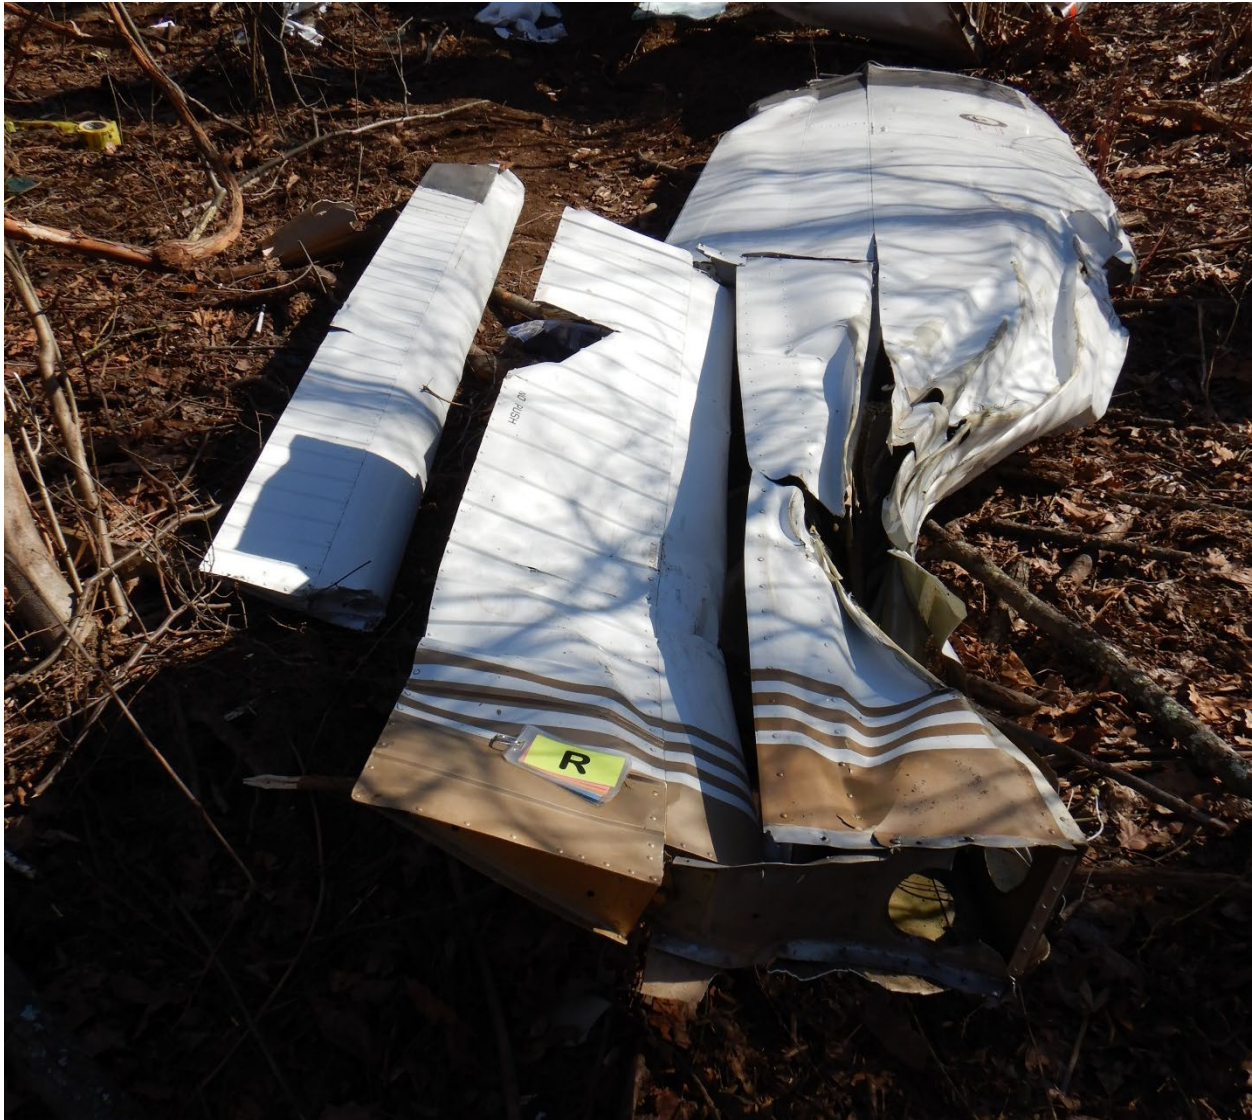
*Figure 5. Right Wing*

The right wing was impact separated and remained attached to the fuselage through cables. The cables were cut to facilitate recovery. The right flap was separated from the right wing. The right aileron remained attached to the right wing at all attach points. The right wheel was impact separated from the right wing and located along the debris path. The right wing fuel cap remained seated and locked. The right wing fuel tank was breached. Control cable continuity was confirmed from the aileron to the cockpit.

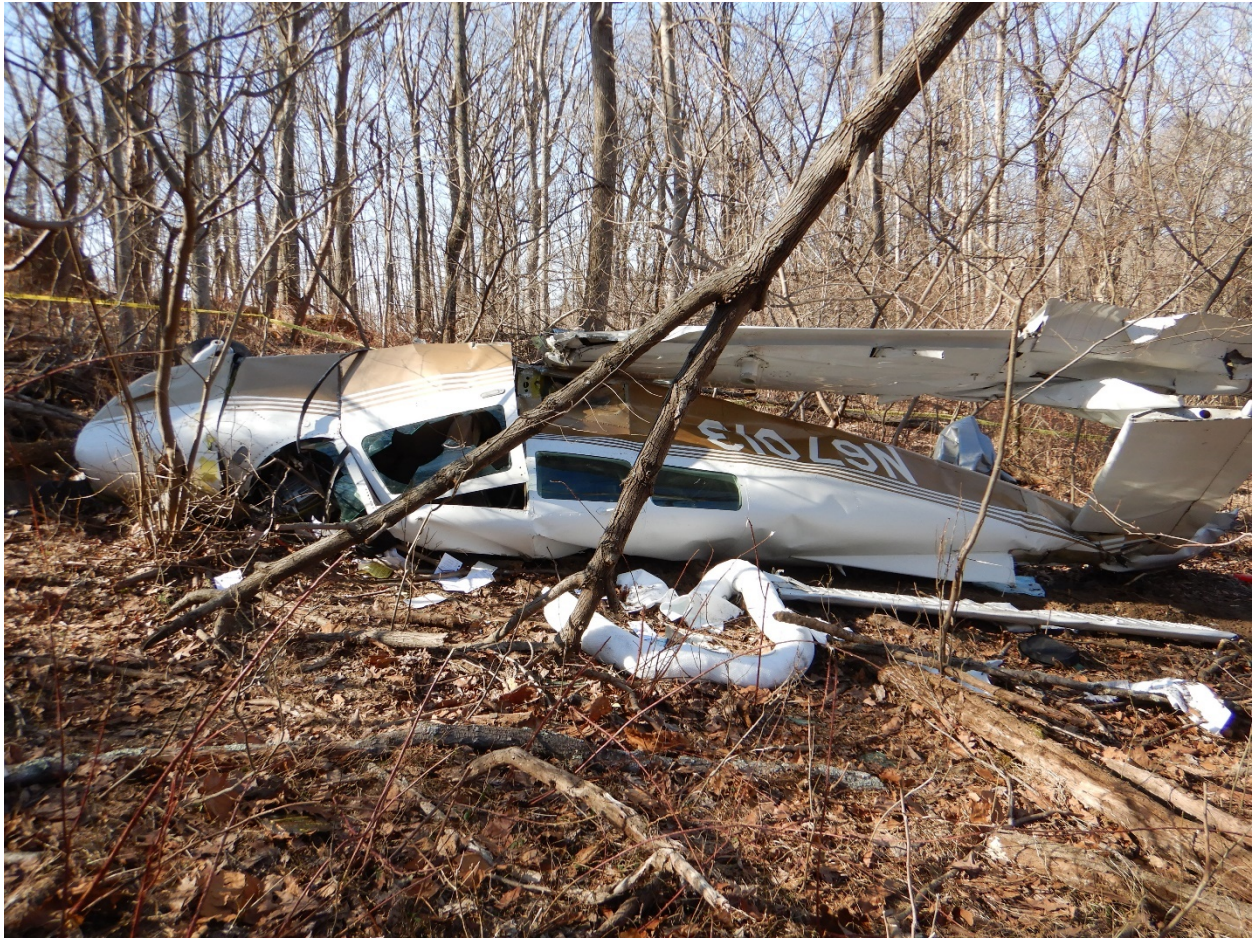
*Figure 6. Main Wreckage*

The fuselage was wrinkled and exhibited impact damage along the entire length. The cabin door remained attached to the fuselage and the handle was in the closed position. The door latch was not impact damaged and could be operated by hand. The cabin was crushed down on the left side and the windscreen was shattered. Both control yokes remained attached to the control columns and the rudder pedals remained attached to their mounts.

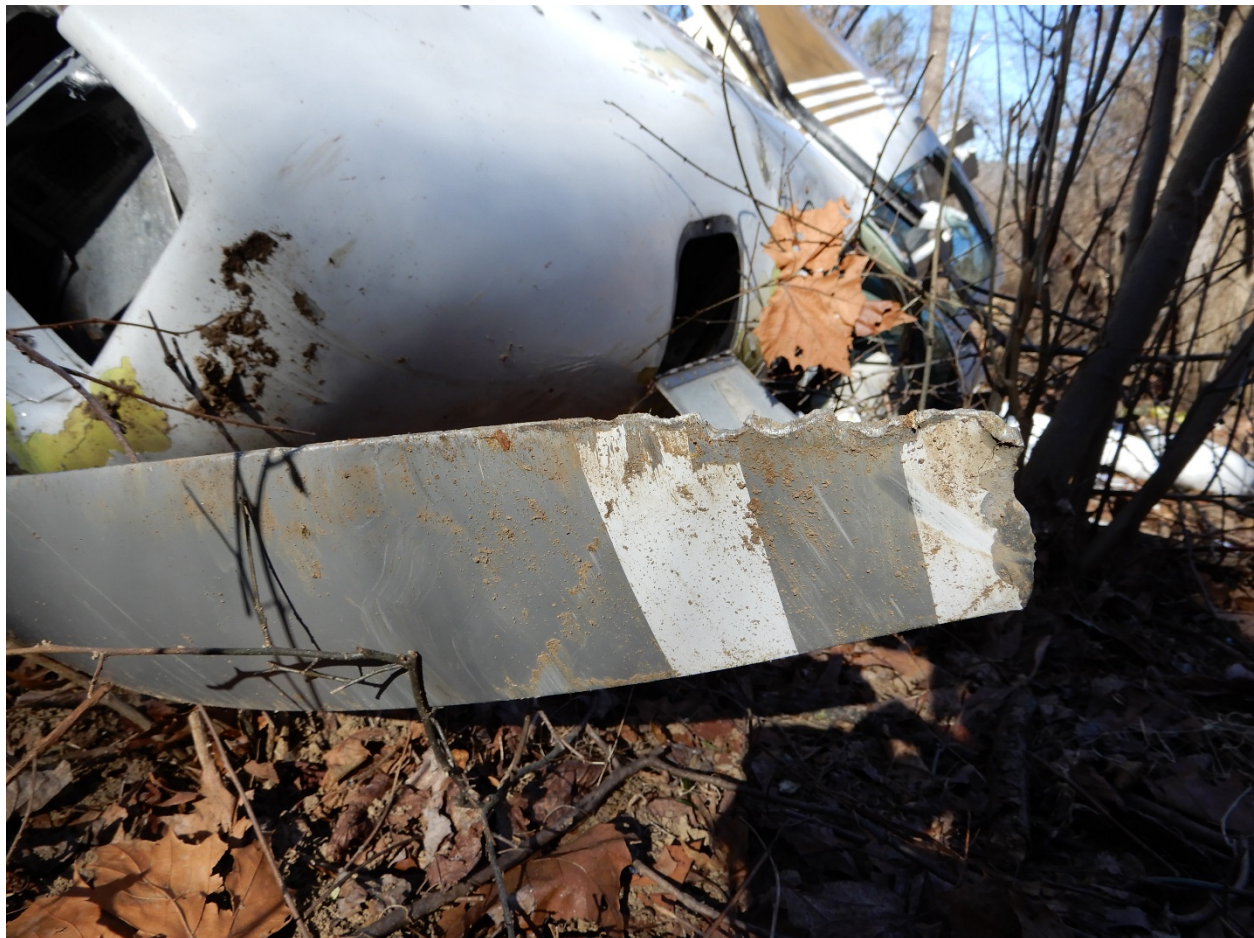
The fixed-pitch propeller remained attached to the engine. Both propeller blades remained attached to the propeller hub. One blade was bent aft about 45° and exhibited leading edge gouging and chordwise scratching. The other propeller blade was slightly bent aft and exhibited chordwise scratching, leading edge gouging, and tip tearing.

Figure 7. View of leading edge gouging, chordwise scratching, and tip tearing on one propeller blade.
