**NATIONAL TRANSPORTATION SAFETY BOARD**  
Vehicle Recorder Division  
Washington, DC 20594

## **Security Video Summary & Sound Spectrum Study**

### **Specialist's Factual & Study Report By Kyle Garner**

Location:           Pembroke Pines, Florida  
Date:                March 15, 2021  
Vehicle:            Beechcraft B36TC Bonanza  
Registration:       N236BC  
Operator:           Private  
NTSB Number:      ERA21FA154

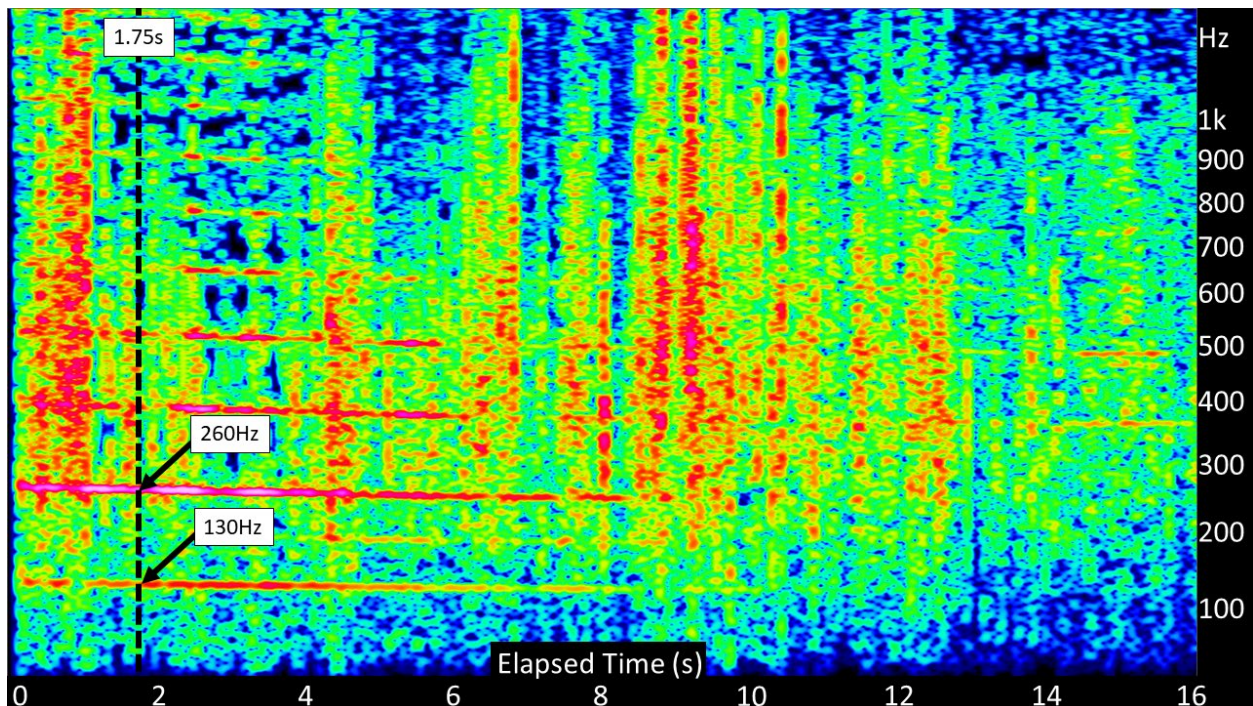
Figure 4. Spectrogram of camera 1 audio file from 0s to 16s.

Figure 4 is a spectrogram showing the frequency content of one channel of audio from camera 1 from 0s to 16s elapsed time. The x-axis represents time in elapsed seconds and the y-axis represents sound frequency in Hz. The color represents sound intensity, with blue being the lowest intensity sound and pink being the highest intensity. Lines of frequency representing approximately 130Hz and the first harmonic of 260Hz are annotated for reference.

Note the gradual downward slope of the lines of intense frequency as time passes, suggesting that the influence of the Doppler effect should be considered.

Note that the lines of intense frequency associated with the aircraft engine's fundamental frequency seem to dissipate at approximately 12s elapsed time.

- Audio data from camera 1 indicated that the aircraft's engine during takeoff from runway 10L was likely operating at about 2600rpm at the point of passage closest to the camera.
- No sound energy consistent with the aircraft's engine was noted on the camera 4 audio recording, likely due to a low signal-to-noise ratio or because the engine was not operating prior to impact.

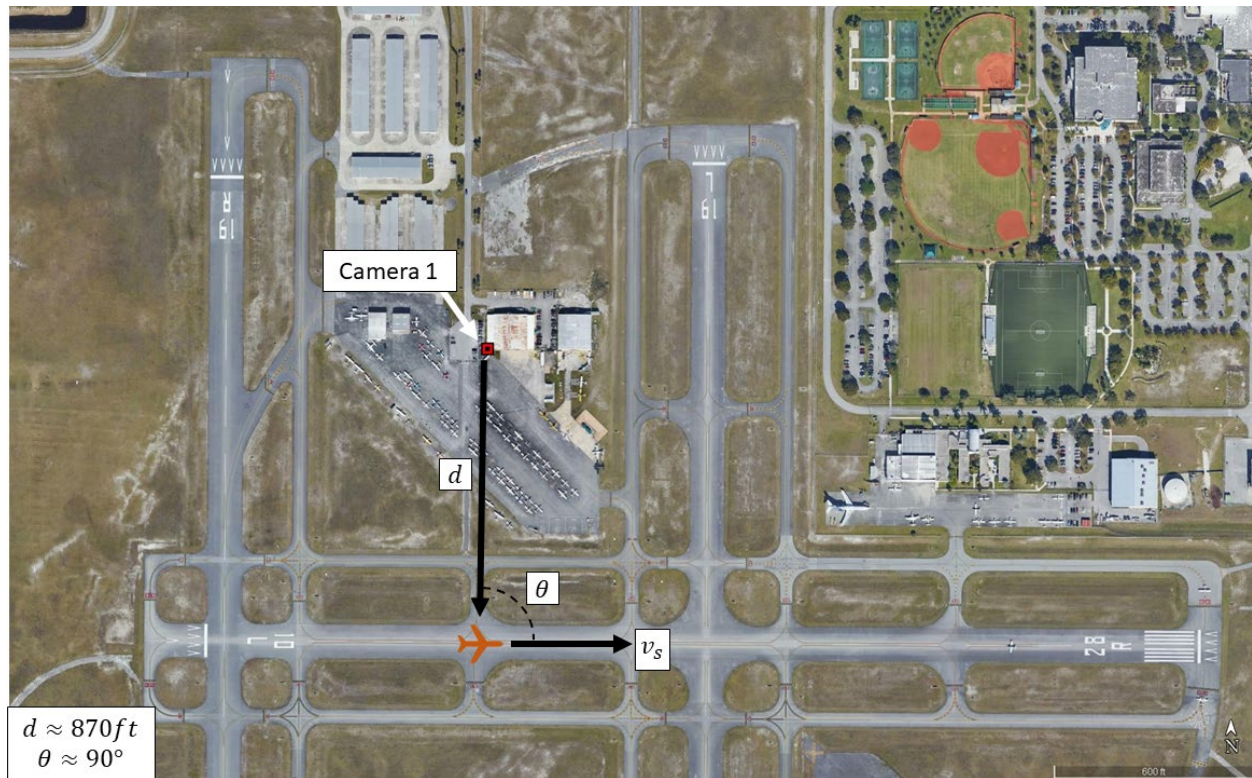
**Figure 5. Doppler effect – aircraft at position closest to camera.**

As the aircraft accelerated down runway 10L for takeoff, the aircraft was closest to camera 1 at approximately 1s elapsed time. At this time, the angle of the line of sight from the observer to the source,  $\theta$ , was about  $90^\circ$  (see Figure 5). Thus, at 1s elapsed time per (2) the sound source velocity component is zero and the source frequency is equal to the observed frequency.

The camera was located about 870 feet (ft) from the centerline of runway 10L thus, the time for the sound waves to travel to the camera should be considered. At 870 ft, the sound emitted at the point of closest passage would take approximately 0.75s to reach the camera. Therefore, the sound waves corresponding to closest passage arrived at the camera at approximately 1.75s elapsed time. Per Figure 4, the fundamental frequency at 1.75s was 130Hz. Using (1), this corresponds to an estimated engine speed during the takeoff roll of about 2600rpm, or slightly below the maximum rated 2700rpm for this engine.

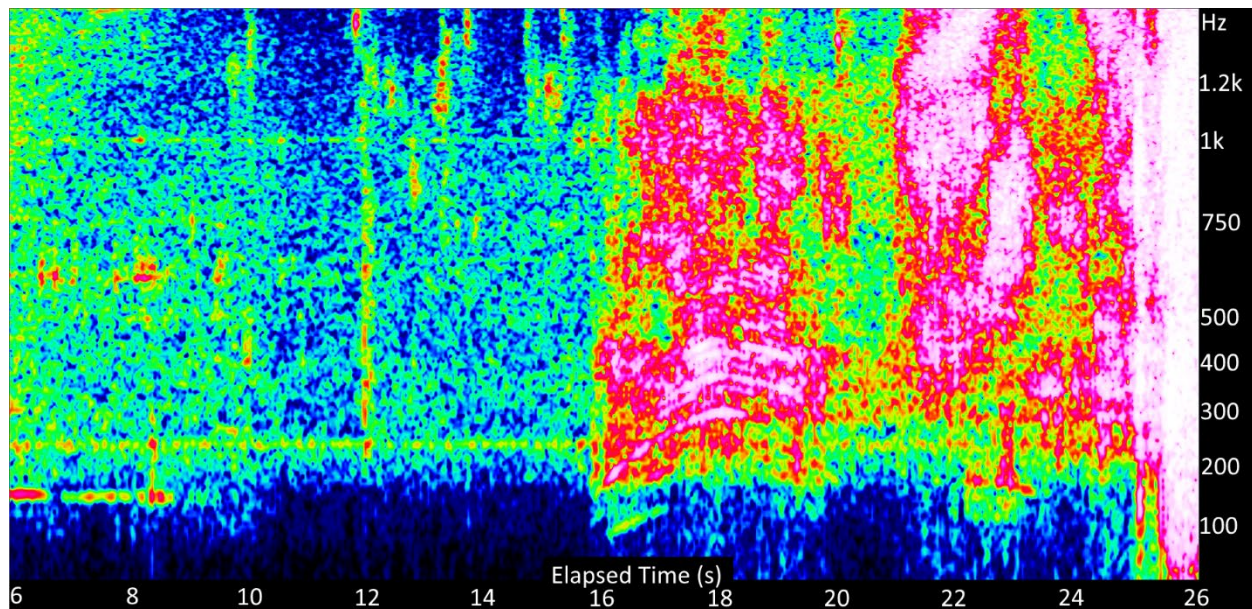
**Figure 6. Spectrogram of camera 4 audio file from 6s to 26s.**

Figure 6 is a spectrogram showing the frequency content of one channel of audio from camera 4 from 6s to 26s elapsed time. The x-axis represents time in elapsed seconds and the y-axis represents sound frequency in Hz. The color represents sound intensity, with blue being the lowest intensity sound and pink being the highest intensity.

Note from Table 4 that the aircraft impacted the ground between 25 and 26s, which is shown as an increase in sound intensity on the spectrogram at the same time. Of interest is the increase in intensity between 16s and 23s, however, as discussed in Table 4 this sound is likely from the white truck accelerating and then passing the camera during this time.

No sound energy consistent with the aircraft's engine was noted on the camera 4 audio recording, likely due to a low signal-to-noise ratio or because the engine was not operating prior to impact.
