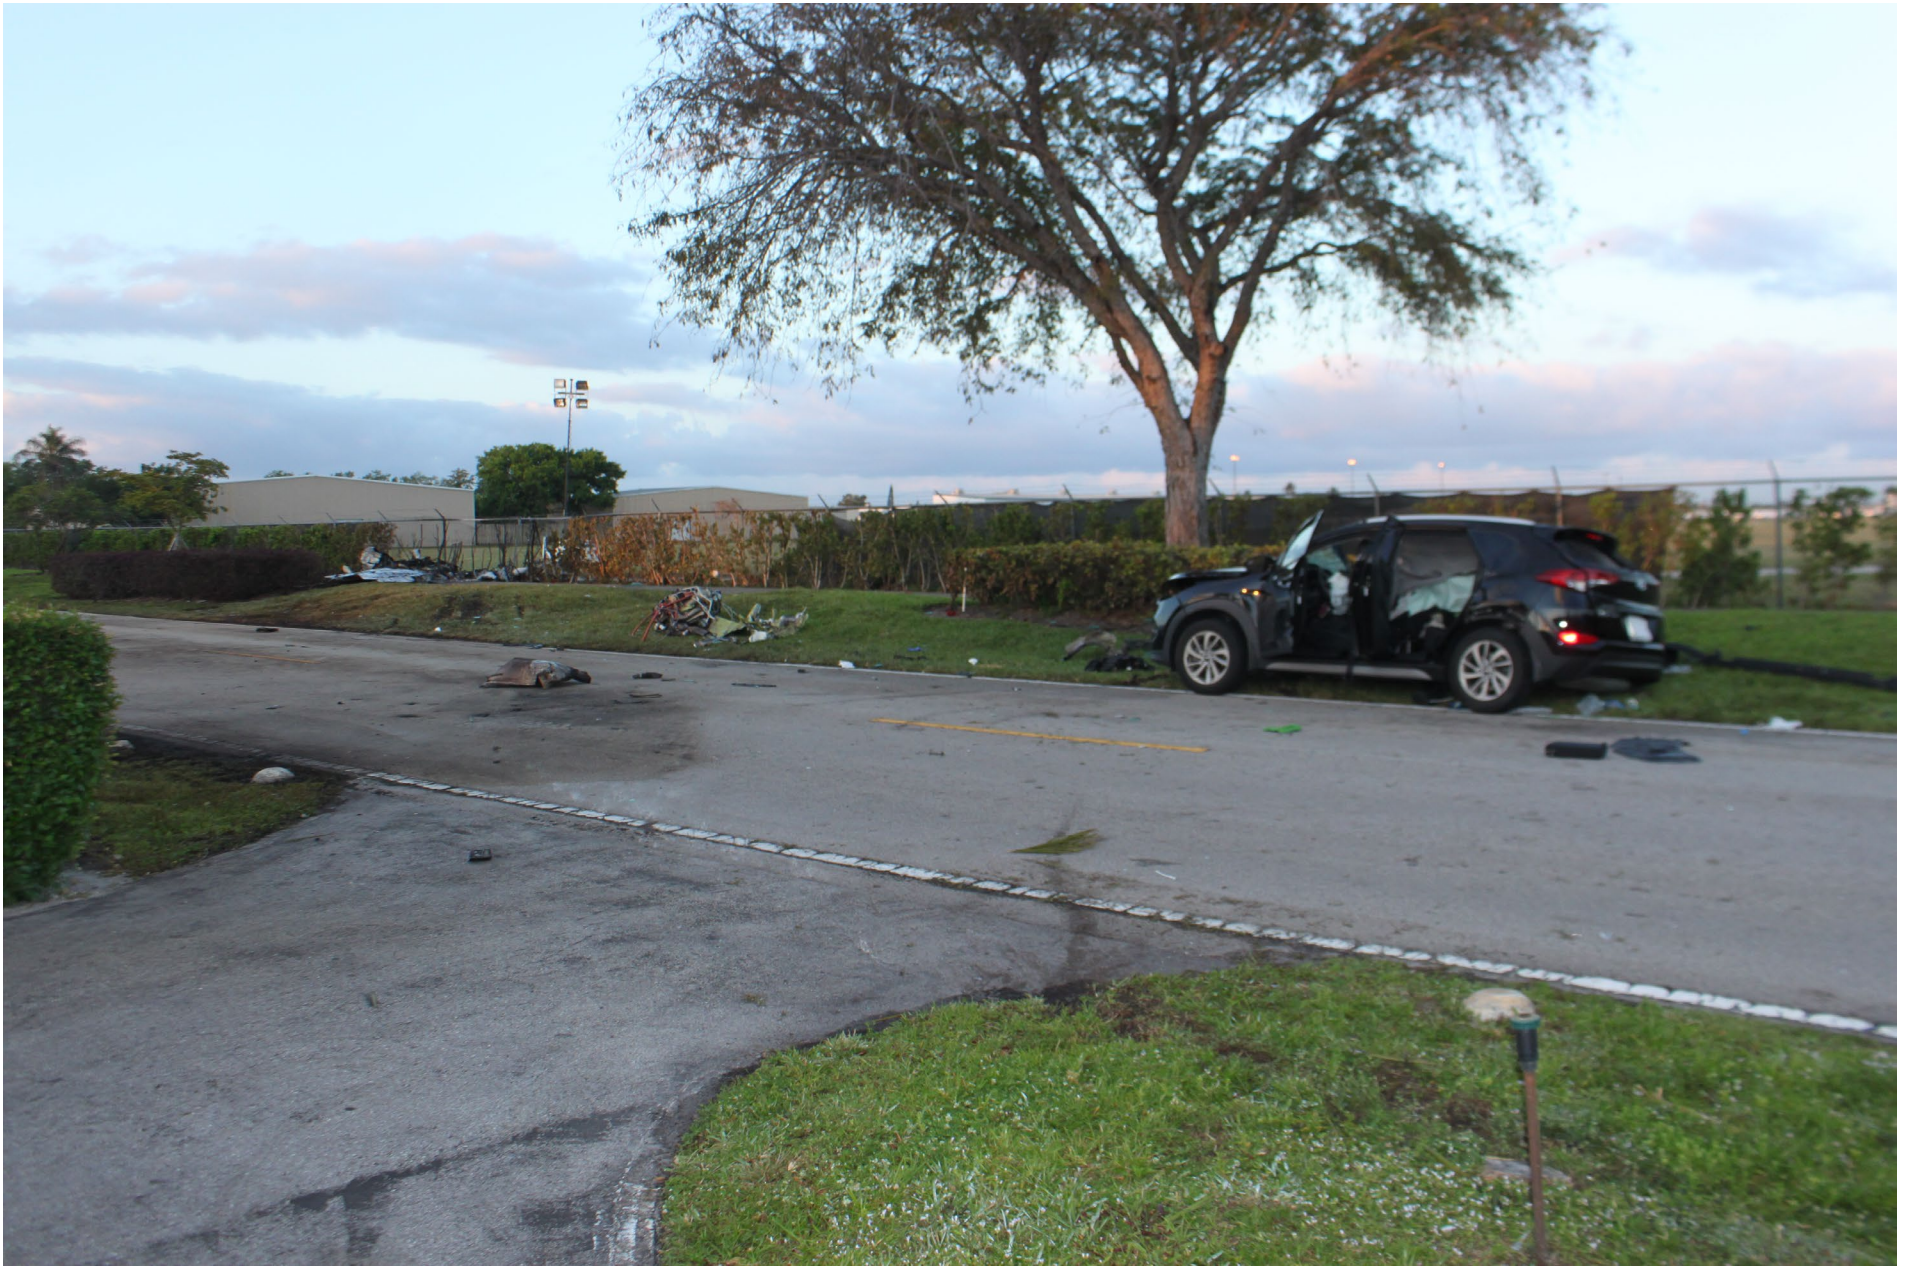
**Photo 1 – NTSB Digital Photograph. View Looking Southwest Along Energy Path. Note the Wreckage in the Background, Impacted Car, and Separated Engine.**

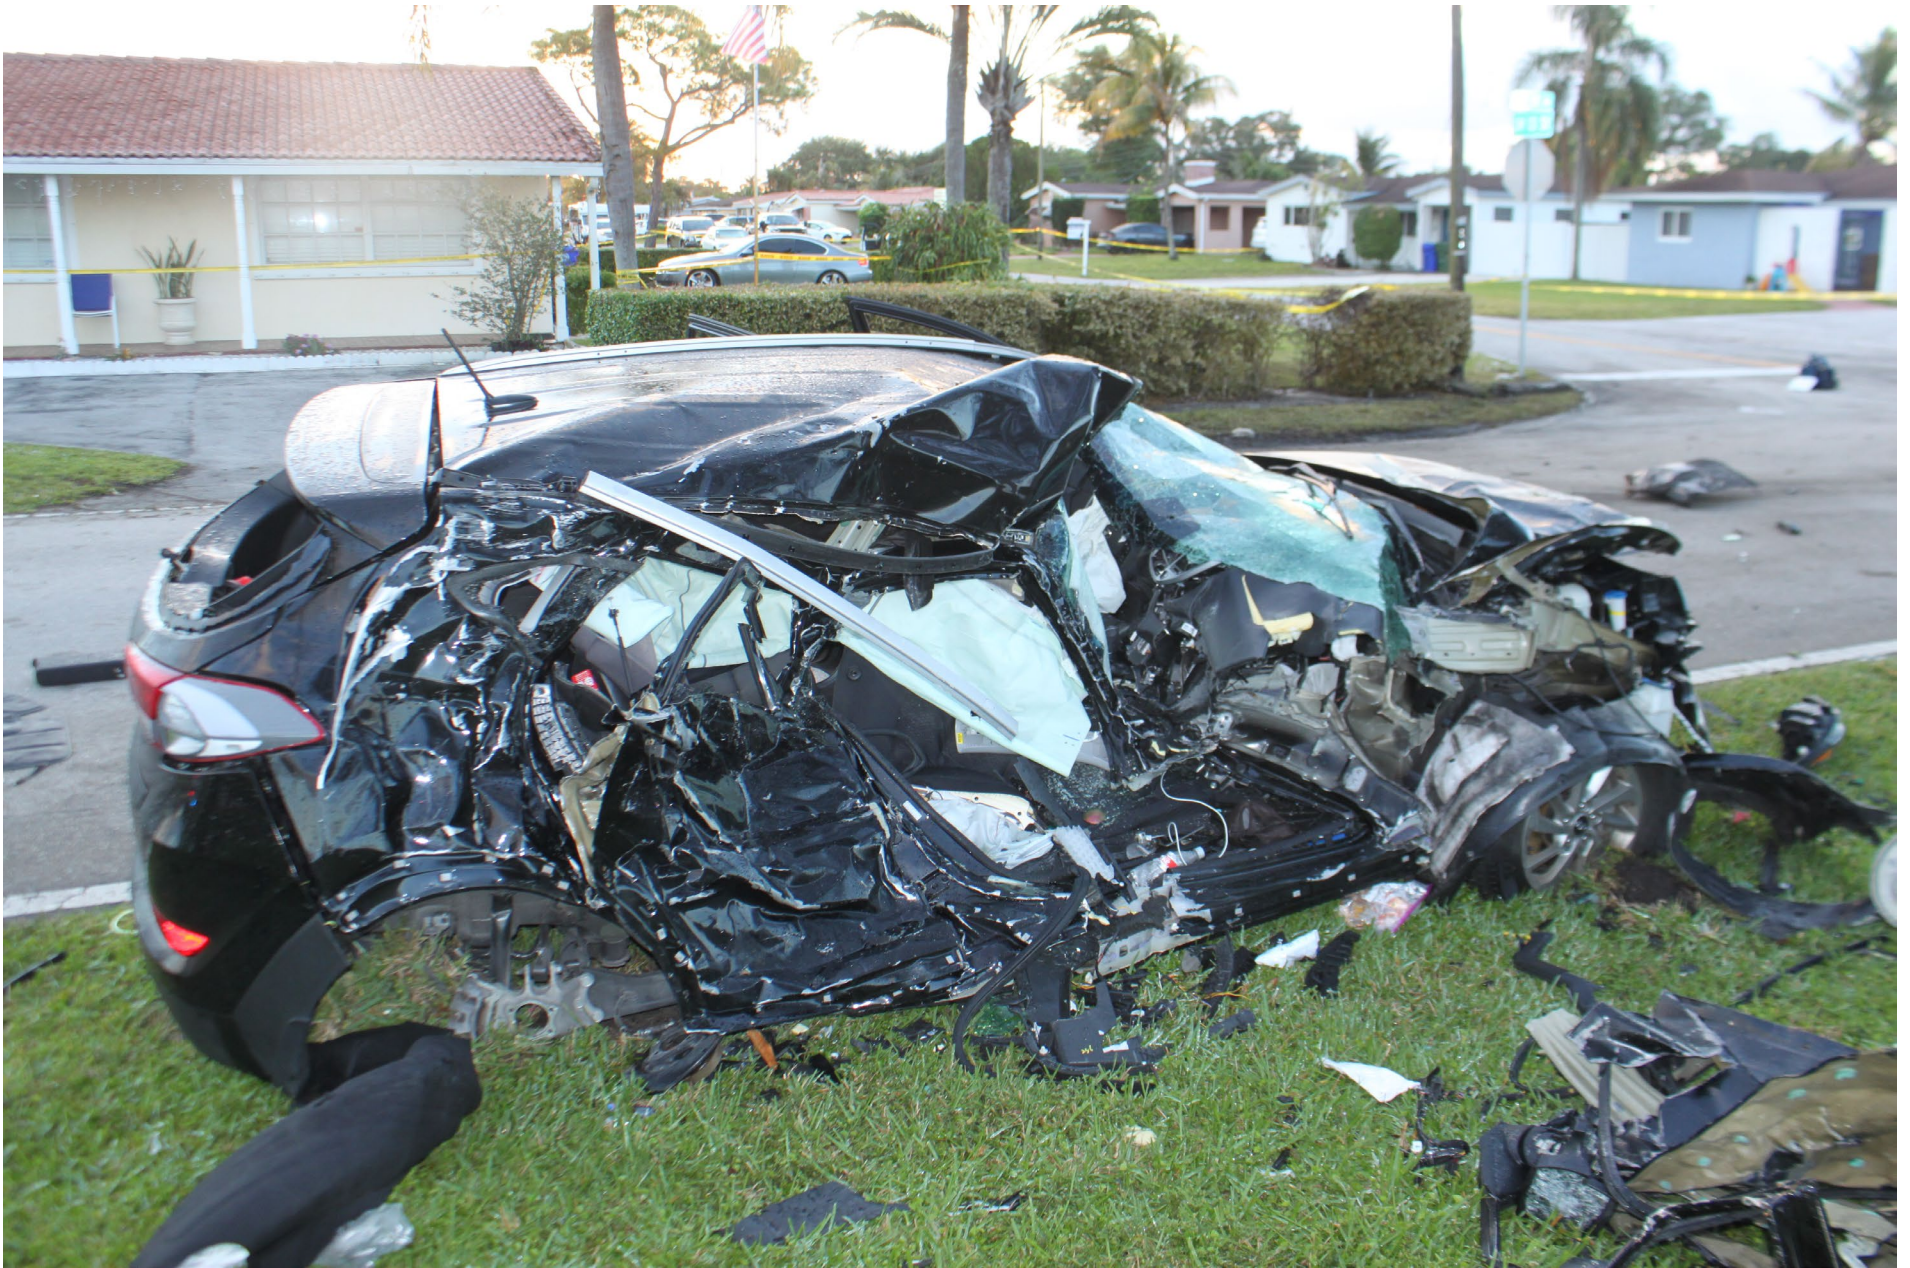
**Photo 2 - NTSB Digital Photograph. View of Right Side of Impacted Car.**

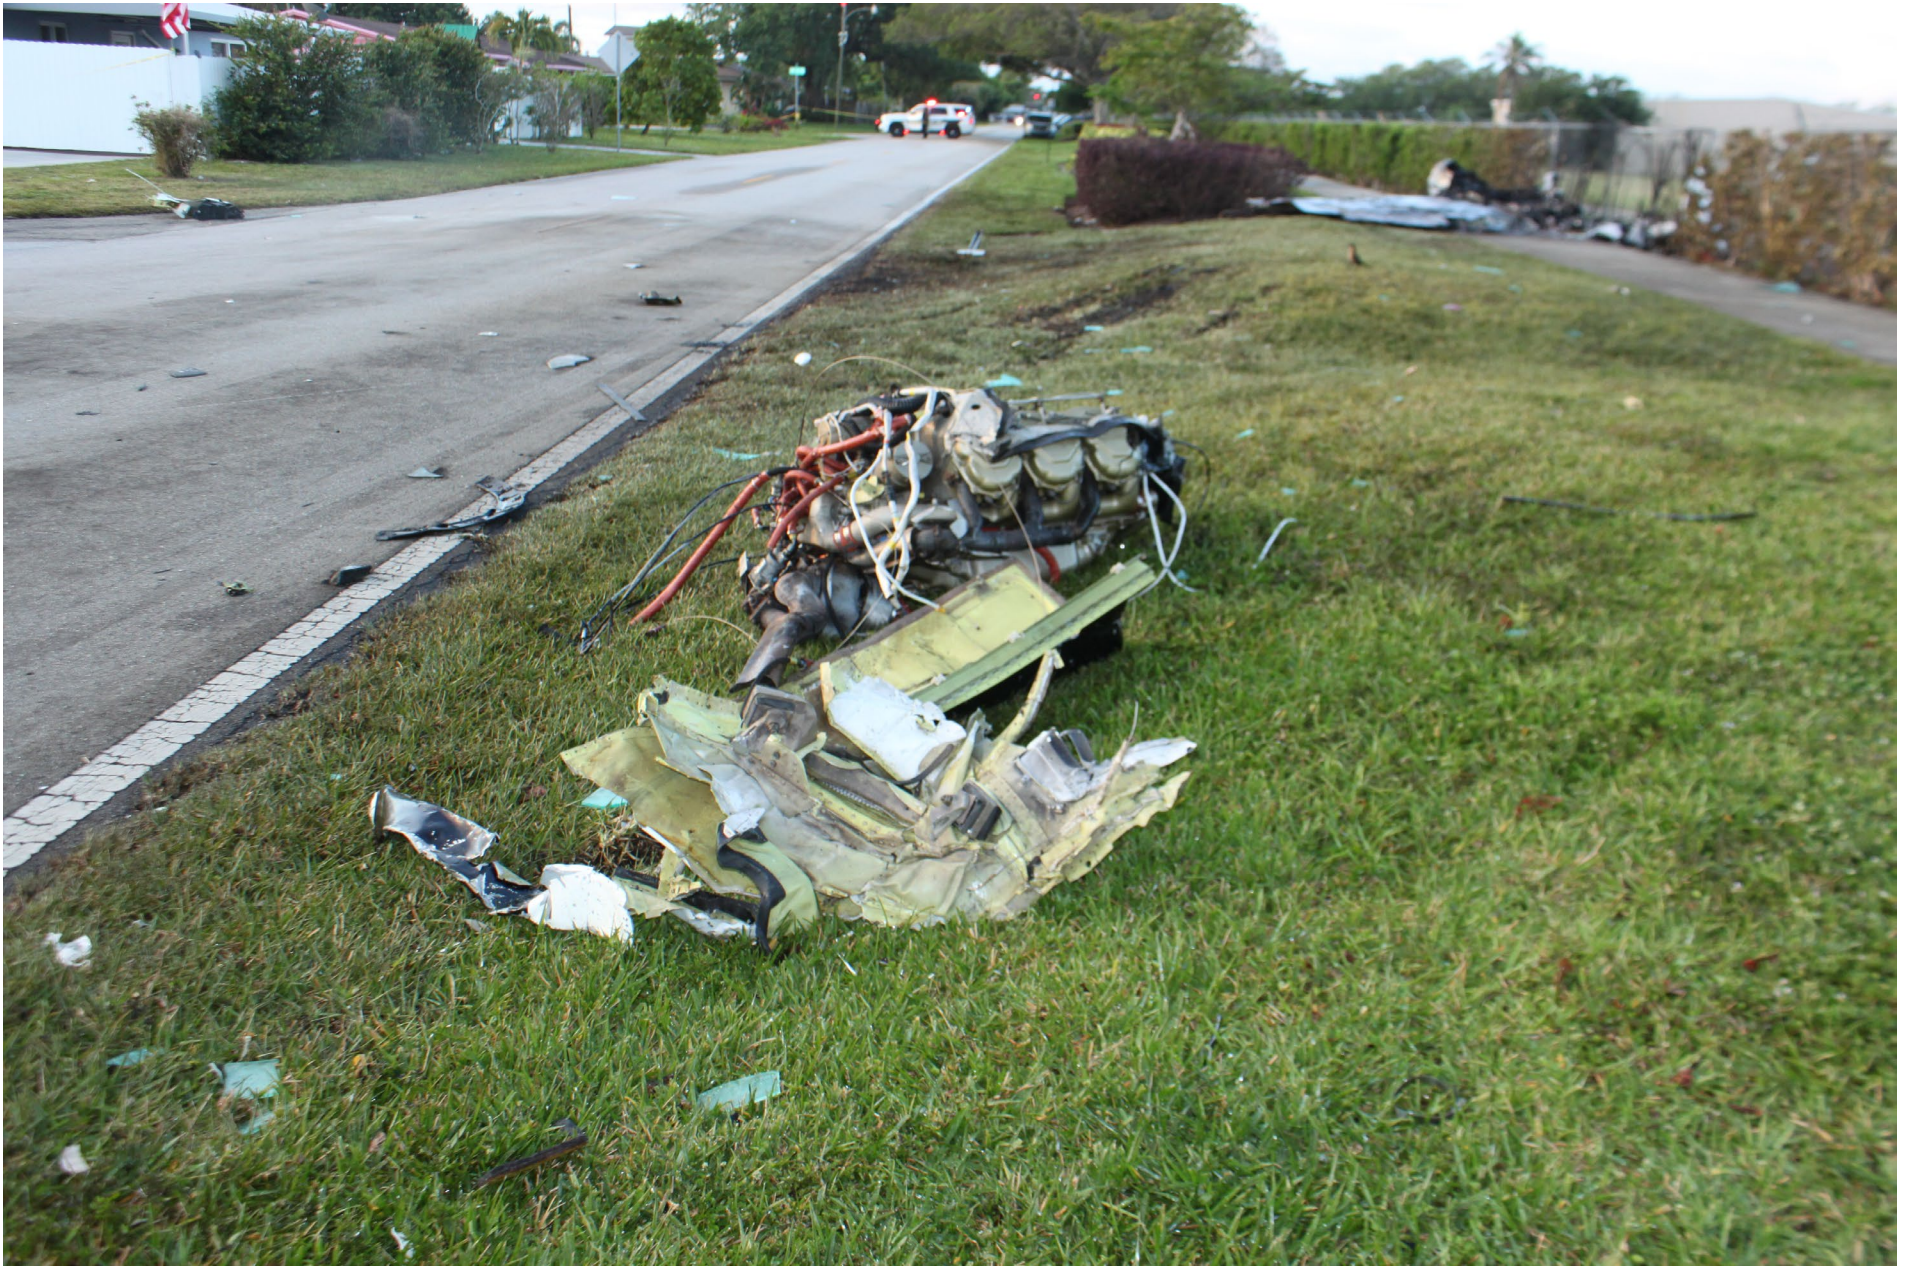
**Photo 3 - NTSB Digital Photograph. View of the Separated Engine. Note the Wreckage in the Background.**

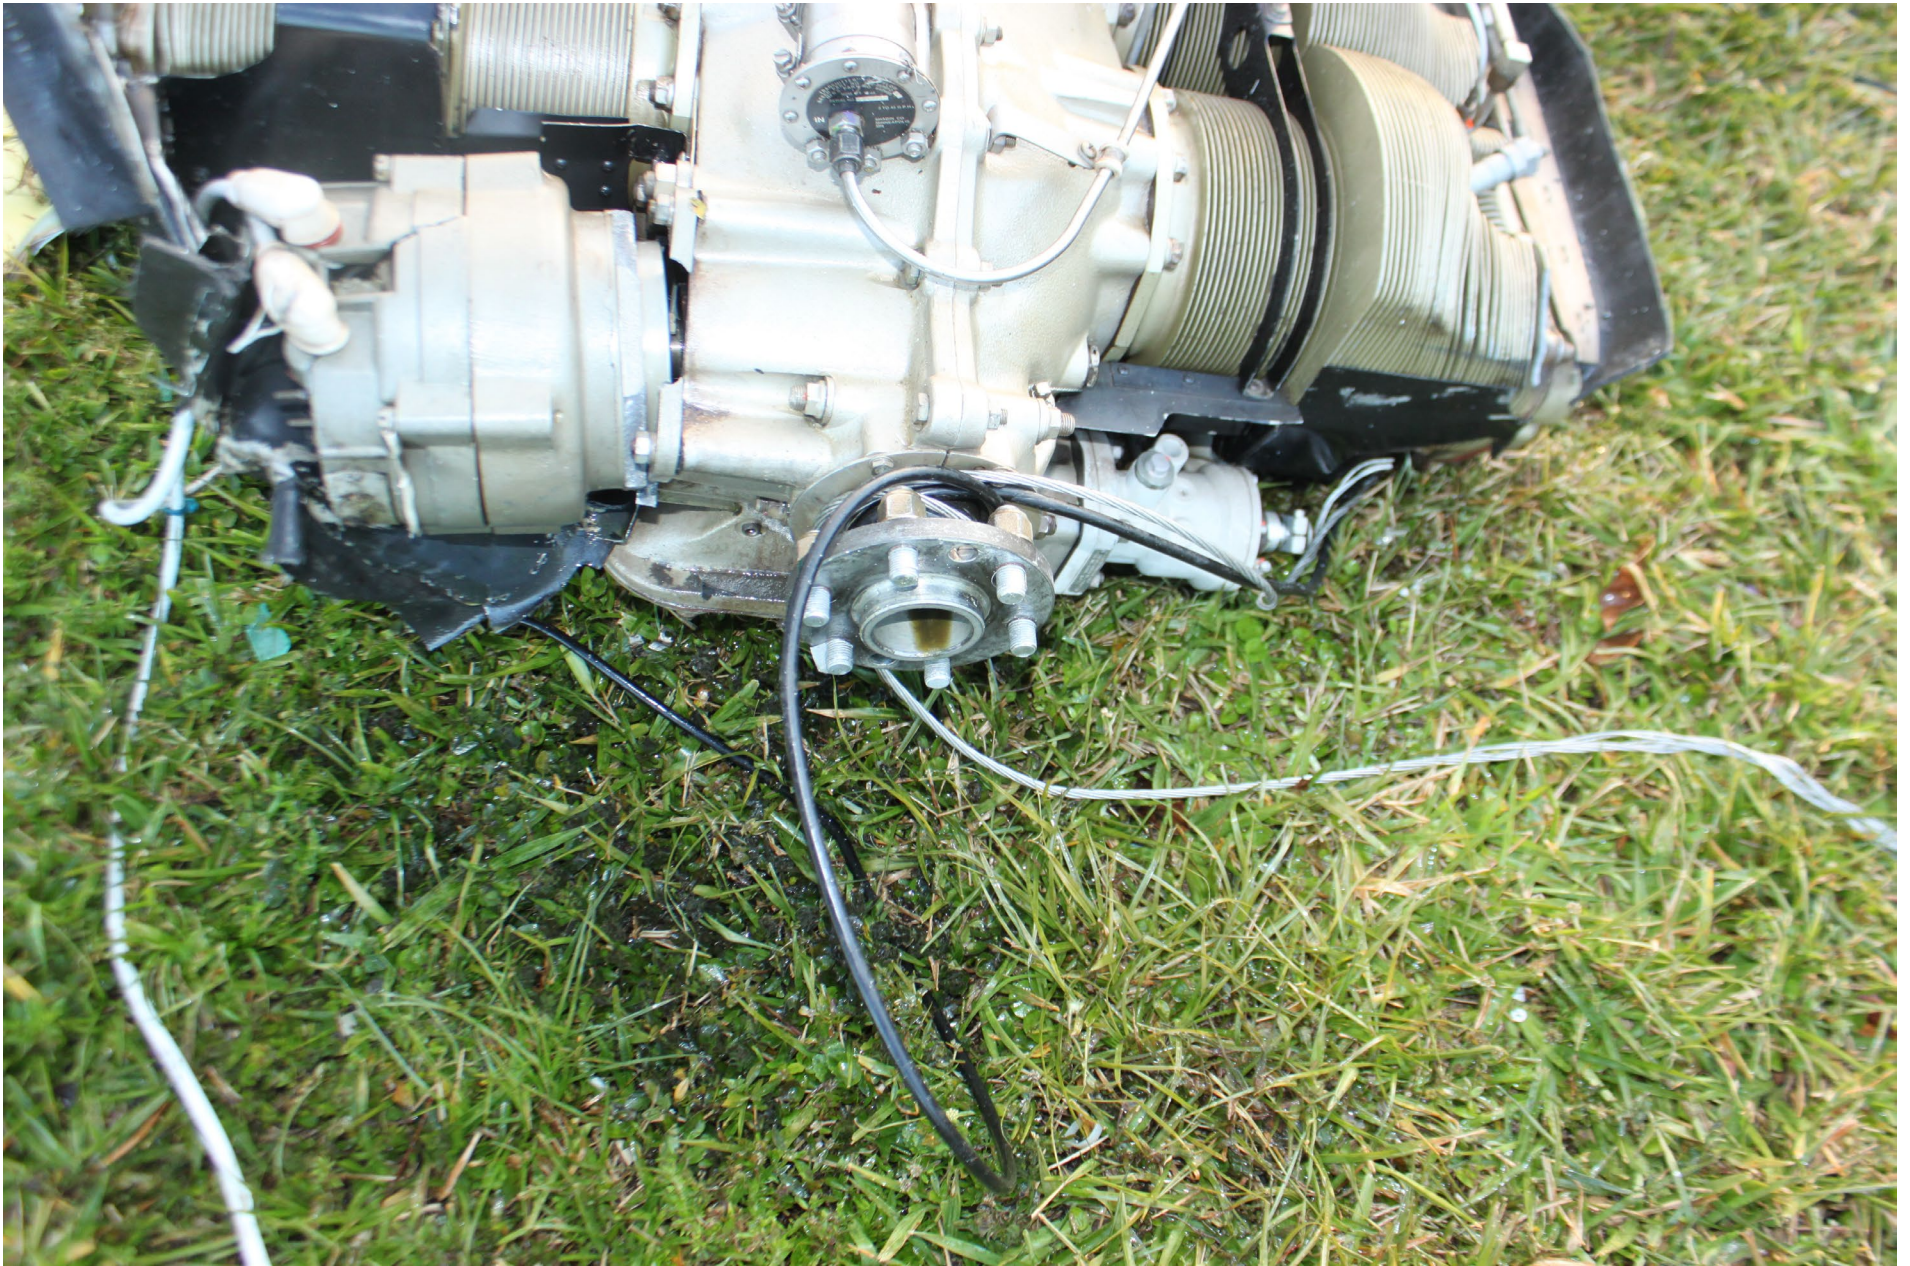
**Photo 4 - NTSB Digital Photograph. View of Front Portion of the Engine. Note the Insulated Powerline Wrapped Around the Crankshaft and the Separated Propeller.**

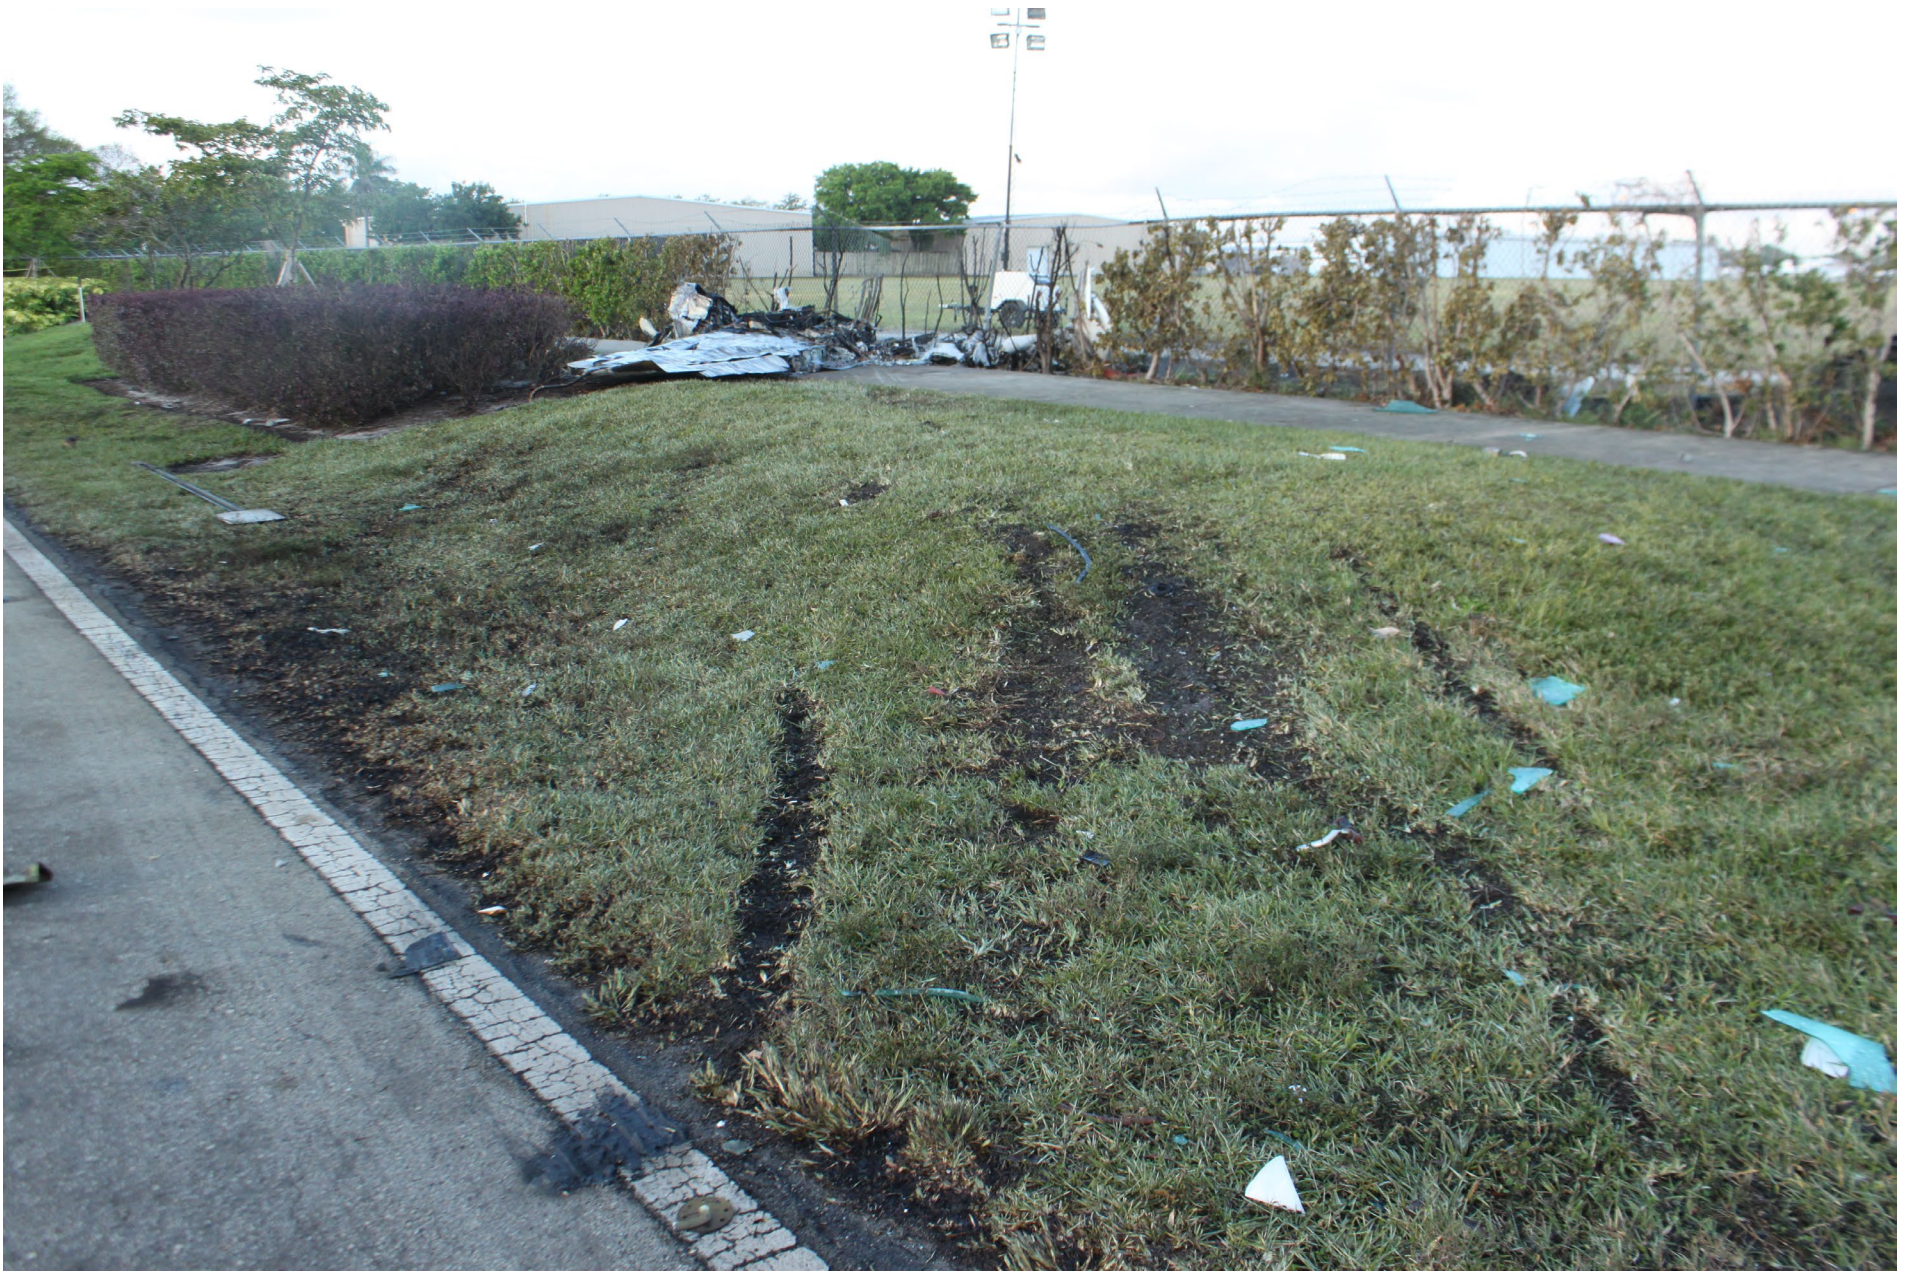
**Photo 5 - NTSB Digital Photograph. View Showing the Ground Scars and Resting Position of the Wreckage.**

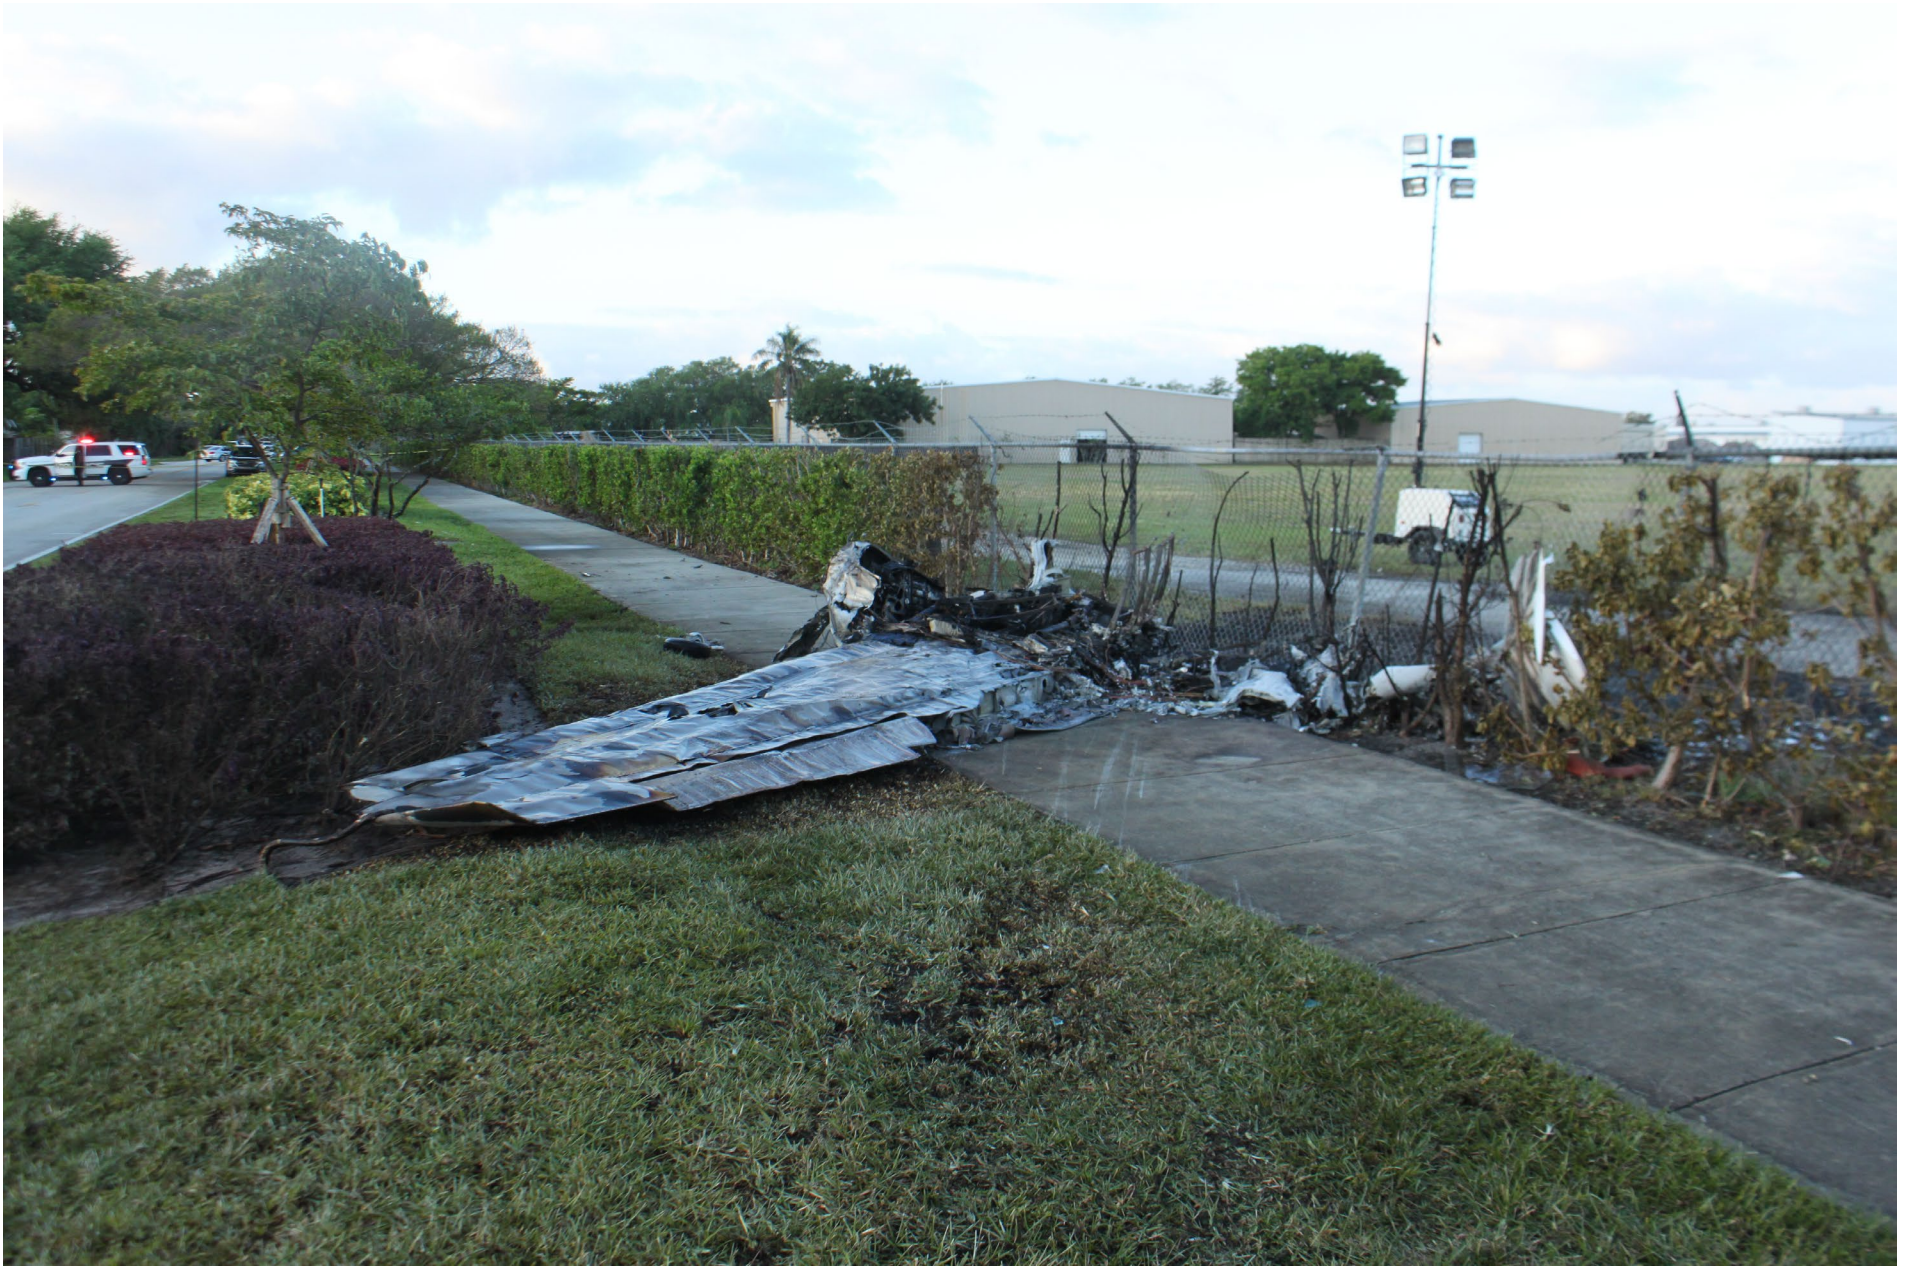
**Photo 6 - NTSB Digital Photograph. Left Rear Quartering View of The Wreckage at the Accident Site.**

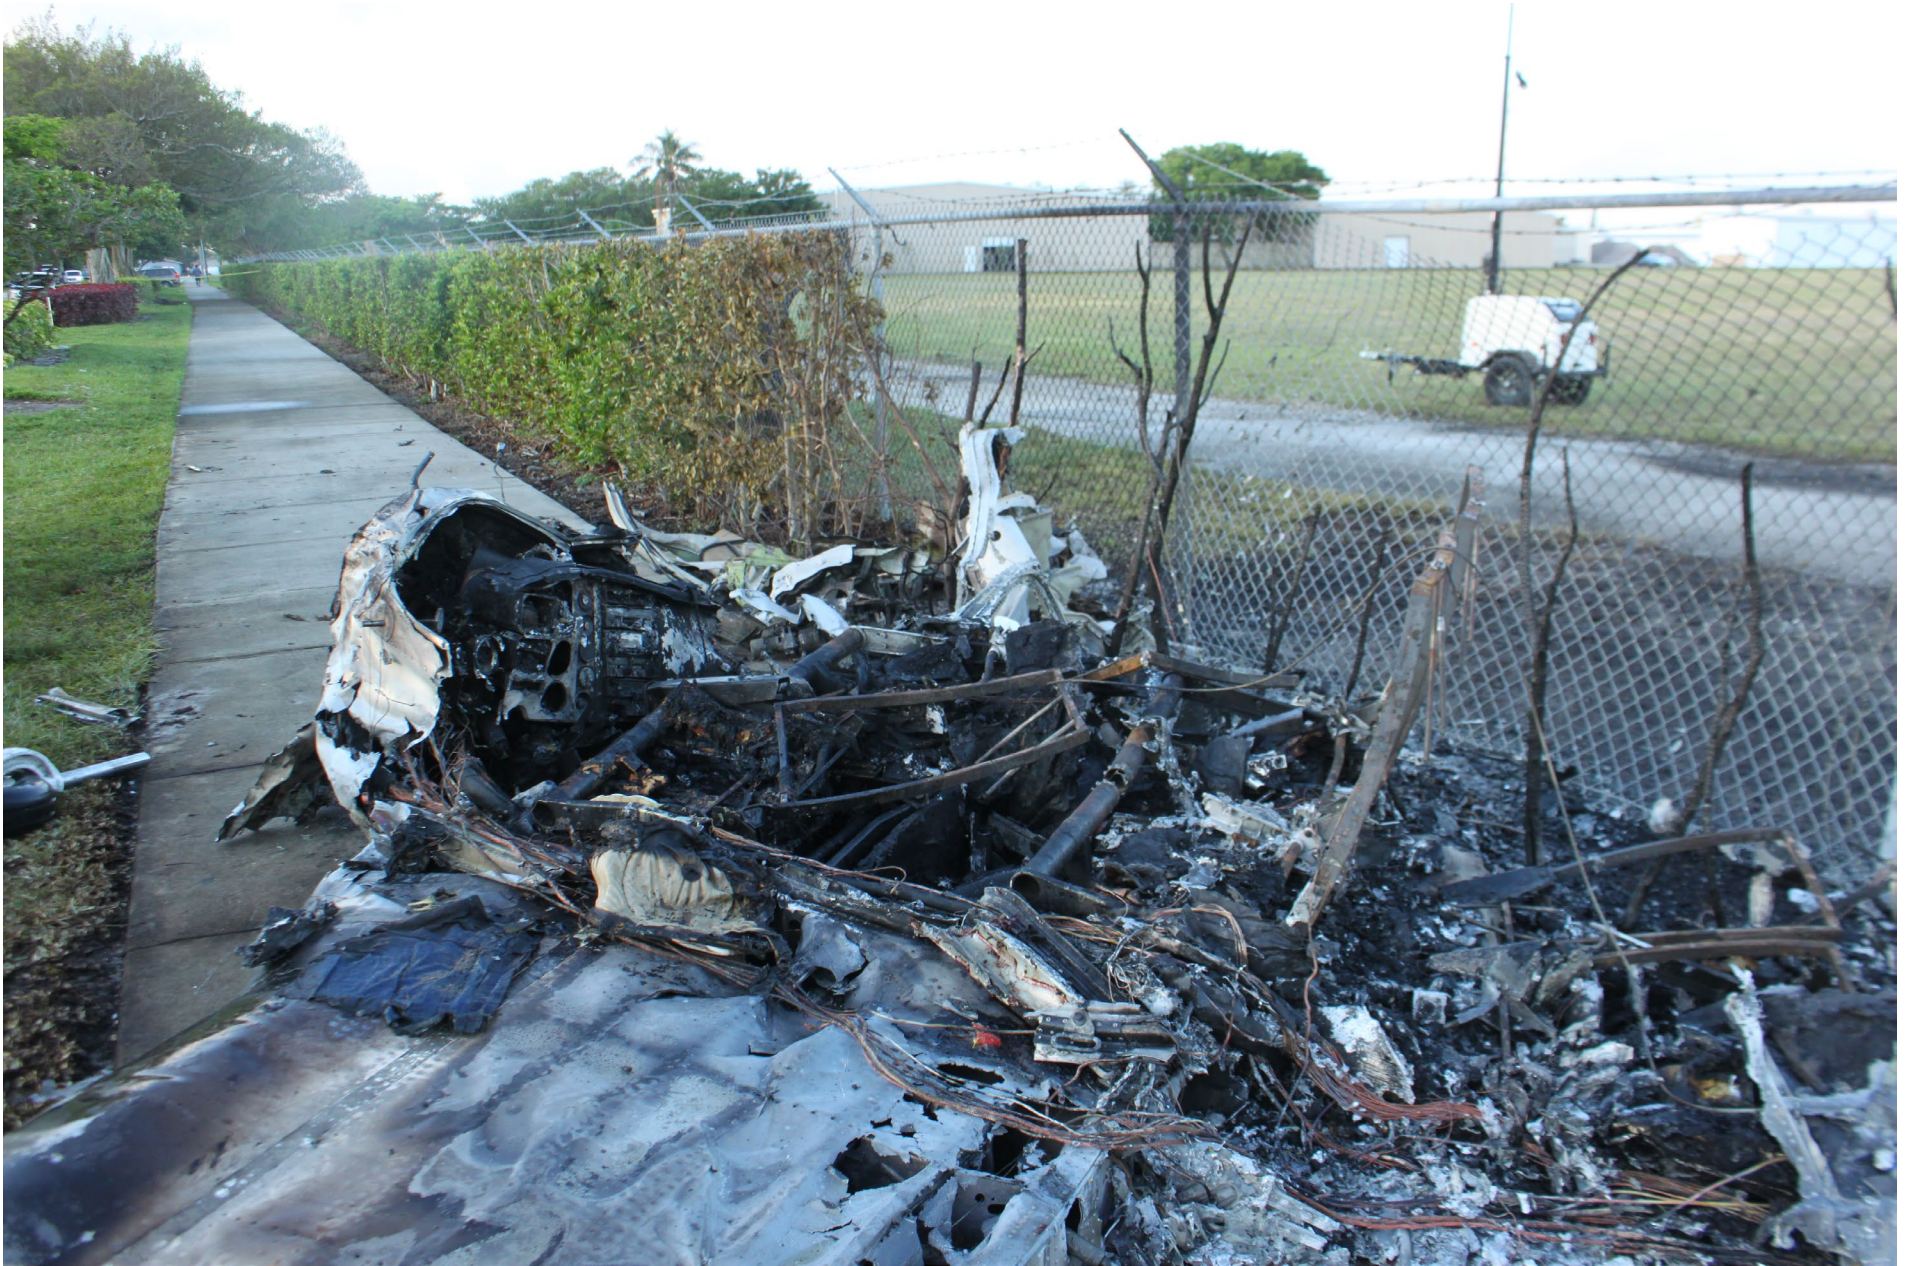
**Photo 7 - NTSB Digital Photograph. Left Side View Showing the Inboard Portion of the Left Wing, and Heat Damaged Cockpit and Cabin.**

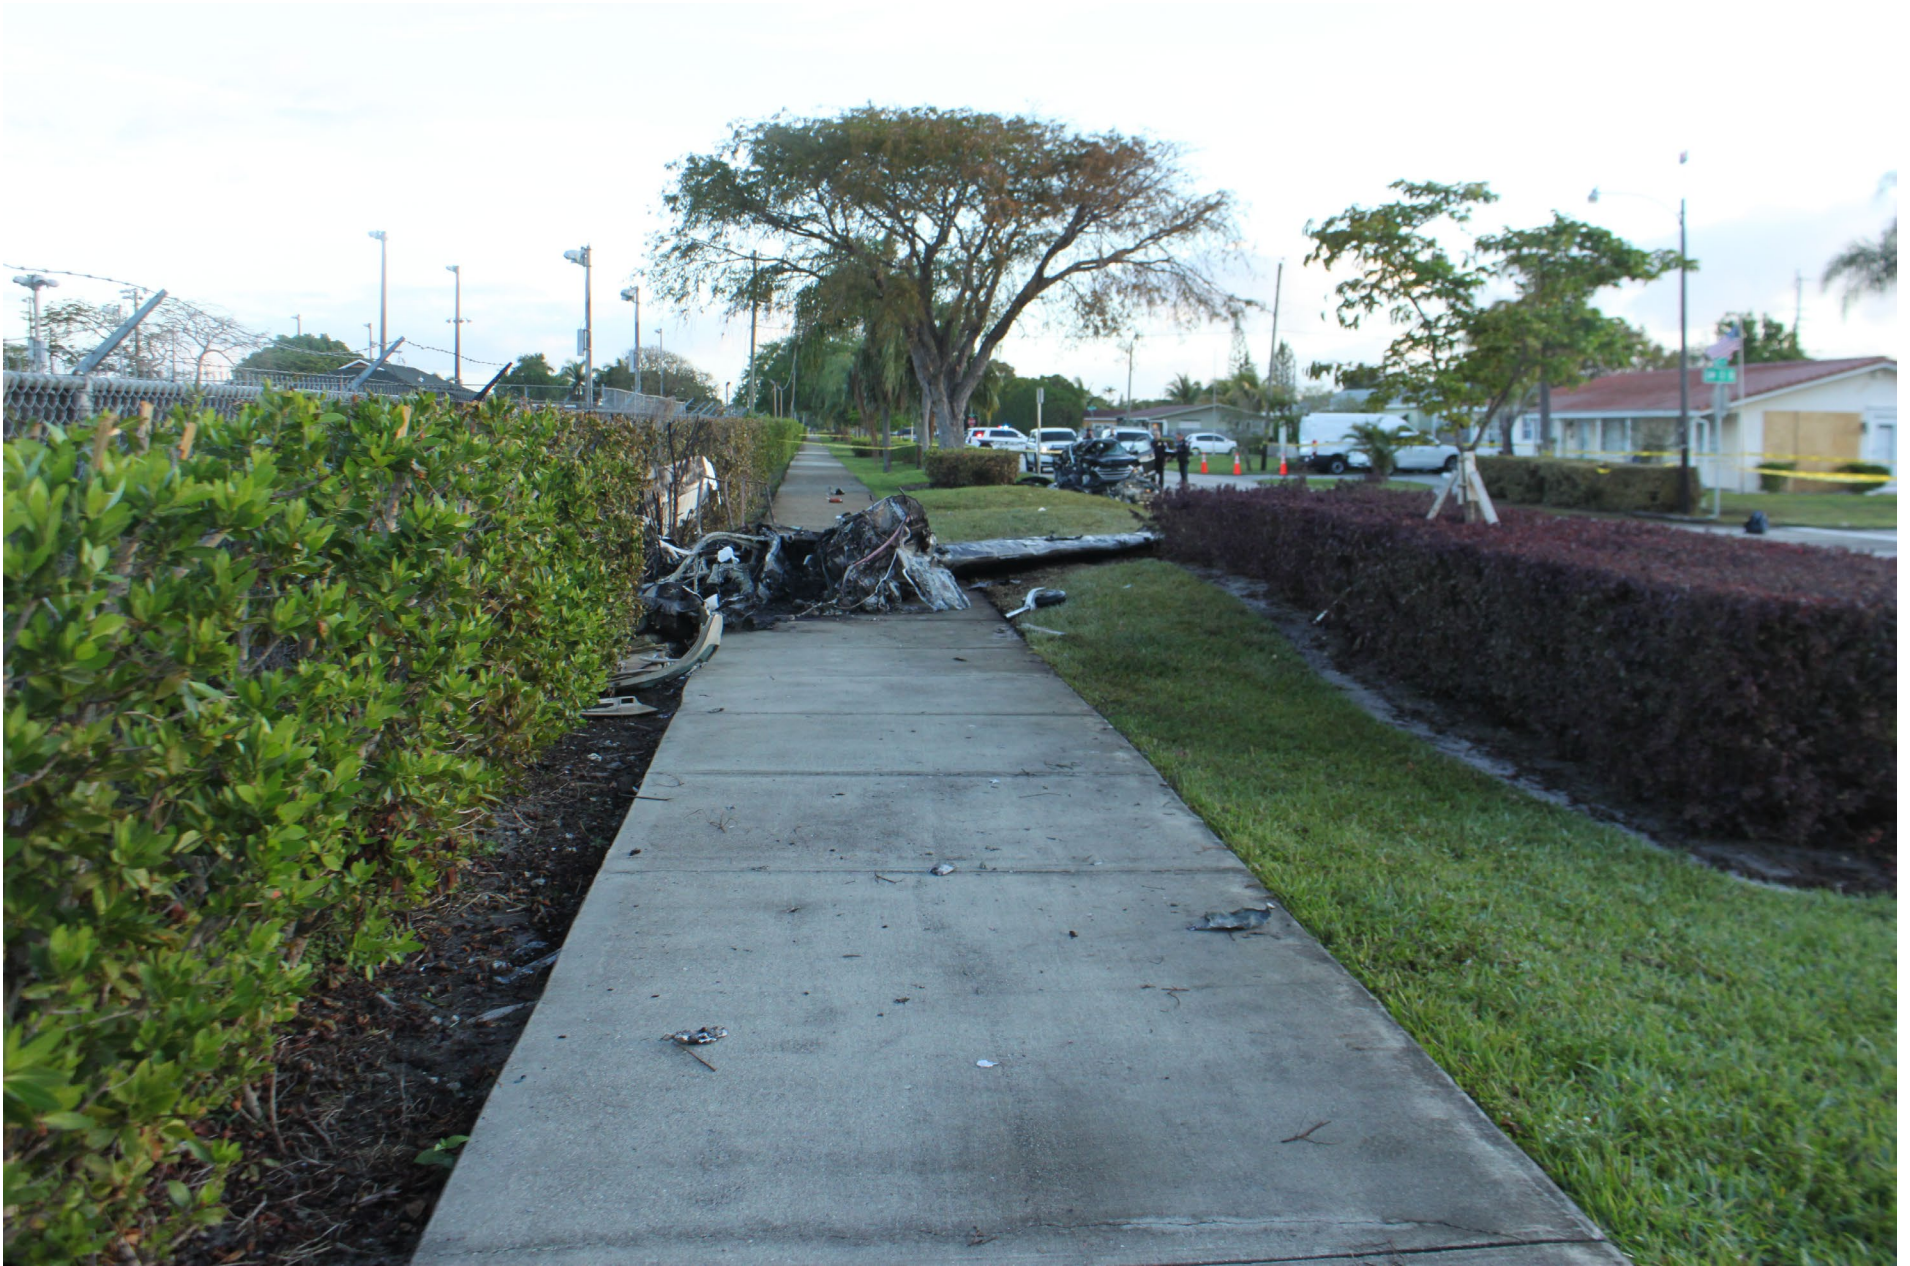
**Photo 8 - NTSB Digital Photograph. View Looking North. Frontal View of the Resting Position of the Wreckage.**

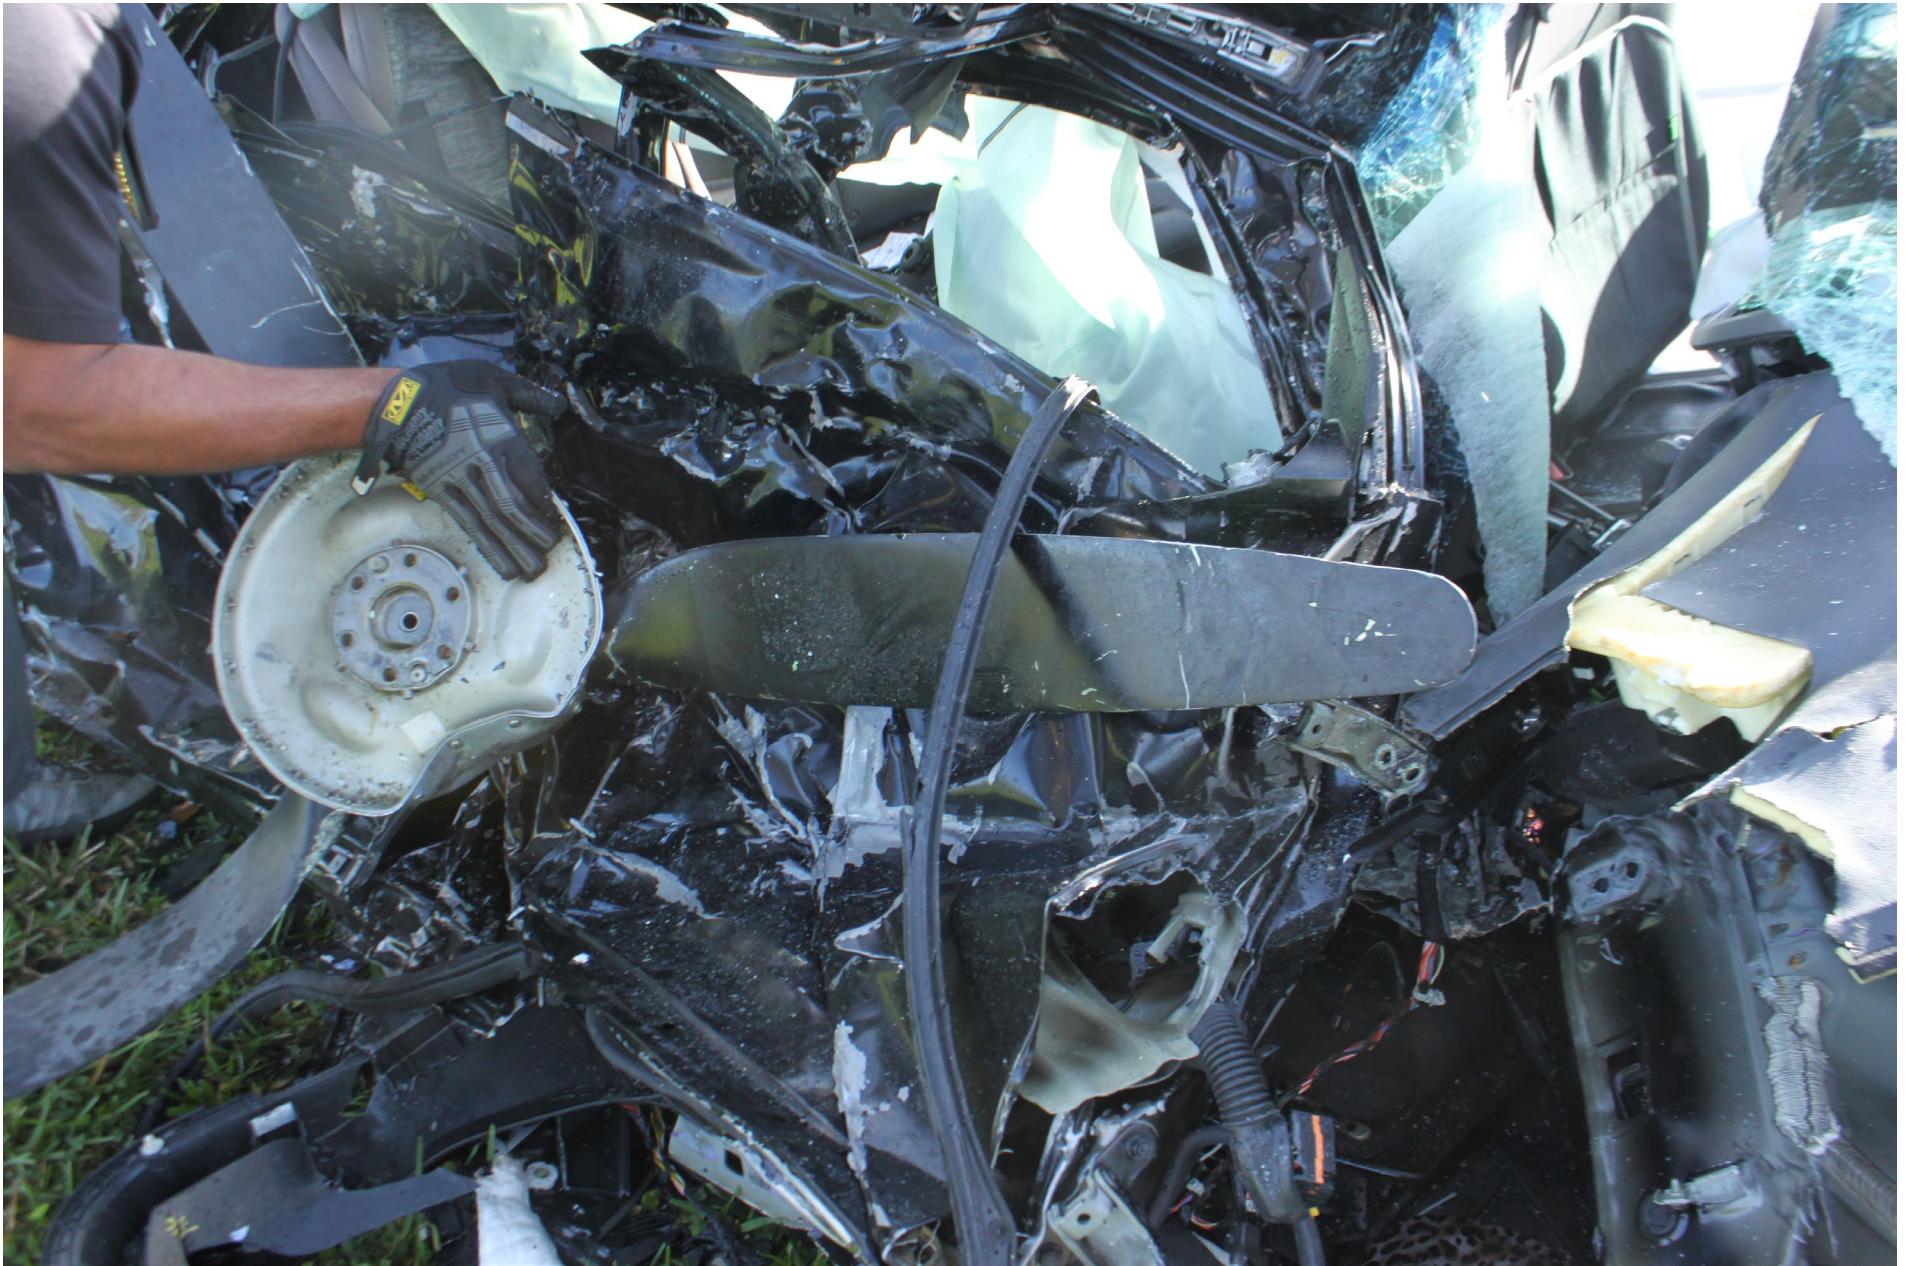
**Photo 9 - NTSB Digital Photograph. View Depicting the Crease in the Right Side of the Car and Propeller in Approximate Position.**
