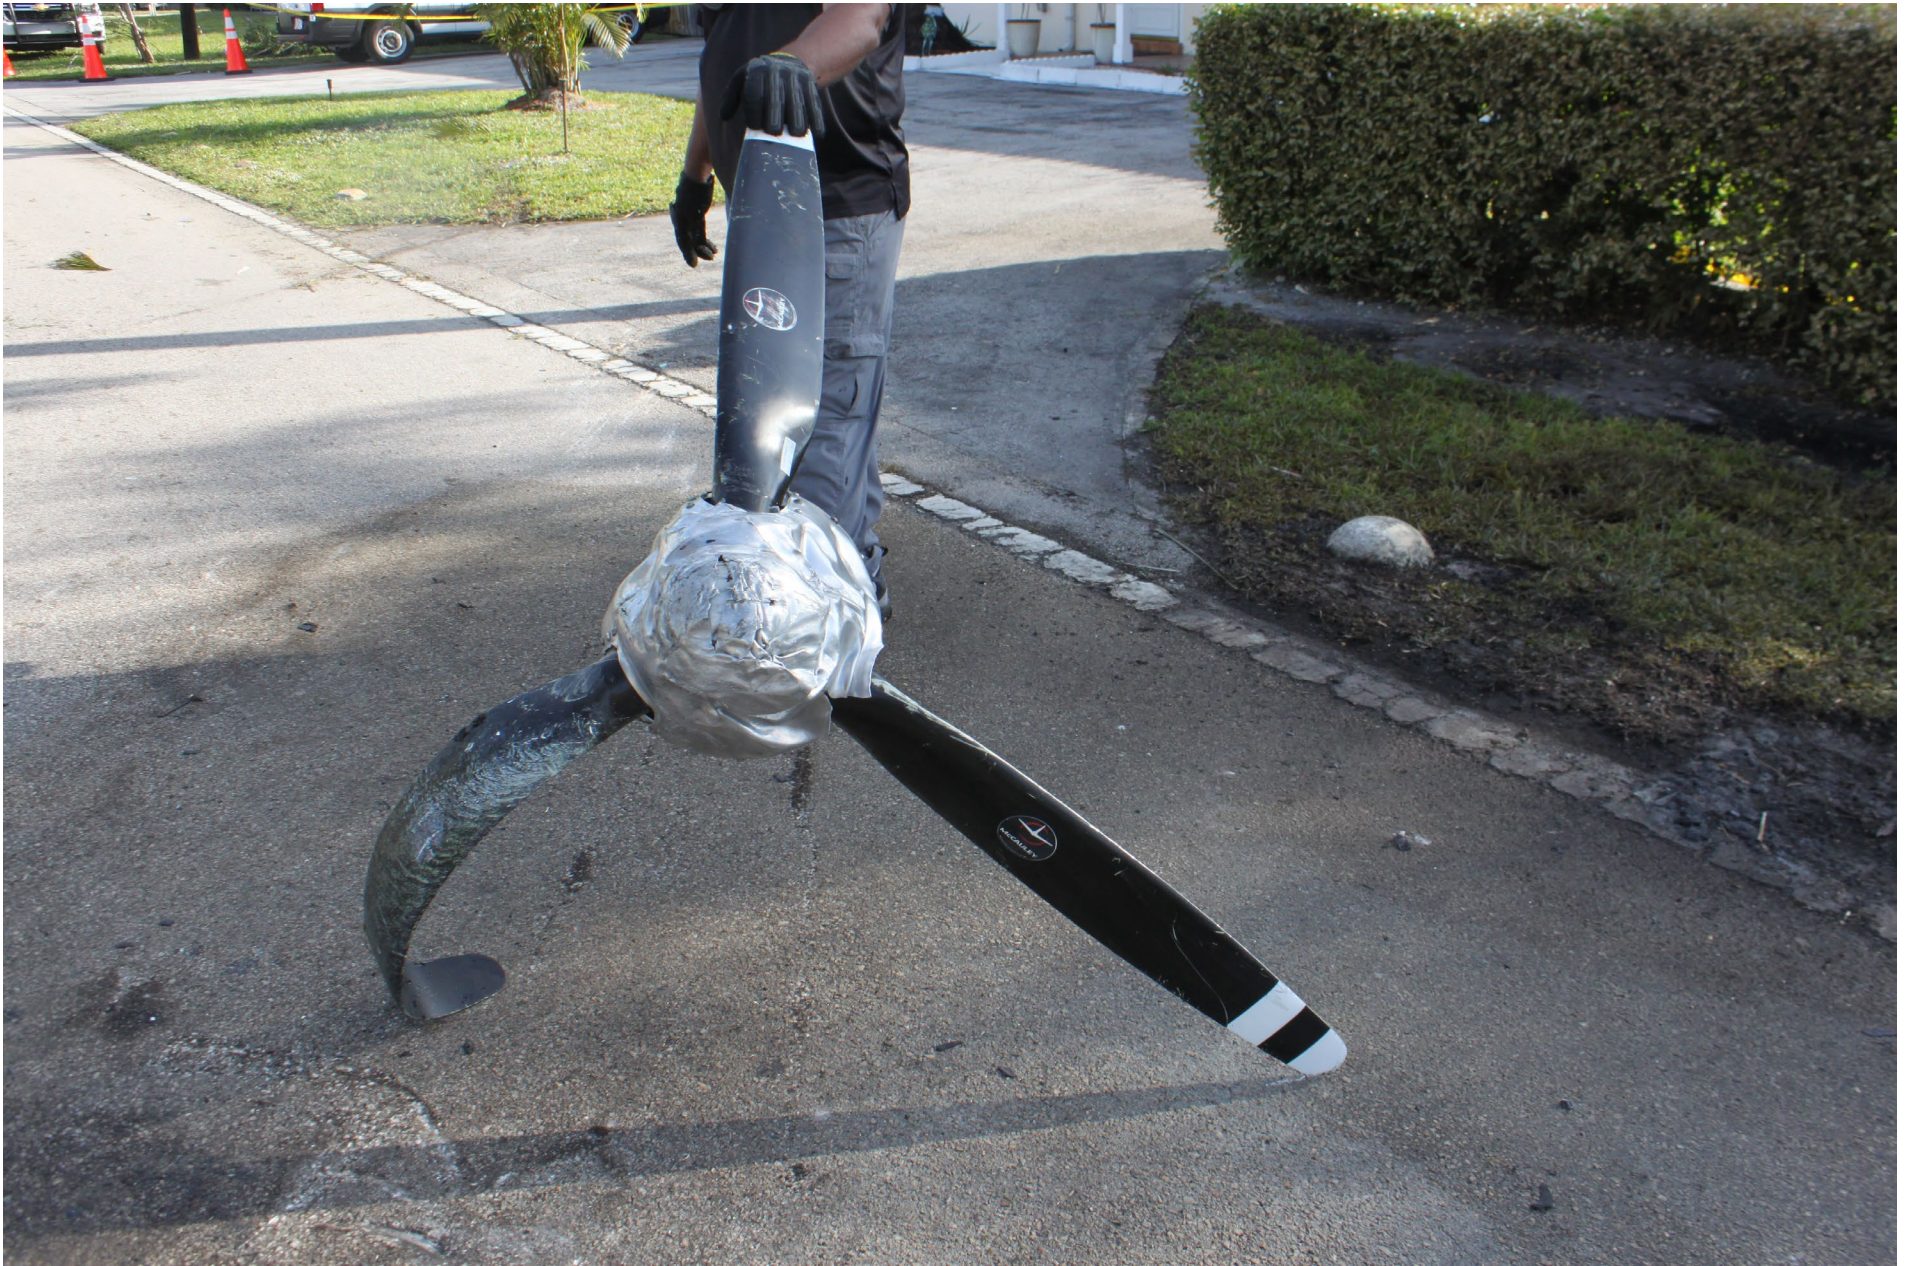
**Photo 10 - NTSB Digital Photograph. Frontal View of the Separated Propeller.**

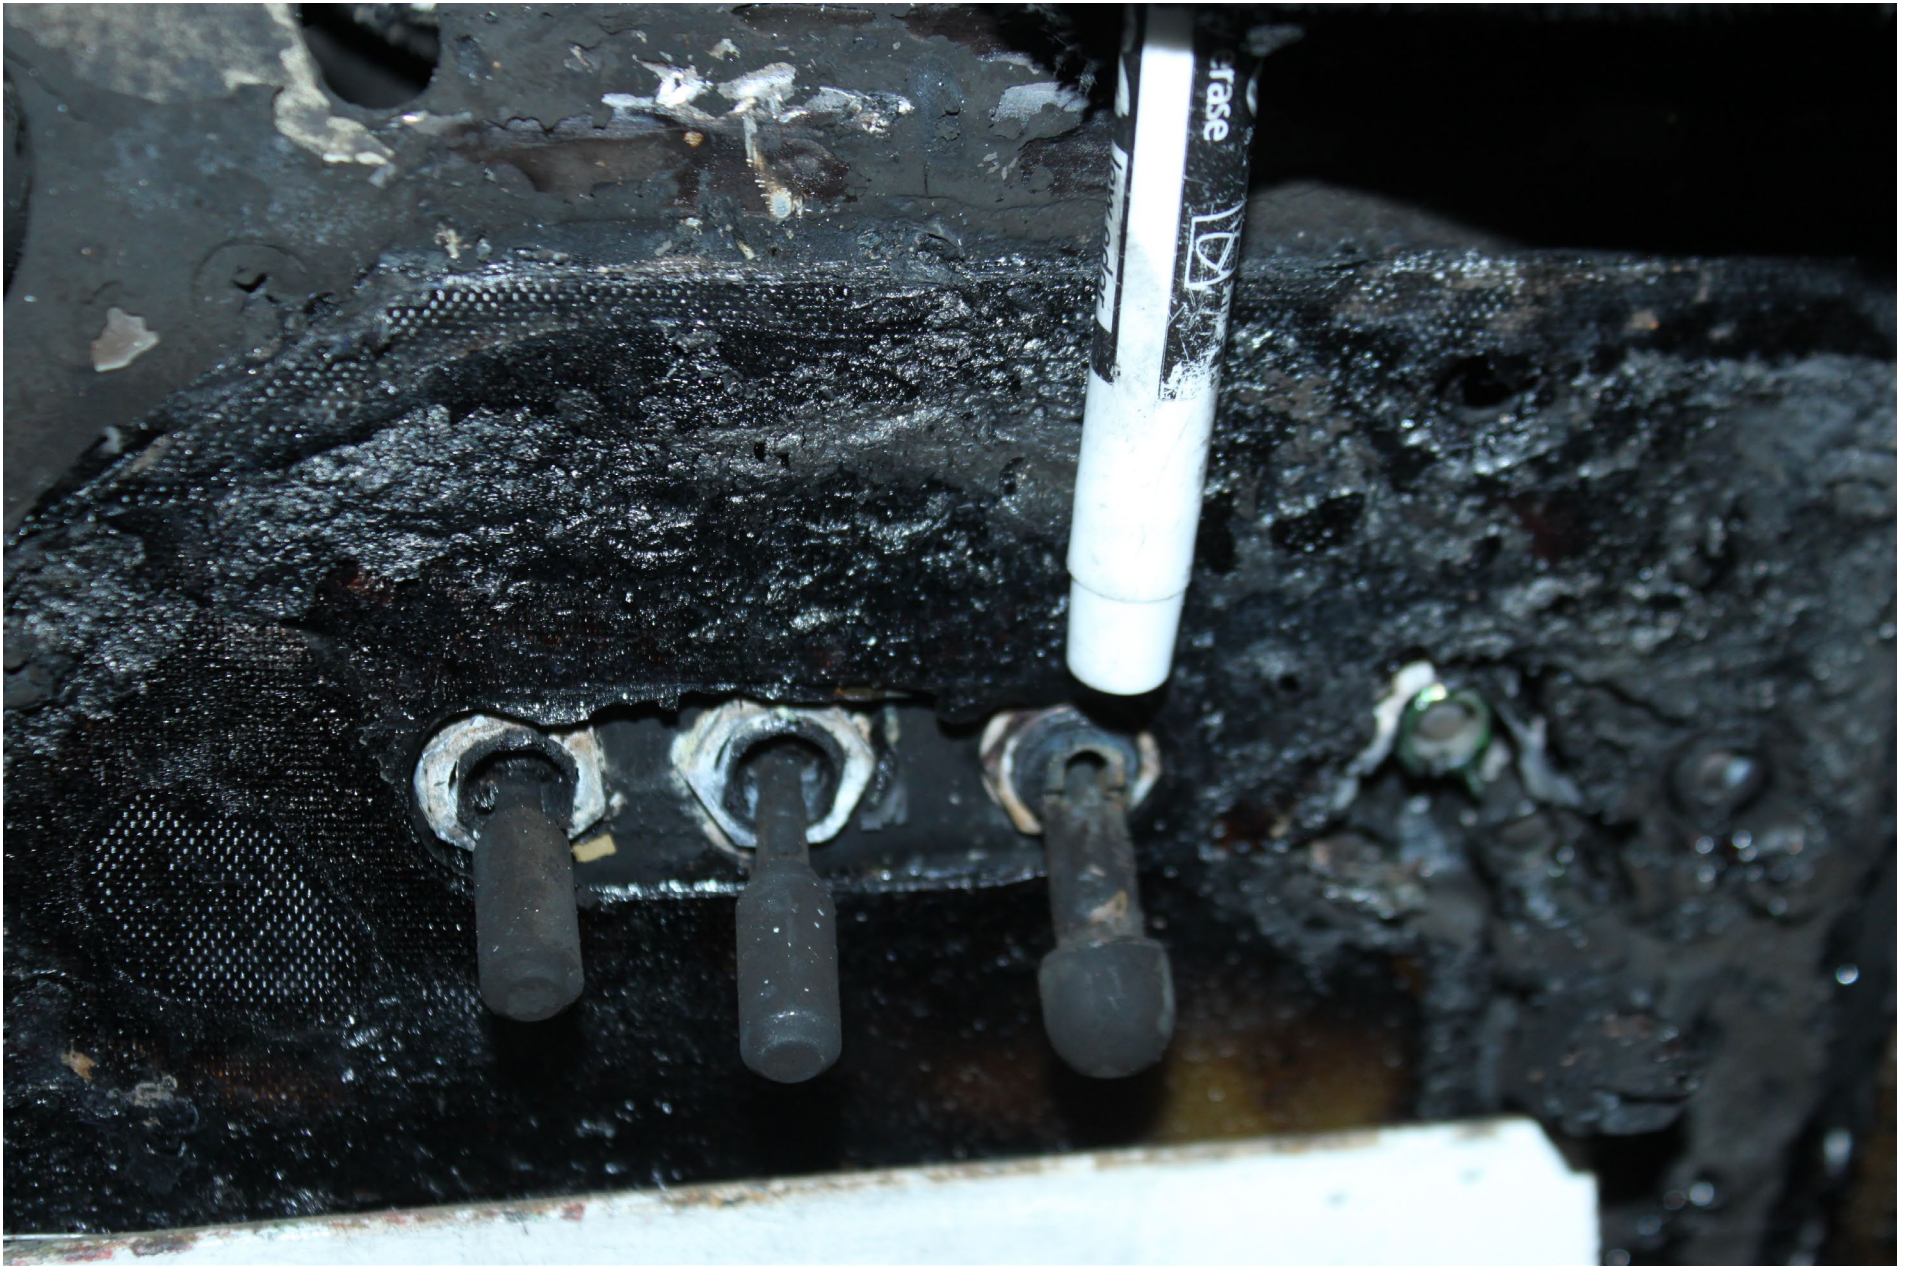
**Photo 11 - NTSB Digital Photograph. Pen points to Auxiliary Fuel Pump Switch.**

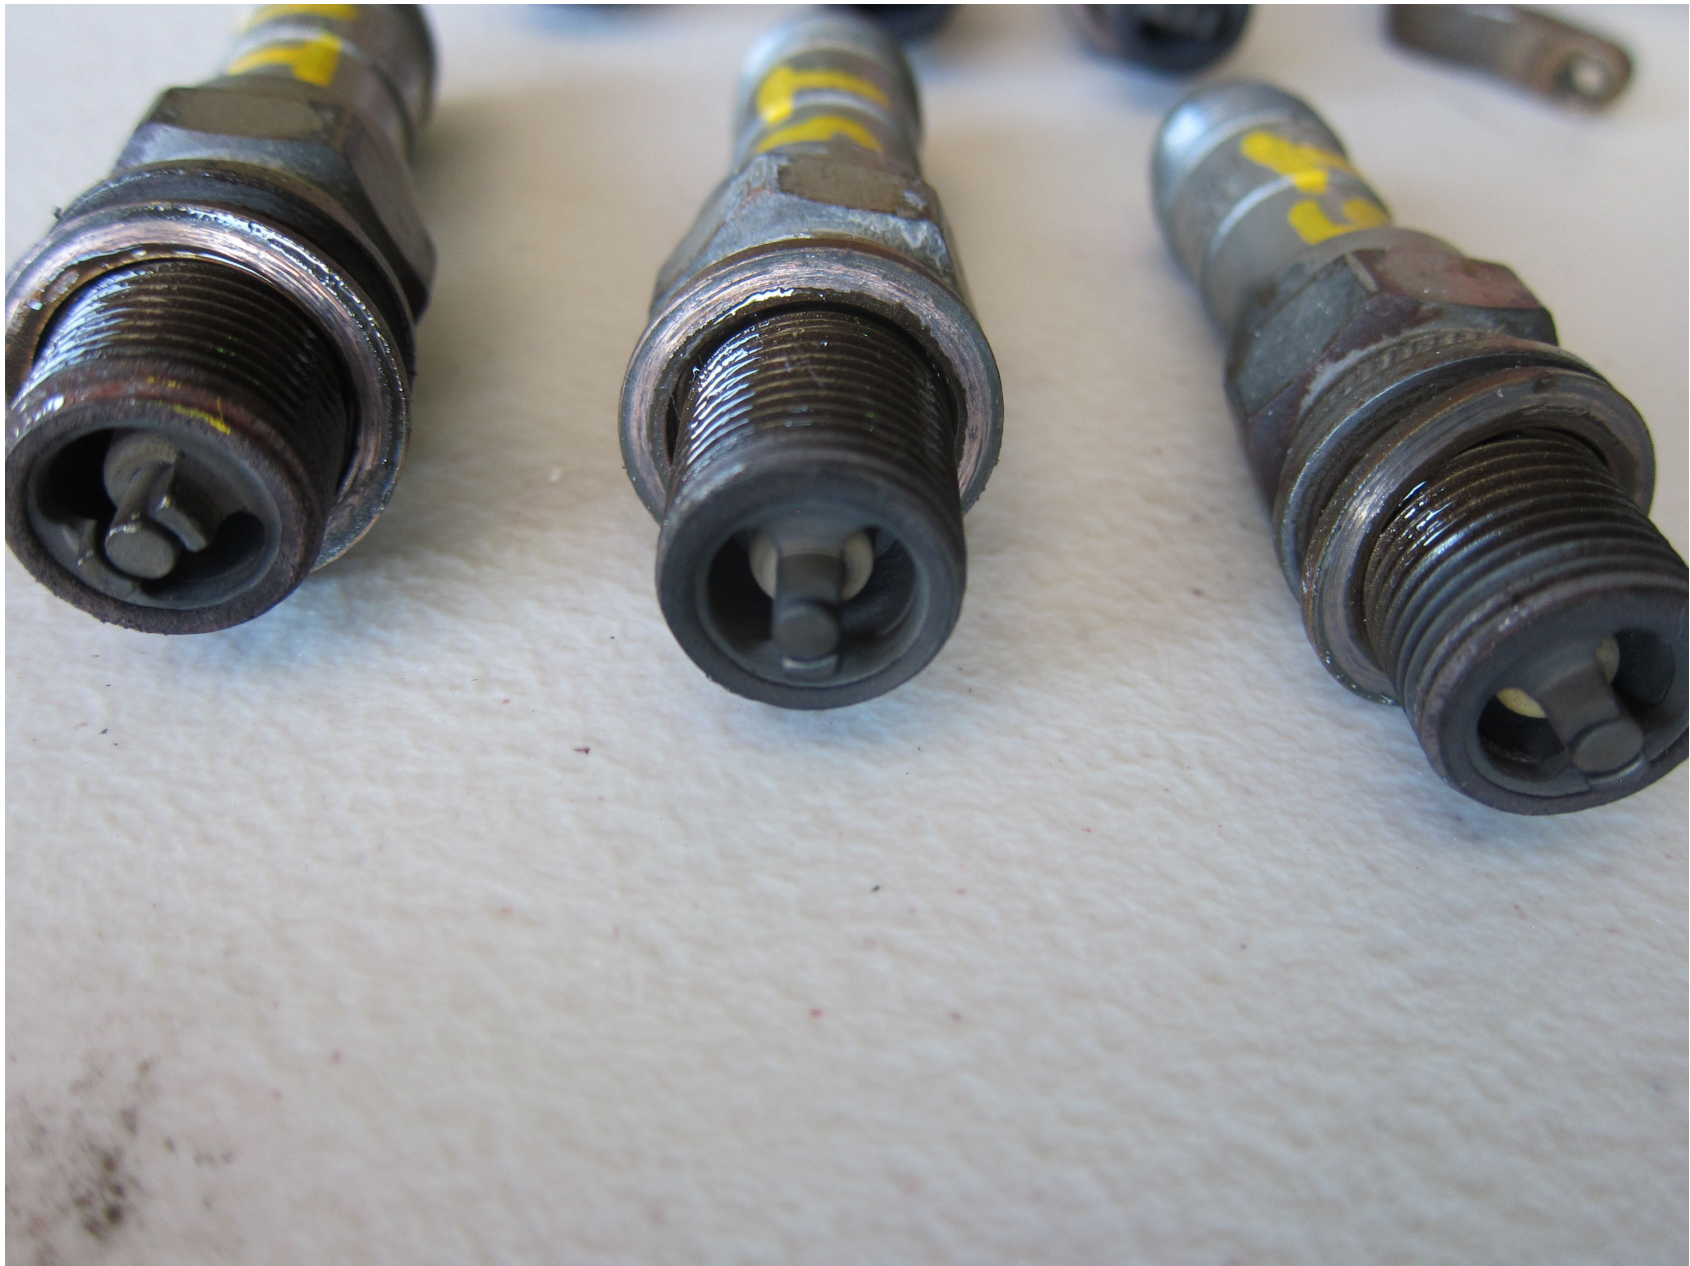
**Photo 12 – Continental Aerospace Technologies Digital Photograph. View of the Nos. 1, 3, and 5 Top Spark plugs. No. 1 is on the Left. Note the soot color.**

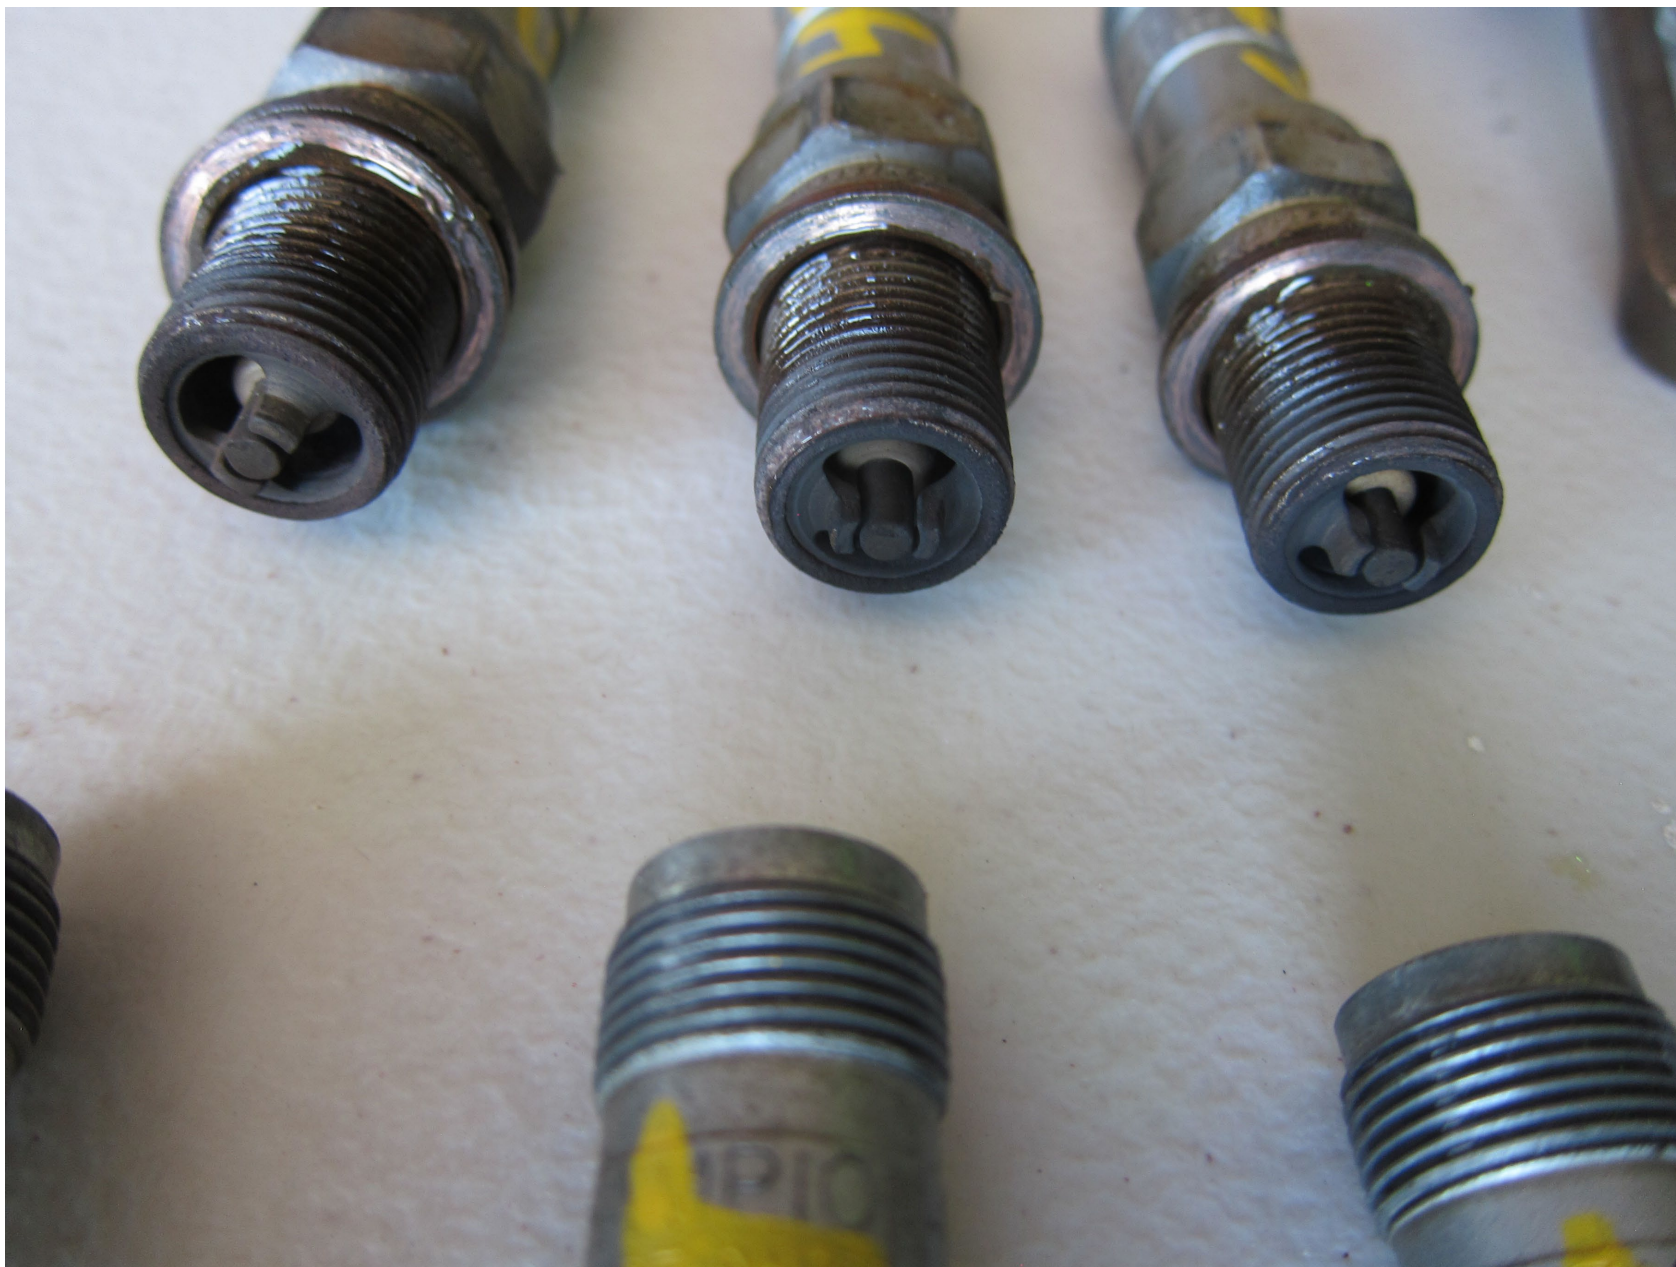
**Photo 13 - Continental Aerospace Technologies Digital Photograph. View of the Cylinder Portions of the Nos. 2, 4, and 6 Top Spark Plugs. No. 2 is on the Left. Note the soot color.**

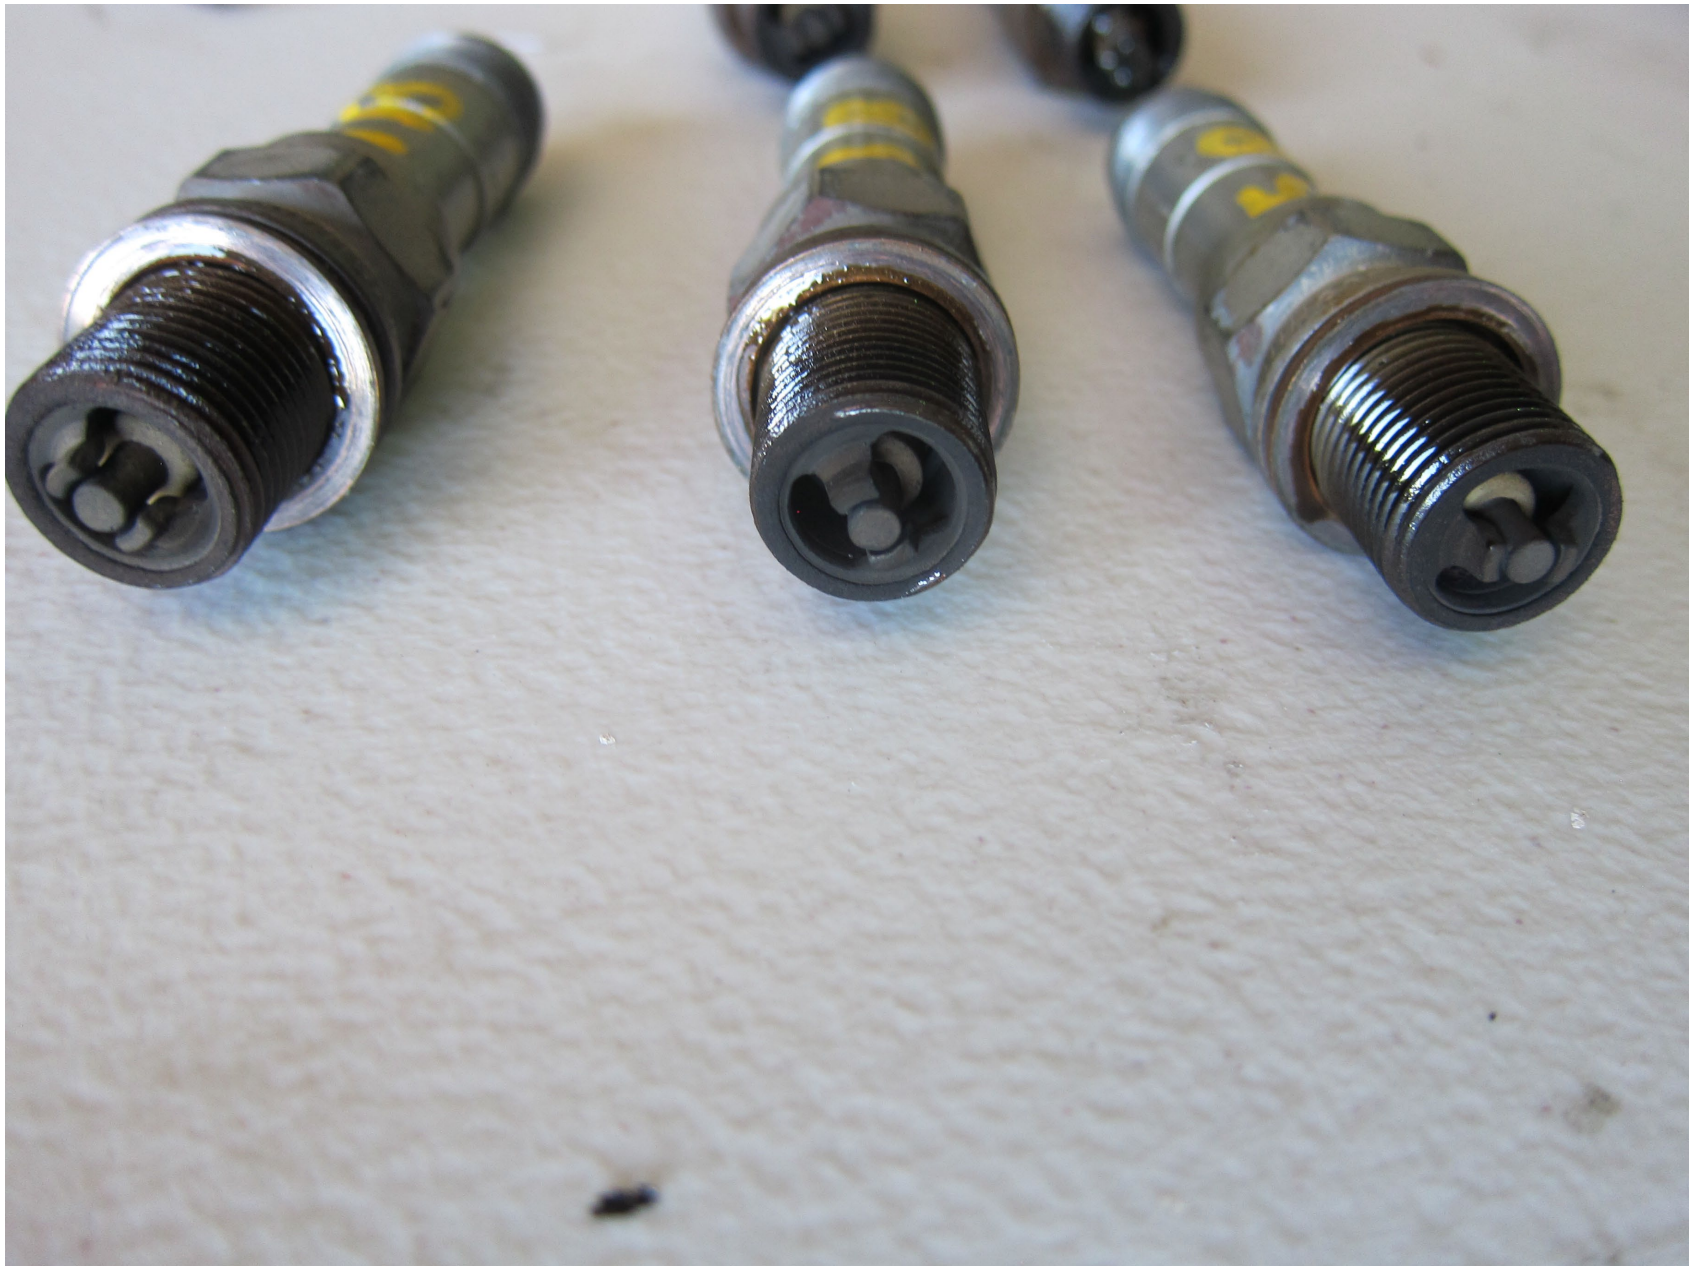
**Photo 14 - Continental Aerospace Technologies Digital Photograph. View of the Cylinder Portions of the Nos. 1, 3, and 5 Bottom Spark Plugs. No. 1 is on the Left. Note the soot color for Nos. 3 and 5.**

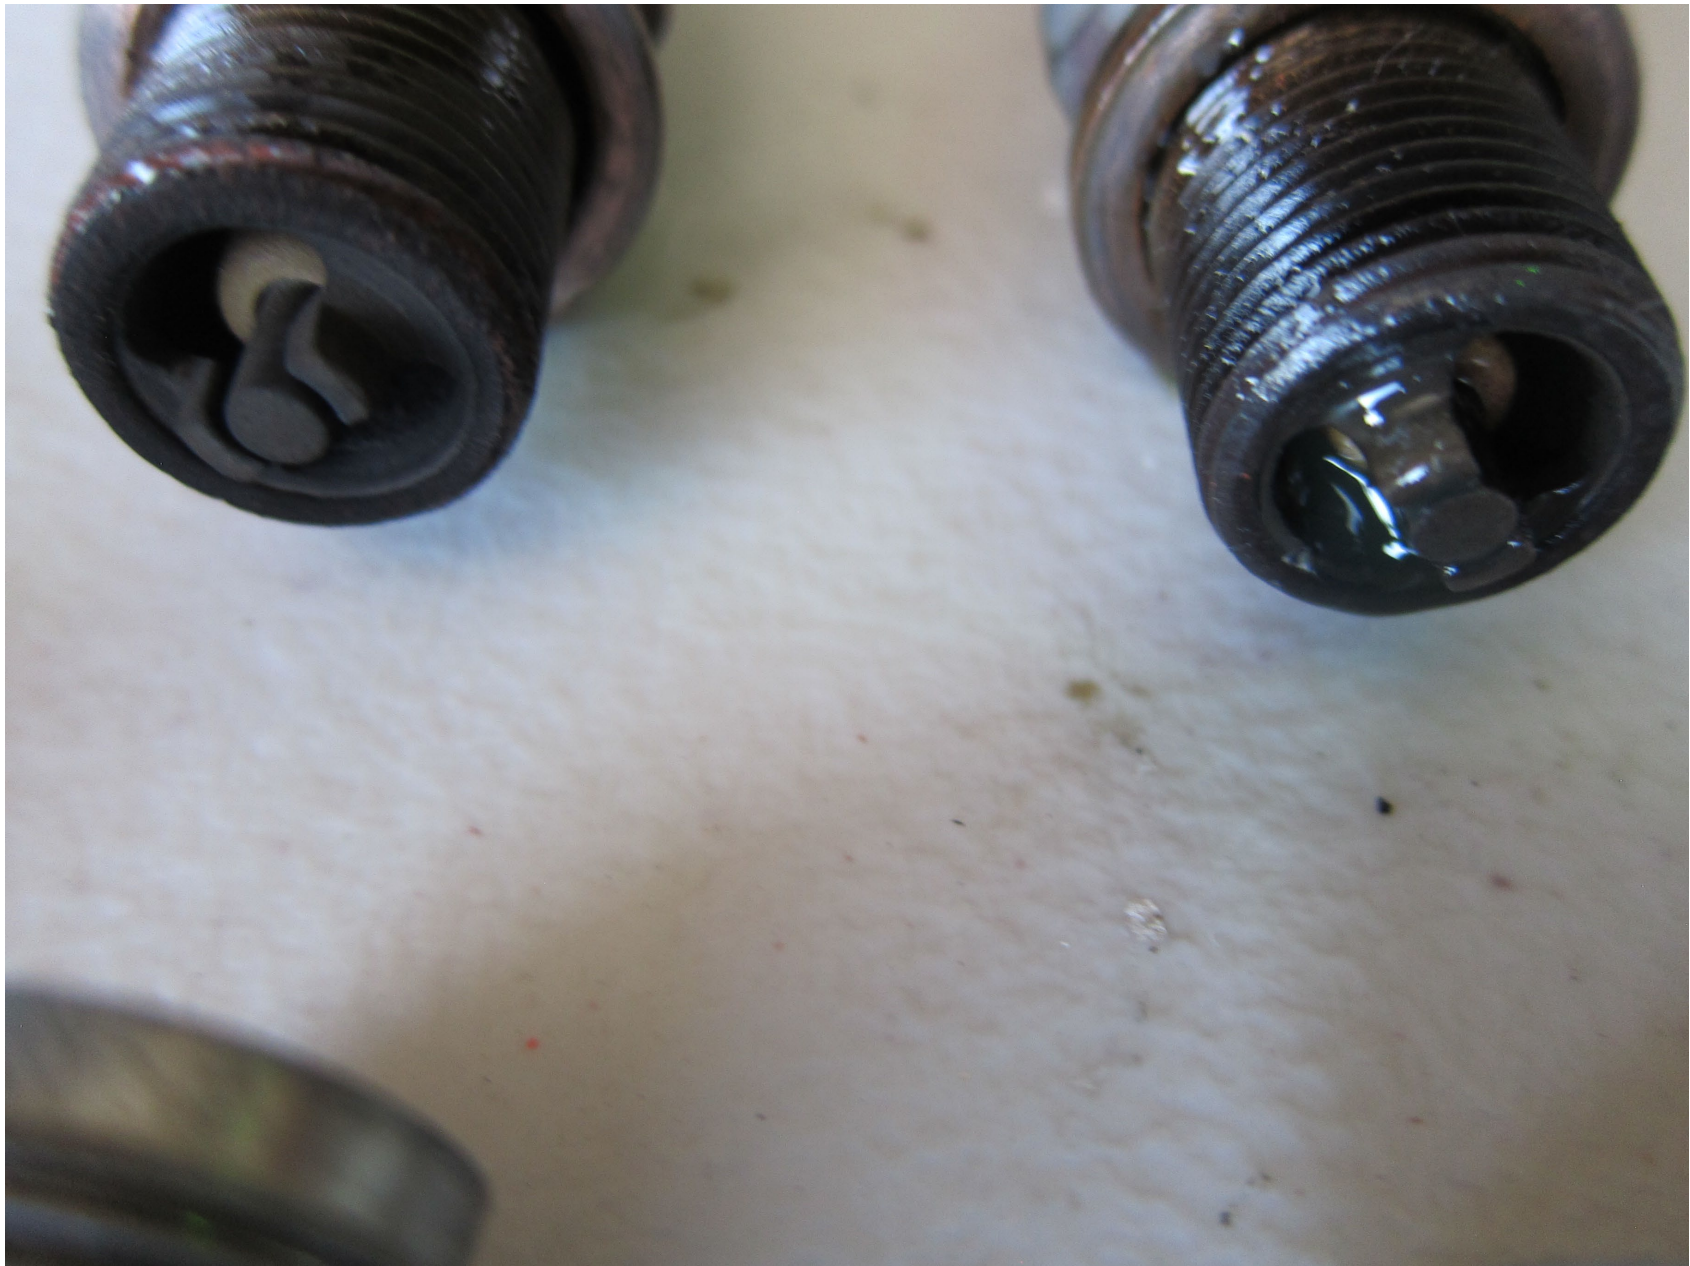
**Photo 15 - Continental Aerospace Technologies Digital Photograph. View of the Cylinder Portions of the Nos. 4 and 6 Bottom Spark Plugs. No. 4 is on the Left. Note the soot color.**

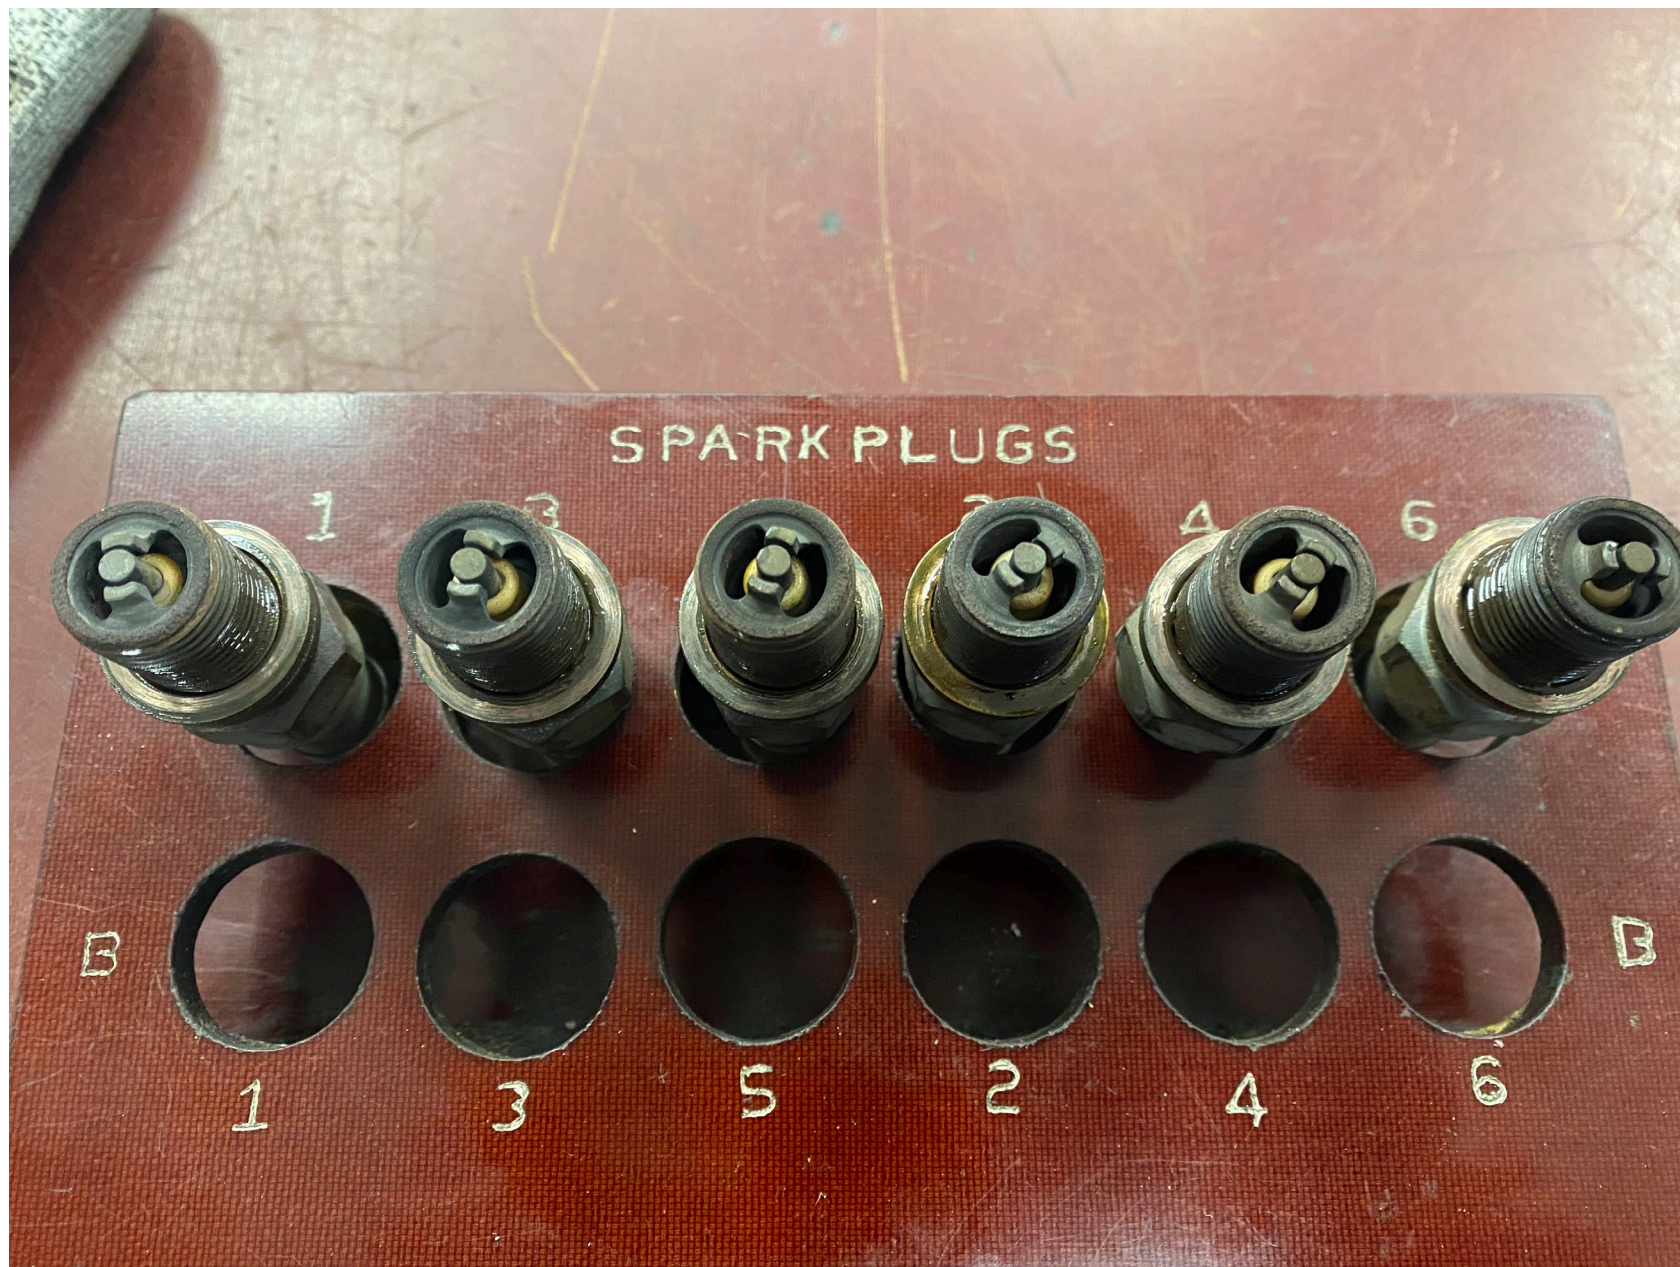
**Photo 16 - Continental Aerospace Technologies Digital Photograph. View of the Cylinder Portions of All Top Spark Plugs Following the Last Full Power Engine Run. Note the Normal Color.**

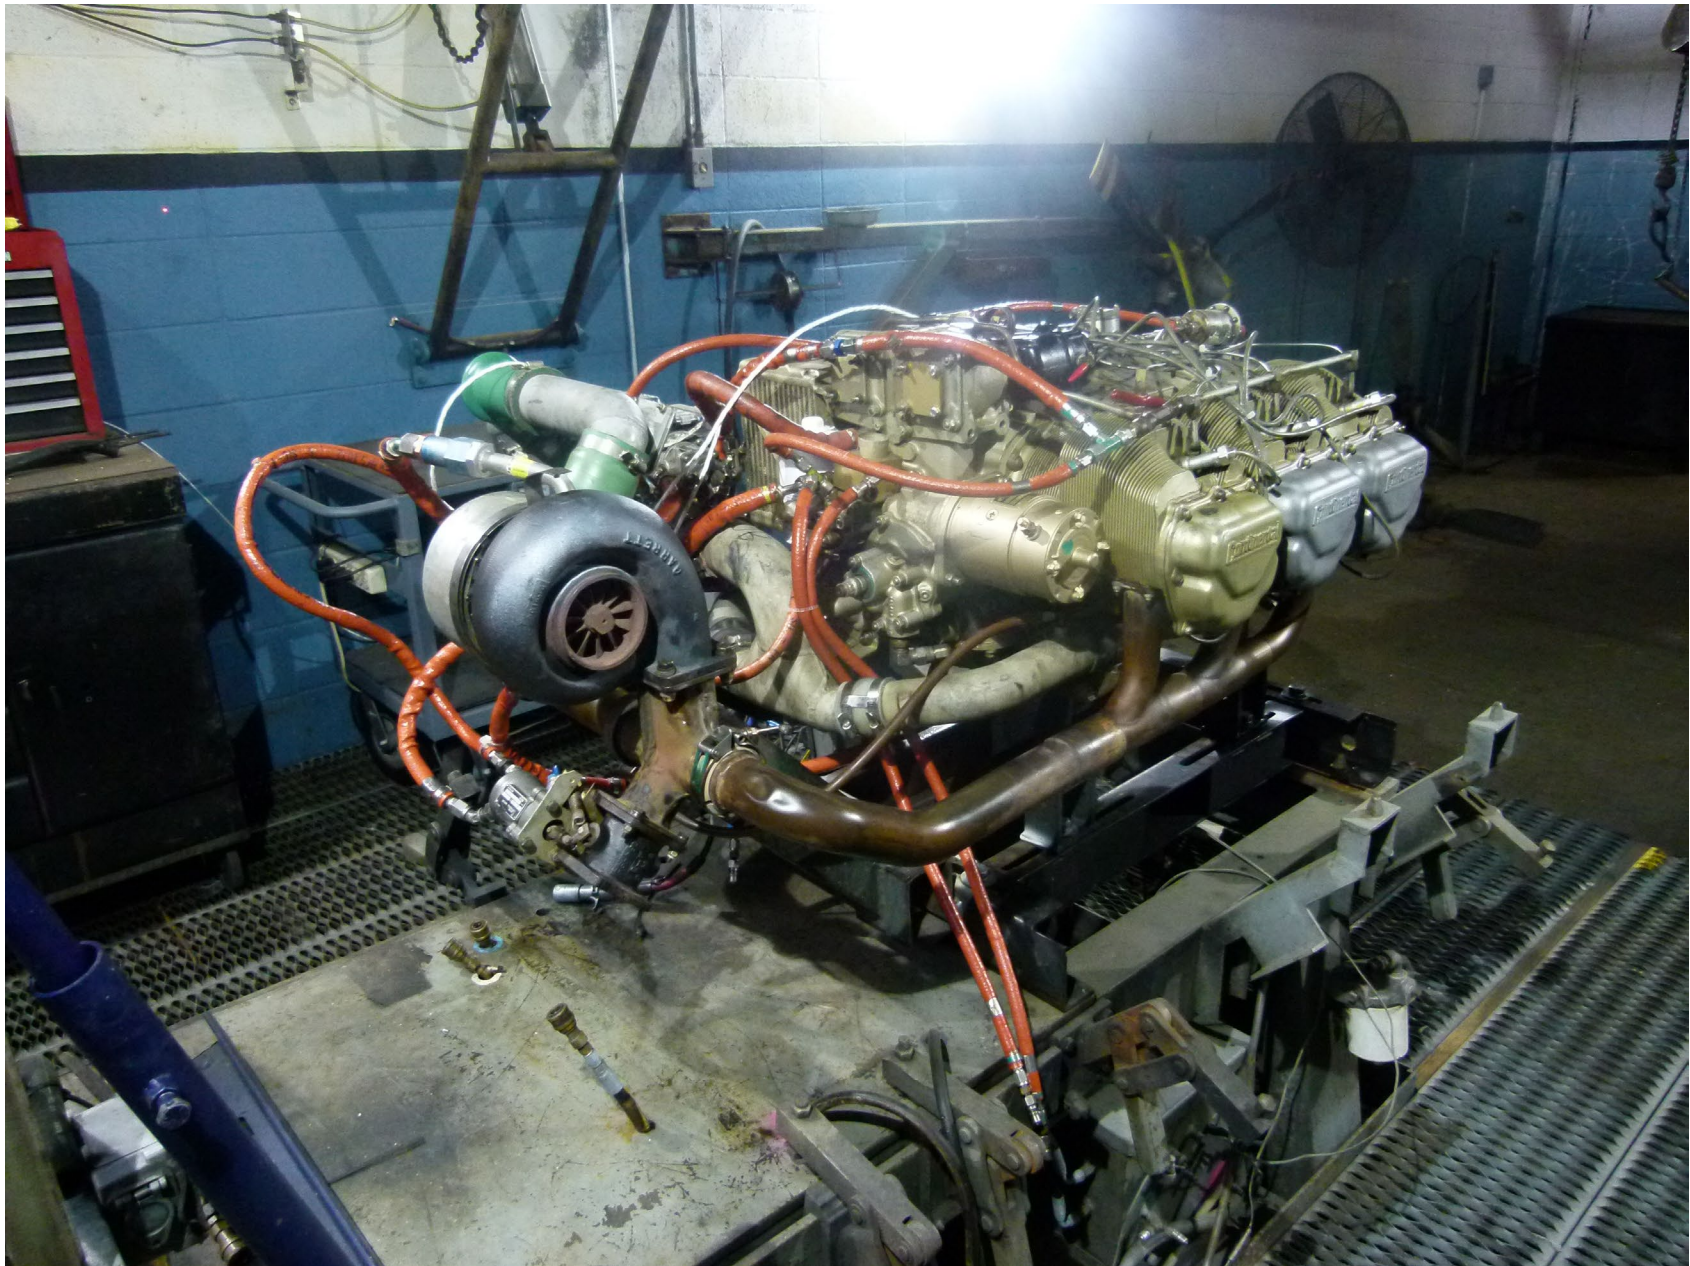
**Photo 17 - Continental Aerospace Technologies Digital Photograph. Right Rear View of the Engine in the Test Cell Before Mounting Test Club Propeller.**
