# National Transportation Safety Board

## **MATERIALS LABORATORY**

Factual Report 22-089

Location: Pembroke Pines, Florida  
Date: March 15, 2021  
Vehicle: Beech B36TC/N236BC  
Investigator: Timothy Monville  
OAS-ERA

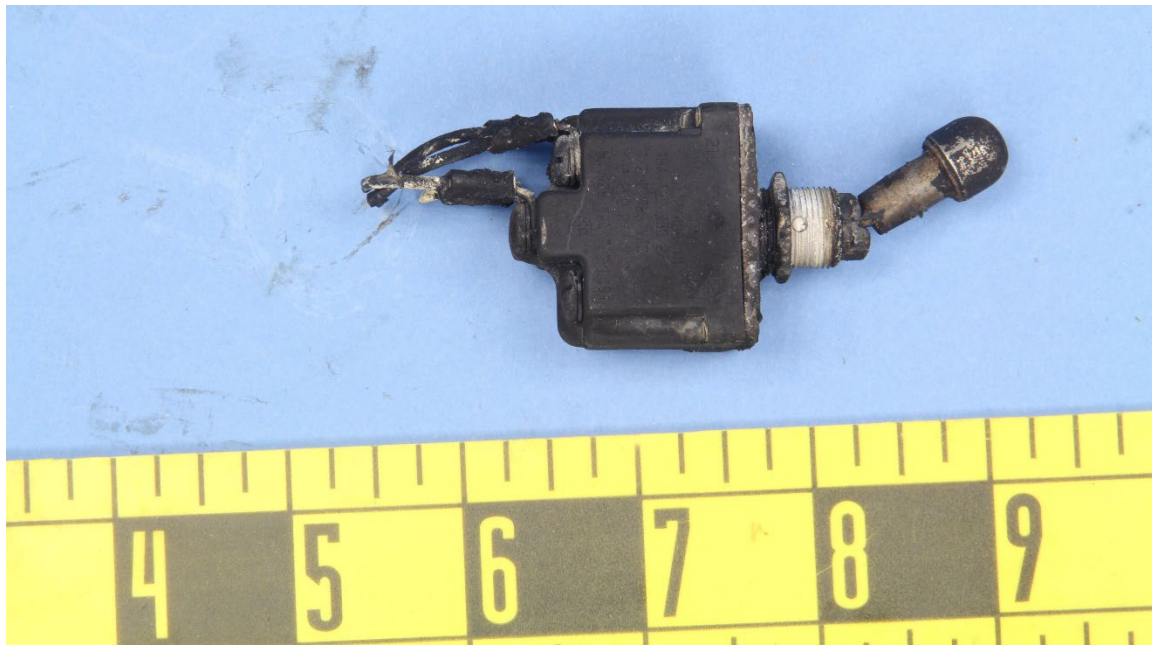
The auxiliary fuel pump switch from the accident aircraft was submitted to the Materials Laboratory for examination. The received component is shown in Figure 1. The switch was received with the toggle between low and off positions and the toggle was immovable. The accident switch was x-rayed to determine contact position and to determine if the switch was internally damaged. The radiograph of the accident switch compared to an exemplar switch in the "down" position is shown in Figure 2. The radiograph showed that the contacts were also in the "down" position, however, the spring that held the contacts in position was shown to be damaged. Therefore, pre-impact position of the switch could not be determined with the radiograph image.

**Figure 1.** Overall photograph of accident switch.

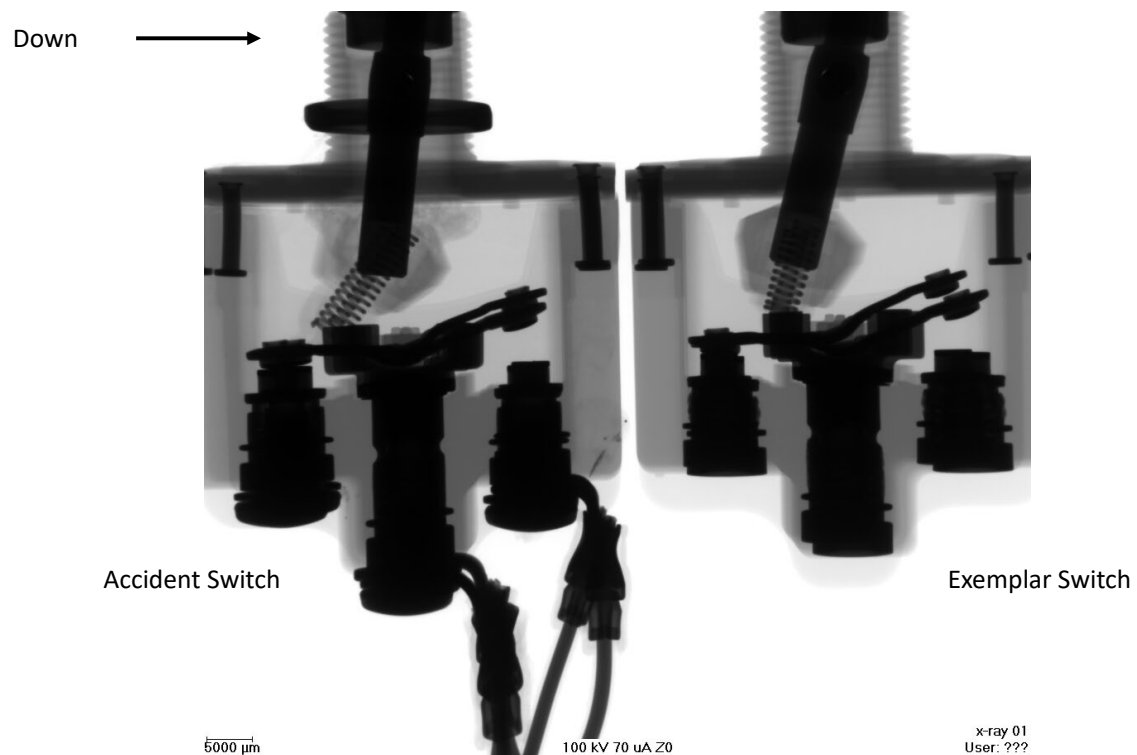
**Figure 2.** Radiograph of accident (on left) and exemplar (on right) switches.

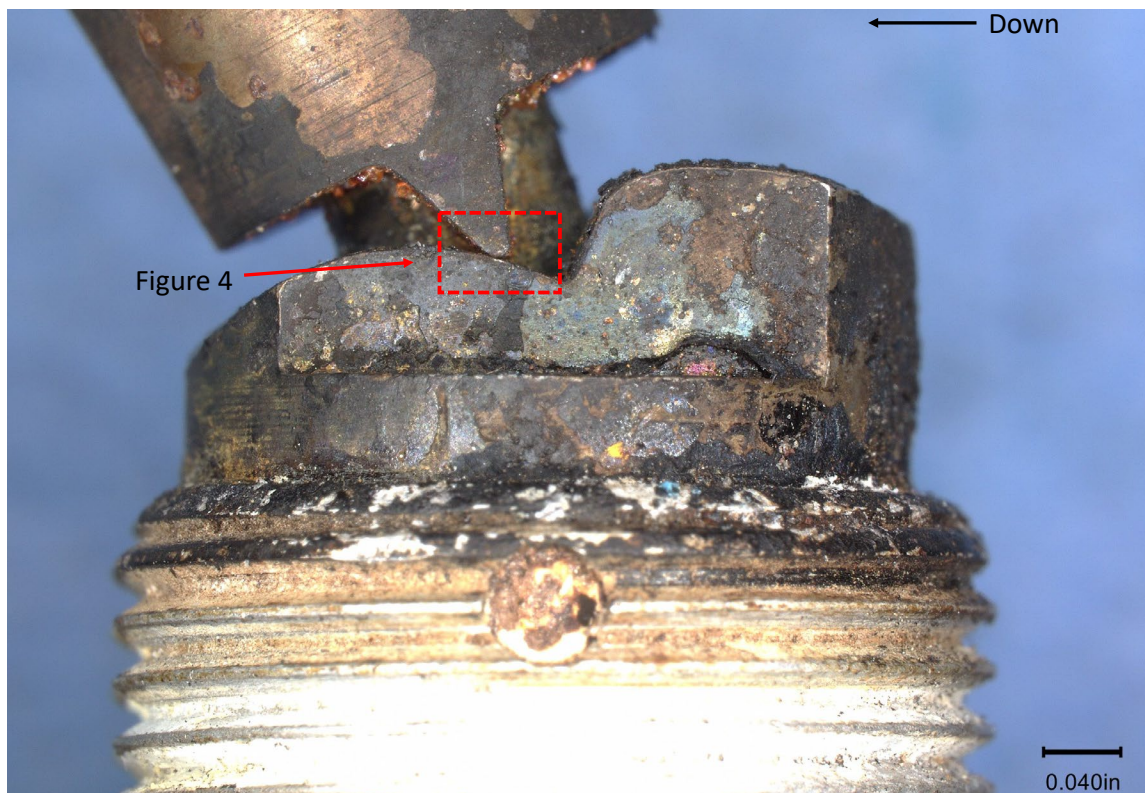
The surface of the accident switch locking collar, shown in Figure 3, was examined to see if any witness marks indicating pre-impact position were present. The only witness mark found is shown in Figure 4. The mark corresponds to the final position of the locking notch and the clean (void) area protected by the notch during exposure to the post-impact fire. No other marks or gouges were found on the surface of the locking collar. The damage and discoloration present were consistent with exposure to fire.

**Figure 3.** Photograph of left side (right side as installed in aircraft) of locking collar on accident switch.

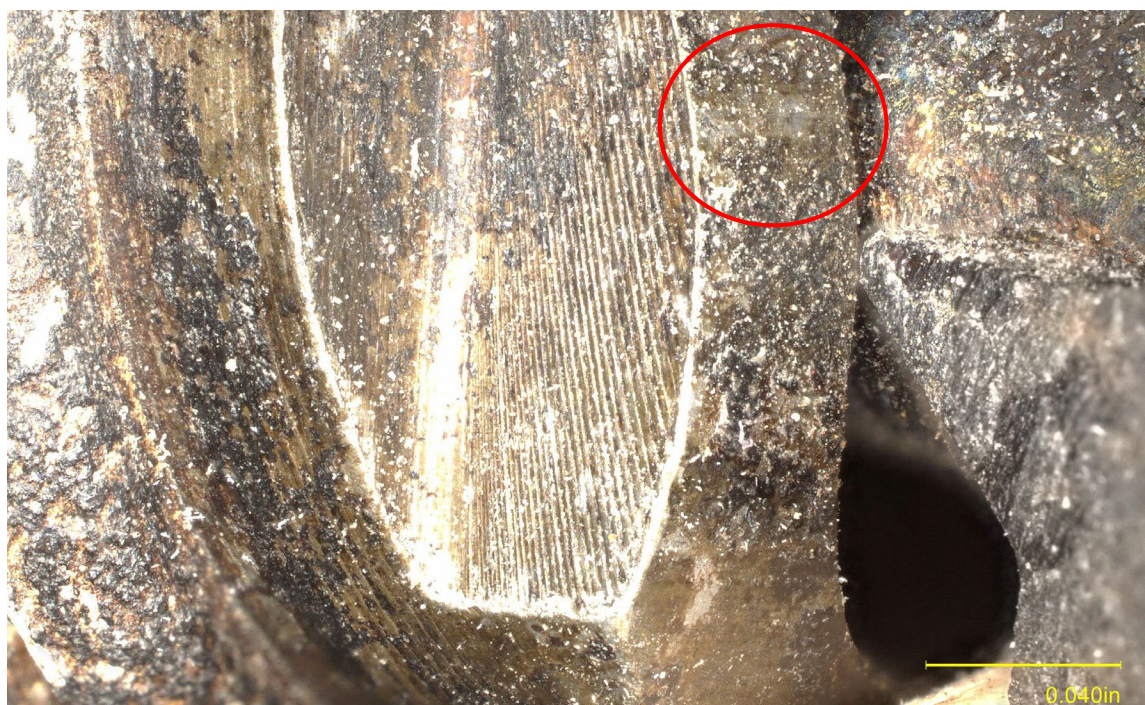
**Figure 4.** Close-up photograph of protected area under switch locking notch on left side (right side as installed in aircraft) of locking collar. Area highlighted with red circle.
