**ERA21FA194**

**April 28, 2021**

**Beech C-23, N6009U**

**WRECKAGE EXAMINATION**

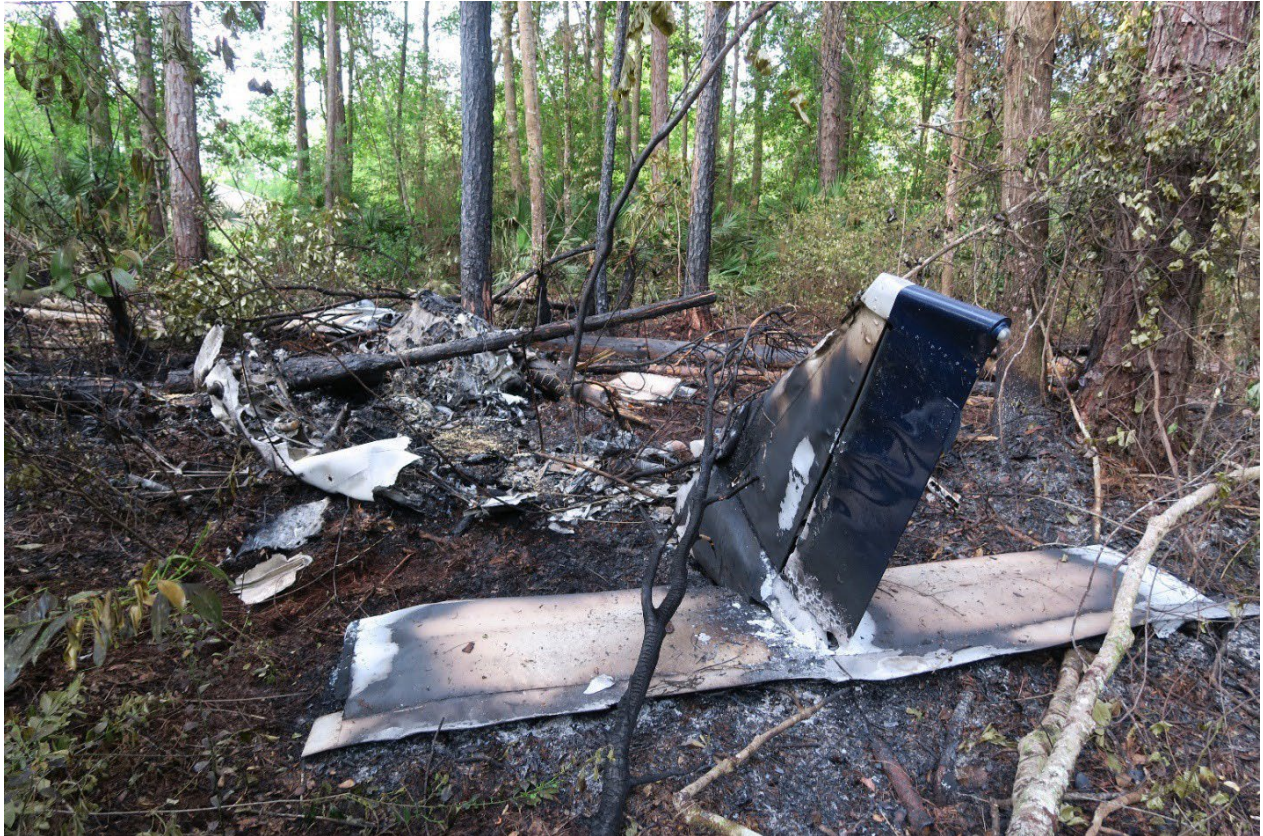
The aircraft struck trees at about 70' AGL on a heading of 270° and created an approximately 300' long wreckage path in the woods. The cabin and instrument panel were destroyed by the post-impact fire. The wings sustained tree impact damage and appeared to be partially separated from the fuselage. Both wings came to rest in front of the engine and sustained significant post-impact fire damage. The right flap was separated from the wing and remained in one piece. A small fragment of the left flap was found forward of the engine. The tail sustained minimal impact damage; thermal damage and soot were observed.

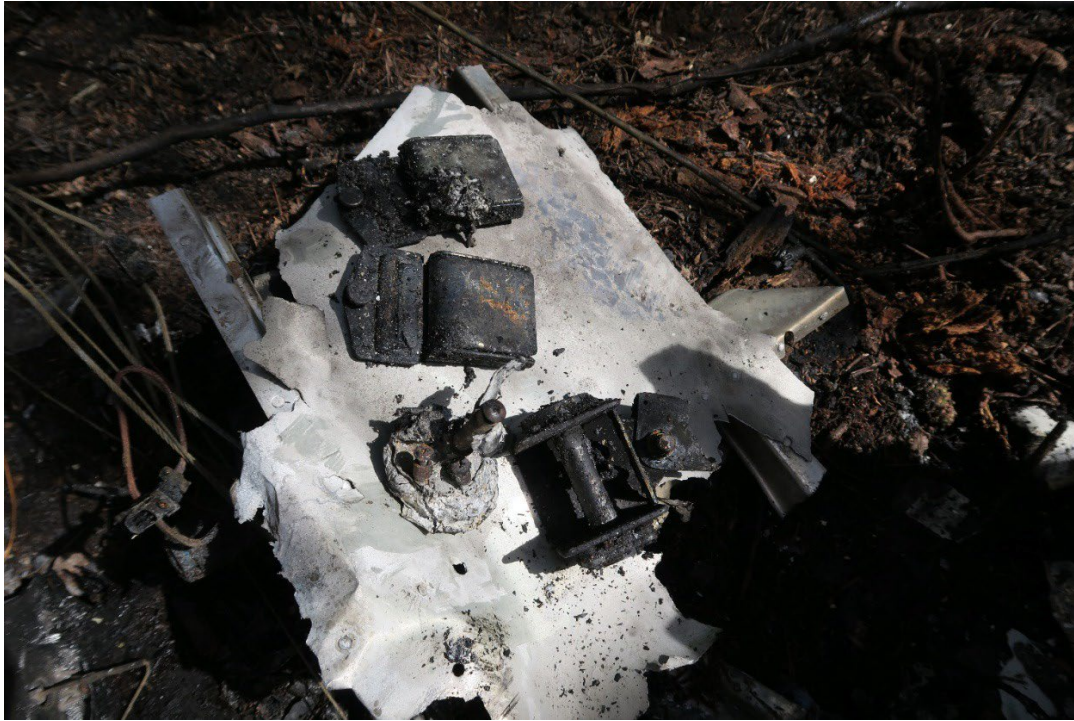
The seats and seat belt webbing were destroyed by the post-impact fire. Two fire-damaged seat belt buckles were found fastened in the front seat area.

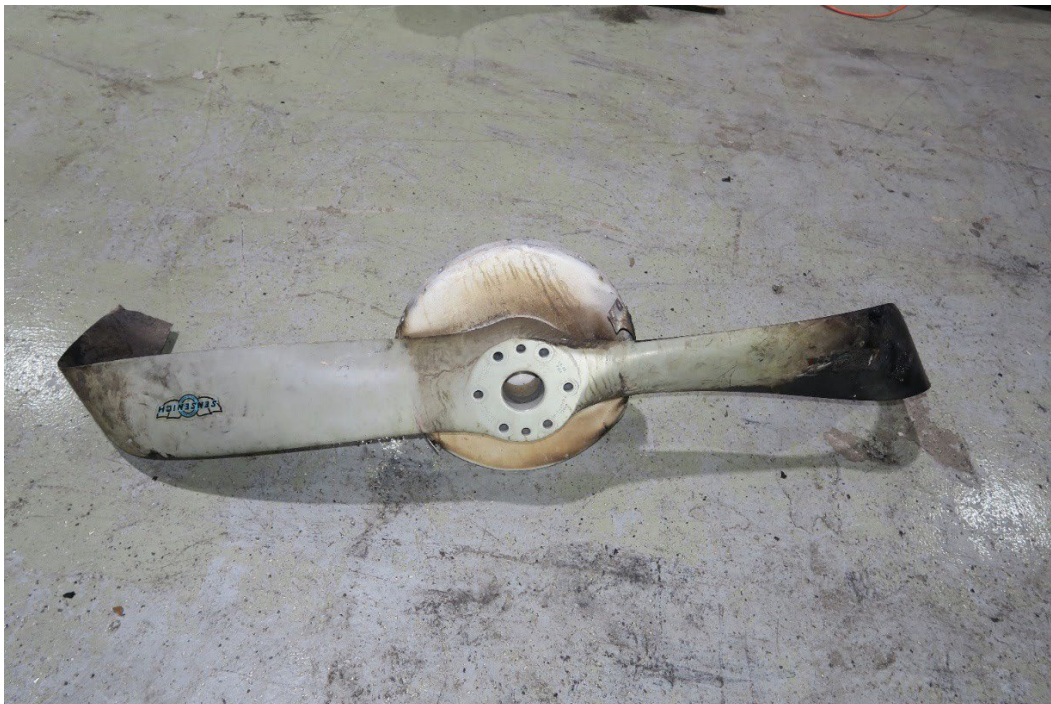
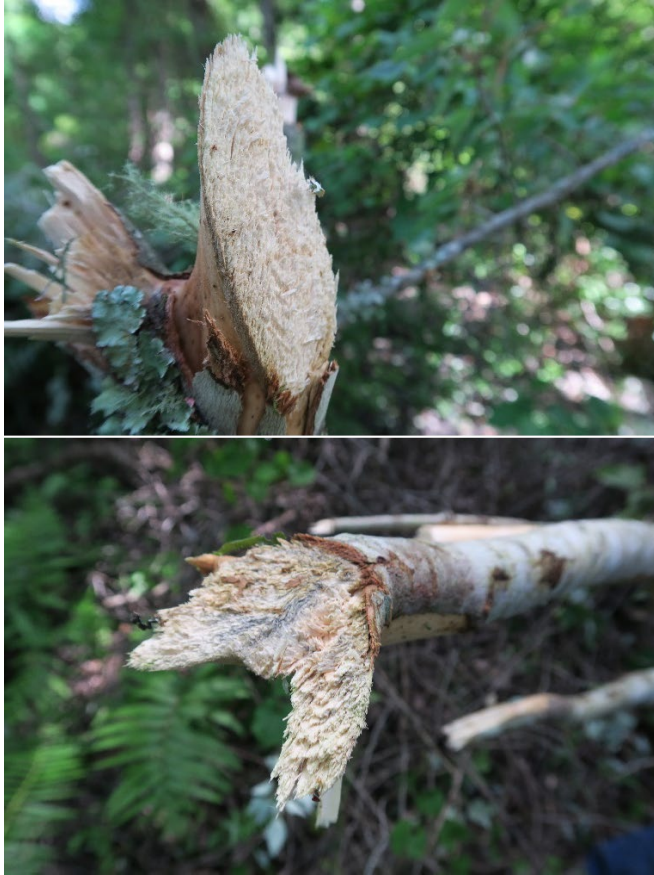
The Sensenich propeller was removed from the engine. Both blades were twisted with S-bending and both tips were separated. Multiple tree limbs were found with propeller cuts.
