**NATIONAL TRANSPORTATION SAFETY BOARD**  
Vehicle Recorder Division  
Washington, D.C. 20594

## **Global Positioning System Devices**

**Specialist's Factual Report**  
**By W. Deven Chen**

Location: Wingate, North Carolina  
Date: May 2, 2021  
Aircraft: Robinson R44 helicopter  
Registration: N4528T  
Operator: Kritter Cropdusting Inc.  
NTSB Number: ERA21FA200

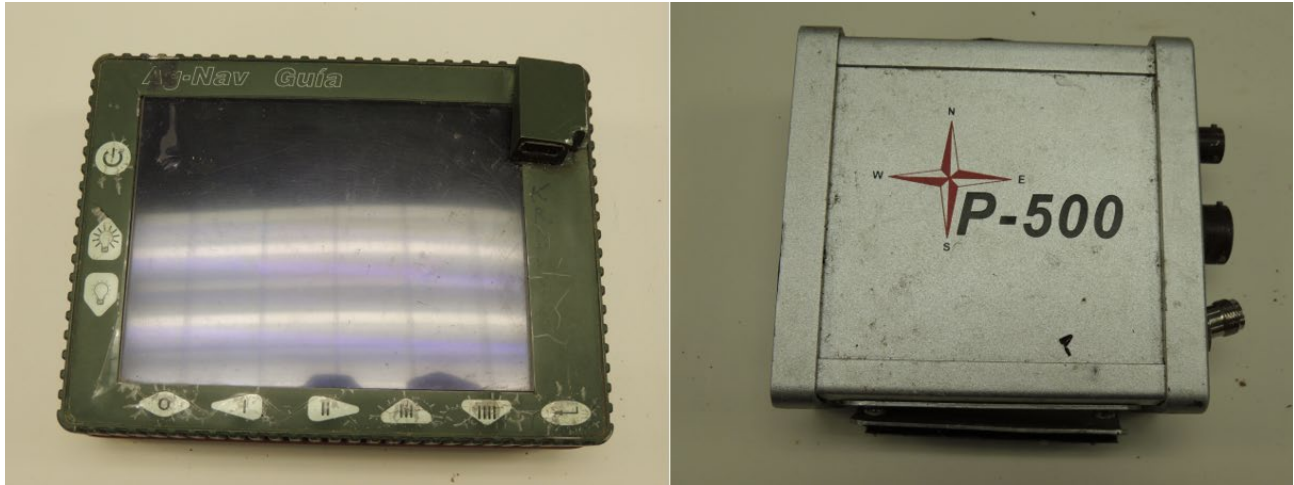
Upon arrival at the Vehicle Recorder Division, an exterior examination revealed the two devices had sustained minor impact damage, as shown in Figure 1. The main display which

**Figure 1: AgNav main display (left) and GPS receiver (right) as received.**

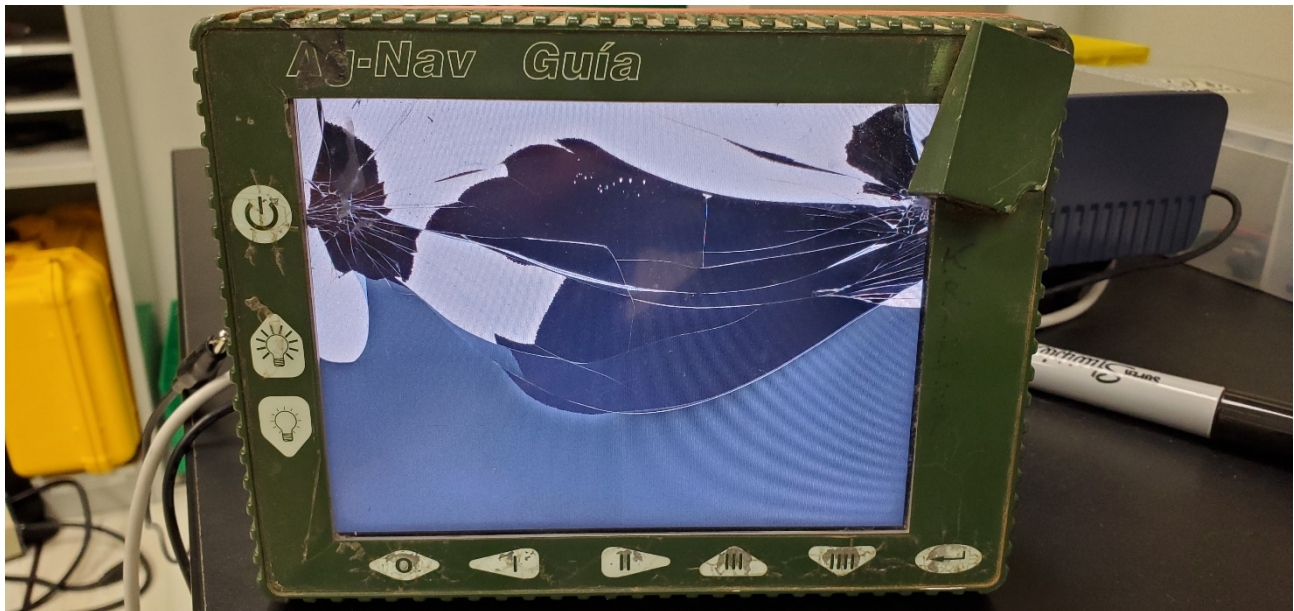
is equipped with non-volatile memory <sup>1</sup>(NVM) powered on, but the screen was not functional due to the impact damage, as shown in Figure 2, thus a normal data download could not proceed. The NVM was removed from the device, and the data were extracted by placing the NVM into a surrogate device provided by the manufacturer. The extracted data included 155 sessions of recording. The session recorded on the accident date, May 2, 2021, was sent to the manufacturer for decoding.

**Figure 2: AgNav main display powered on with damaged screen.**
