**NATIONAL TRANSPORTATION SAFETY BOARD**

**June 8, 2021**

**AIRFRAME AND ENGINE EXAMINATION**

**ERA21FA200**

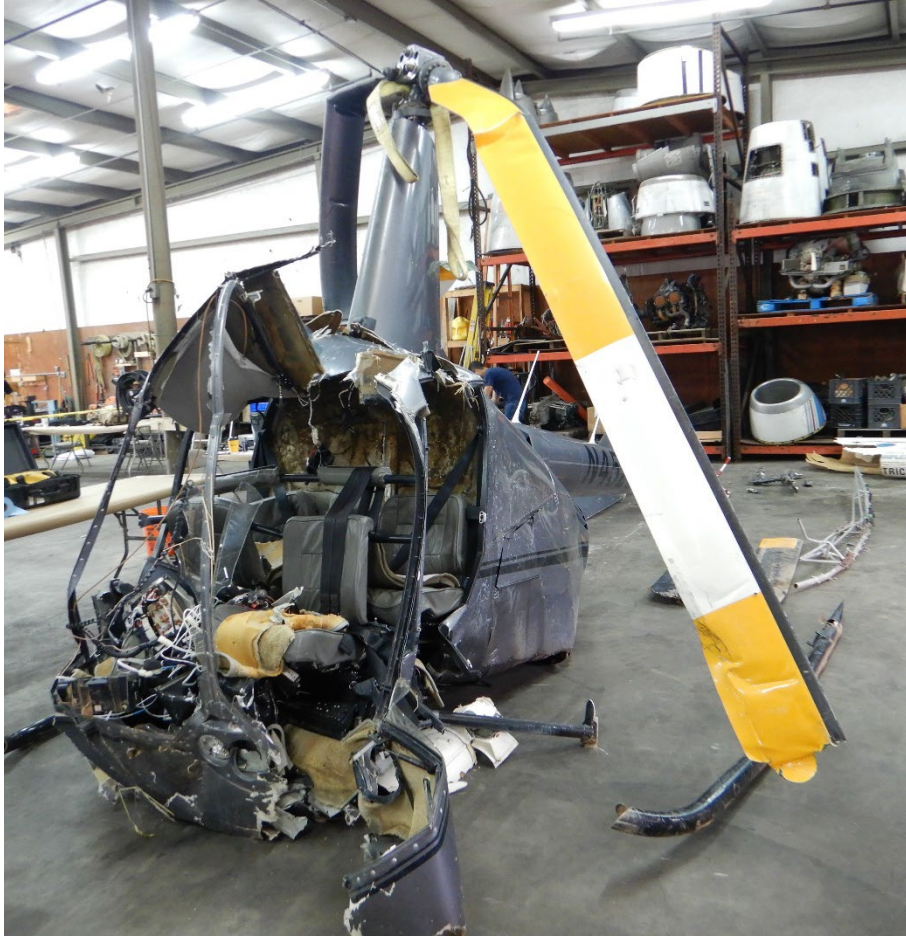
The helicopter came to rest on its left side. The fuselage was crushed and deformed aft. The tail boom remained attached to the main fuselage; however, the empennage, composed of the upper and lower vertical stabilizers, horizontal stabilizer, the tail rotor and its gearbox, were separated from the tail boom. The windscreen and door windows were separated from the fuselage and fragmented. Both main rotor blades remained attached to the hub. One blade was bent downwards about 2 ft outboard of the blade grip, and the other was bent downward and in a U-shape. The agricultural hopper remained partially attached to the fuselage. It was breached and its lower side was crush-damaged. The engine compartment and engine remained intact.

*Figure 1: Wreckage viewed from front left*

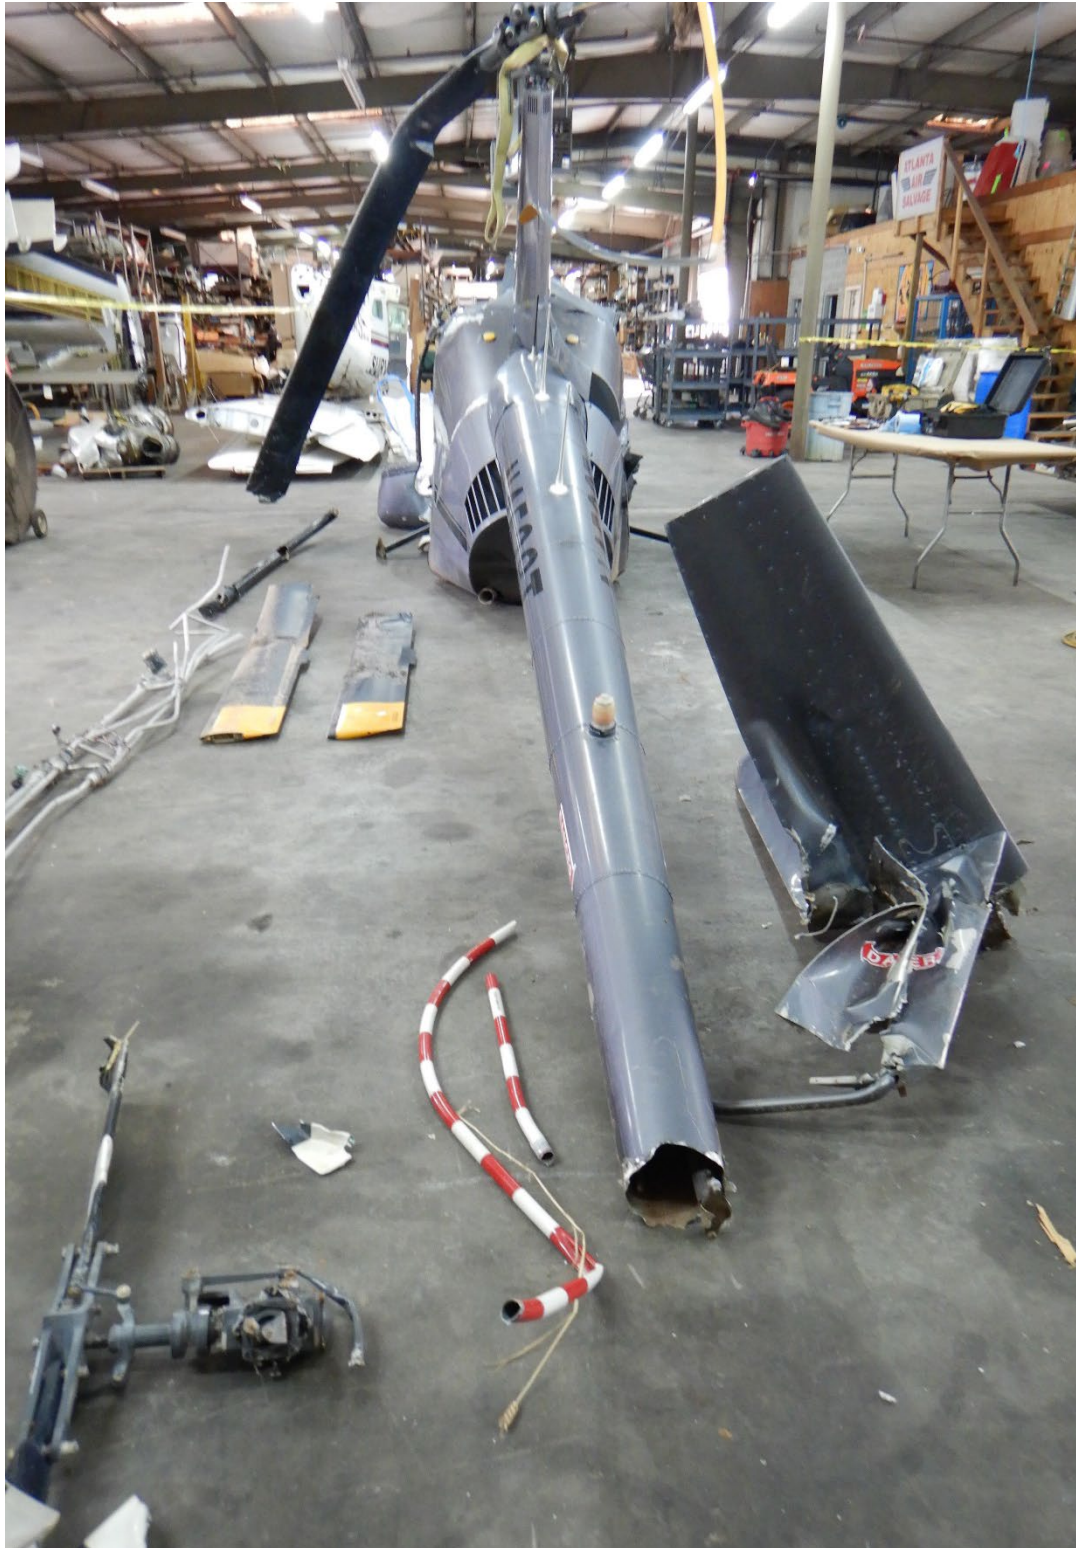
*Figure 2: Wreckage viewed from tail*

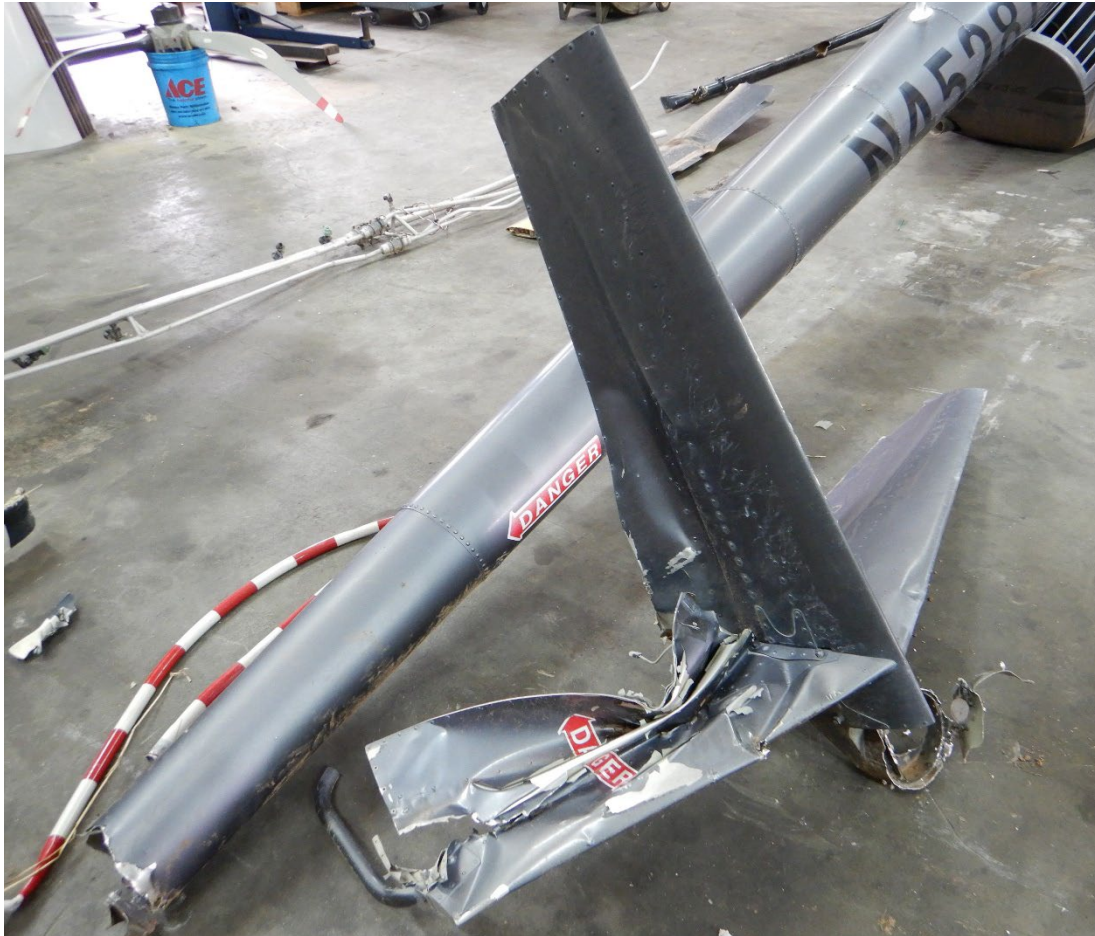
The empennage was located 99 ft and 336° from the main wreckage. The lower vertical stabilizer sustained trailing edge impact and semi-circular crush damage just below the horizontal stabilizer. The tail rotor gearbox was intact but separated from its airframe mount and was located about 112 ft and 208° from the main wreckage. The tail rotor hub remained attached to the tail rotor gearbox output shaft and portions of the two tail rotor blades remained attached to the hub. One tail rotor blade was missing about 5 inches of its tip end and the other tail rotor blade was missing about 2 ft of its outboard span. One of these sections was not recovered. The leading edges of both tail rotor blades exhibited impact damage. A fractured segment of one of the tail rotor blades, measuring about 18 inches in length, was located 170 ft and 44° from the main wreckage. The tip portion of one of the fractured tail rotor blades, measuring about 5 inches, was located 119 ft and 3° from the main wreckage. The tip portion exhibited impact scars consistent with a wire strike as well as impact with the tail rotor guard.

*Figure 3: Empennage*

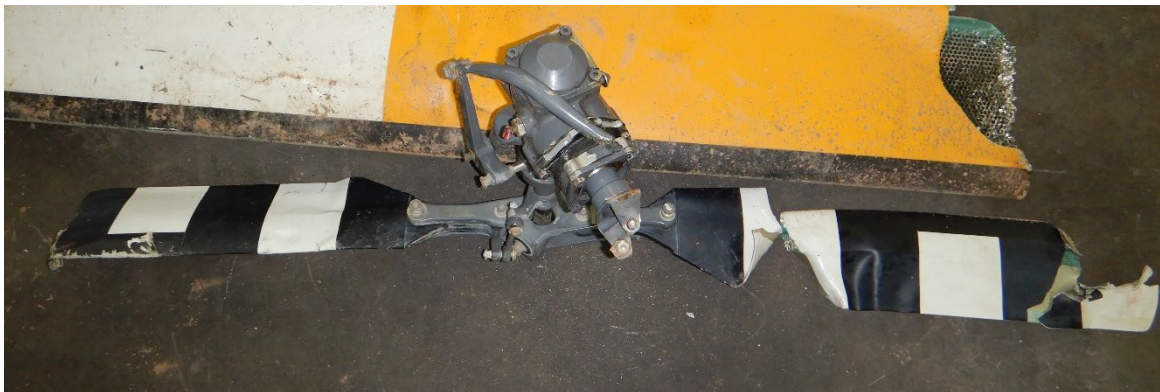
Tail rotor blade S/N 6275 was fractured in two locations, one at the root end about 5 inches from the outboard blade attachment bolt, and another fracture at the tip end. The mid-span segment of blade was about 14.5 inches in length. At the tip end fracture, the leading edge was crushed in the direction opposite of normal rotation. At the [separated] tip end section, the inboard surface of the blade skin had a red-colored transfer marking.

Tail rotor blade S/N 6274 was fractured in one location near the tip end about 13.5 inches from the outboard blade attachment bolt.

*Figure 4: Tail rotor blades*

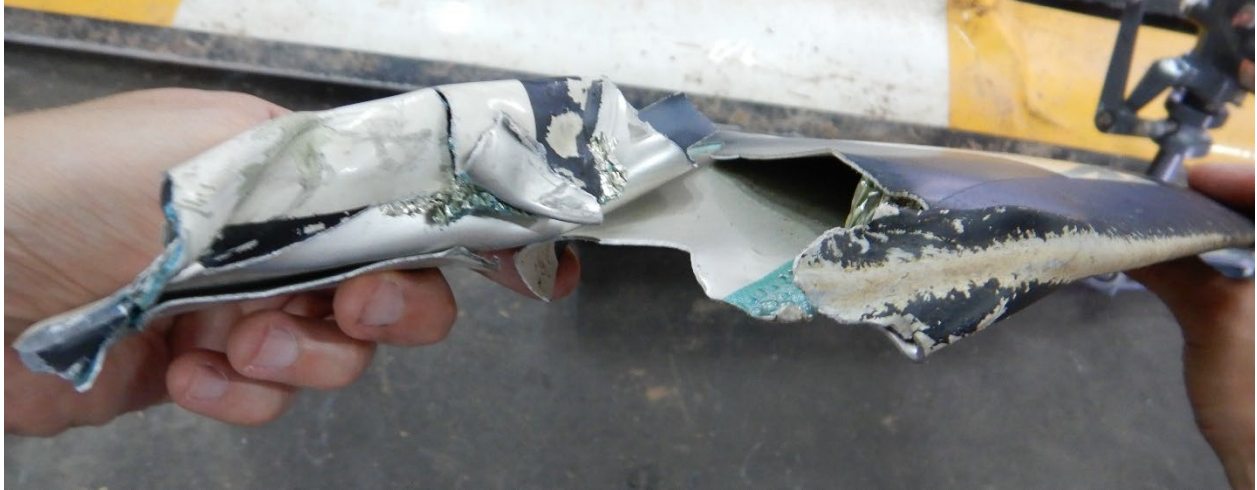
*Figure 5: Fractured tail rotor blade*

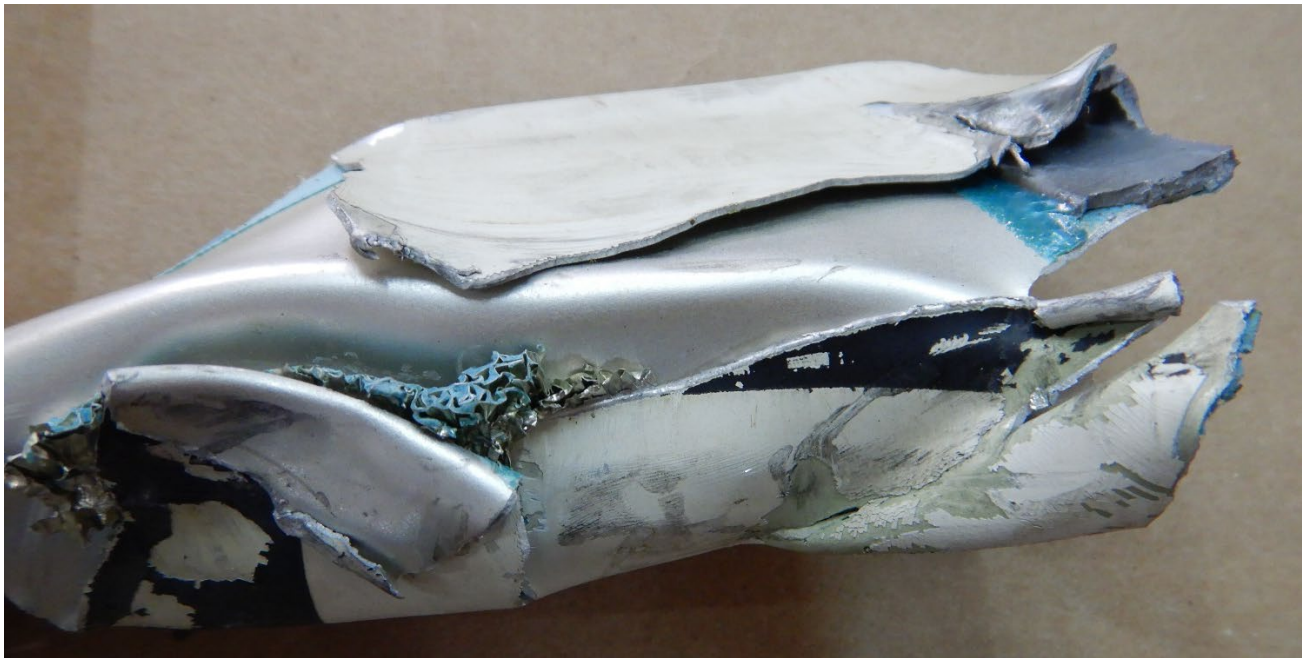
*Figure 6: Close up view of wire strike impact signatures*

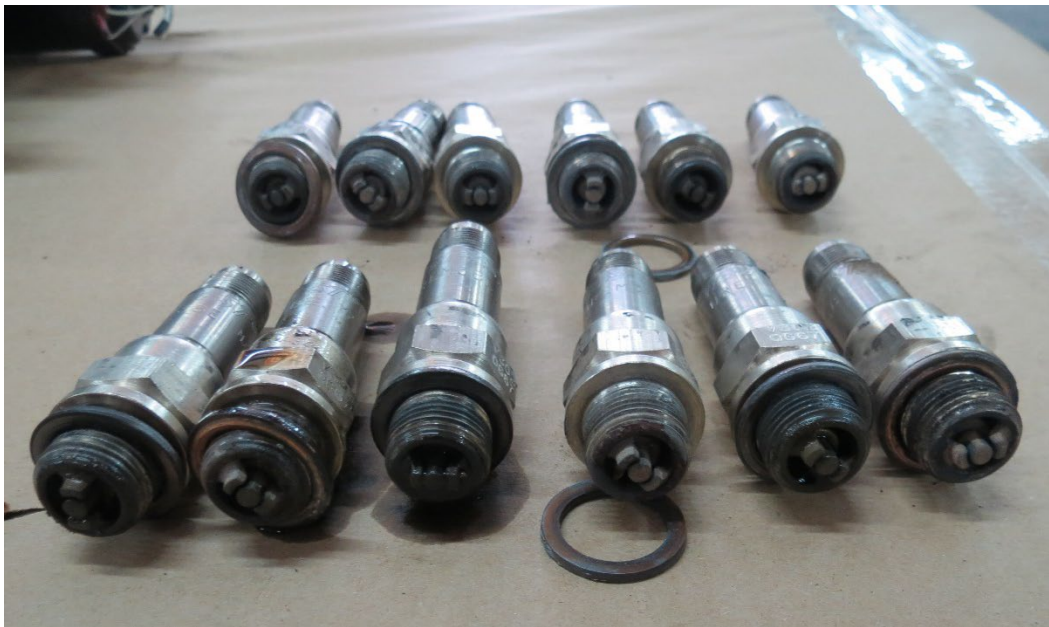
The spark plugs exhibited gray coloration and worn normal condition. The #1, #3 and #5 bottom spark plugs were oil soaked.

*Figure 12: Sparkplugs*

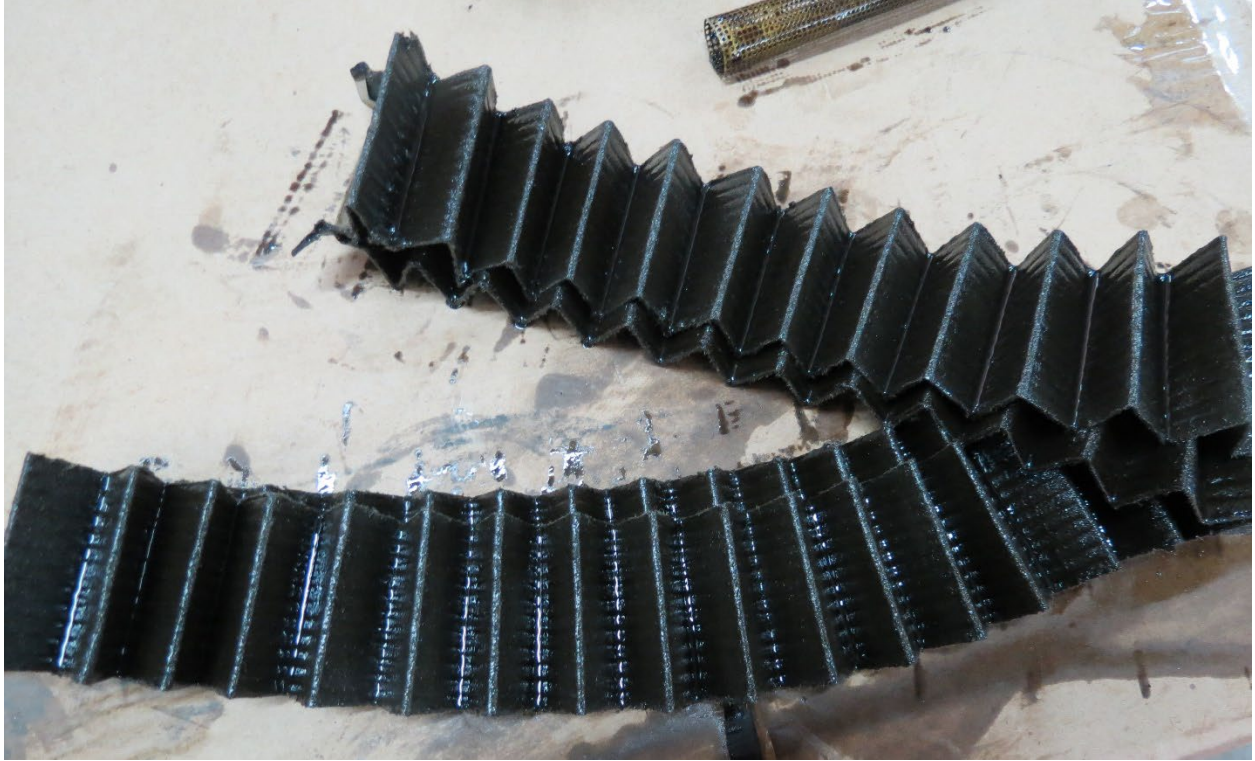
Oil was observed in the engine. The oil suction screen and oil filter were unobstructed.

*Figure 13: Oil filter*

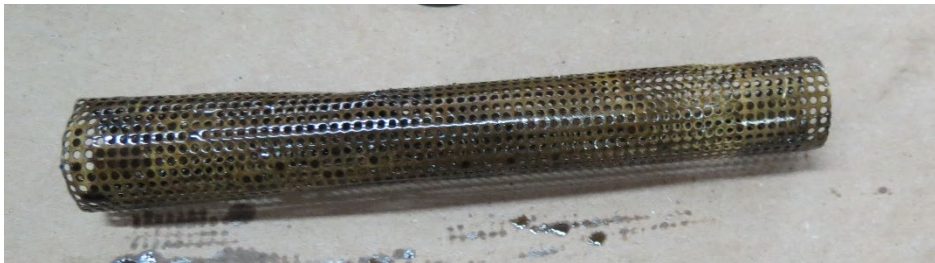
*Figure 14: Oil suction screen*

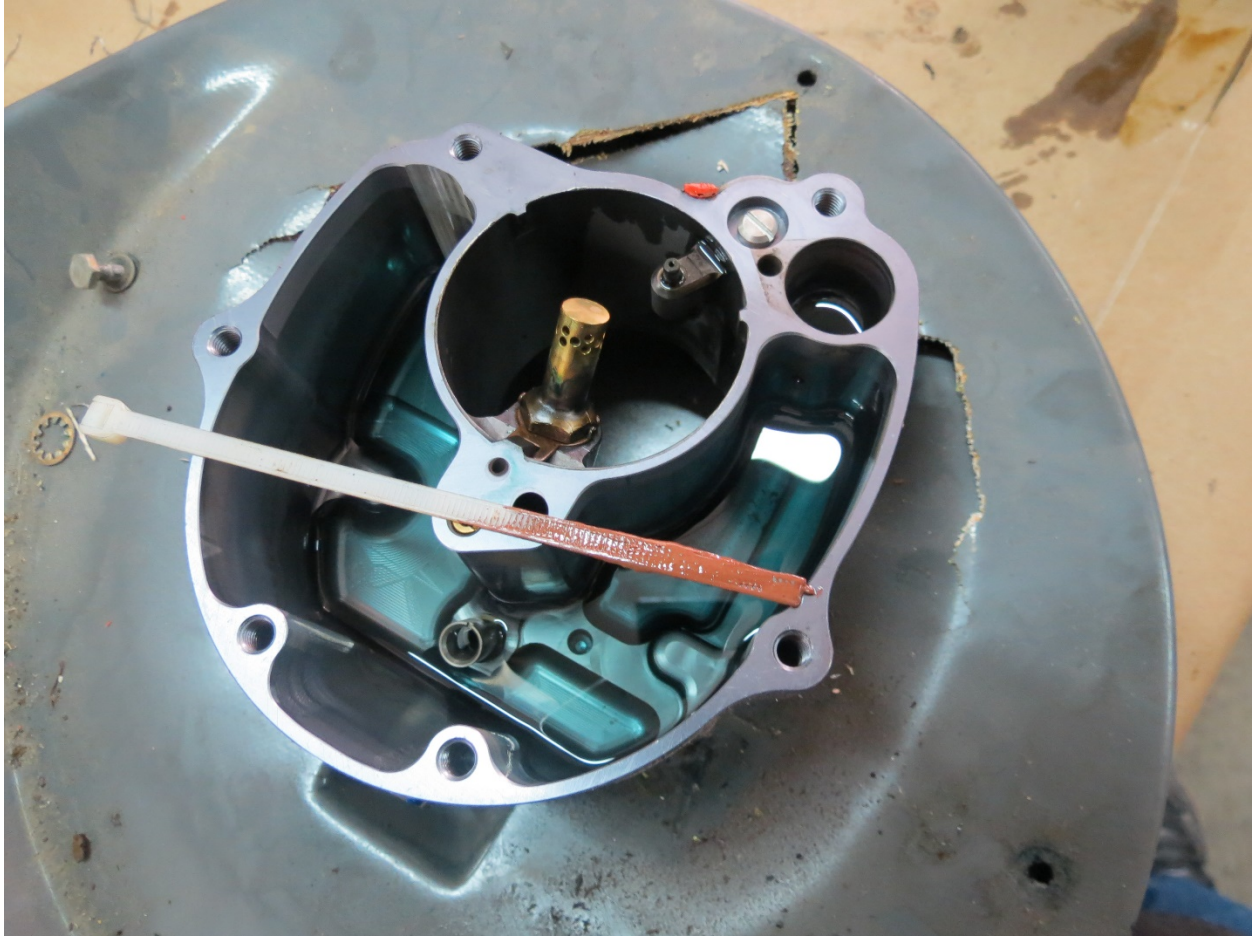
Fuel drained from the carburetor fuel inlet hose when it was removed. The carburetor was removed and partially disassembled. The carburetor float bowl was about half full of a blue liquid with an odor consistent with aviation gasoline. No damage to the brass floats or other internal components was noted. The carburetor fuel inlet screen was unobstructed.

*Figure 15: Carburetor bowl with fuel and test stick showing no water contamination*
