**NATIONAL TRANSPORTATION SAFETY BOARD**

Office of Aviation Safety  
Eastern Region

**Photo Array**

**ERA21FA200**

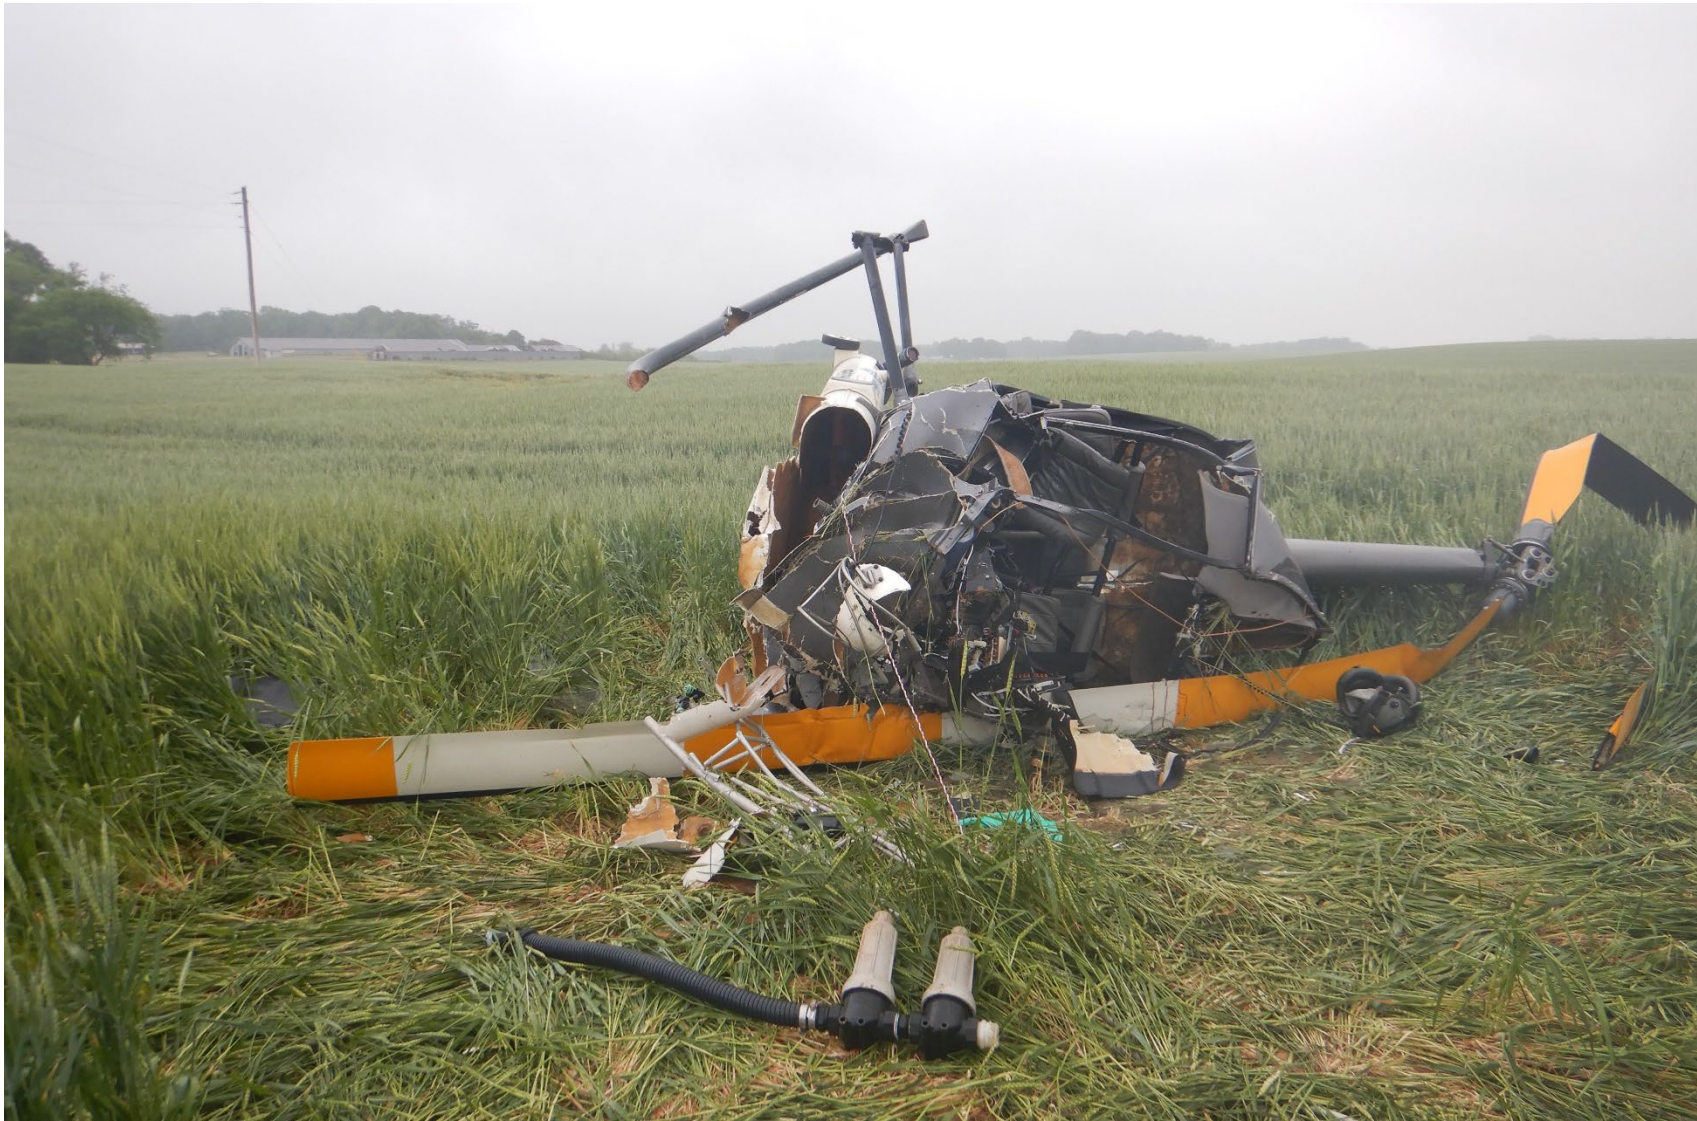
**Photo 1 – View of helicopter from front**

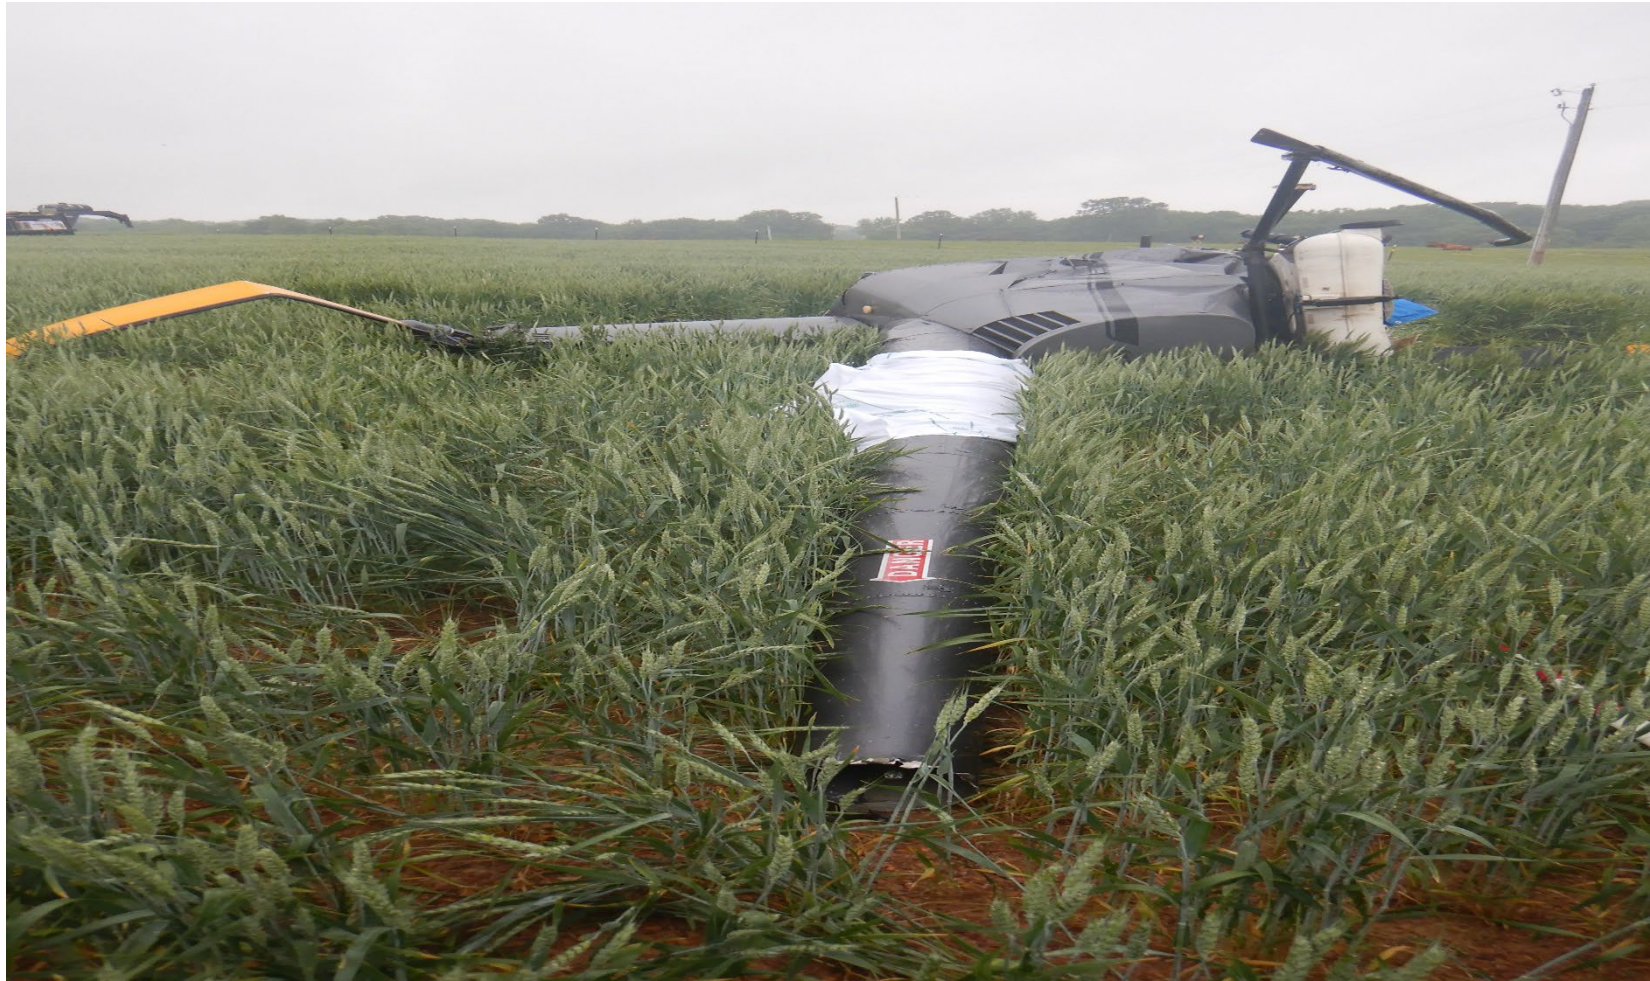
**Photo 2 – View of helicopter from fractured tail cone**

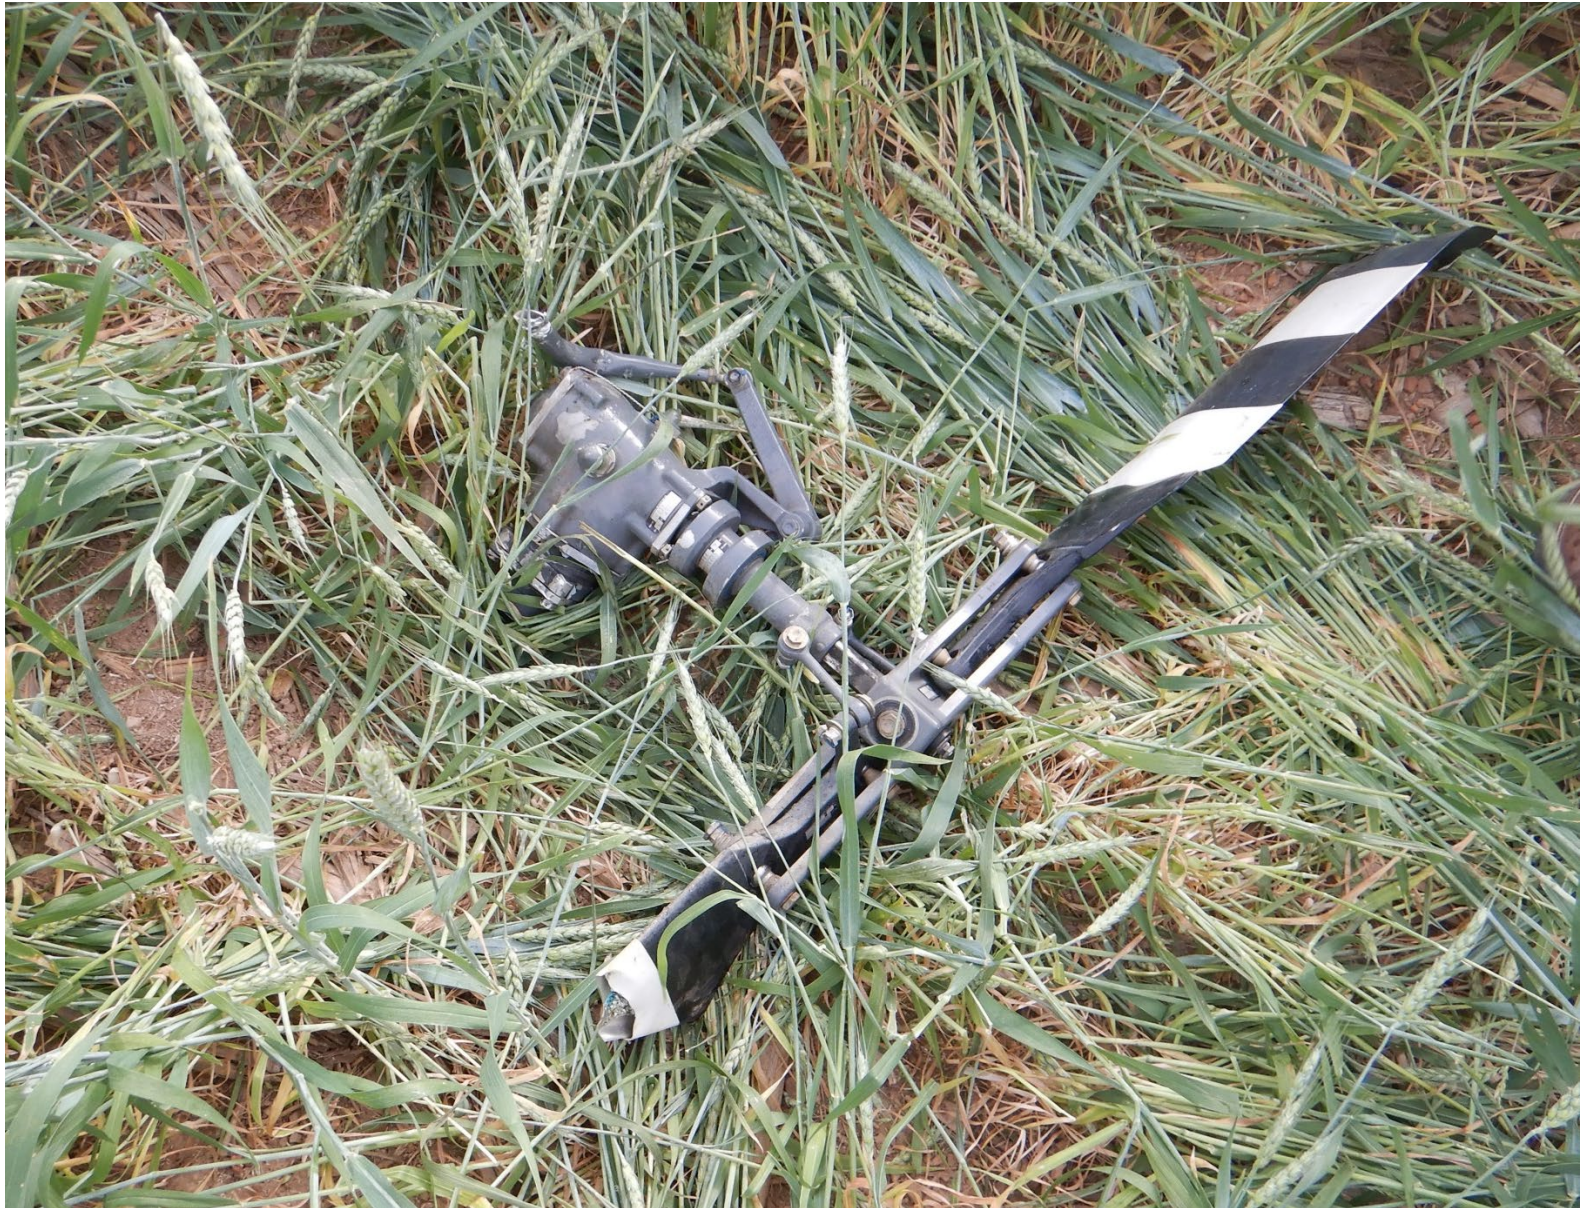
**Photo 3 – View of tail rotor with gear box**

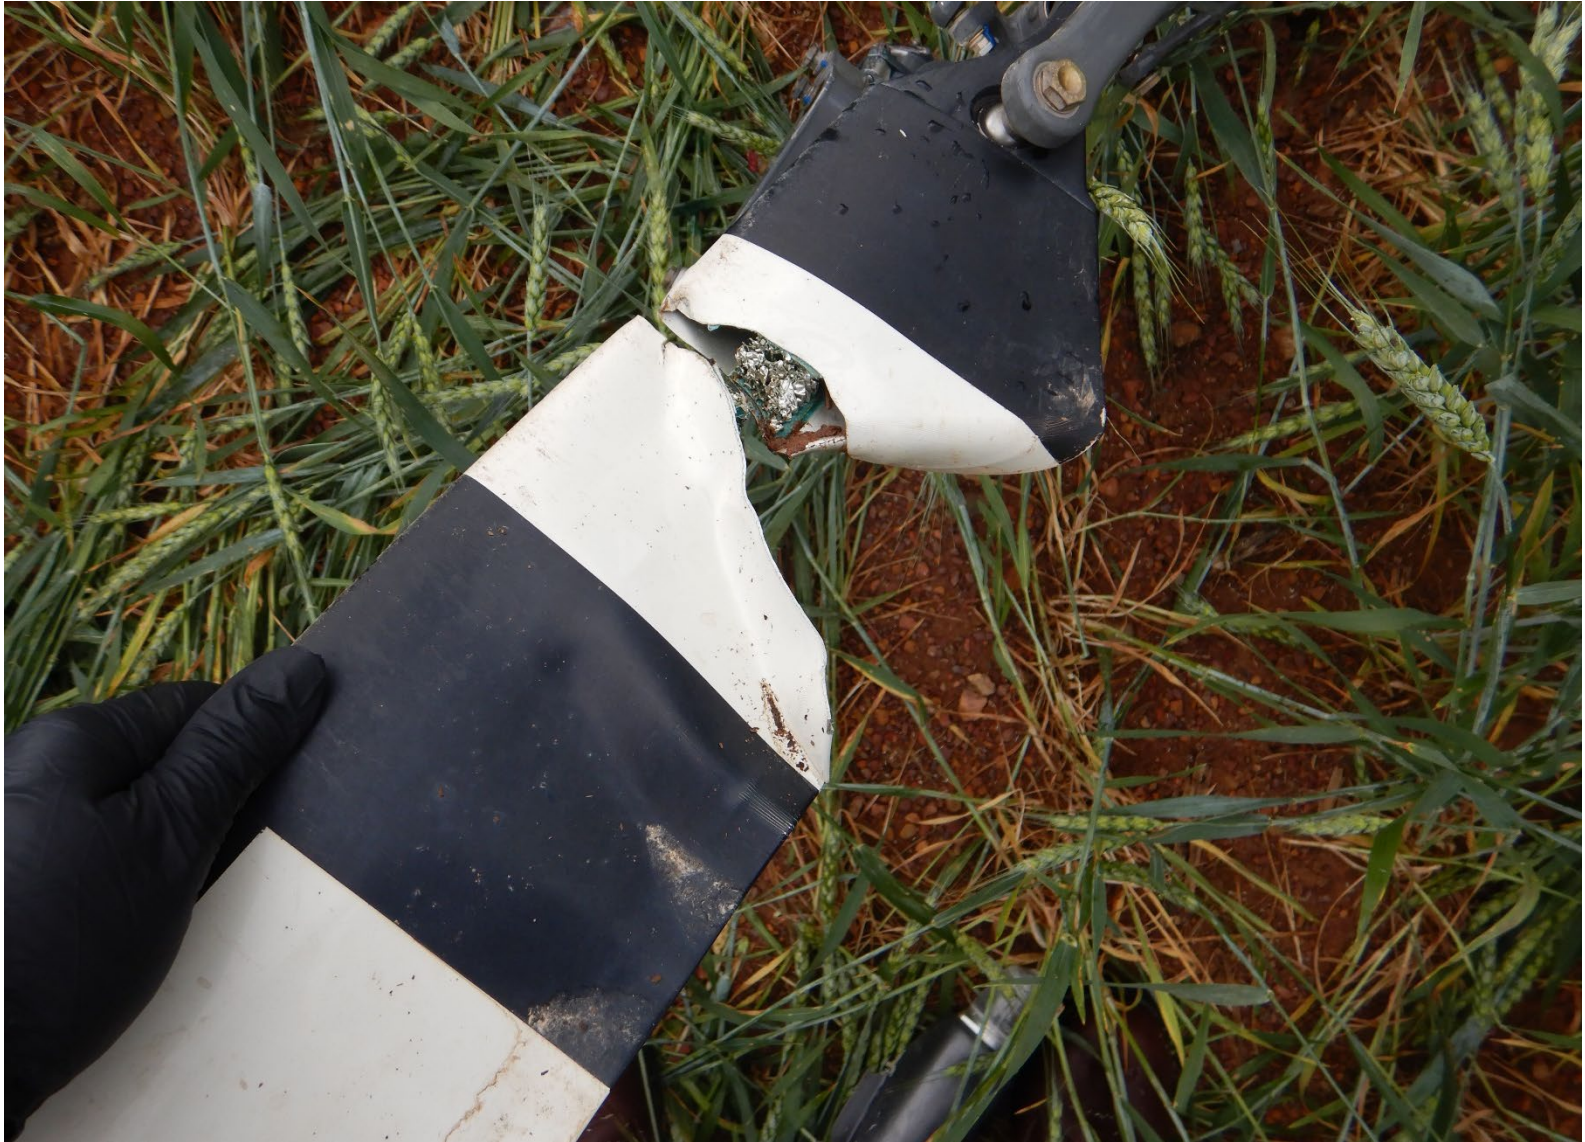
**Photo 4 – View of fractured tail rotor blade**

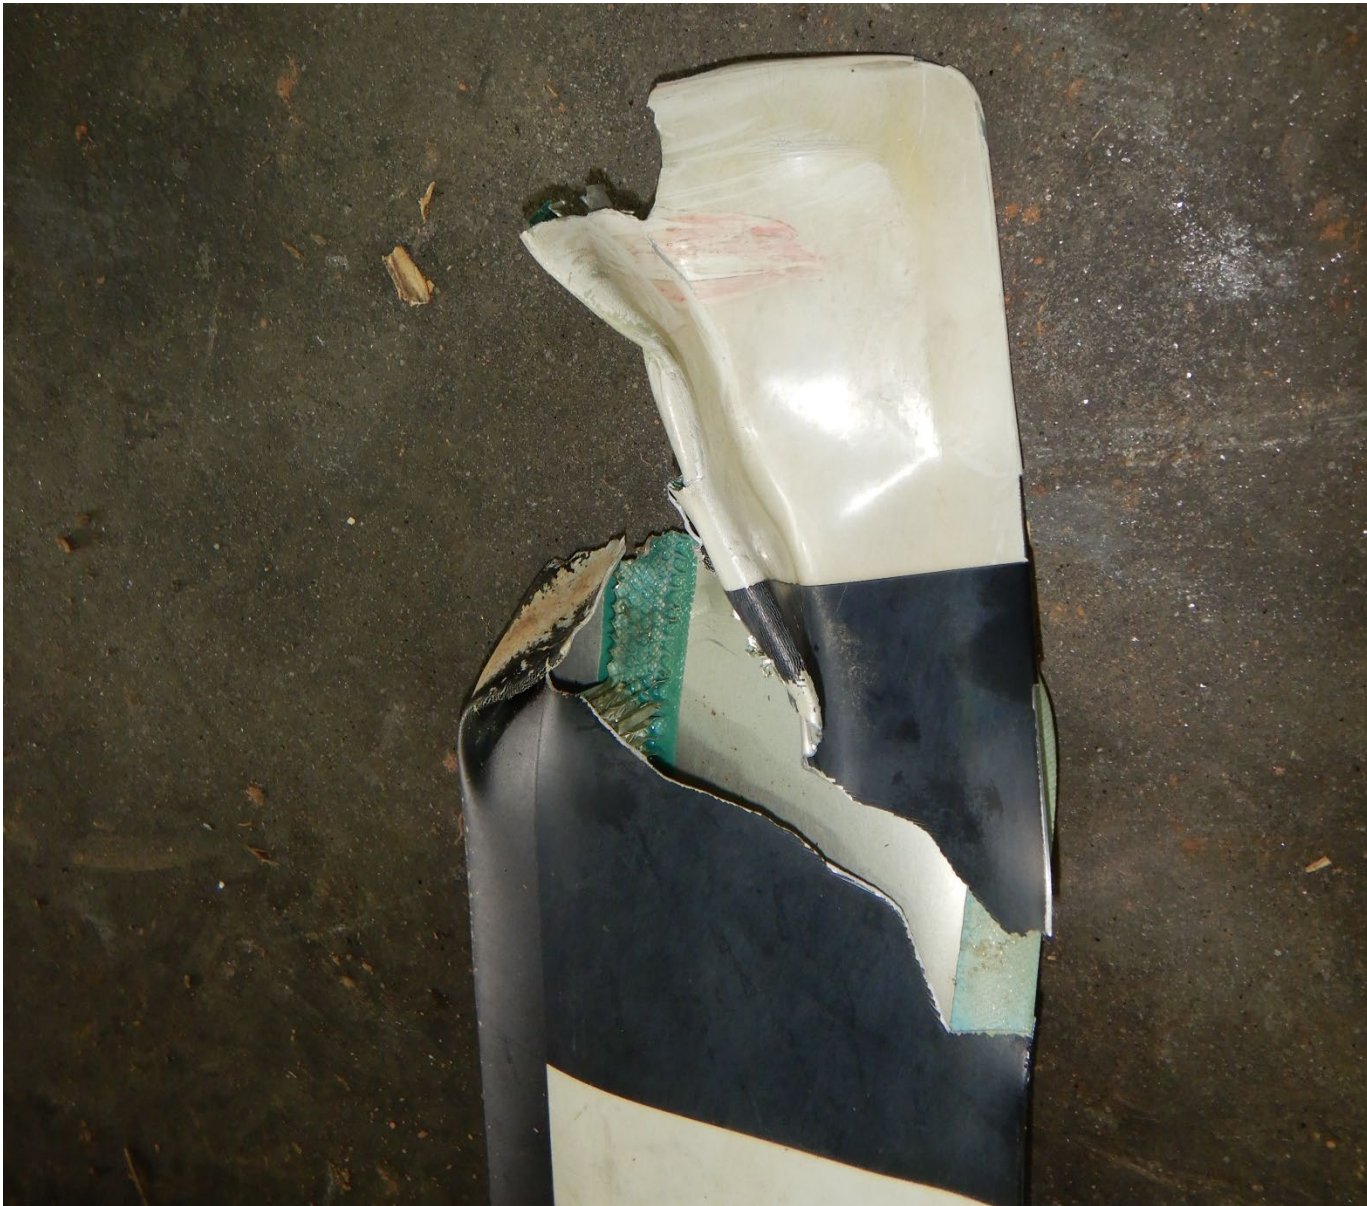
**Photo 5 – View of rotor blade tip with evidence of impact with the tail rotor guard**

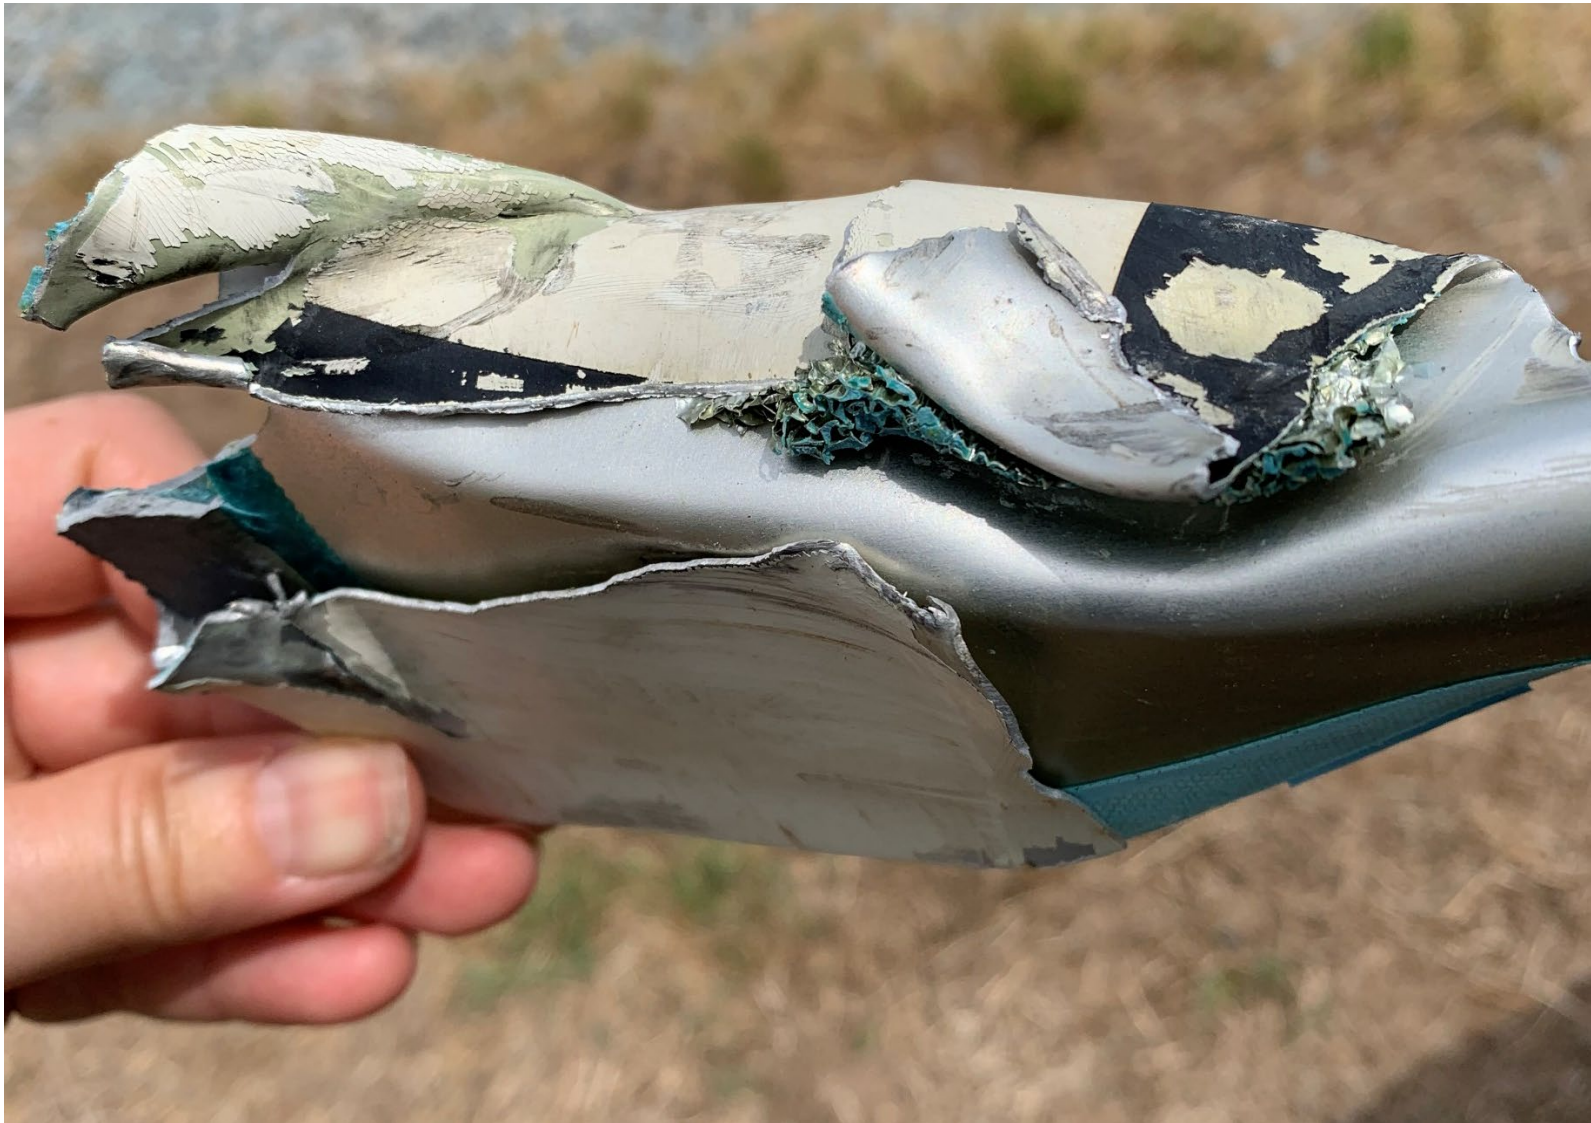
**Photo 6 – View of rotor blade tip with evidence of wire strike**

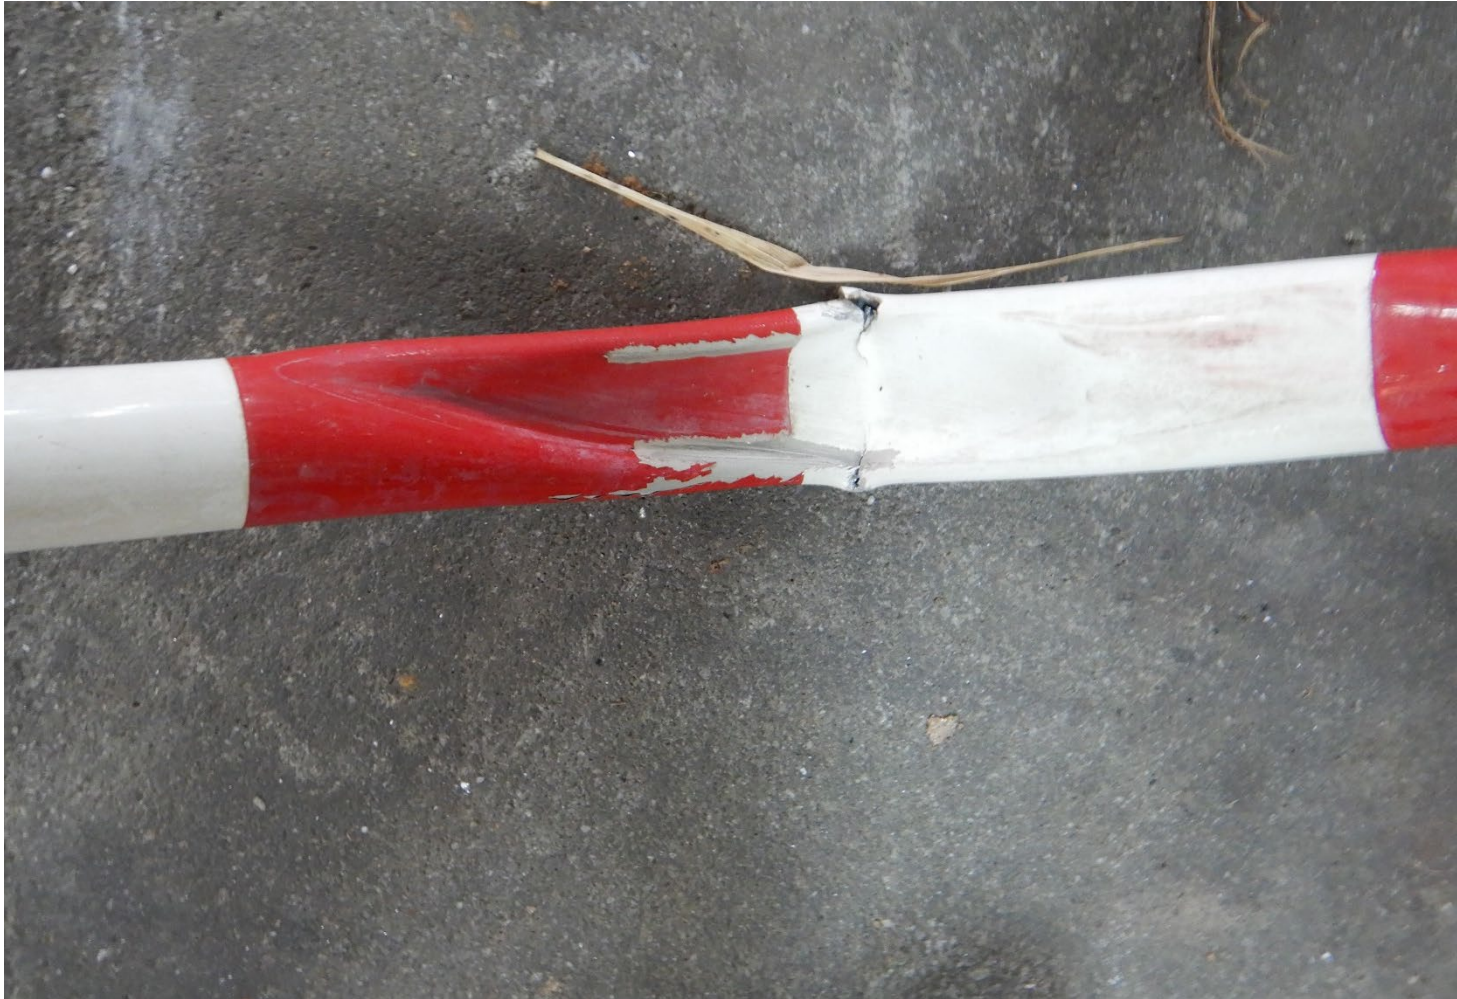
**Photo 7 – View of tail rotor guard damage**
