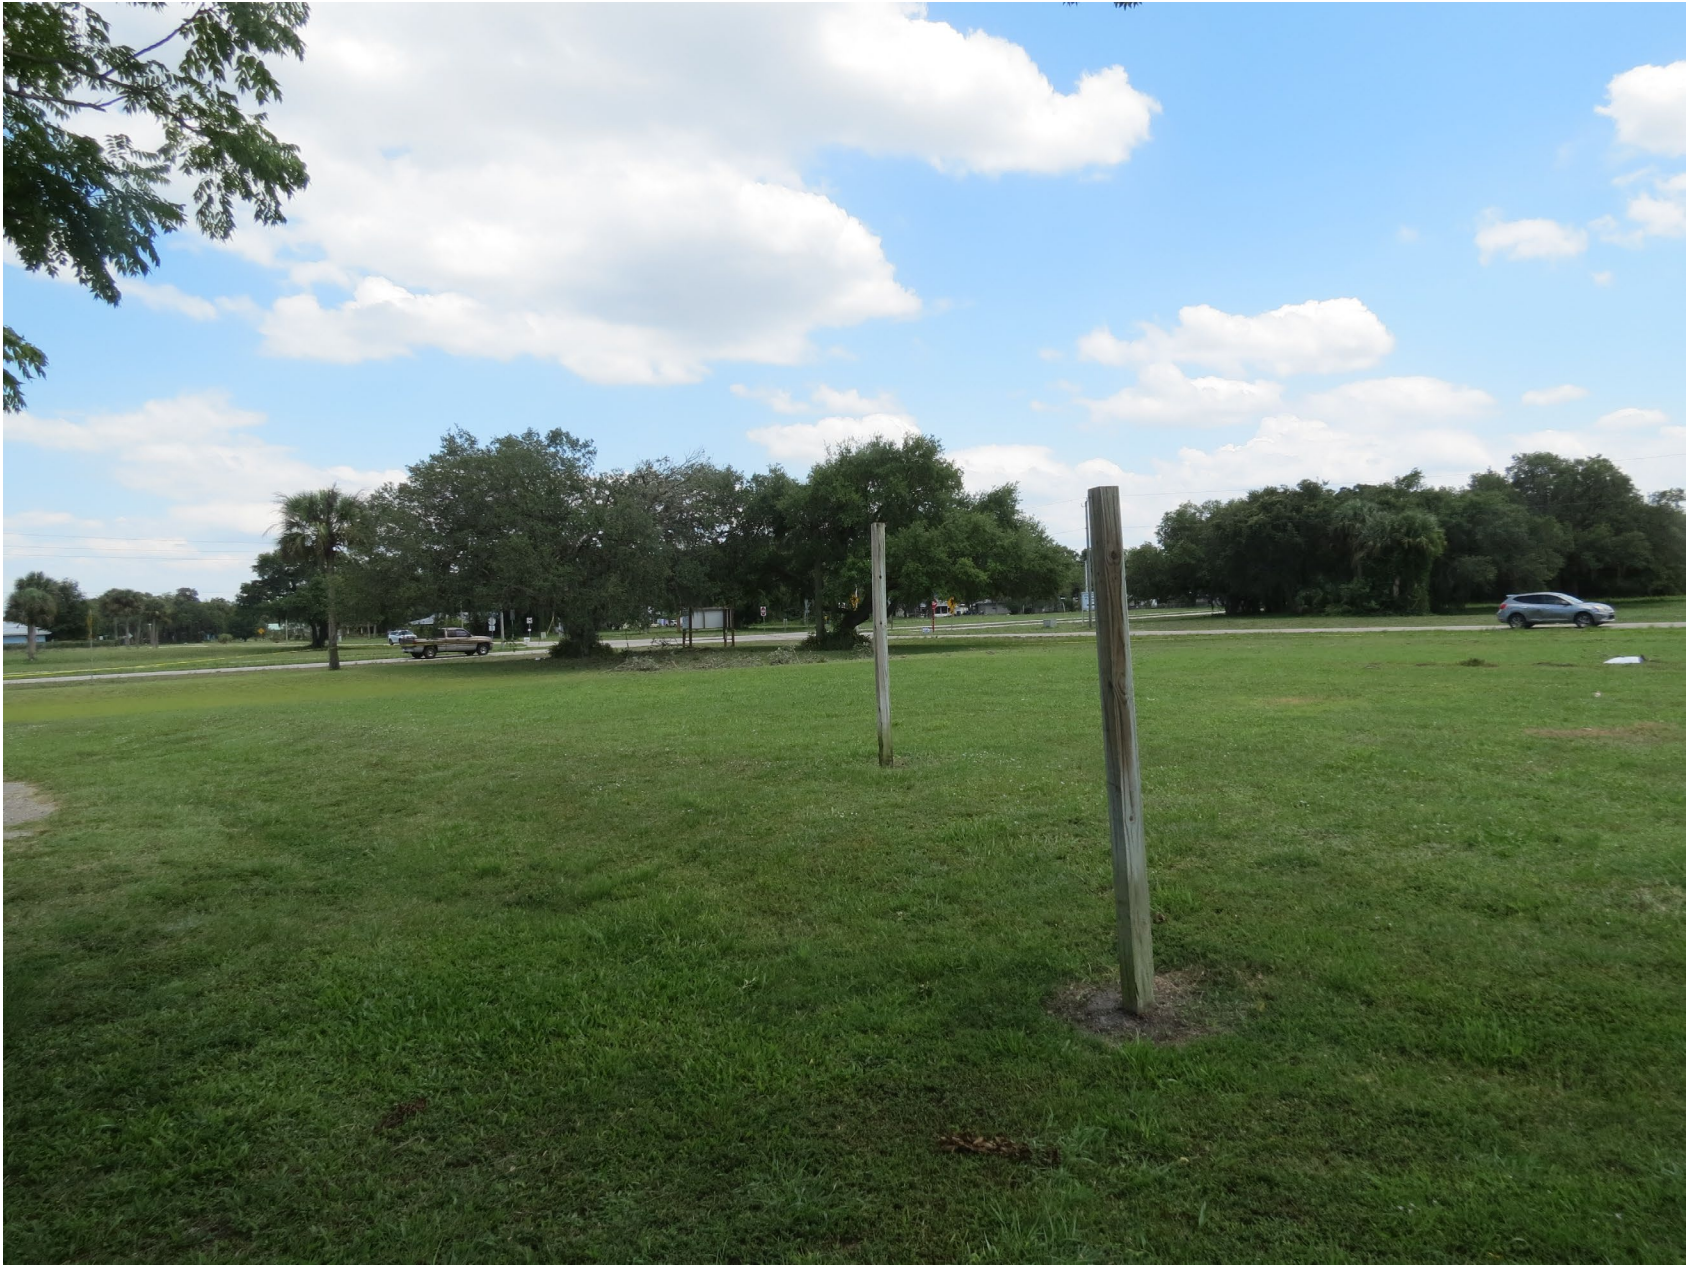
**Photo 1 – View of Initial Tree Strike Facing Opposite Direction of Travel (Lycoming)**

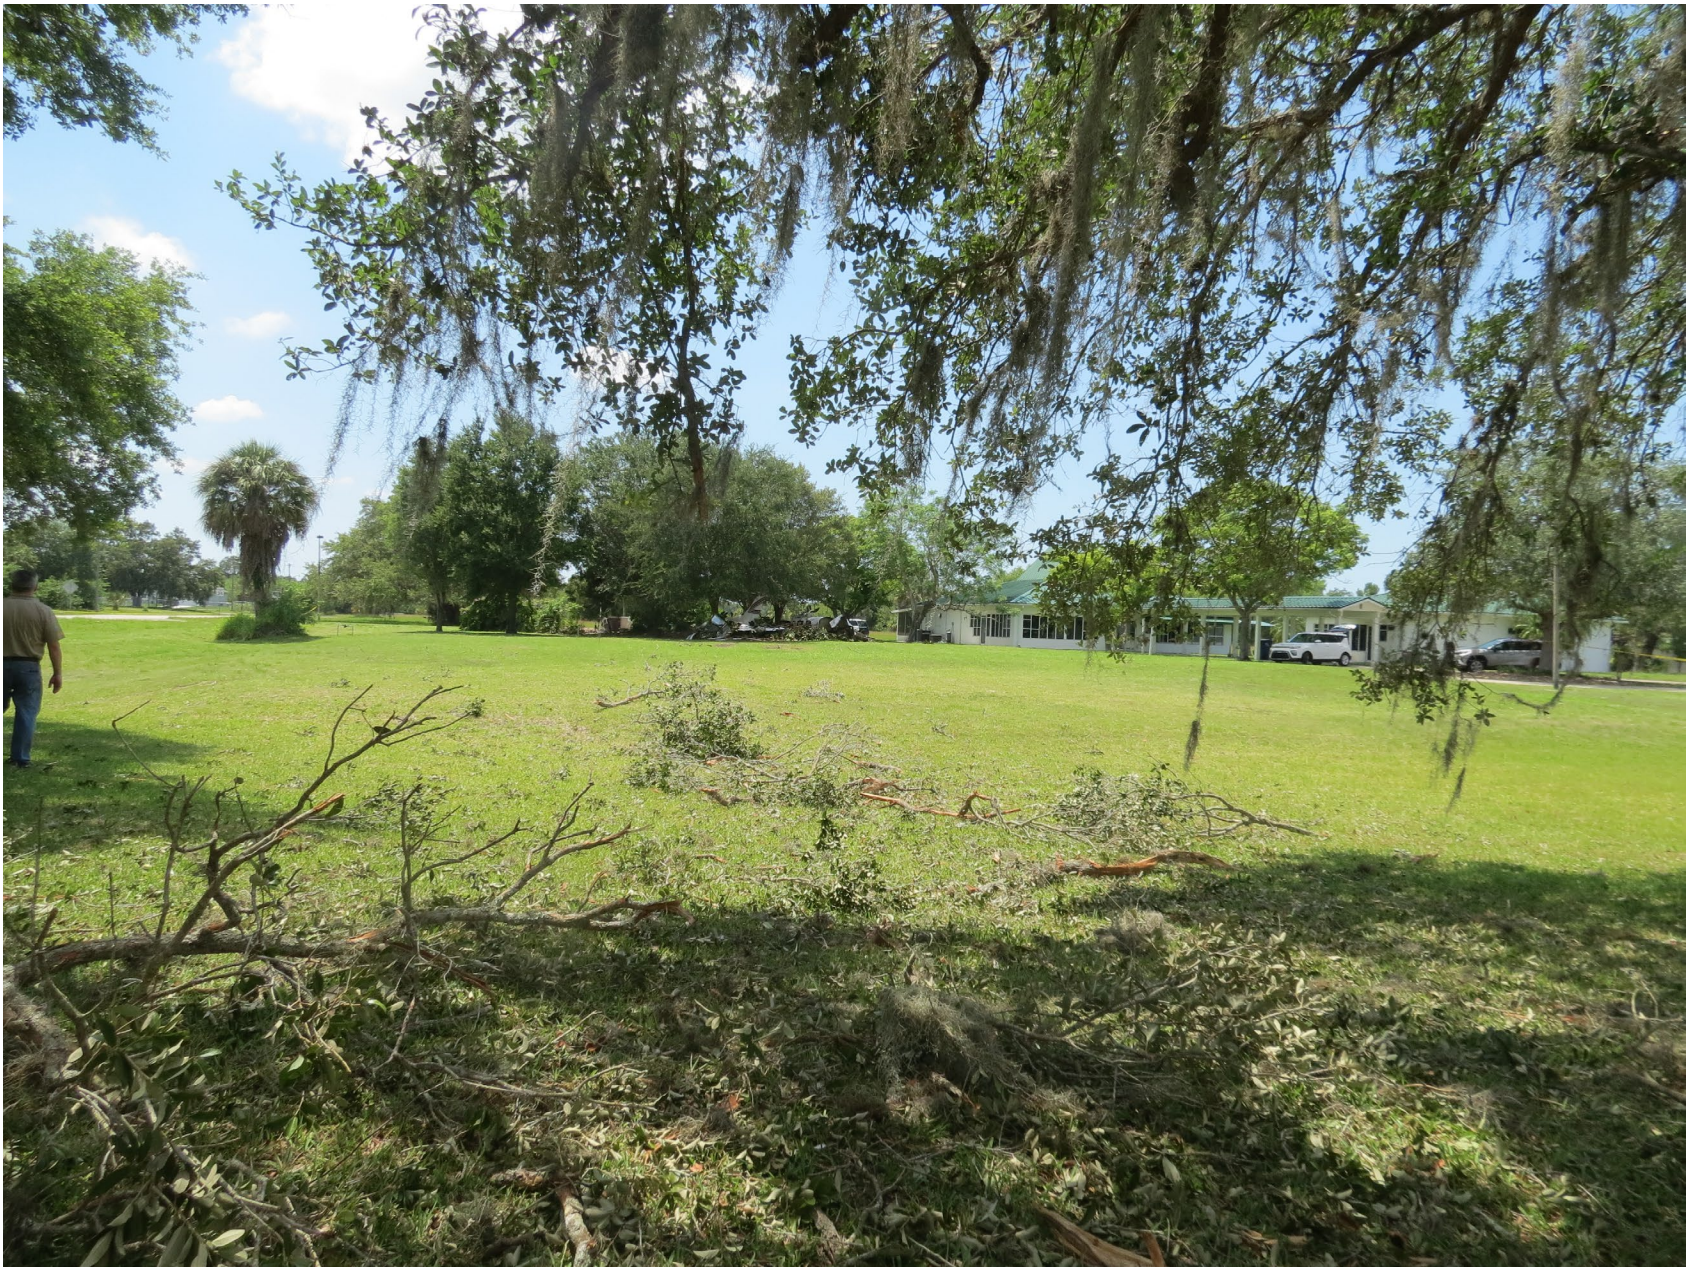
**Photo 2 – View from Beneath Tree Strike Facing Direction of Travel (Lycoming)**

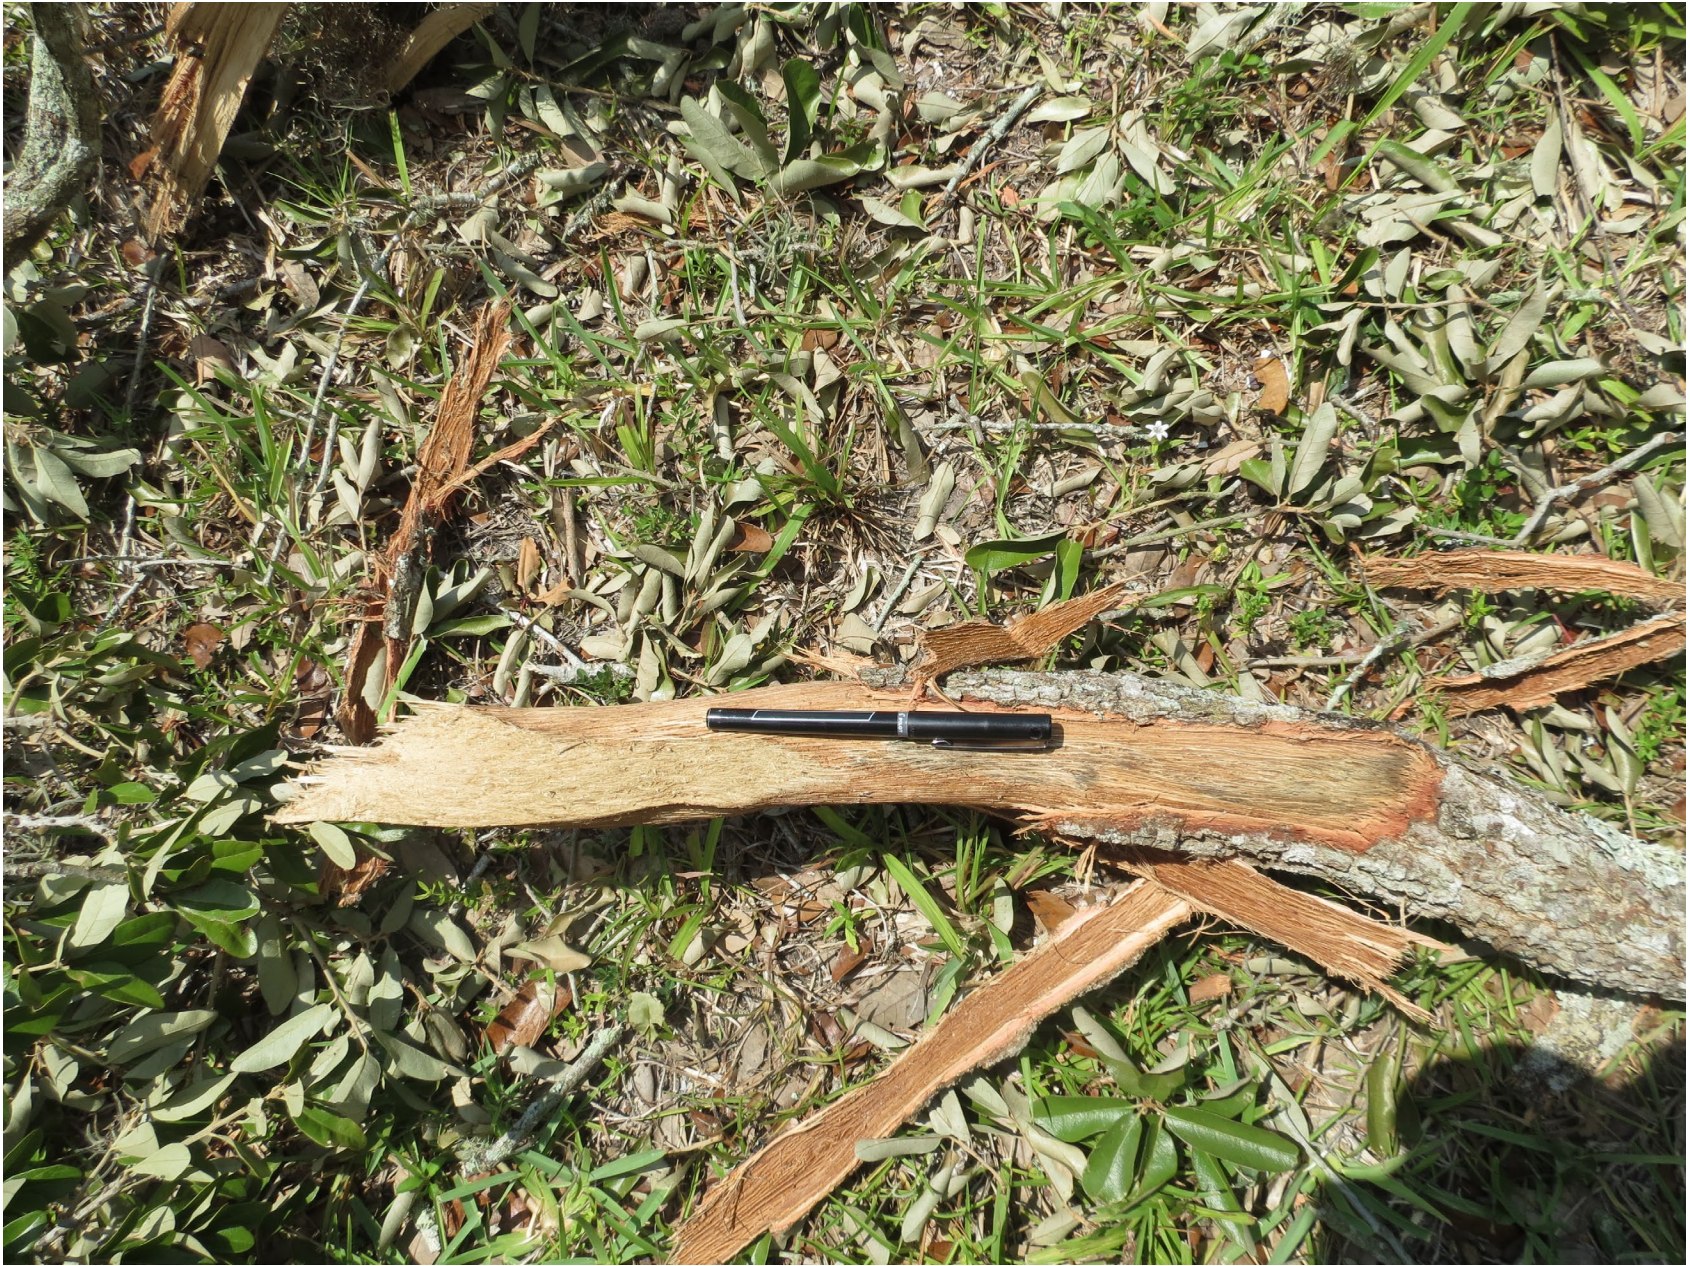
**Photo 3 – Angularly Cut Wood with Paint Transfer (Lycoming)**

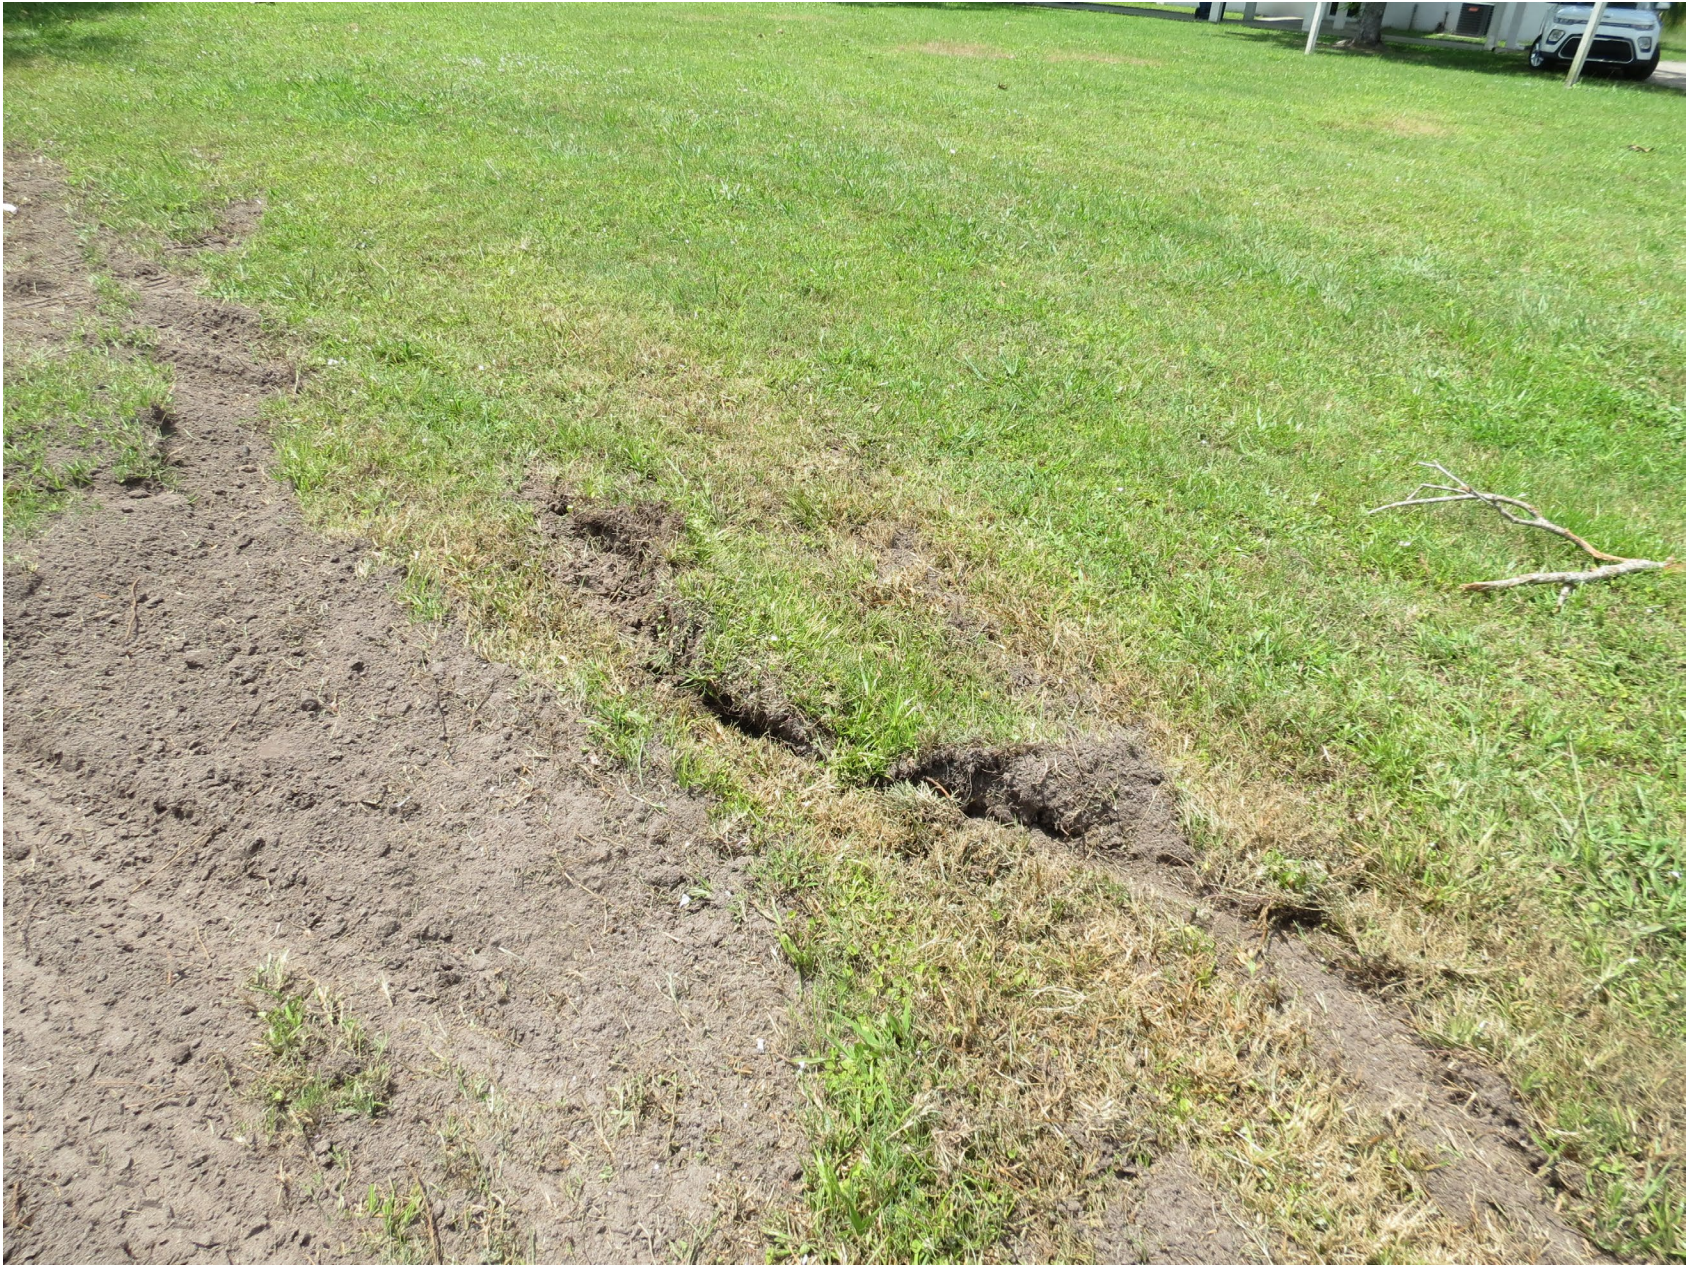
**Photo 4 – S-Shaped Slash Marks Along Wreckage Path (Lycoming)**

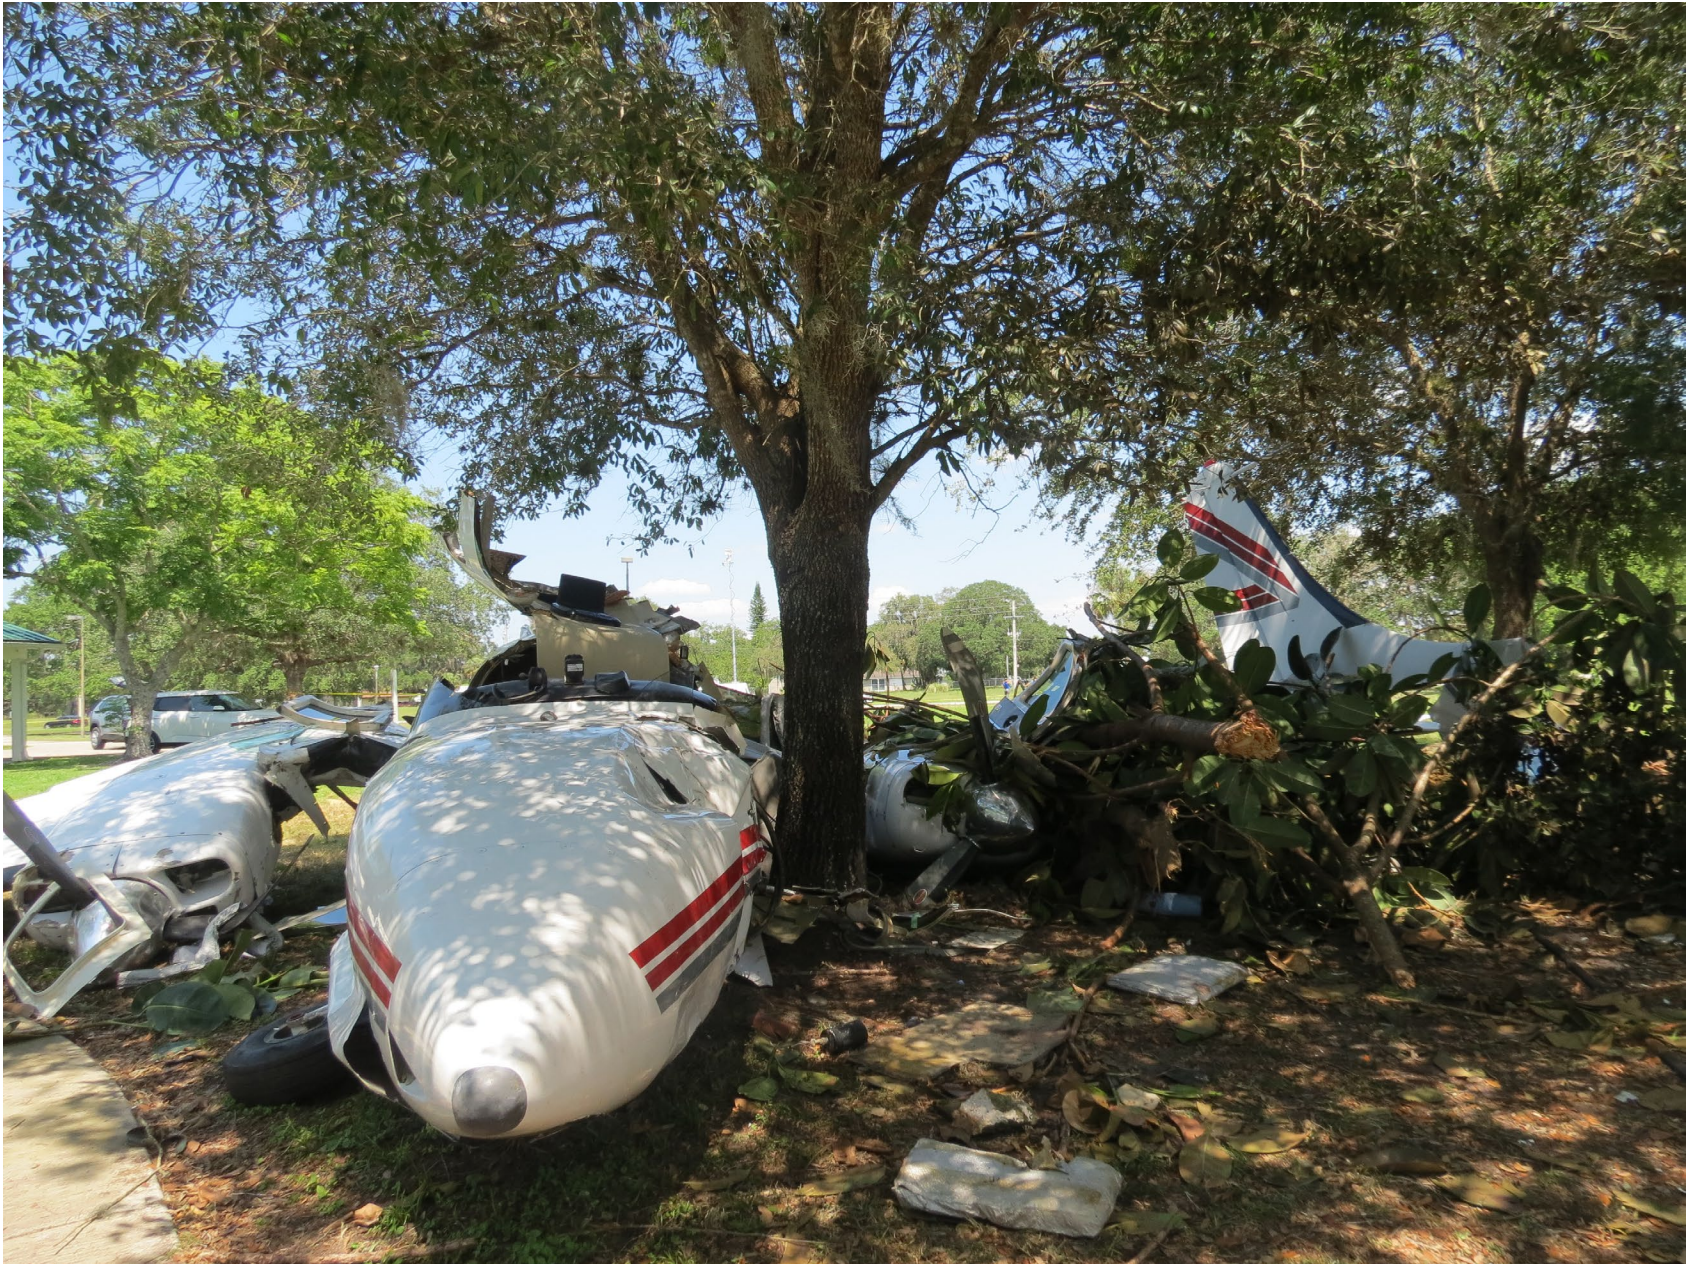
**Photo 5 – Main Wreckage Facing Opposite Direction of Travel (Lycoming)**

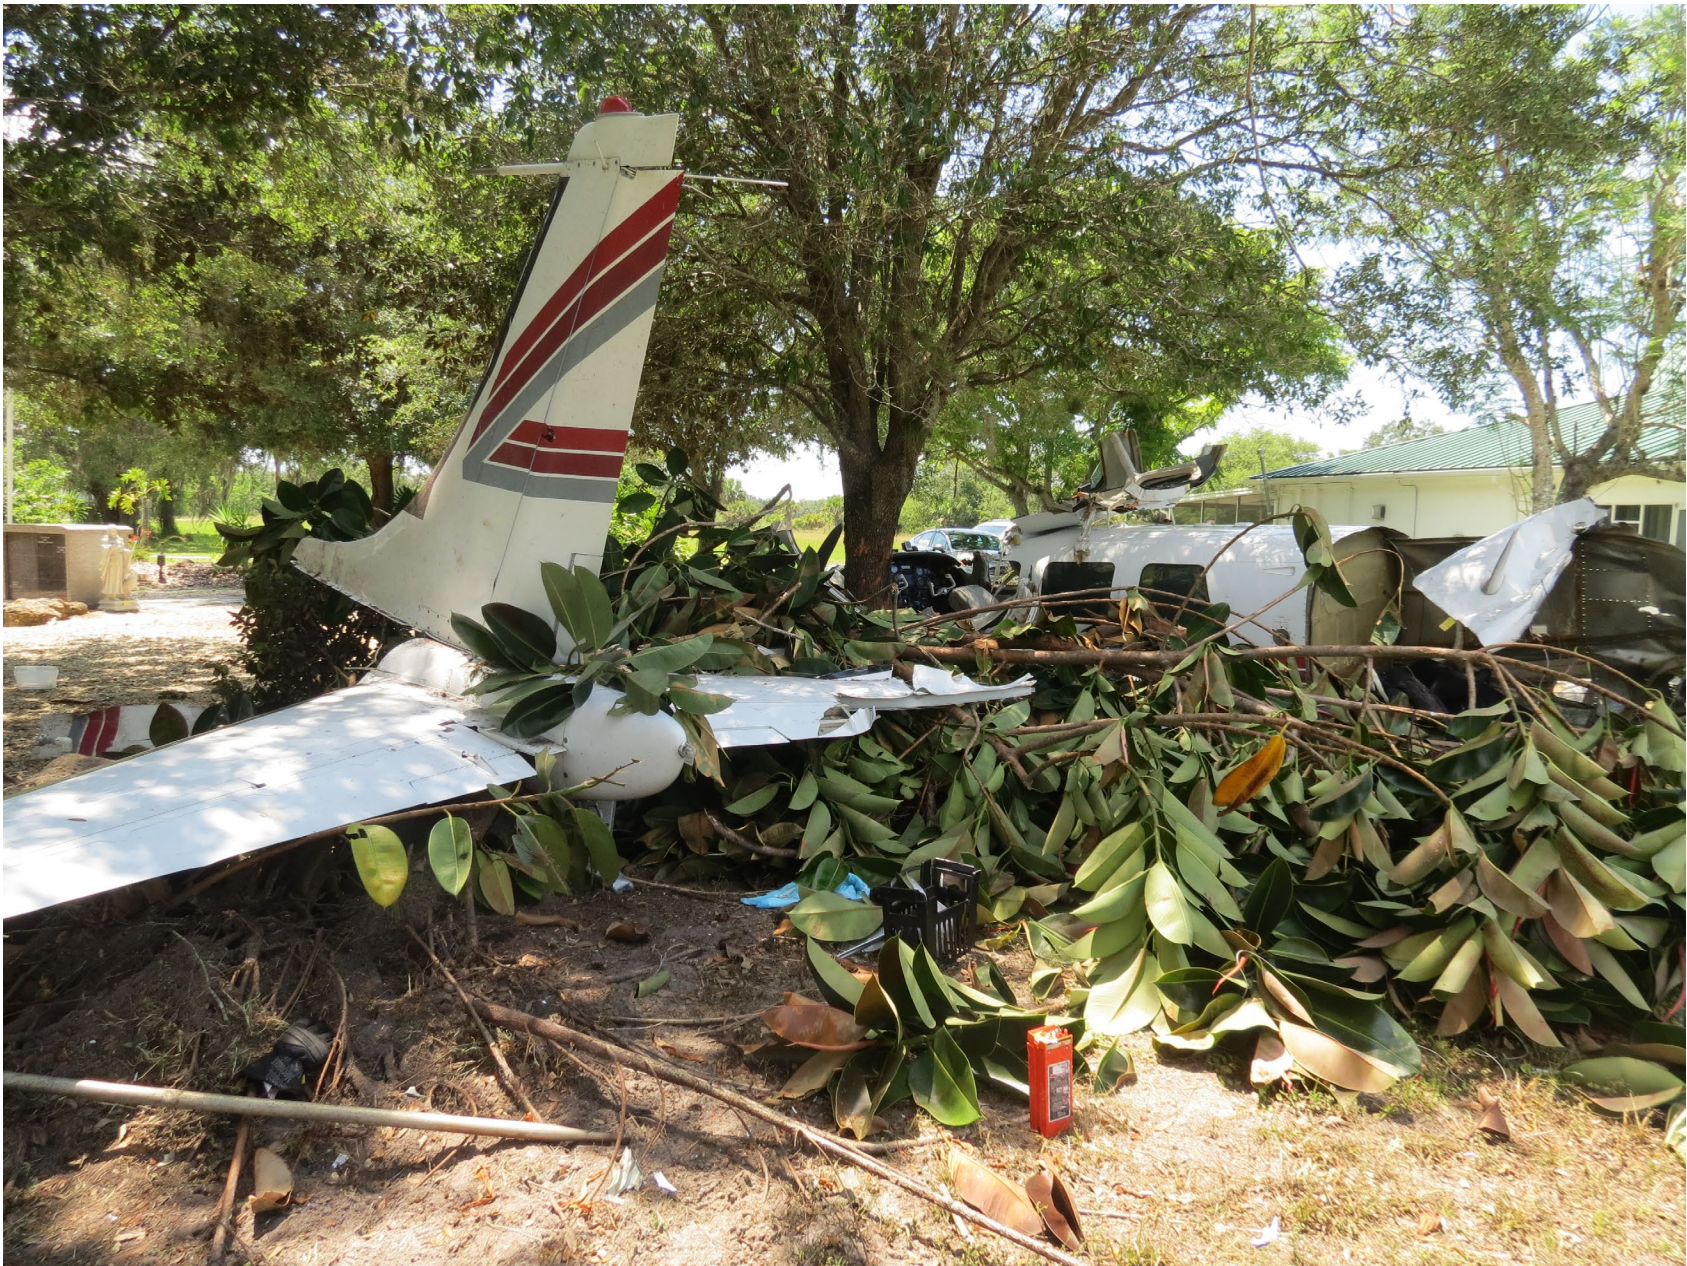
**Photo 6 – View of Tail Section Adjacent to Main Wreckage (Lycoming)**

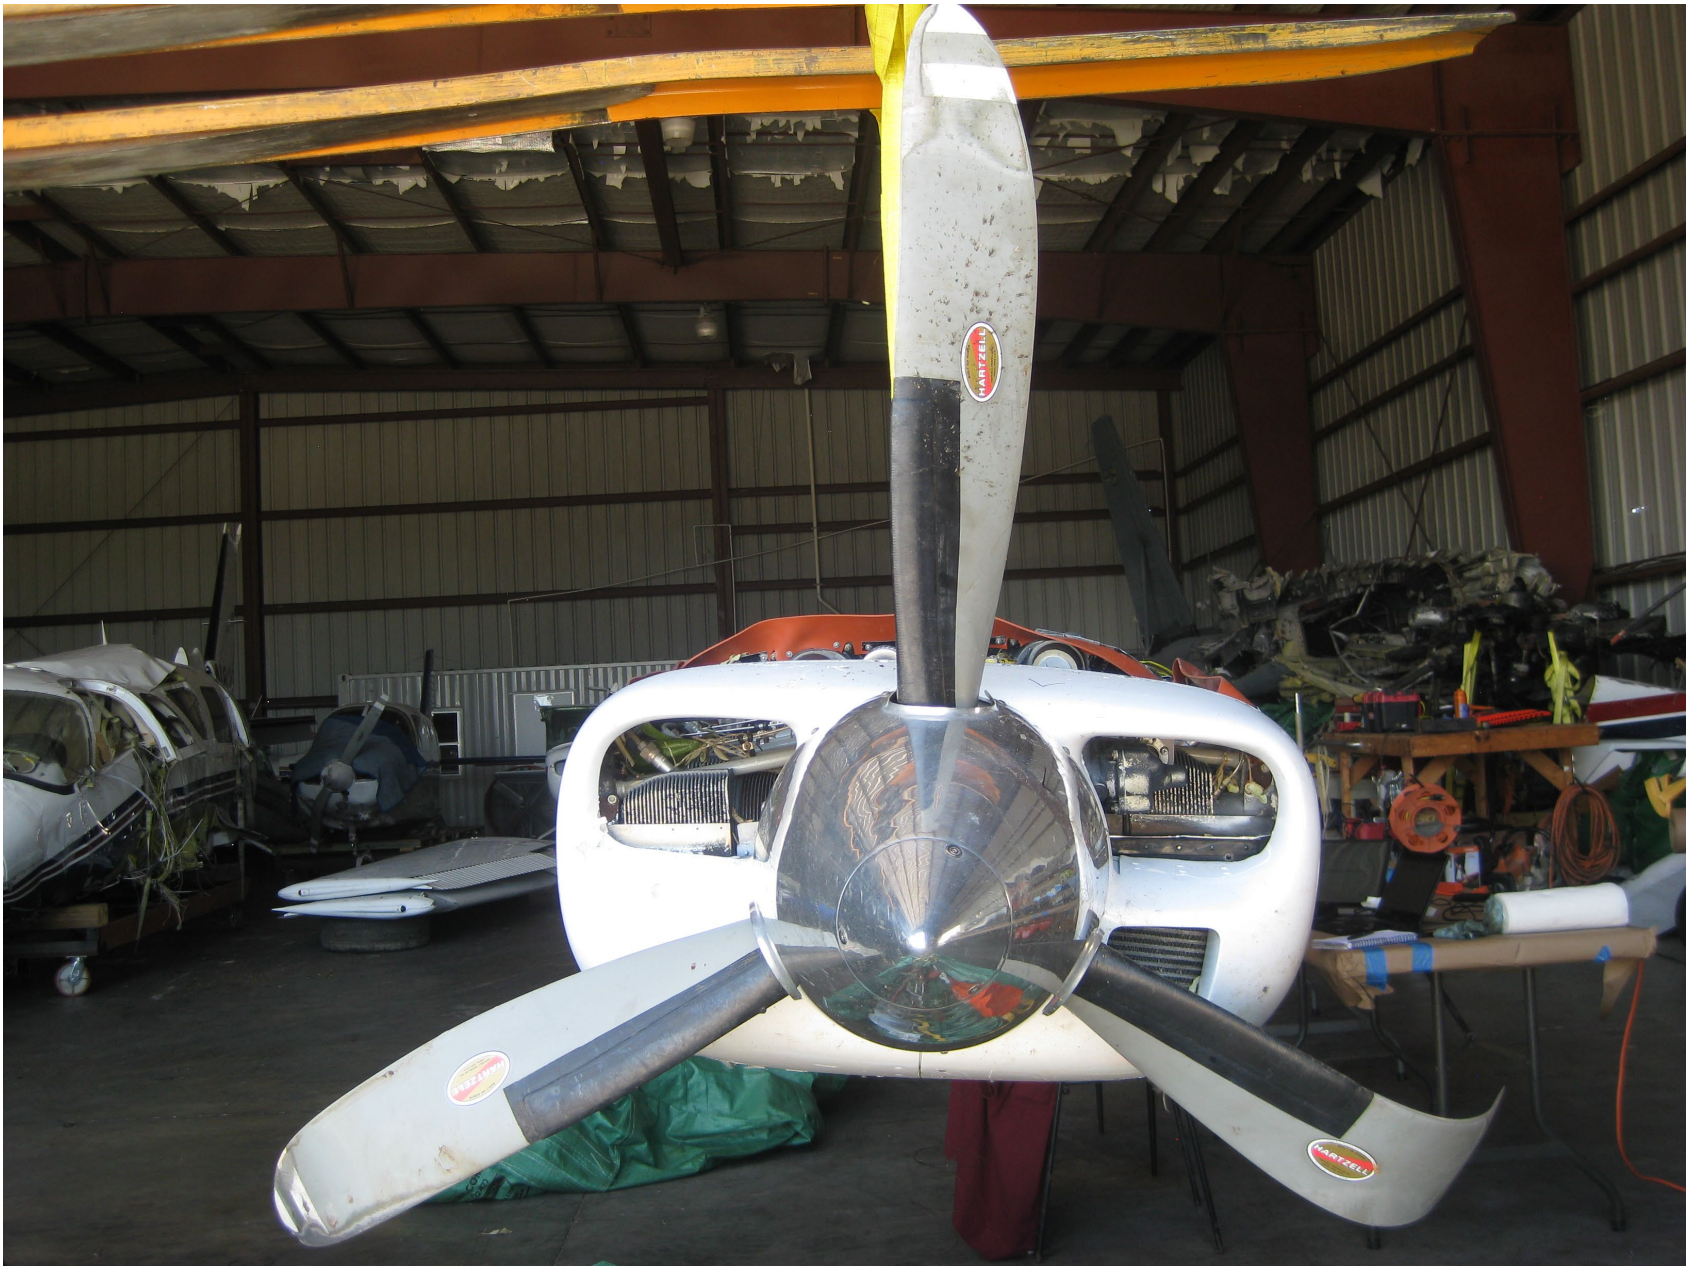
**Photo 7 – View of Left Propeller Tip Curl and Blade Polishing (Lycoming)**

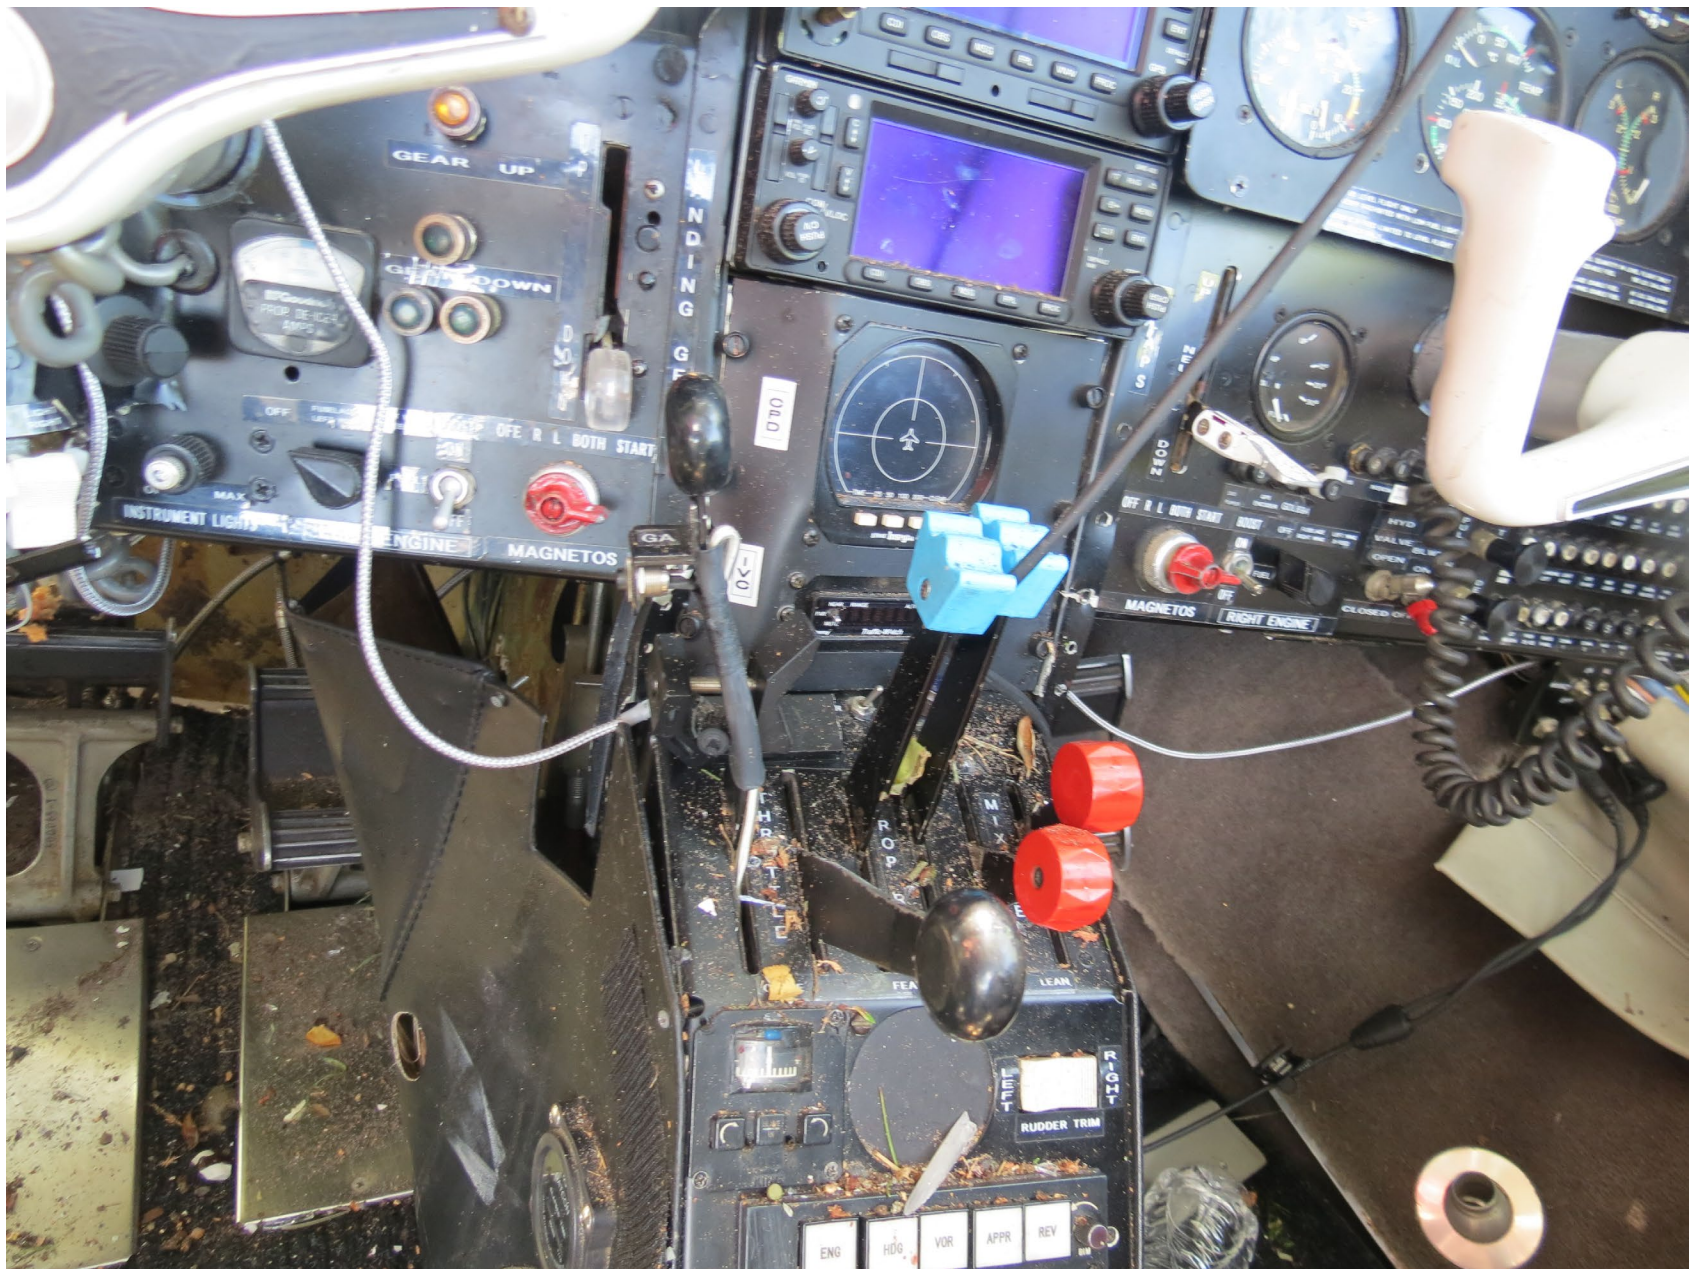
**Photo 8 – View of Throttle Quadrant (Lycoming)**
