**NATIONAL TRANSPORTATION SAFETY BOARD**  
Office of Aviation Safety

**WRECKAGE EXAMINATION SUMMARY**

**A. ACCIDENT      ERA21FA224**

Location: Myrtle Beach, South Carolina  
Date: May 21, 2021  
Time: 1814 Eastern Daylight Time (EDT)  
Operator: Private  
Aircraft: Piper PA-31P  
Registration: N575BC

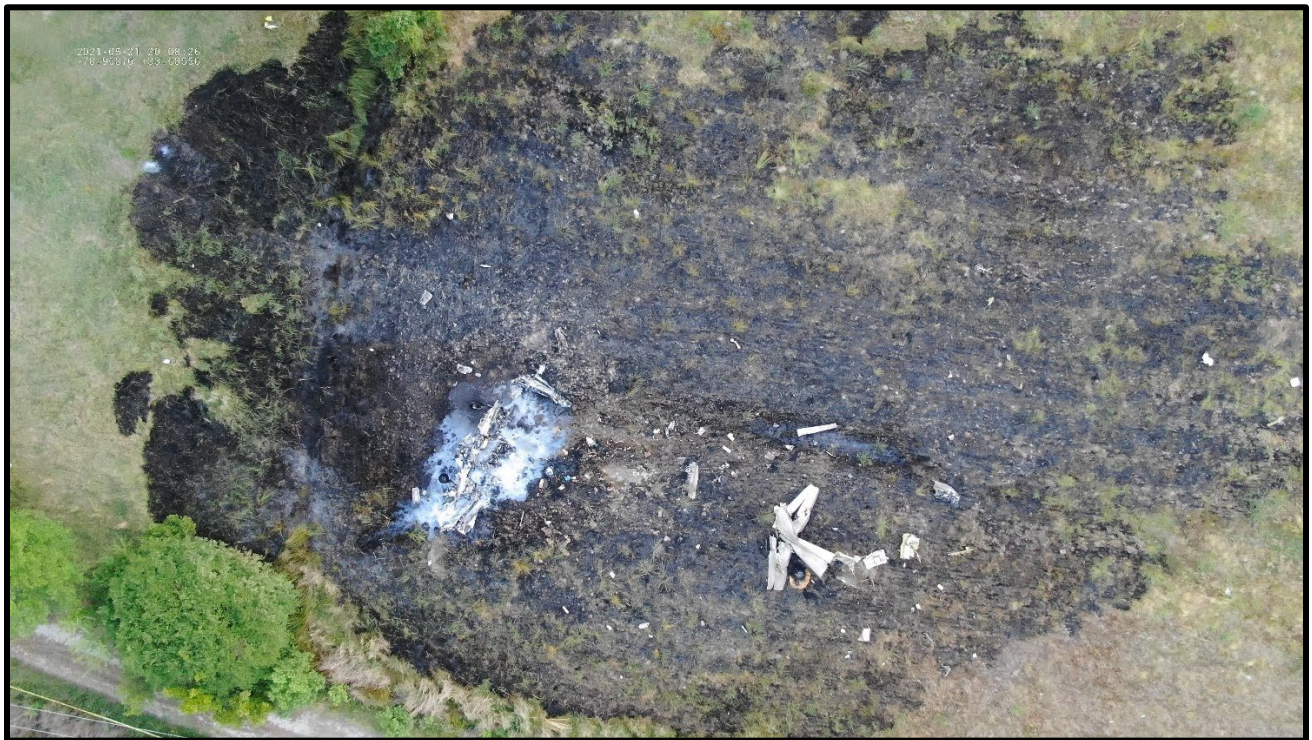
Figure 3 - Main Accident Site

The airplane impacted terrain about 2.4 miles from MYR at an elevation of 20 ft mean sea level. The airplane came to rest in a field and a post impact fire ensued. The debris field was on a 347° heading. The debris field was about 400 ft long and about 150 ft wide. An odor of 100LL aviation fuel was noted at the accident site.

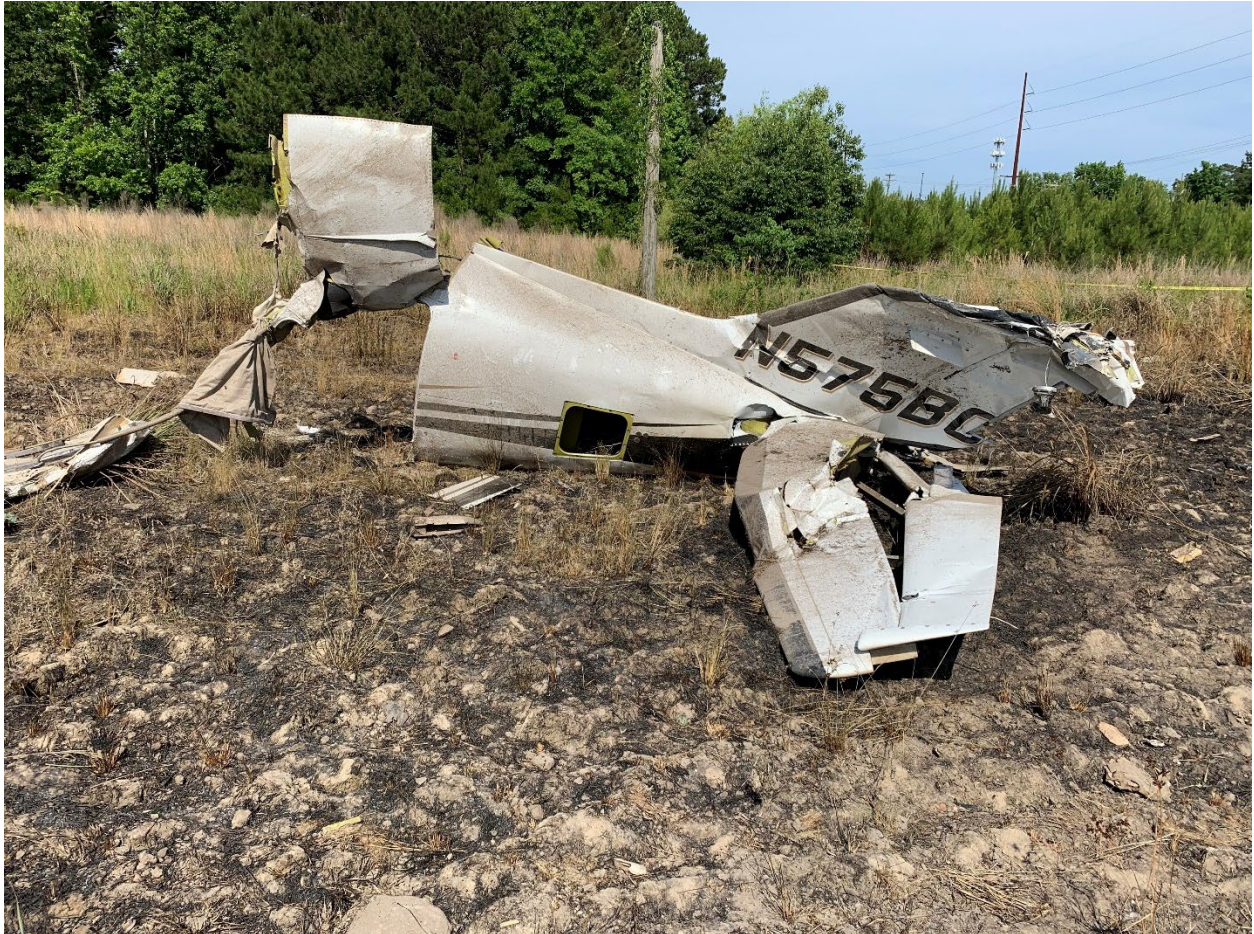
*Figure 4 - View of empennage*

The empennage was separated from the fuselage and located about 50 ft from the main wreckage. The cabin door remained attached to the empennage through the door cable. The door was in the locked position and all pins were extended. The elevator and rudder cables were impact separated in tensile overload.

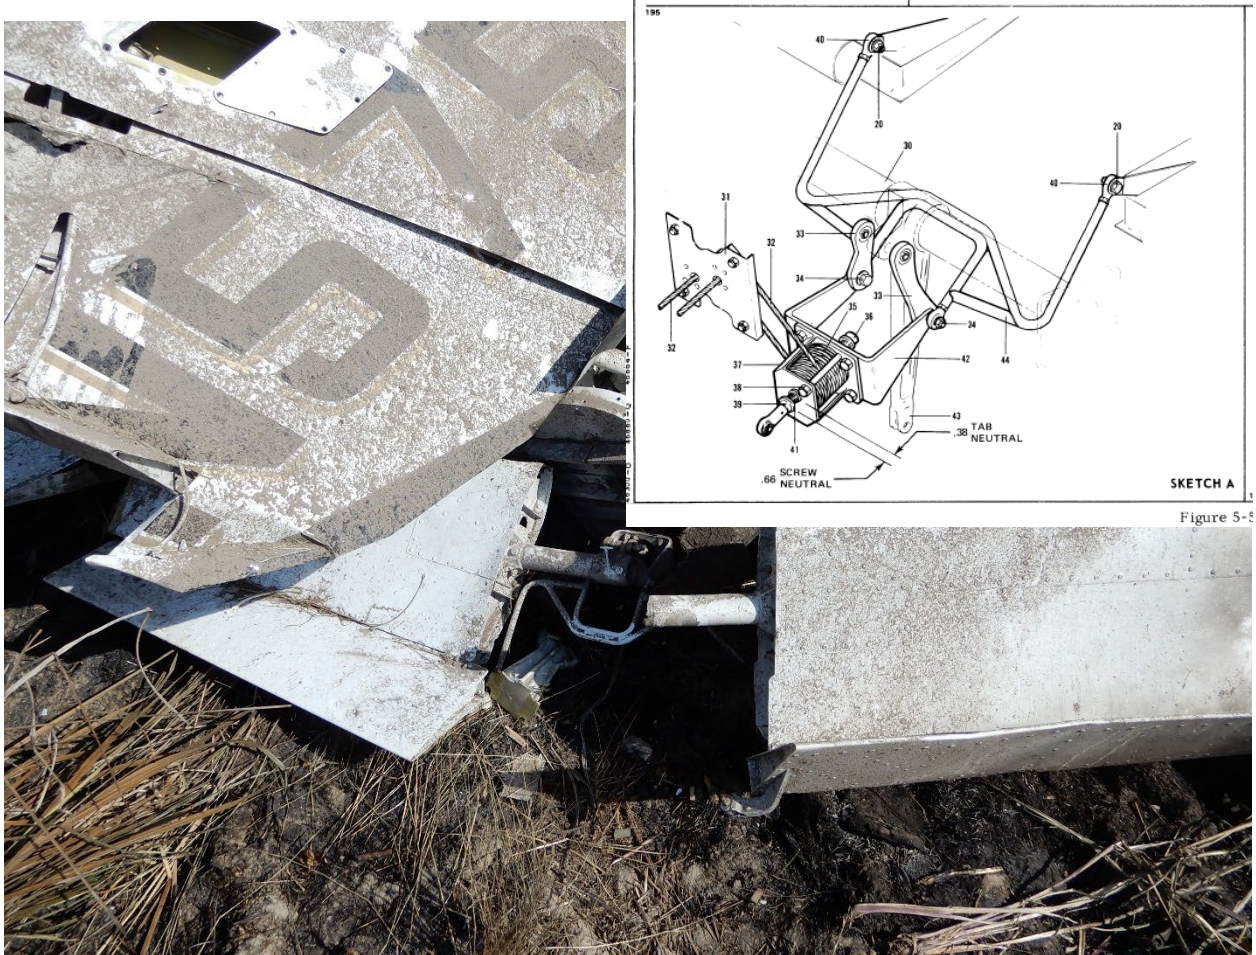
Further examination of the elevator trim tabs revealed that they were installed upside down and reversed. The tab that should be located on the top of the trim tab was located on the bottom. Note the control horn on the bottom of the trim tab on the accident airplane.

Figure 5 - View Elevator Trim Tabs. Note elevator trim tab attach points are on the bottom of the elevator trim tab as compared to the PA-31P maintenance manual where the trim tab attach points are on the top of the elevator trim tab.

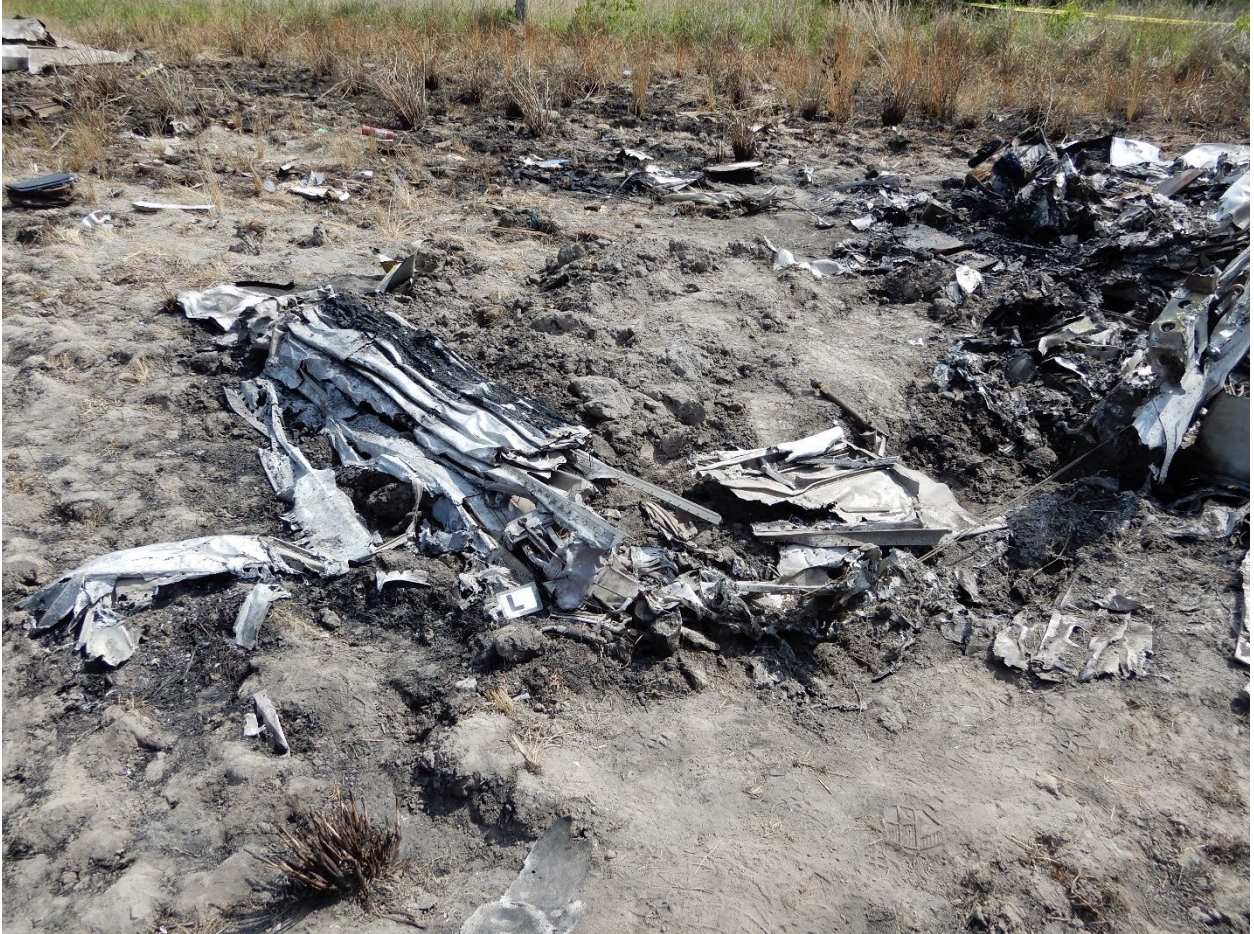
*Figure 6 - View of Left Wing*

The left wing remained attached to the fuselage and a majority was consumed by fire. The remaining skin and structure exhibited accordion-like impact damage. The left aileron was impact separated and located approximately 10 ft from the empennage. The left flap was in the UP position. The aft portion of the flap was consumed by fire. The left inboard fuel cap remained in place and was seated. The surrounding skin was consumed by fire. Both aileron cables remained attached to the bell crank and the rod was fractured at the rod bearing. The left aileron balance weight remained attached to the aileron.

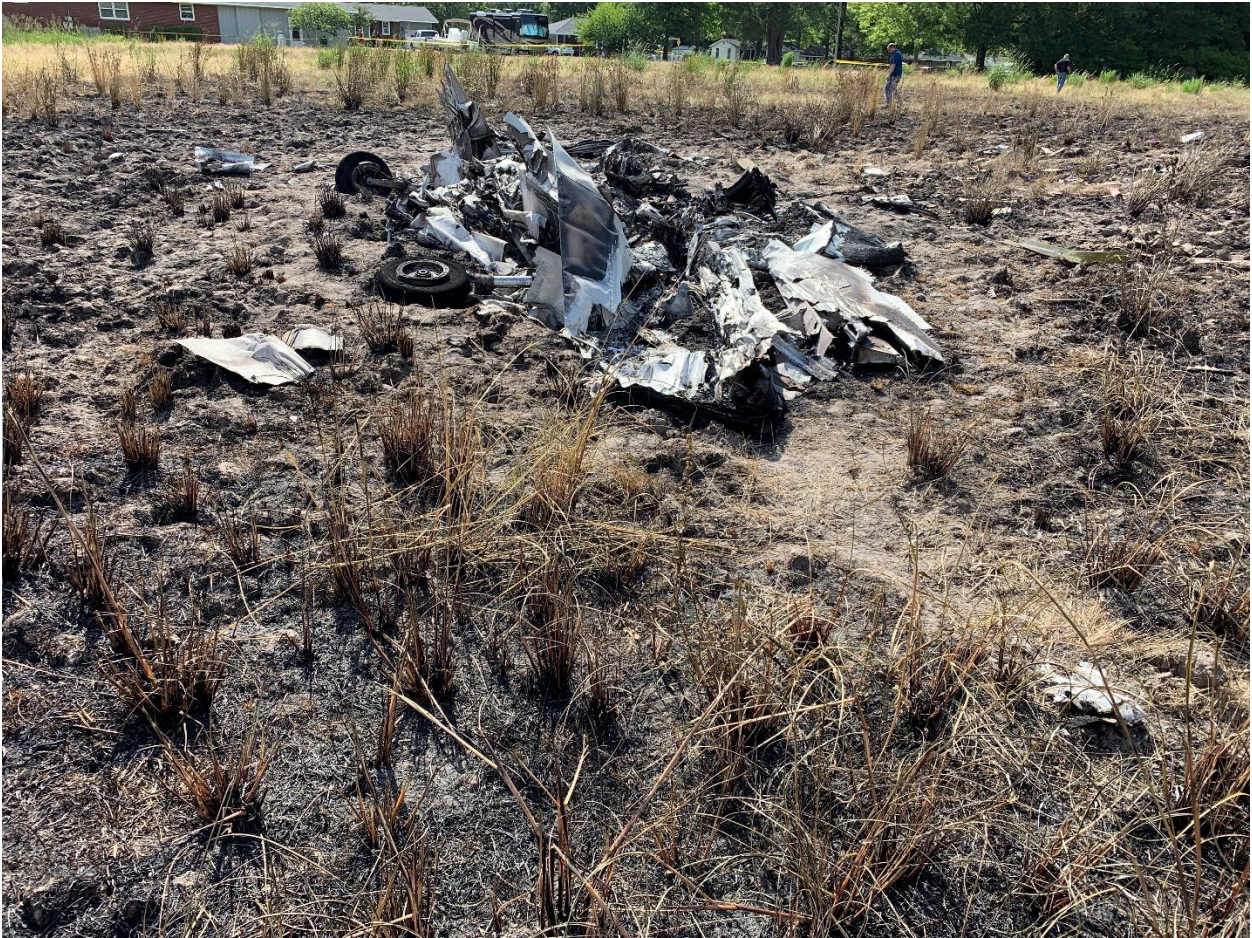
The right wing remained attached to the fuselage and was mostly consumed by fire. The flap was in the UP position and mostly consumed by fire. The wing skin that remained exhibited accordion-like impact damage. The aileron remained attached to the right wing. The aileron trim remained attached to the inboard side of the aileron and was separated from the outboard section. The right aileron cable turnbuckle separated at the bellcrank. The aileron trim barrel was measured and corresponded to a “neutral to slight left aileron roll” trim setting.

Figure 7 - View of Right Wing. Note: Wing imprint in dirt.

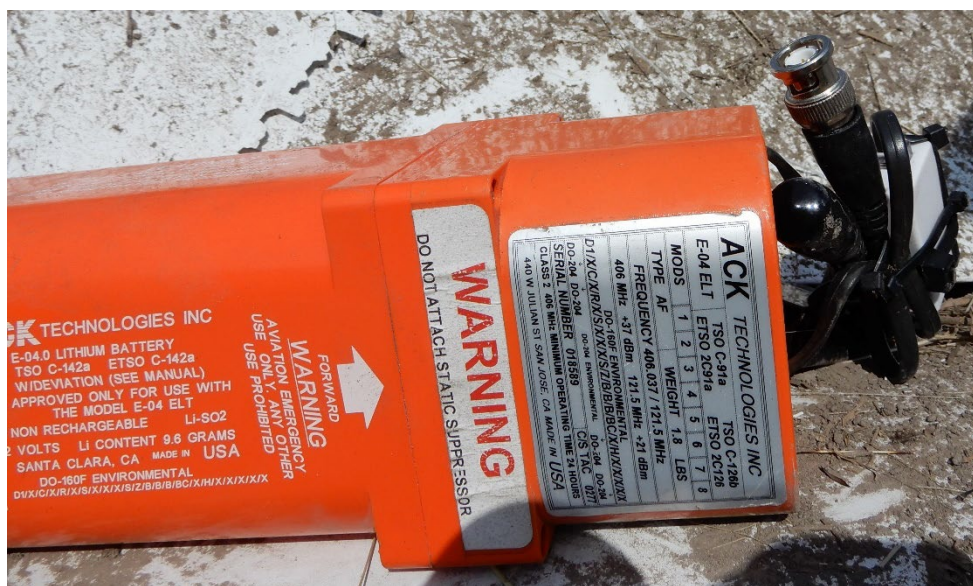
Figure 8 - View of ELT

The ELT remained secured in the empennage of the airplane. It was located in the “armed” position and was turned off by an FAA inspector.

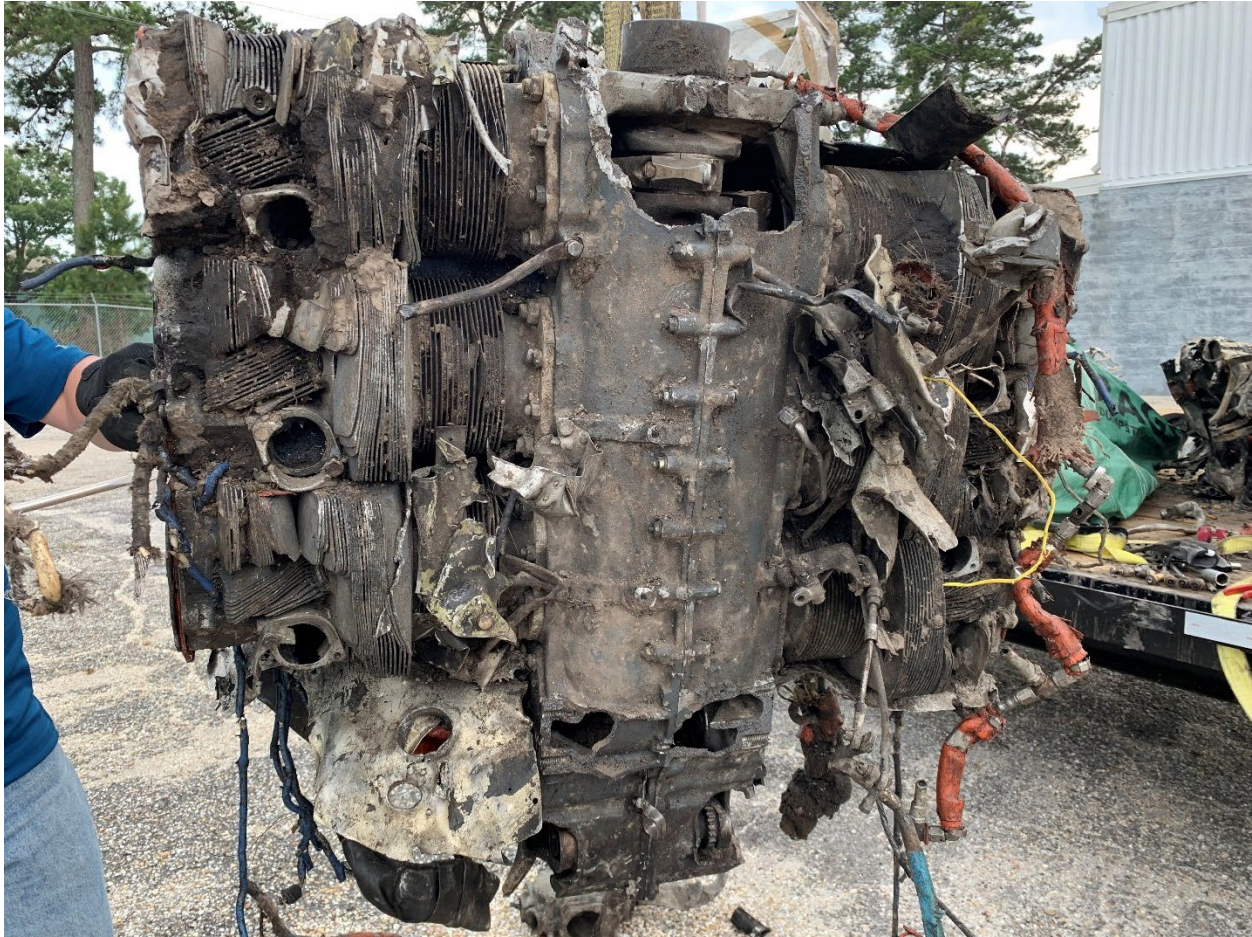
Figure 9 - Left Engine

The left engine was located in a 6 ft crater. The crankcase was damaged in multiple places. The gearbox was impact separated. All valve covers remained intact and attached to the cylinders. The valve covers were removed and no anomalies were noted. Crankshaft and camshaft continuity was confirmed by using a lighted boroscope to examine the internal components of the engine. In addition, the cylinders were examined using a lighted boroscope and no anomalies were noted. All connecting rods remained connected to the crankshaft. The air manifold remained attached to the engine and was impact damaged. Multiple intake tubes were crushed. The left engine gascolator was impact separated and crushed. The oil suction screen was removed and contained debris similar to the terrain at the accident site. The left engine turbocharger was impact separated, would bind when it rotated, and scoring was noted on the casing. The alternator was impact separated and fragmented. The fuel inlet screen on the fuel servo was not located. The fuel servo was impact

separated and fragmented. Both magnetos were impact separated and fragmented. The vacuum pump was impact separated and fragmented. The fuel pump was impact separated and fragmented. The turbocharger waste gate and turbocharger controllers were impact separated and fragmented. The intercooler was impact separated.

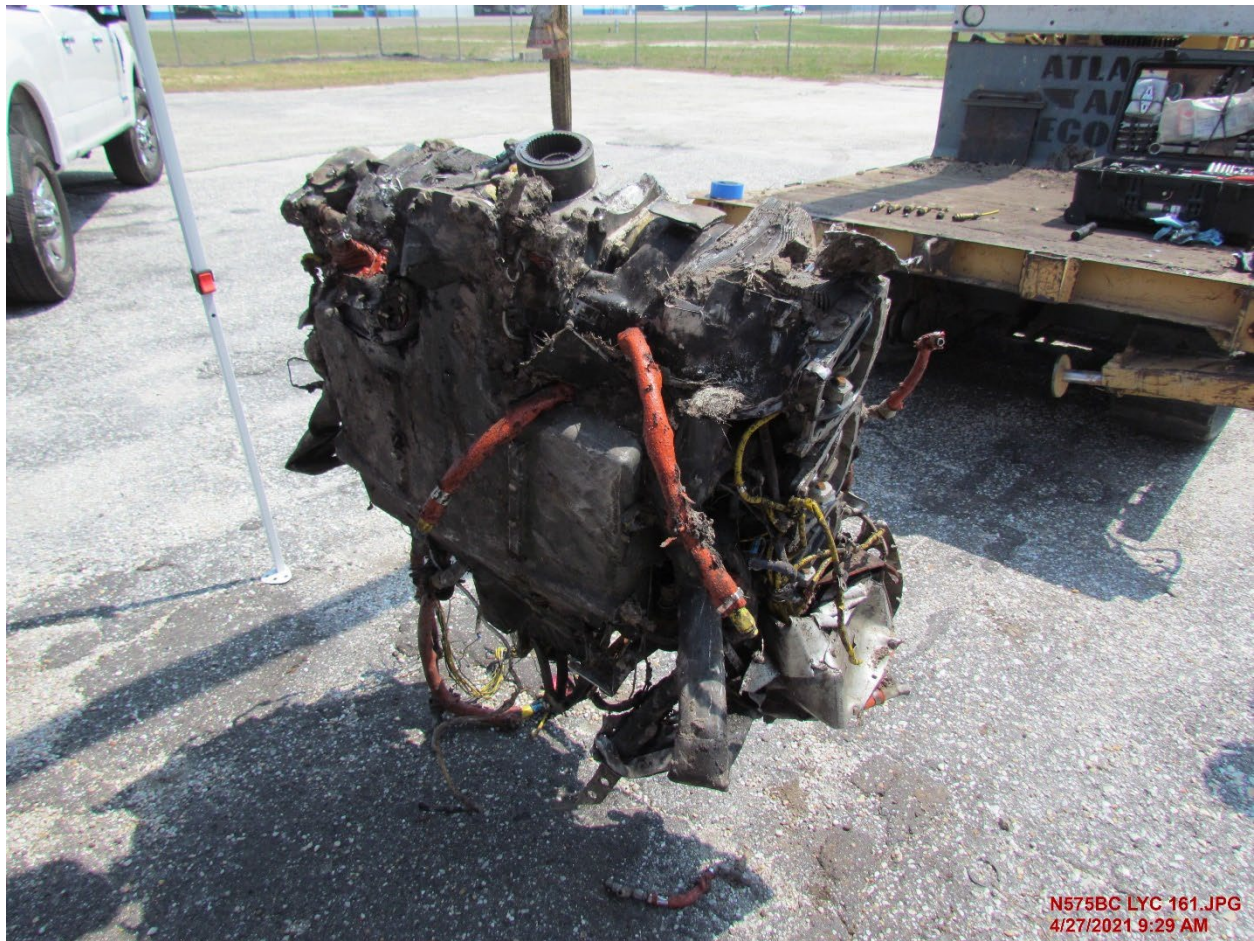
*Figure 10 - Right Engine*

The right engine was located in a 5 ft crater. The crankcase was damaged in multiple places. The gearbox was impact separated. All valve covers remained intact and attached to the cylinders. The valve covers were removed and no anomalies were noted. Crankshaft and camshaft continuity was confirmed by using a lighted boroscope to examine the internal components of the engine. In addition, the cylinders were examined using a lighted boroscope and no anomalies were noted. All connecting rods remained connected to the crankshaft. The air manifold remained attached to the engine and was impact damaged. Multiple intake tubes were crushed. The right engine gascolator was impact separated and crushed. The oil suction screen was removed and was not occluded. The right engine turbocharger was impact separated and would bind when it rotated. The alternator was impact separated and fragmented. The fuel servo was impact separated and fragmented. Both magnetos were impact separated and fragmented. The vacuum pump was impact separated and

fragmented. The fuel pump was impact separated and fragmented. The turbocharger controllers were impact separated and fragmented. The intercooler was impact separated.

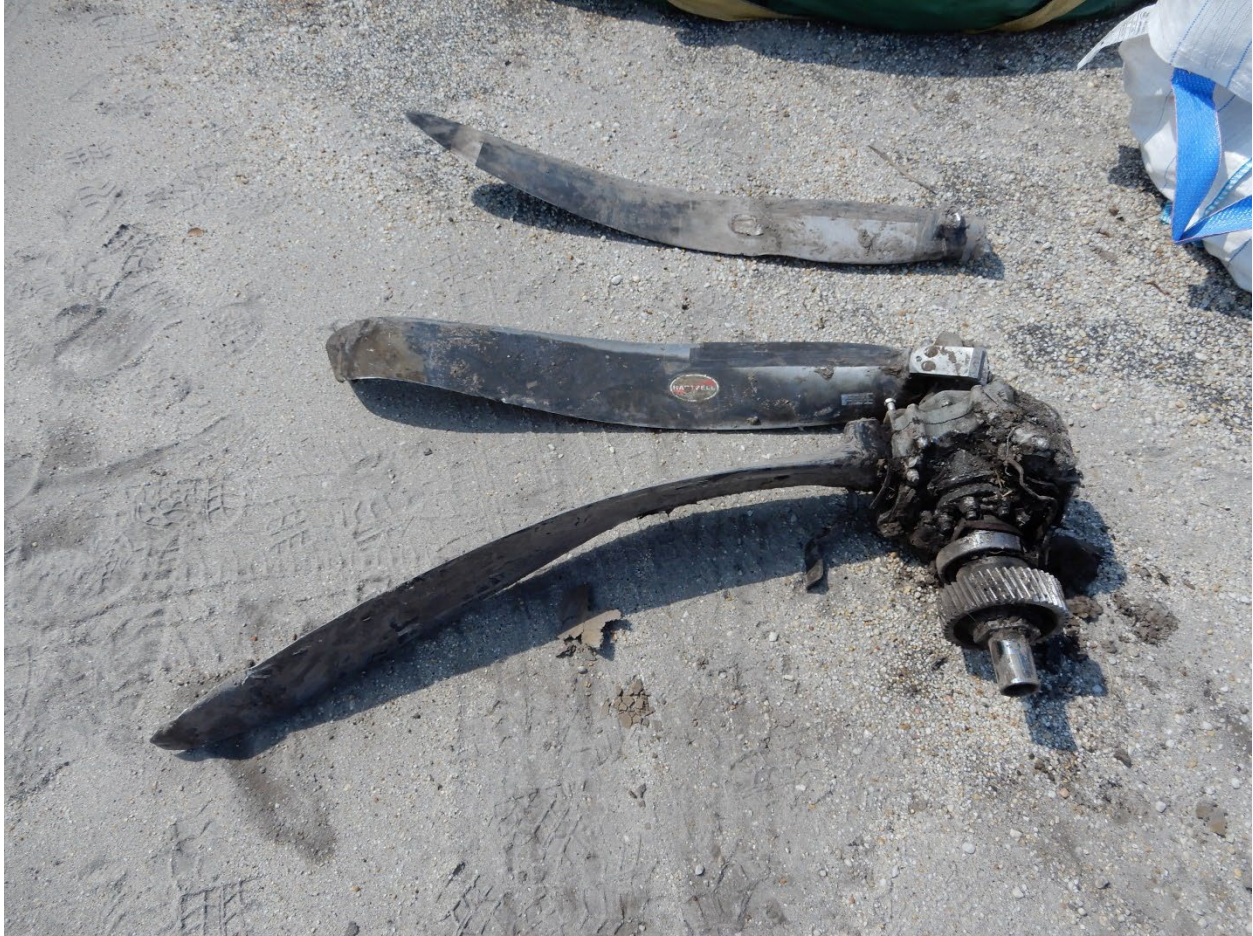
*Figure 11 - Left Propeller*

The left propeller was impact separated from the engine. Two of the 3 blades were separated from the hub. All blades exhibited polishing. One blade was bent forward, one exhibited tip curling, and the last blade was bent aft. The blade that was bent aft remained attached to the propeller hub.

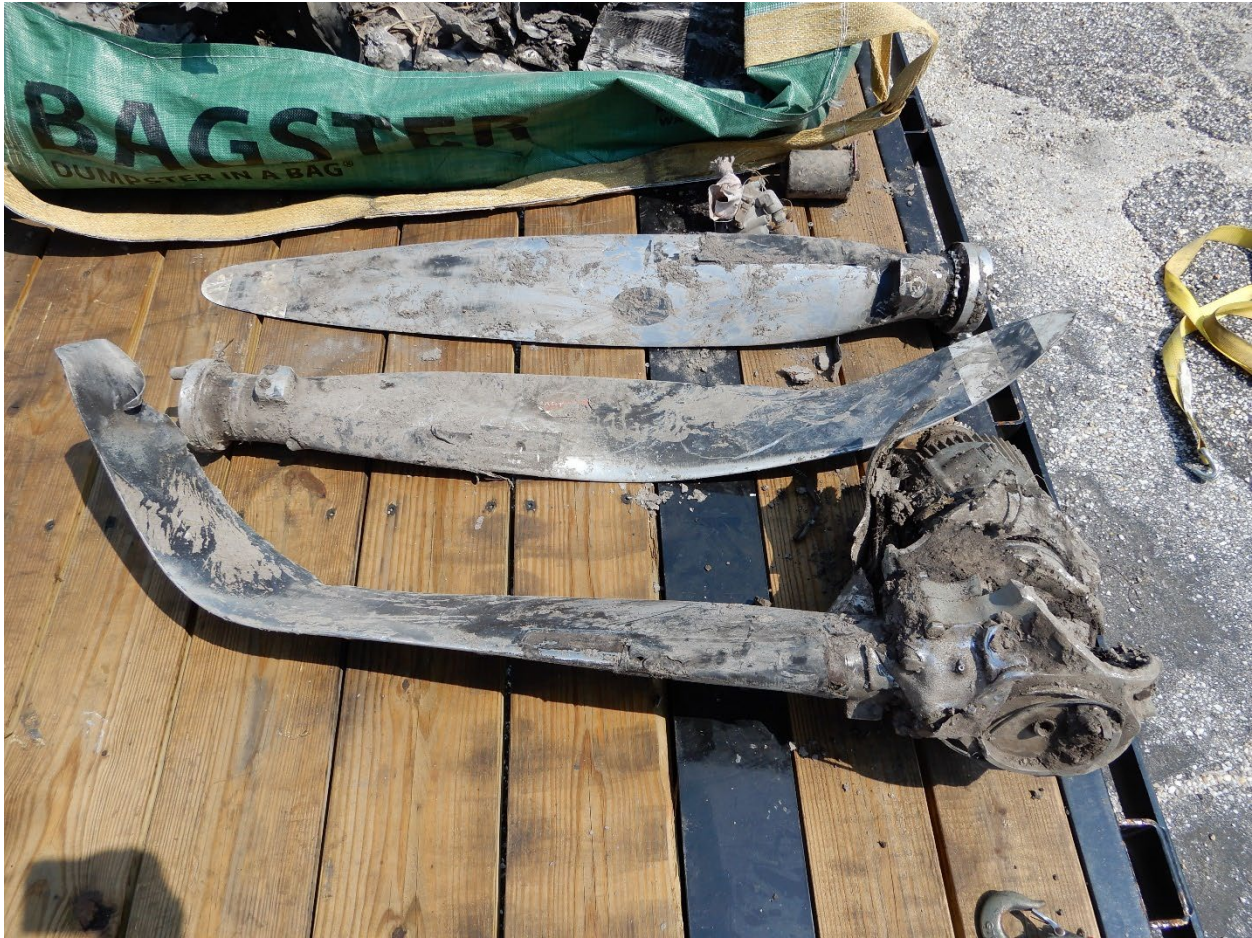
*Figure 12 - Right Propeller*

The right propeller was impact separated from the right engine. Two of the 3 blades were impact separated from the hub. All blades exhibited polishing. One blade was bent forward, one blade was bent aft, and one blade remained straight. The straight blade remained attached to the propeller hub.
