# NATIONAL TRANSPORTATION SAFETY BOARD

## MATERIALS LABORATORY FACTUAL REPORT

Report No. 22-030

Place : Winterville, NC  
Date : 5/22/2021  
Vehicle : Flight Design CTSW, N708JM  
NTSB No. : ERA21FA225  
Investigator : Timothy Monville

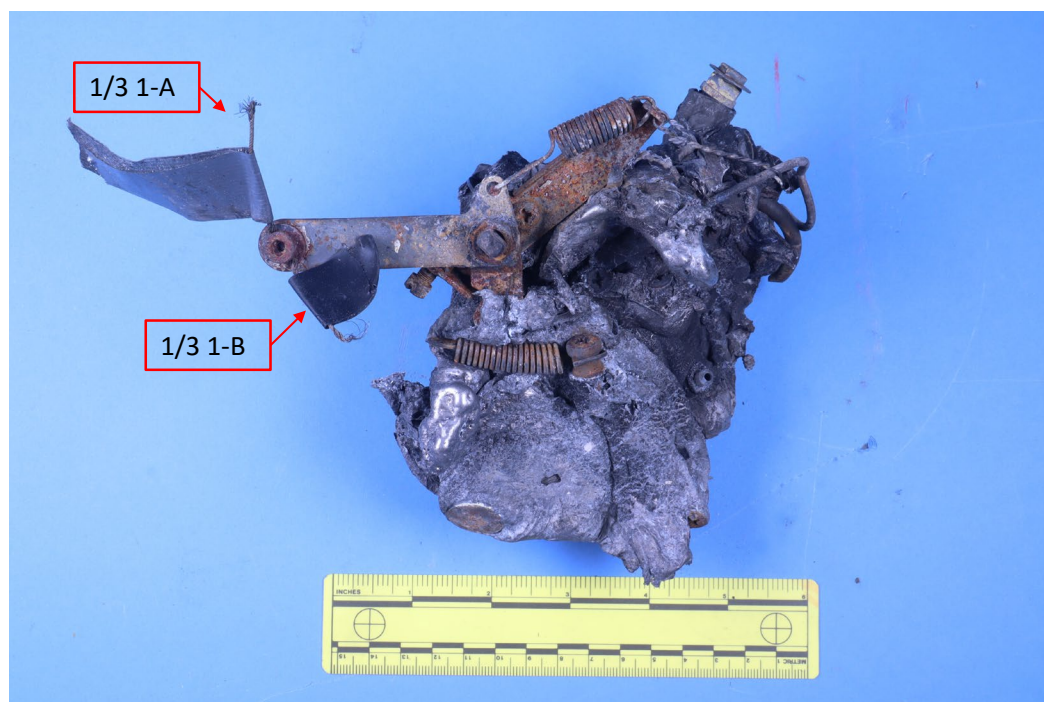
The carburetors submitted for examination had been exposed to a post-crash fire. The aluminum body of carburetor No. 1/3 had mostly melted and formed an amorphous mass with the throttle lever arm and other steel components attached and embedded within the mass (Figure 1). Two portions of control cable were attached to the throttle lever and assigned a label as shown in the figure. The aluminum body of carburetor No. 2/4 exhibited some areas of melting and deformation but overall, still resembled a carburetor body with a throttle lever and a choke lever attached (Figure 2). Two portions of control cable were attached to the each of the throttle and choke levers and these cables were assigned labels as shown in the figure.

Figure 1: Carburetor No. 1/3 with cables labeled.

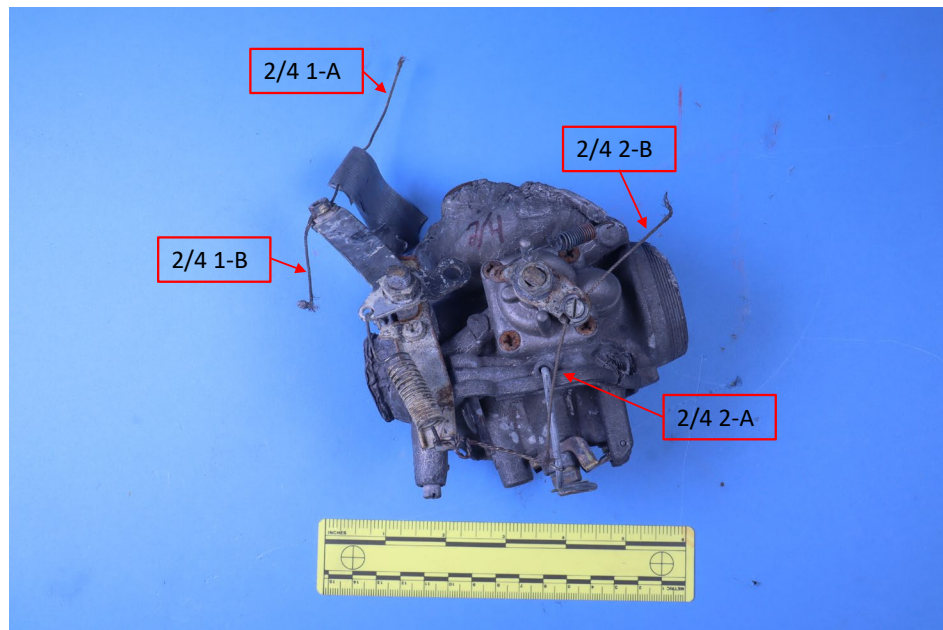
Figure 2: Carburetor No. 2/4 with cables labeled.

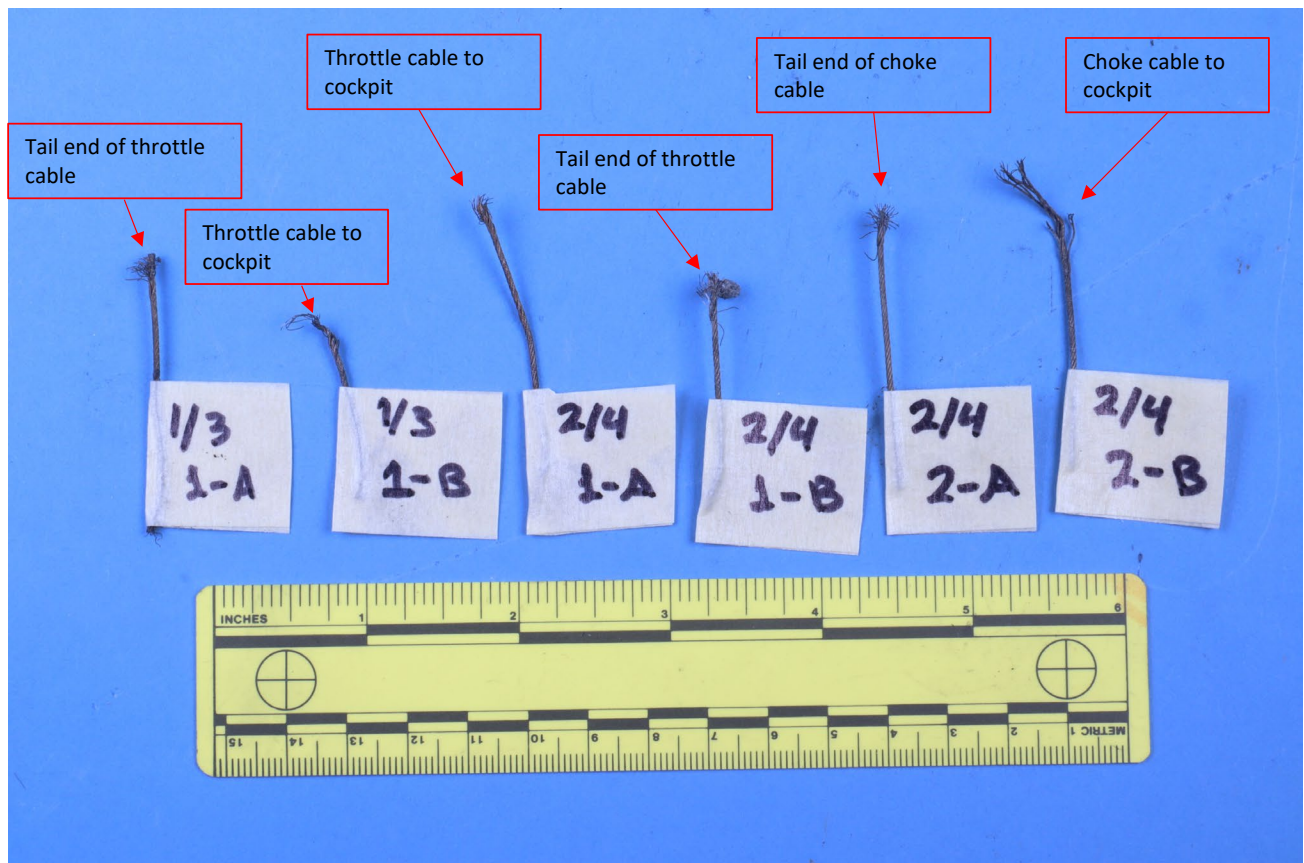
The control cables were cut from their respective lever arms to facilitate microscopic examination. The labeled control cables along with their respective function are shown in Figure 3. The cables described as "tail ends" were the portions of the control cables that extended past the lever arms and terminated. These cable tail ends exhibited chisel point fractures of the wires consistent with having been cut with a wire cutter tool.

Figure 3: Control cables after separation from carburetors.

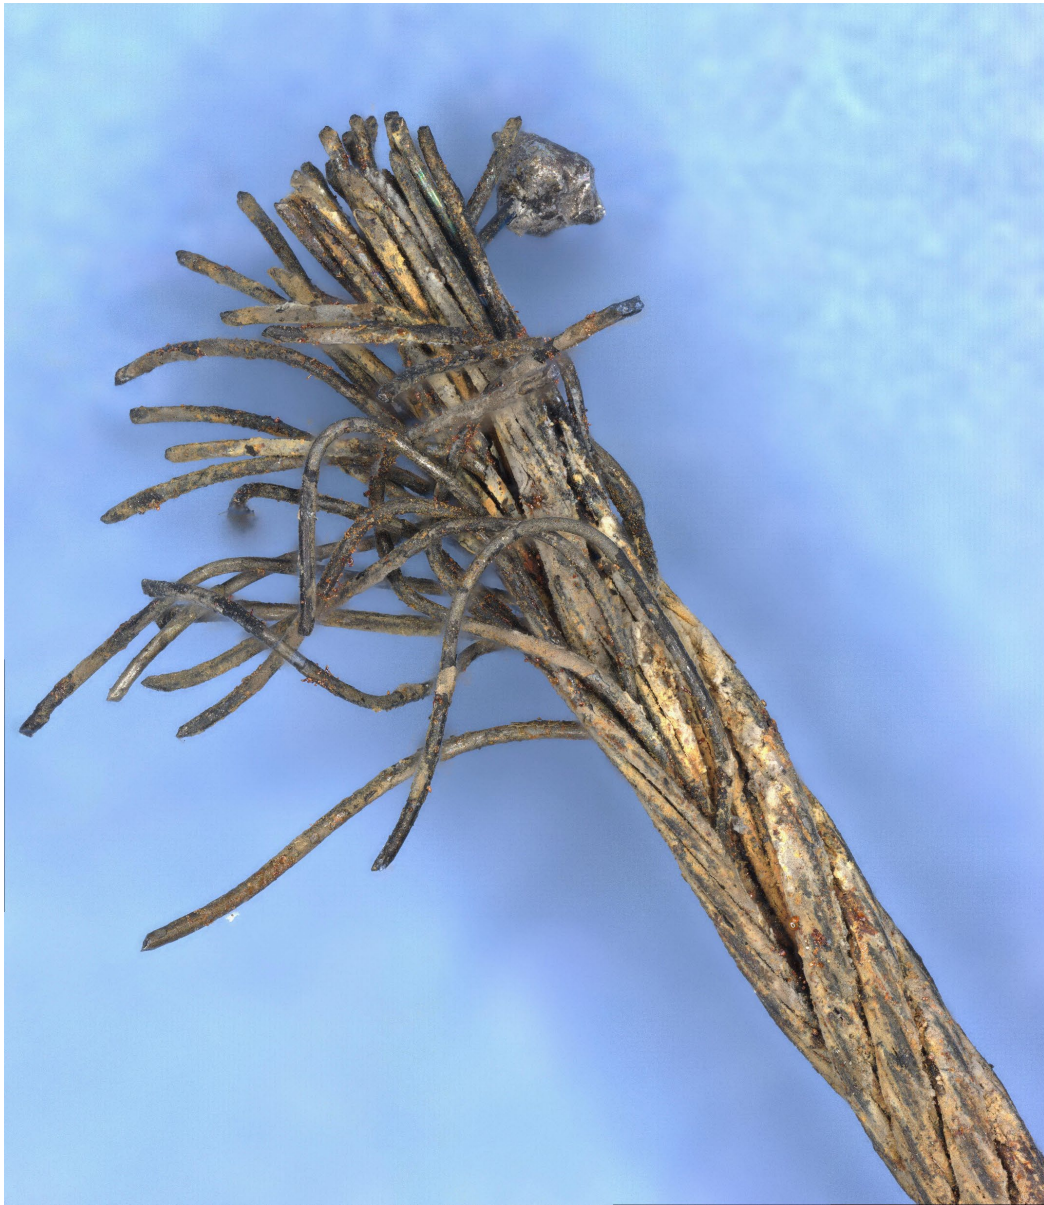
Figure 4: Cable 1/3 1-A (overall view).

Cable 1/3 1-A (Figures 4, 5) exhibited wires with chisel point fracture surfaces consistent with having been cut with wire cutters.

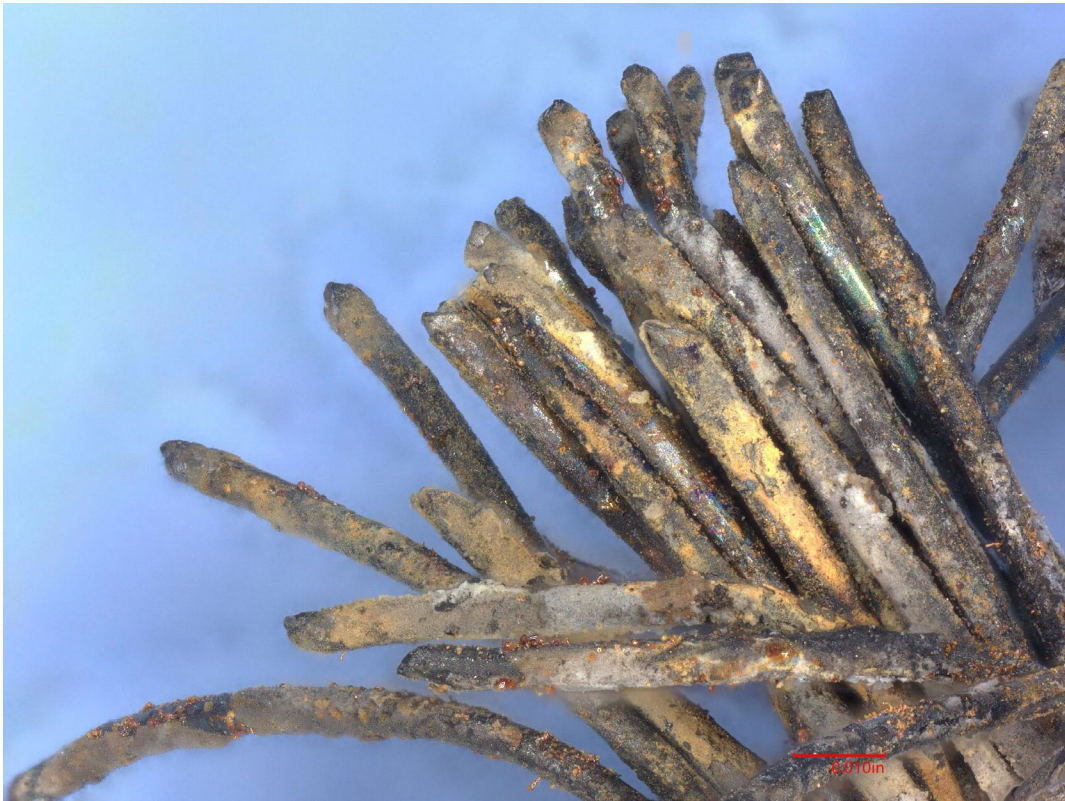
Figure 5: Wires from cable 1/3 1-A exhibiting chisel point fractures.

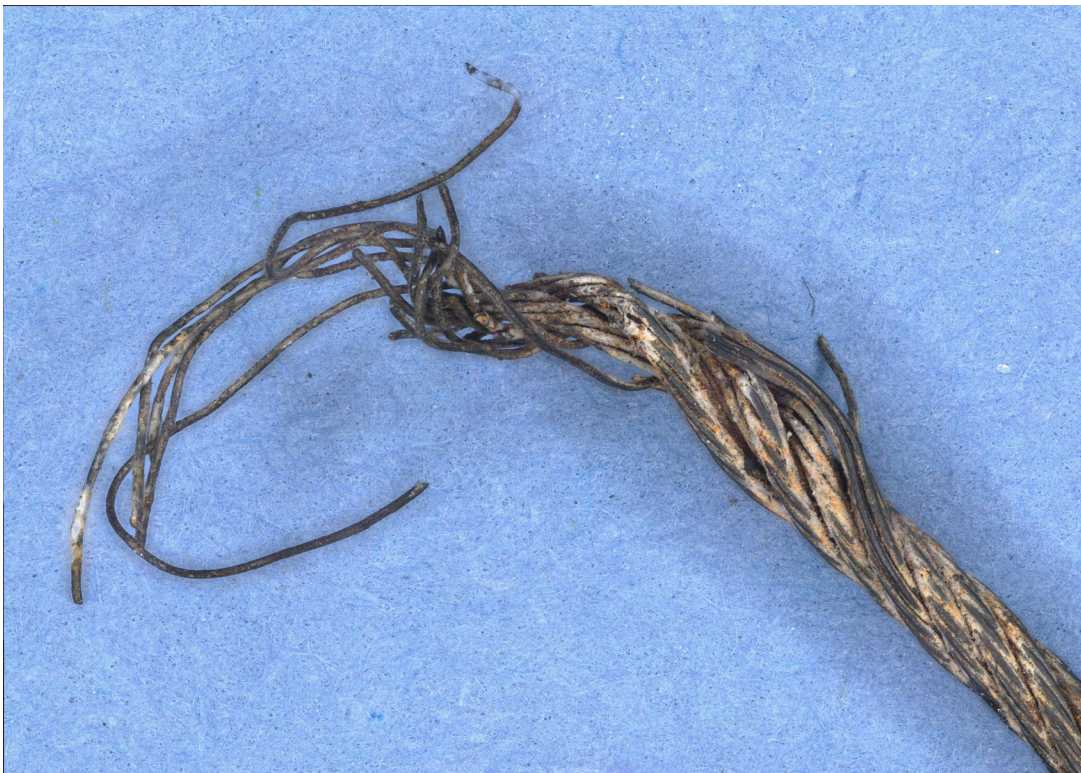
Figure 6: Cable 1/3 1-B (overall view).

Cable 1/3 1-B (Figures 6, 7) exhibited wires with necking down towards the fracture. The fractures were distributed along varying lengths along the cable. The fractures exhibited cup shapes in some instances as well as slant fractures. The failure mode of cable 1/3 1-B is consistent with overstress.

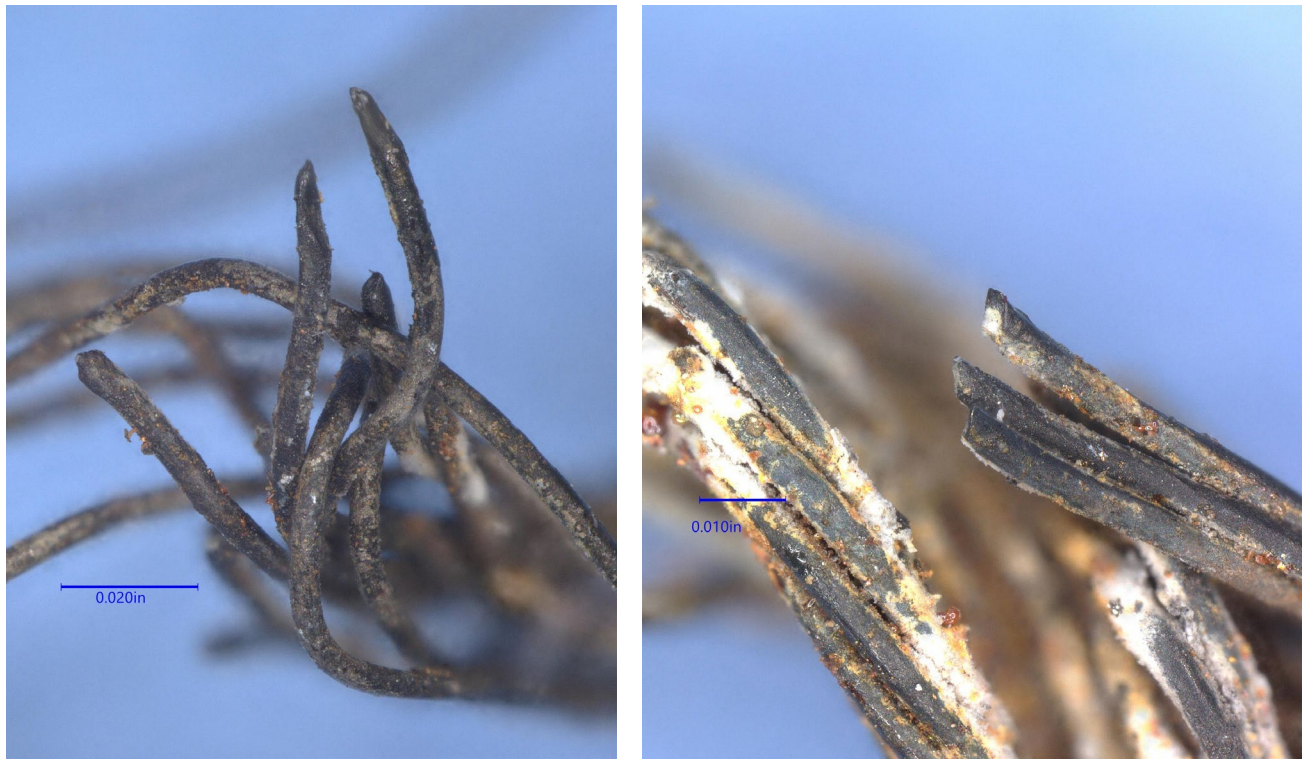
Figure 7: Wires from cable 1/3 1-B exhibiting necking, cup, and slant fractures.

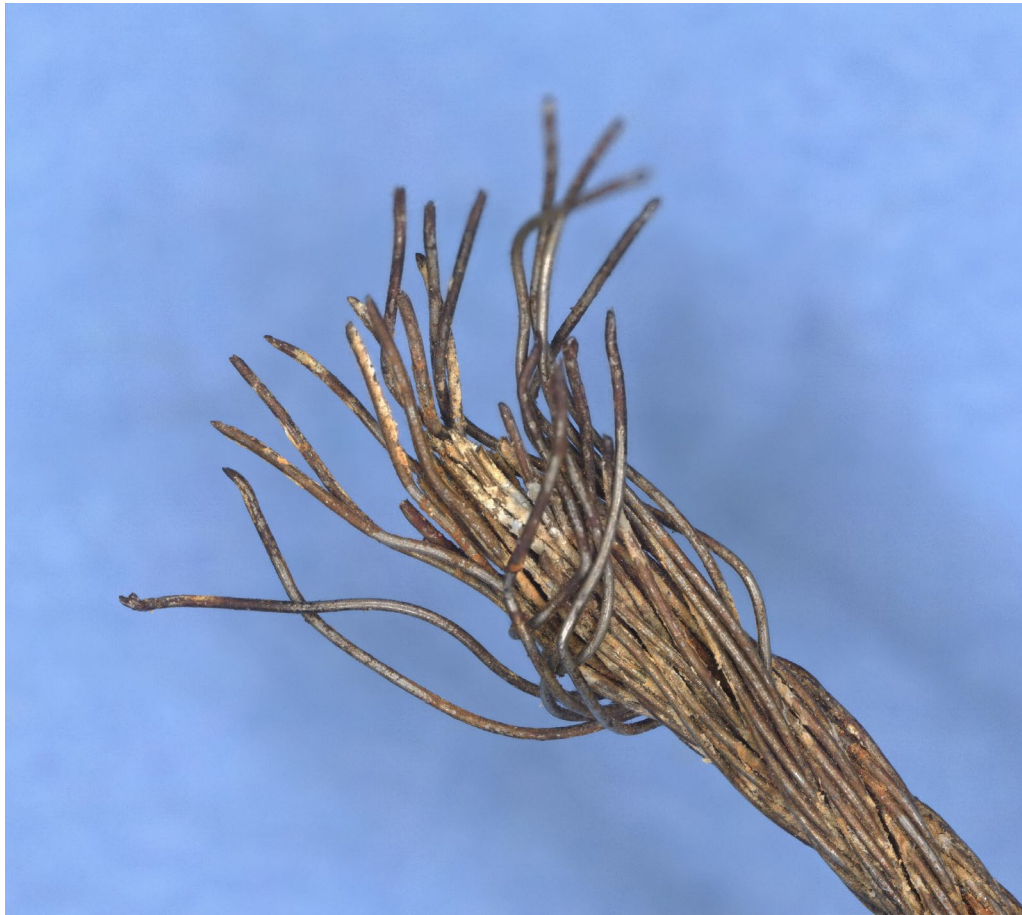
Figure 8: Cable 2/4 1-A (overall view).

Cable 2/4 1-A (Figures 8, 9) exhibited wires with necking down towards the fracture. The fractures were distributed along varying lengths along the cable. The fractures exhibited cup shapes in some instances as well as slant fractures. The failure mode of cable 2/4 1-A is consistent with overstress.

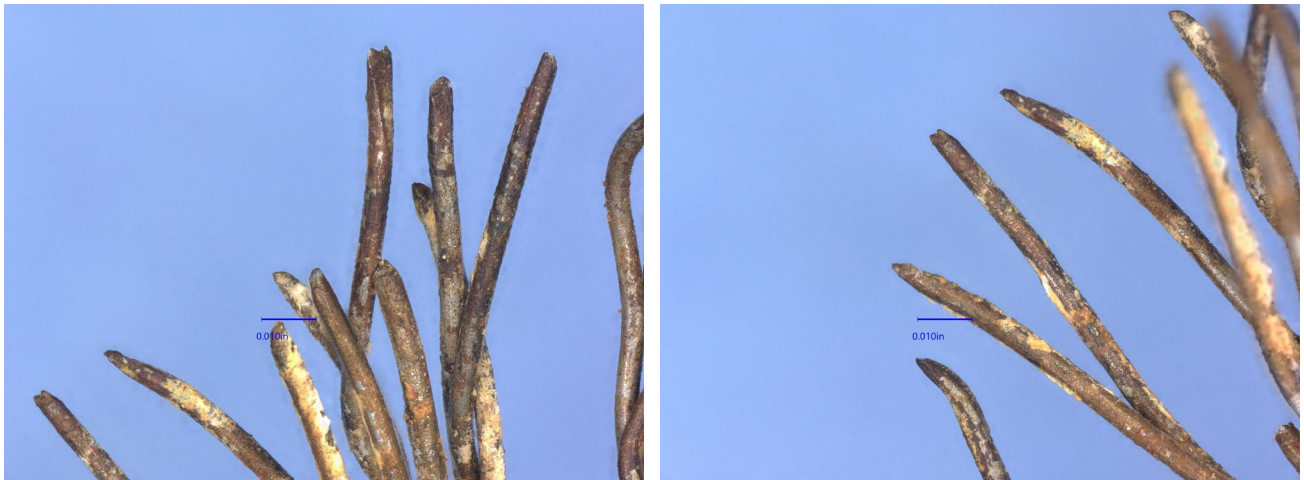
Figure 9: Wires from 2/4 1-A exhibiting necking, cup, and slant fractures.

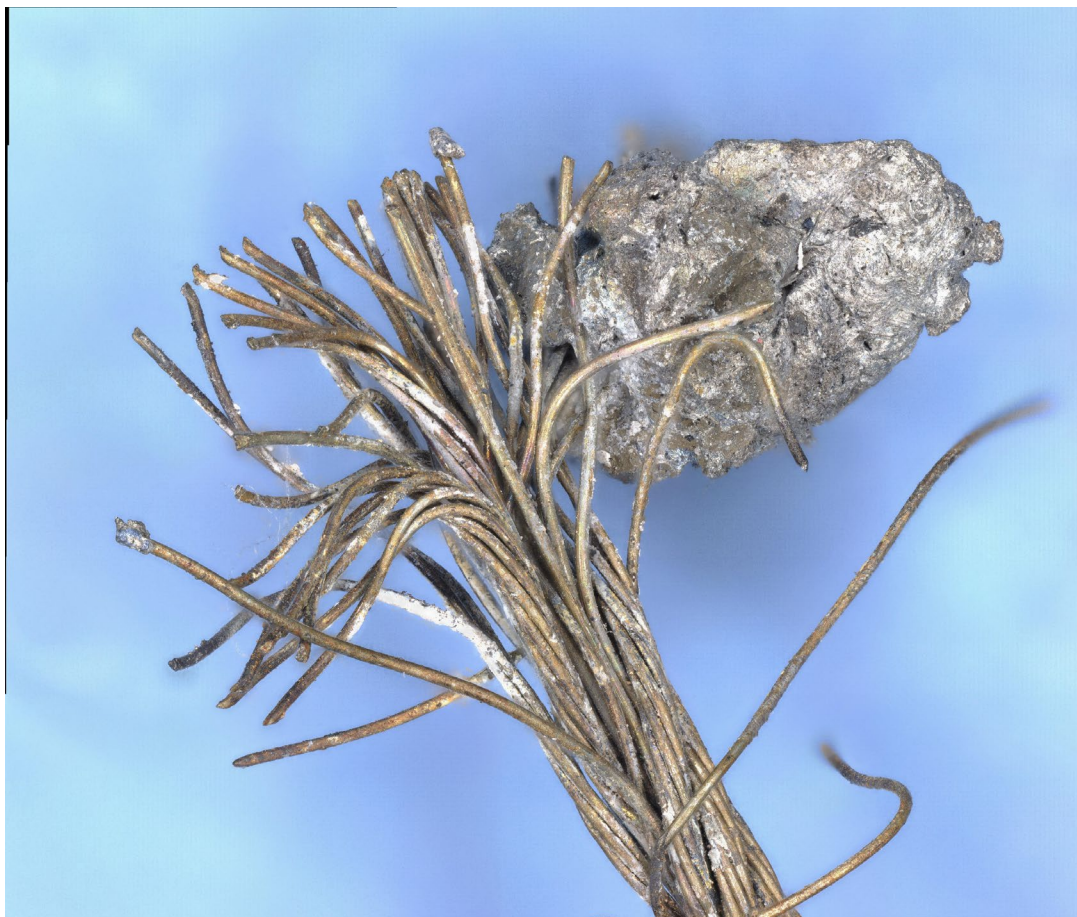
Figure 10: Cable 2/4 1-B (overall view).

Cable 2/4 1-B (Figures 10, 11) exhibited wires with chisel point fracture surfaces consistent with having been cut with wire cutters.

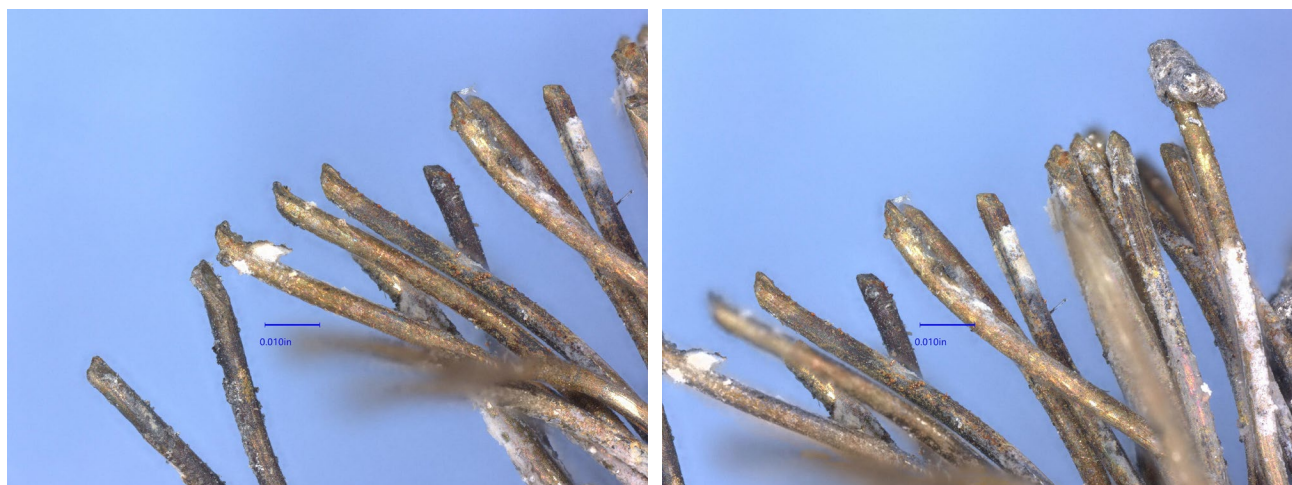
Figure 11: Wires from 2/4 1-B exhibiting chisel point fractures.

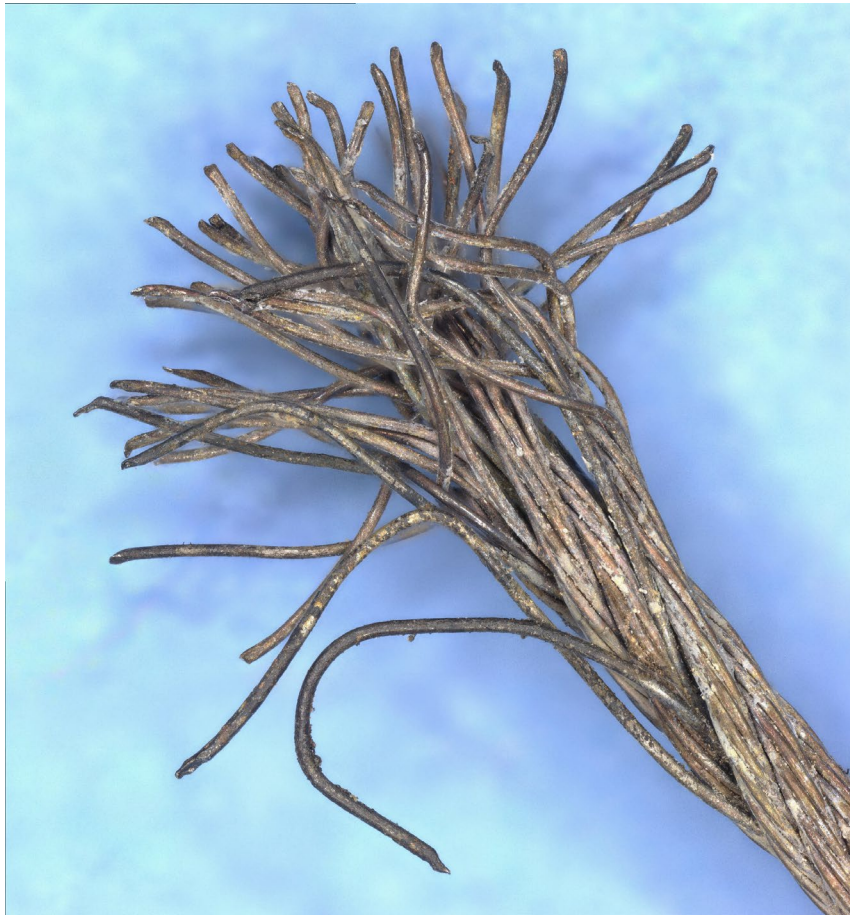
Figure 12: Cable 2/4 2-A overall view.

Cable 2/4 2-A (Figures 12, 13) exhibited wires with chisel point fracture surfaces consistent with having been cut with wire cutters.

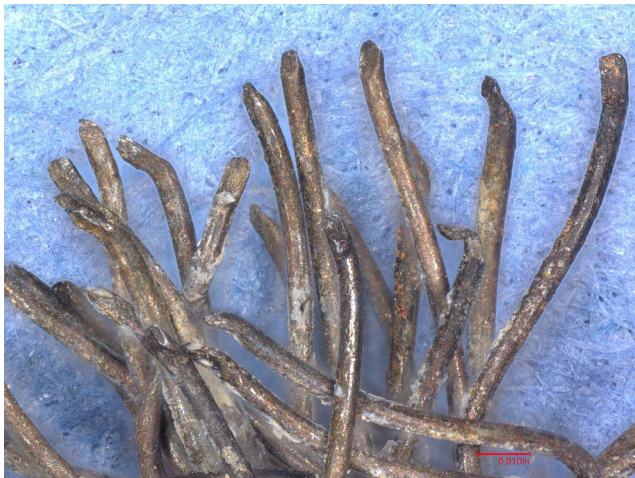
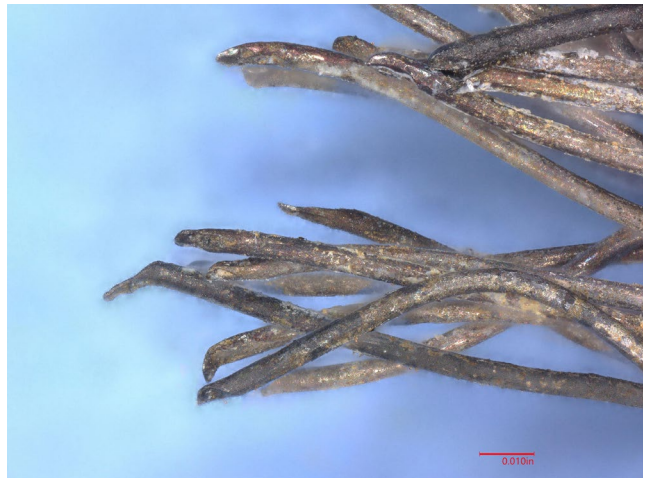
Figure 13: Wires from 2/4 2-A exhibiting chisel point fractures on the ends.

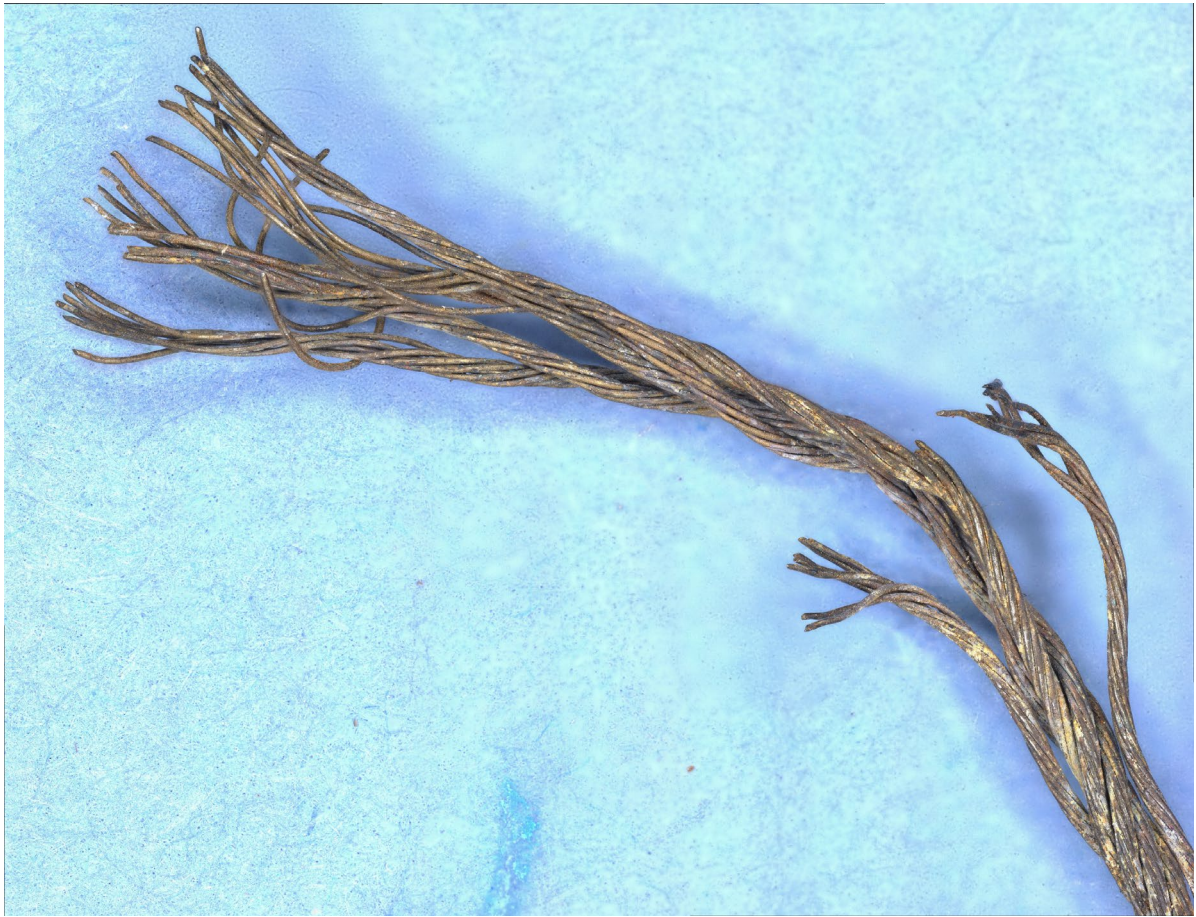
Figure 14: Cable 2/4 2-B overall view.

Cable 2/4 2-B (Figures 14, 15) exhibited wires with necking down towards the fracture. The fractures were distributed along varying lengths along the cable. The fractures exhibited cup shapes in some instances as well as slant fractures. The failure mode of cable 2/4 2-B is consistent with overstress.

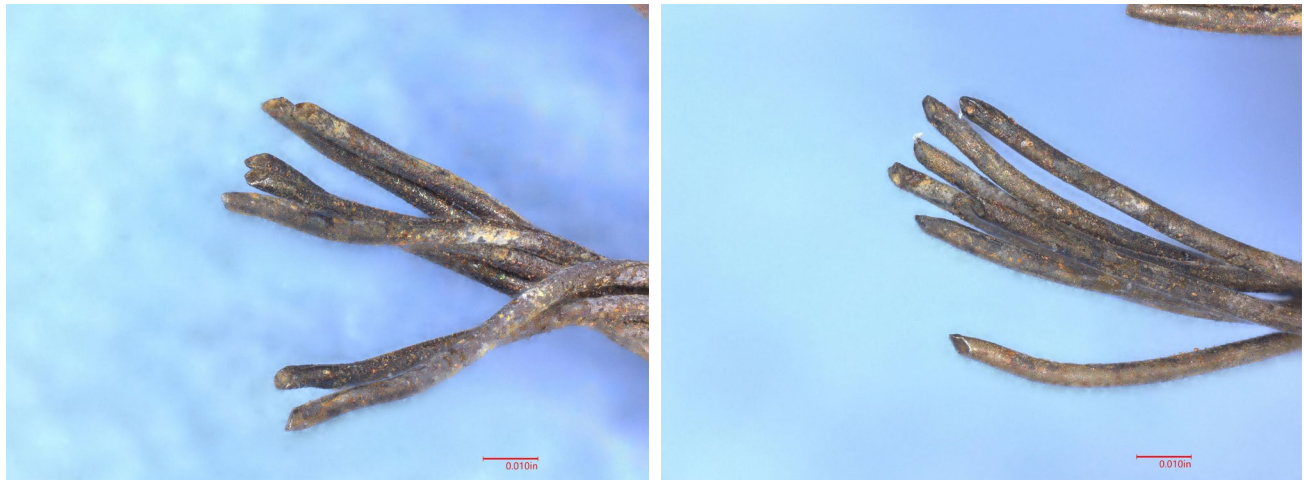
Figure 15: Wires from 2/4 2-B exhibiting necking and slant fractures.
