## Memorandum For Record

**Date: March 23, 2023**  
**NTSB Accident Number: ERA21FA225**

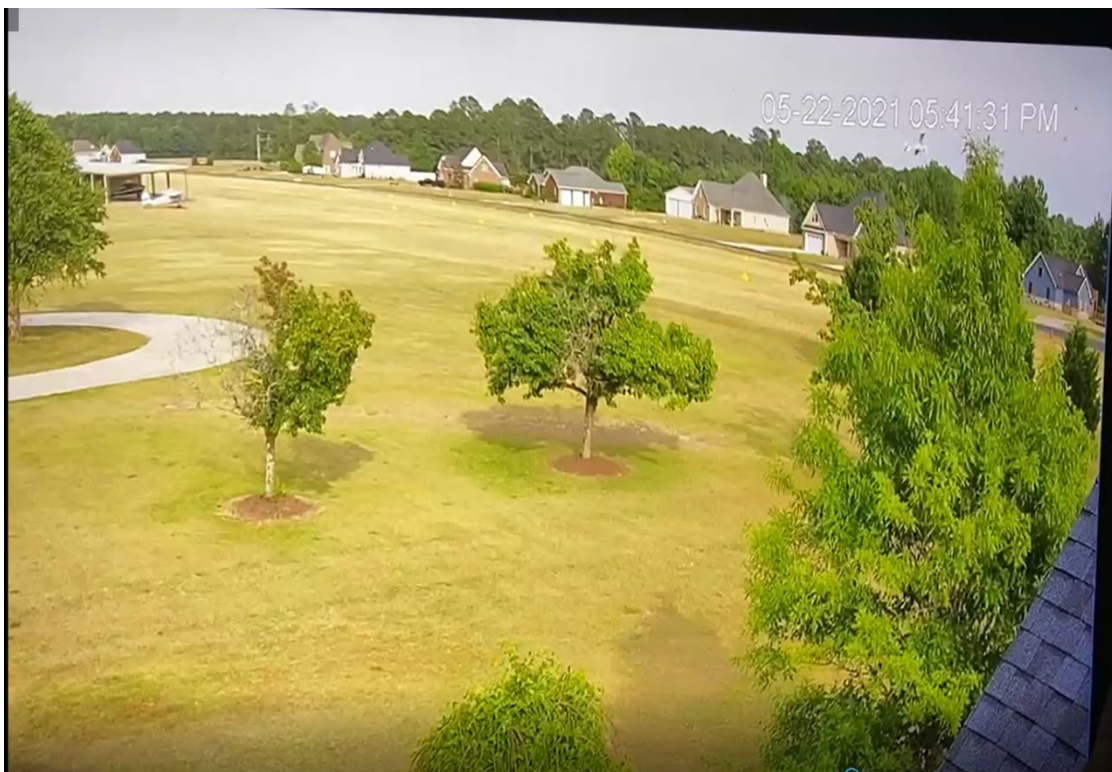
IMG\_1663 - The 1 minutes 19 seconds long video without sound was recorded on a hand-held device. The video had a view looking to the east and at the start of the video the airplane was on short final approach descending to the runway. At 10 seconds elapsed time the airplane went out of view then re-emerged at 19 seconds elapsed time on the runway during the landing roll. The video continued to record the airplane on the runway then at 24 seconds elapsed time while on the runway in a nose-high attitude, the airplane began a climbing left turn. The airplane climbed to an estimated altitude of between 50 and 100 ft while still banking left and in a nose-high attitude. The airplane began a left descending turn with the bank angle increasing to past 45° (Figure 1). While descending the bank angle increased to about 90° and the airplane went out of view at 51 seconds elapsed time or as depicted on the clock at 1741:34. At 1 minute 3 seconds elapsed time of as depicted on the clock at 1741:41 black smoke was seen rising above trees in the area where the airplane was last noted in the video. The video ended at the displayed clock time of 1741:49.

Figure 1: Screenshot from Video IMG\_1663 Depicting Left Bank During Go-Around. Note The Bank Angle Greater Than 45°.

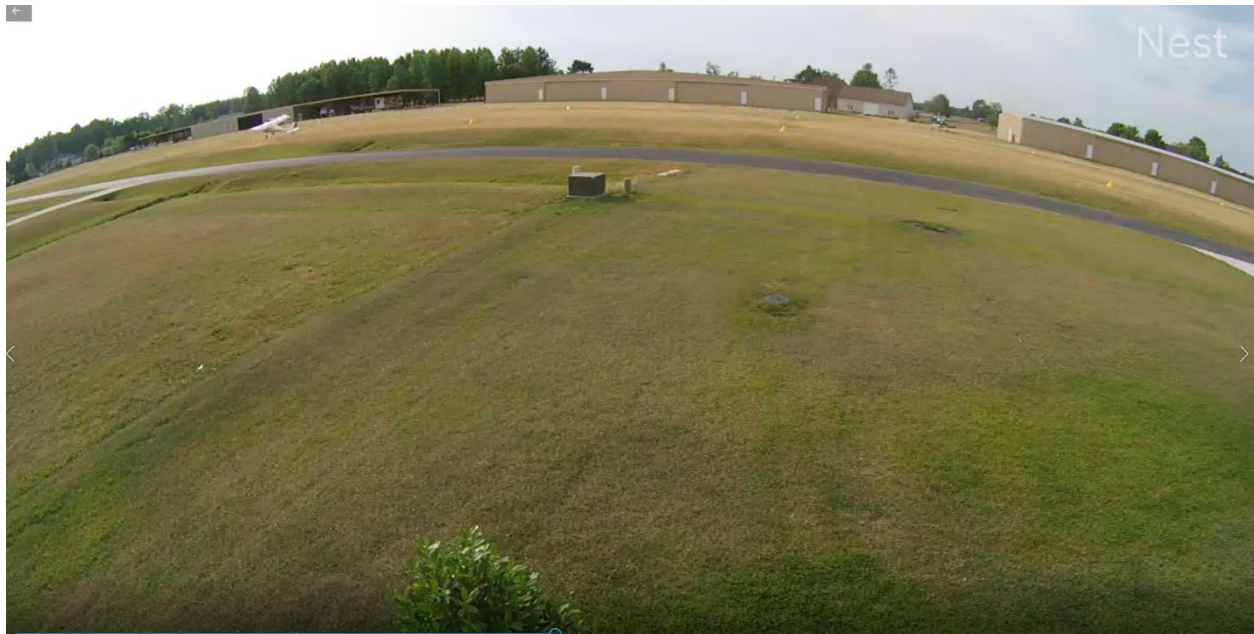
IMG\_1628 - The 1 minute long video without sound had a view looking north and west. At about 22 seconds elapsed time the front portion of the airplane came into view. Almost immediately after coming into view the airplane went from a slight tail low to nose level attitude. The airplane remained on the runway then at 26 seconds elapsed time the airplane was in a nose-high, tail low attitude described by the head of airworthiness of flight design of the airplane as a “very high angle of attack” (AOA). At 27 seconds elapsed time the airplane departed the runway just past a culvert of the left side of the runway located at 35.482392° north latitude and - 77.354444° west longitude (Figure 2). The airplane began to climb and went out of view of the camera at 30 seconds elapsed time. The head of airworthiness of flight design of the airplane also reported that a ground roll of about 5 seconds was a minimal amount to set the flaps and go-around. No other aircraft were noted on the runway before or after the accident airplane.

Figure 2: Screenshot from Video IMG\_1628 Depicting the Rotation Point Along the Runway.

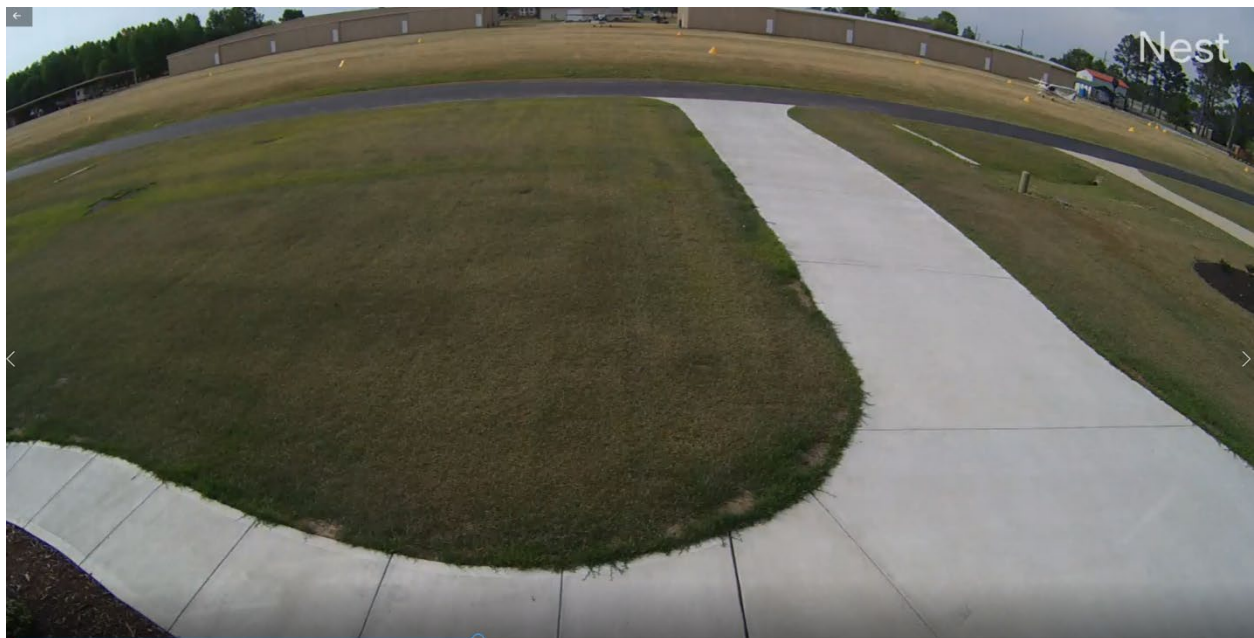
seconds elapsed time, the front portion of the airplane was just in view. The airplane at that time was about 10 ft above the runway just before the approach end of the runway. The airplane continued descending and touched down between the 1<sup>st</sup> and 2<sup>nd</sup> cones on the left side of the runway (Figure 3), or at 35.482662° north latitude and -77.353357° west longitude or about 122 ft from the approach end of the runway. After touchdown the airplane went from a slight tail low to nose level attitude then continued along the runway. At about 28 seconds elapsed time the airplane began a tail low and nose-high attitude then was lost from camera view at about 30 seconds elapsed time. The head of airworthiness of flight design of the airplane reported, “nice flare on landing indicates quite a low airspeed on touchdown.”

Figure 3: Screenshot from Video IMG\_1629 Depicting the Touchdown Point Along the Runway Between the 1<sup>st</sup> and 2<sup>nd</sup> Cones.
