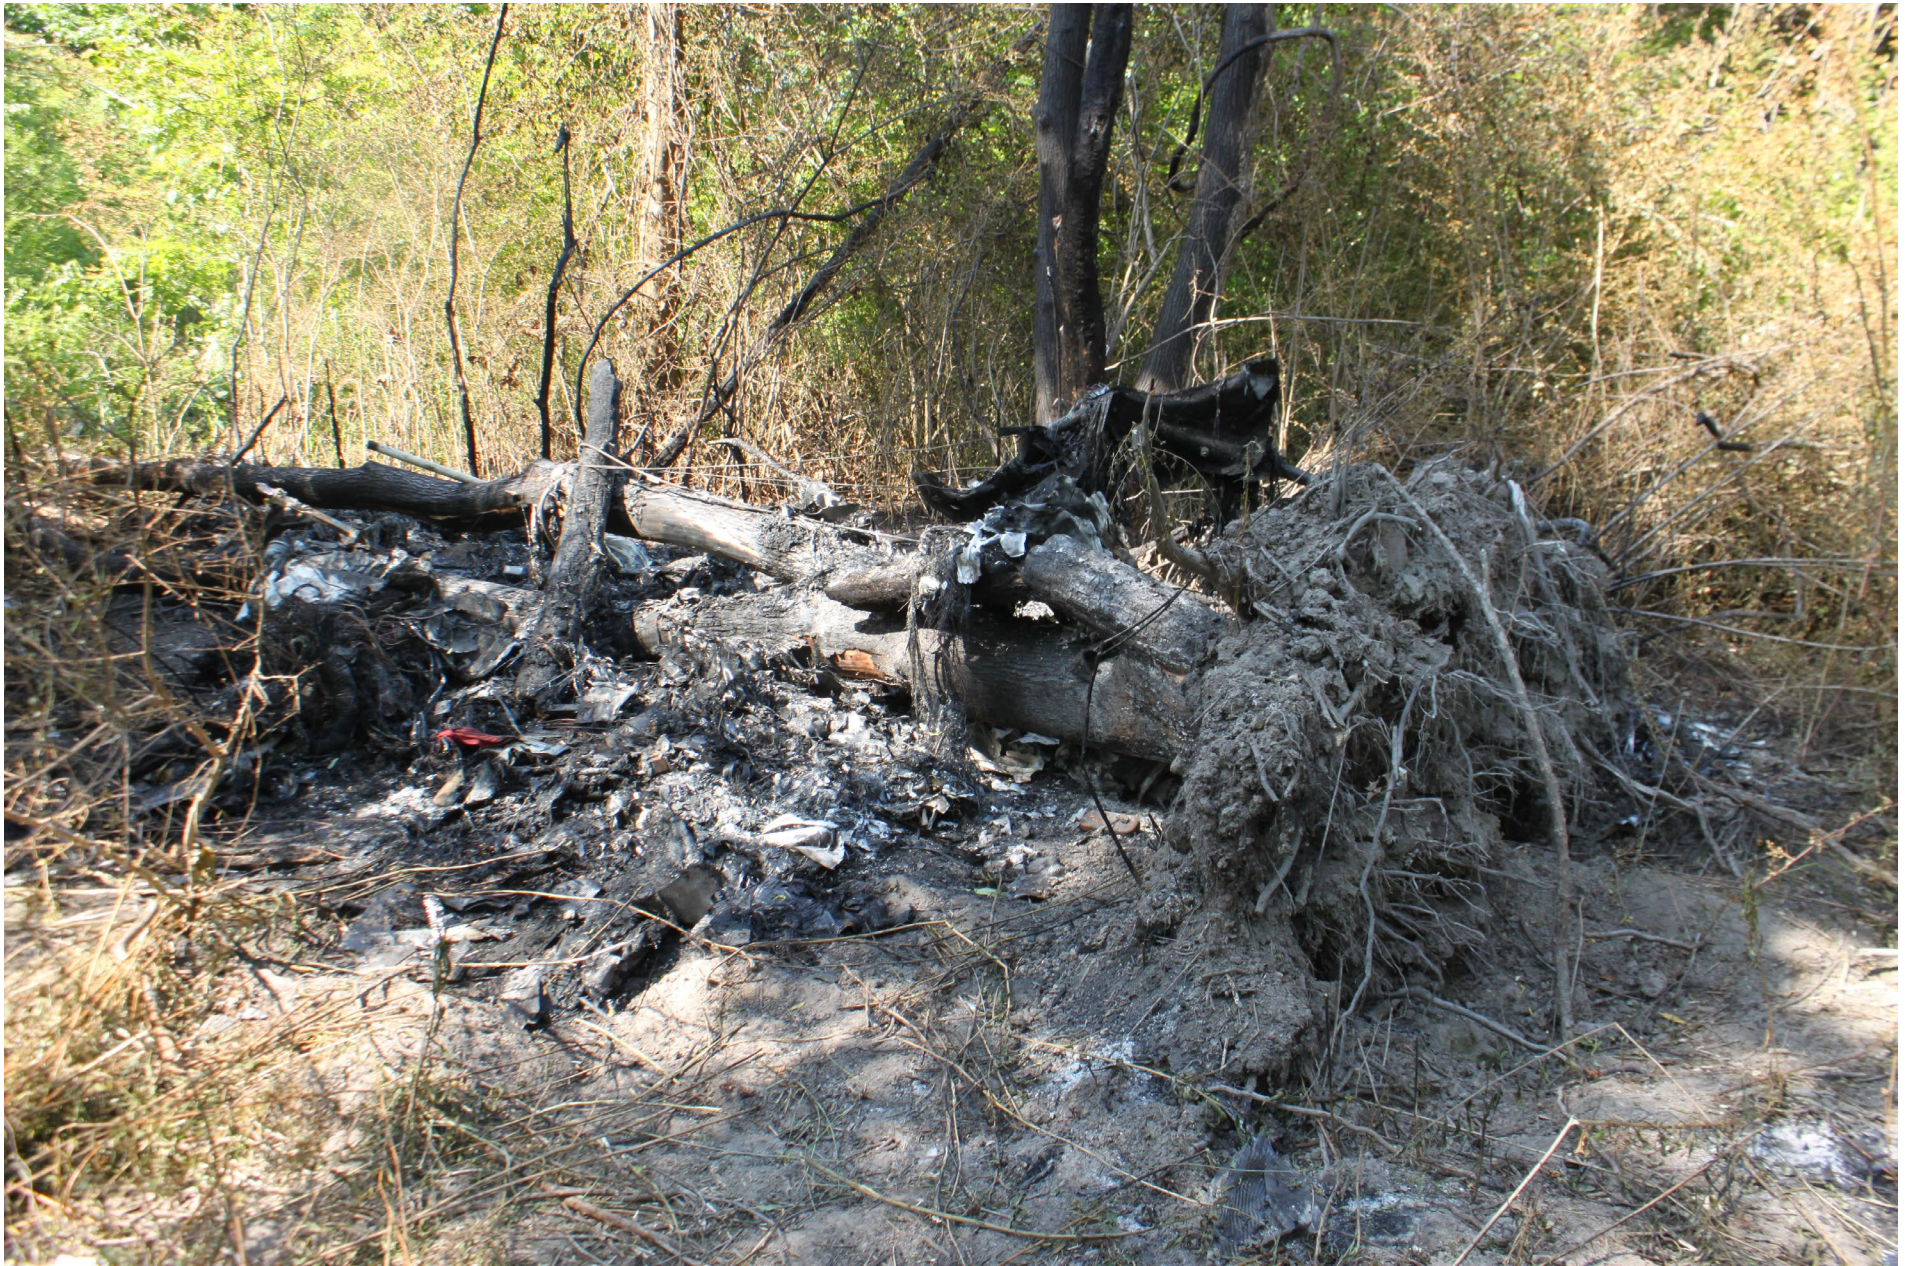
**Photo 1 – NTSB Digital Photograph. View of the Accident Site Depicting the nearly Consumed Airframe and Downed Tree.**

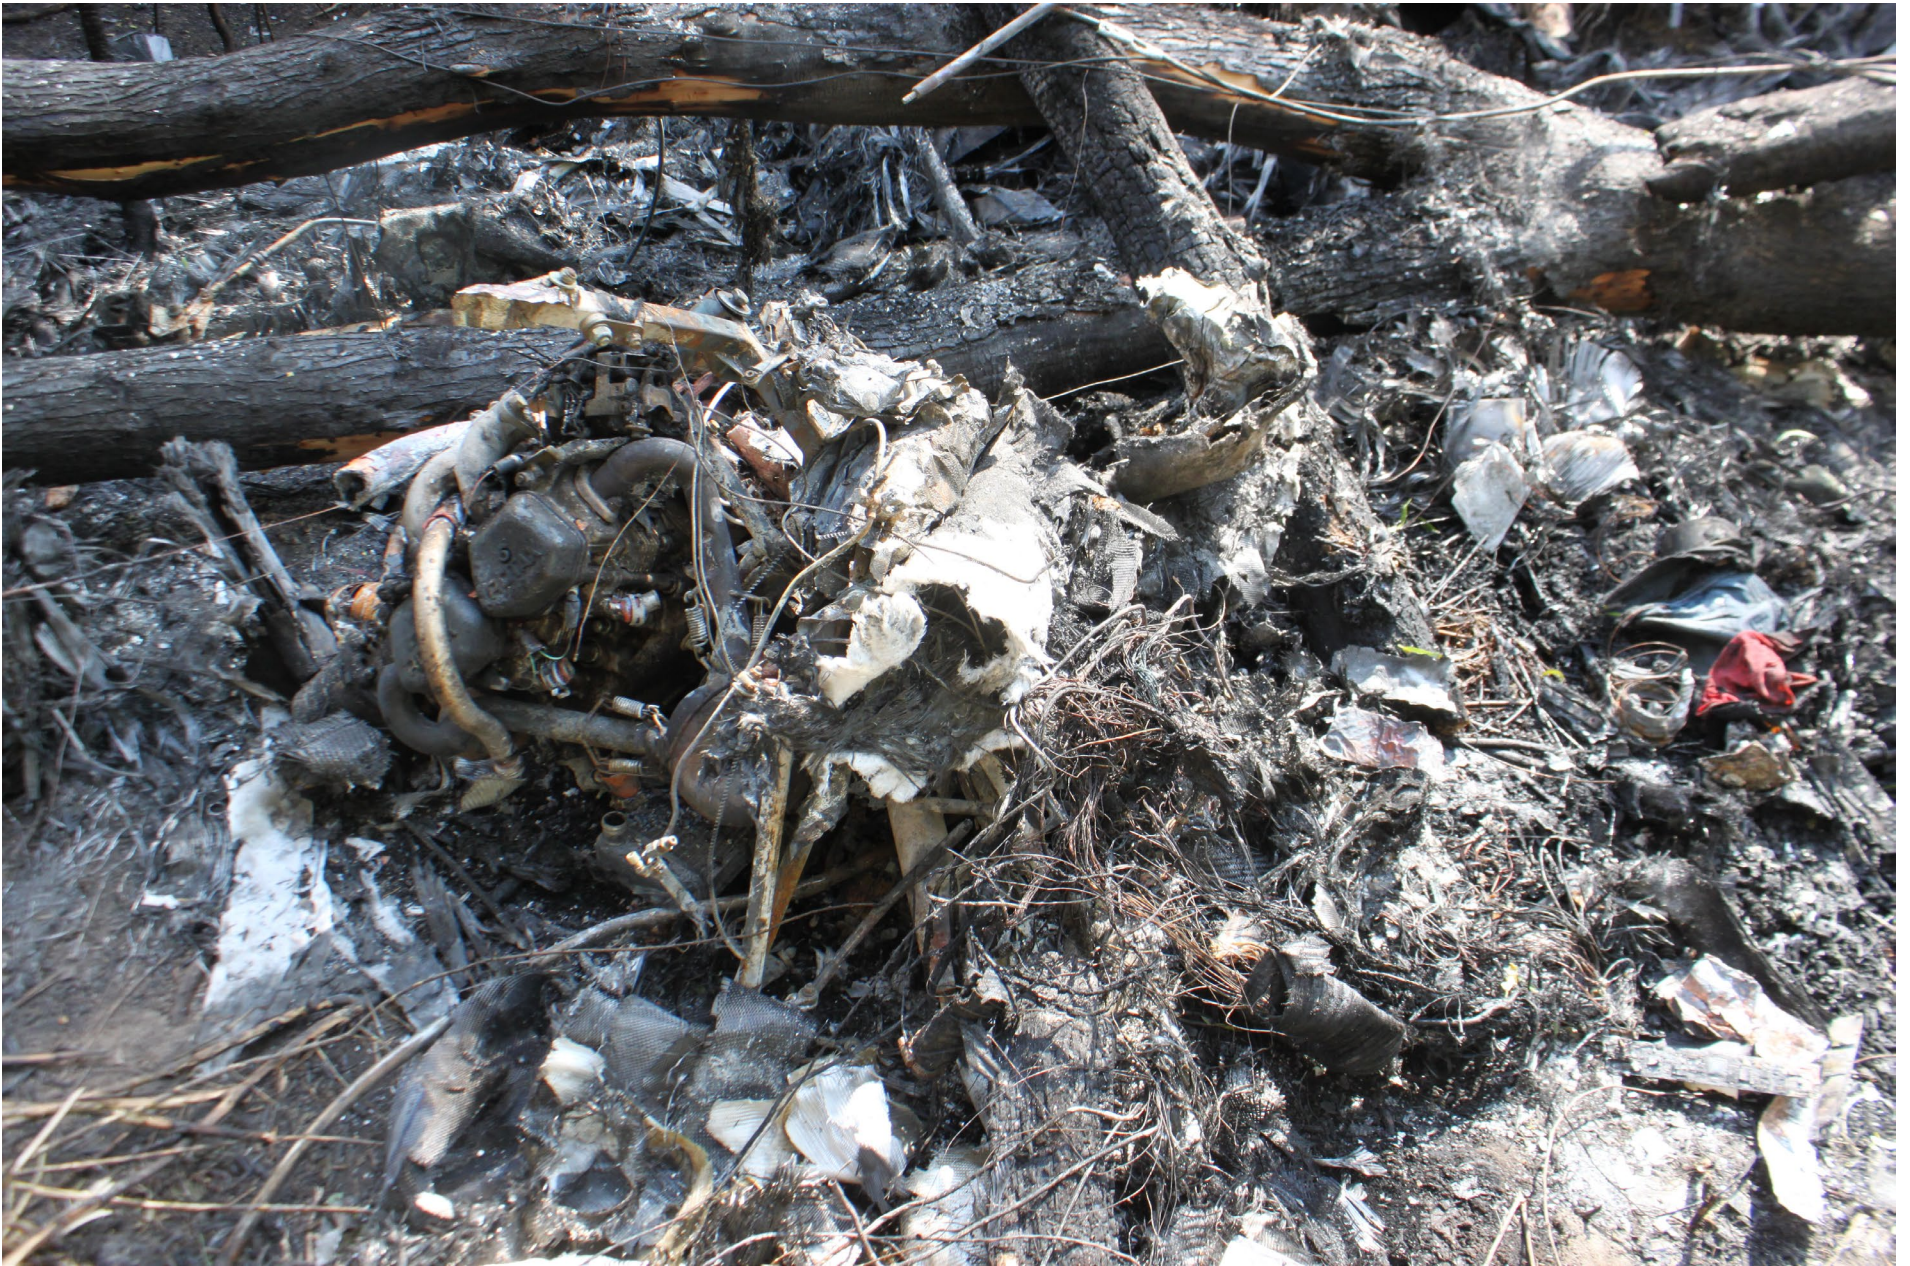
**Photo 2 - NTSB Digital Photograph. View of the Extensively Heat Damaged Engine Assembly At the Accident Site.**

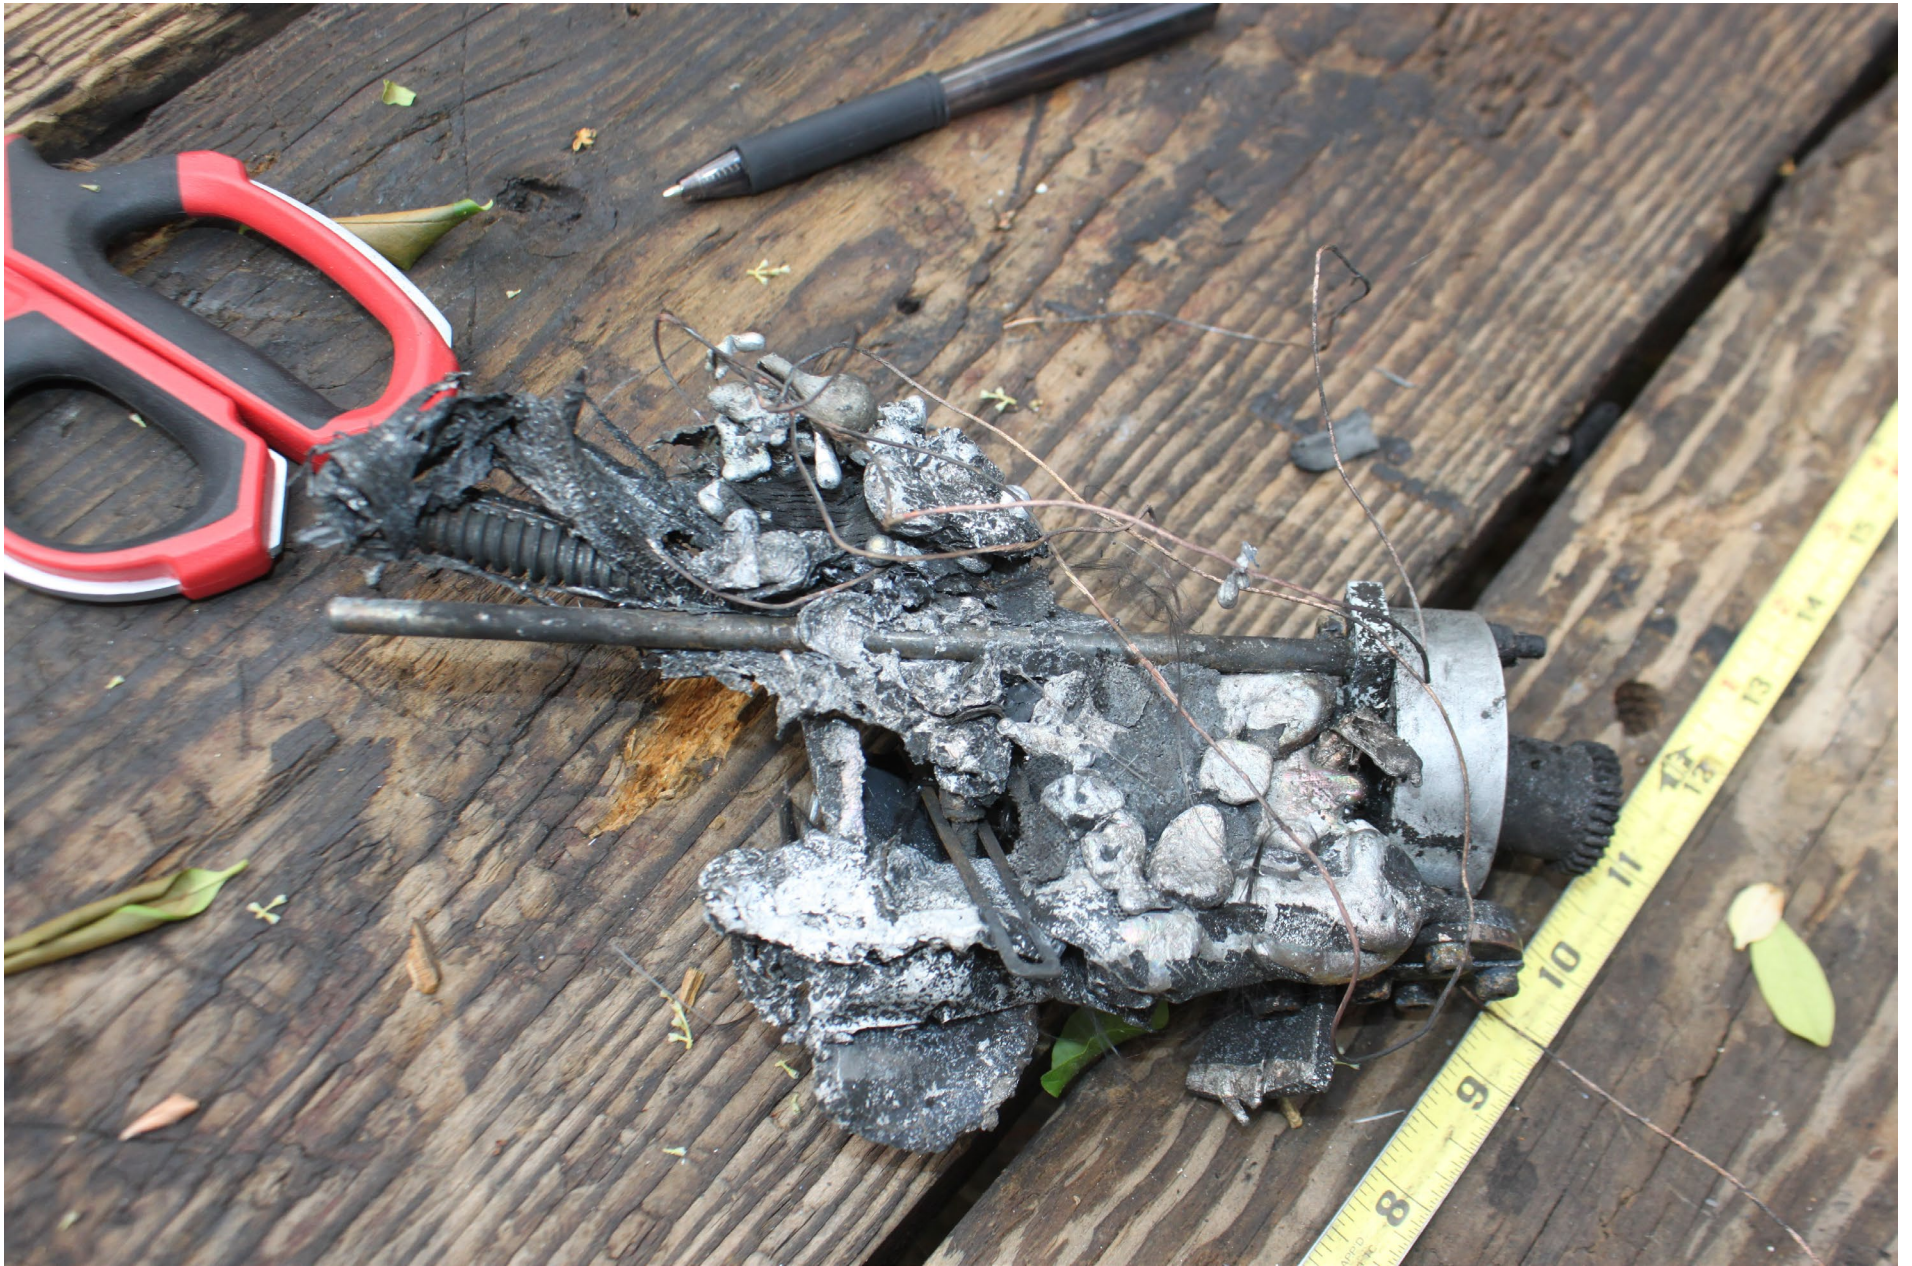
**Photo 3 - NTSB Digital Photograph. View of the Extensively Heat Damaged Flap Motor/Actuator Assembly.**

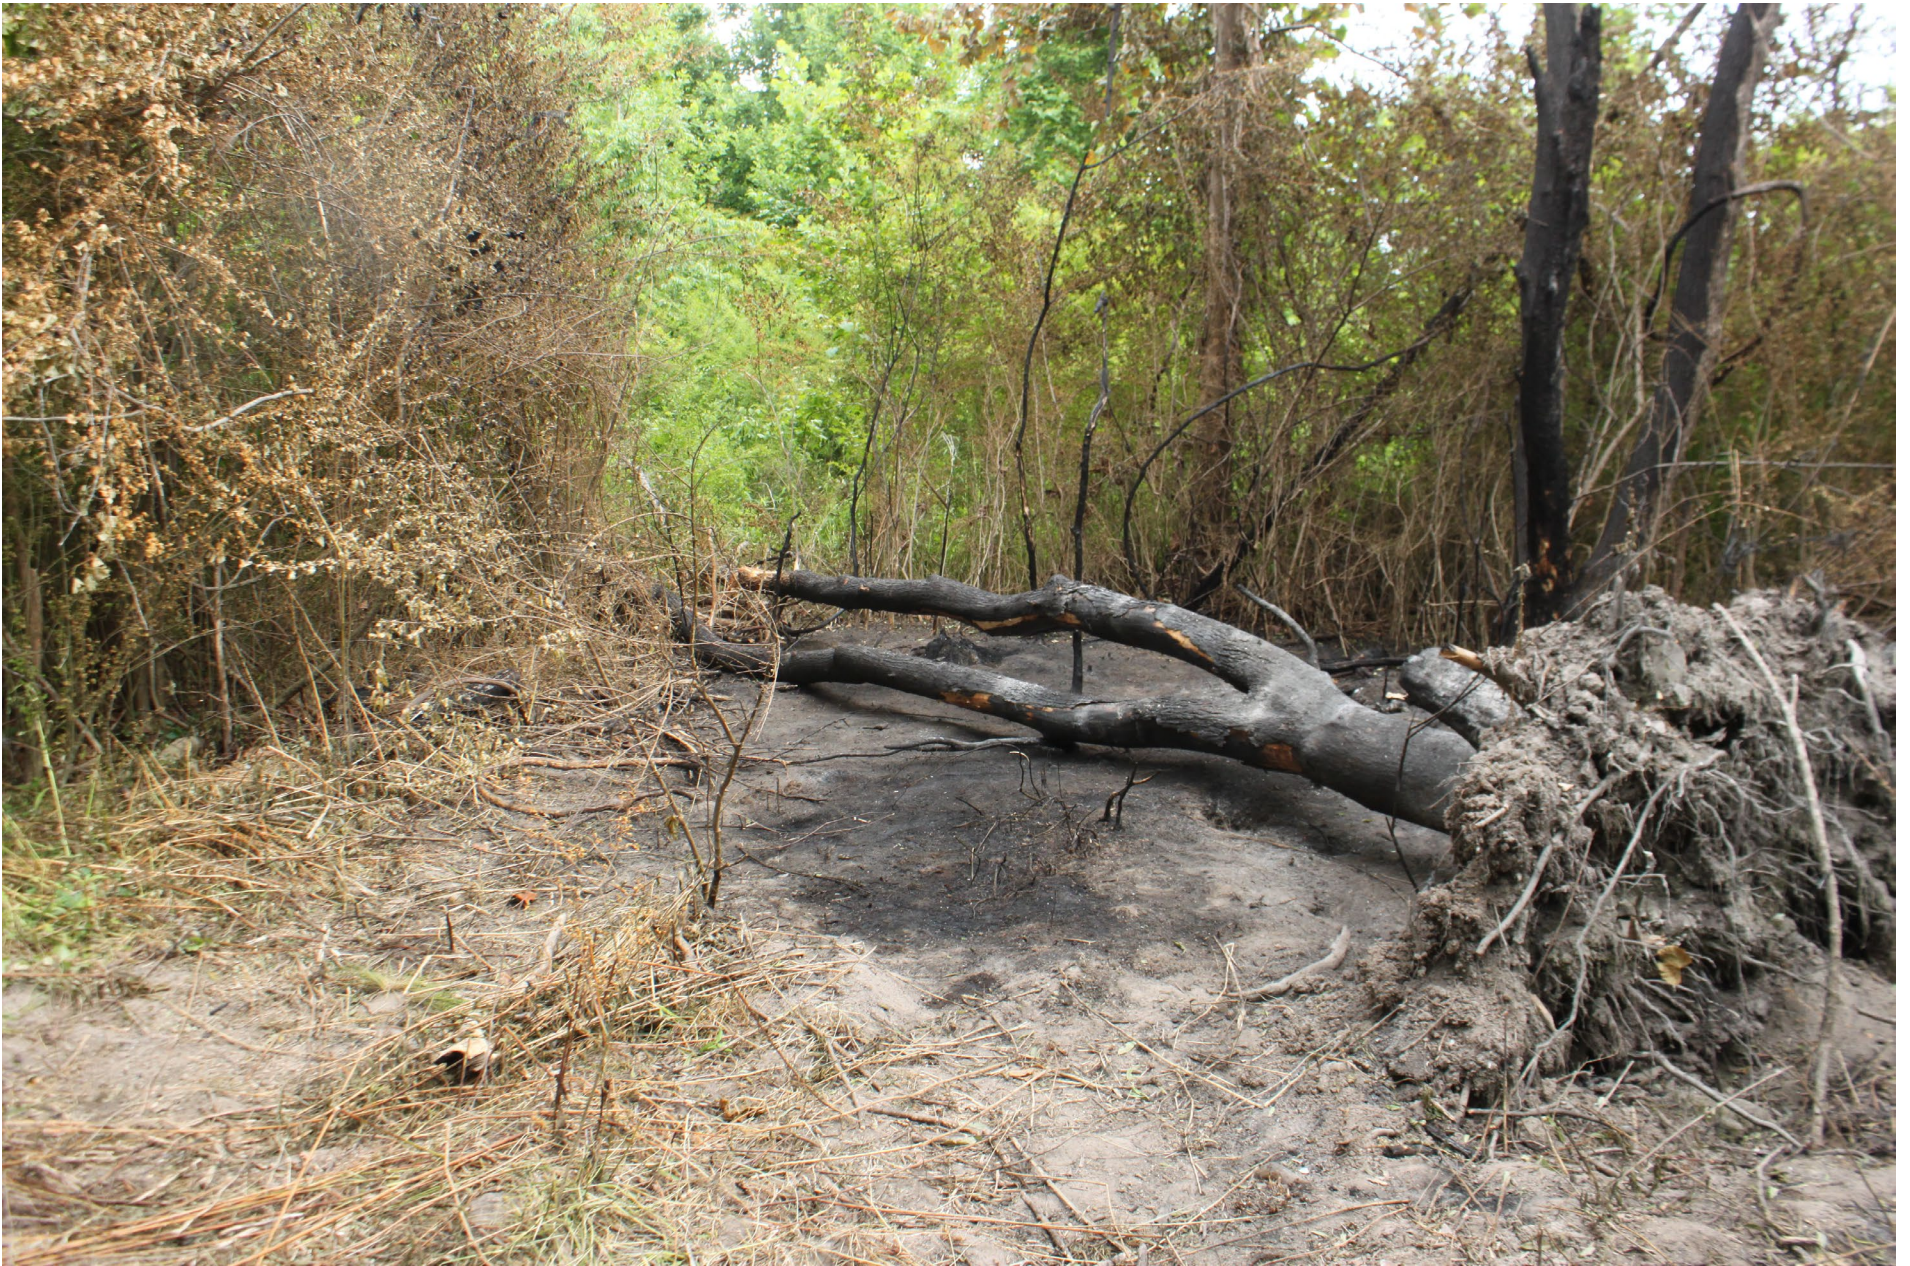
**Photo 4 - NTSB Digital Photograph. View of the Accident Site Following Recovery and Clean-Up.**

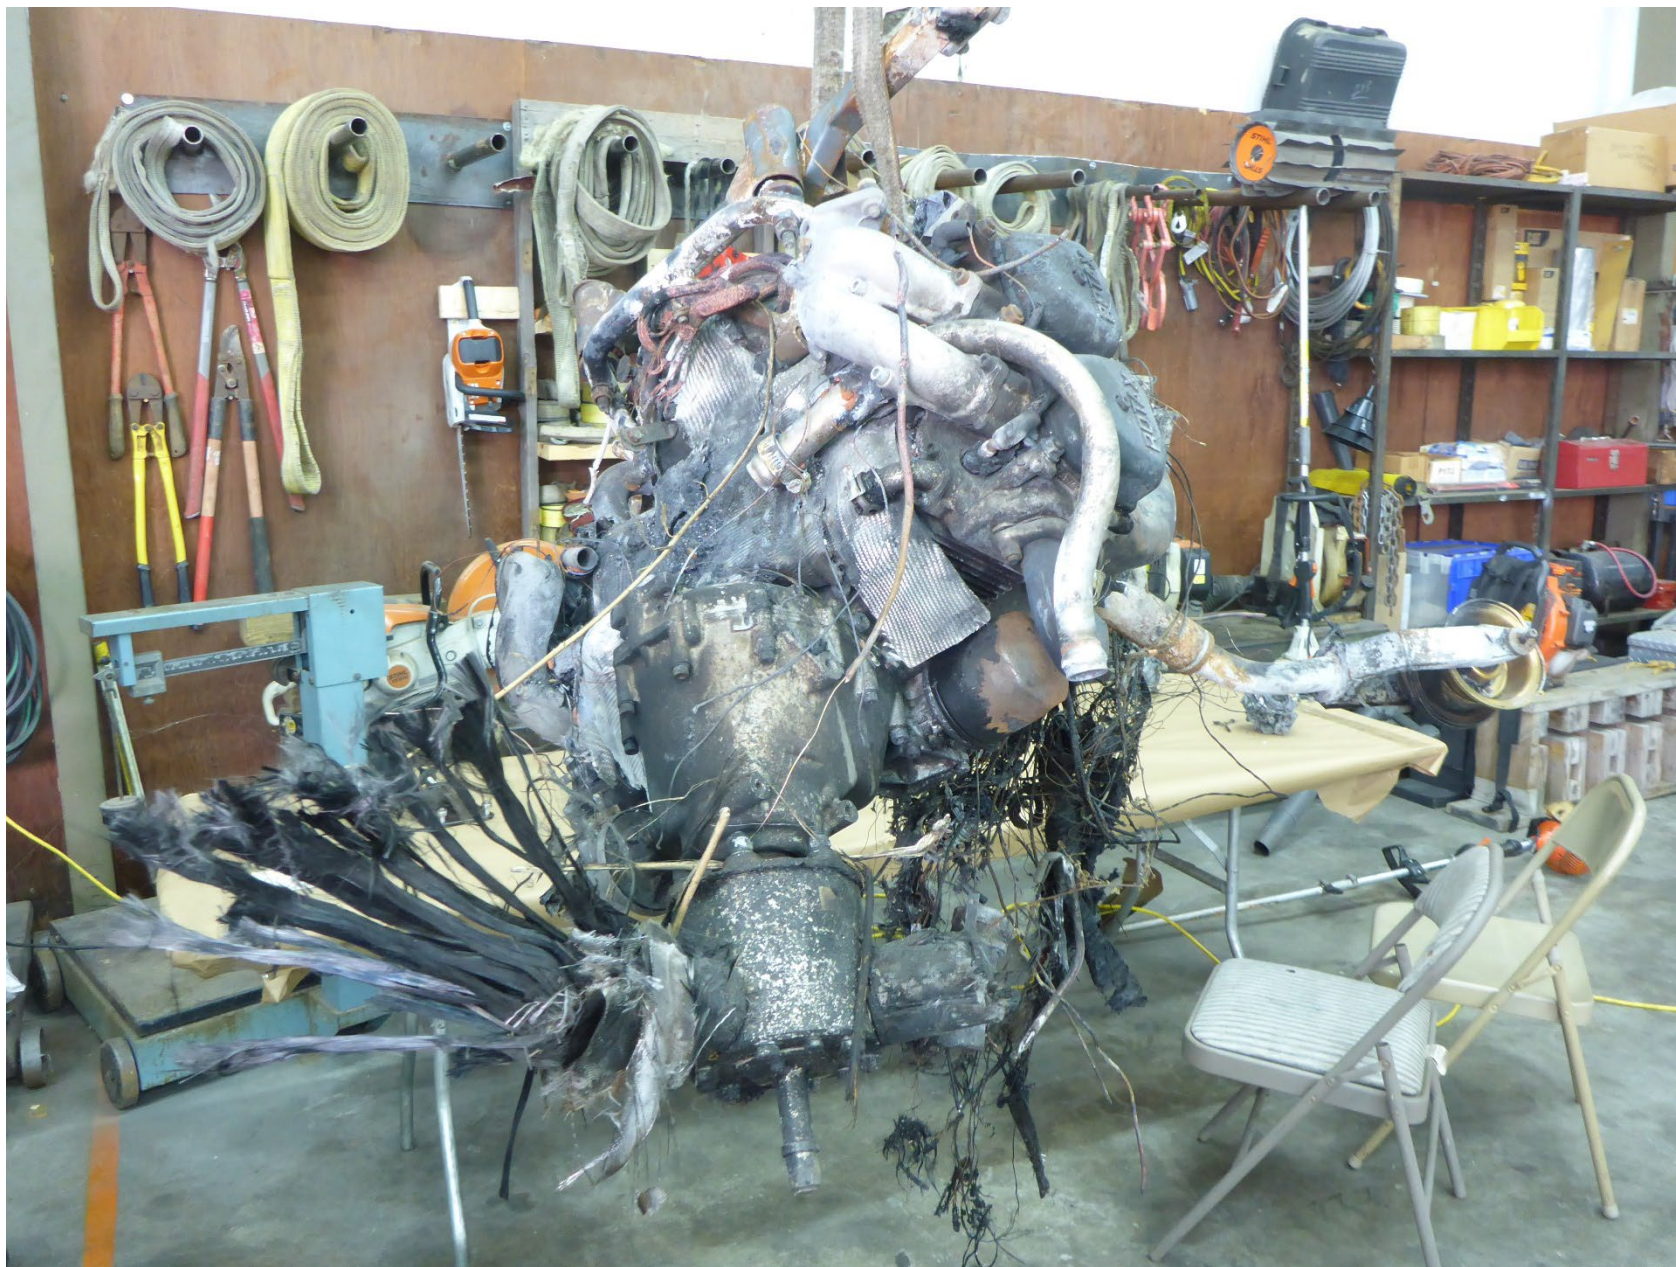
**Photo 5 – Rotech Flight Safety Digital Photograph. Front and Top Views of the Extensively Heat Damaged Engine and Propeller Assembly Following Recovery.**

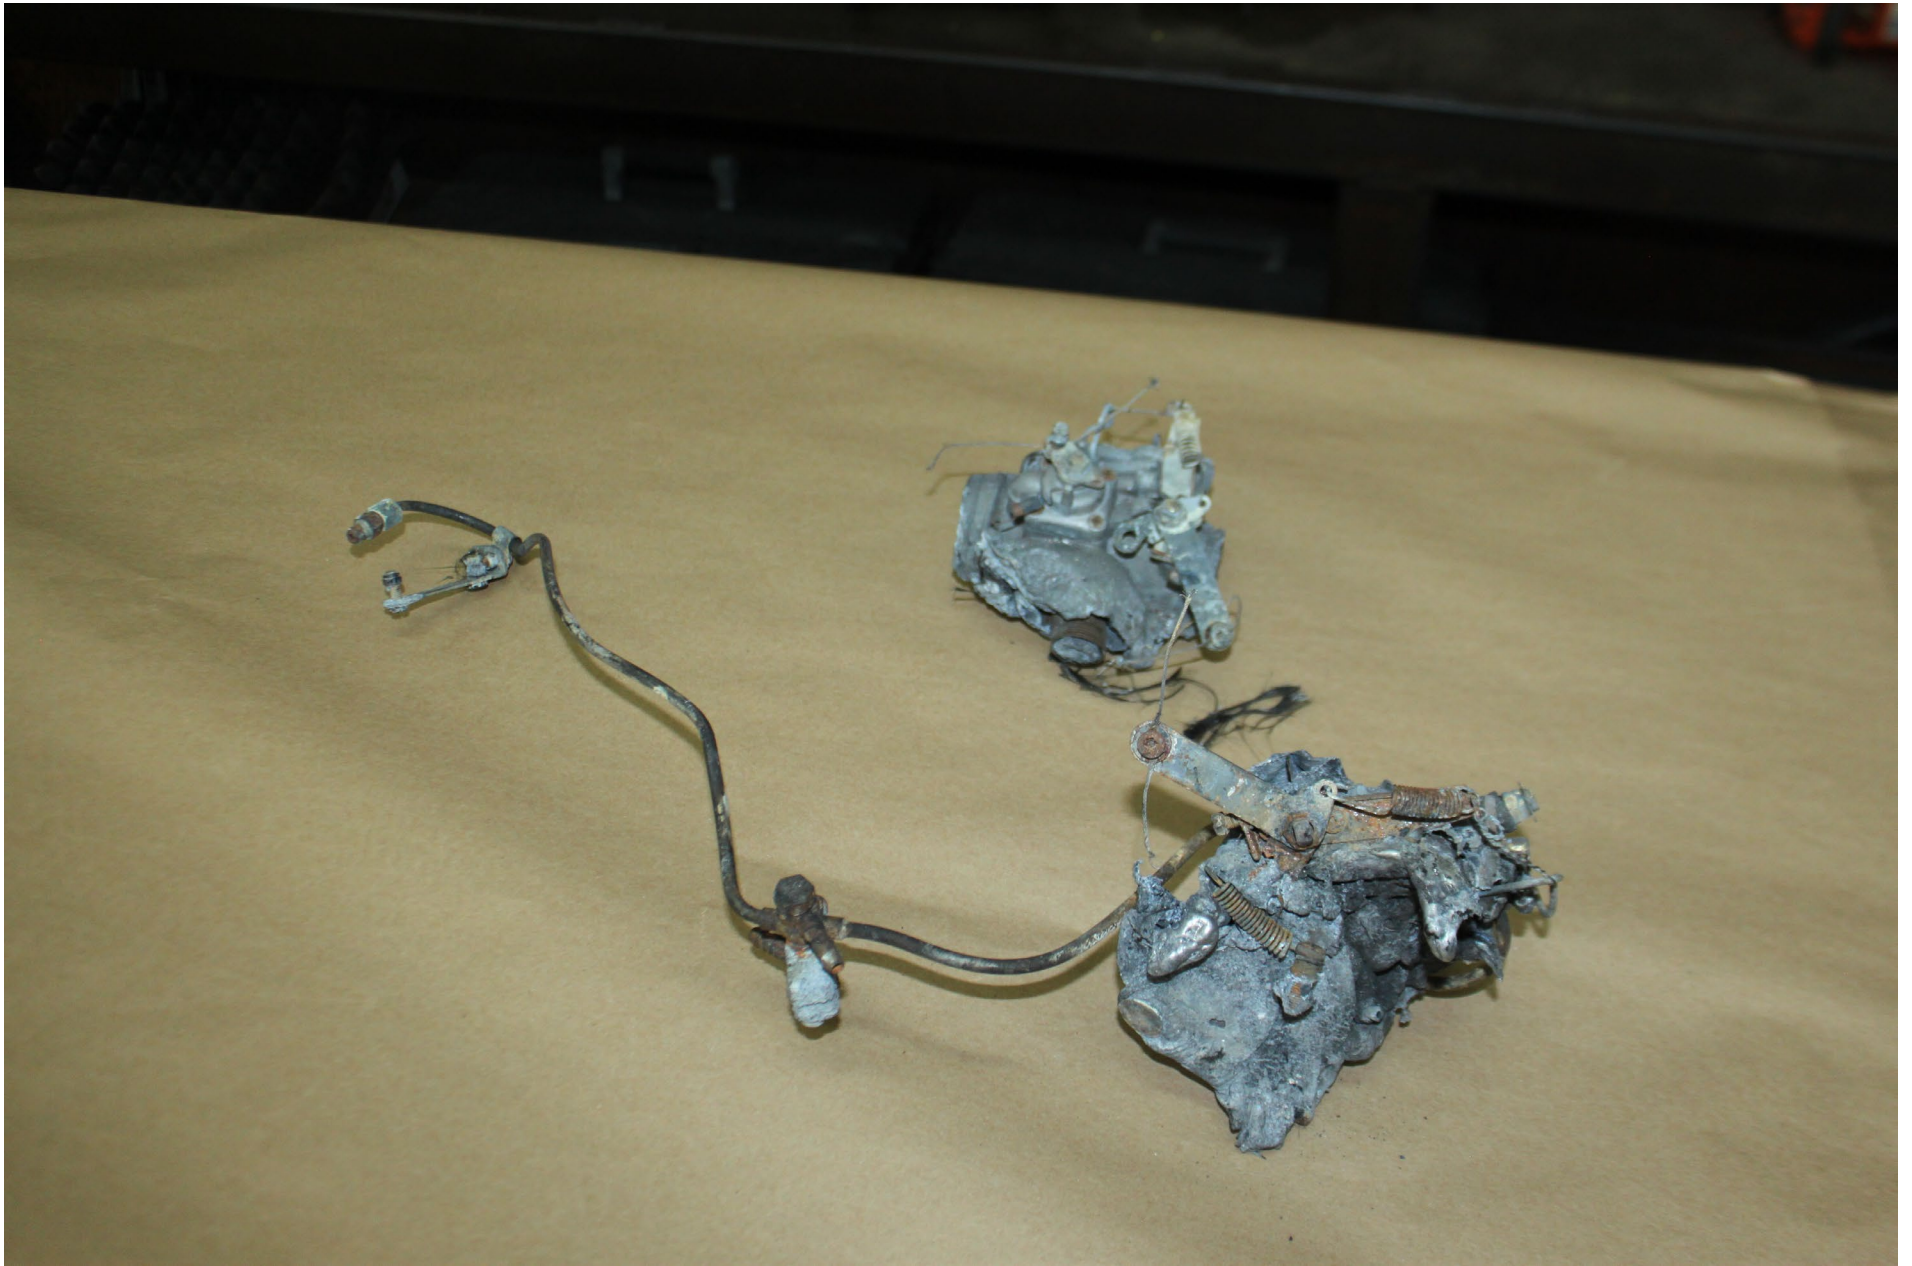
**Photo 6 - NTSB Digital Photograph. View of the Extensively Heat Damaged Carburetors. Note the Nos. 1/3 Carburetor is in the Foreground and the Nos. 2/4 Carburetor is in the Background.**
