# NATIONAL TRANSPORTATION SAFETY BOARD

## MATERIALS LABORATORY FACTUAL REPORT

Report No. 21-051

Place : Crossville, Tennessee  
Date : May 25, 2021  
Vehicle : Gulfstream American AA-5A, N26889  
NTSB No. : ERA21FA232  
Investigator : Brian Rayner, AS-ERA

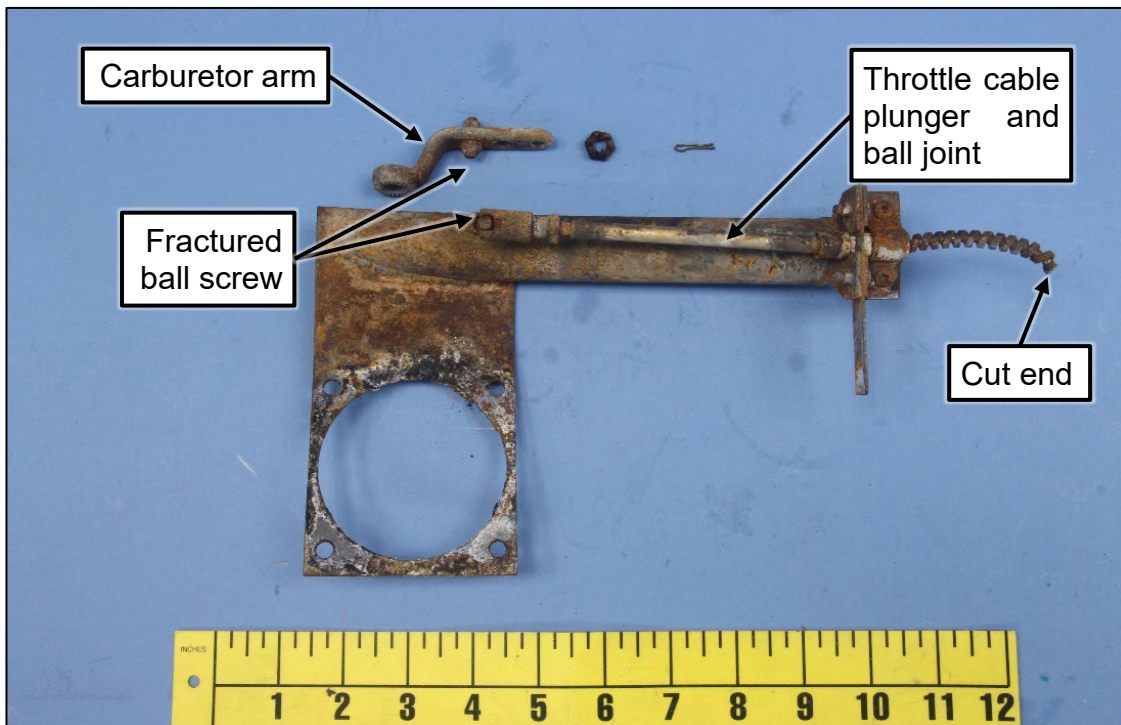
An overall view of the submitted components as received are shown in figure 1. The airplane had reportedly been mostly consumed by a post-crash fire, and the submitted components were darkened and oxidized consistent with exposure to that fire. The throttle cable had been cut at the location indicated, and the carburetor arm had been disassembled from the carburetor to facilitate shipment to the NTSB Materials Laboratory. The nut and cotter pin for attaching the carburetor arm were also submitted as shown in figure 1.

Figure 1. Overall view of the submitted components as received.

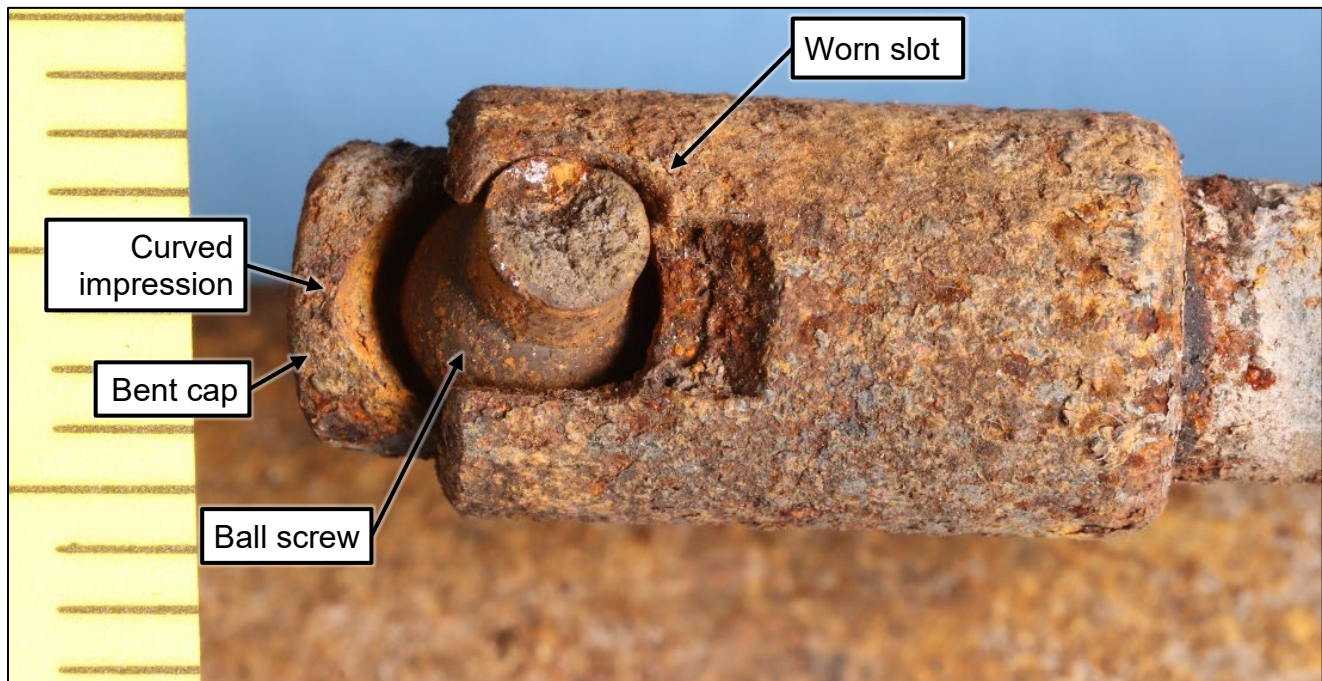
The ball screw at the carburetor end of the throttle cable assembly was fractured. The ball end of the ball screw remained in the ball joint, and the threaded end of the ball screw remained attached to the carburetor arm. A close view of the ball joint as received is shown in figure 2. The ball end of the ball screw moved freely within the joint. One side of the slot had a curved profile, and the ball screw is shown positioned within the curved profile in figure 2. The edges of the curved side did not appear deformed, indicating the curved profile likely occurred due to wear between the ball screw and the side of the slot. The cap piece at the end of the ball joint was bent such that the slot side was displaced axially away from the joint relative to the opposite side and the edge facing the slot was deformed with a curved impression consistent with contact with the ball screw.

Figure 2. Throttle ball joint with fractured ball screw.

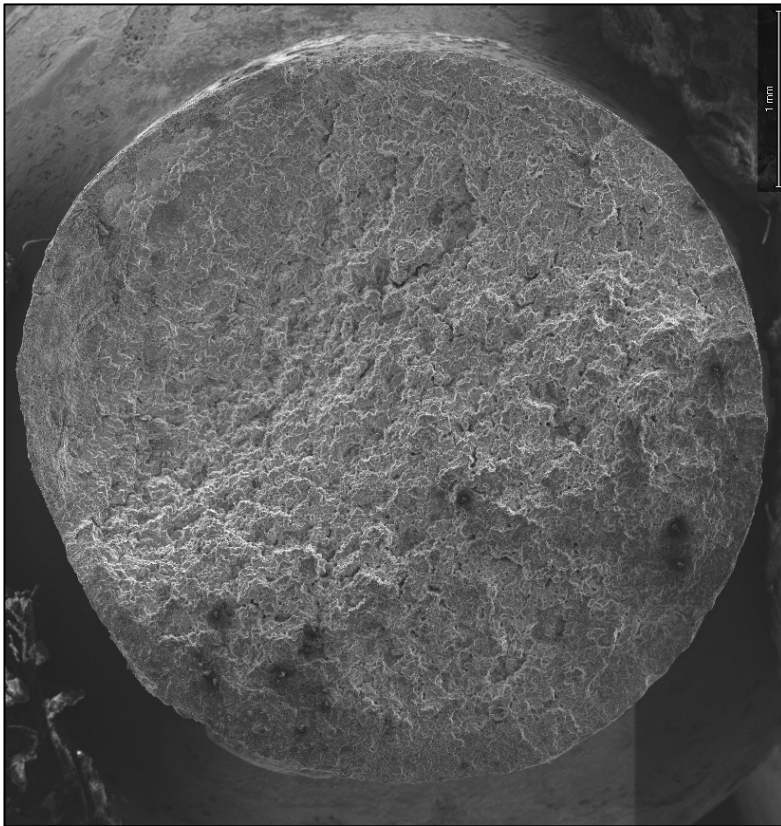
Next, the cleaned and deoxidized ball screw piece was examined using an optical stereomicroscope and a scanning electron microscope (SEM). A series of SEM images stitched together to form a montage image of the fracture surface is shown in figure 3. Most of the fracture surface had rough features with an oxidized intergranular fracture appearance and crevices intersecting the fracture surface, features consistent with high-temperature overstress fracture. Smoother features in planes perpendicular to the outer surface were observed at the edge of the fracture around nearly 2/3 of the circumference (between the 1 o'clock and 8 o'clock positions in figure 3) consistent with overstress fracture of a surface-hardened part. Approximately 1/4 of the fracture surface (maroon and orange-oxidized quadrant shown at the upper left side in figures 2 and 3) had a concave shape, and some areas with dimple features were observed in that quadrant where oxides had been removed from the surface, features consistent with ductile overstress fracture.

Figure 3. Montage of SEM images showing the cleaned and deoxidized ball screw fracture surface.

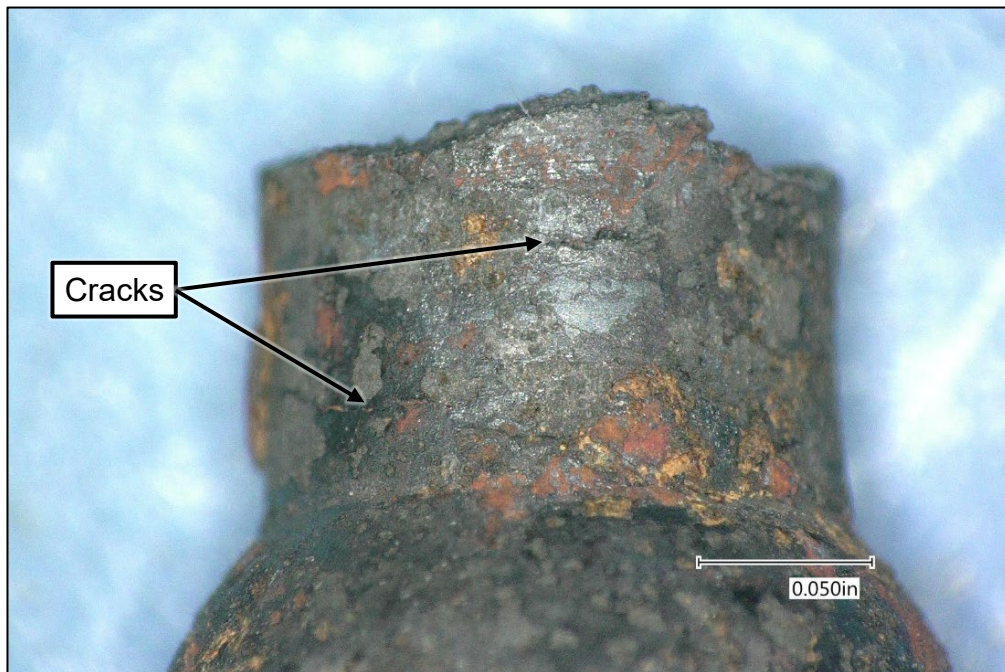
An optical image of the ball end of the ball screw is shown in figure 4. The side of the ball screw shown in figure 4 is at the 3 o'clock position in figure 3. Cracks were observed in the shank of the ball screw as indicated in figure 4. The shorter crack closer to the fracture surface was gaped open consistent with overstress fracture.

Figure 4. Side of the ball screw at the 3 o'clock position in figure 3 after disassembly, cleaning, and deoxidation showing secondary cracks in the shank.
