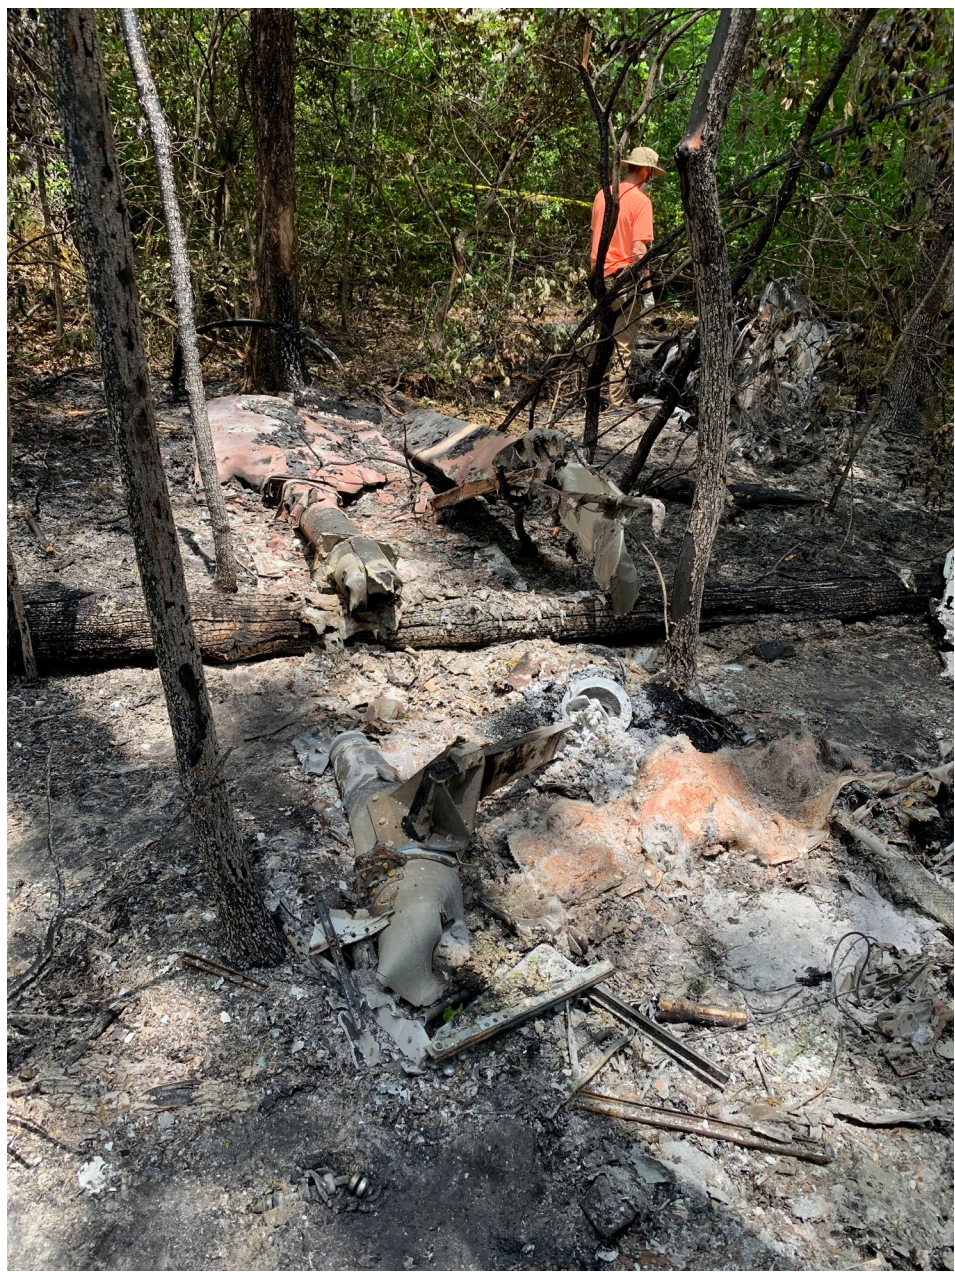
**Photo 1 – View of Main Wreckage Facing Direction of Travel**

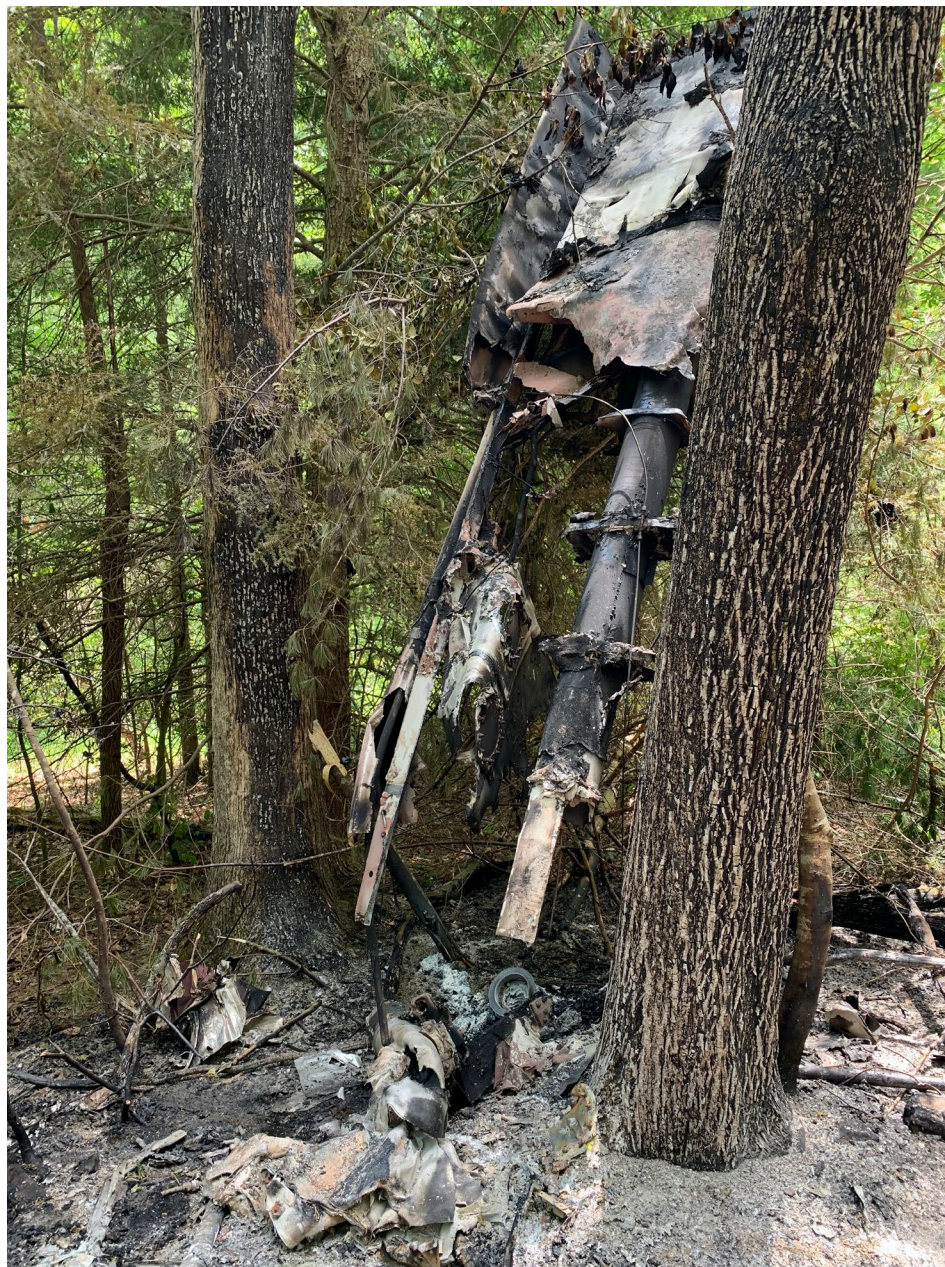
**Photo 2 – View of Left Wing and Main Landing Gear Leg**

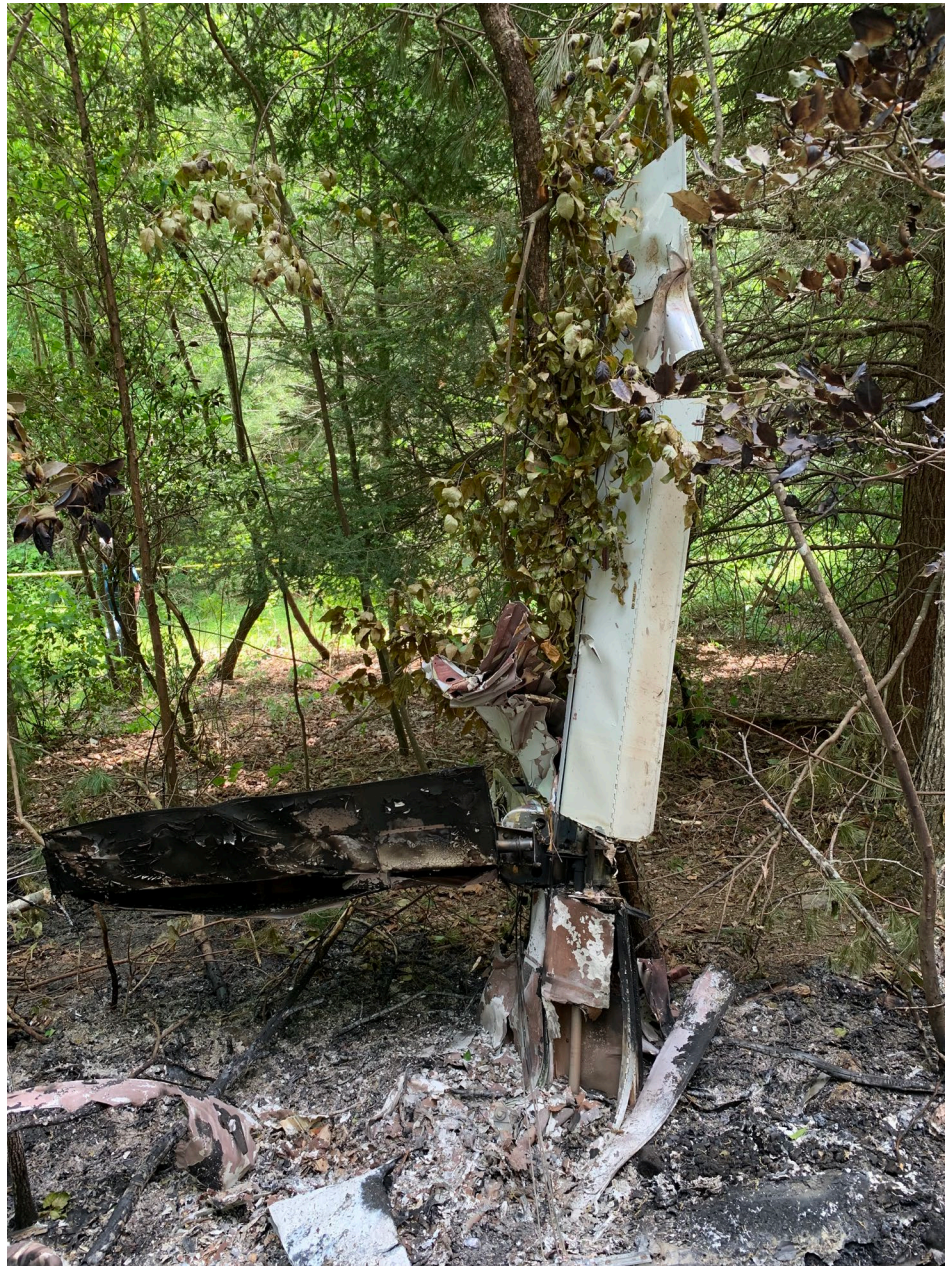
**Photo 3 – Remains of Impact and Fire-Damaged Tail Section**

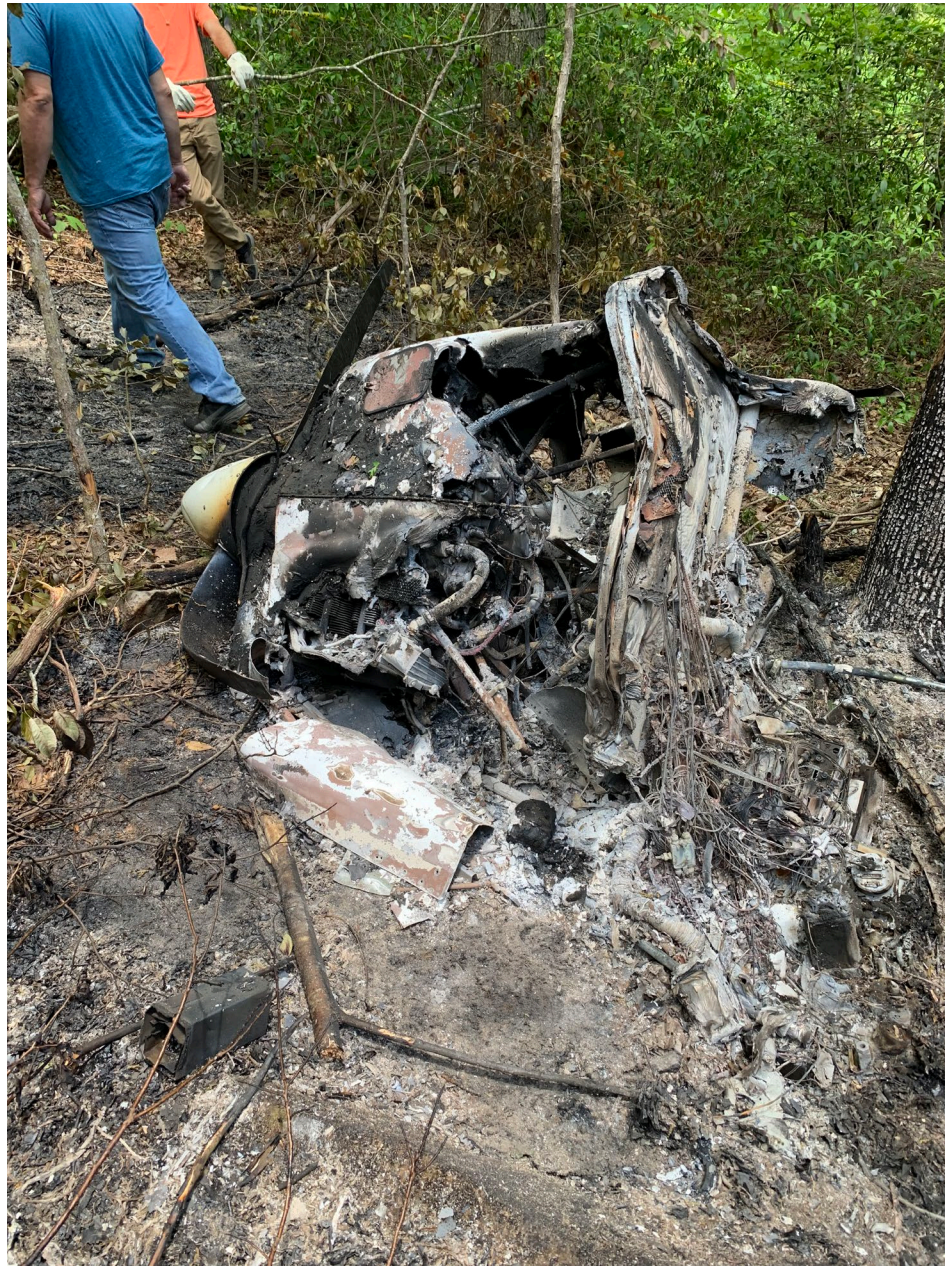
**Photo 4 – View of Engine, Firewall, and Remains of Instrument Panel**

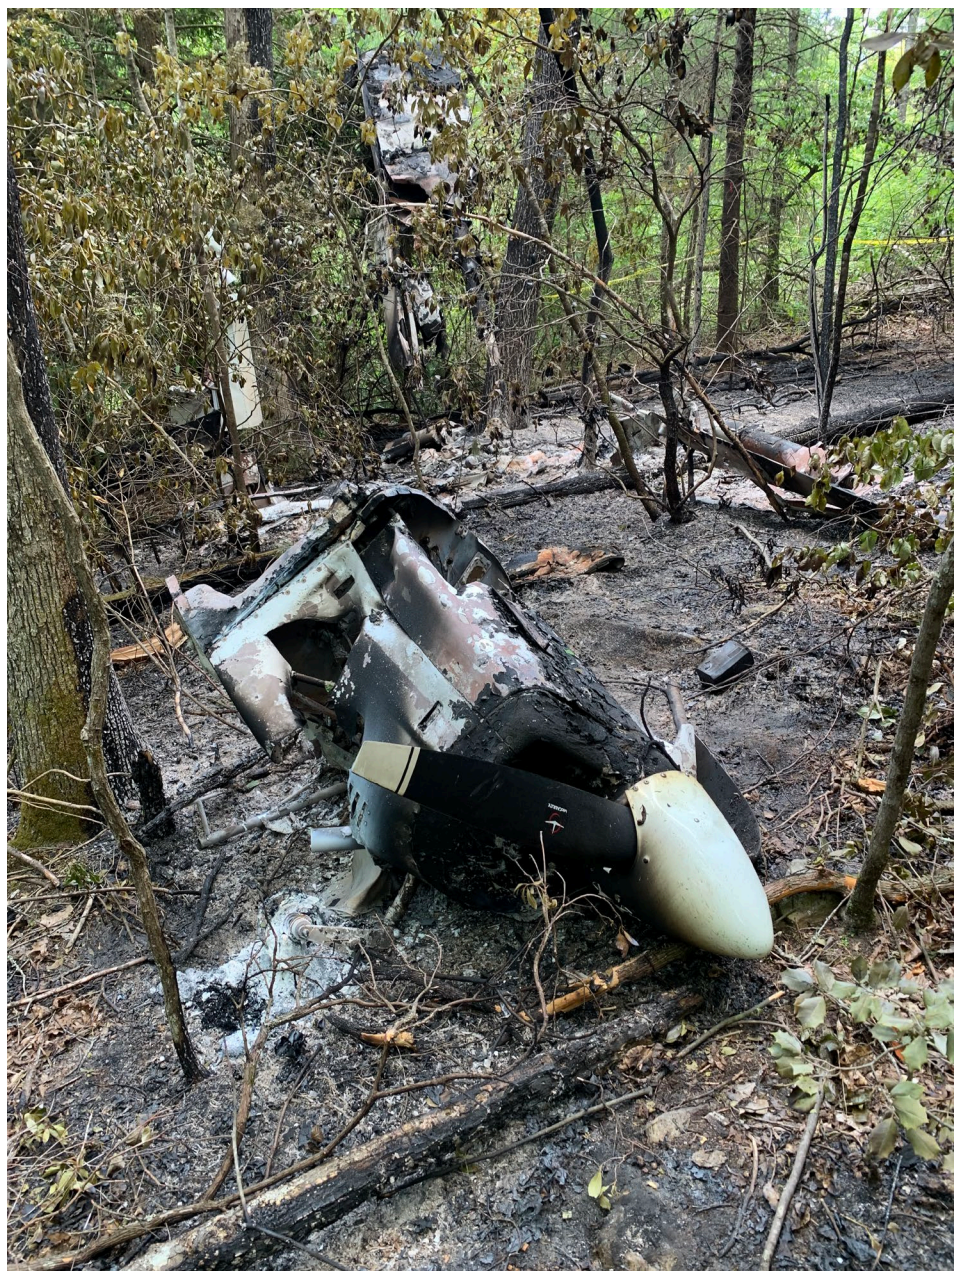
**Photo 5 – View of Wreckage Path Opposite Direction of Travel**

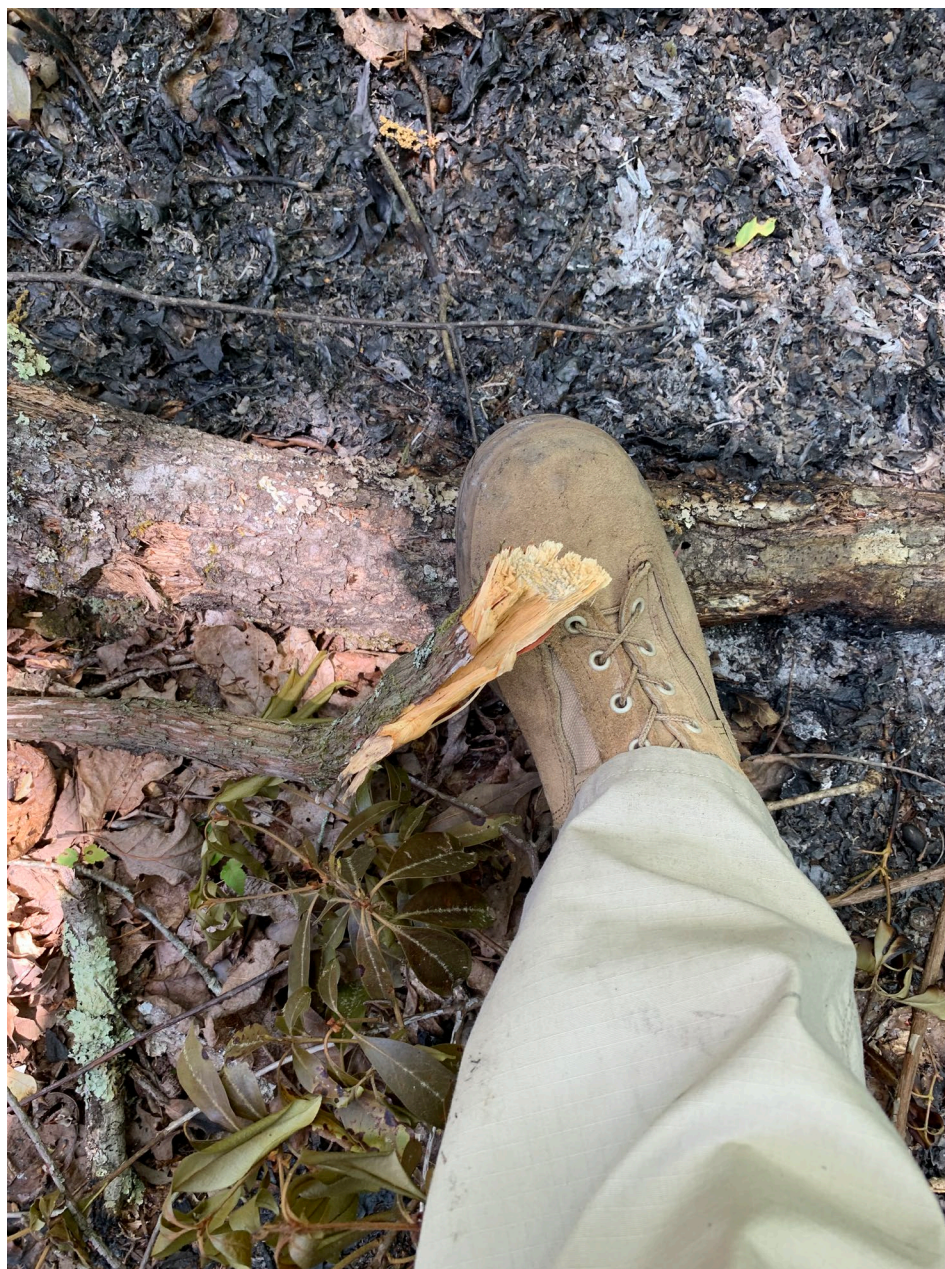
**Photo 6 – View of Angularly Cut Wood at Accident Site**

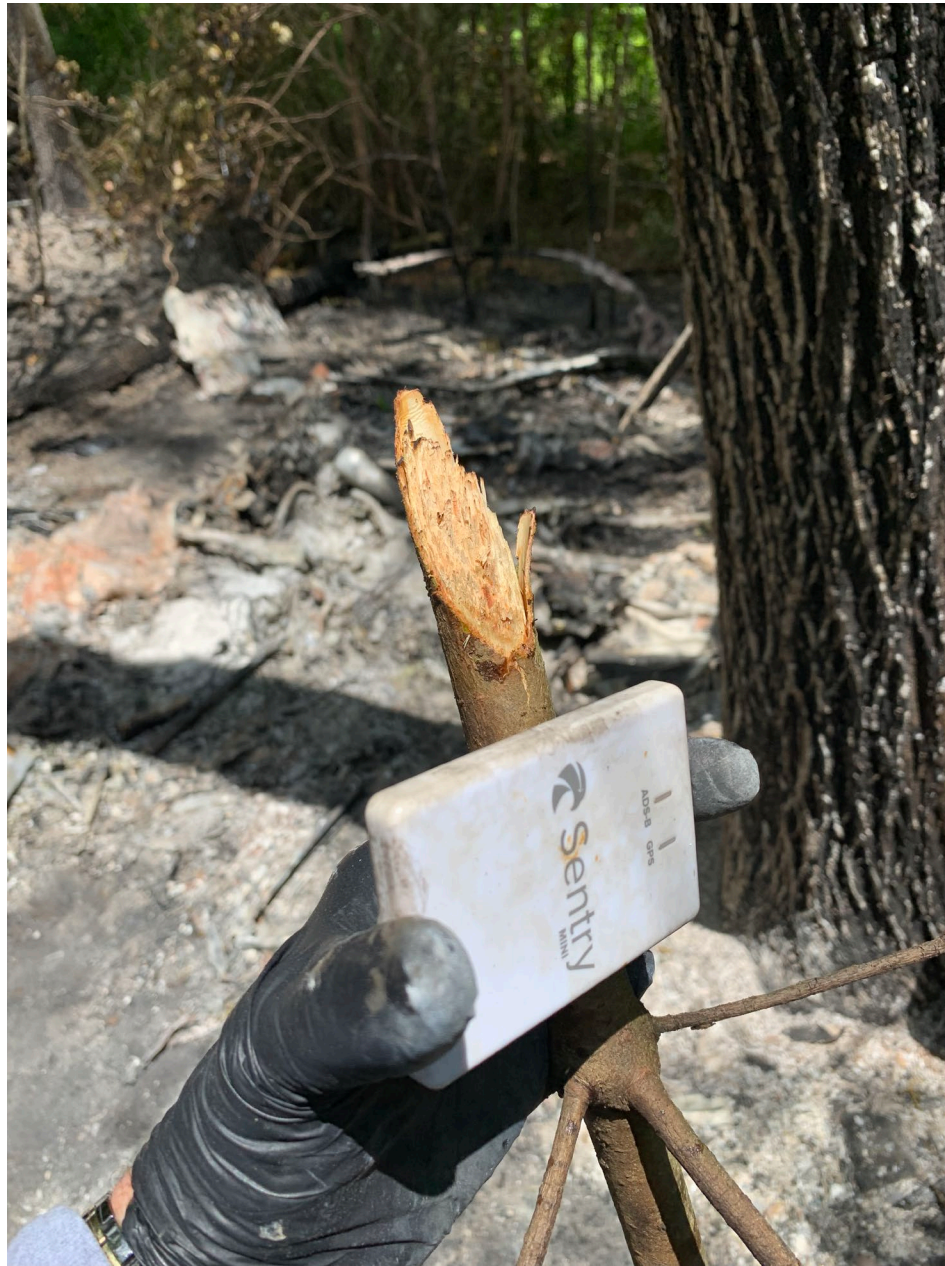
**Photo 7 – Angularly Cut Branch at Accident Site**
