# National Transportation Safety Board

ERA21FA233

Helicopter Specialist's Factual Report

Location: Leesburg, FL  
Date: May 25, 2021  
Time: 1745 Eastern daylight time (EDT)  
2145 Universal coordinated time (UCT)  
Helicopter: BHI H60 Helicopters LLC, UH-60A / N9FH

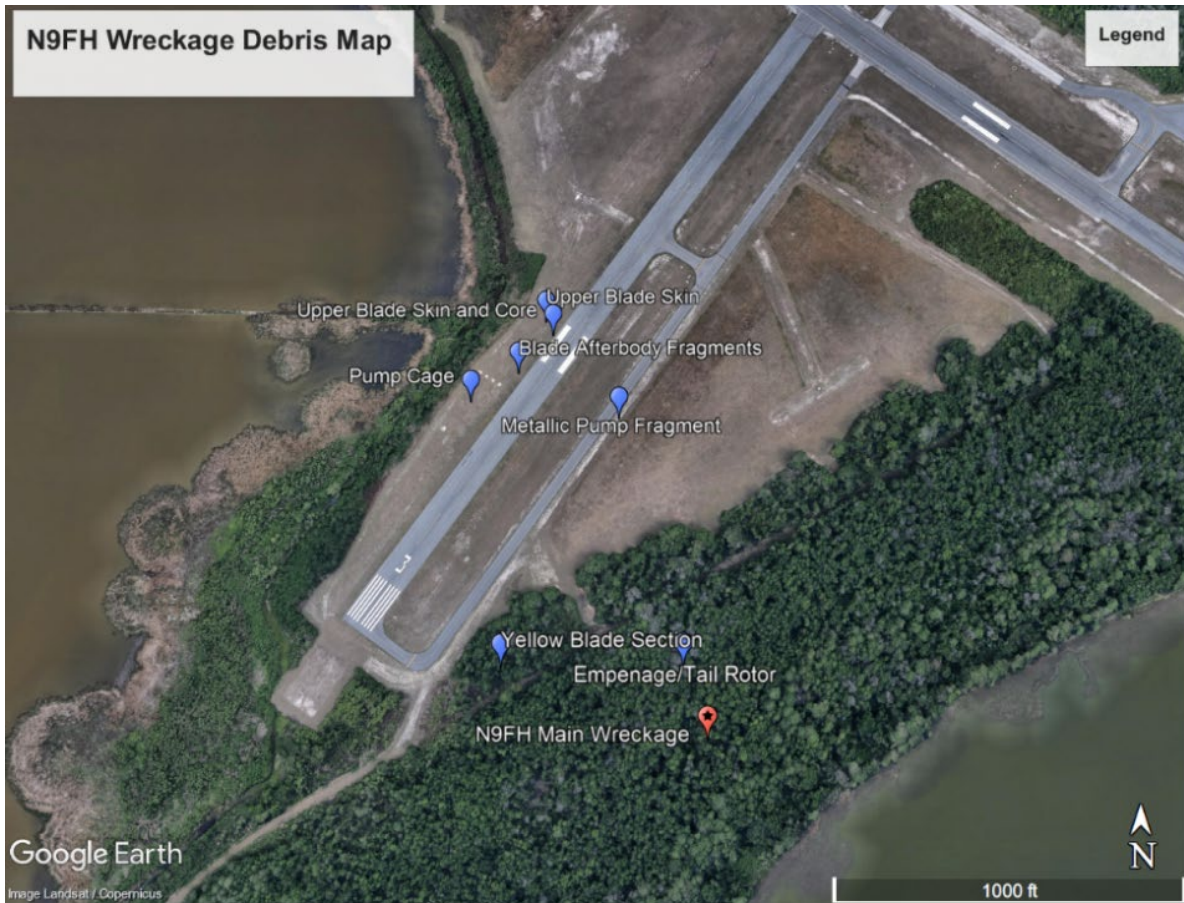
**Figure 2.** Wreckage debris map.

The wreckage was located in a localized swamp approximately 1,000 feet southeast from the approach end of runway 3 of the Leesburg Airport (LEE), Leesburg Florida (Figure 2). The terrain was flat, and the localized swamp was populated with mature oak trees with a dense underbrush of scrub oak, and the soil was soft mud to a depth of 1.5 feet in some locations. The wreckage was contained in a 31-foot diameter vertical impact crater and had been consumed by fire (Figure 3). The wreckage was oriented on a tail-nose bearing of 055° magnetic. Sections of all 4 rotor blades were contained with the main wreckage. The orientation of the main wreckage indicates that the helicopter impacted with its left side partially inverted. The right engine (No. 2) was exposed, and the left engine (No. 1) was not visible under the debris. The main gearbox had been completely consumed by fire exposing the internal main drive gear assemblies. The vertical tail, tail rotor, stabilator, and aft portion of the empennage was located about 50 yards away on a bearing 020° magnetic from the main wreckage (Figures 4 & 5). The tail section had not been exposed to fire and all tail rotor and stabilator components were present.

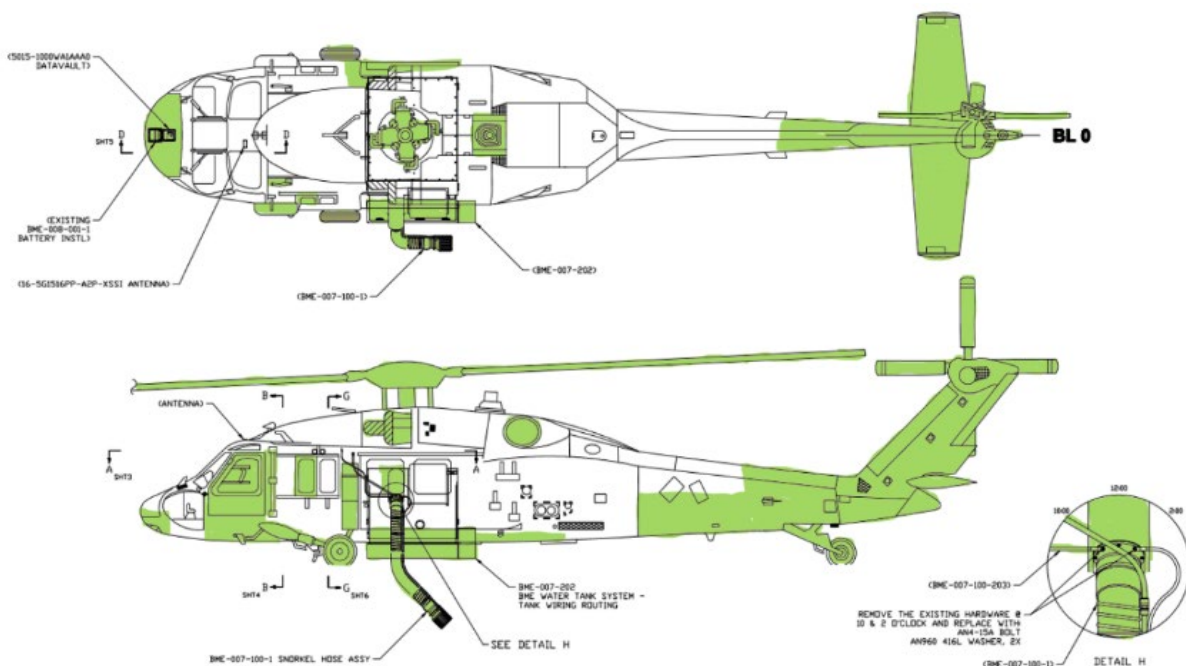
Parts of what remained of the wreckage (Figure 6) were transported to Florida Air Recovery, Jacksonville, Florida, on May 28, 2021, to facilitate further examination.

**Figure 6.** Green areas indicate the sections of the helicopter that were recovered and examined.

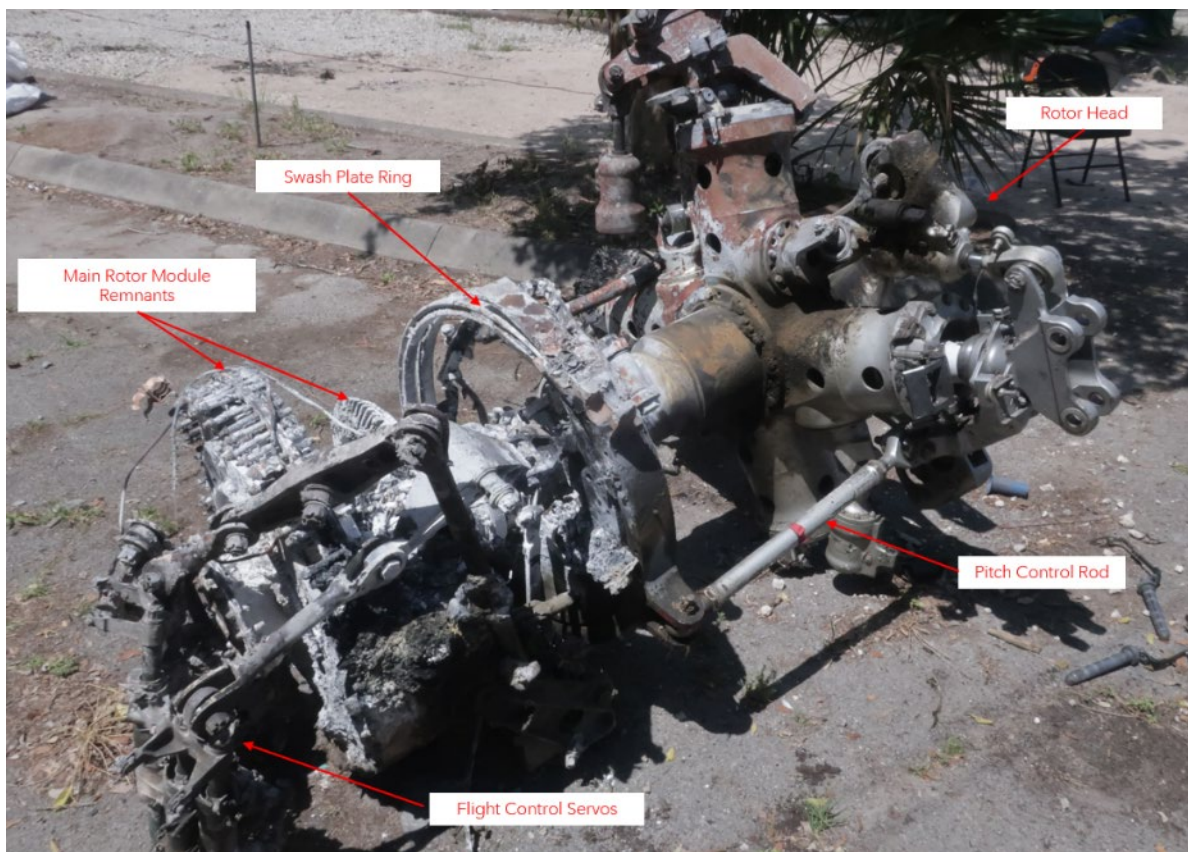
The main rotor module (transmission) and rotor head were co-located with the main wreckage (Figure 7). Three blade roots remained attached to their spindles; one blade had separated from the spindle (blue). Both engine input module cases had been consumed by the post-crash fire and the majority of the main module case had been consumed. The sun gear and planetary gears were present on the main rotor shaft. One hydraulic module and one generator were recovered. The bridge beam was not present but the forward, aft, and lateral hydraulic servos and linkages to the stationary swashplate were present. The aft and lateral remained connected, the forward servo was disconnected from the swashplate because half the stationary swashplate ring was not present, presumed consumed by the post-crash fire. Both sets of rotating scissors were connected to the lower pressure plate but not connected to the rotating swashplate. Each end of the scissors had the swashplate attachment hardware still connected.

**Figure 7.** Main rotor module (transmission) and rotor head.

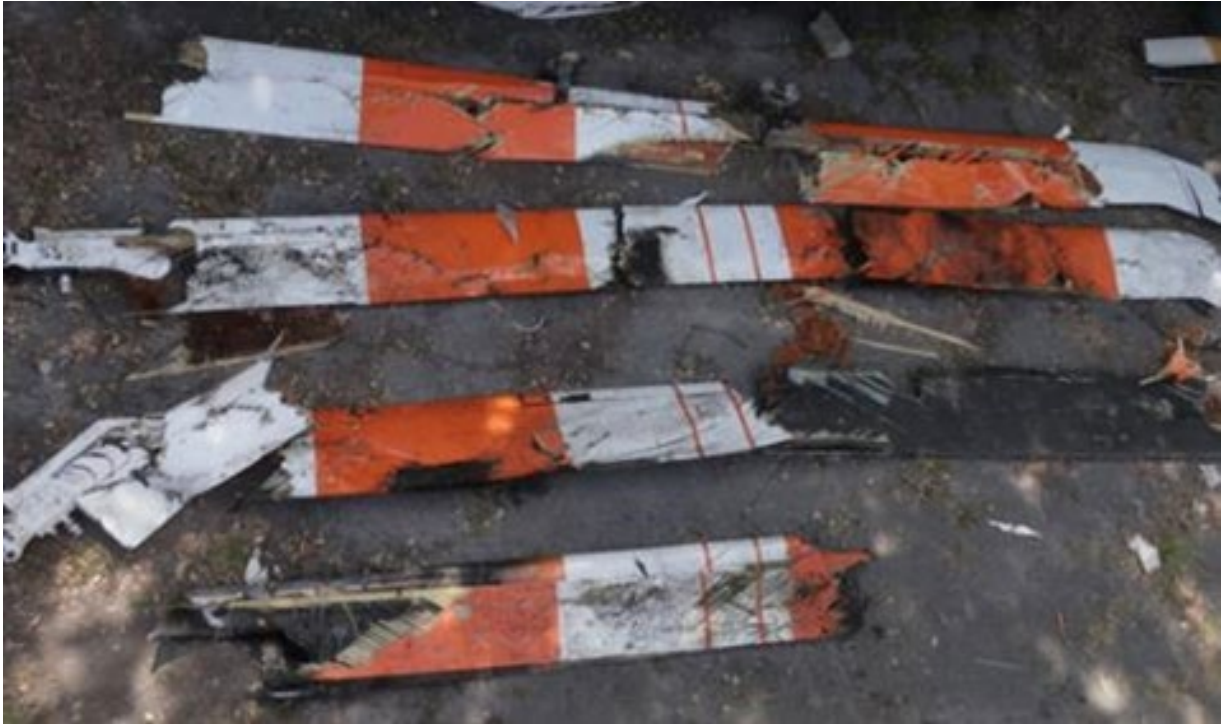
**Figure 8.** Overhead view of the main rotor blades laid out for examination.

Portions of all four rotor blades were recovered (Figure 8).

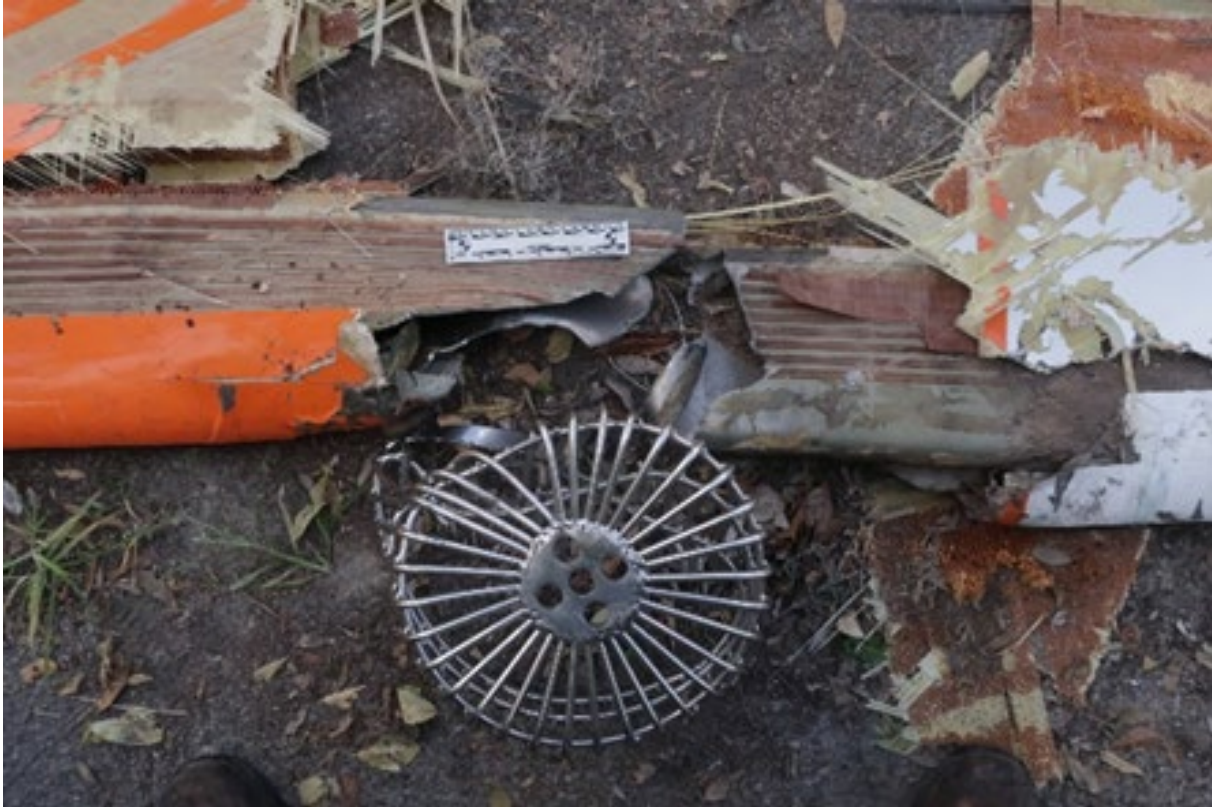
The blade was fractured 10-inches outboard of the blade grip. Blade afterbody separation was in two halves from 6 feet to 19 feet 8 inches. A leading-edge witness mark from the copilot's pilot tube was located at 8 feet 9 inches. The spar was fractured at the 13 feet 2 inch location. A 7-inch diameter semicircular deformation with witness indentations consistent with the spacing of the nozzle cage rods was evident (Figure 9). The spar fracture's leading-edge bottom was curled up and aft. The fracture characteristics include 45° shear lips along the edge. Blue paint transfer was observed on the upper leading edge at the 11-to-12-foot location, and the blade tip aft outboard edge was damaged.

**Figure 9.** Yellow blade exhibiting semicircular shaped leading-edge separation and the snorkel pump basket deformed in the shape of the blade leading edge.

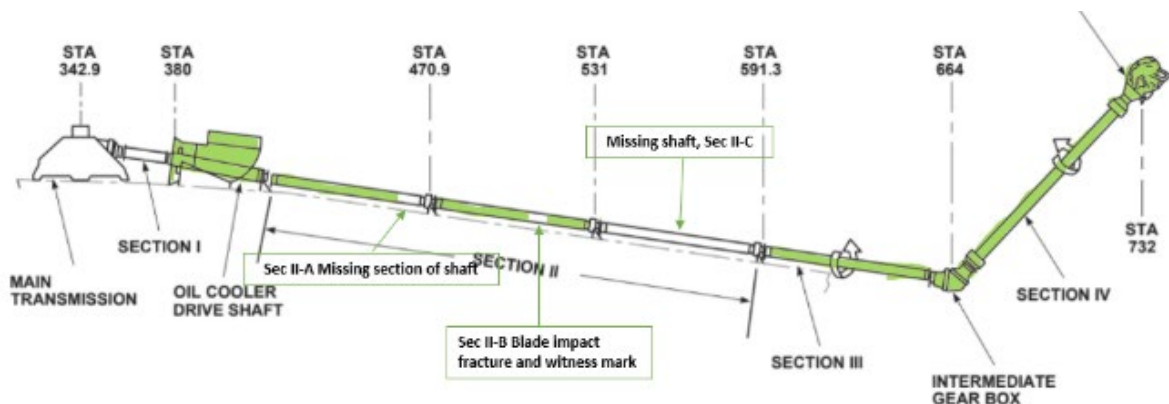
A diagram of the tail rotor drive shafts recovered for examination is depicted in Figure 12. The Section IV drive shaft remained in place on the vertical stab, the Section III drive shaft remained in situ on the tail boom and intermediate gear box but had separated at both Thomas couplings. The Section IV remained attached to the intermediate gearbox and tail rotor gearbox. The Section III drive shaft was intact, unbent, had rotational scoring along its length at multiple locations. Both Thomas couplings exhibited overload torsional separations. The Section II-C drive shaft was not located. Section II-B (mid) drive shaft had an impact crease lengthwise 36 inches from the aft end, about 6 inches of mid shaft were missing, and 18 inches of the forward end was located. Both Thomas couplings exhibited fractures consistent with torsional overload. Section II-A was missing 19 inches of the aft end including the end fixture and Thomas coupling. A dent and rotational score marks were observed at the same location. The forward end and Thomas coupling had separated in torsional overload. The oil cooler drive shaft had separated from the cooler fan assembly in overload at the coupling, and the opposite end Thomas coupling has separated in torsional overload. The Section I short shaft, between main transmission and the fan assembly was not located. The intermediate gear box had no damage, and the input-output was smooth when rotated by hand. The tail rotor moved in concert smoothly with no binding.

**Figure 10** Tail rotor drive system schematic. Sections annotated in green were recovered and examined.

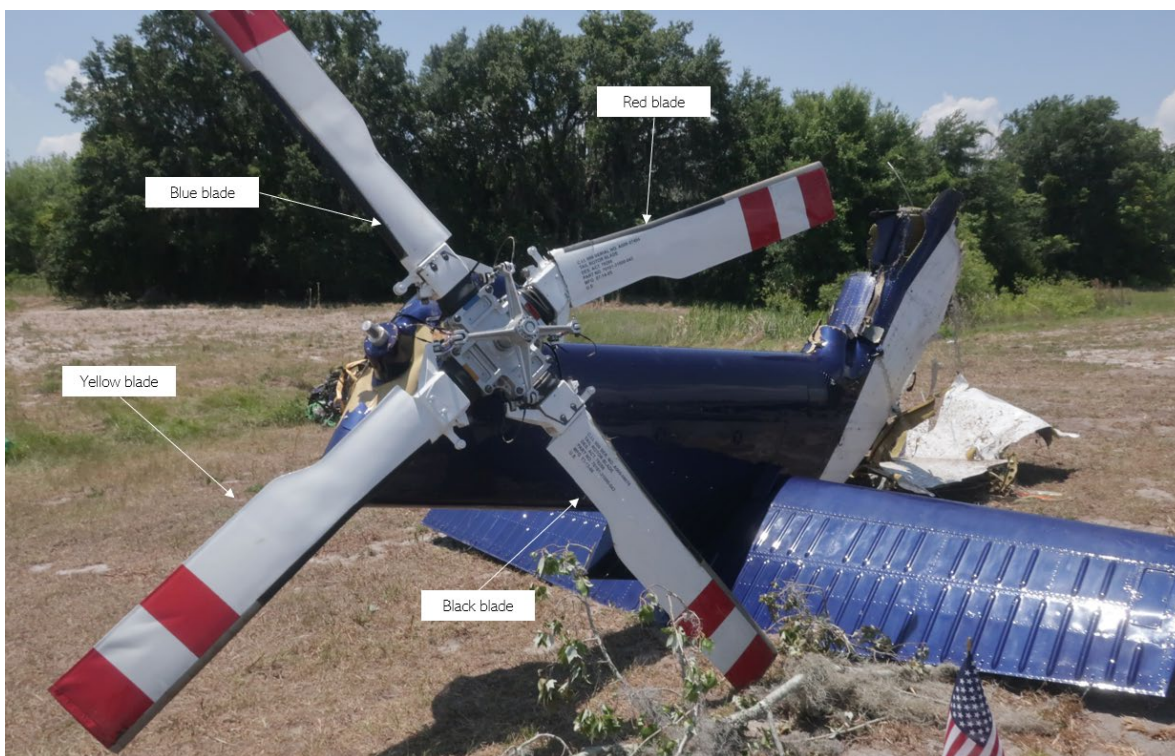
**Figure 11.** Tail rotor, vertical fin, and stabilator.

The empennage and tail rotor were located about 50 yards north of the main wreckage. All four blades were attached to the hub, the red blade was broken at the root (Figure 13). The pitch change beam was connected to the drive shaft, all pitch links were connected to their respective blade pitch horns. The tail rotor control quadrant was undamaged. Tail rotor control cables connected to the quadrant and moved the pitch beam when manipulated by hand. The control cables were traced up to the tail boom separation, cable ends were broomstrawed at the ends.

| Red blade | SN: A009-07494 | Broken at the blade grip. |
| Black blade | SN: A009-09078 | Leading edge damage about 6 inches outboard for root. Tip cap missing. Chordwise scratches on the inboard side of the blade. |
| Yellow blade | SN: not marked | Skin oil canning on outboard half of blade. |
| Blue blade | SN: not marked | Blade tip cap missing, blade tip damage. |

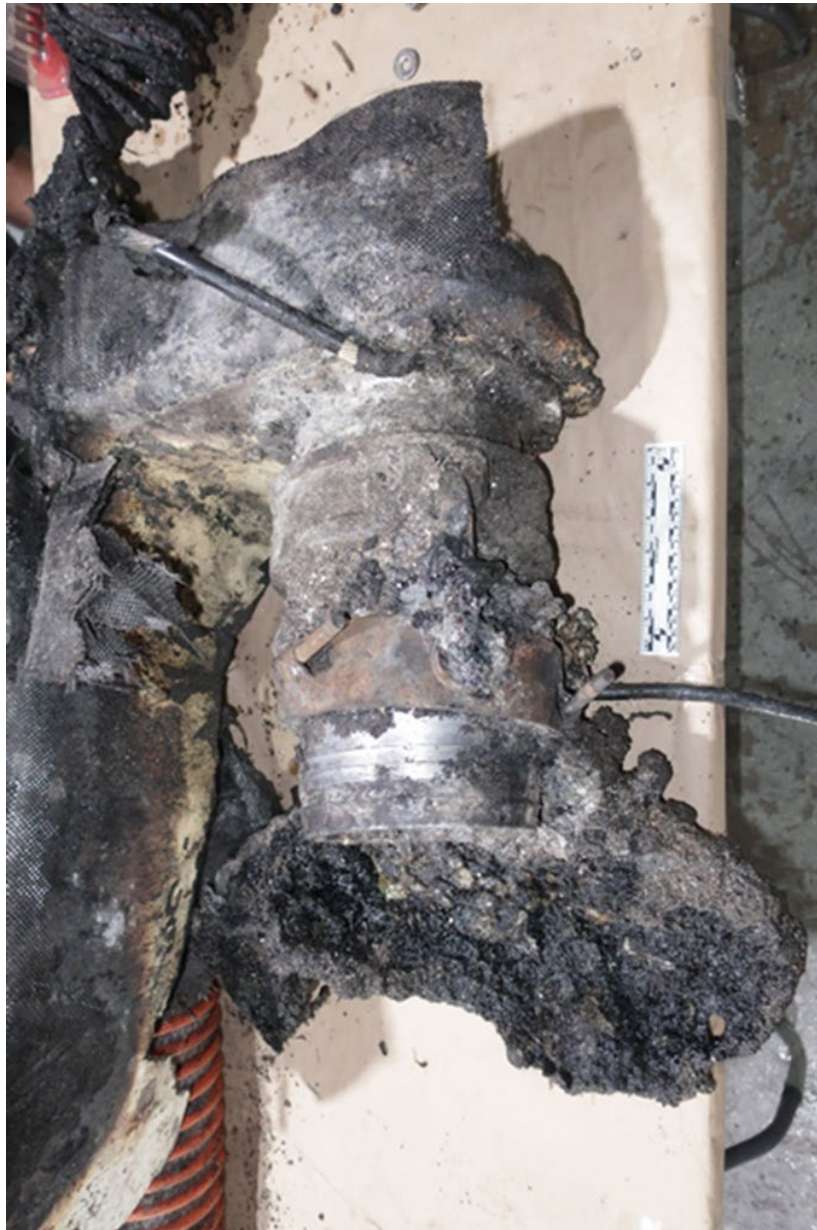
**Figure 13.** Forward side of the fire tank nozzle support and the snorkel hose connection.

The upper section of the hose that was clamped to the tank nozzle was examined and disassembled. One-third of the hose was attached to the tank snorkel support and coupler, while two-thirds had been torn away with the tear line coincident with the hose coupler plate. The hose coupler was discolored black and

brown consistent with exposure to extreme heat (Figure 15). Both hose coupler locking levers were in the down (locked) position, one lever had thermal damage and the other was undamaged. Portions of a zip tie encircling the entire coupler that restrained the locking levers was present. The flapper valve inside the tank nozzle was attached and functioned by returning to the close position when opened by hand. A 10 inch braided bonding wire was connected to the tank nozzle and frayed at the opposite end. A second 3 feet of bonding wire was attached to the tank nozzle and routed under one of the coupler's locking handles and had a frayed end. Fire tank nozzle support structure had torn away from the aft side of the coupler assembly, revealing a ripped and deformed portion of nut plate. The nut-bolt fastener were in place but had ripped through the nut plate material (Figure 16).
