# NATIONAL TRANSPORTATION SAFETY BOARD

## MATERIALS LABORATORY FACTUAL REPORT

Report No. 22-033

Place : Buckingham, Pennsylvania  
Date : June 15, 2021  
Vehicle : Vans RV6A, N74MS  
NTSB No. : ERA21FA253  
Investigator : Todd Gunther, ASI – ERA

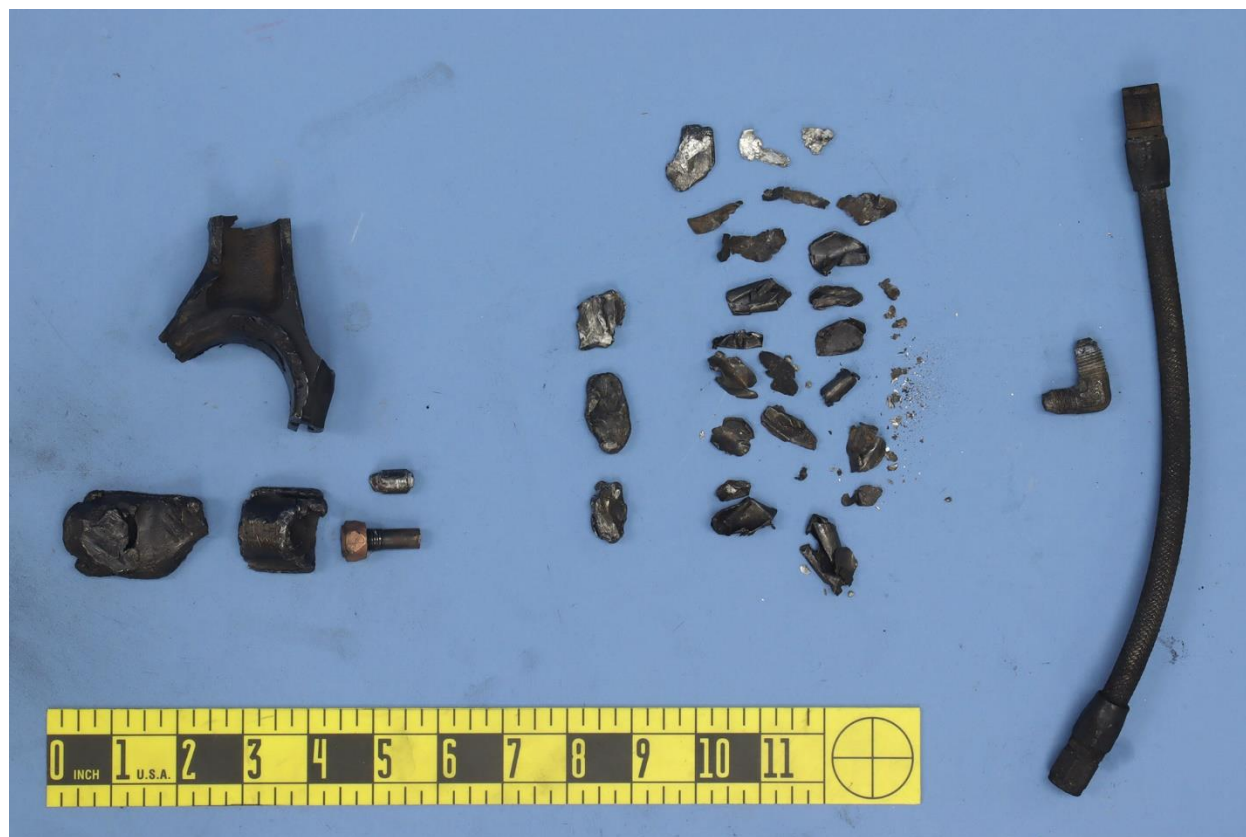
Pieces of a Lycoming O-360-A1A engine were submitted to the NTSB Materials Laboratory for examination as listed above and shown below in figure 1. The number 4 connecting rod was fractured through the yoke and the end cap was fractured into multiple pieces. Both connecting rod bolts were fractured and multiple metal fragments had been retrieved from the oil sump. An oil line and elbow fitting were obstructed by an unidentified substance. The connecting rod pieces, associated bolts, and sump contents were examined first followed by the oil line components.

**Figure 1:** Connecting rod assembly pieces, fragments from sump, oil line, and elbow fitting, as received.

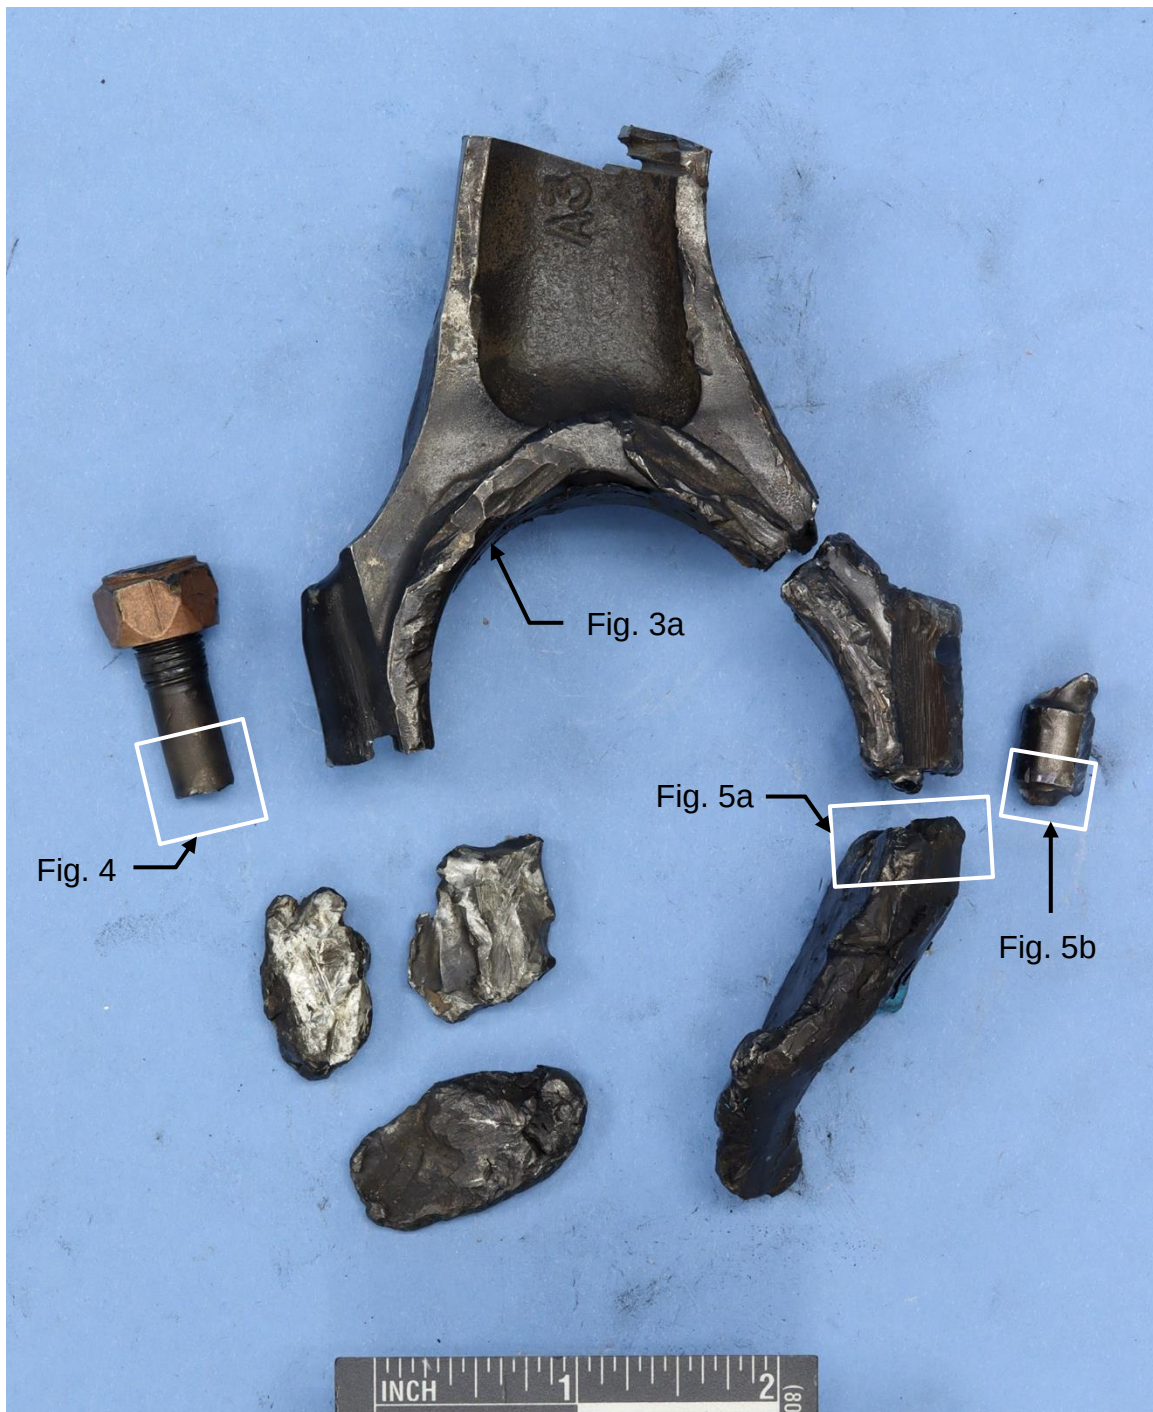
The relative positions of the connecting rod, end cap and bolt fragments were determined by examining mating fracture faces and interlocking surfaces. The nominal configuration is shown in figure 2. The right side of the connecting rod, as oriented in figure 2, had fractured near the yoke to rod transition. The end cap fragment was oriented by matching a battered slot on the large cap fragment to a battered tab on the yoke fragment. A bolt fragment, entrapped in the end cap was matched to a fracture surface on one of the free-standing bolt pieces (see below). The other bolt fragment was then matched to the opposite side (left side of figure 2). Three metal fragments from the sump had a size and thickness that were consistent with fractured pieces of the cap and are also shown in figure 2. The fragments were battered, and their exact orientation could not

be determined. The rod and yoke exhibited bending deformation. The end cap had also deformed in bending, opening the cap and reducing its curvature.

**Figure 2:** Connecting rod assembly pieces placed in their relative positions using fracture and interlocking surface features. Three fragments found in the sump were battered and their position could not be identified.

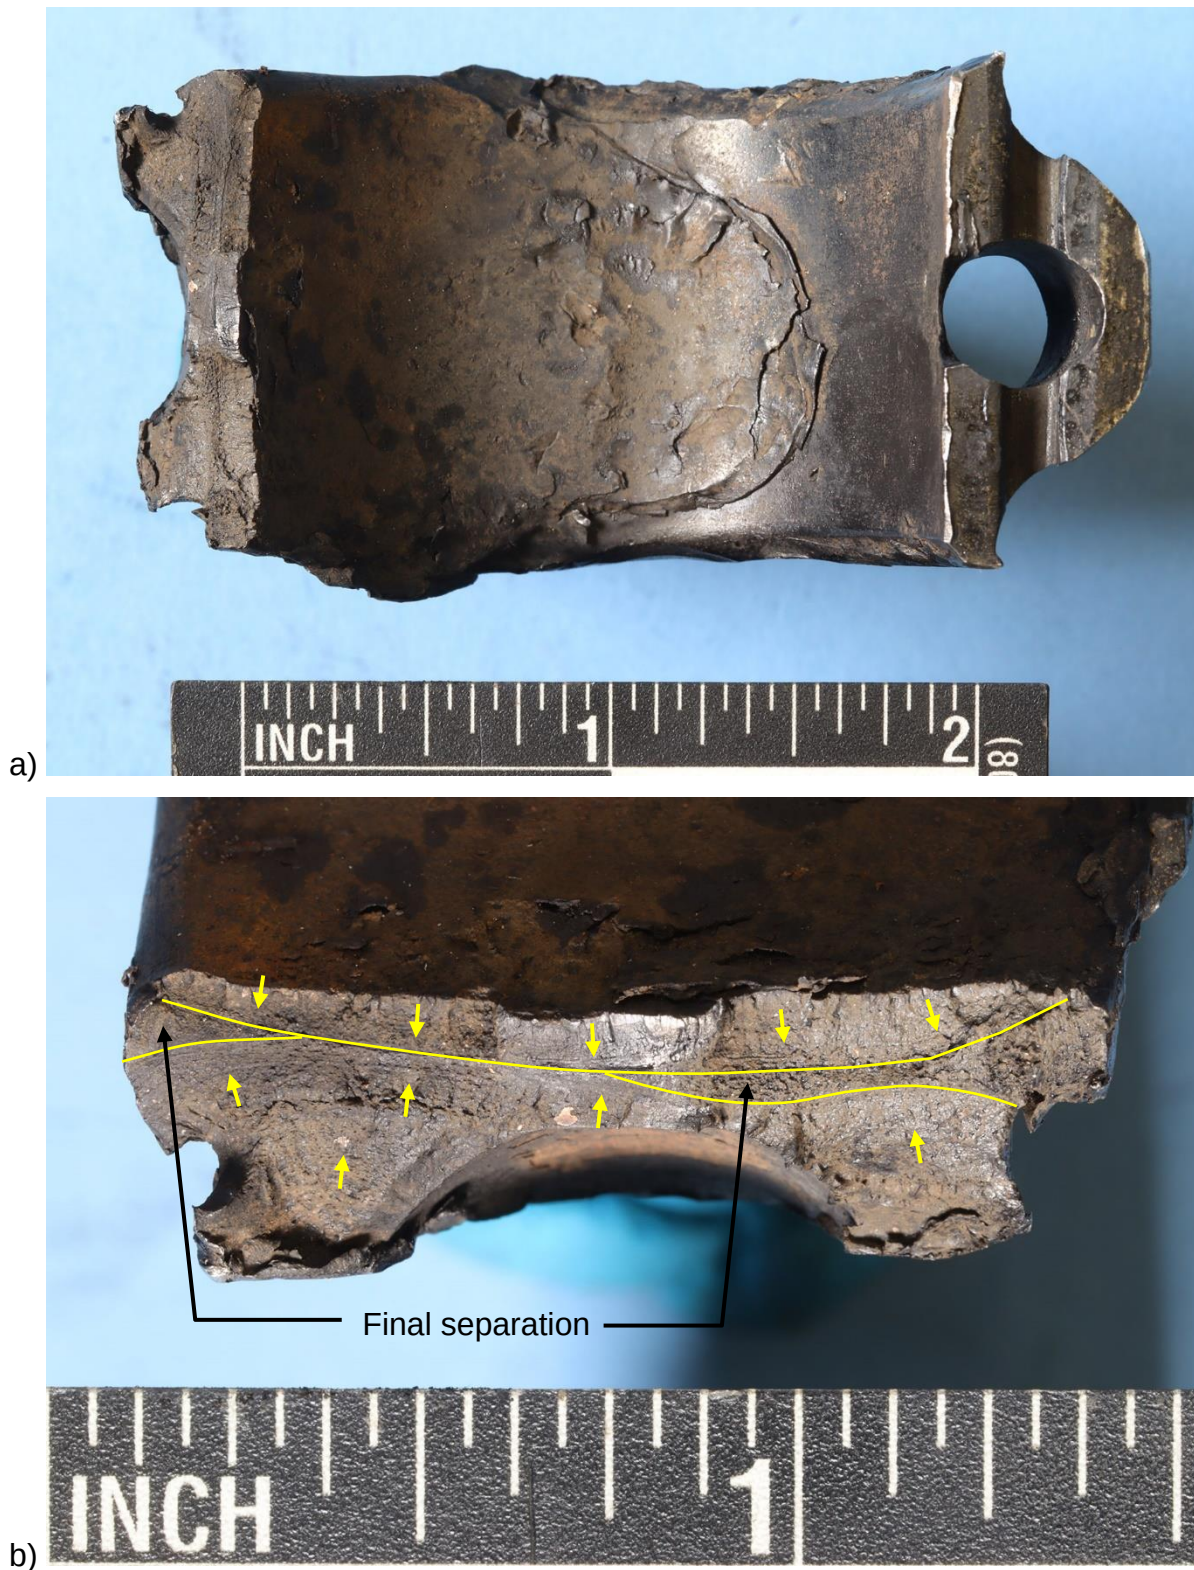
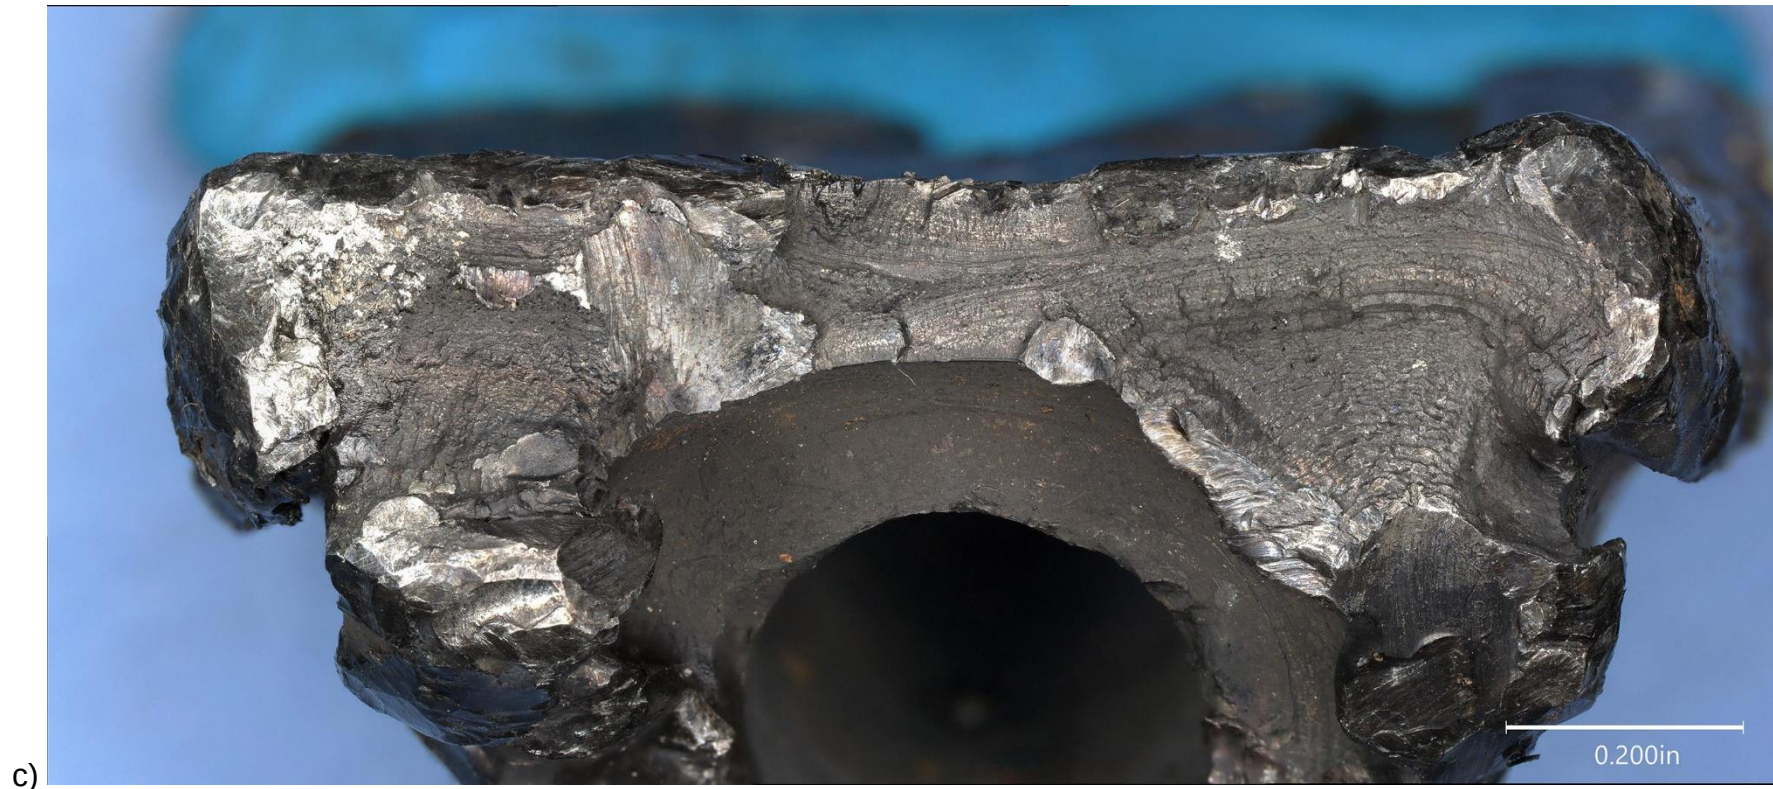
The bearing saddle (backing surface for the bearing insert) on the connecting rod is shown in figure 3a and the yoke fracture faces are shown in figures 3b and 3c. A metal layer was smeared across part of the saddle that was consistent with remnants of the bearing insert. The insert, saddle, and surrounding material exhibited a dark, heat-tinted appearance, consistent with high-temperature exposure. The yoke fracture surfaces were examined with the aid of a stereomicroscope. Ratchet marks and striated features were observed originating from the inner diameter surface progressing radially outward. Striated features were also observed progressing radially inward from the outside of the yoke, but the origin areas were battered. Areas of final overstress separation were observed where the two cracks met. The direction of crack progression and the regions of final separation are indicated by yellow arrows and solid lines, respectively, in figure 3b. The features were consistent with a fracture in reverse bending fatigue.

**Figure 3:** a) Image of the bearing saddle and fractured yoke on the connecting rod fragment;  
b) annotated view of the yoke fracture; and

**Figure 3 (cont.): c) the yoke's mating fracture face.**

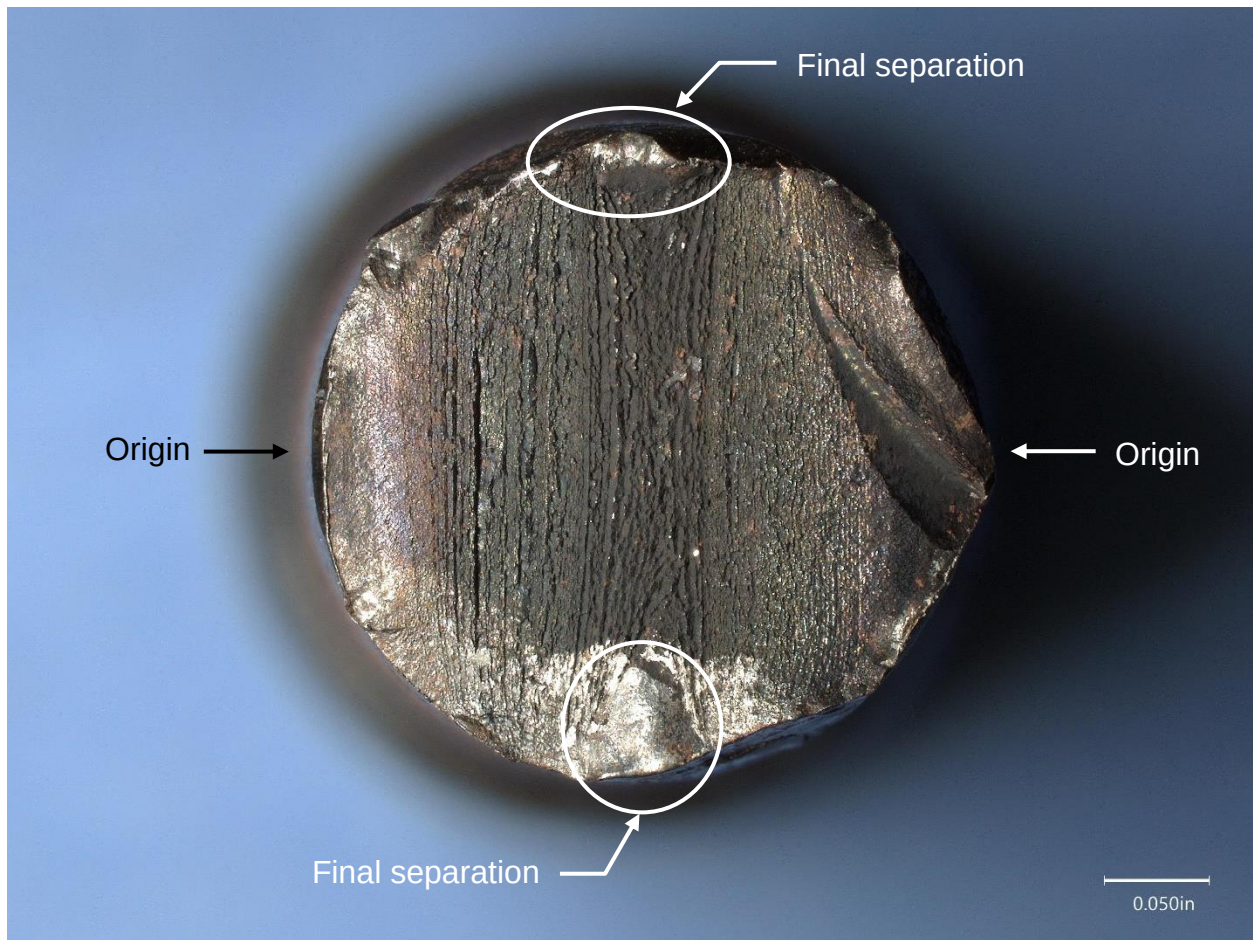
The connecting rod bolts from the left and right sides of figure 2 were similarly examined with the stereomicroscope. Both bolt fragments exhibited a dark tint similar to the connecting rod, consistent with high-temperature exposure. The fracture surface on the left-side bolt fragment, shown in figure 4, exhibited striated features, consistent with fatigue, that originated from two locations on opposite sides of the bolt and met along a line near the center of the bolt. Two regions of overstress separation, indicated in figure 4, were observed along the edge of the bolt, approximately 90° around the circumference from either origin. The bolt cross section and overstress areas were measured on the image and the calculated fatigue fraction was 0.96. The features were consistent with a high-cycle fatigue fracture under reverse bending. The mating fracture surfaces from the right-side bolt are shown in figures 5a and 5b. The fracture was nominally coplanar with the plane of the end cap / yoke joint. Coarse striated features, consistent with fatigue, were observed that originated on the side closest to the end cap / yoke inner diameter. The striated features progressed partially across the bolt in a radially outward direction, then transitioned to an out of plane fracture with coarse features, consistent with a final separation in overstress. The fatigue fraction was approximately 0.45. A second fracture on the free-standing bolt fragment exhibited coarse fracture features on an inclined plane, consistent with a bending overstress fracture.

**Figure 4:** Image of fracture surface from the bolt fragment on the left side of the connecting rod in figure 2.

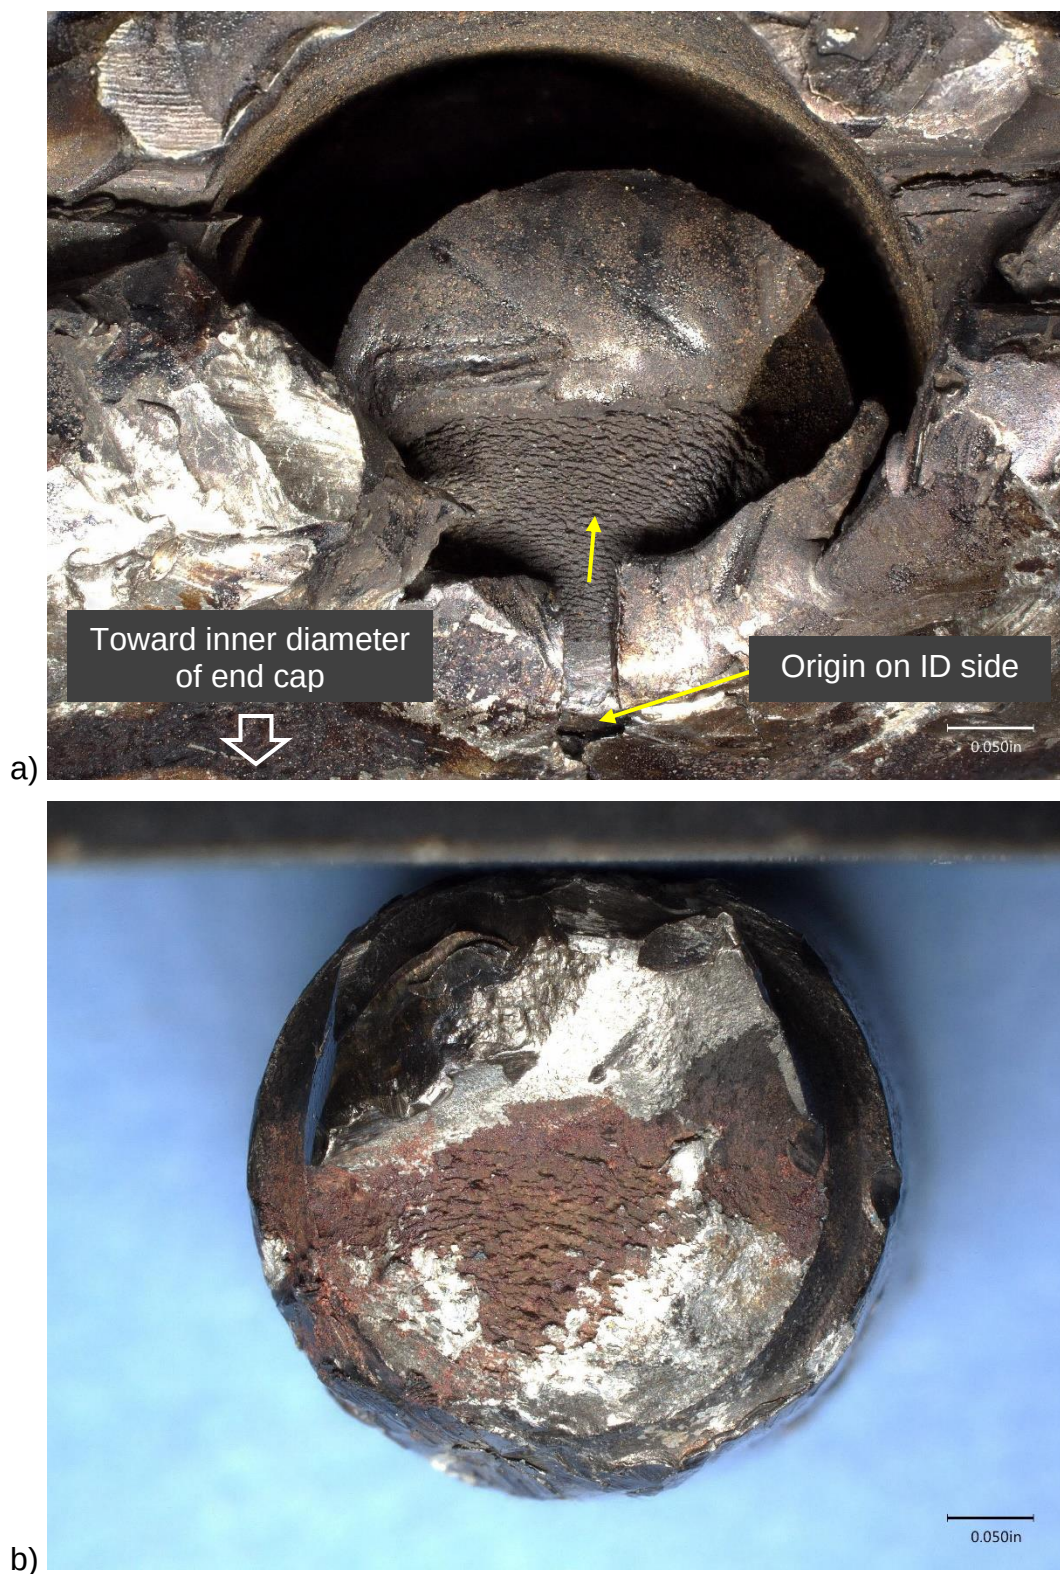
**Figure 5:** Images of mating fracture faces from the bolt on the right side of the connecting rod in figure 2: a) fracture face on a piece of bolt trapped in the end cap and b) mating fracture face on a free-standing bolt fragment.

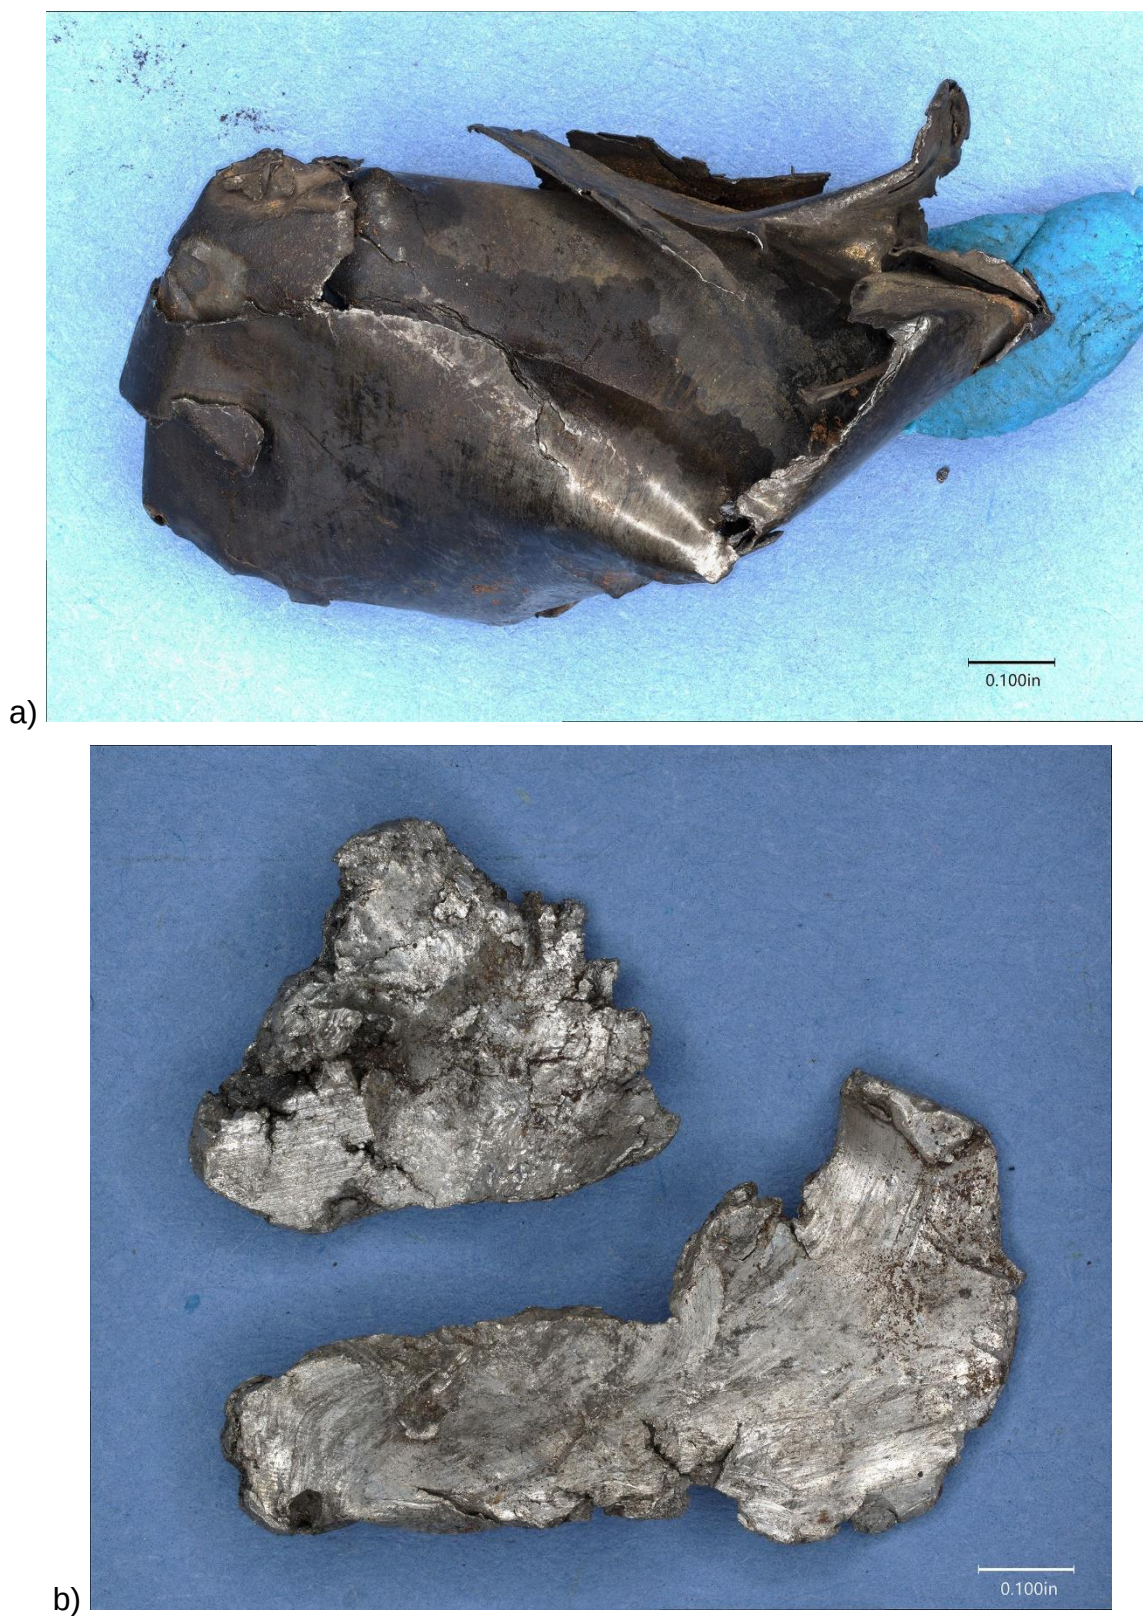
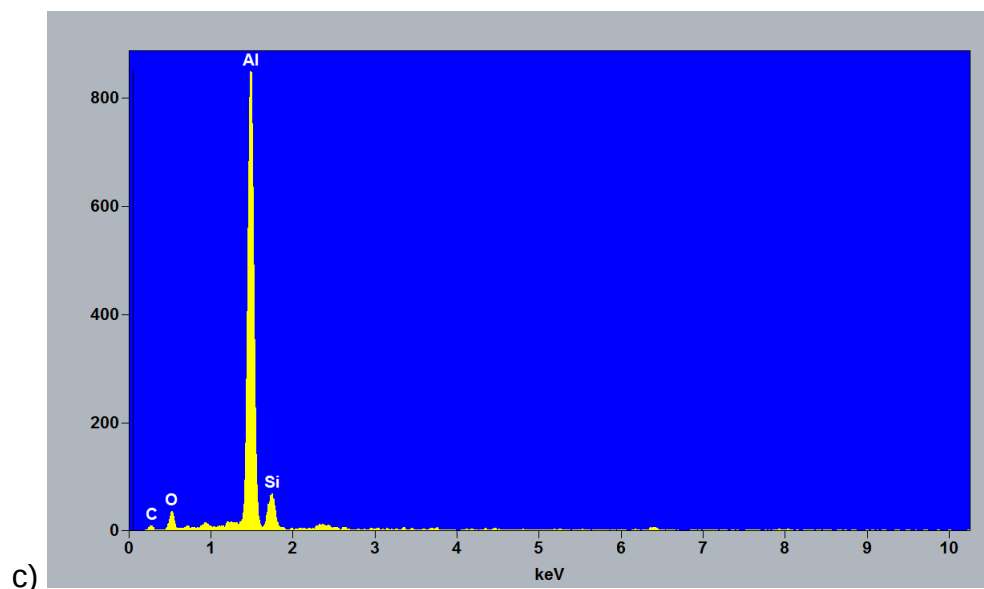
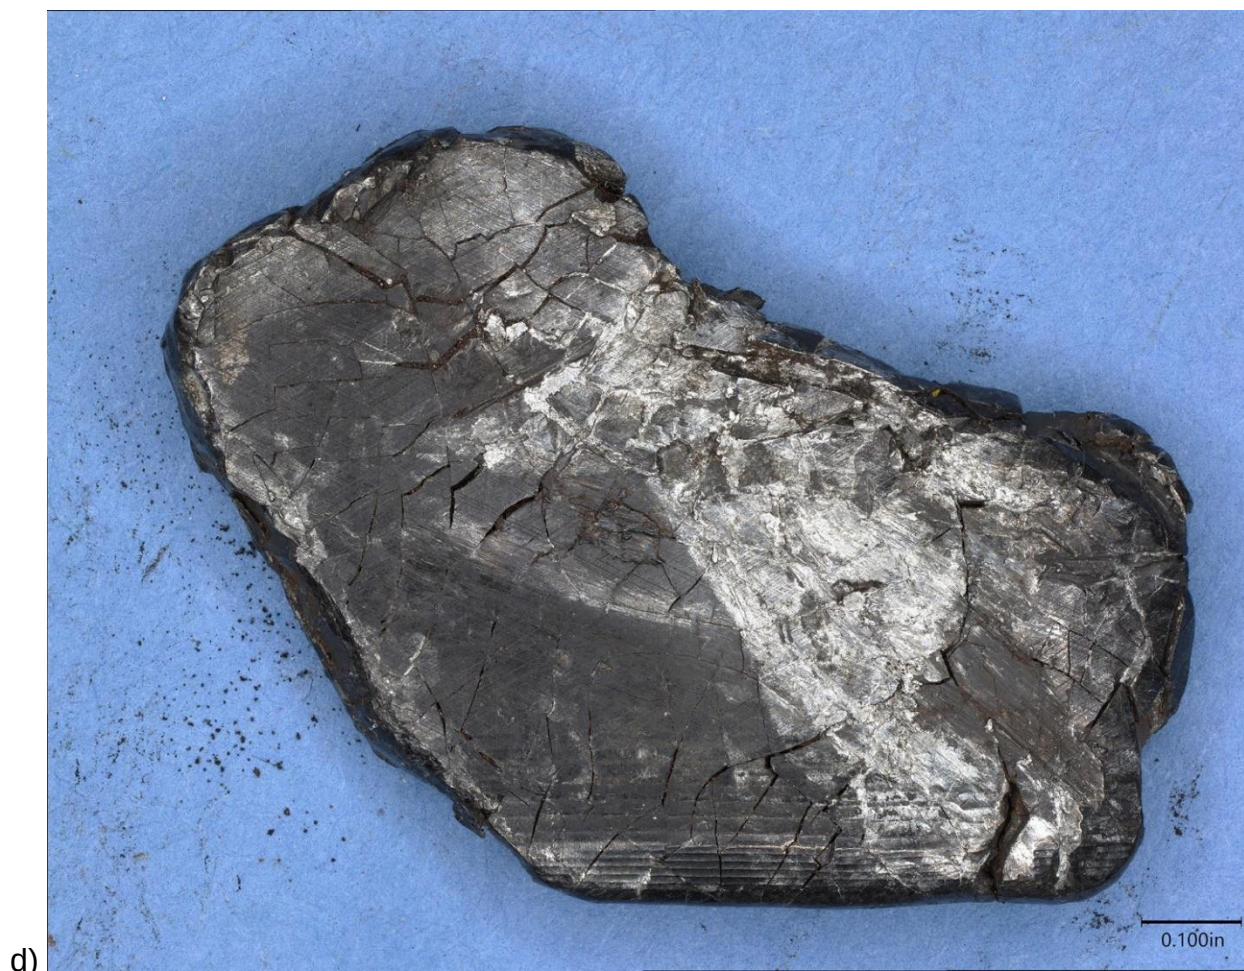
The metal chips from the sump were examined visually and were partitioned into three groups. Most of the chips were similar to that shown in figure 6a, exhibiting laminate separations and indications of thermal distress. The thicknesses of several chips were measured using a point micrometer and the thickness ranged from 0.0035 inch to 0.0089 inch. Two chips exhibited a silver-metallic appearance as shown in figure 6b. The chemical composition of one of the chips was examined in a scanning electron microscope (SEM) equipped with an energy dispersive X-ray spectrometer (EDS) as shown in figure 6c. The spectrum consisted primarily of aluminum (Al), silicon (Si), and oxygen (O).

Finally, one chip, shown in figure 6d, was thicker than the other chips, measuring between 0.0772 inch and 0.0845 inch according to the point micrometer. One edge of the chip was straight. The adjacent flat face was beveled and exhibited longitudinal machining lines. Elsewhere on the face of the chip, the surface exhibited mud cracking and a smeared silver-metallic residue. The fractured edges of the chip were examined and exhibited features consistent with either batter or overstress. The chip was examined in the SEM (shown in figure 7a) and by EDS. The spectra from two spots, indicated by the yellow dots in figure 7a, are shown in figures 7b and 7c, one at a location with the silver-metallic residue and a second in a region without the residue, respectively. The region with the residue, shown in figure 7b, exhibited primarily Al and Si, with an additional peak of iron (Fe). The region without the residue, shown in figure 7c, exhibited primarily iron (Fe) with additional peaks of Al and chromium (Cr).

**Figure 6:** a) Image of a typical chip from the sump; b) two silver-metallic chips found in sump;

**Figure 6 (cont.):** c) EDS spectrum from one of the silver-metallic chips showing the presence of aluminum (Al) and silicon (Si); and d) thicker metal chip exhibiting mud cracking and smeared silver-metallic material.

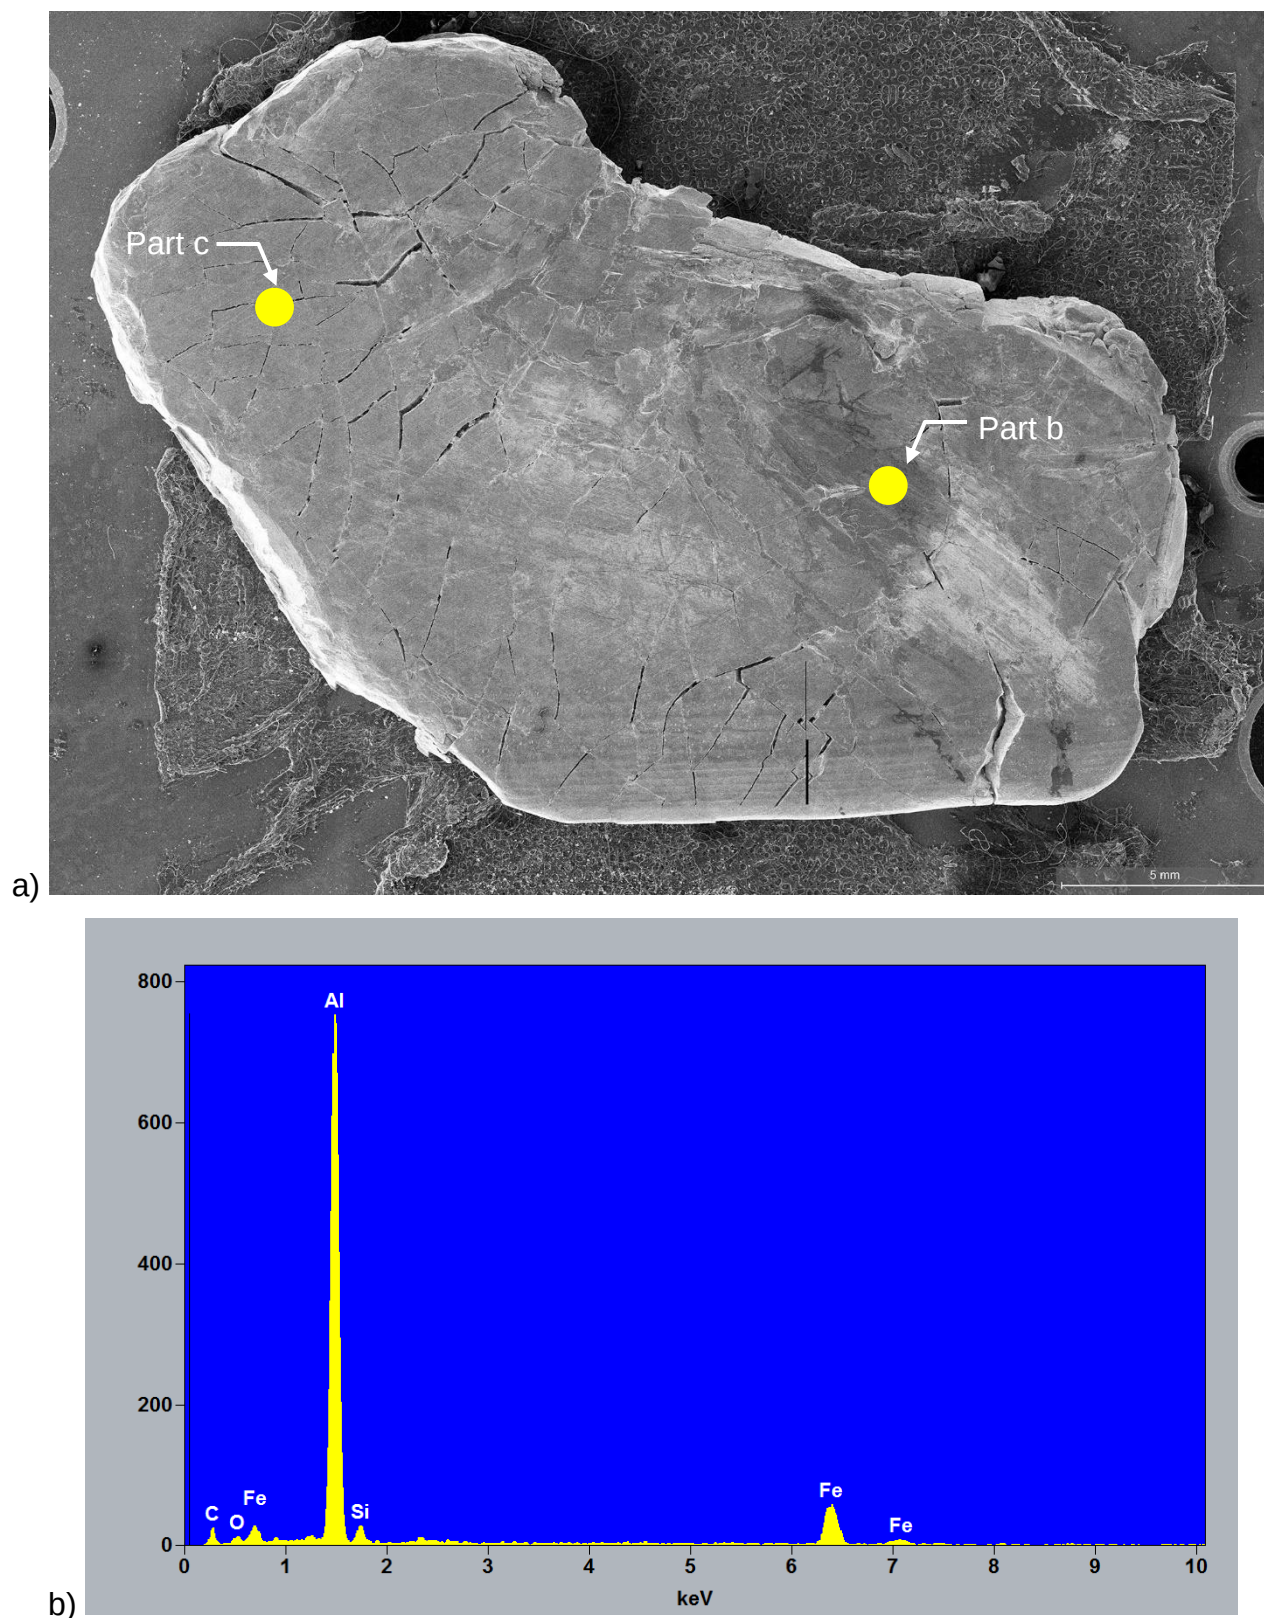
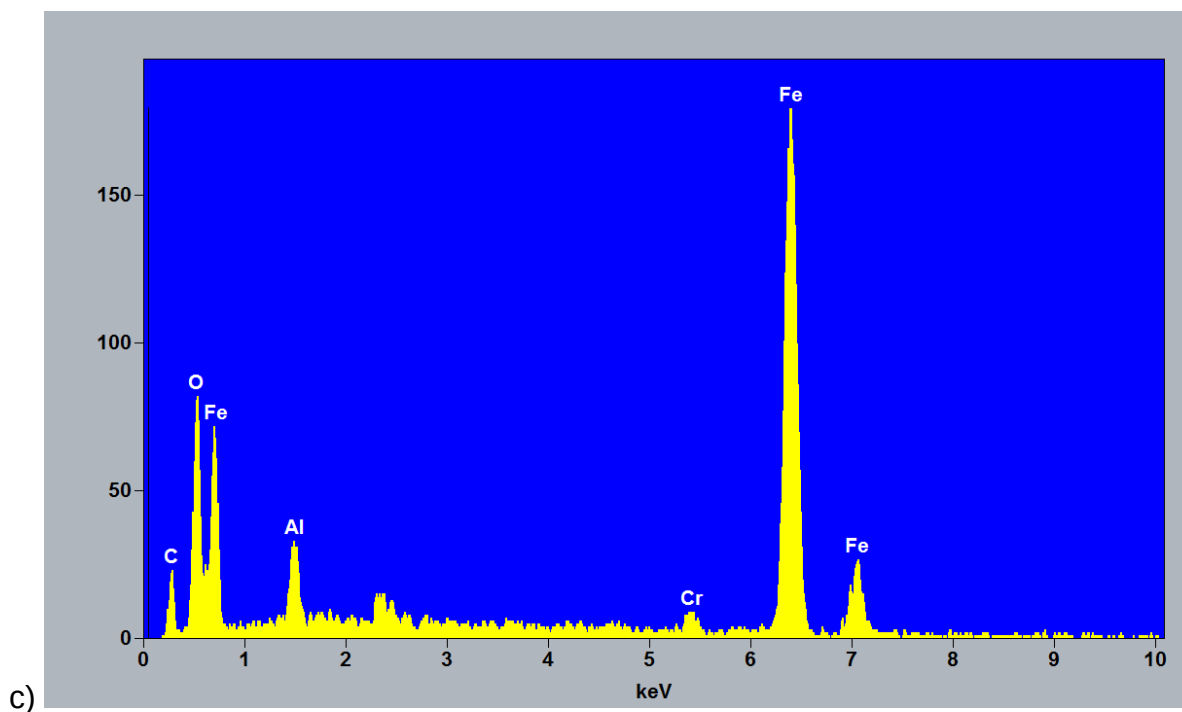
**Figure 7:** a) SEM image of the chip from figure 6d; b) EDS from a location with the silver-metallic region, exhibiting primarily Al and Si and an additional iron (Fe) peak; and

**Figure 7 (cont.):** c) EDS spectrum from a typical dark matte region exhibiting primarily Fe with additional peaks from Al and chromium (Cr).

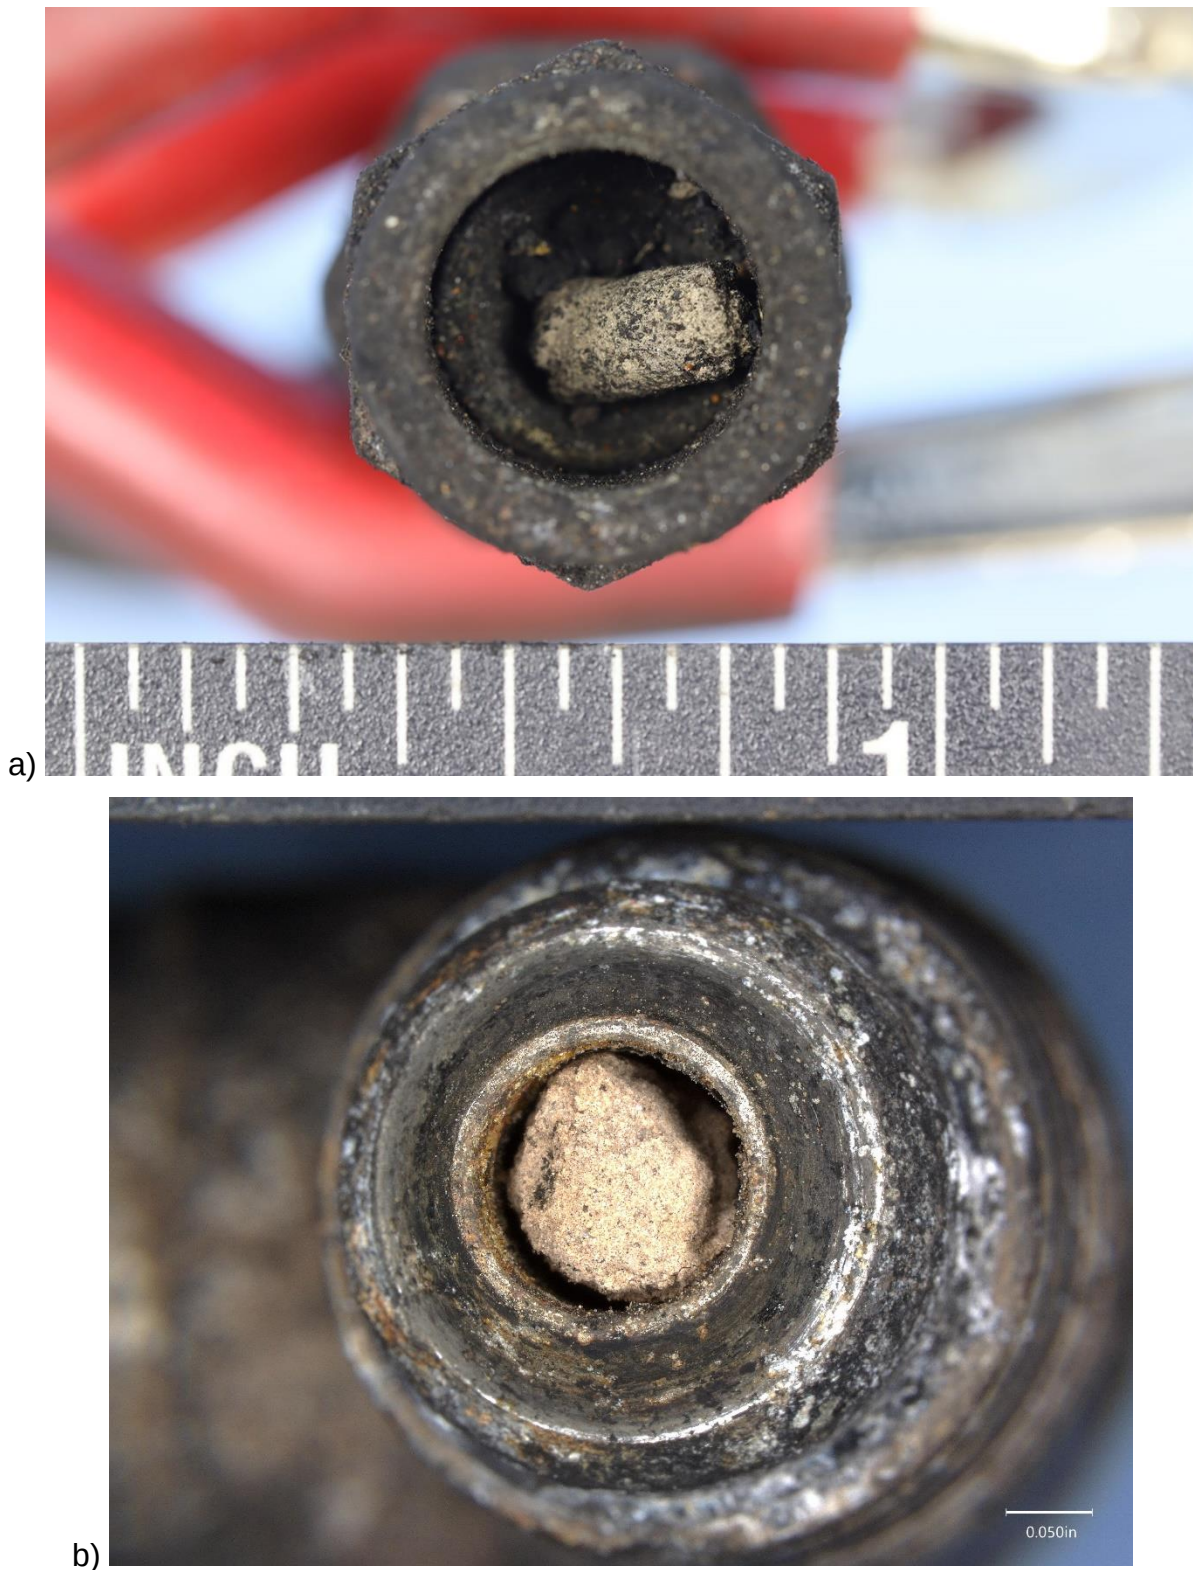
The oil line and elbow fitting were examined by eye and with the aid of the stereomicroscope. A plug of material was observed at one end of the oil line, as shown in figure 8a. Using a fiber optic light, an obstruction was also observed within the passage of the elbow fitting. The obstruction, after mechanically dislodging it, is shown in figure 8b. The plug of material was extracted from the fitting as shown in figure 9a. A sample of the material was collected on a piece of carbon tape and examined by SEM/EDS, as shown in figure 9b. The spectrum consisted primarily of Si, Al, and O, with traces of sodium (Na), magnesium (Mg), chlorine (Cl), potassium (K), calcium (Ca), and Fe.

**Figure 8:** a) One end of the oil line showing an obstruction and b) the elbow fitting showing a piece of the obstruction at the entrance to the internal passage after it had been dislodged.

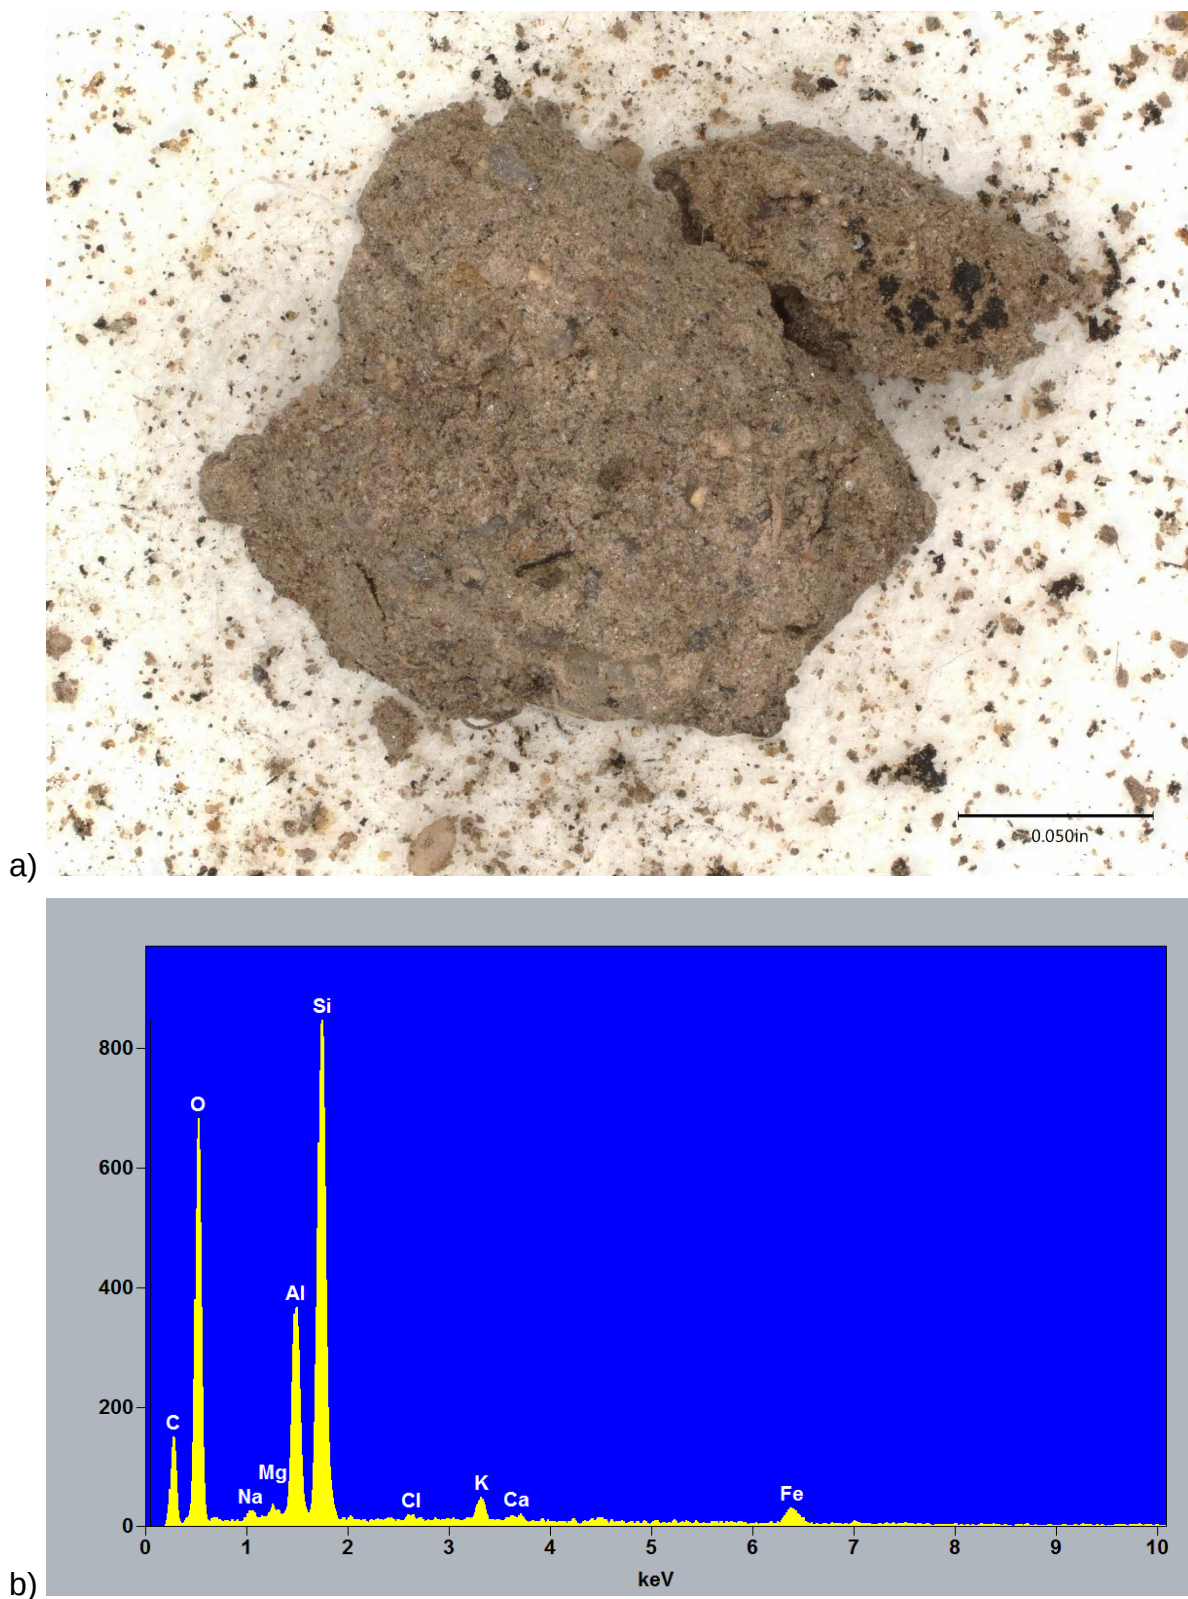
**Figure 9:** a) image of the obstructing material after extraction from the elbow fitting and b) EDS spectrum of the debris showing primarily Si, Al, and O, with additional peaks from Na, Mg, Cl, K, Ca, and Fe.
