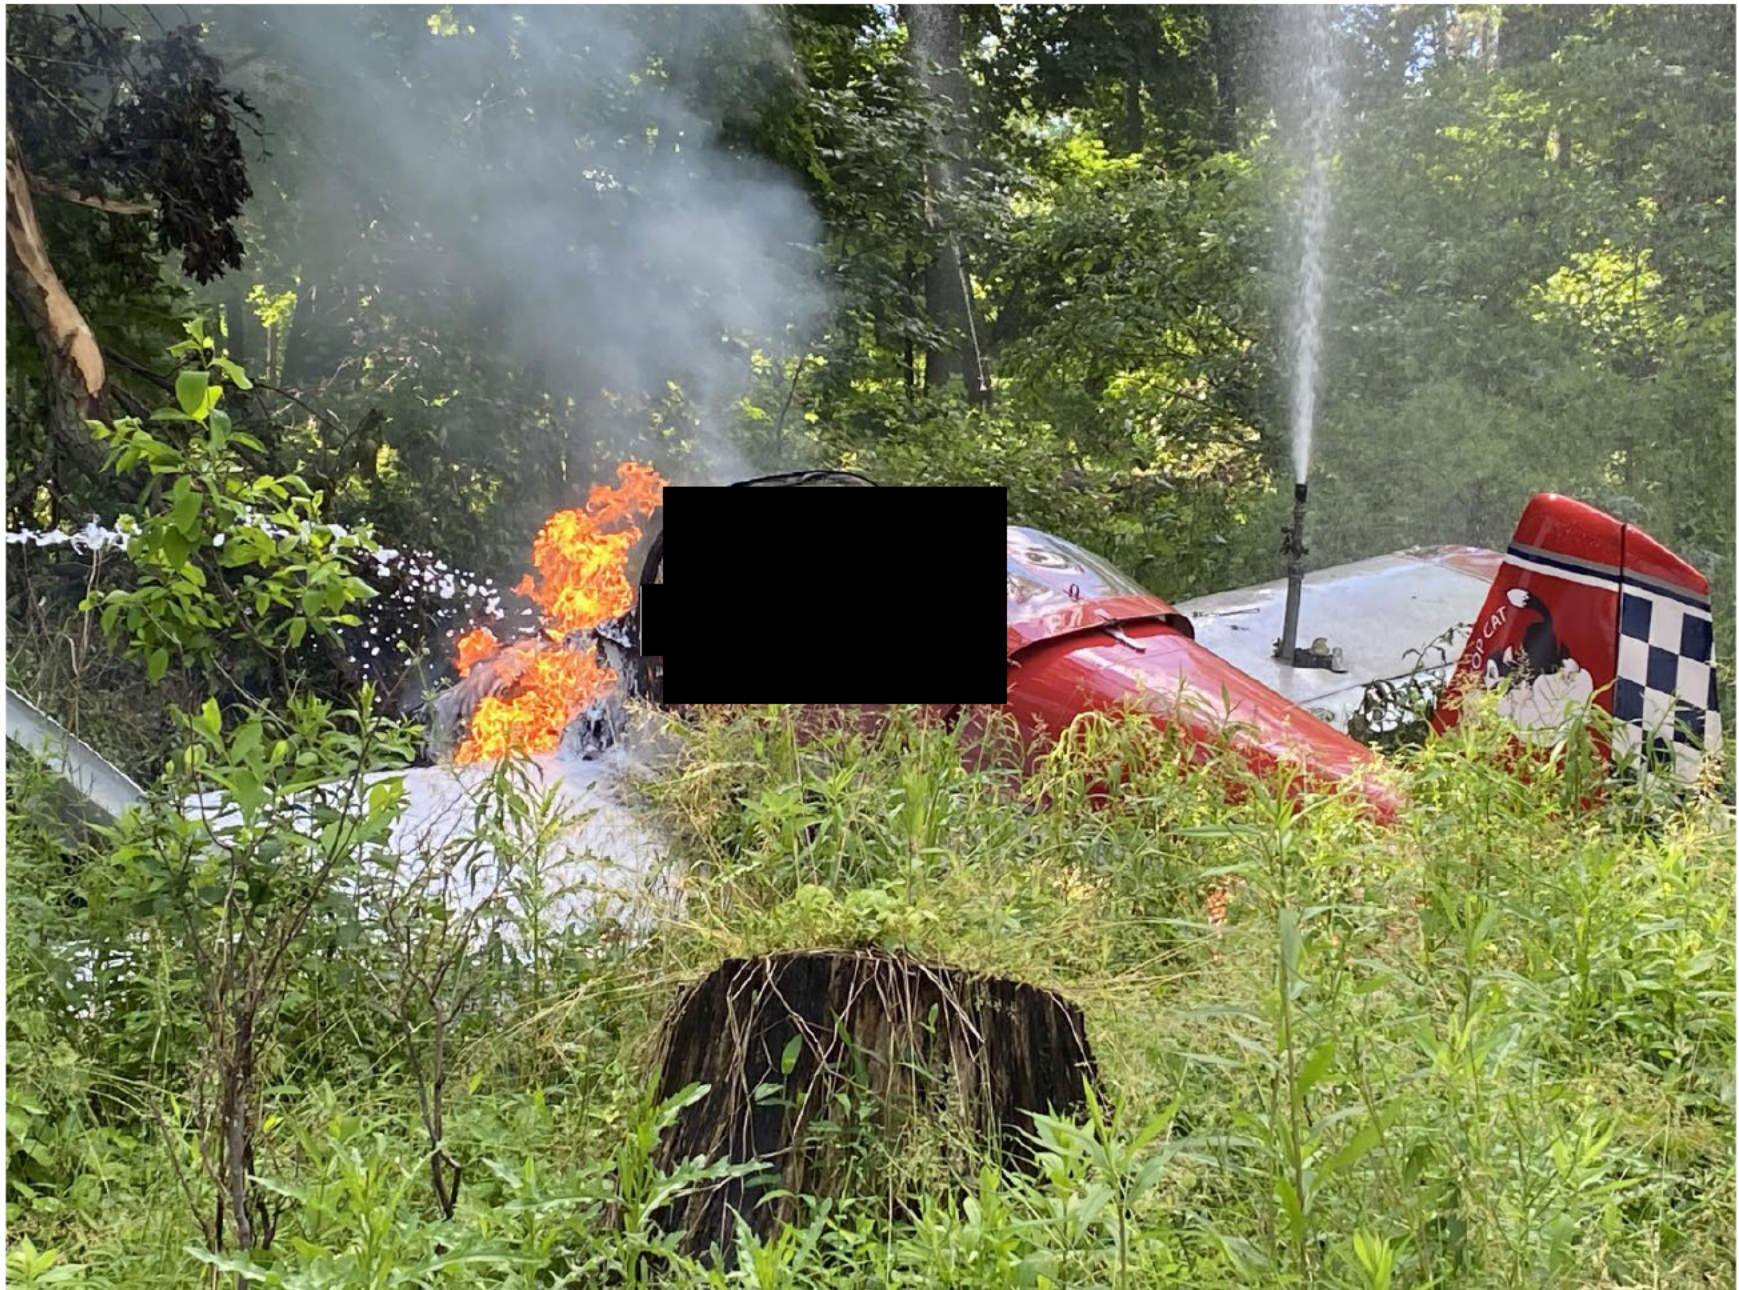
**Photo 1 – Main Wreckage – Courtesy of Buckingham County Emergency Management**

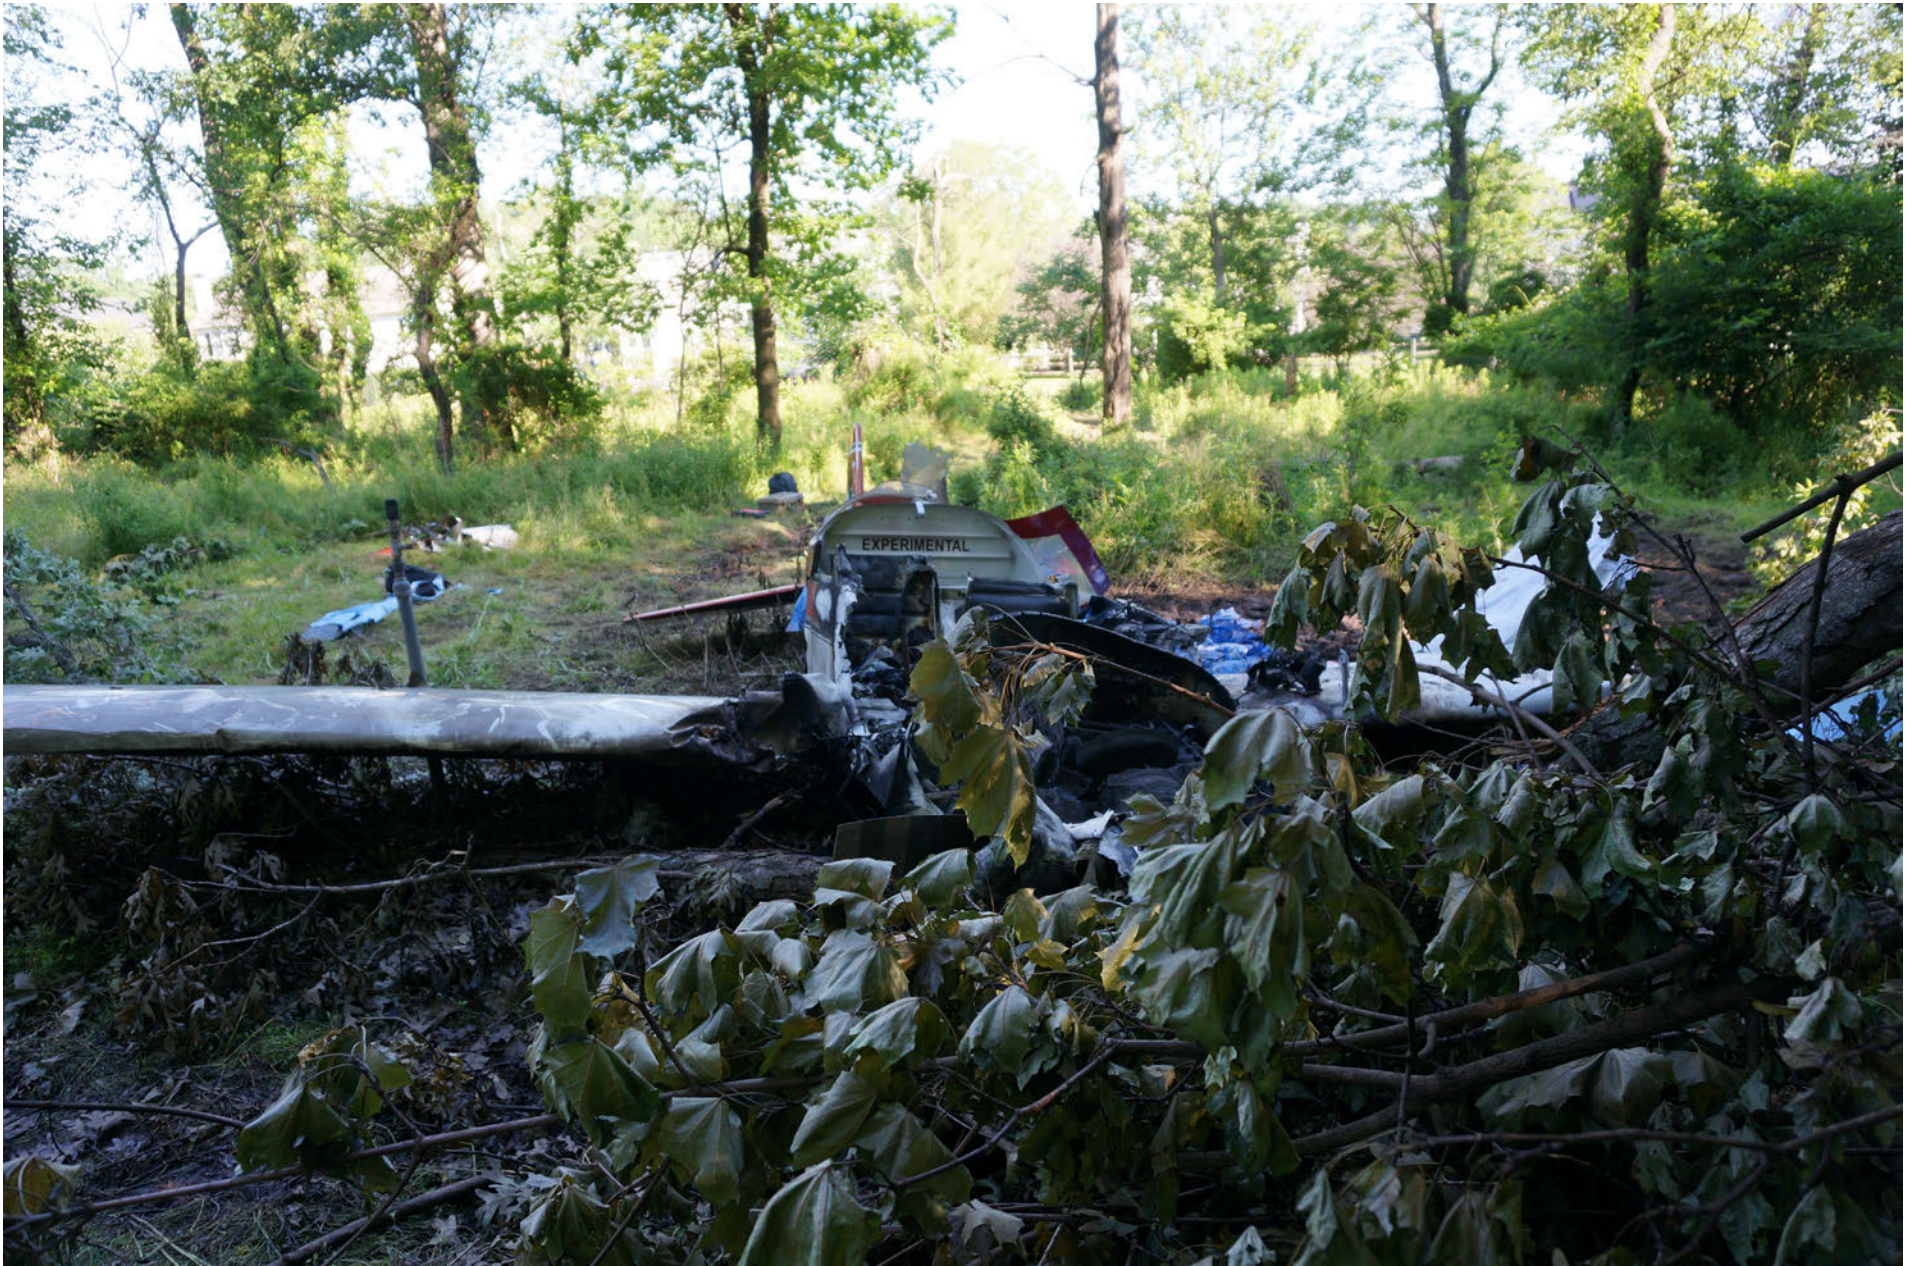
**Photo 2 – Front View of Main Wreckage**

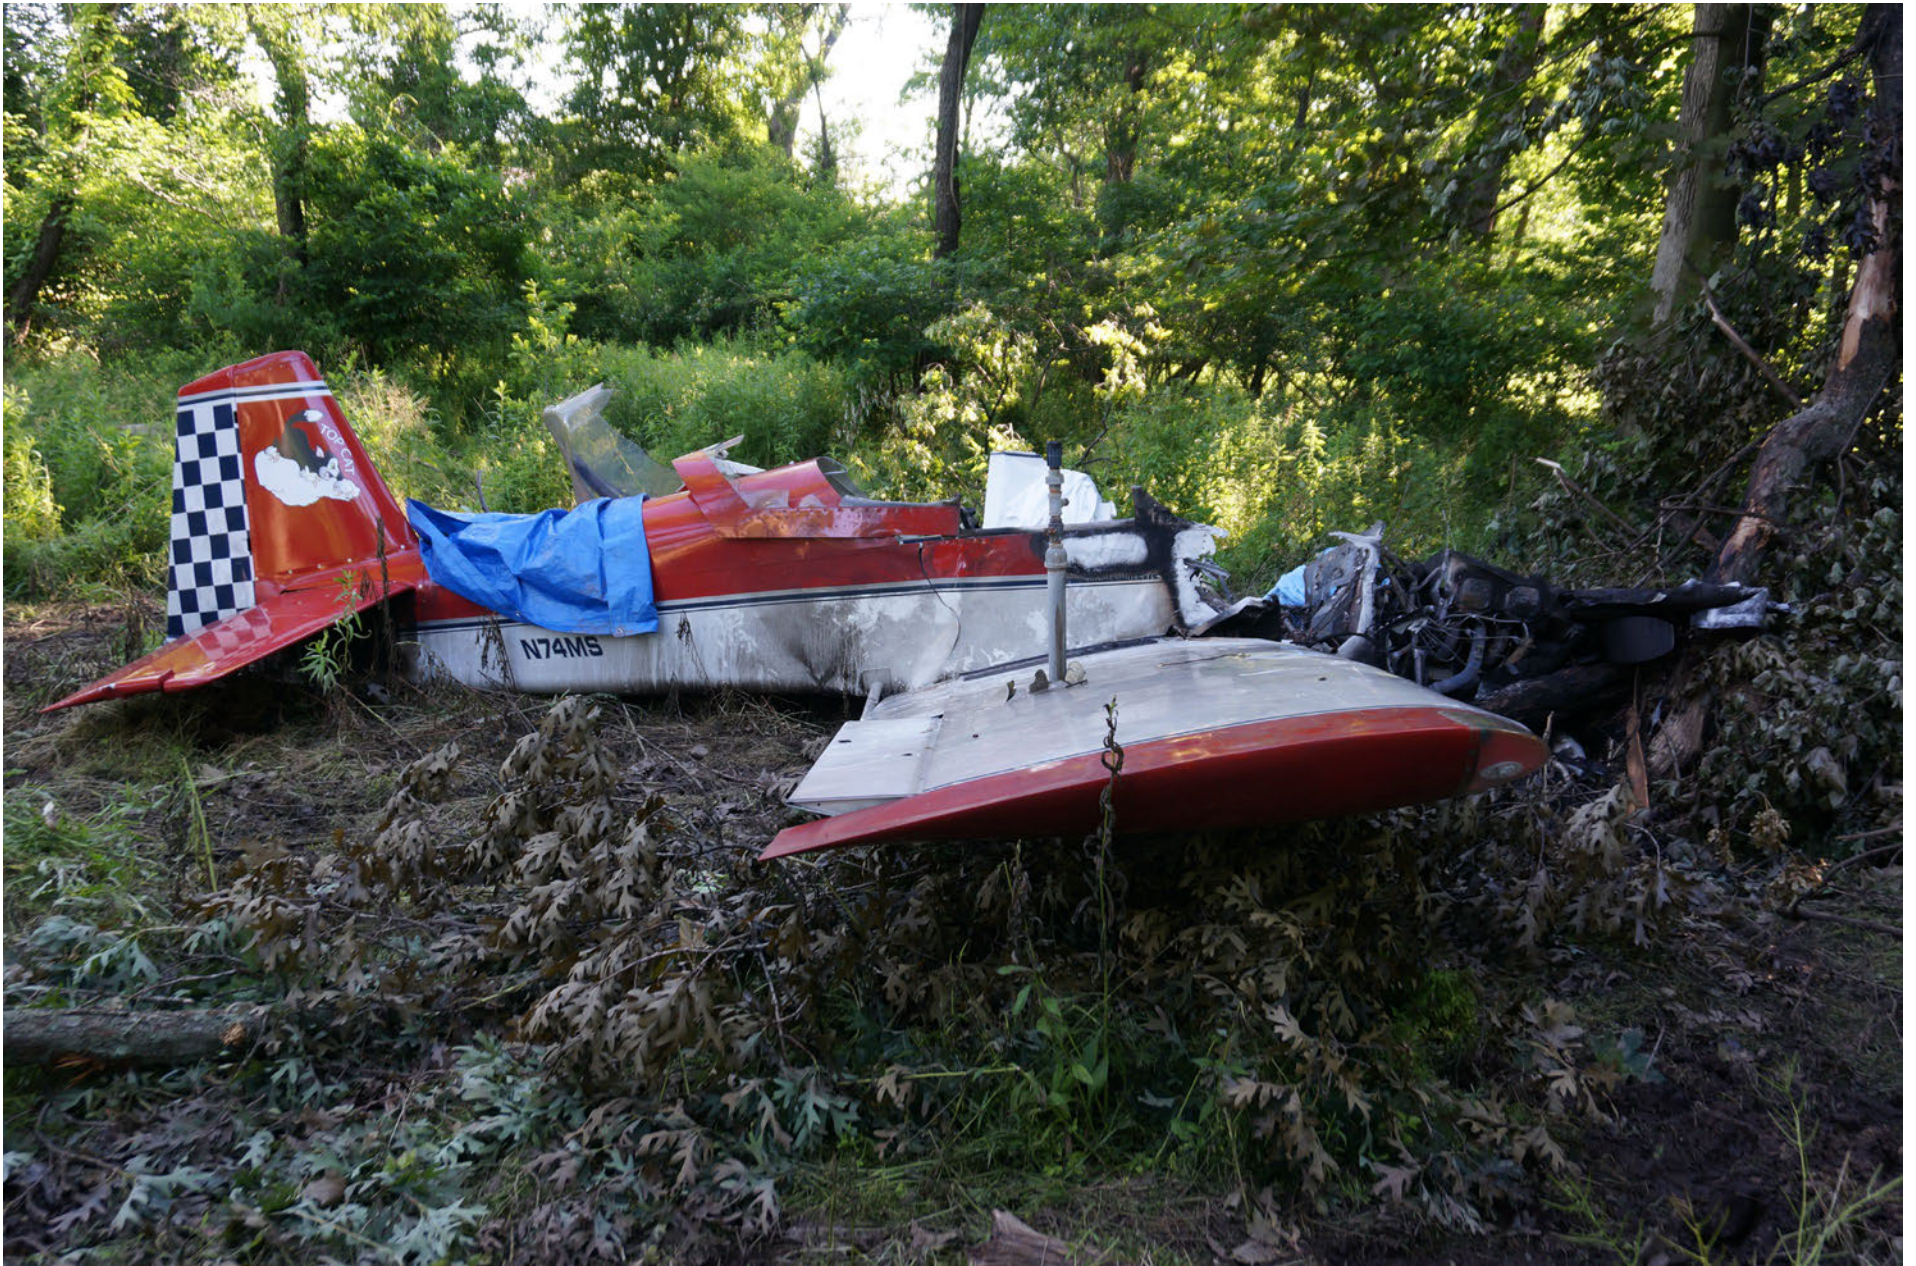
**Photo 3 – Right Side View of Main Wreckage**

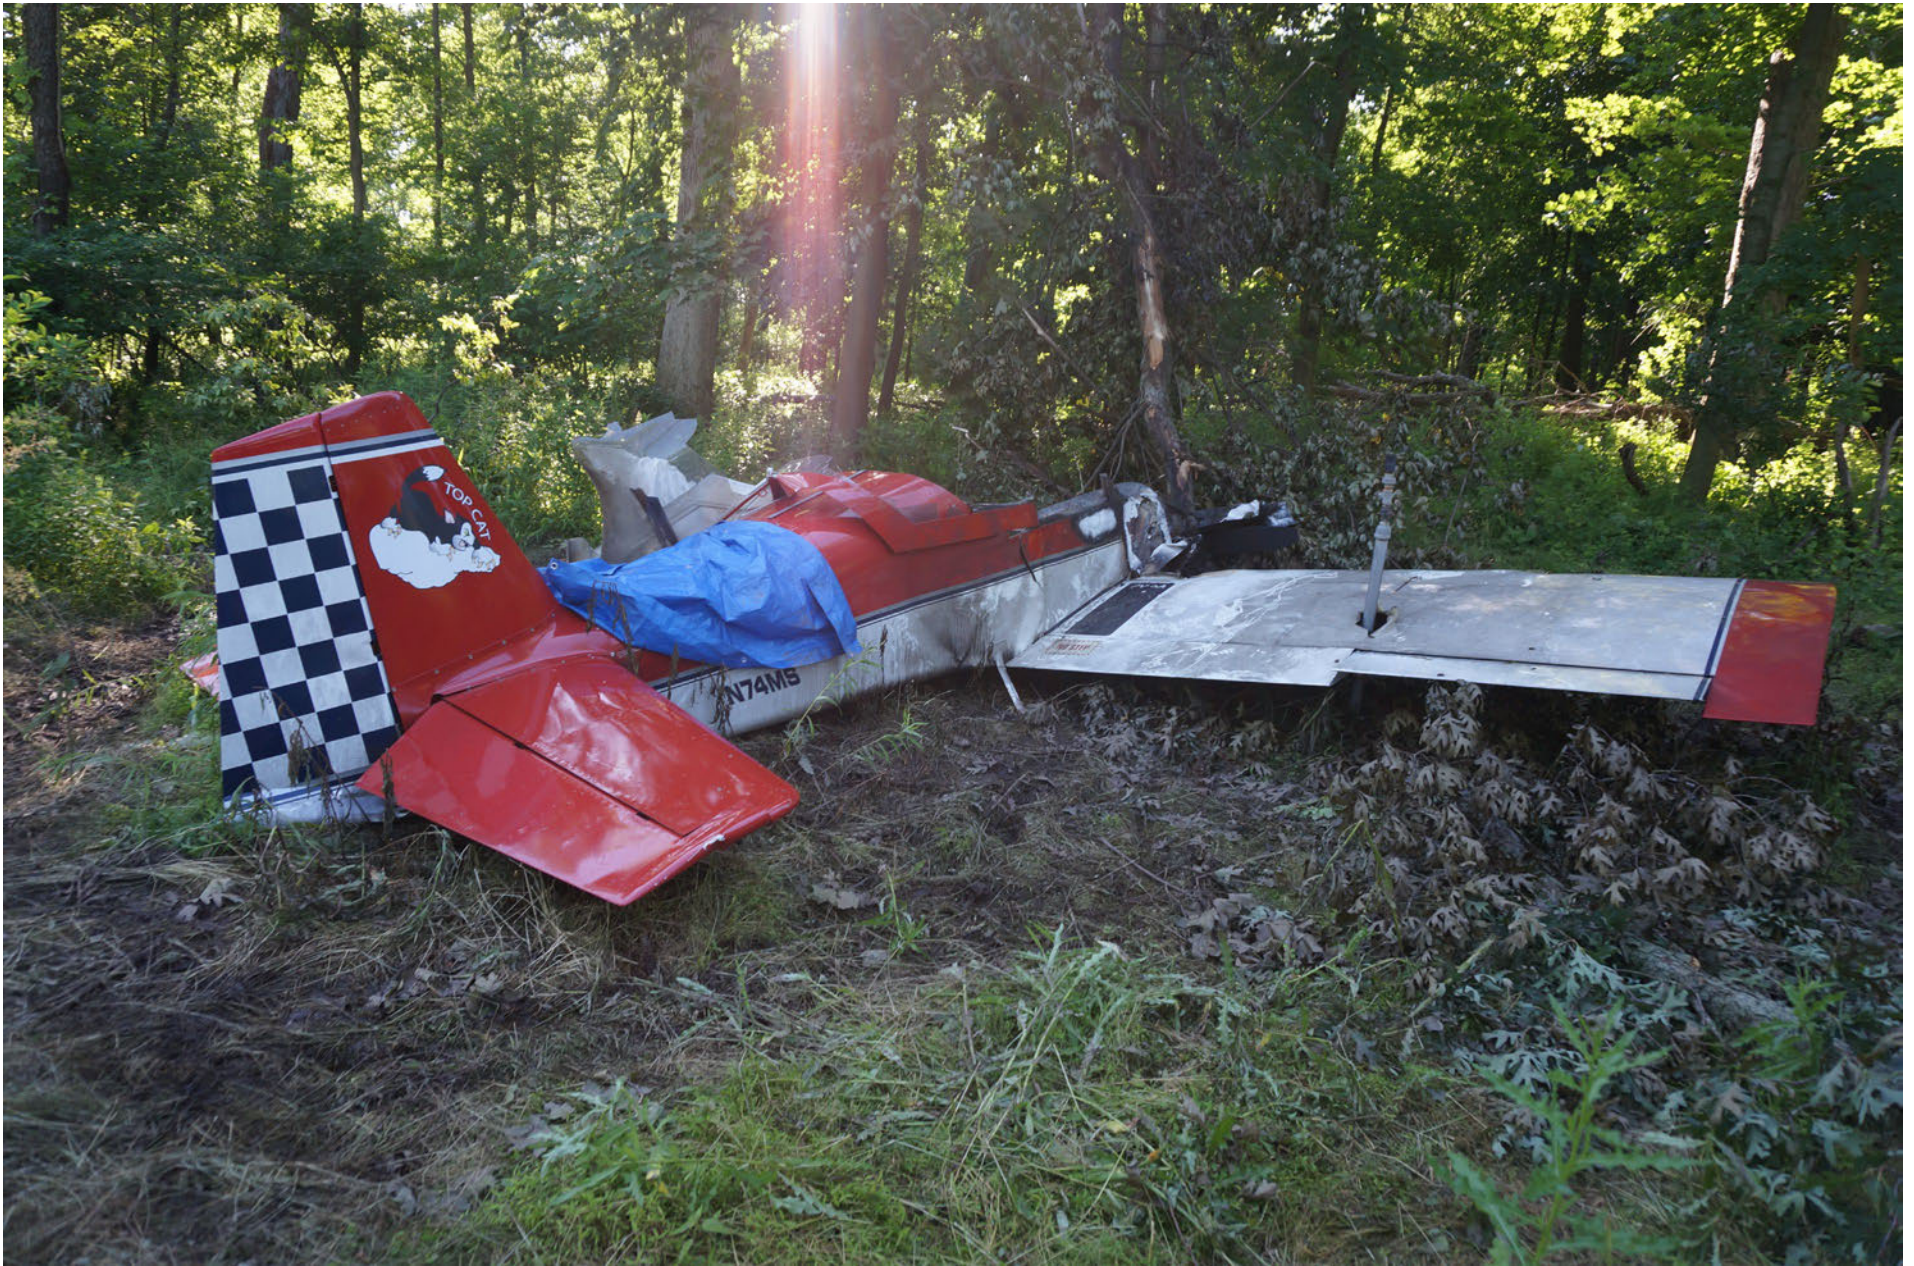
**Photo 4 – Right Rear View of Main Wreckage**

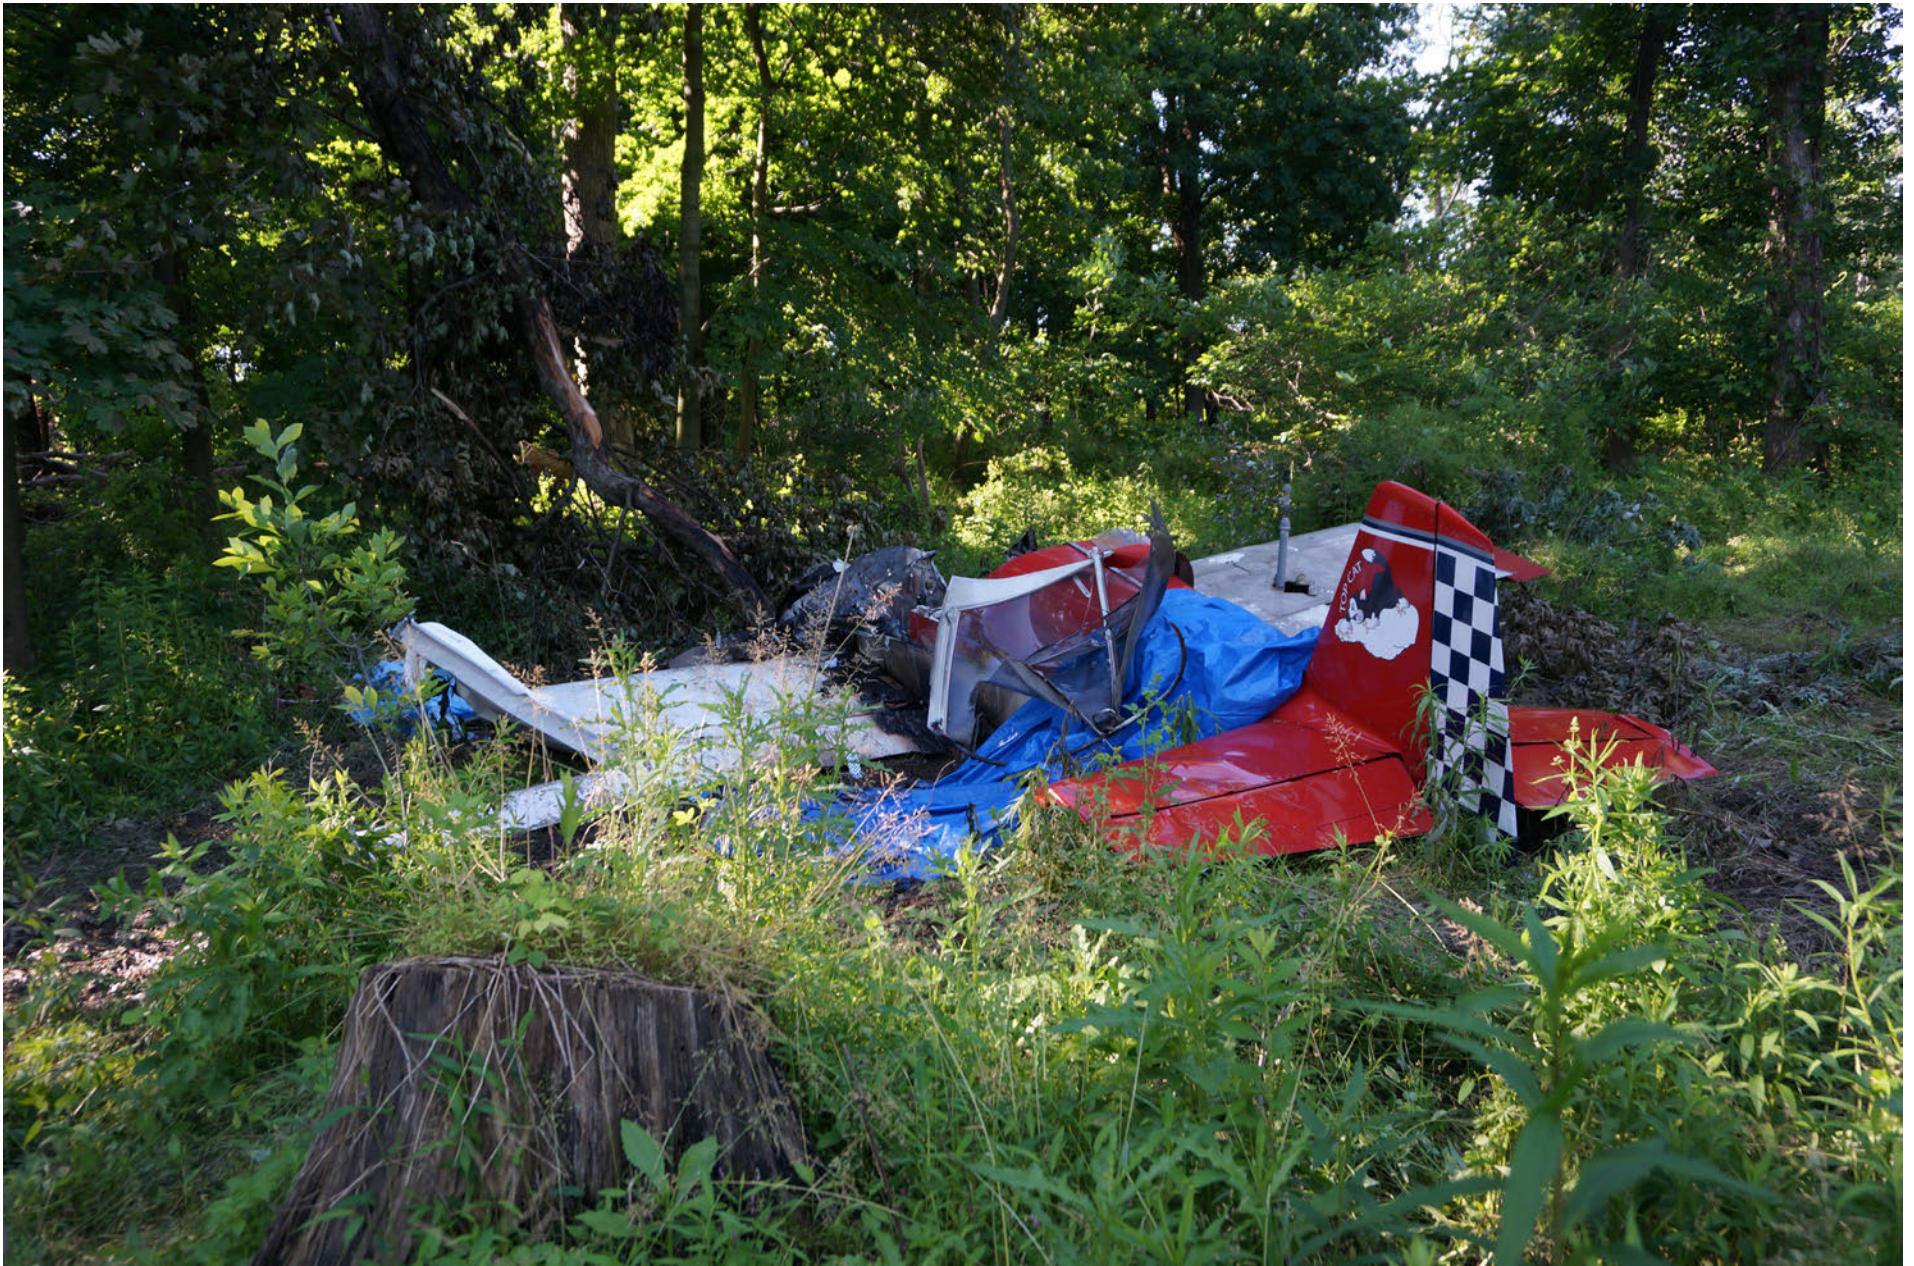
**Photo 5 – Left Rear View of Main Wreckage**

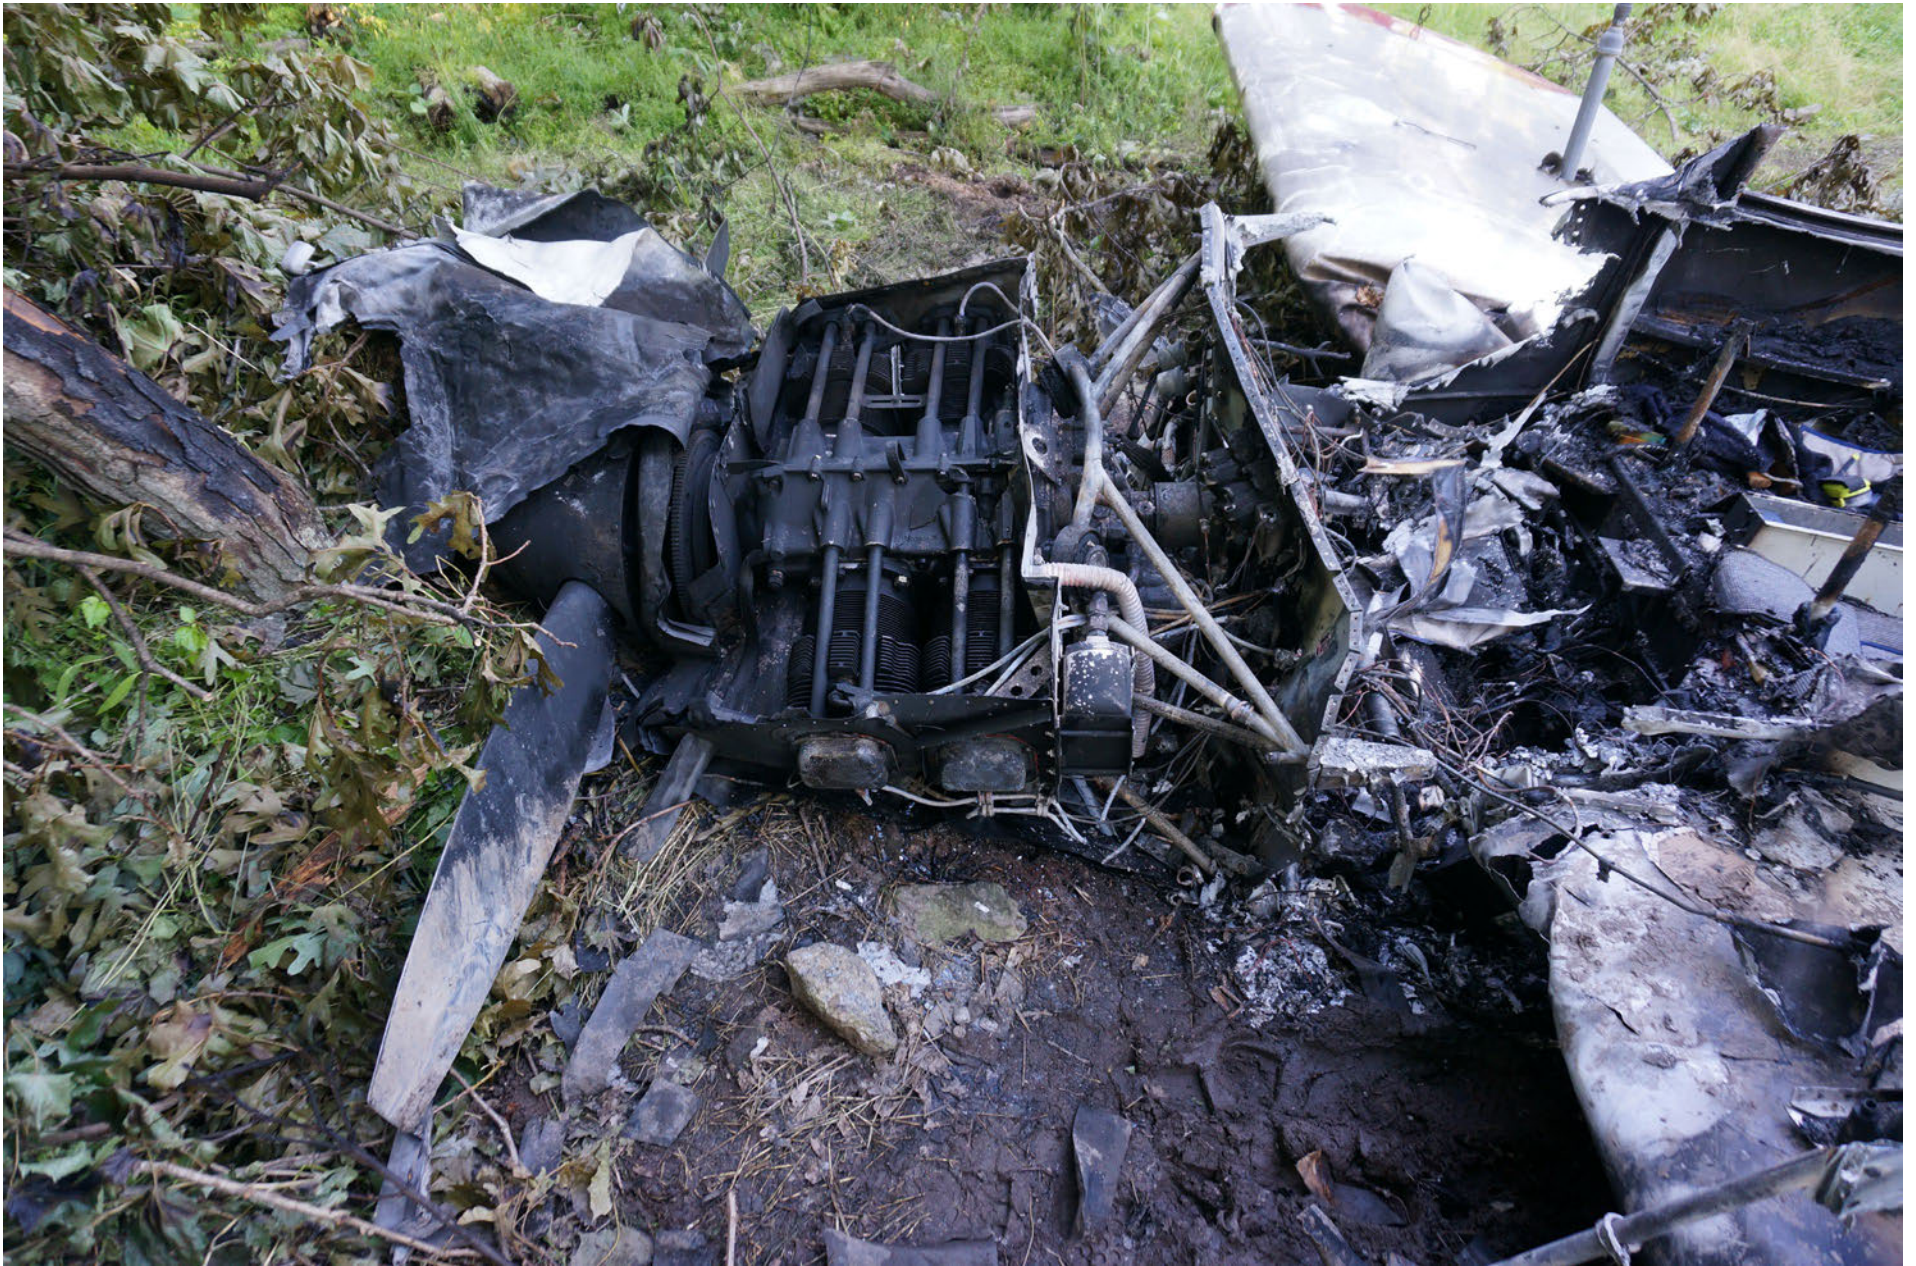
**Photo 7 – Propeller and Engine**

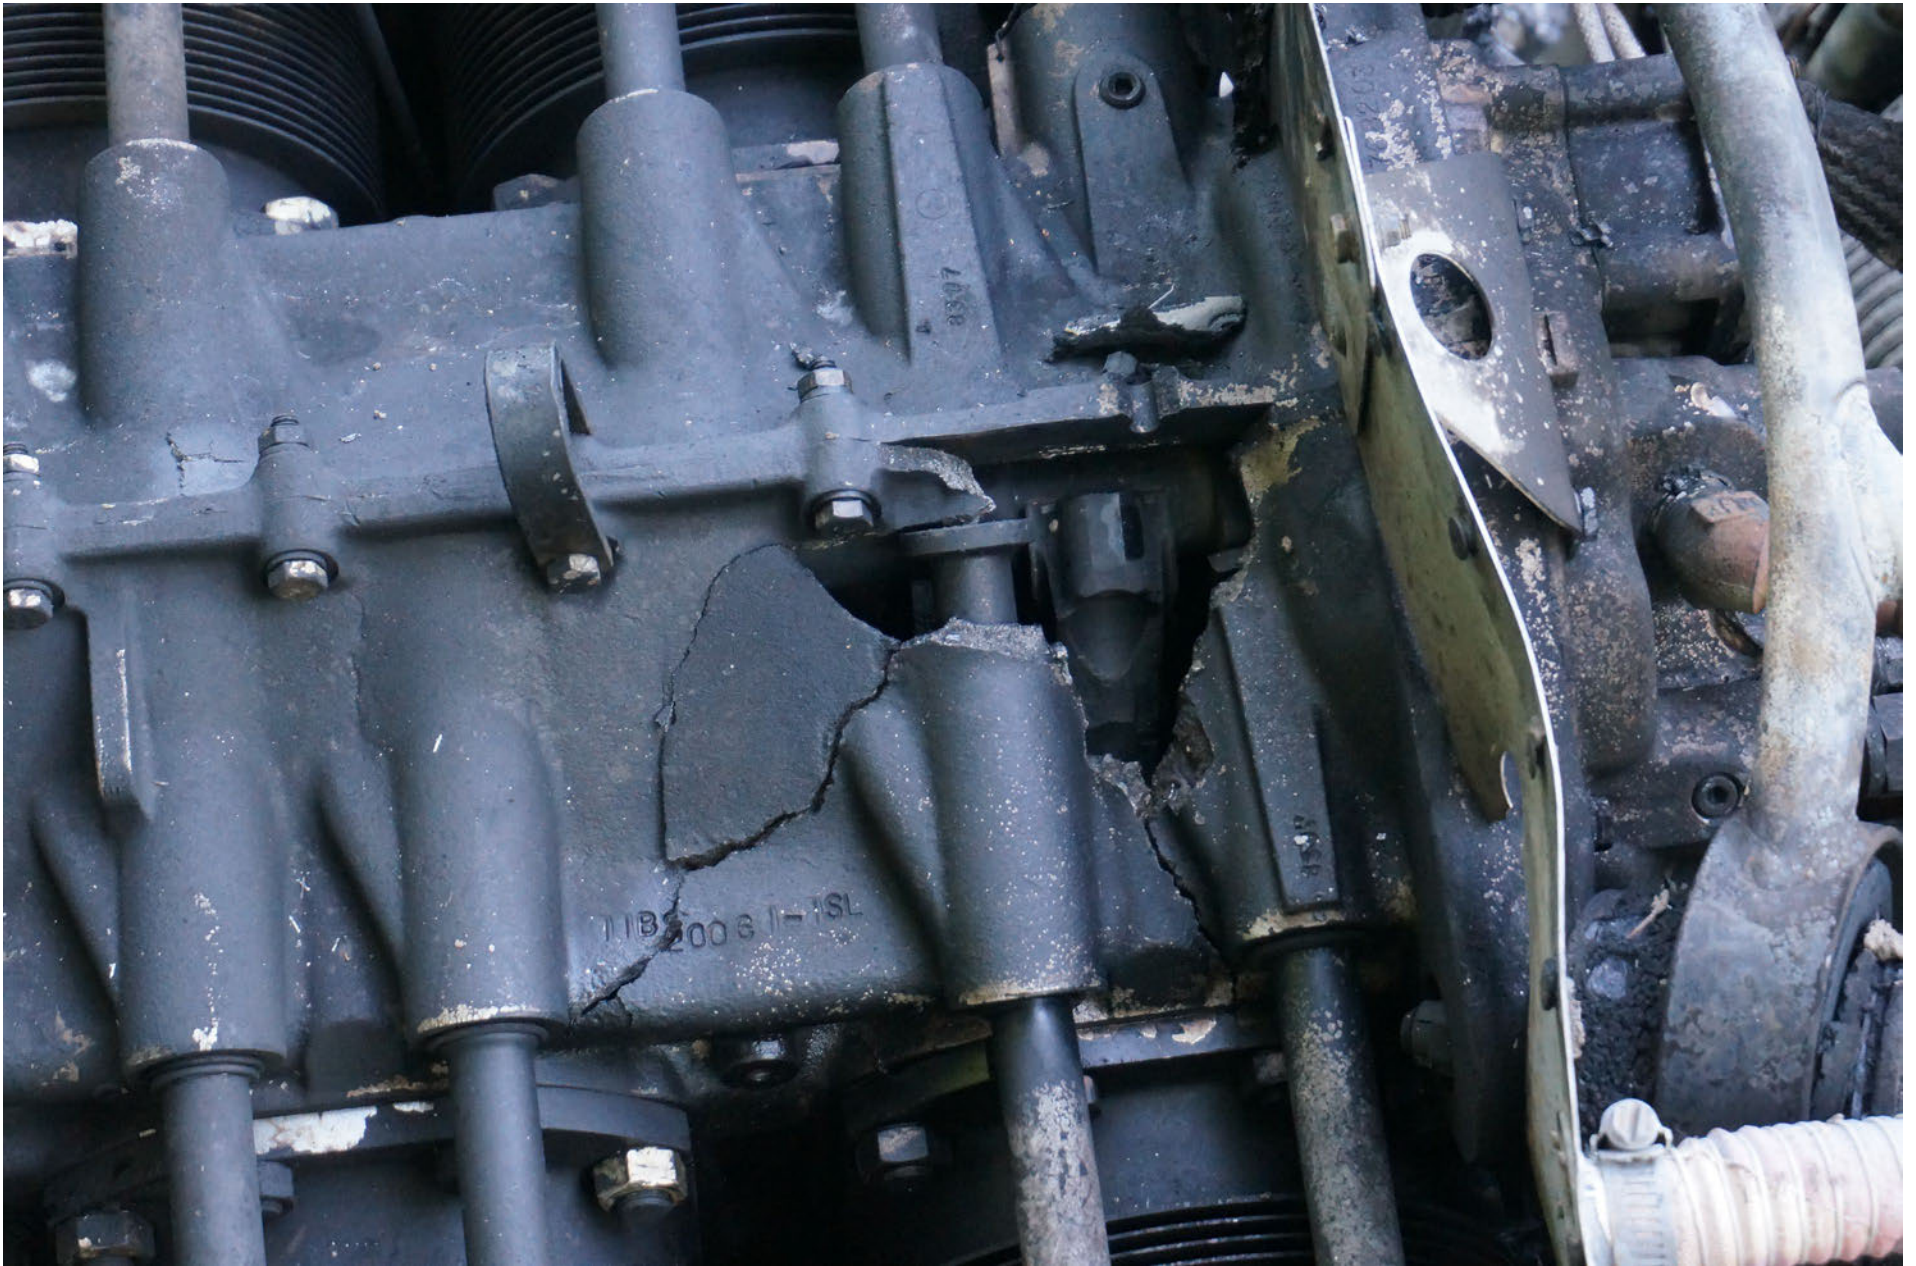
**Photo 8 – Top of Engine Case Near No. 4 Cylinder**

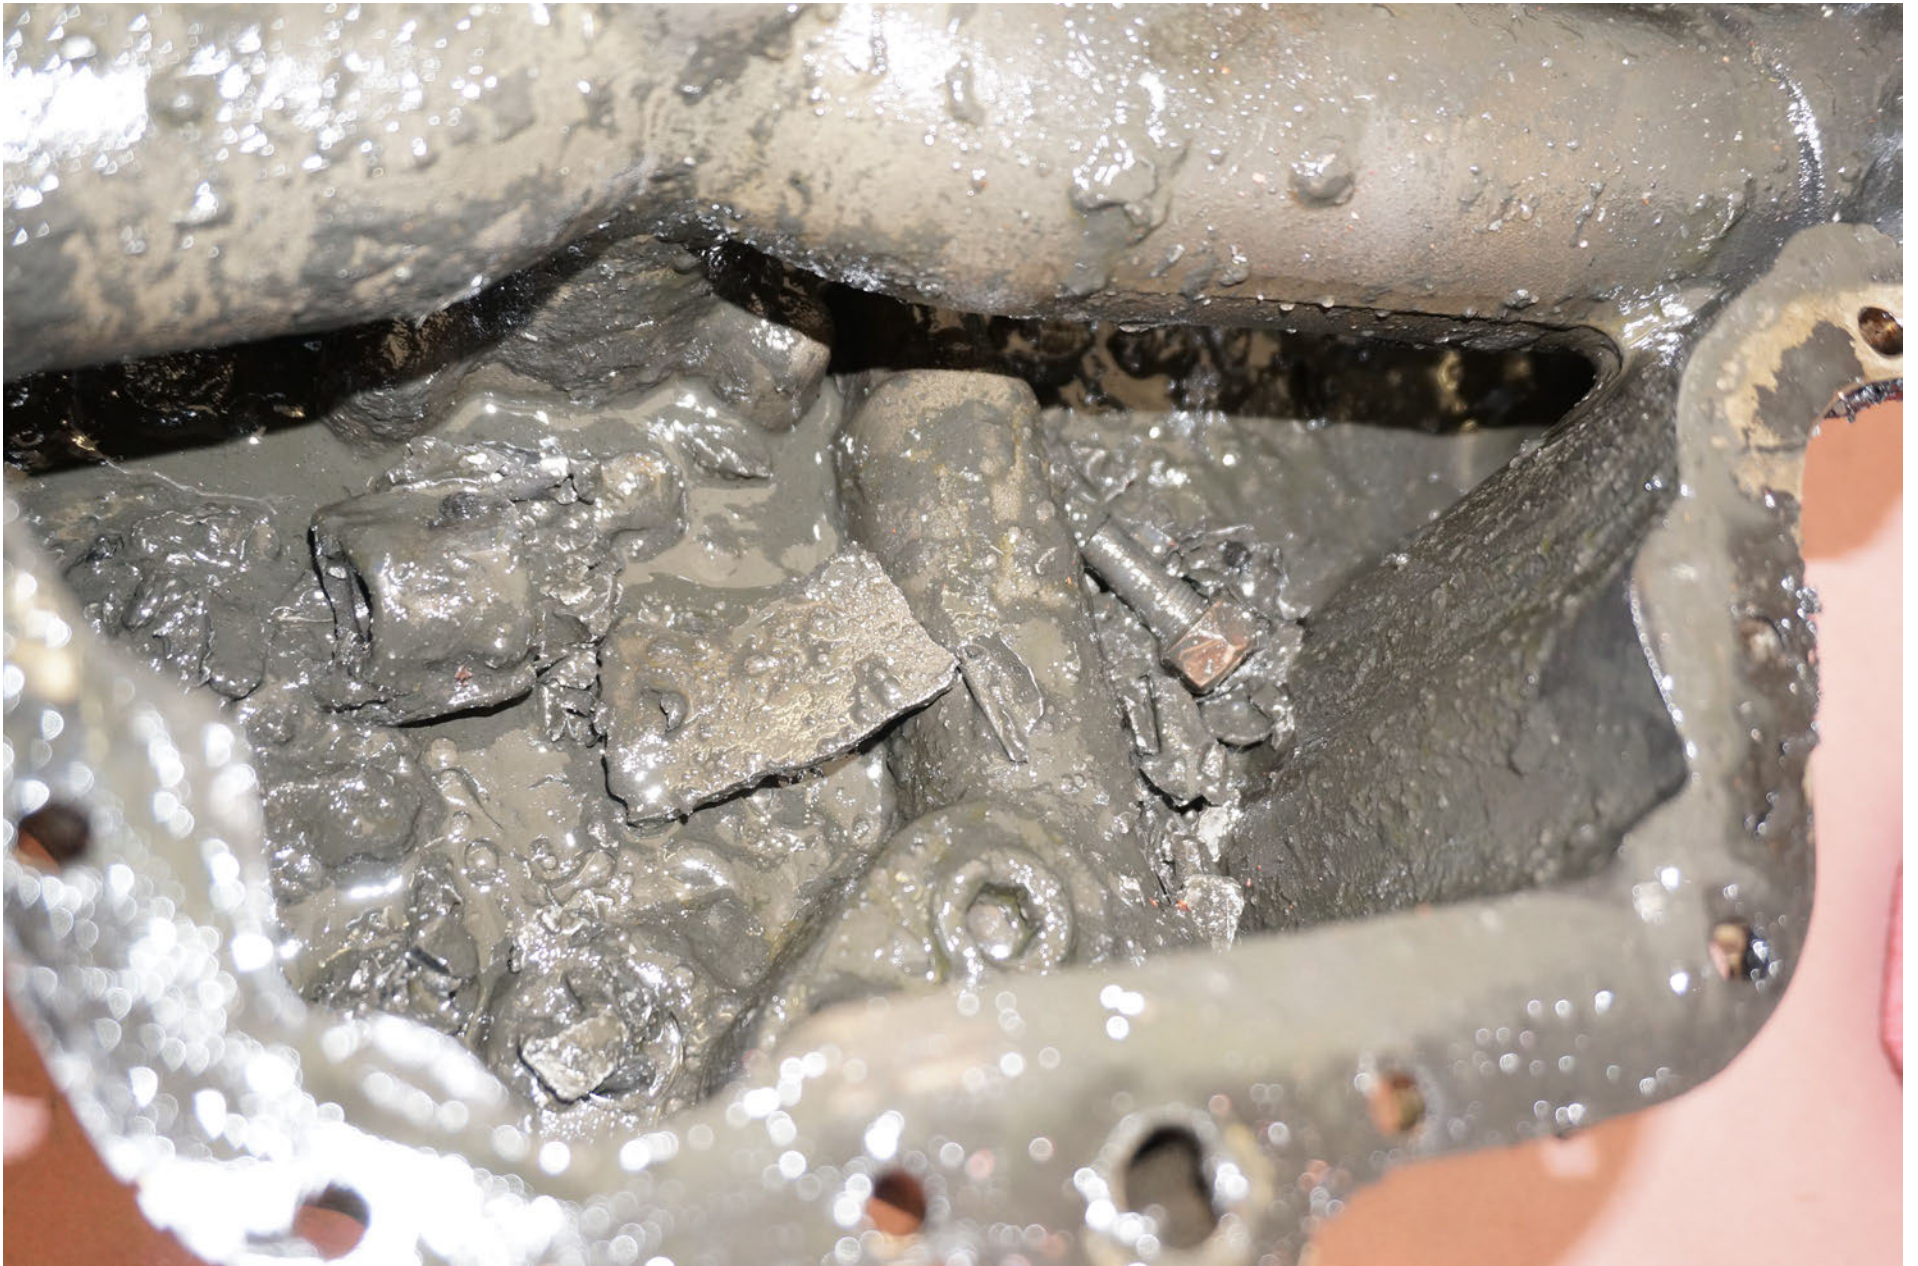
**Photo 9 – Inside of Oil Sump**

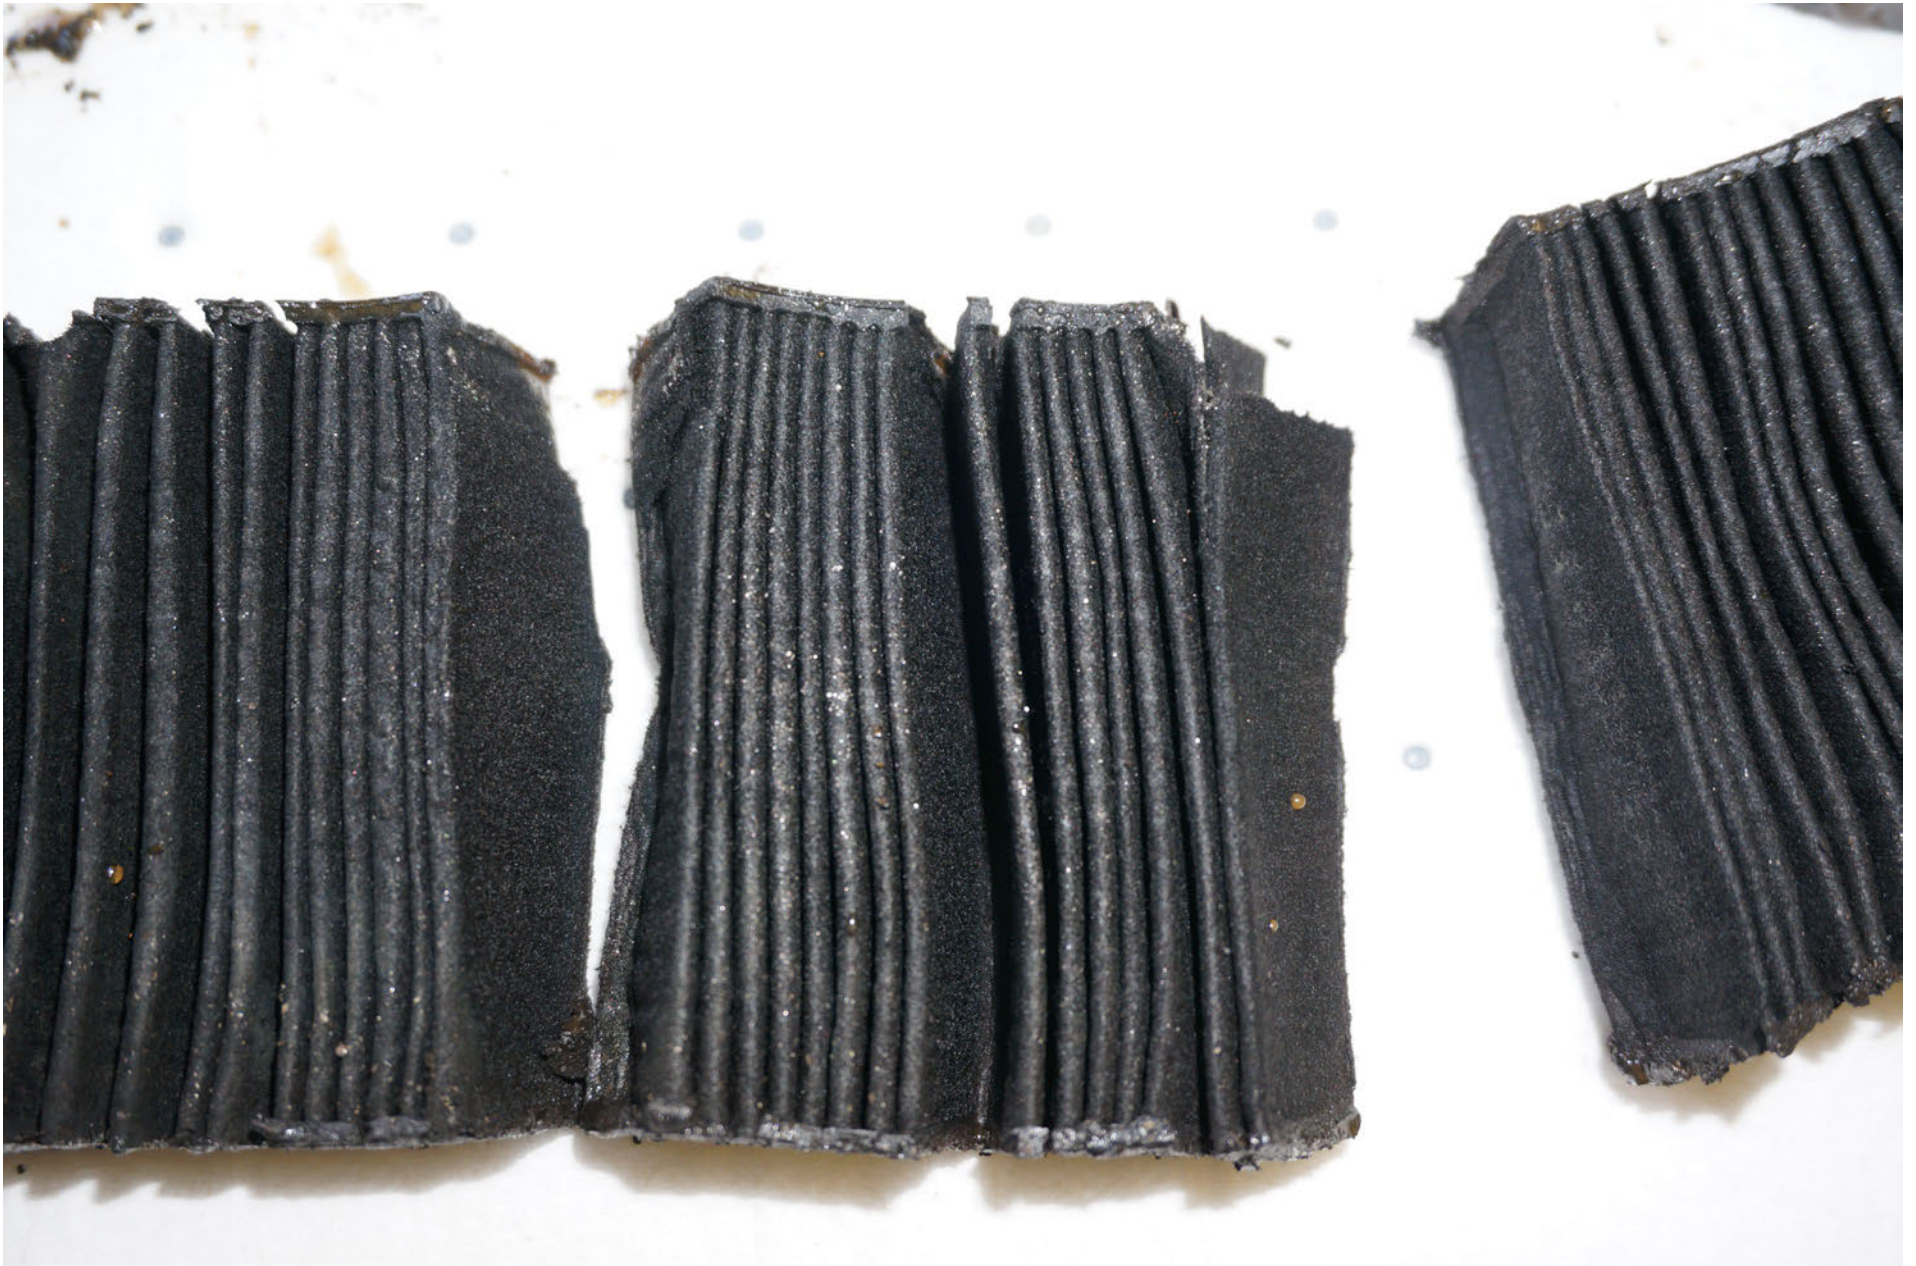
**Photo 10 – Oil Filter Pleats**
