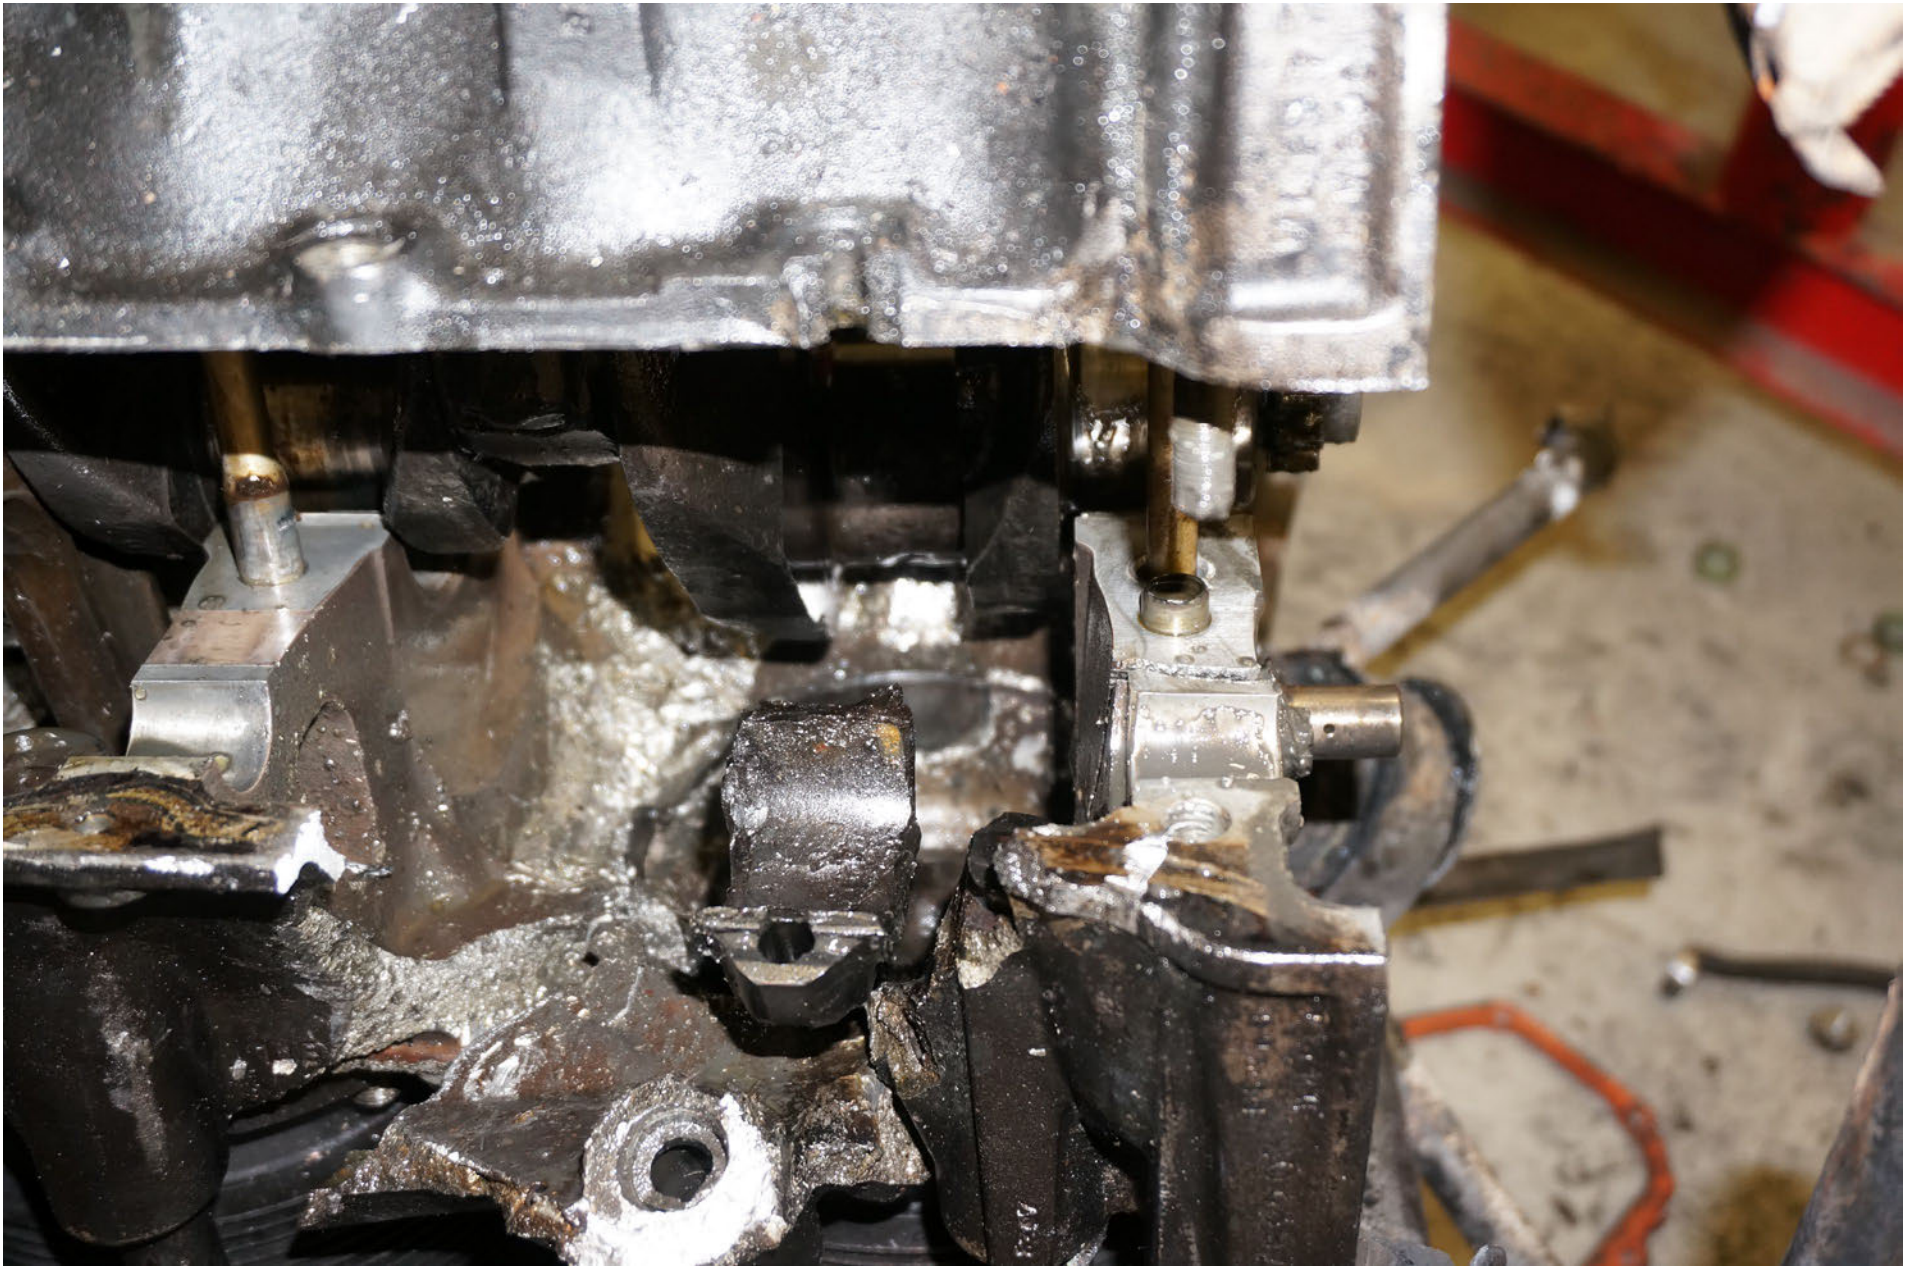
**Photo 13 – Connecting Rod**

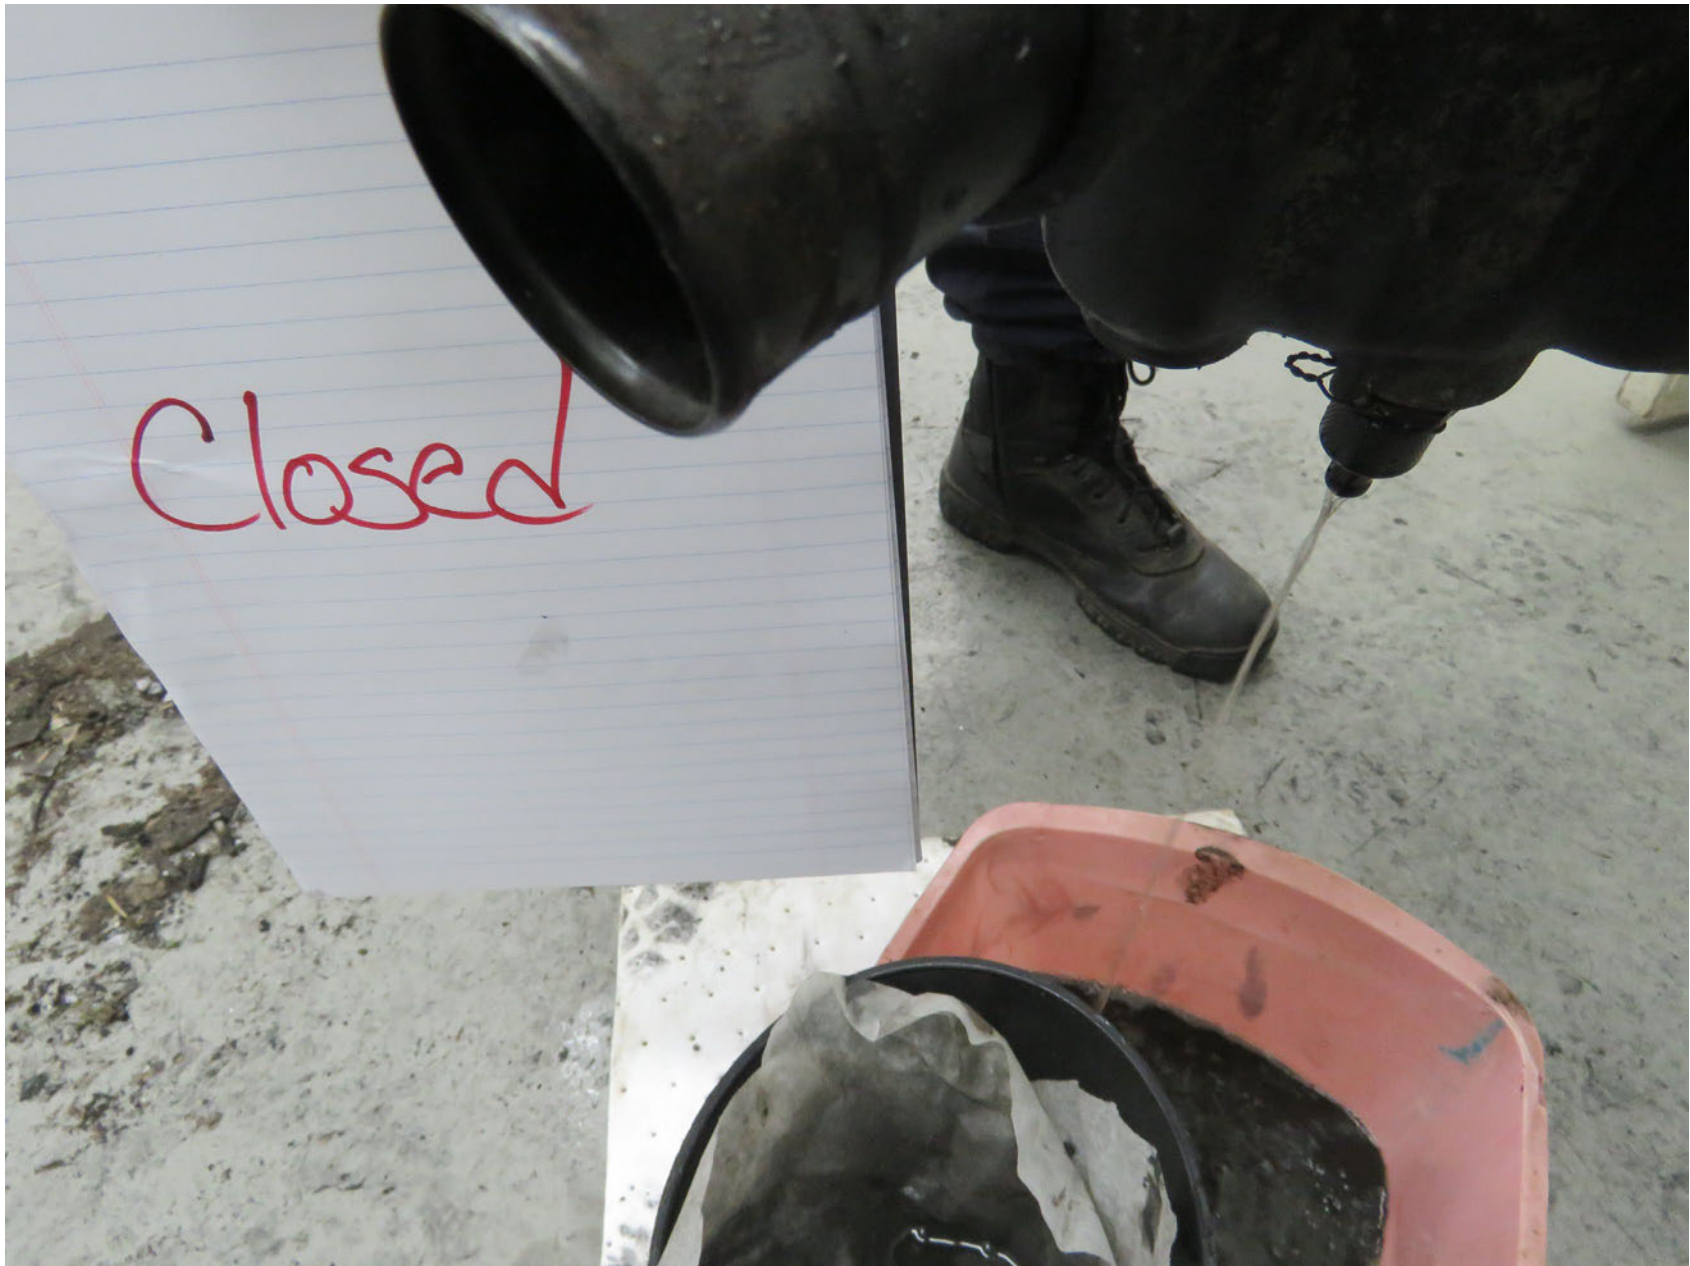
**Photo 14 – Oil Quick Drain Leaking in Closed Position – Courtesy of Lycoming Engines**

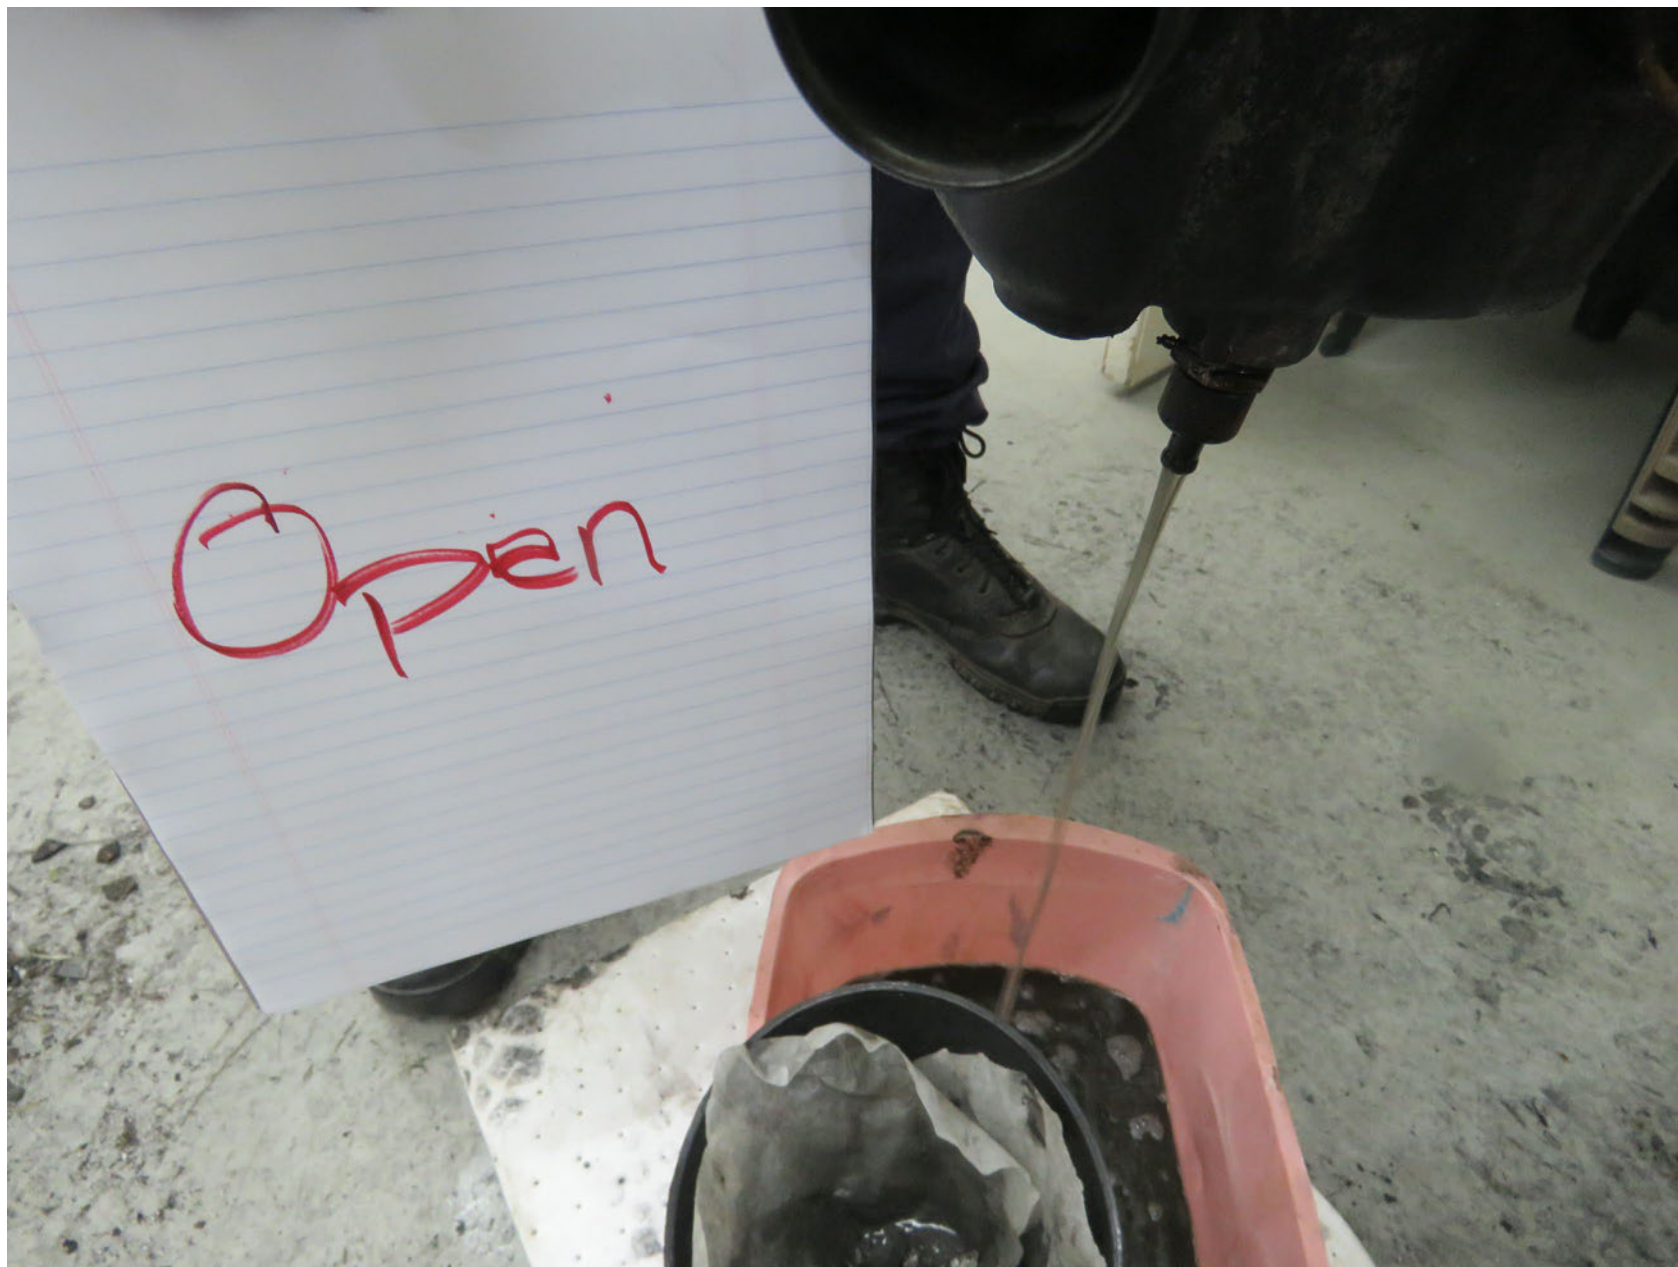
**Photo 15 – Oil Quick Drain in Open Position – Courtesy of Lycoming Engines**

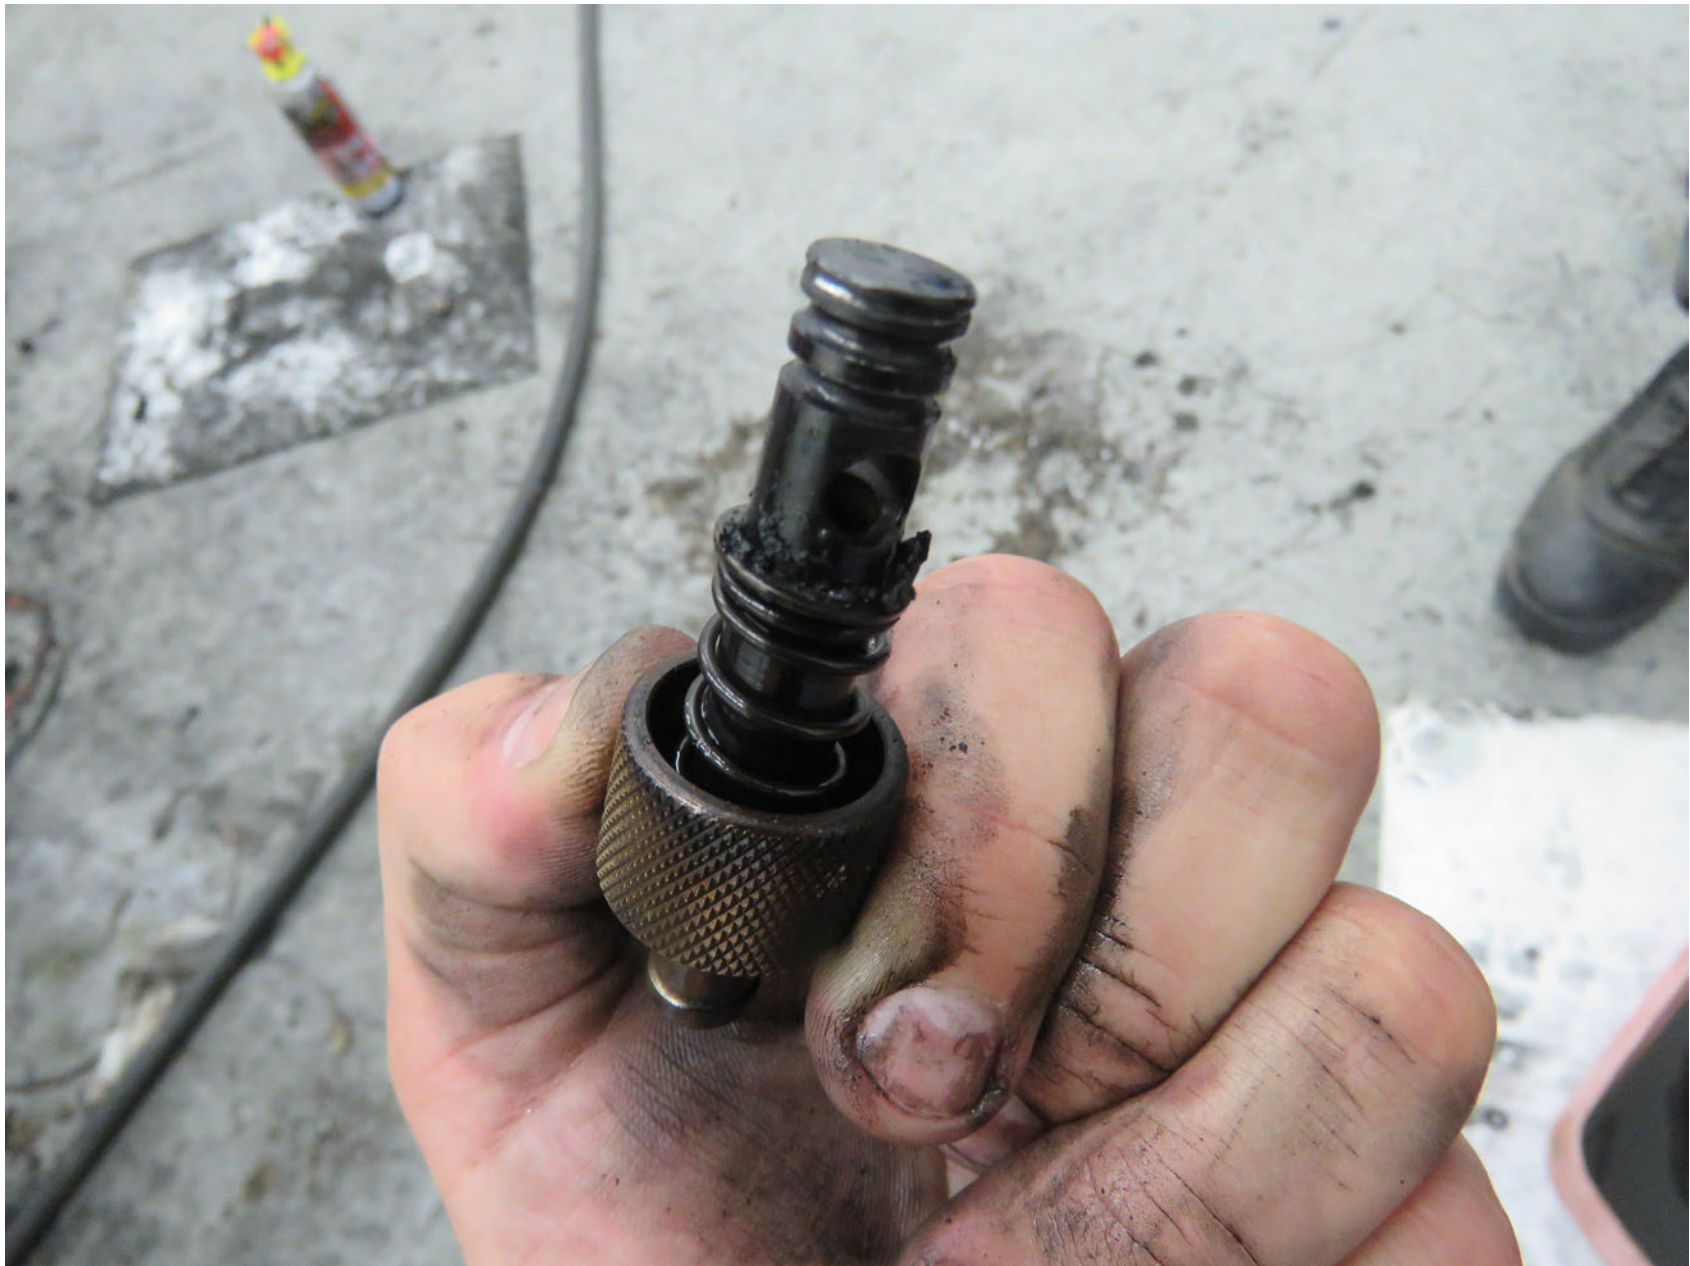
**Photo 16 – Oil Quick Drain Displaying Gold Coloration and Thermal Damage – Courtesy of Lycoming Engines**

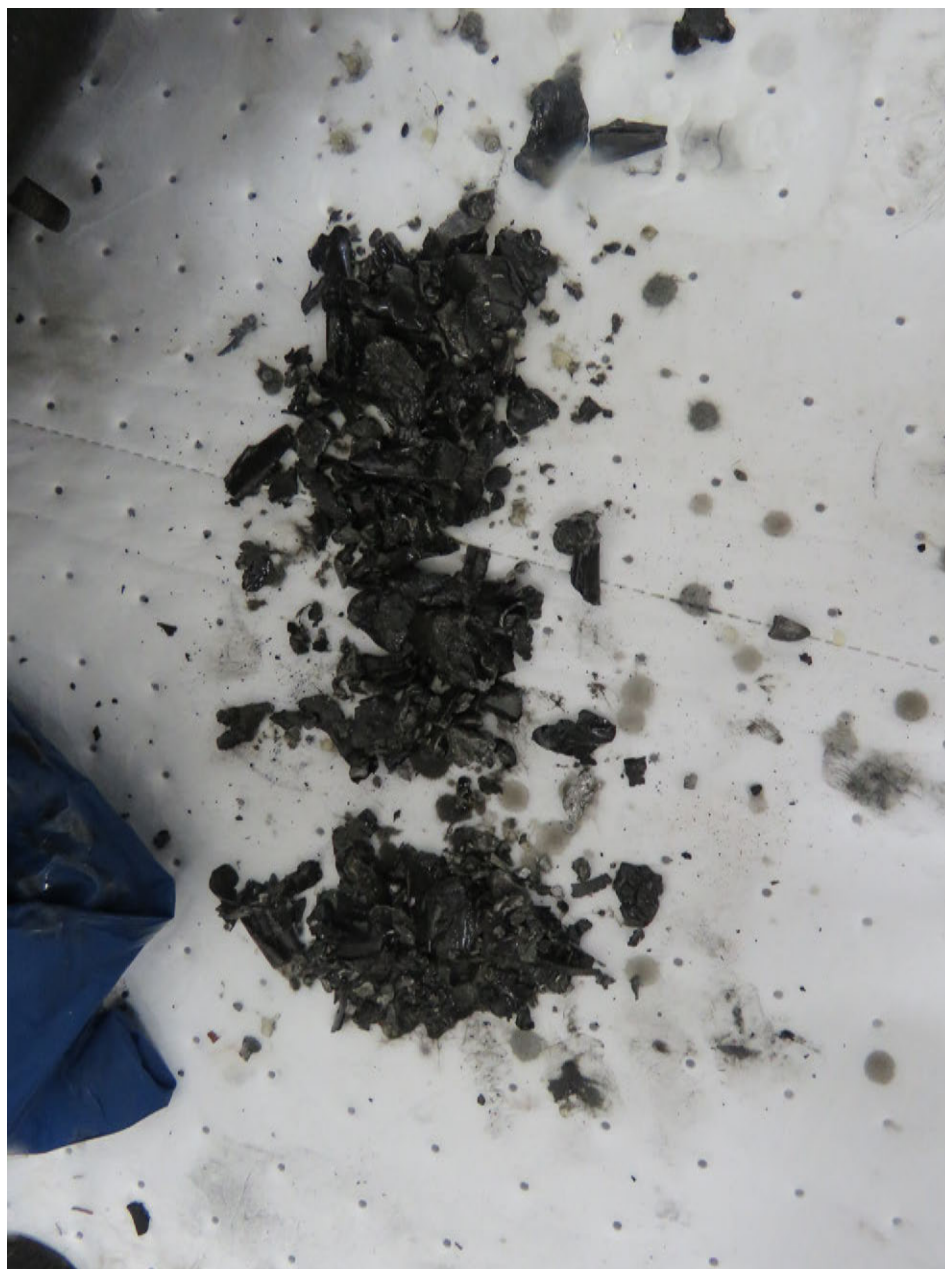
**Photo 17 – Metallic Debris from Oil Sump – Courtesy of Lycoming Engines**

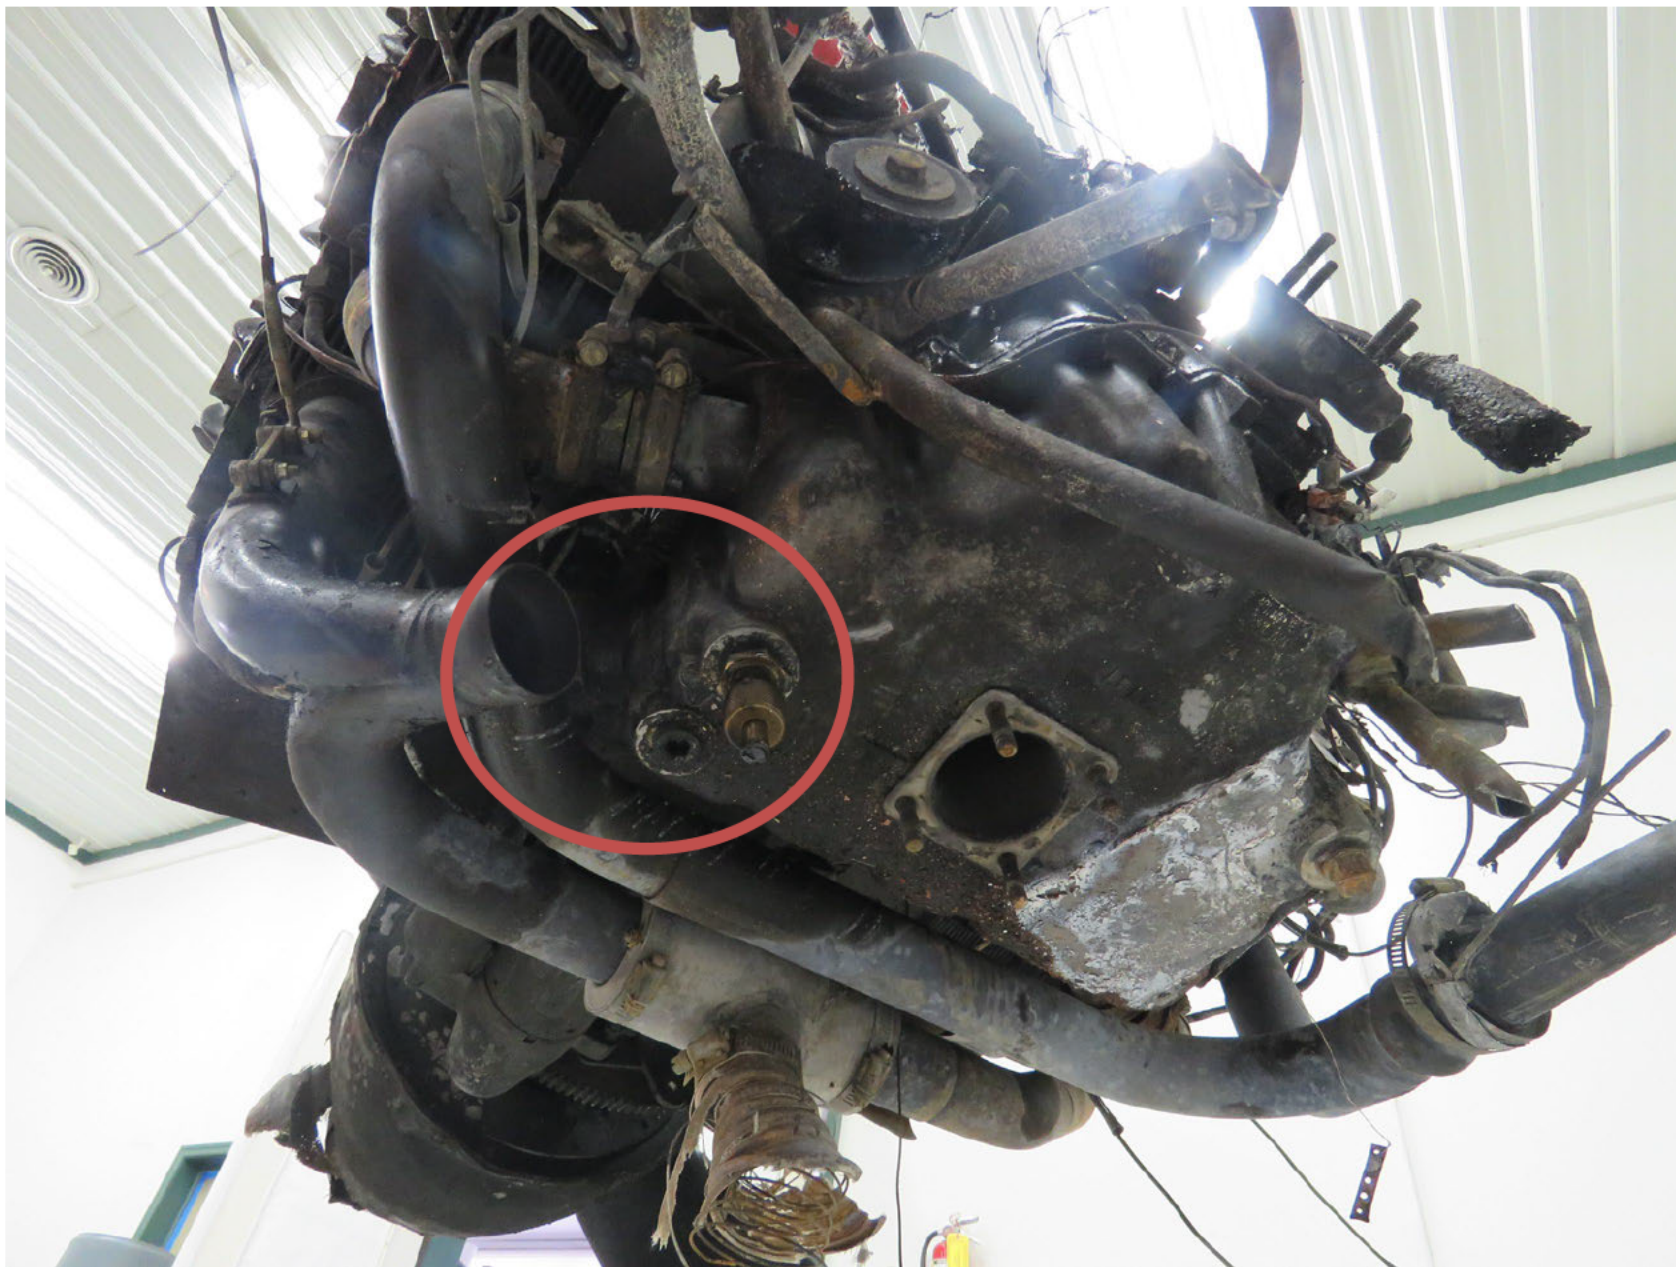
**Photo 18 – Exhaust Stack and Oil Quick Drain – Courtesy of Lycoming Engines**

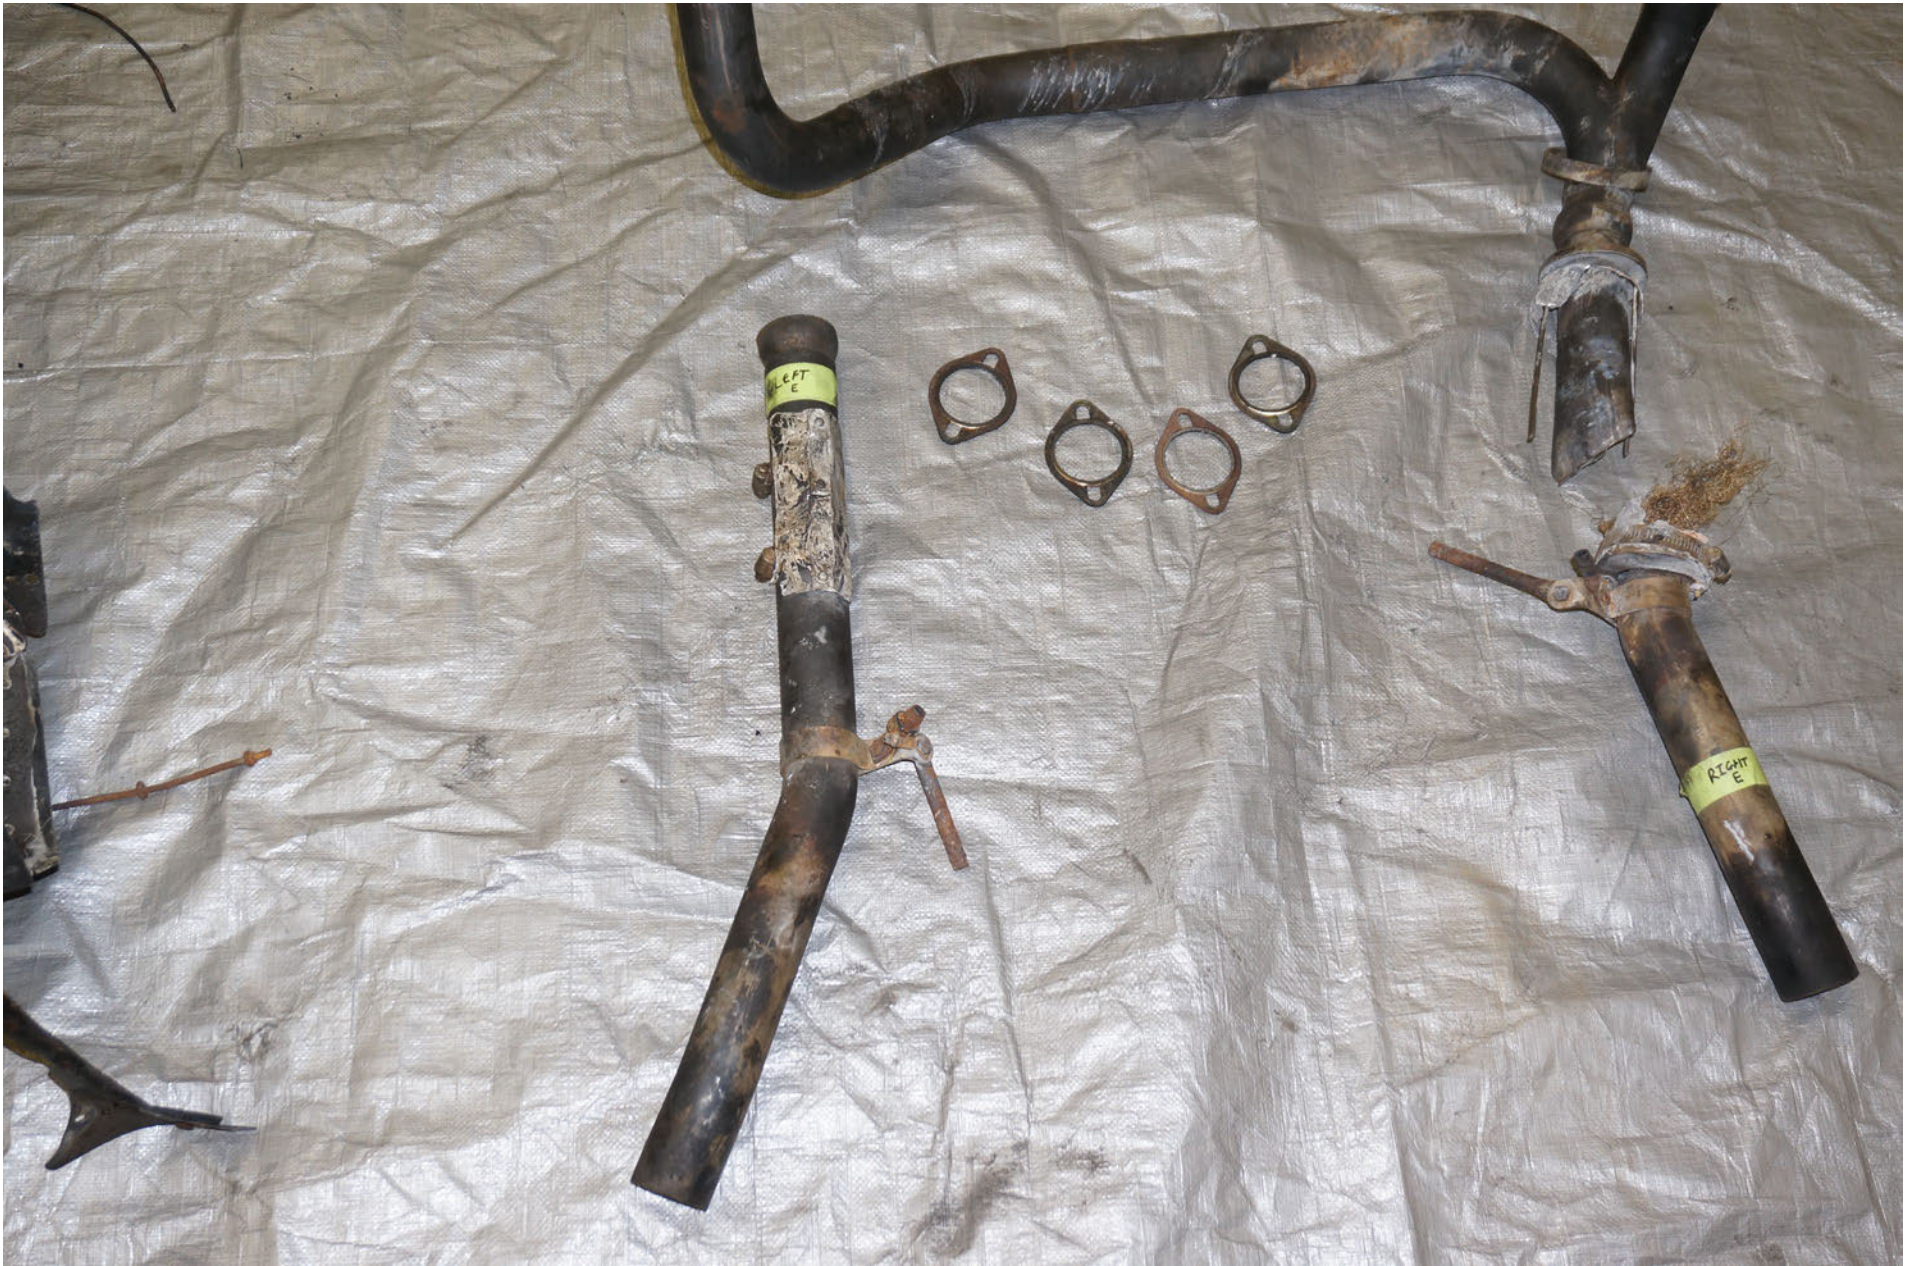
**Photo 19 – Left and Right Exhaust Pipes**

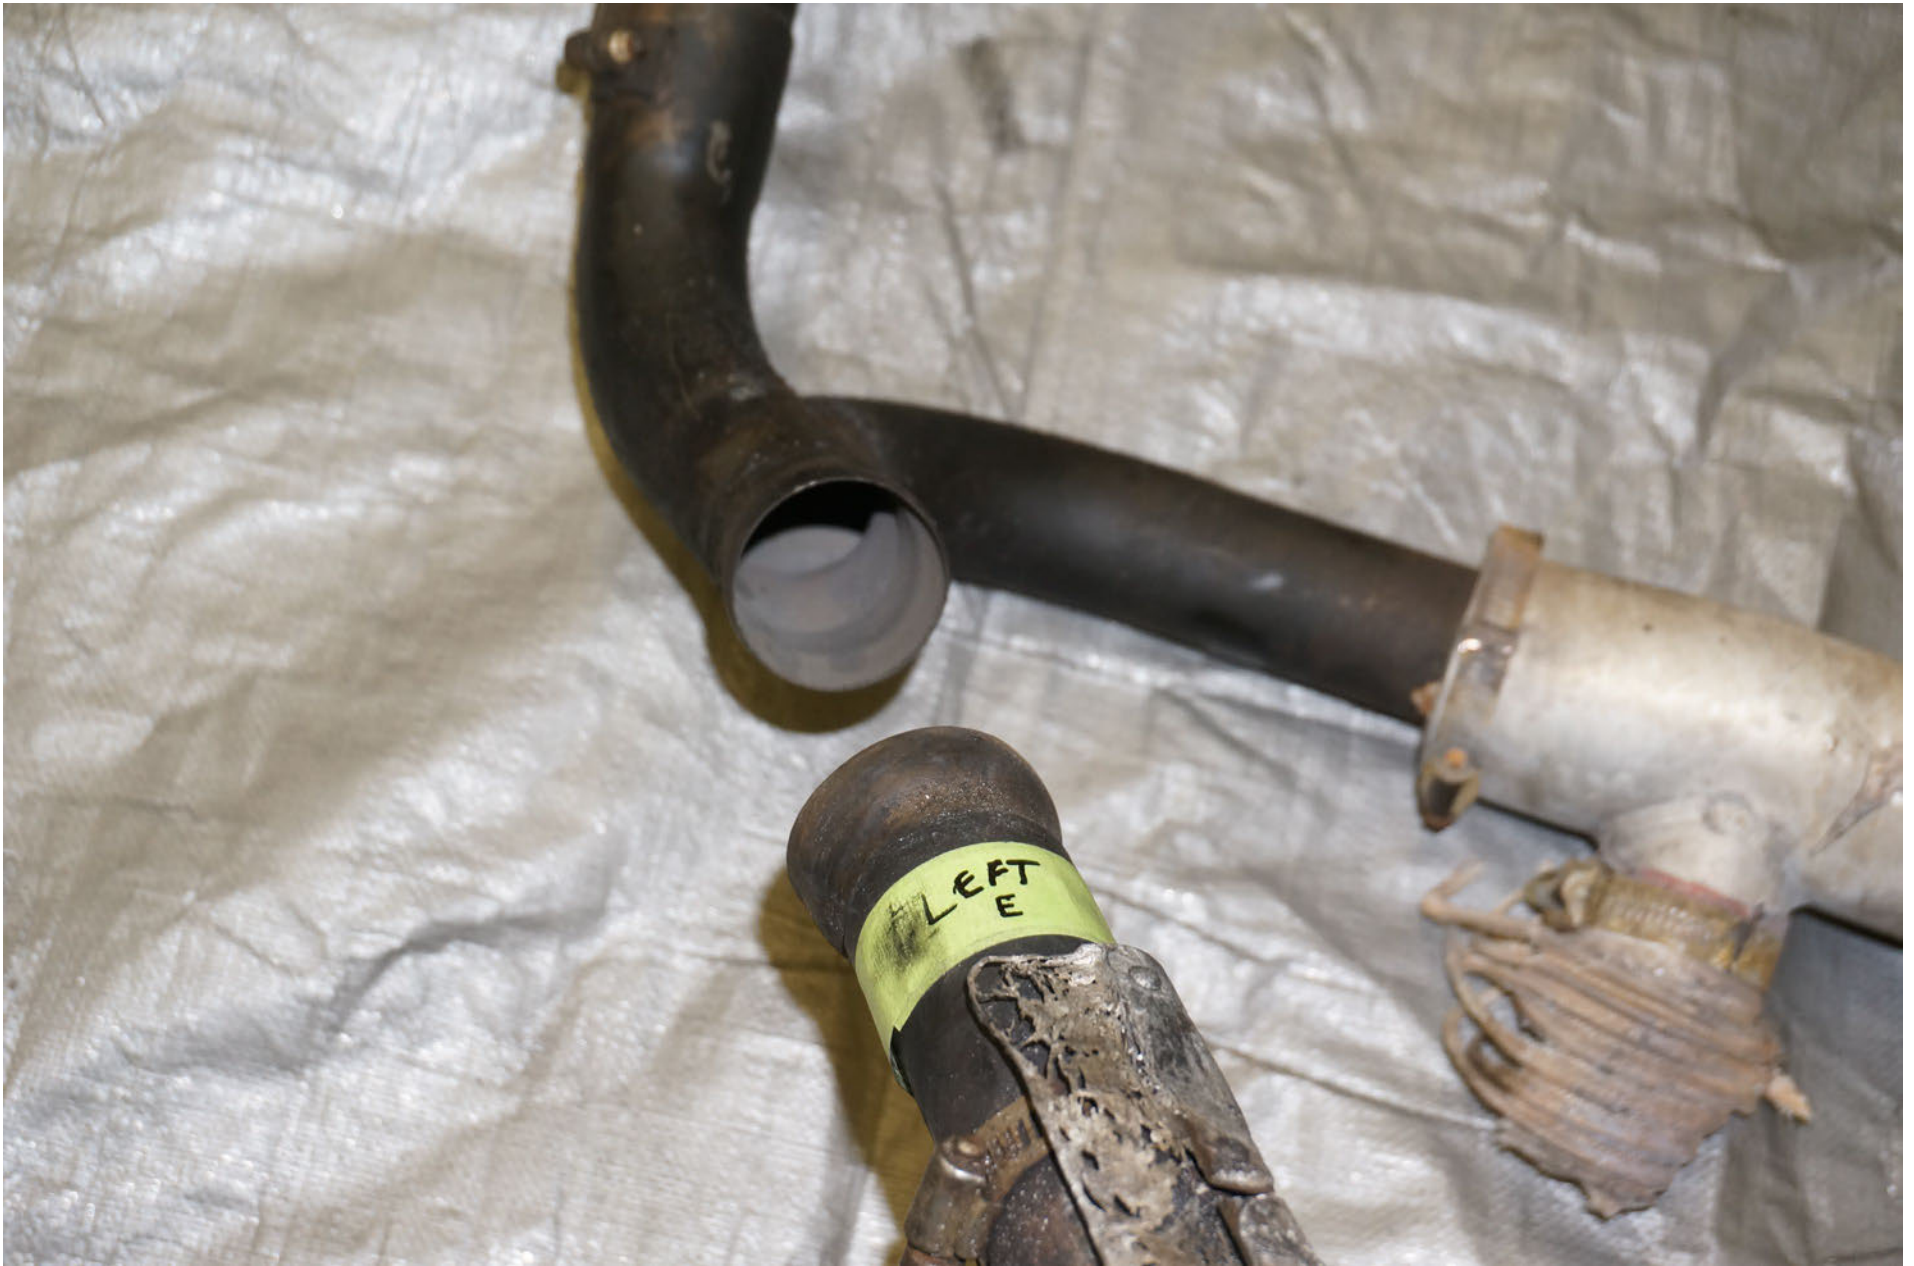
**Photo 20 – Close Up of Left Side Exhaust Configuration**
