## AIRFRAME AND ENGINE EXAMINATION

NTSB ACCIDENT NUMBER: ERA21FA257

AIRCRAFT REGISTRATION: N402SJ

ACCIDENT LOCATION: Kinston, NC

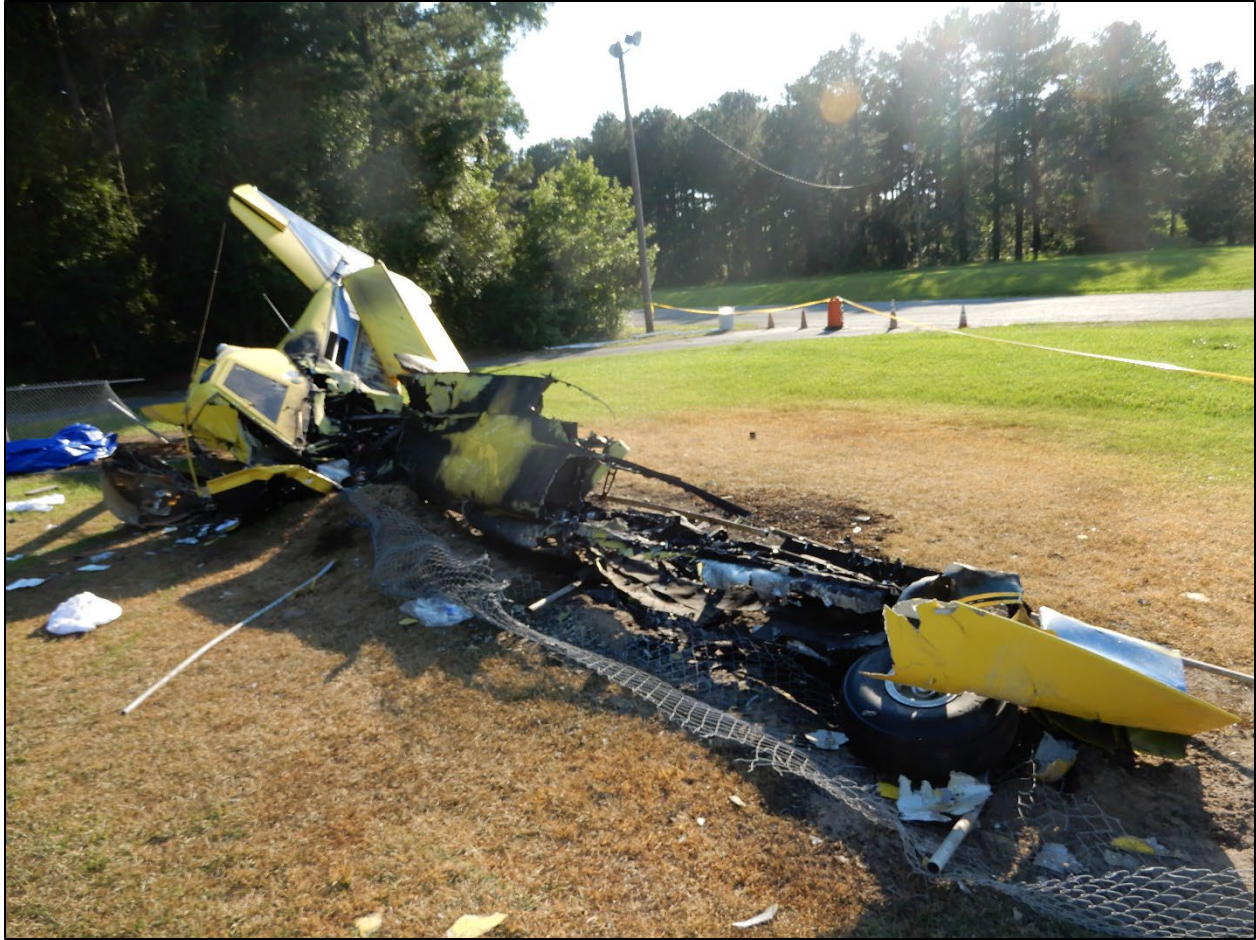
The wreckage was located on the property of the Kinston Drag Racing Strip. The wreckage impacted grass and a chain fence that ran parallel along the drag racing pavement. The wreckage was consistent with a near vertical impact. A postcrash fire was observed which damage portions of the left side of the fuselage and the left wing. All four corners of the airplane were located with the fuselage. The fuselage was oriented on about a 090° heading located at 35.231413, -77.635800.

The engine was located submerged in terrain under the fuselage and firewall.

Figure 5: View of the airplane at the accident site

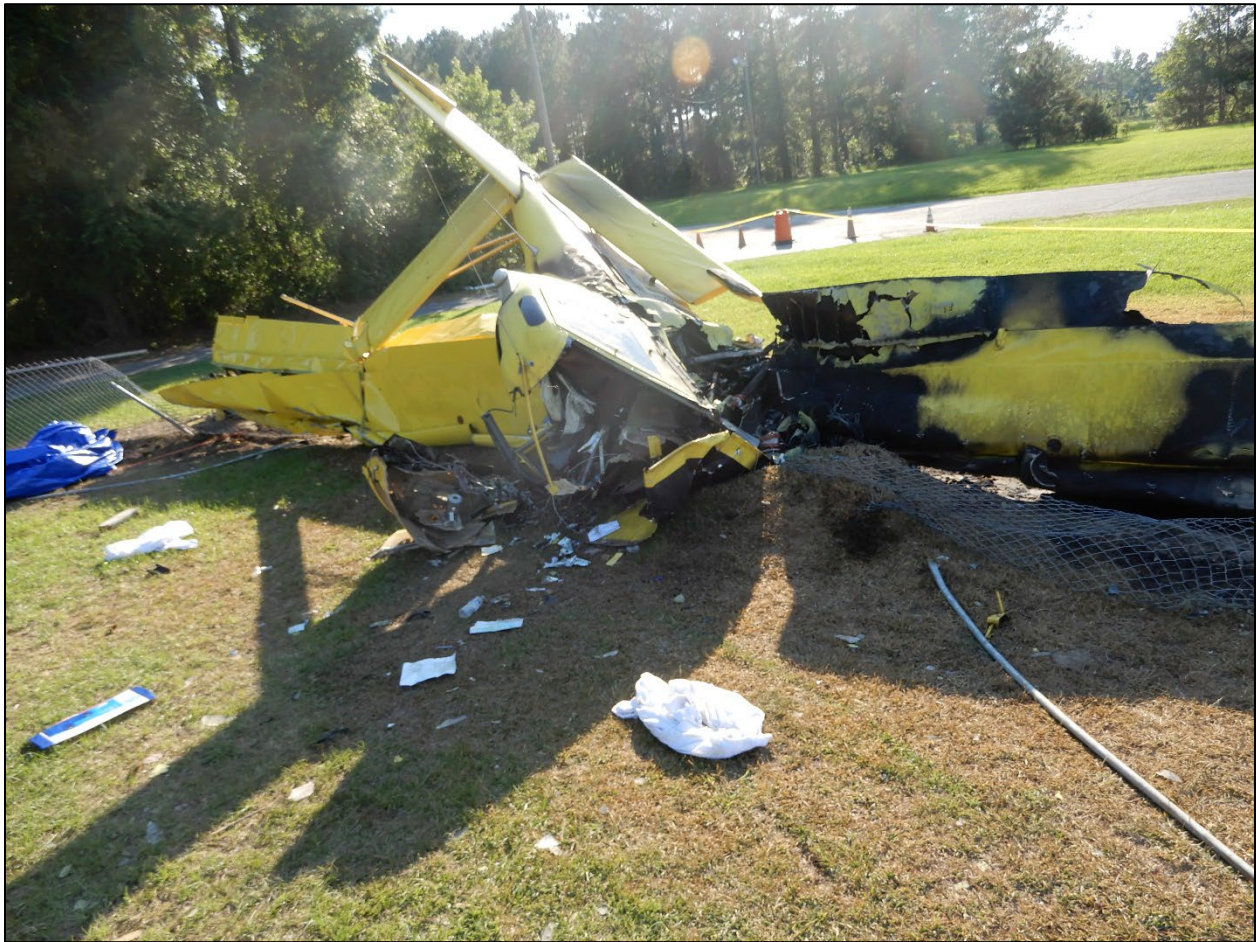
Figure 6: View of the airplane at the accident site

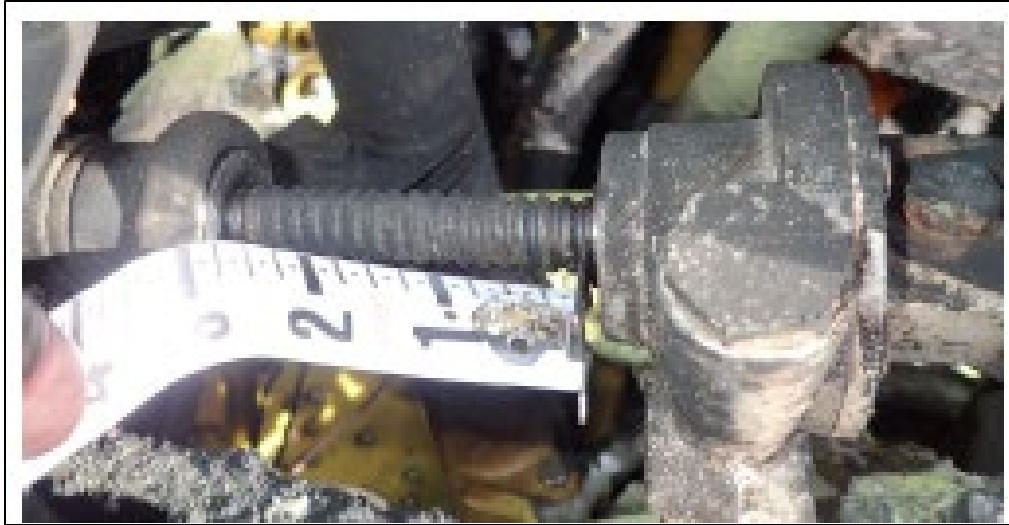
The flap actuator was found connected to the fuselage. The flap actuator motor was separated from the flap actuator. The flap actuator extension measured approximately 2.8" which corresponds to a flap extension of approximately 21°. The flap control system was found to be continuous to both flap control horns.

*Figure 7: View of the flap jackscrew actuator*

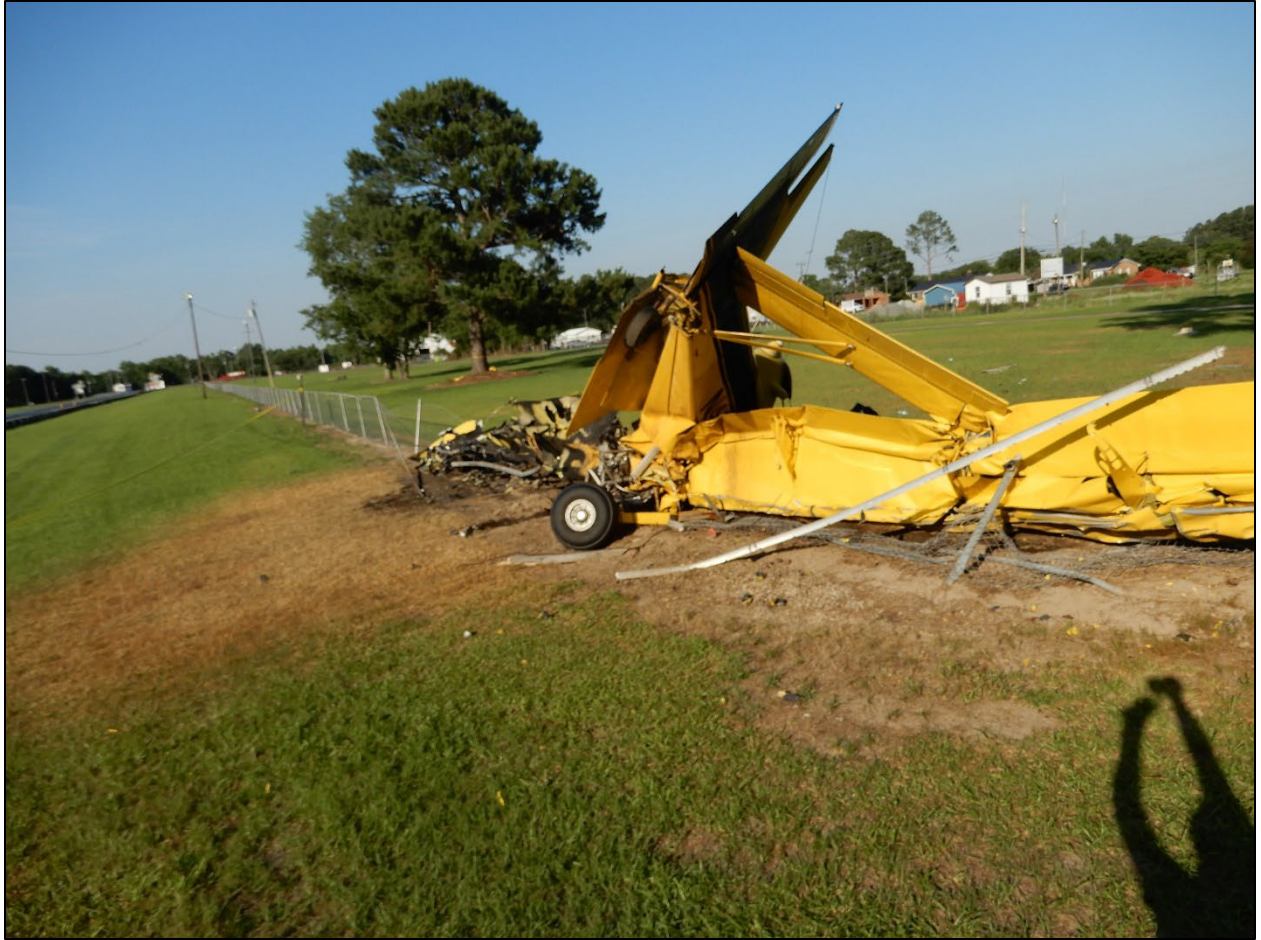
Figure 8: View of the airplane at the accident site

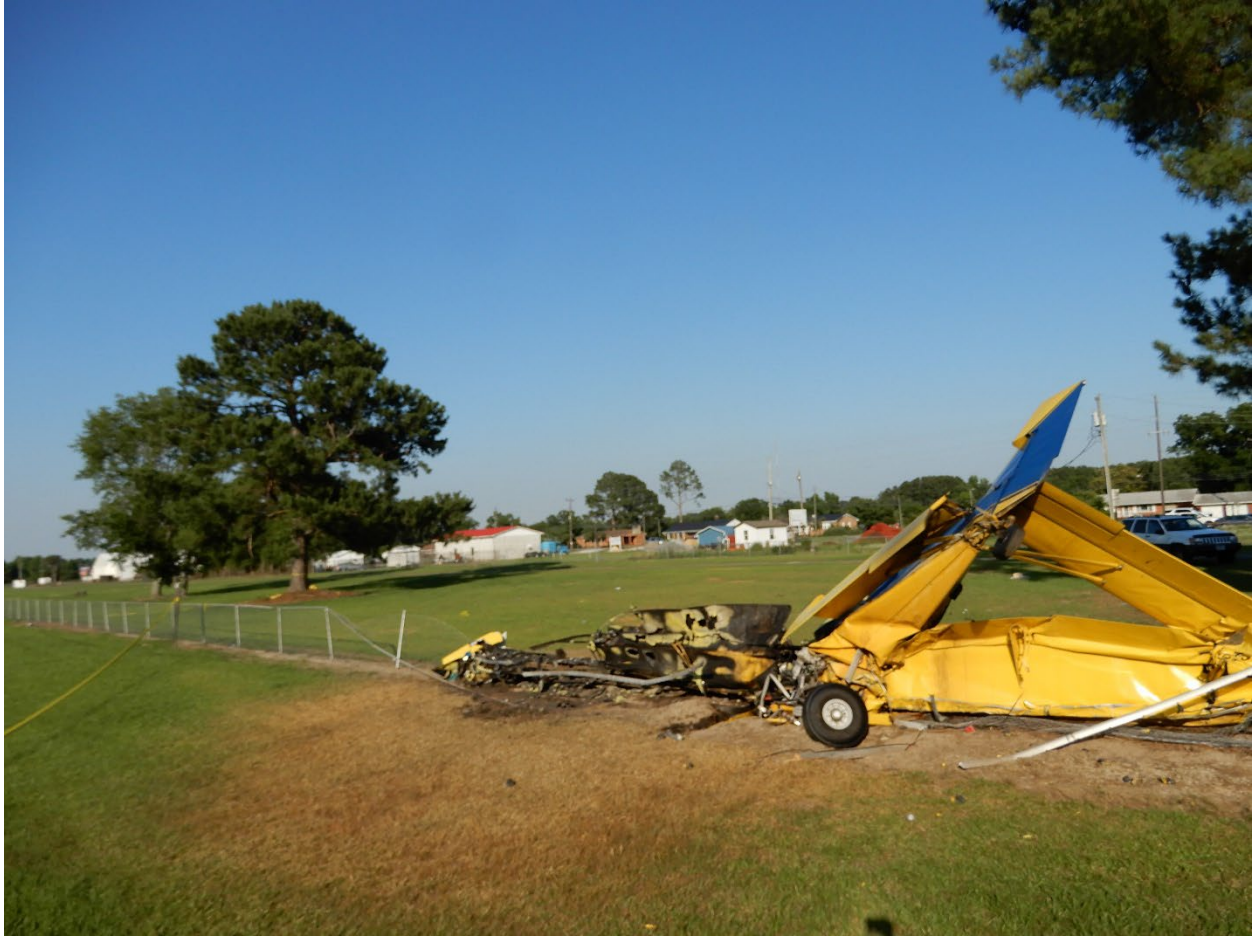
*Figure 9: View of the airplane at the accident site*

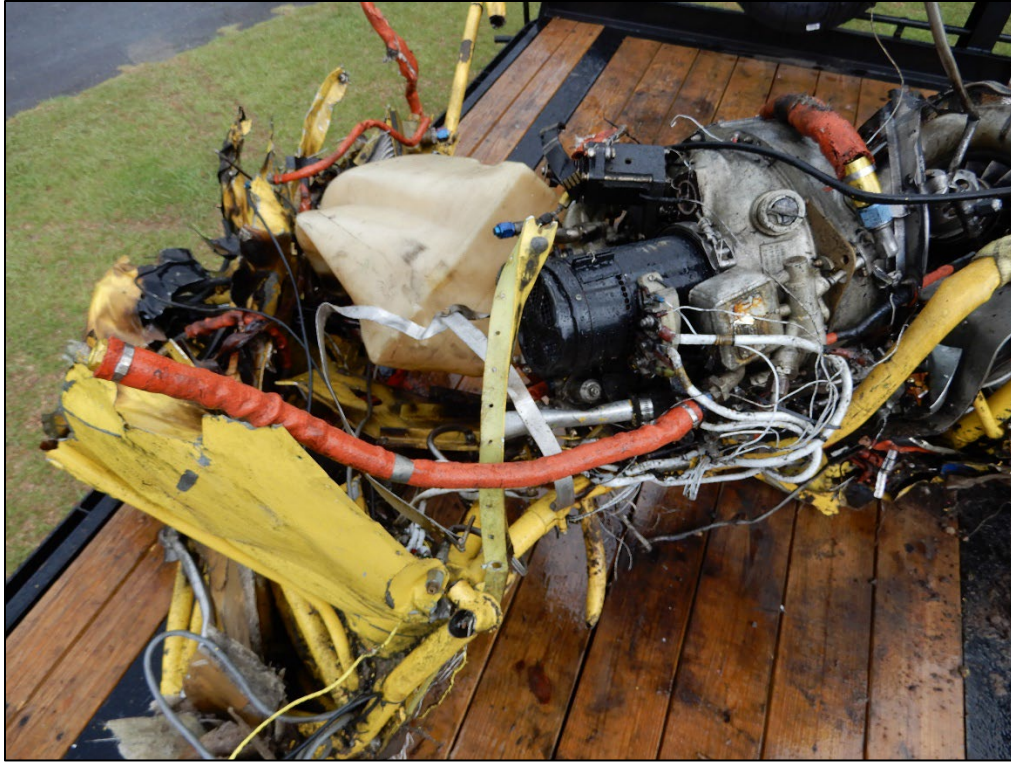
The engine was confirmed to be a Pratt & Whitney PT6A-34AG, Serial Number PCE-PH0858. The engine was completely submerged beneath the terrain. Once removed, the engine displayed a significant amount of impact damage and some thermal damage from the postcrash fire. The rear portion of the engine, beginning at the accessory gear box area, had fractured from the forward portion of the engine.

Figure 10: View of the engine once removed from terrain

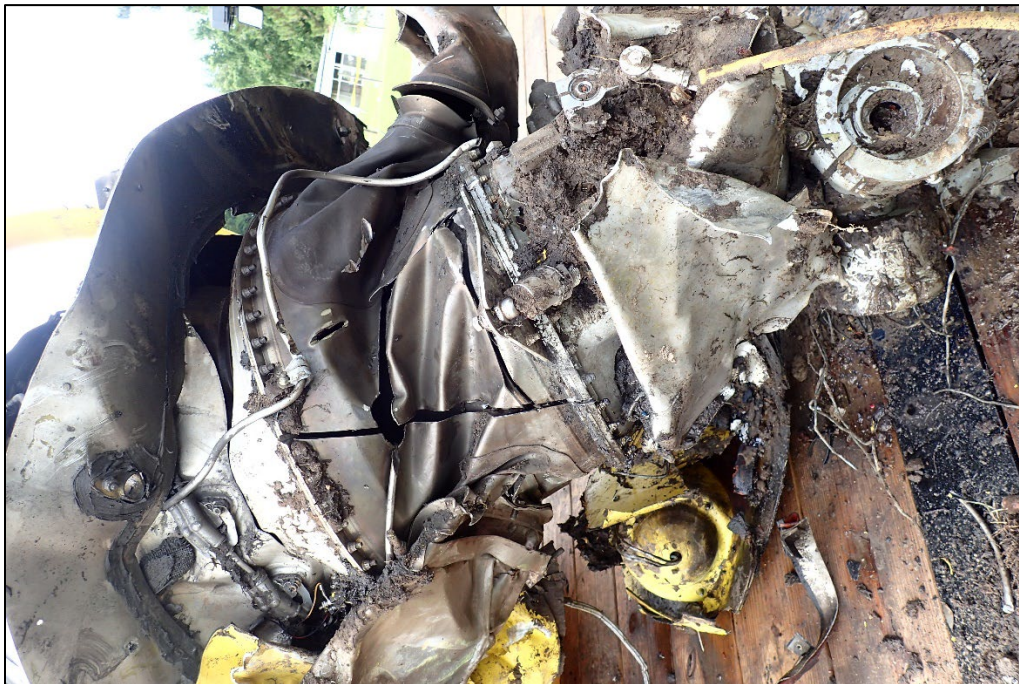
Figure 11: View of the engine once removed from terrain

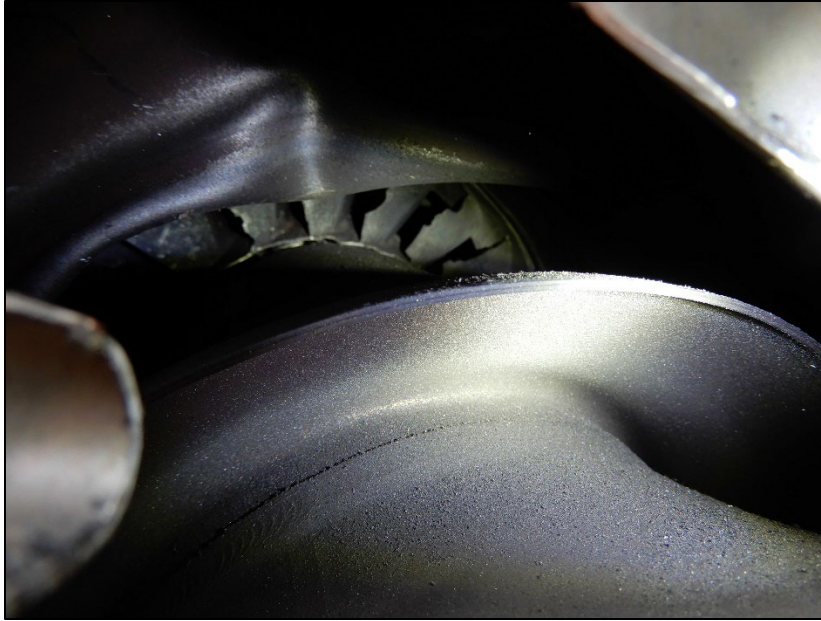
A small cut was made by recovery personnel at the direction of the NTSB IIC near the forward section of the engine. Significant leading-edge gouging and debris was observed in the power section of the engine. Leading edge gouges and witness marks were observed on the stators. Compressor blade fragments had fractured and were located loose in the engine. The air intake section was crushed by impact forces.

Figure 12: Interior view of the engine

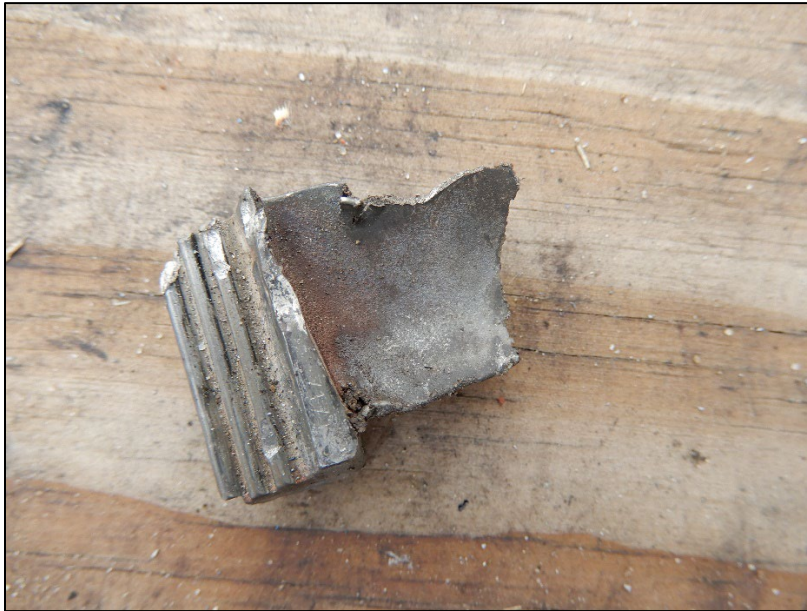
Figure 13: Fragments of internal core engine

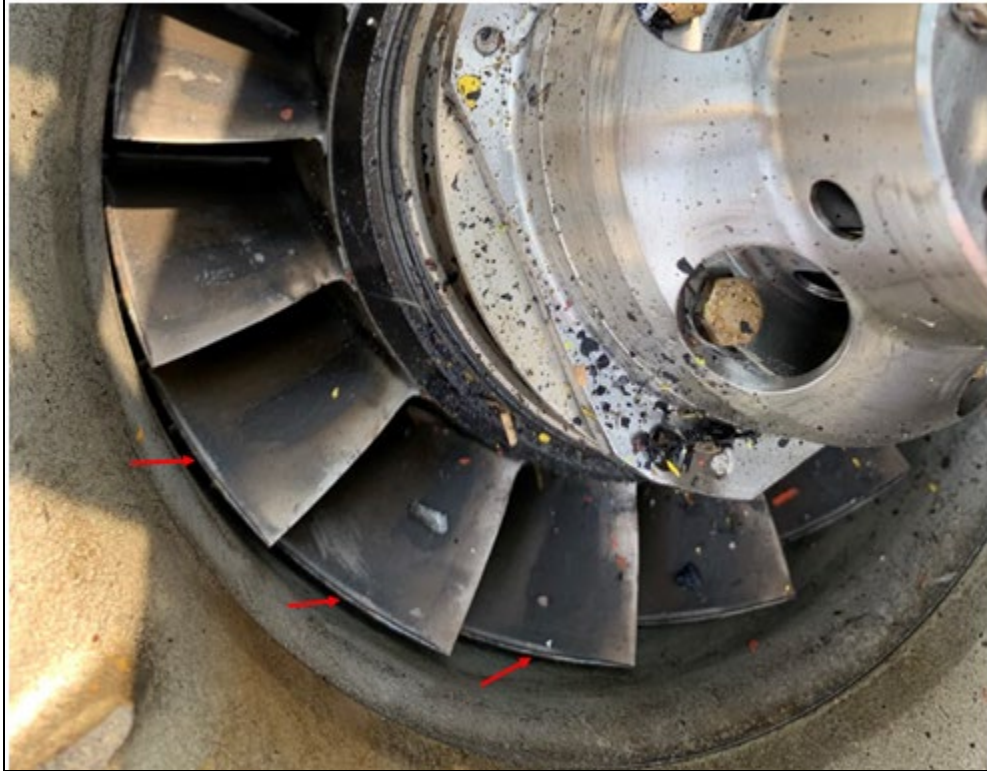
The first stage compressor rotor blade tips displayed rubbing and burr material (red arrows in the photo below):

Figure 14: First stage compressor rotor blade

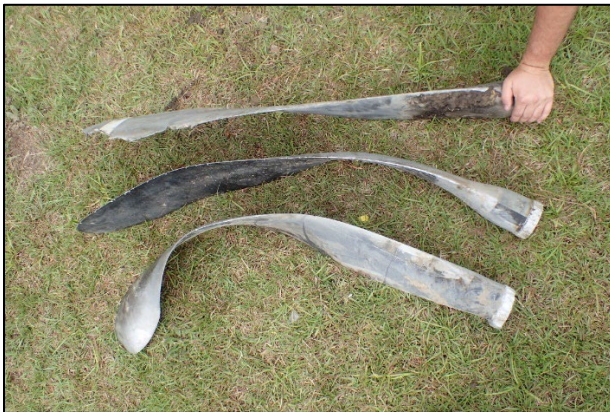
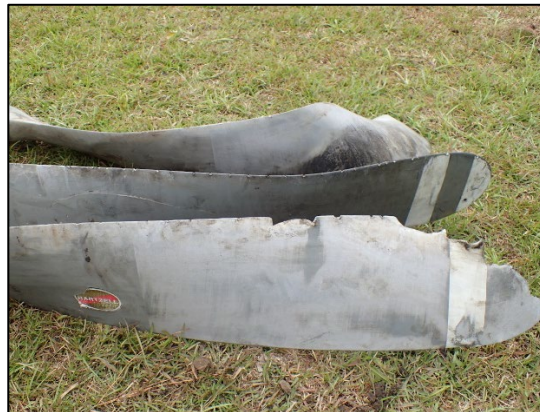
All three propellers separated from the hub and were located near the engine. One blade exhibited significant torsional bending. Each blade exhibited varying degrees of leading-edge gouges. One blade had pronounced leading edge gouges that were consistent with the length of the chain length fencing the airplane impacted.

Figure 15: View of all three propellers

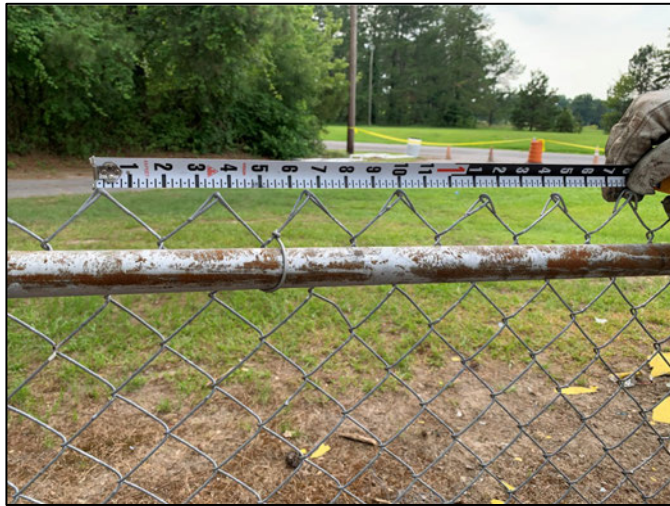
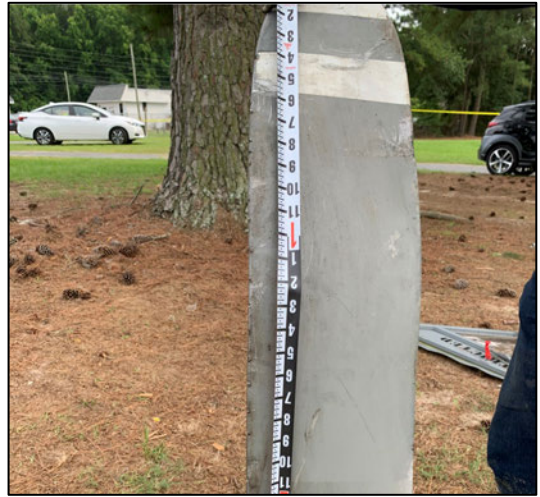
Figure 16: View of a propeller blade displaying impact marks and measurements of a chain fence impacted by airplane
