# NATIONAL TRANSPORTATION SAFETY BOARD

## MATERIALS LABORATORY FACTUAL REPORT

Report No. 22-027

Place : Yulee, Florida  
Date : June 18, 2021  
Vehicle : Cessna 150L, N1300Q  
NTSB No. : ERA21FA258  
Investigator : Ralph Hicks (AS-ERA)

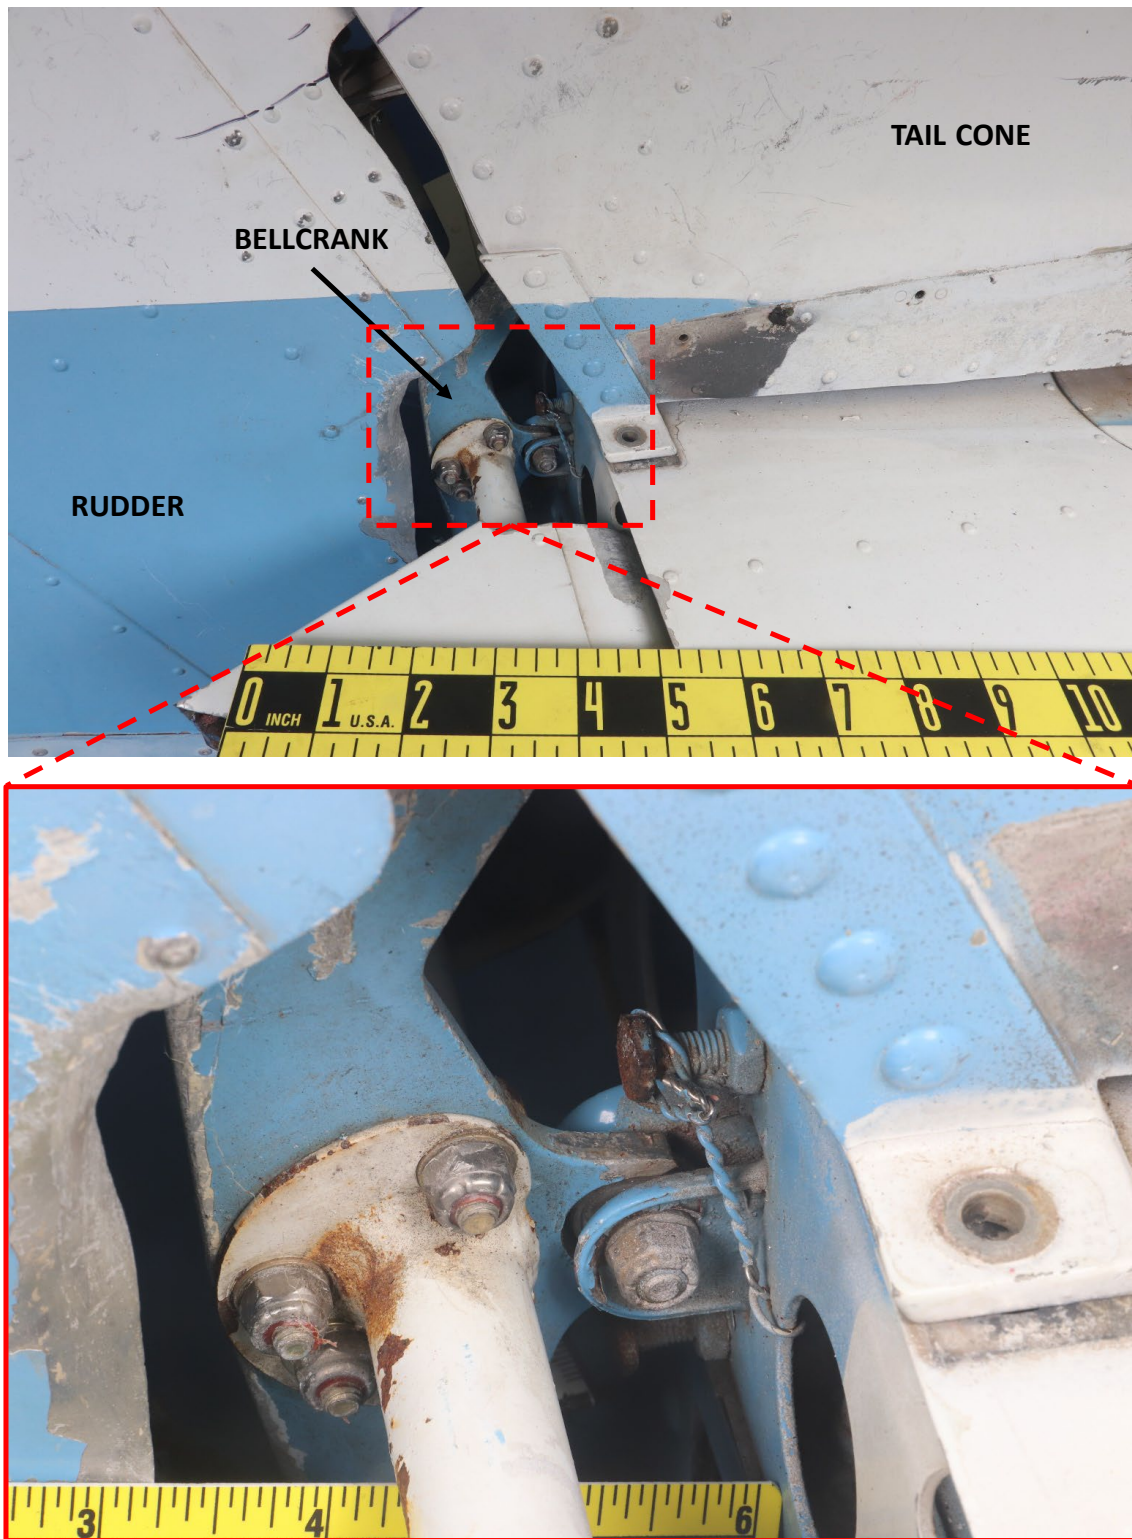
Figure 2: Close-up photos of the bolted connection between the elevator bellcrank and the mating tail cone.

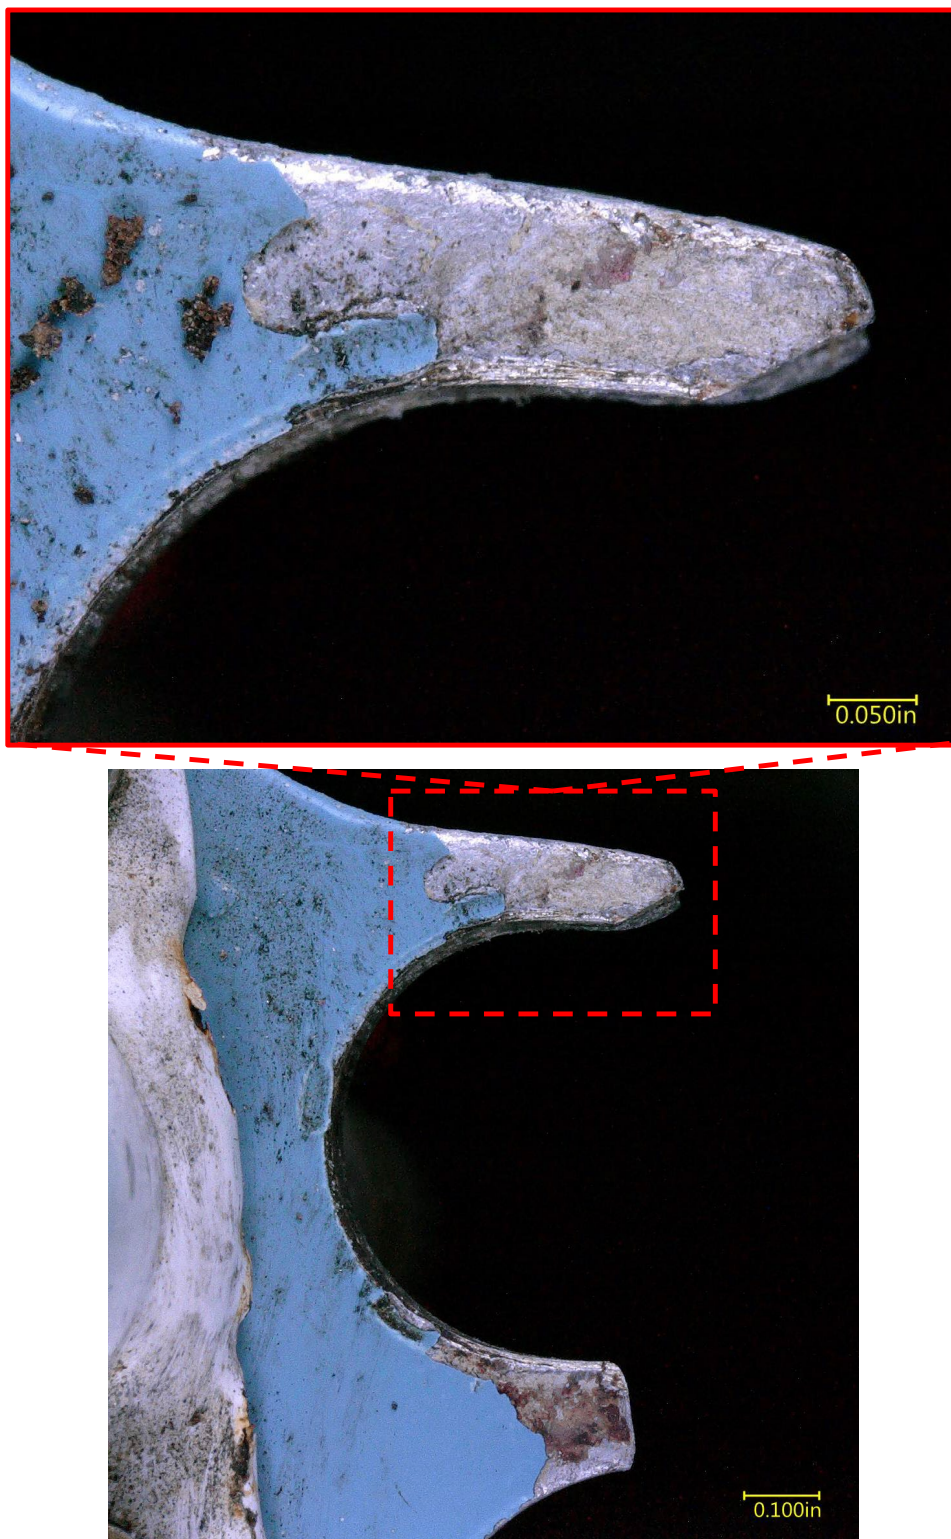
Figure 1 shows the submitted components positioned as though assembled. Close-up photos of the elevator bellcrank are shown in Figure 2. The elevator bellcrank had been assembled to the tail cone via a bolted joint; however, a portion of the connection thru-hole in the bellcrank had separated, as shown in Figure 3. The separated portion consisted of roughly one-half of the thru-hole circumference, which allowed the bellcrank to separate from the mating bolt. Wear and deformation were observed around the remaining circumference of the thru-hole, and the upper portion of the remaining thru-hole had thinning of its width compared to the lower portion.

Figure 3: Digital microscope images of the elevator bellcrank connection thru-hole.

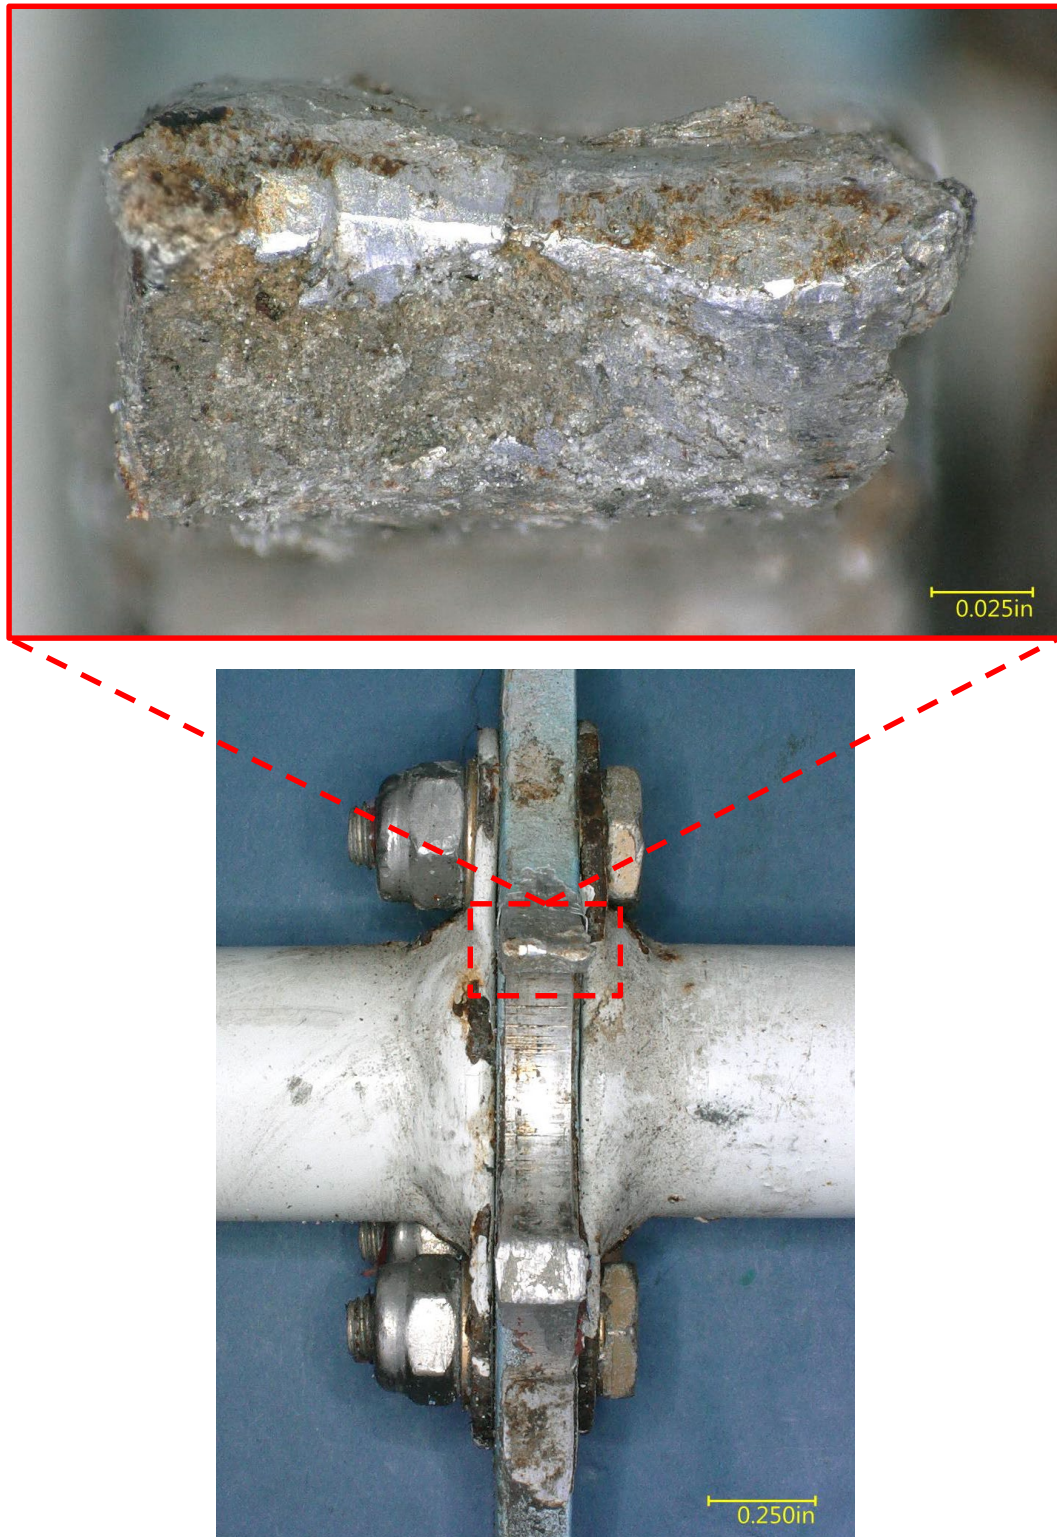
Figures 4 and 5 show digital images of the fracture surfaces on the upper and lower portions, respectively, of the bellcrank thru-hole circumference. Both fracture surfaces had rub damage that obscured large areas. The undamaged areas on the fracture surfaces had features consistent with overstress.

Figure 4: Close-up photo (bottom) and digital microscope image (top) of the fracture surface of the upper bellcrank thru-hole circumference.

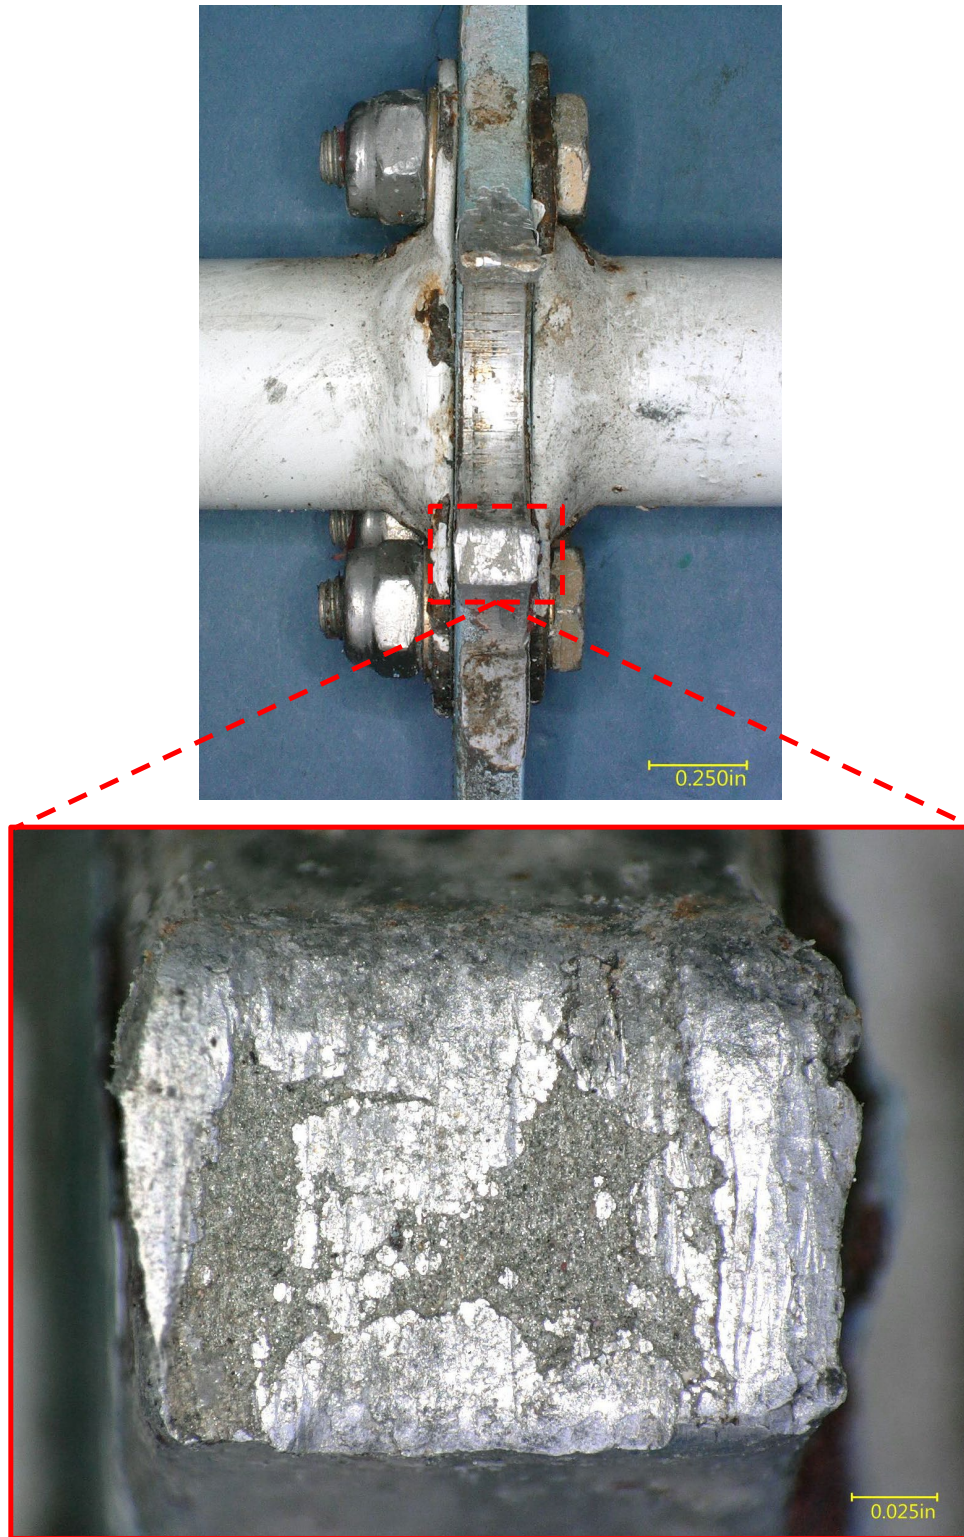
Figure 5: Close-up photo (bottom) and digital microscope image (top) of the fracture surface of the lower bellcrank thru-hole circumference.

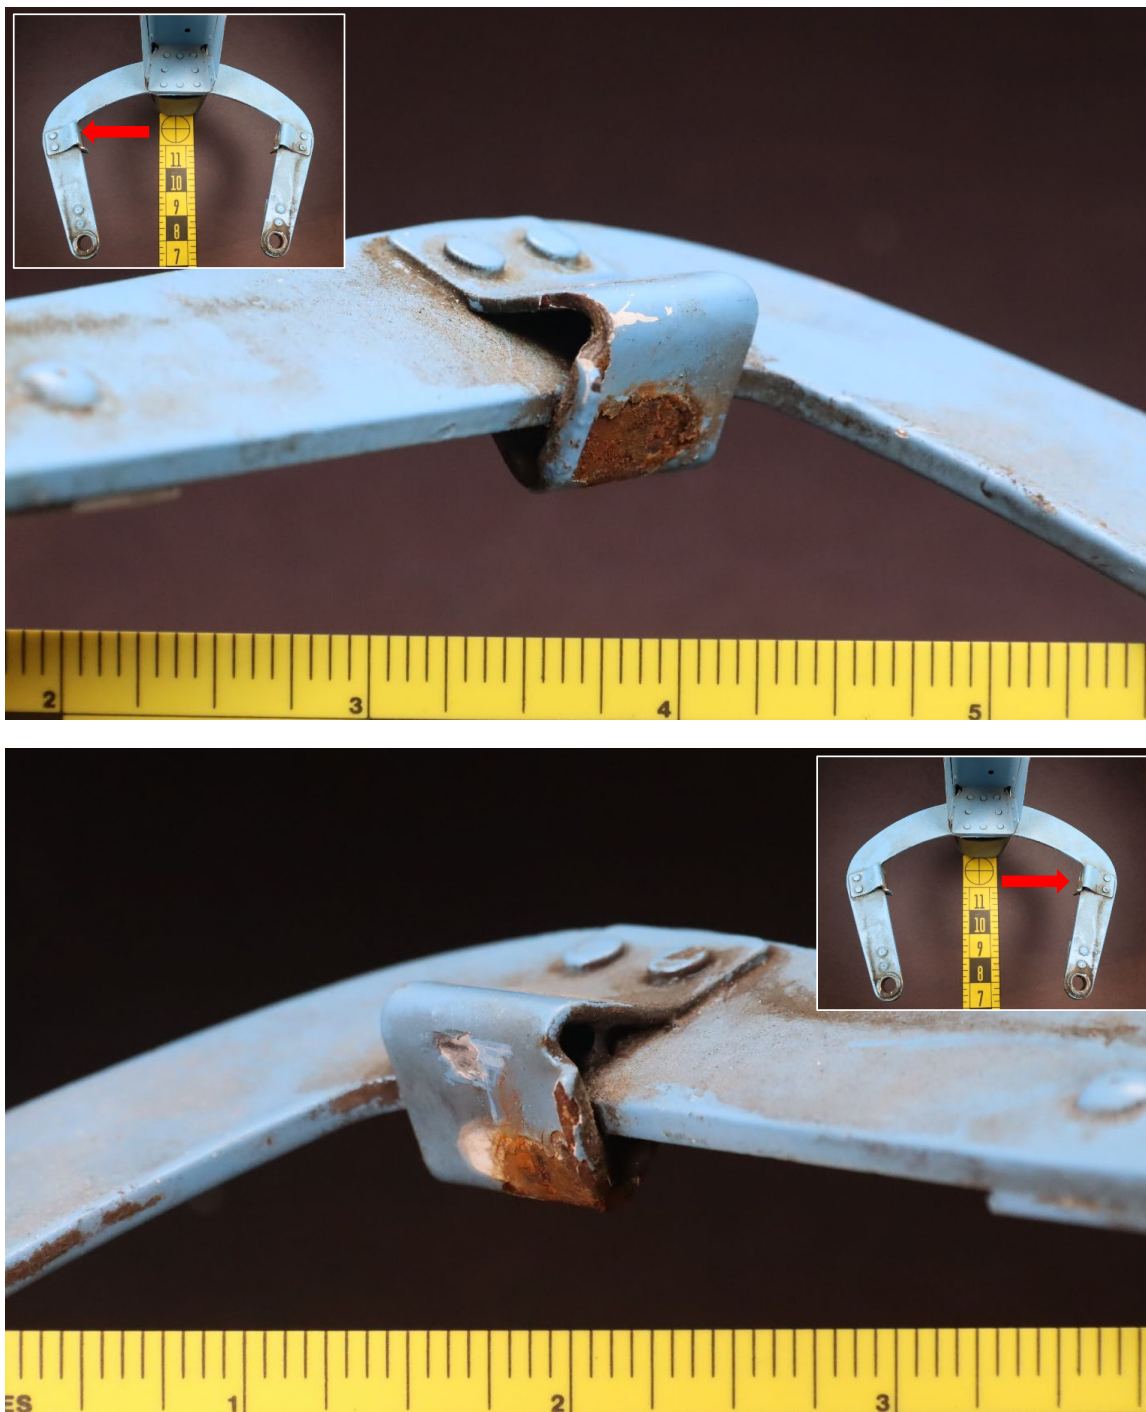
Figure 6 shows the rudder horn still assembled to the rudder. Close-up photos of the bumpers on the rudder horn are shown in Figure 7. Both bumpers had damage from contact with the mating rudder stop bolts assembled in the tail cone. The rudder stop bolts are shown still assembled to the tail cone in Figures 8–10. The heads of the bolts had rub damage consistent with contact with the rudder horn bumpers. Neither bolt had a nut

Figure 7: Close-up photos of the bumpers on the rudder horn.

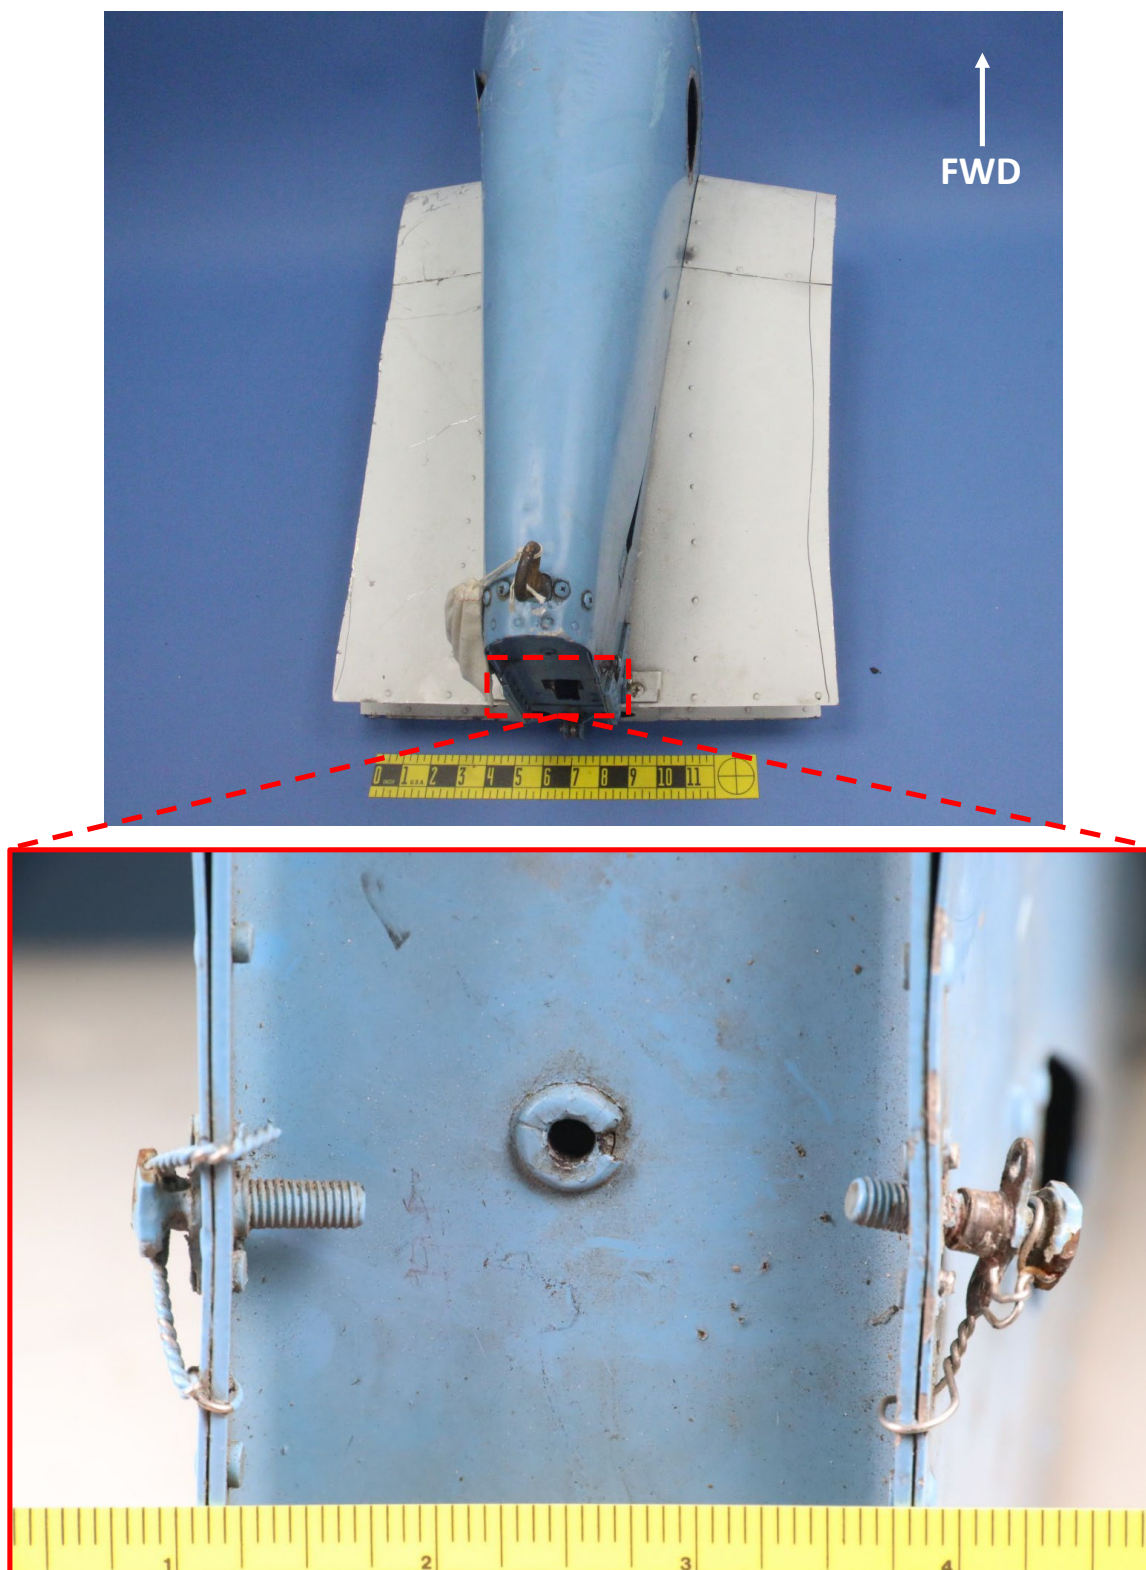
Figure 8: Overall (top) and close-up (bottom) photos of the rudder stop bolts still assembled to the tail cone.

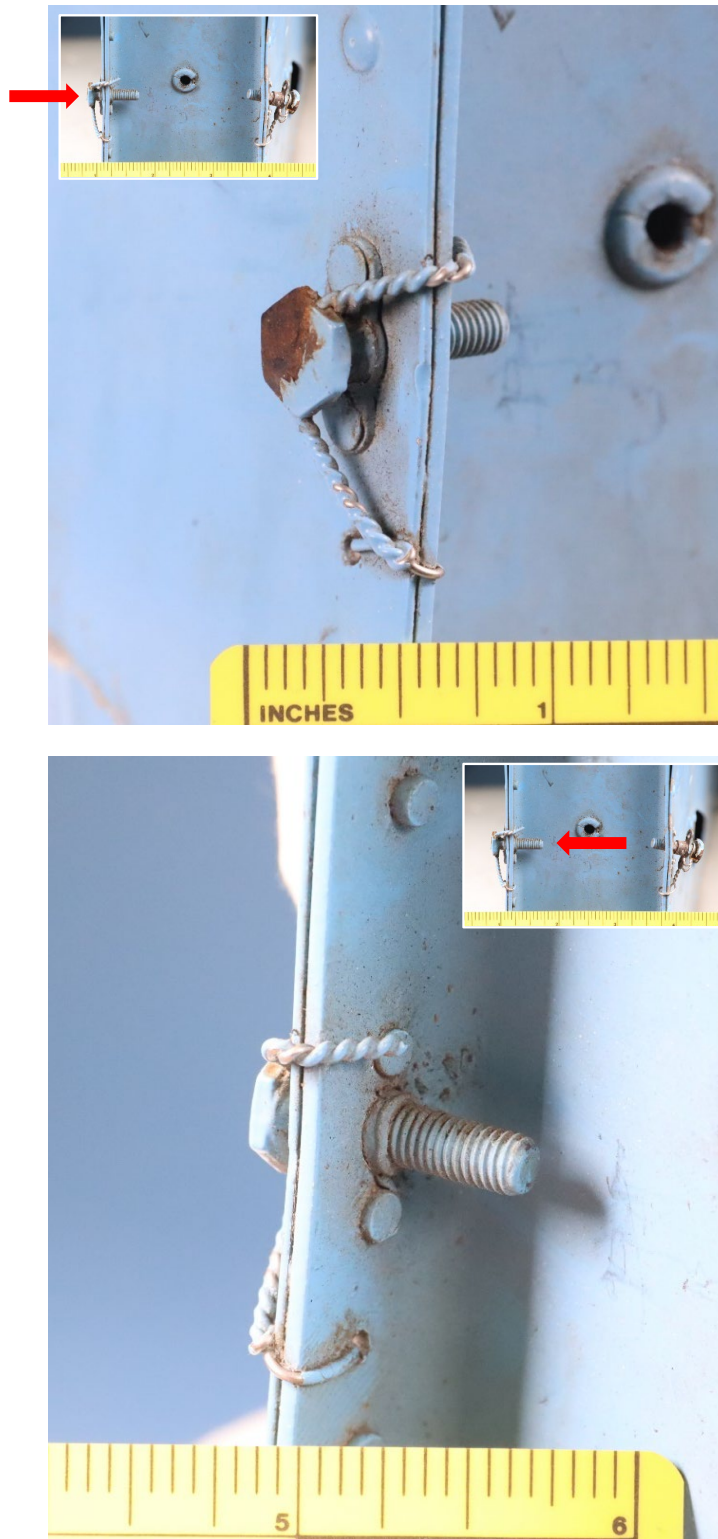
assembled on the inner side, but both had safety wire attached. The safety wire on the left side bolt was intact and the bolt was still sitting inside the nutplate, which was snug against the tail cone skin, as shown in Figure 9. The safety wire on the right side bolt was missing at the top nutplate hole, and the top rivet head had sheared off. The right side bolt was still assembled within the nutplate, but the nutplate was no longer assembled against the tail cone skin, as shown in Figure 10.

Figure 9: Close-up photos of the left rudder stop bolt.

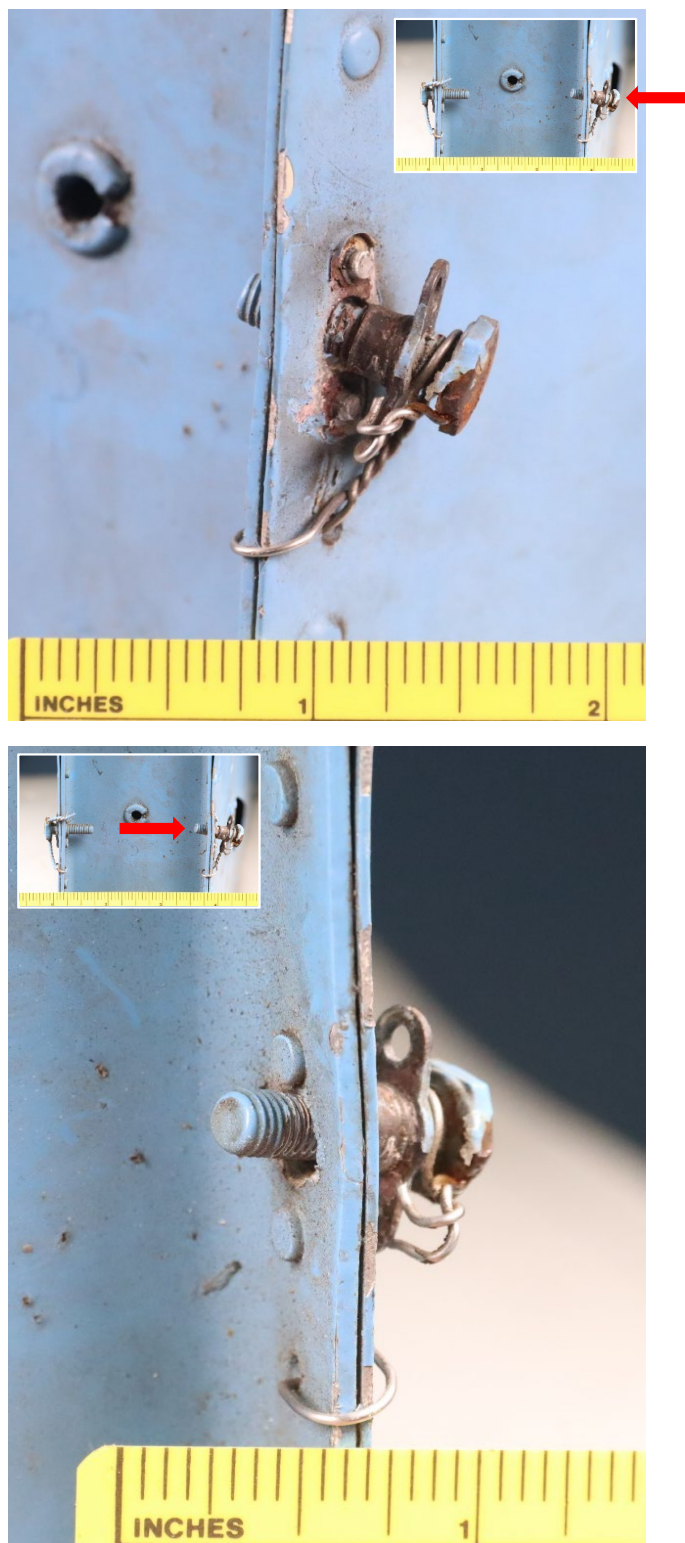
Figure 10: Close-up photos of the right rudder stop bolt.

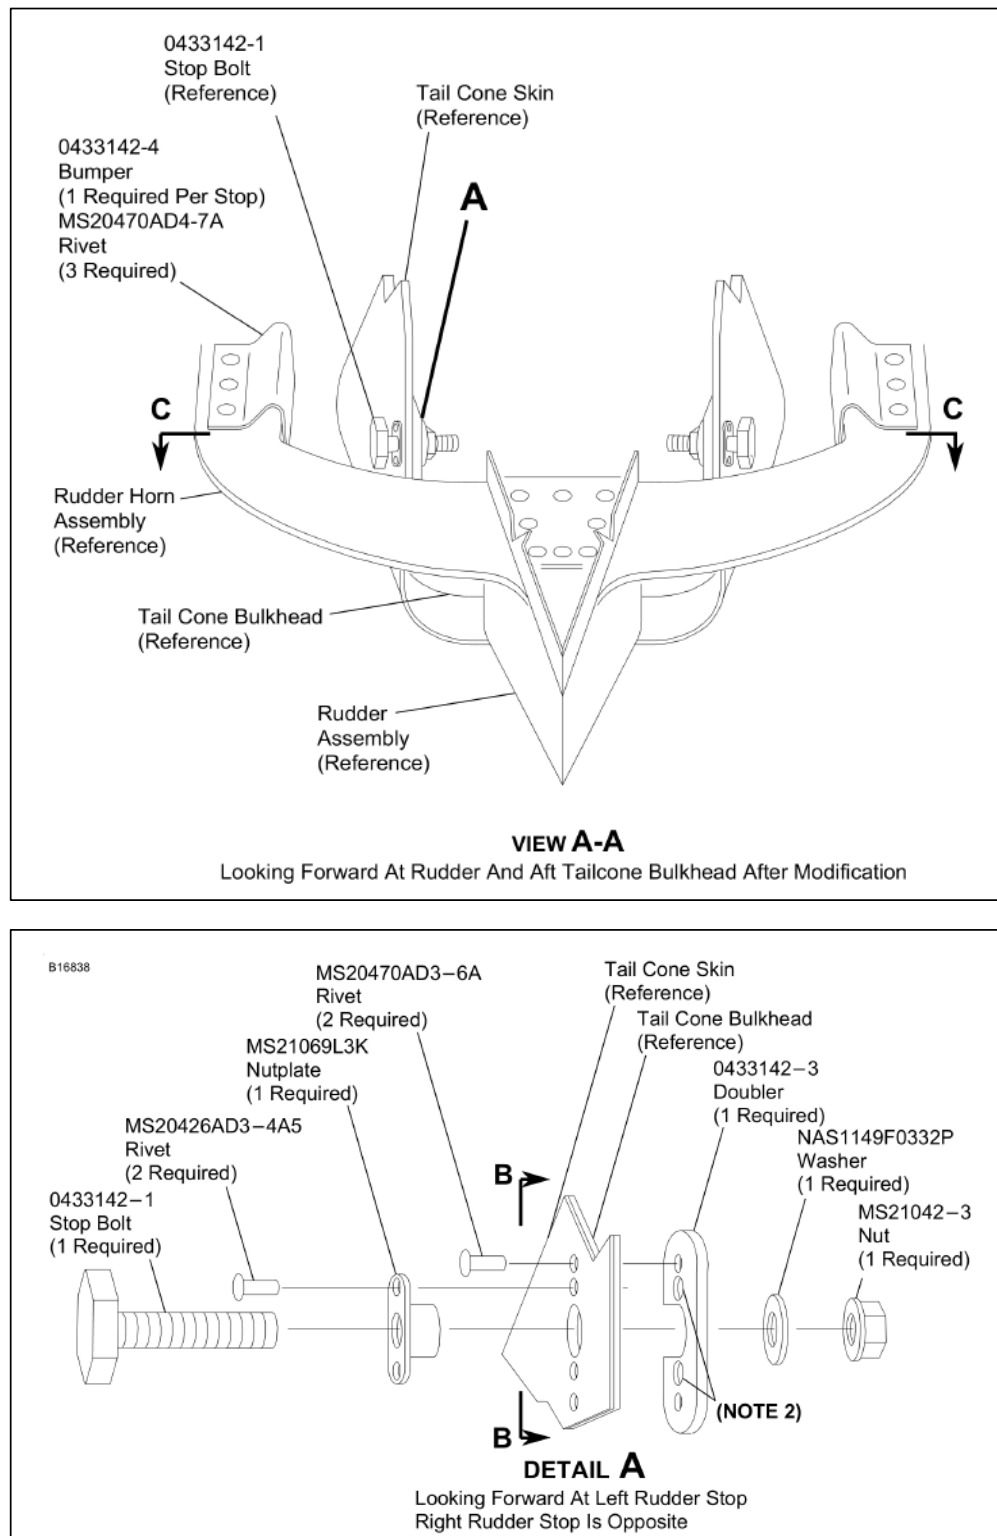
According to FAA Airworthiness Directive (AD) 2009-10-09 all Cessna 150 model aircraft should have either a placard prohibiting spins and other aerobatic maneuvers or service kit part number SK152-25 installed. SK152-25 replaces the rudder stop, rudder stop bumpers, and the attachment hardware with new duplicate parts and includes the addition of a doubler. The service kit also replaces the safety wire with jamnuts. Diagrams of the service kit hardware taken from a Textron Aviation document outlining the replacement of the parts is shown in Figure 11. Neither stop bolt on the accident aircraft had a doubler nor a nut and washer assembled on the inside surface of the tail cone skin, which indicated that a service kit was not installed.

Figure 11: Diagrams of the service kit hardware taken from a Textron Aviation document outlining the replacement of the parts on the rudder stop bolts.
