# NATIONAL TRANSPORTATION SAFETY BOARD

## MATERIALS LABORATORY FACTUAL REPORT

Report No. 22-024

Place : St. Augustine, Florida  
Date : June 29, 2021  
Vehicle : Cessna 152, N25513  
NTSB No. : ERA21FA274  
Investigator : Peter Wentz, ASI – ERA

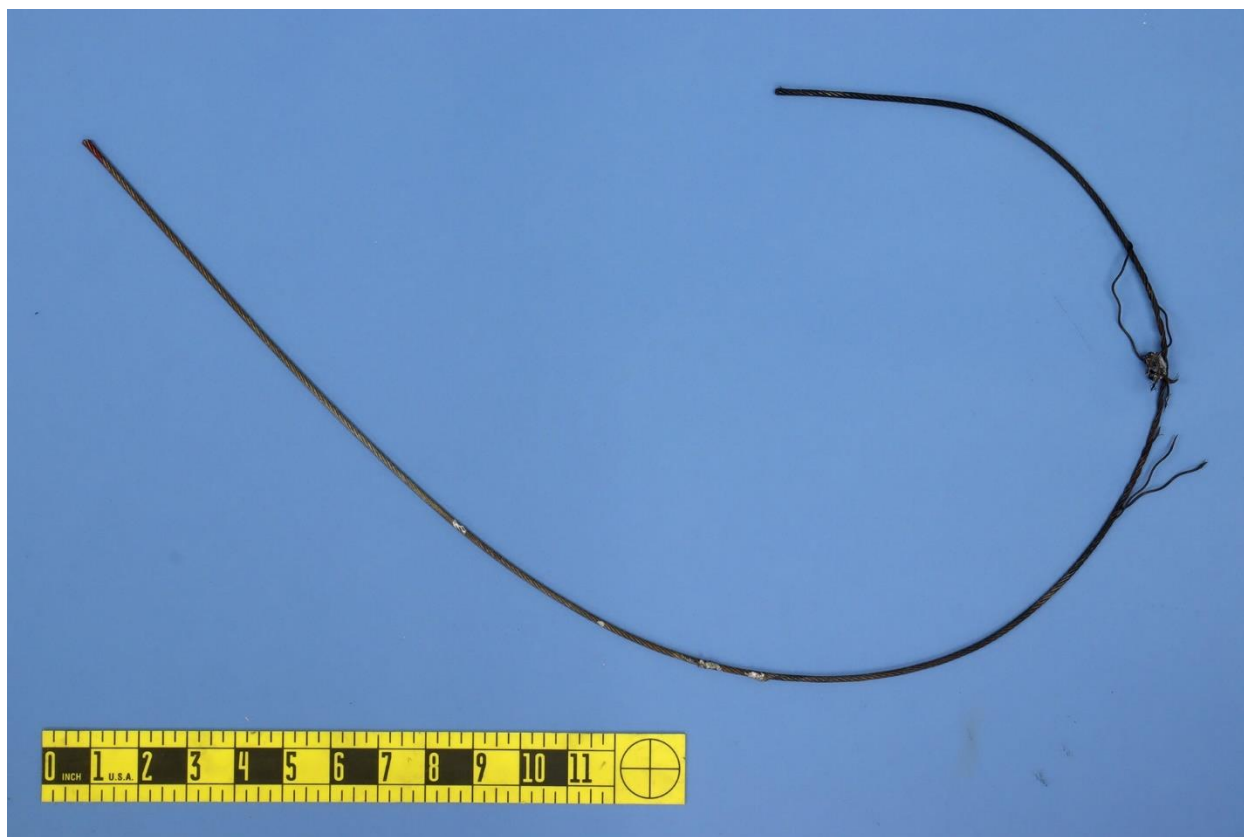
**Figure 1:** The section of rudder cable as received.

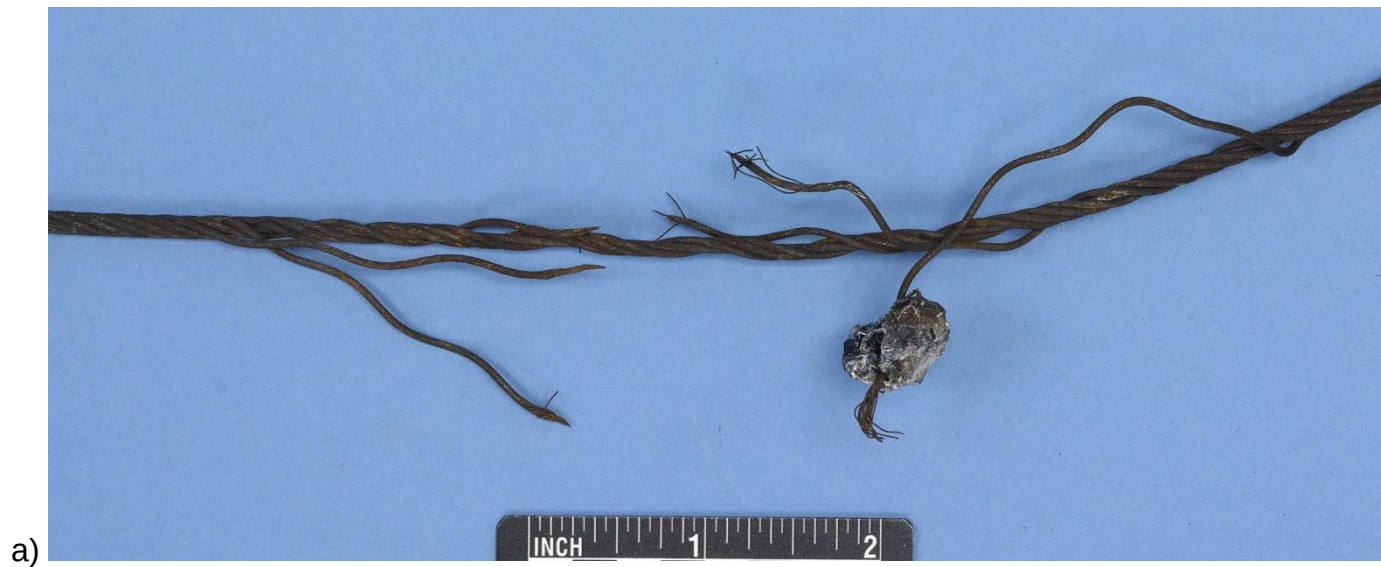
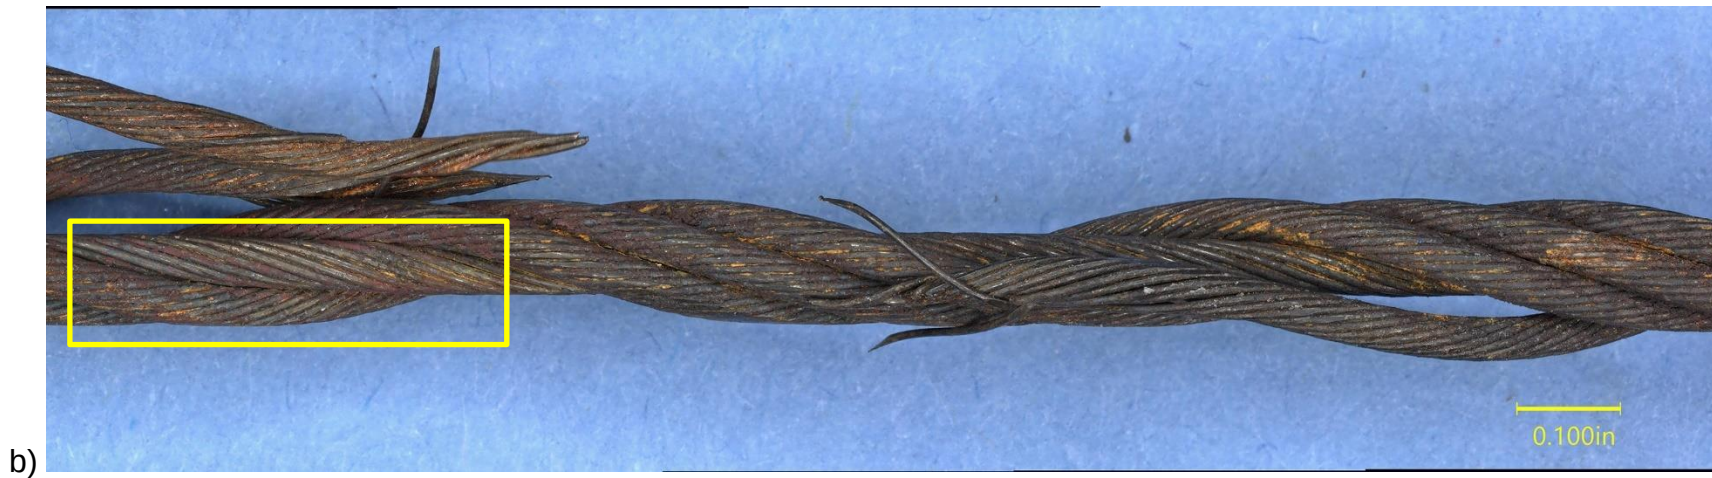
A section of a rudder control cable was submitted to the NTSB Materials Laboratory for examination as shown in figure 1. The cable consisted of seven (7) strands and each strand consisted of 19 wires. As seen in figures 2a and 2b, three of the strands had separated and four were intact. The intact strands exhibited some regions of wear on their outward facing wires, one such region being indicated by the yellow rectangle in figure 2b.

**Figure 2:** a) and b) higher magnification images of the cable at the point of strand separation. A yellow box in part b) highlights a region exhibiting wear of outward-facing wires on an intact strand.

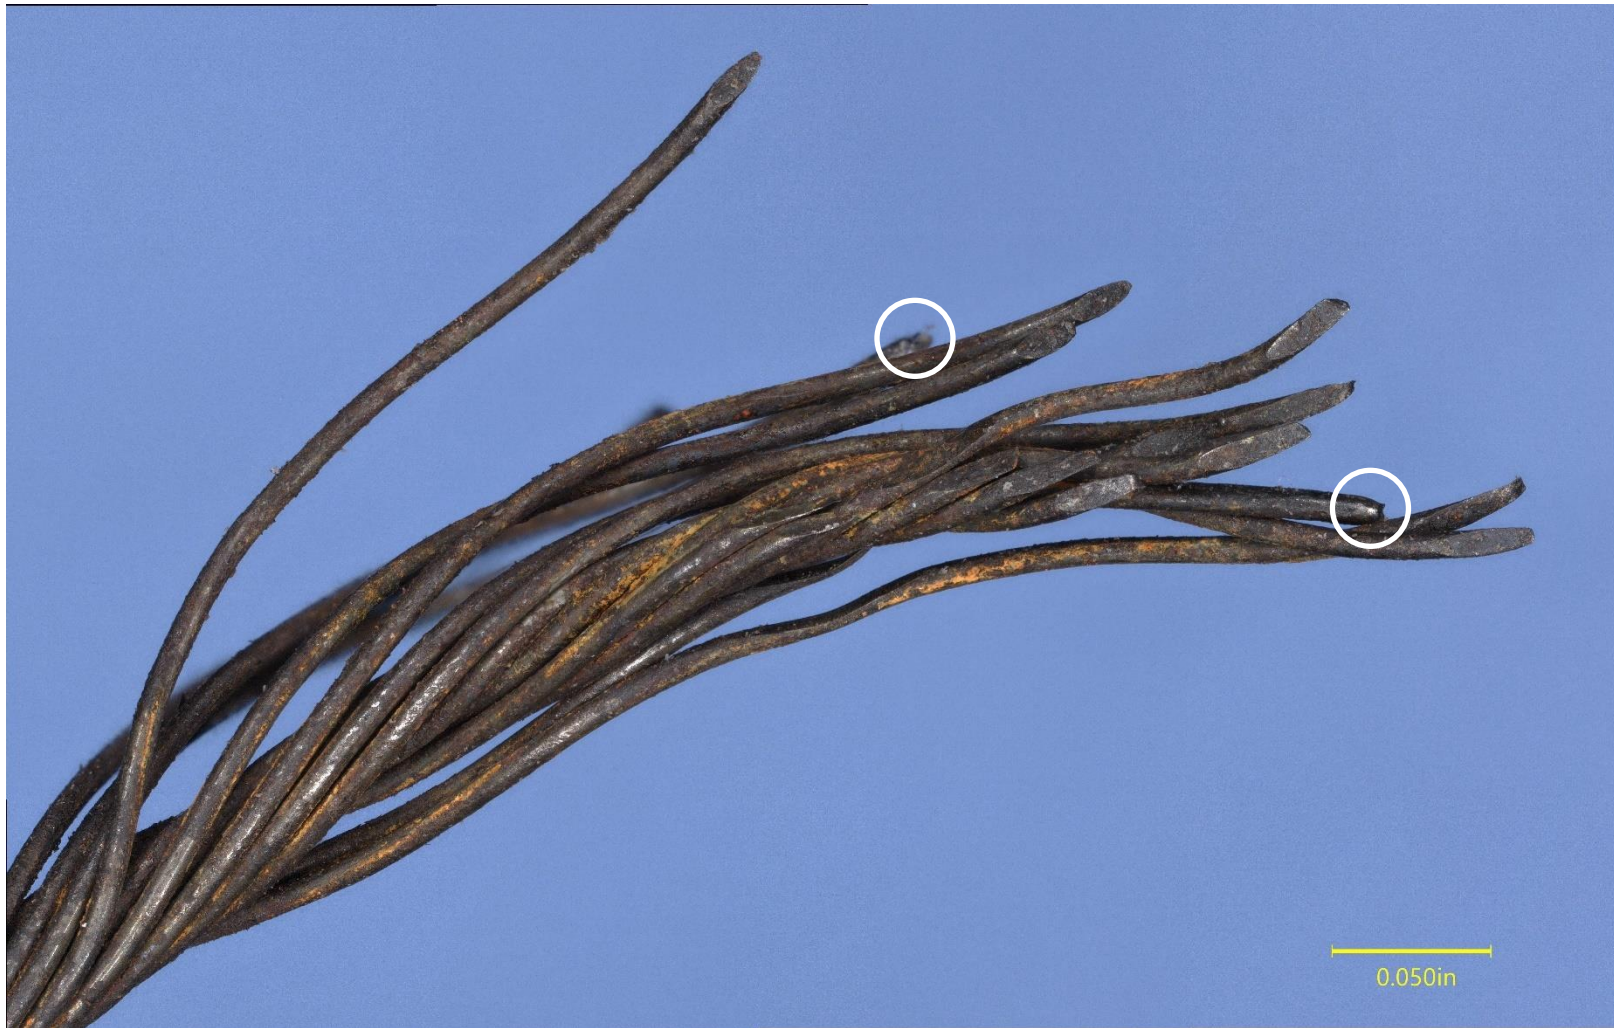
The three separated strands were examined with the aid of a stereomicroscope and all three strands exhibited features consistent with wear at the point of separation, with some individual wires exhibiting fracture features. The three separated strands, numbered arbitrarily as 1 – 3, are shown in figures 3 – 5, respectively. Strand 1 exhibited necking separation for two wires, consistent with overstress, with the remainder exhibiting a beveled appearance that was consistent with wear. All wires on strand 2 exhibited a beveled appearance that was consistent with wear. Finally, strand 3 contained seven fractured wires with the remainder displaying the same beveled appearance. Of the seven fractured wires, two exhibited necking separations consistent with overstress; two exhibited a flat appearance on one side and bending deformation on the other that was consistent with fatigue progression followed by overstress separation; and three were corroded and the fracture mode was undetermined.

**Figure 3:** Strand 1 separated end. Two wires exhibited features consistent with overstress (white circles). The remainder were beveled, consistent with wear.

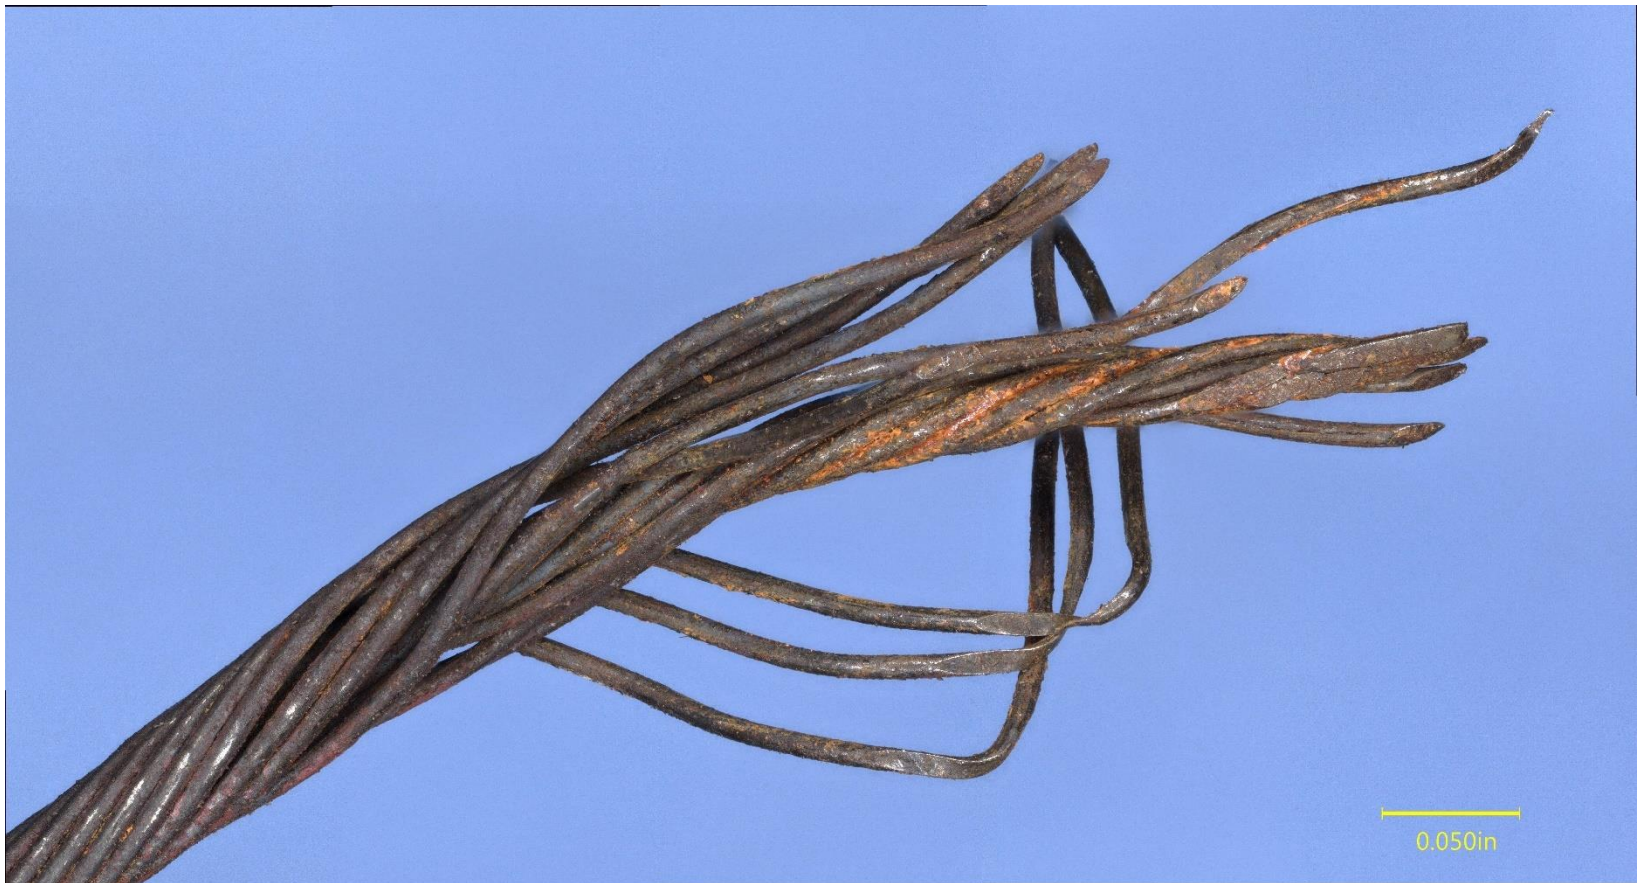
**Figure 4:** Strand 2 separated end. All wires were beveled, consistent with wear.

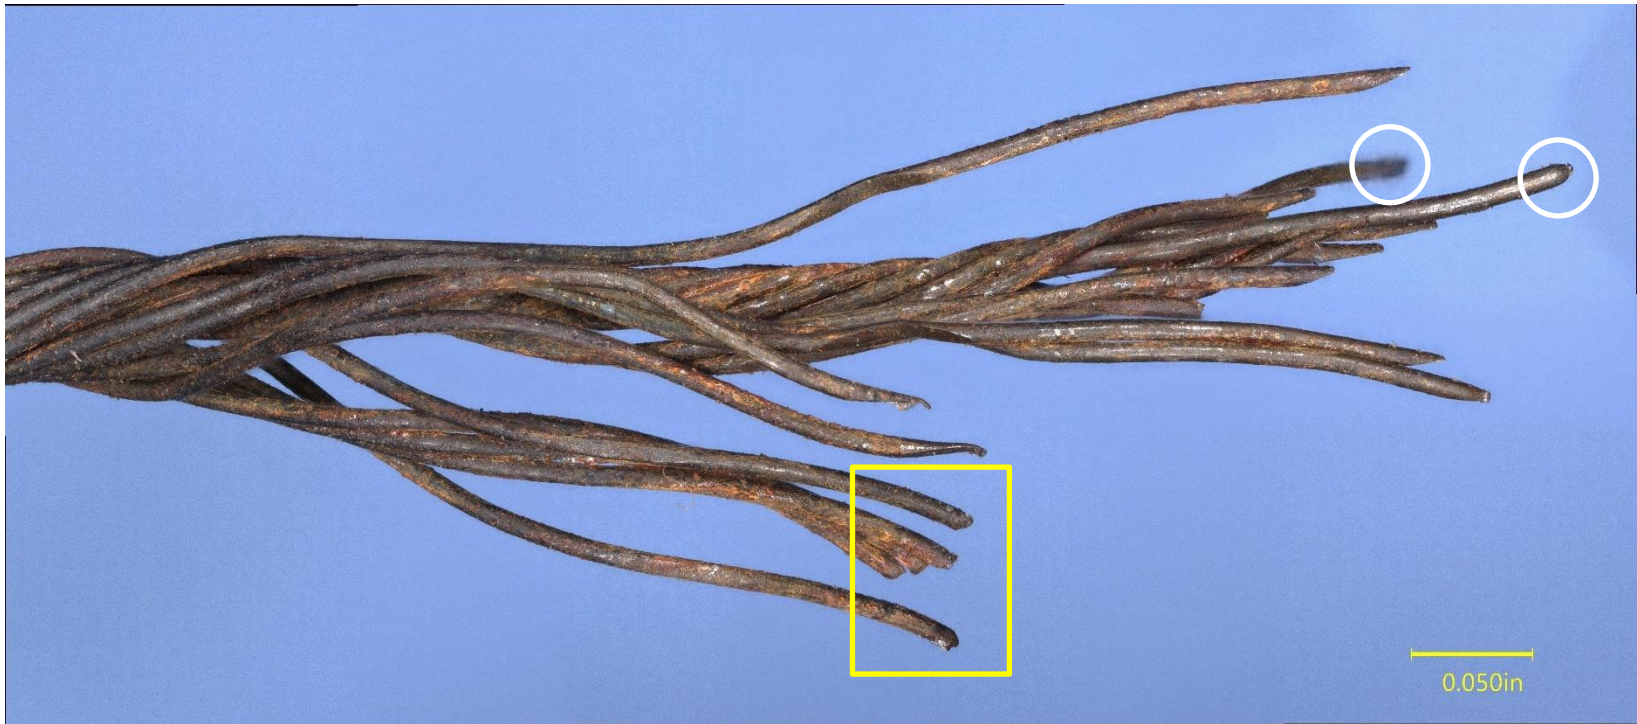
**Figure 5:** Strand 3 separated end. Two wires exhibit features consistent with overstress (white circles), two exhibited features consistent with fatigue initiation followed by overstress, and three could not be determined (fatigue and undetermined indicated together by the yellow rectangle). The remainder were beveled, consistent with wear.
