**NATIONAL TRANSPORTATION SAFETY BOARD**  
Office of Aviation Safety

**Wreckage Examination Summary**

**A. ACCIDENT      ERA21FA274**

Location:            St. Augustine, Florida  
Date:                June 29, 2021  
Time:                1427 Eastern Daylight Time (EDT)  
Operator:           Florida Flyers Flight Academy  
Aircraft:            Cessna 152  
Registration:        N25513

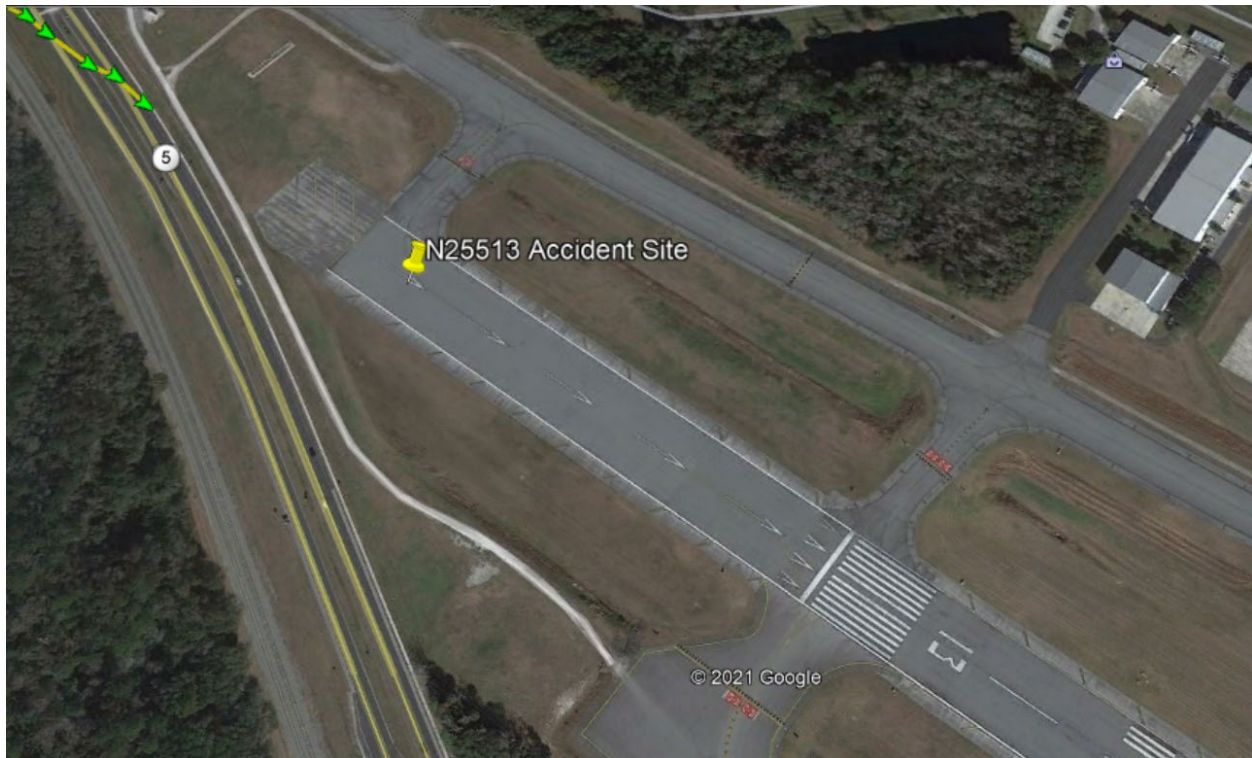
The airplane was located about 927 ft short of the displaced threshold on runway 13 at SGJ on a heading of 148°. It came to rest at an elevation of about 9 ft on the runway surface. After the impact, a postcrash fire ensued. About 2.5 gallons of aviation fuel (100LL) was drained for the left wing while on site.

*Figure 1 - Accident Site*
