# National Transportation Safety Board

ERA21FA317

## WRECKAGE EXAMINATION

Helicopter: Rotorway Exec 162F, Registration N162KJ

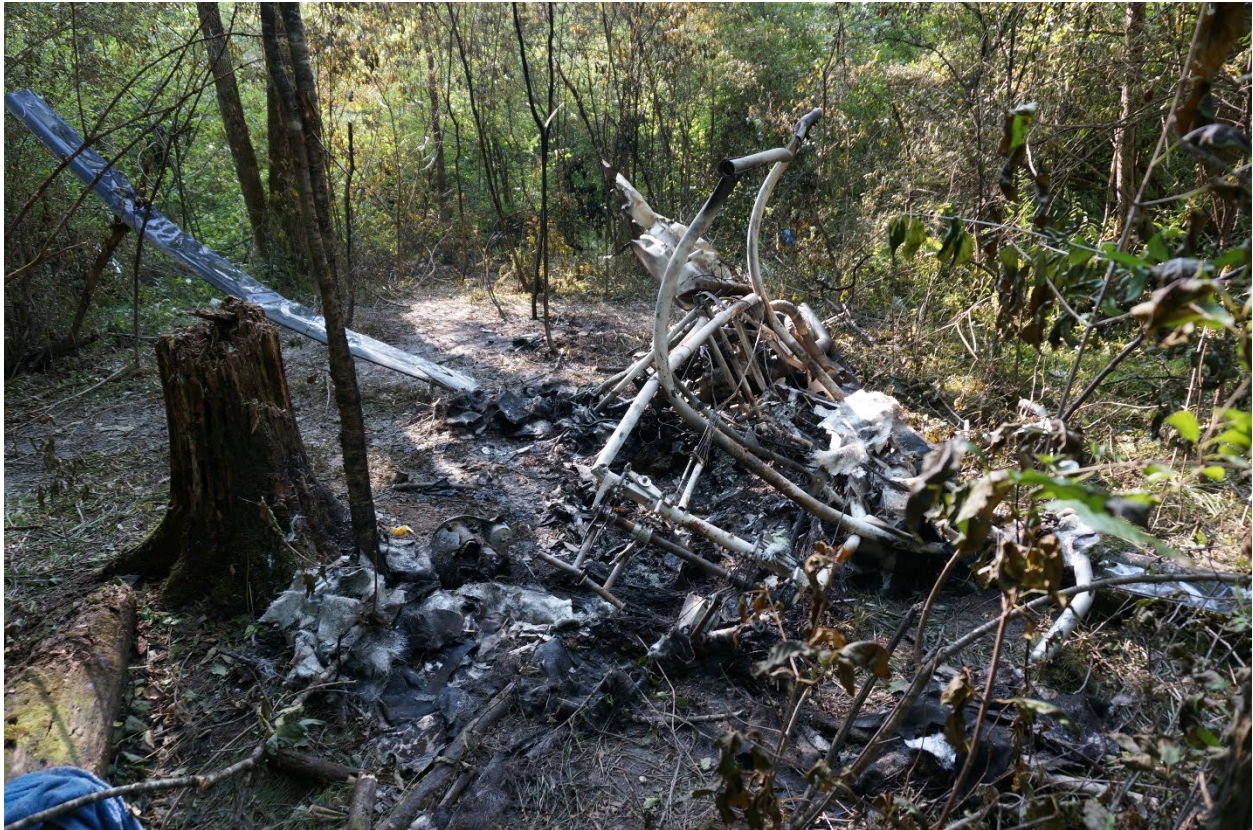
**Figure 1 - Accident Site**

The wreckage path was about 400 ft long and oriented on a heading of 210° magnetic. It began in an open field of 4 ft tall grass, with a 4-inch by 4-inch fractured piece of aluminum skin from the right side of the tailboom, just forward of the tail rotor arc. A portion of the helicopter's registration number was visible on the piece. The path transitioned through a line of trees, and continued into a wooded area, down a steep hill about 200 ft long and ended in flat/low area at the bottom of the incline. The right horizontal stabilizer was located 156 ft along the wreckage path, 70 ft left of the path centerline. The left horizontal stabilizer was located 165 ft along, and 205 ft left, of the path centerline. A section of tail boom, about 4 ft long, including the vertical stabilizer, tail rotor gearbox with 1 tail rotor blade attached was located just downrange of the tree line, about 200 ft along, 10 ft left of the wreckage path. path centerline. Pieces of plastic clear canopy were found on the left and right side of the wreckage path in the wooded area, all along the path and at widely varying distances left and right of the path.

No tree/vegetation damage was found along the wreckage path through the wooded area, except for minor damage to branches immediately surrounding and directly above the main wreckage. There were no grounds cars or tree damage found leading to the main wreckage. The helicopter was destroyed, and largely consumed by a post-crash fire.

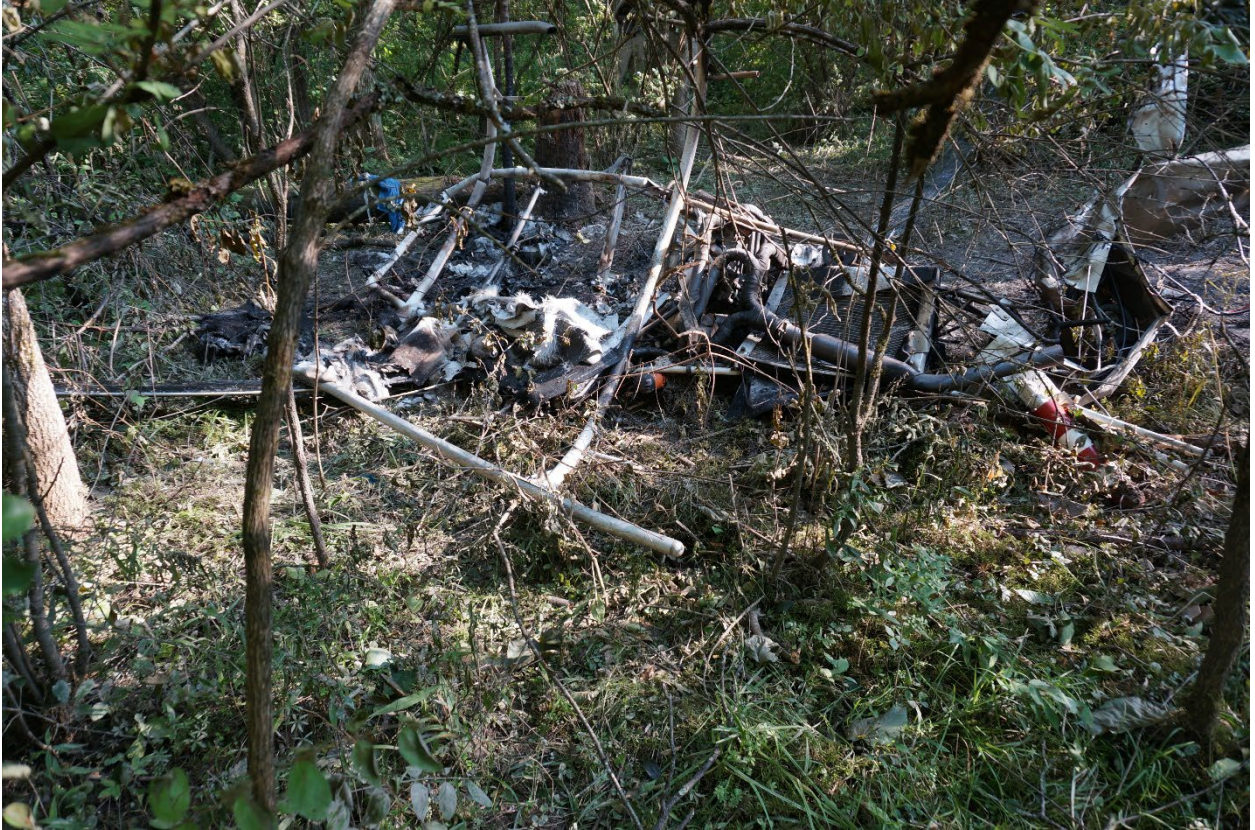
**Figure 3 - Fuselage View from Bottom**

The fuselage was largely consumed by fire, many aluminum components were melted. Significant Fiberglass melted/fabric remains. Steel frame tubes mostly intact but impact displaced/damage. Tubes/plates of fuselage impinging on engine crankshaft sheave. Left landing skid melted away near mid span.

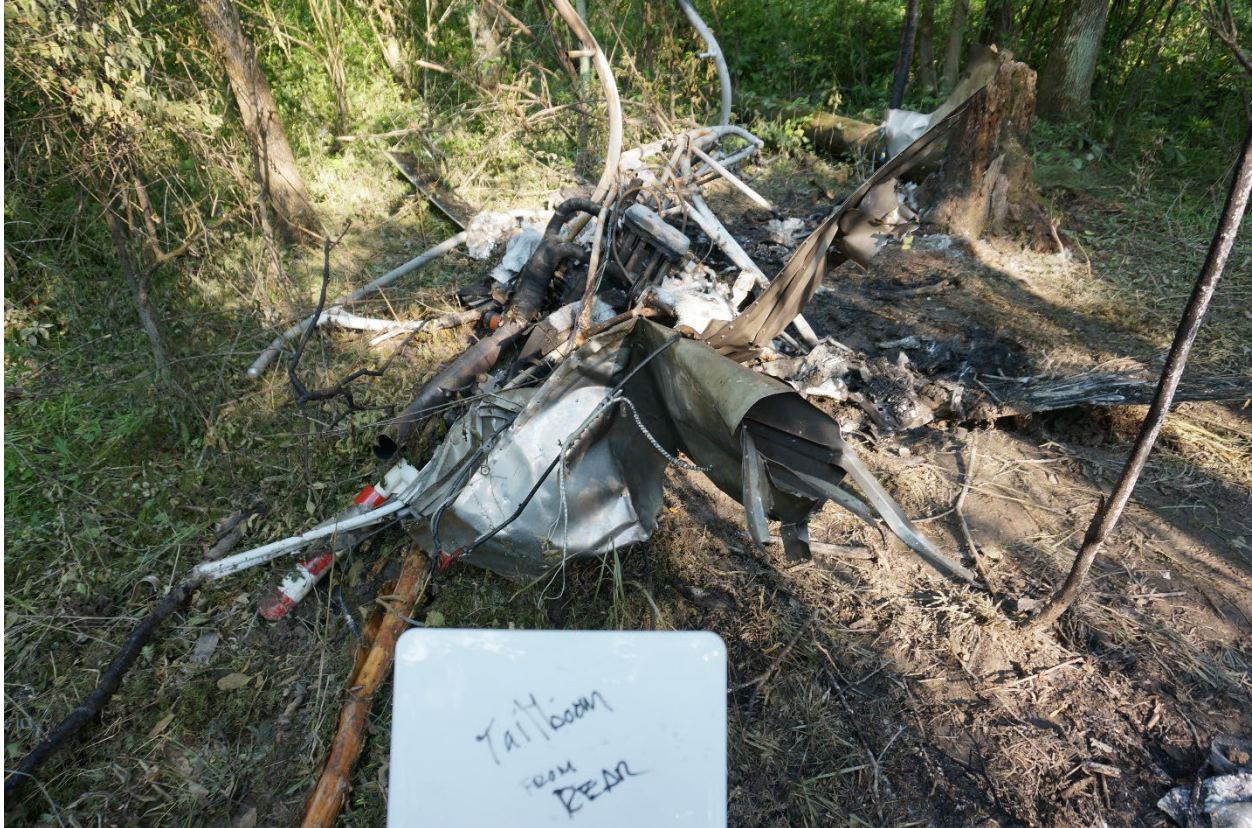
**Figure 4 - Tail boom Section - Attached to Fuselage**

About ½ of the tail boom (about 4 ft long) remained attached to fuselage. It was impact damaged and torn open at its aft end. Remnants of 2-3 circular ring shaped cast aluminum stiffeners were found fractured, ½ of 1 of those remained in tail boom section attached to fuselage. The ballast weight was in place on its centerline mount below the forward tail boom.

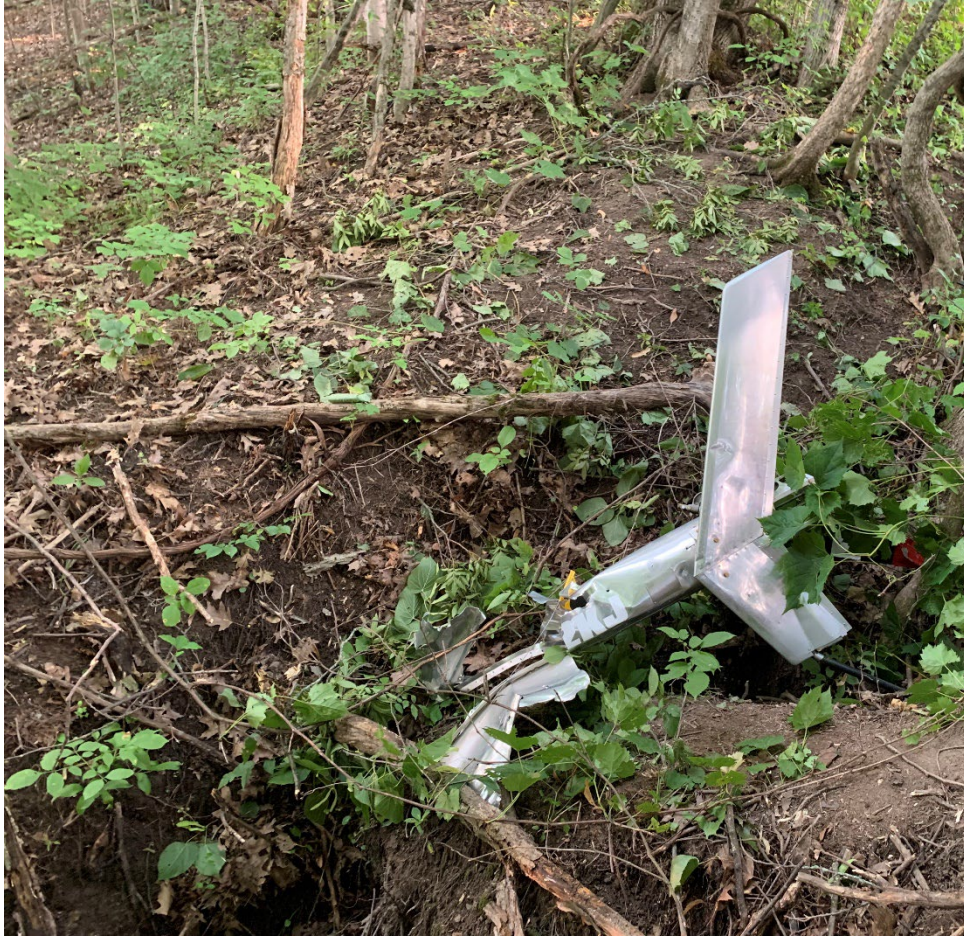
**Figure 5 - Aft Tail Boom Section**

The aft section (about 4 ft long) of the tail boom was found about halfway along the debris path, 200 ft from the main wreckage. The forward end of the section was fractured and torn open. The tail rotor gear box remained attached, along with 1 of the 2 tail rotor blades. The 2<sup>nd</sup> tail rotor blade was not located. The vertical stabilizer and tail rotor guard remained intact.

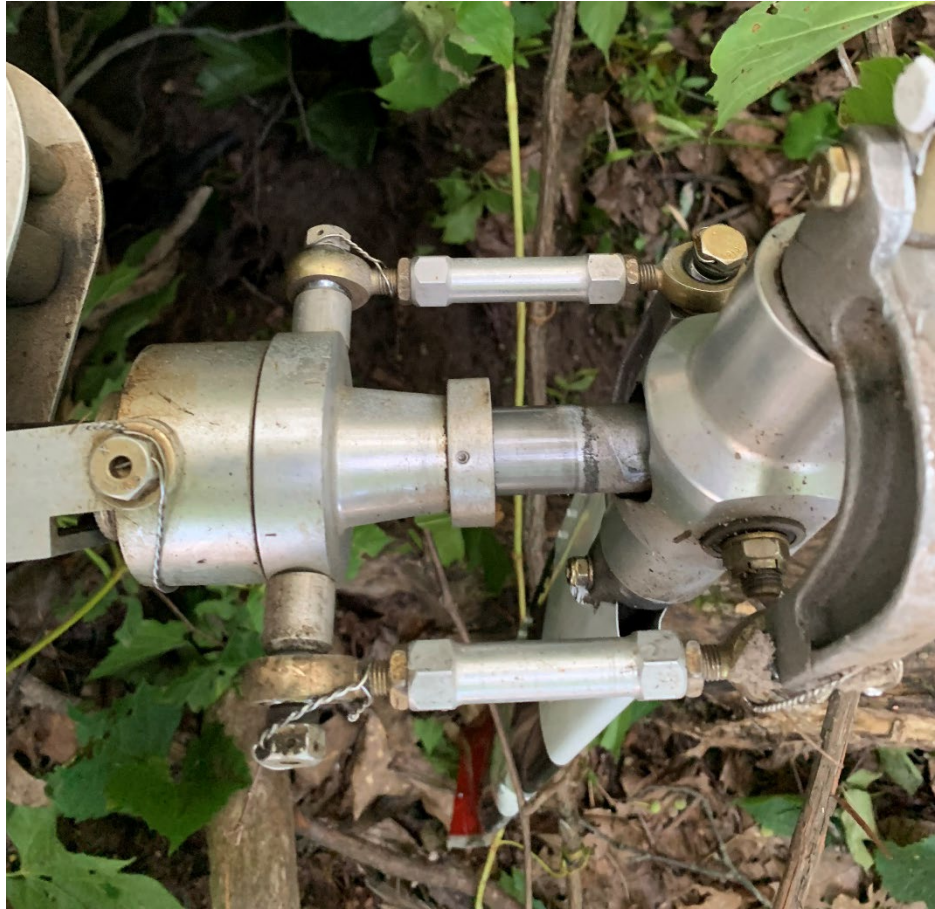
**Figure 6 - Tail Rotor Pitch Change Links**

The pitch change links remained intact, rotated freely, and the pitch change mechanism moved freely. The drive pulley remained attached inside.

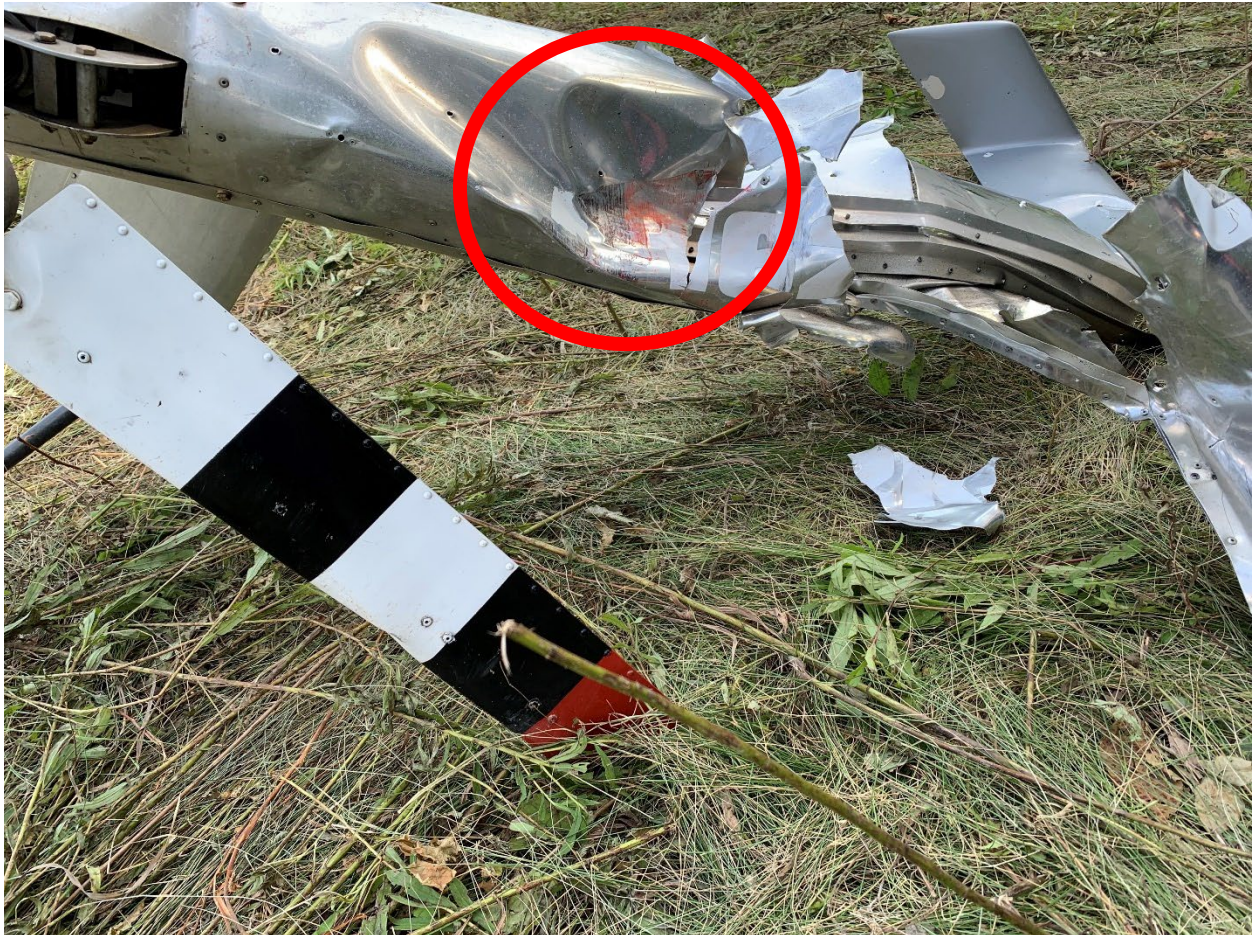
**Figure 7 - Impact Marks and Paint Transfer - Tail Rotor Blade**

Impact marks and paint transfer were found on the right side of the tail boom consistent with the arc and color of the tail rotor blade tips (last 3-4 inches).

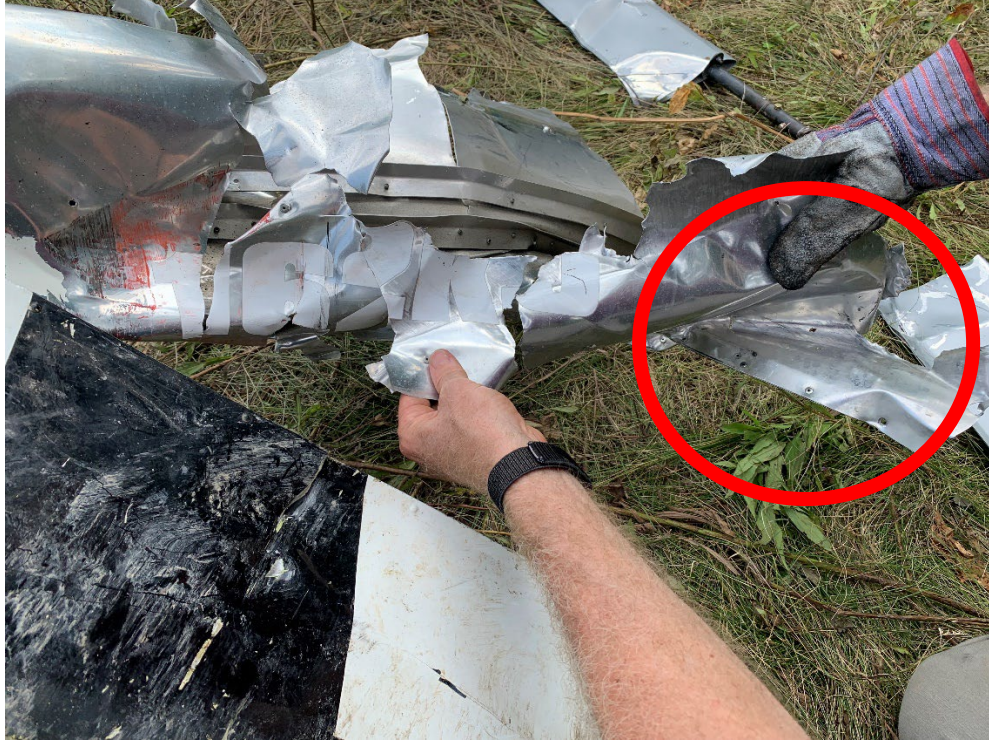
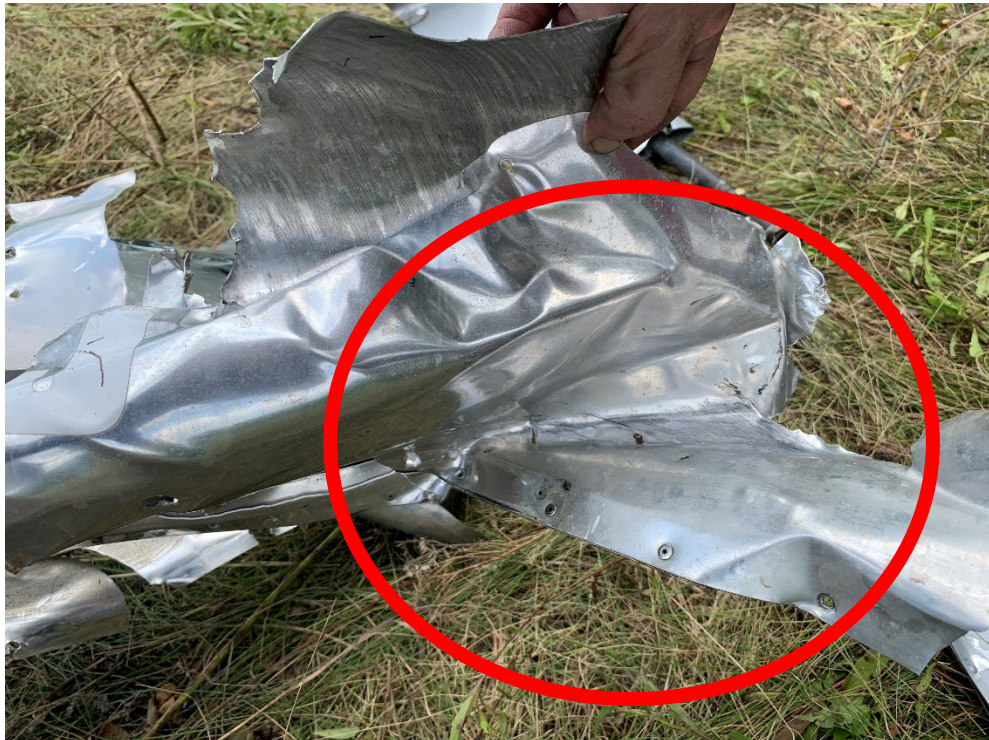
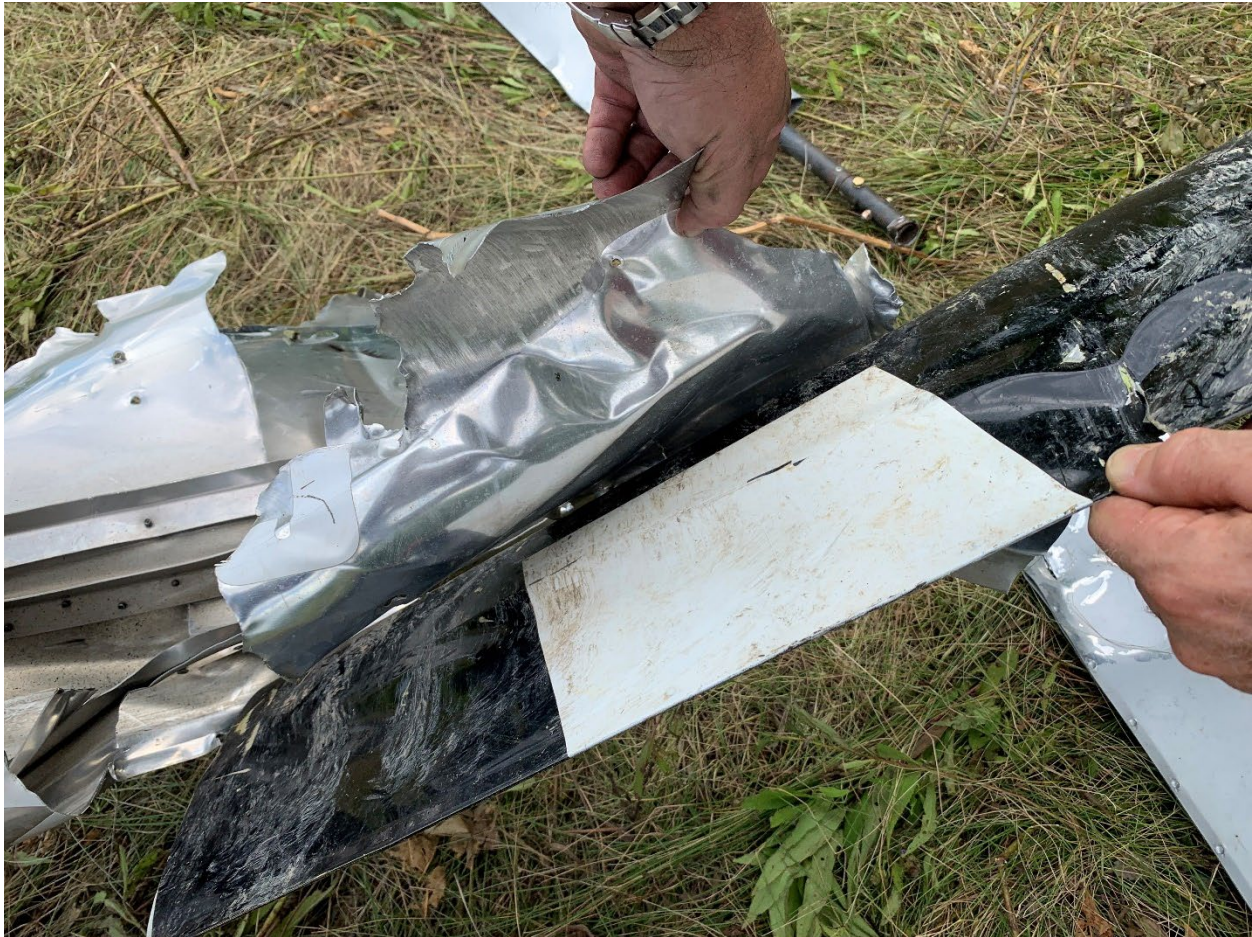
Impact marks at the forward (fractured) end of the tail boom section were shaped similar to the main rotor blade and contained some black marks consistent with main rotor blade paint.

**Figure 8 Impact Marks at Forward End of Tail Boom Section**

**Figure 9 - Impact Marks at Forward End of Tail Boom Section (enlarged)**

**Figure 10 - Main Rotor Blade Shown at Impact Marks**

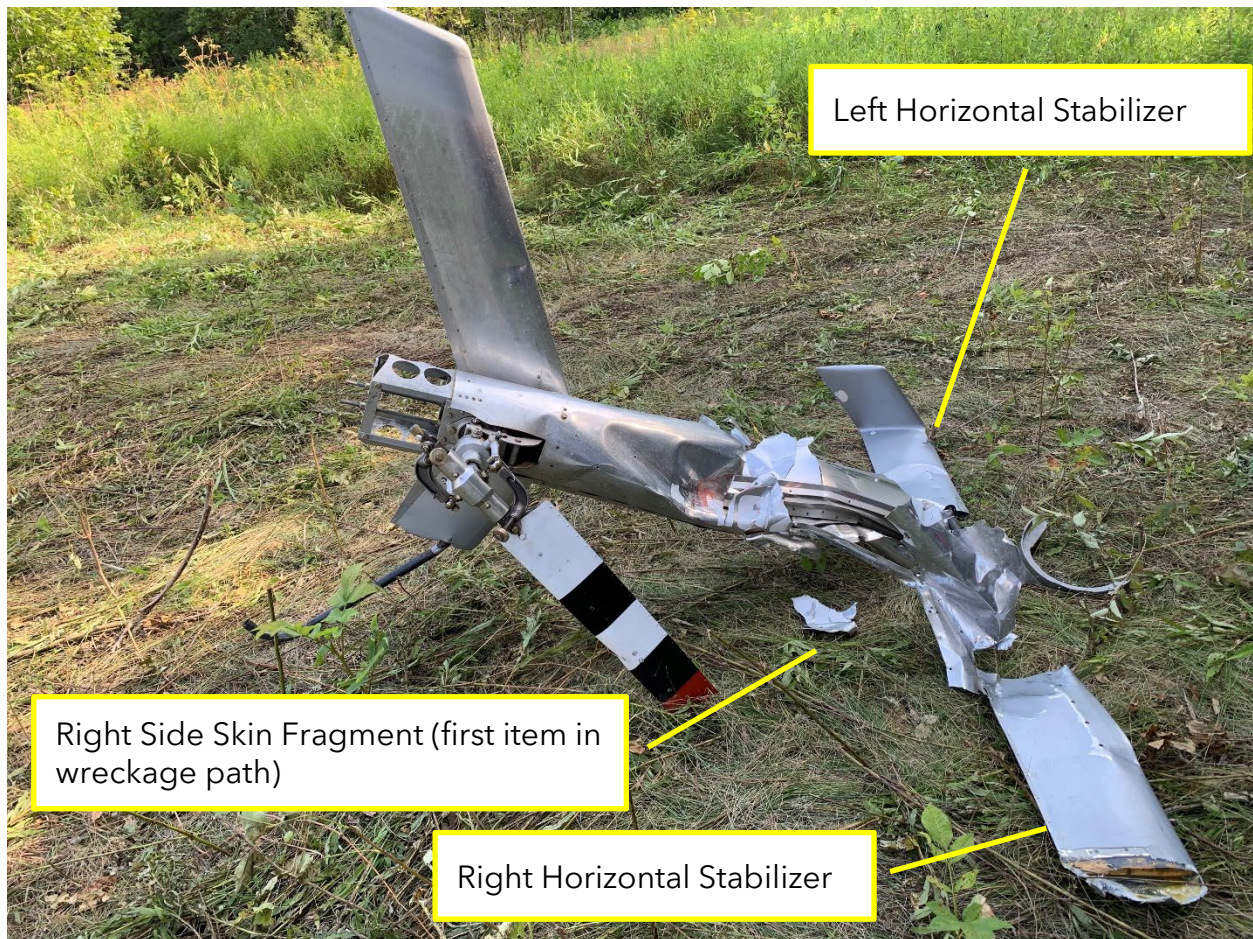
**Figure 11 - Aft Section of Tail Boom**

The left and right horizontal stabilizers were separated from the tail boom and found separately in field along wreckage path (they were mounted at or forward of the fracture/damage area at the front of the separated tail boom section), along with small piece of tail boom skin, with partial N number, from Right side of tail boom, in the fractured/damaged area.

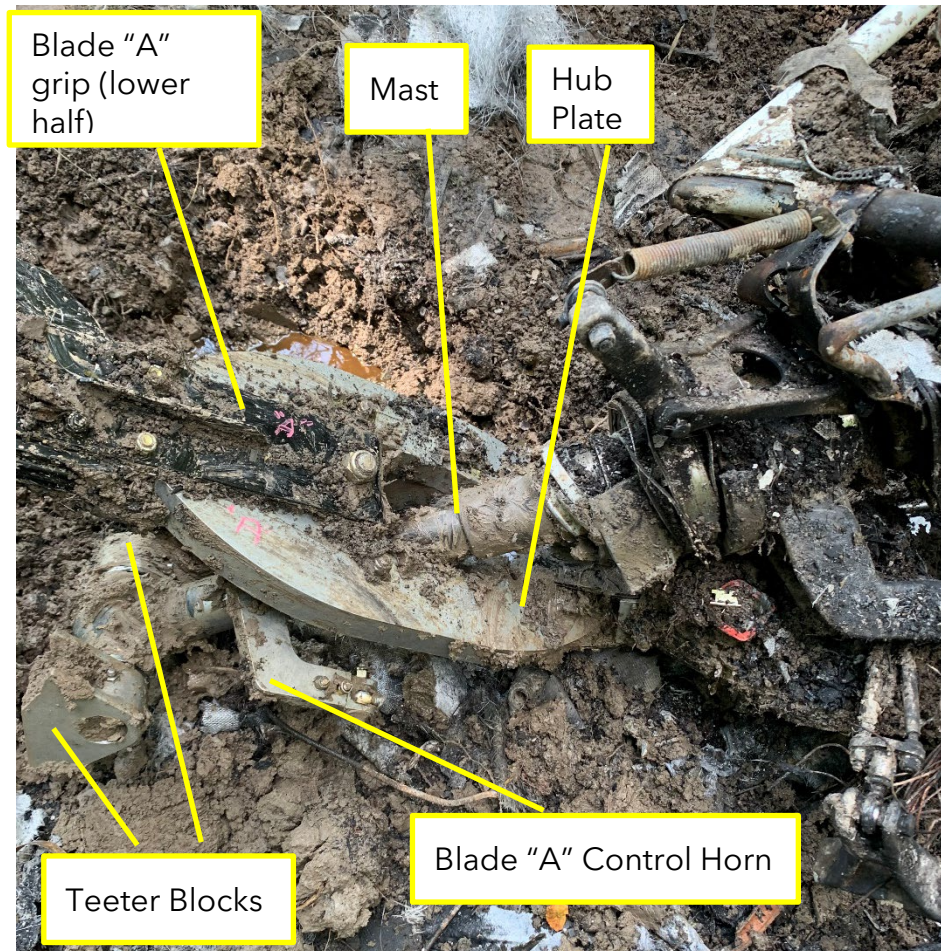
**Figure 12 - Main Rotor Hub (view of bottom side)**

Both main rotor blades remained attached to blade grips at the rotor head. The bolt head of the blade grip to hub attachment bolt on blade "B" was fracture separated. The remainder of the bolt was in place (in the elastomeric bearing and through the opposite side of the grip).

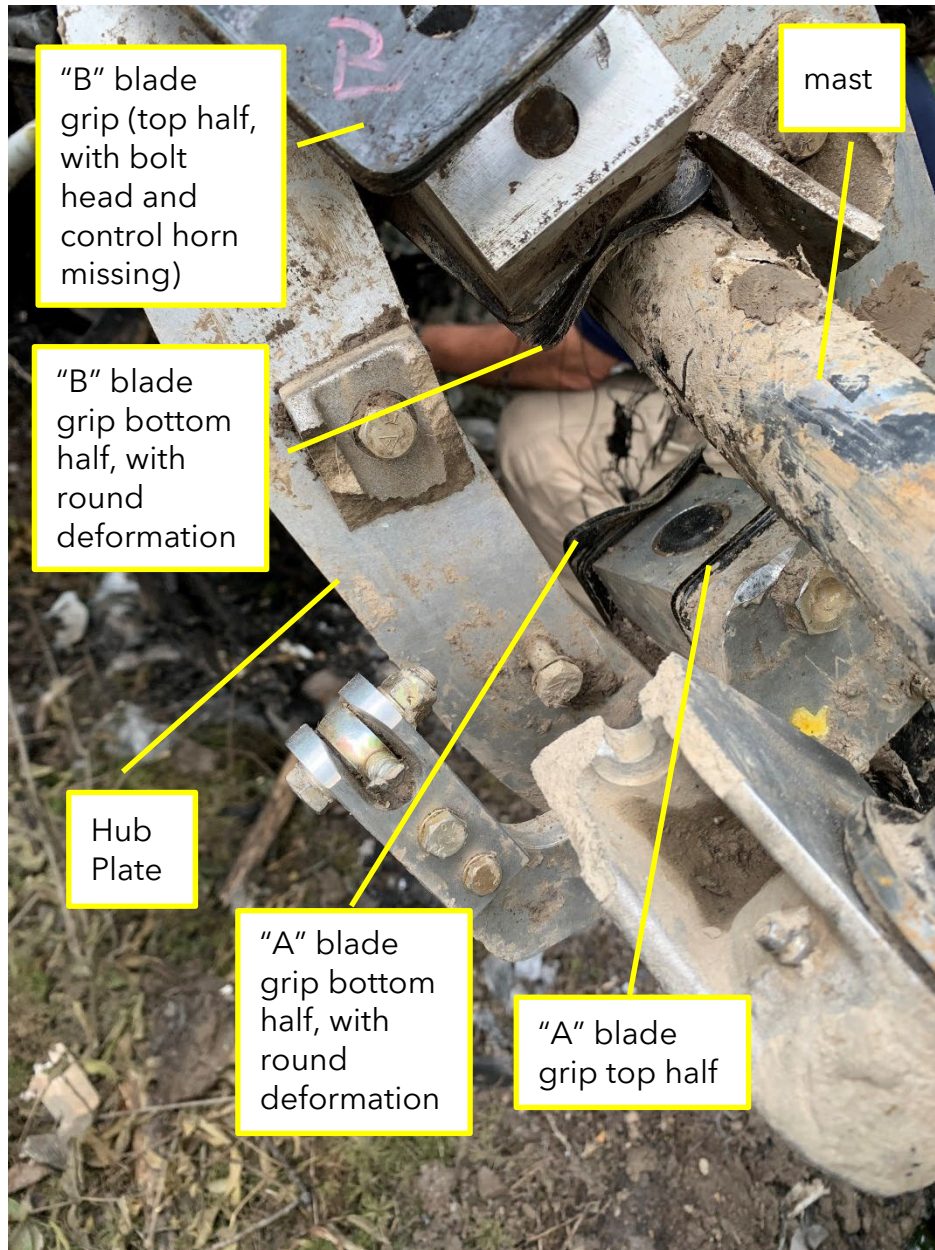
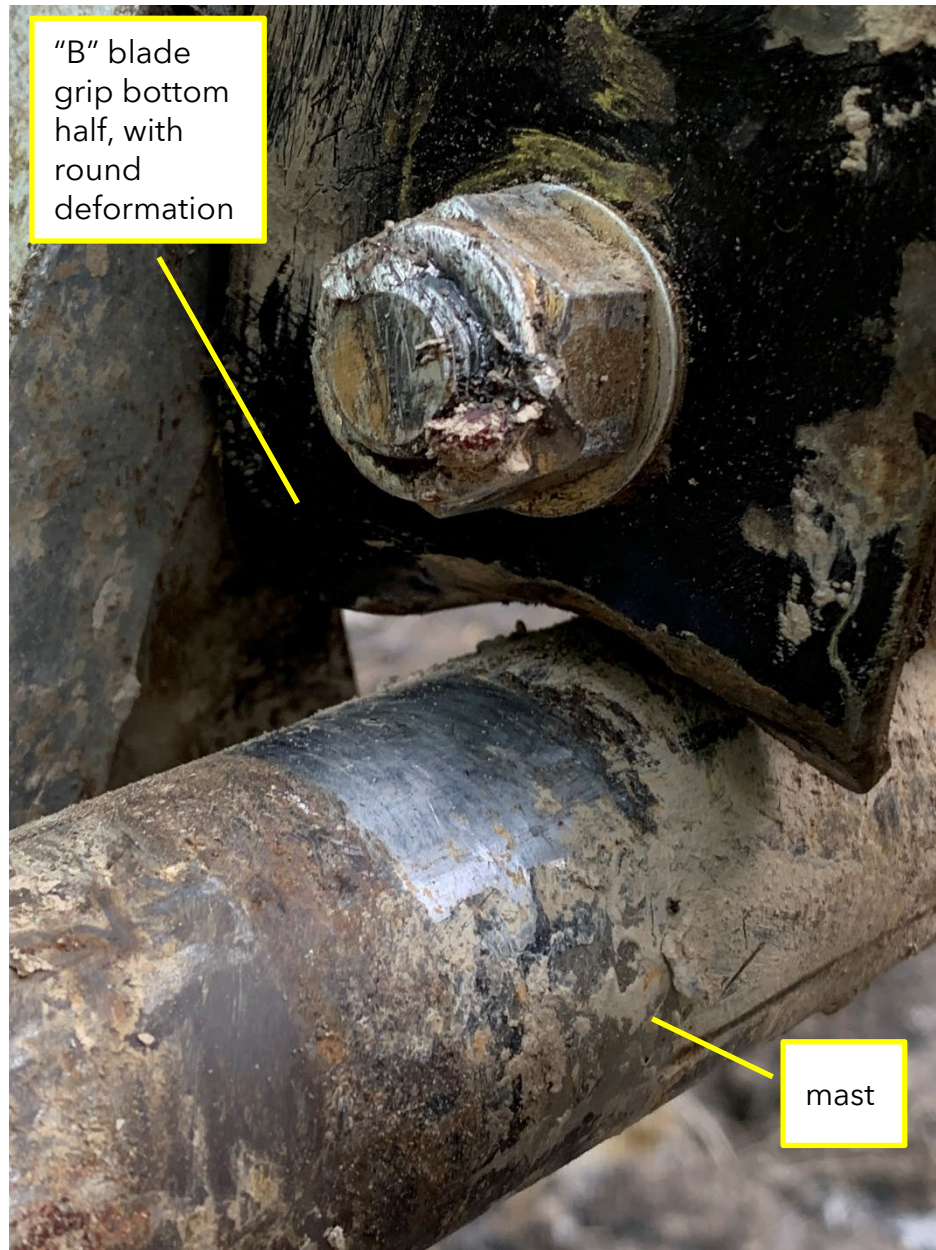
The inboard end (hub side) of both the A and B blade grips (the bottom halves of each grip) were damaged, with round indentations, consistent with the diameter of the mast.

**Figure 13 - Main Rotor Hub - (view from top side)**

**Figure 14 - Blade "B" Lower Half Grip (enlarged, view from bottom)**

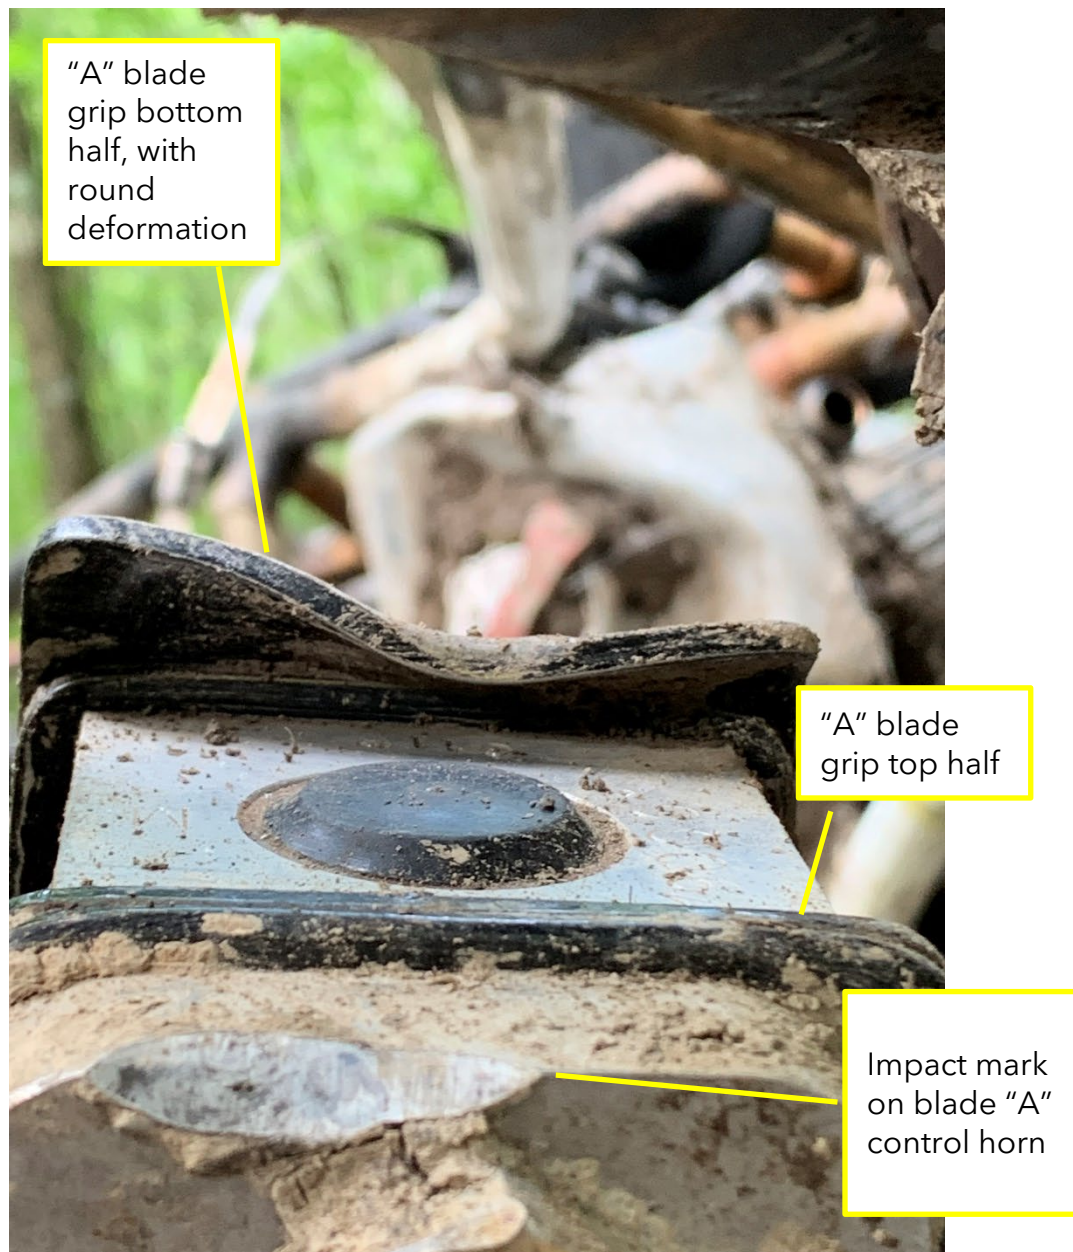
The blade "A" control horn had an impact mark just above the upper half of the blade grip.

**Figure 15 - Blade "A" Lower and Upper Grips and Damage to Control Horn**

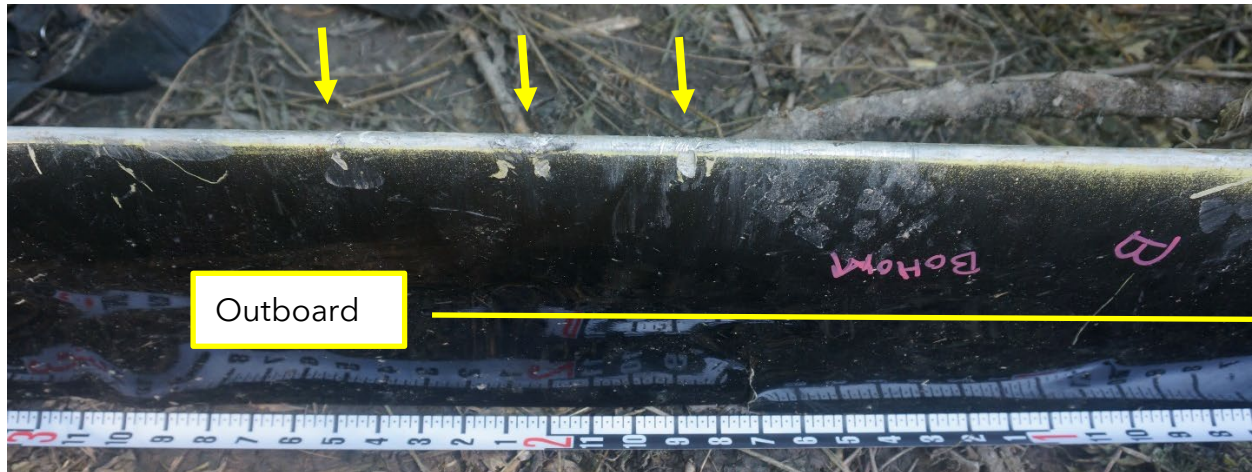
**Figure 16 Blade "B" Leading Edge Damage**

Blade "B" was found mostly underneath helicopter, the inboard half of the span was impact and fire damaged. Some leading-edge gouging was present about 1-3 feet from outboard edge.

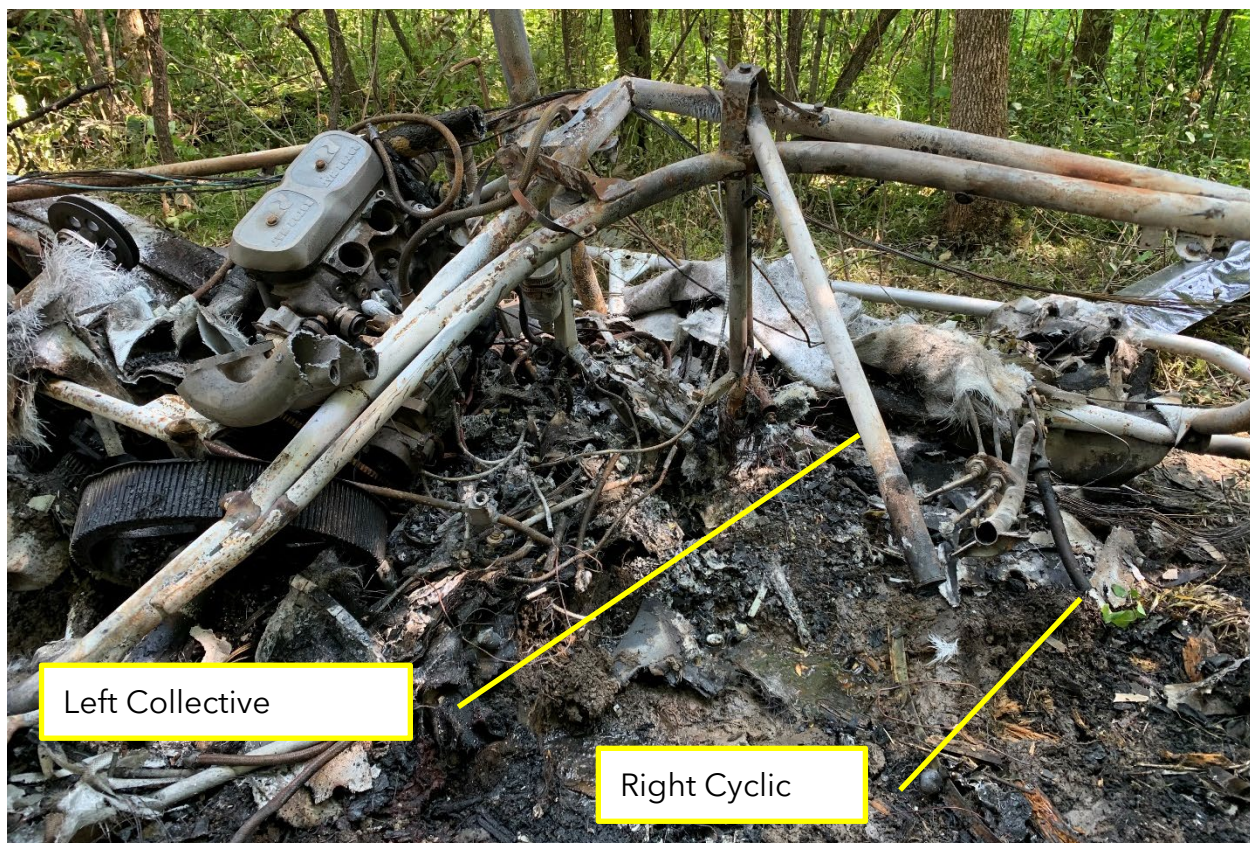
**Figure 17 - Controls**

The right seat collective control tube and left seat cyclic control stick were not found in the wreckage.

The left collective tube remained attached. The throttle control rod was continued from the grip to the base of the collective tube. The lateral throttle control rod was found separated from its attach points. No control cables or rods were found attached to the collective control.

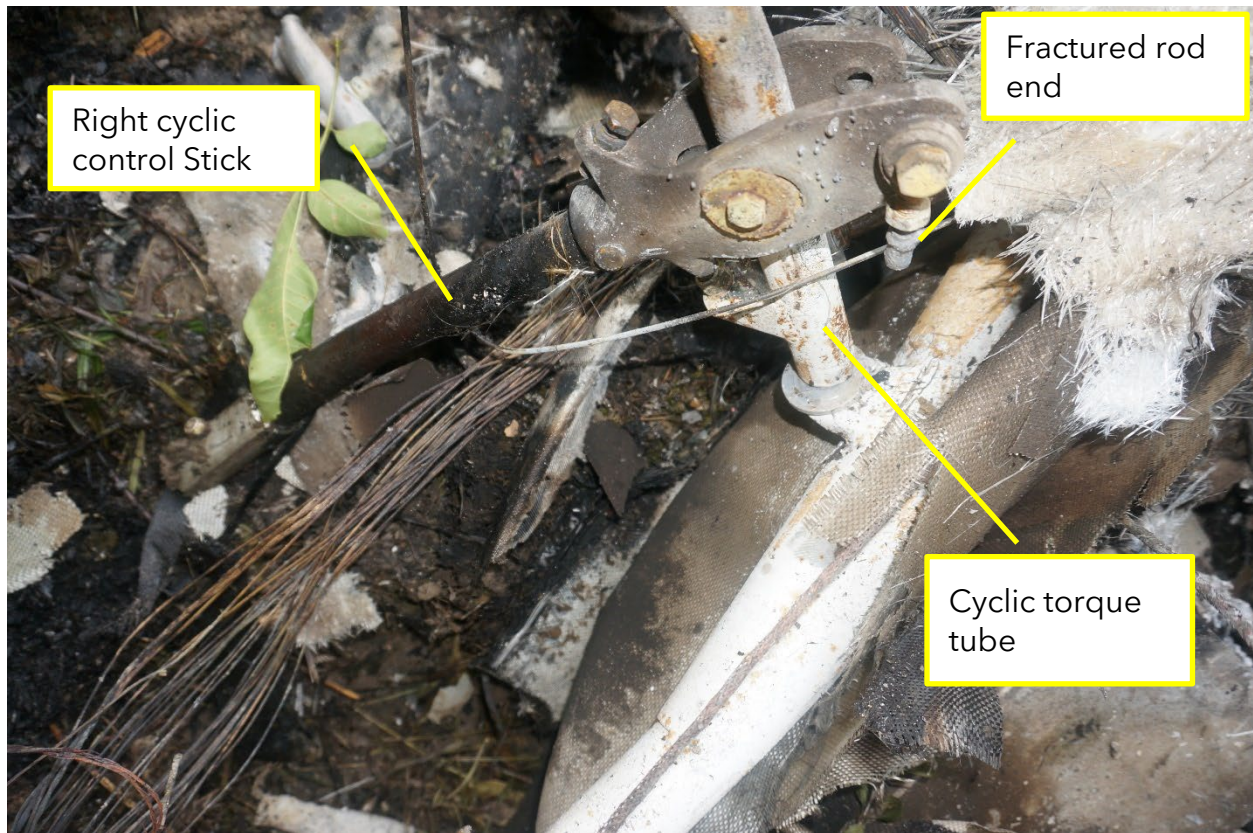
**Figure 18 - Right Cyclic Control Stick**

The right cyclic control stick remained attached to its torque tube. It was not connected to the (missing) left cyclic control stick or any other control cables.

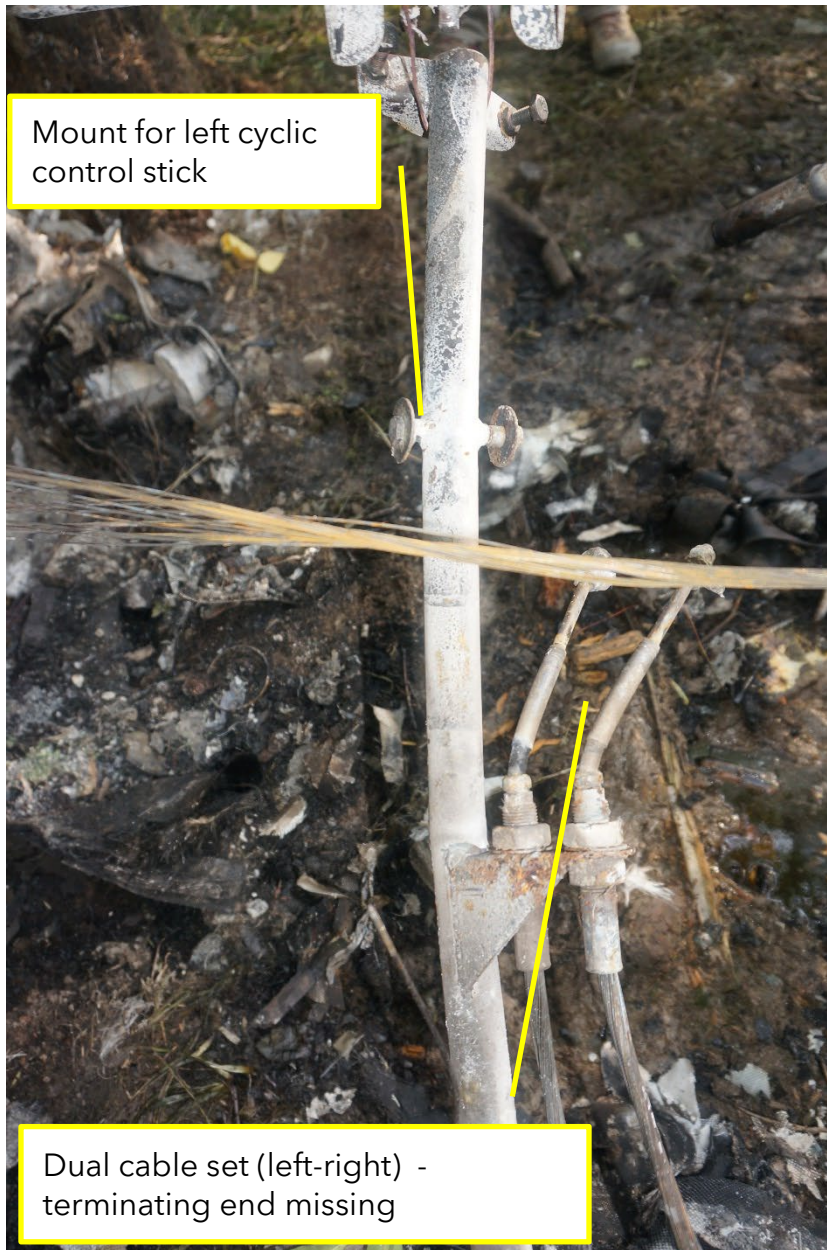
**Figure 19 - Cyclic Torque Tube**

The left-right teleflex (push-pull) cable set, mounted to a weldment on the cyclic torque tube, was found disconnected. The ends of both cables were melted and the terminating block (where the two cables attach to a single "rod end" was missing. The cable ends remained near the mount for the (missing) left cyclic control stick.

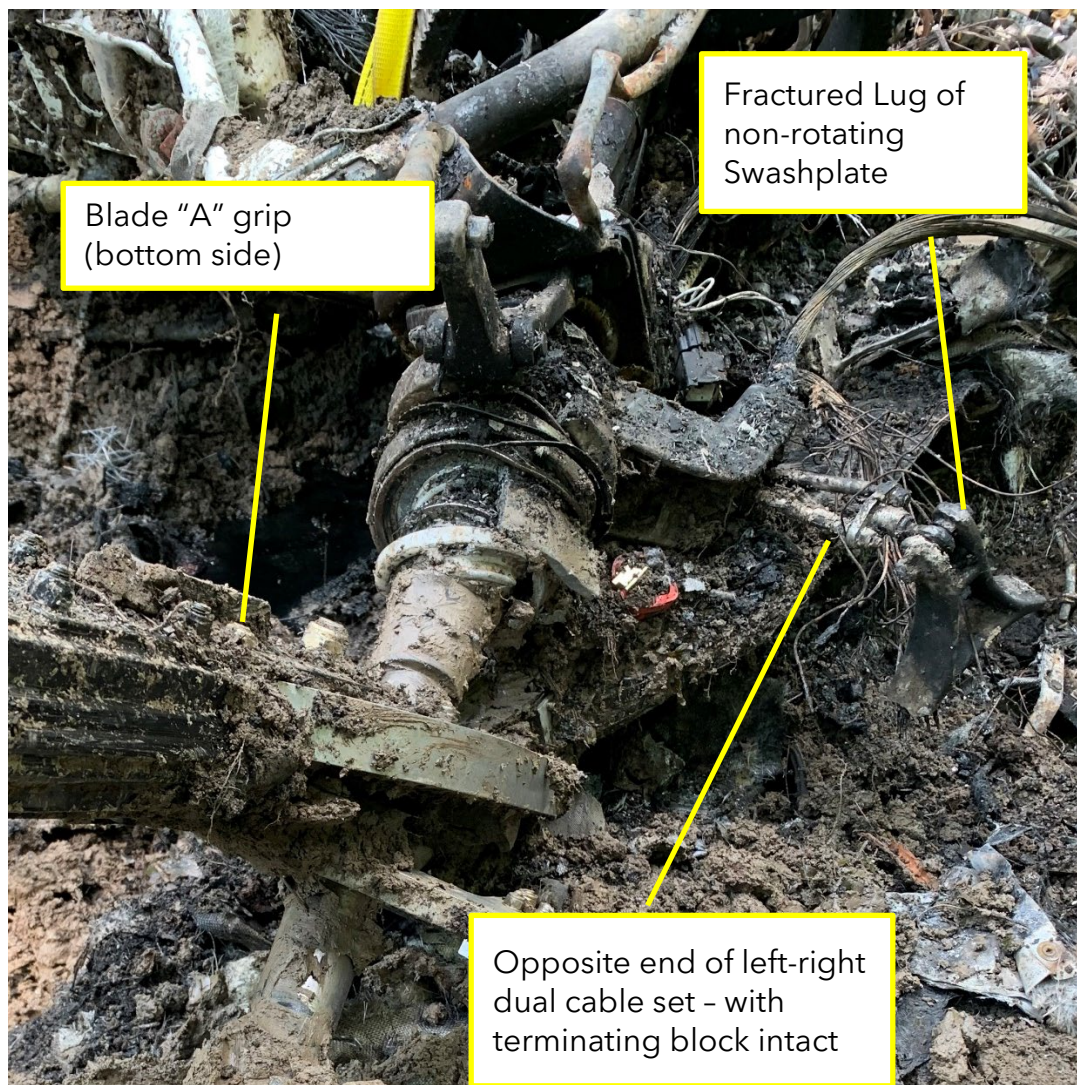
**Figure 20 - Left-Right Cable Set End**

This cable set was continuous to one of the (fractured) lugs on the non-rotating swashplate.

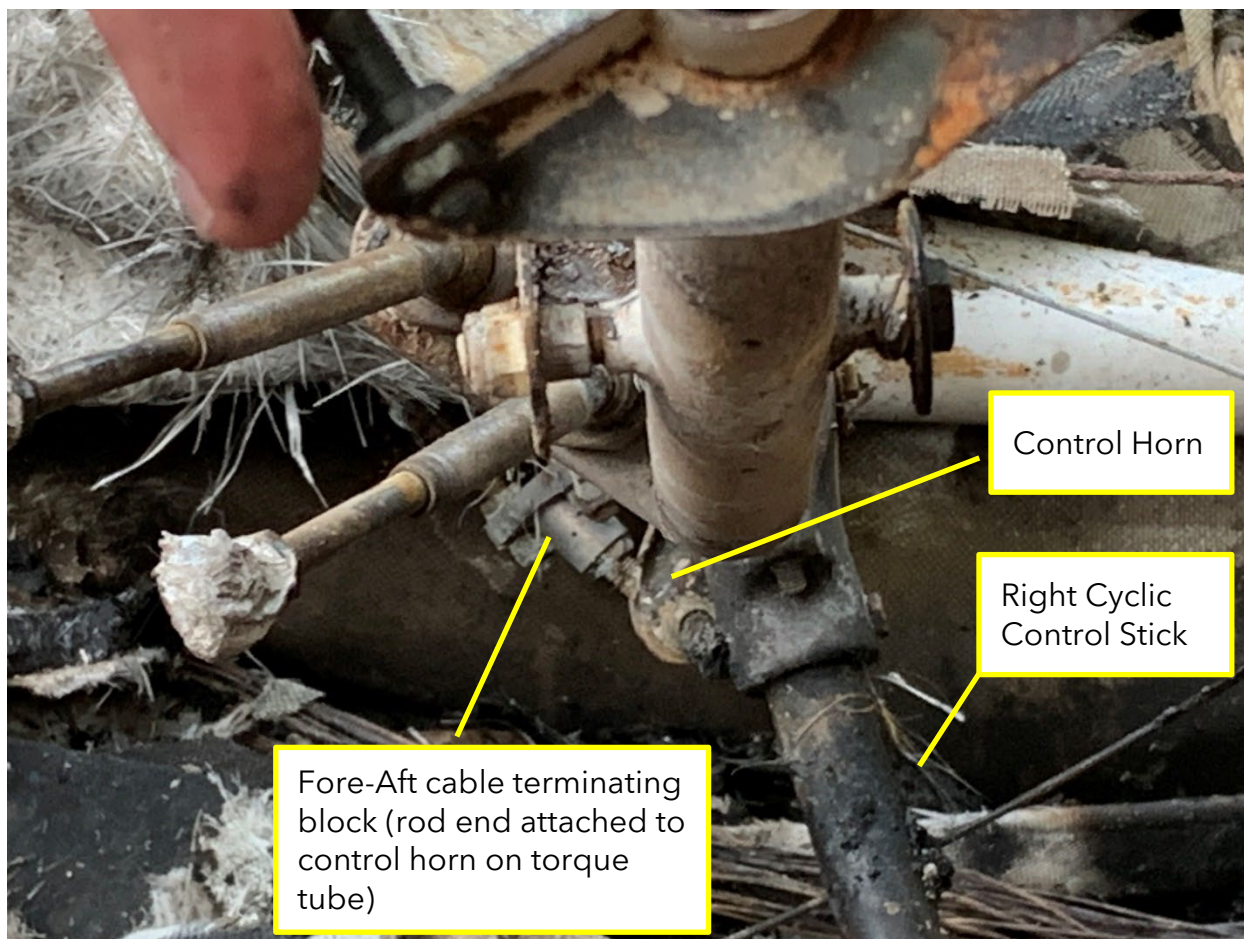
**Figure 21 - Fore-Aft Cable Connected at Cyclic Torque Tube**

The fore-aft teleflex cable set remained attached to the control horn on the cyclic torque tube. The opposite end of this cable was not located.
