# National Transportation Safety Board

ERA21FA317

## WRECKAGE EXAMINATION

Helicopter: Rotorway Exec 162F, Registration N162KJ

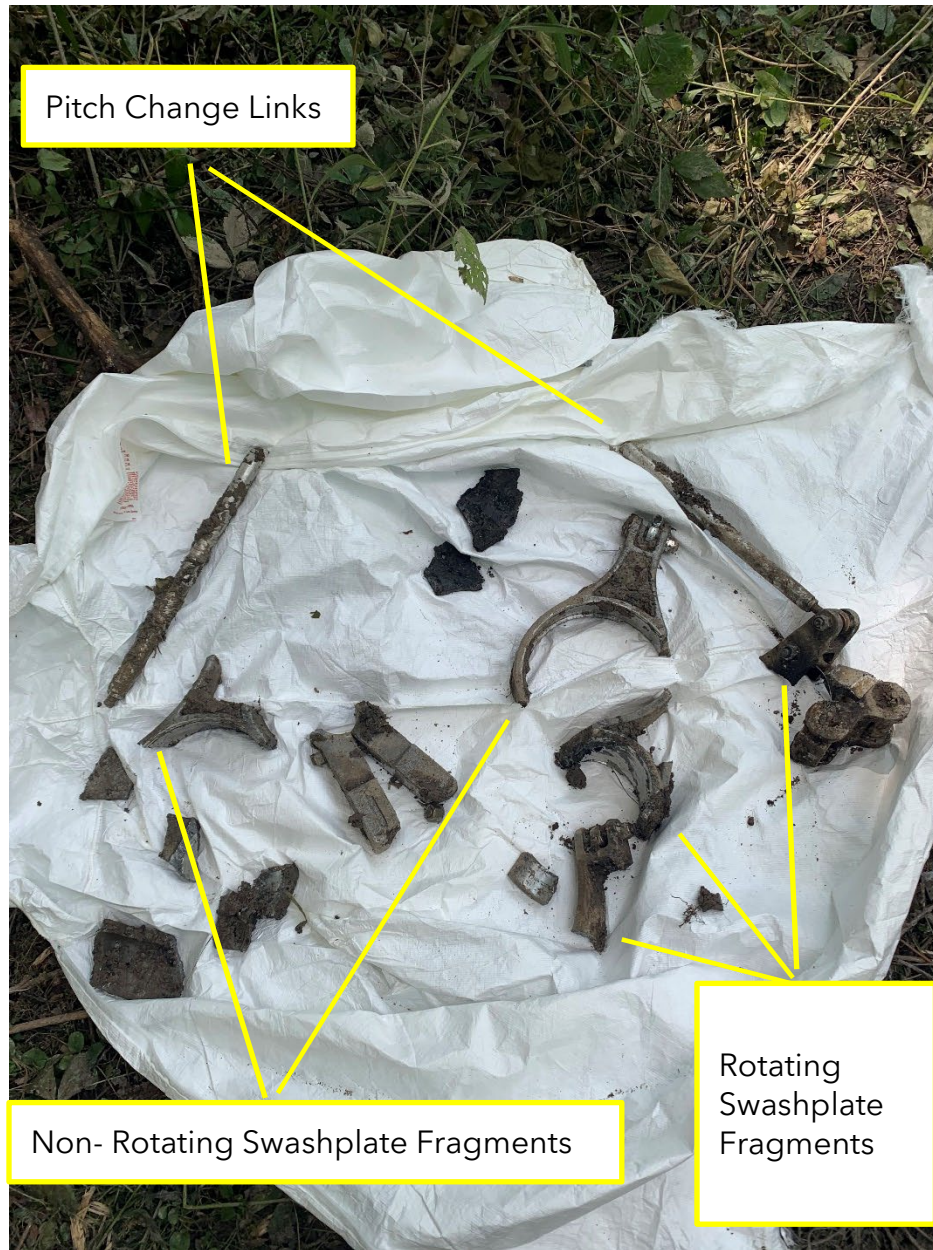
**Figure 22 - Fragmented Rotor Head Components**

Several damaged components were found buried beneath the rotor head. Both pitch change links remained attached to fragments of their lower control horns, one of which separated from the fragment when the helicopter was lifted.

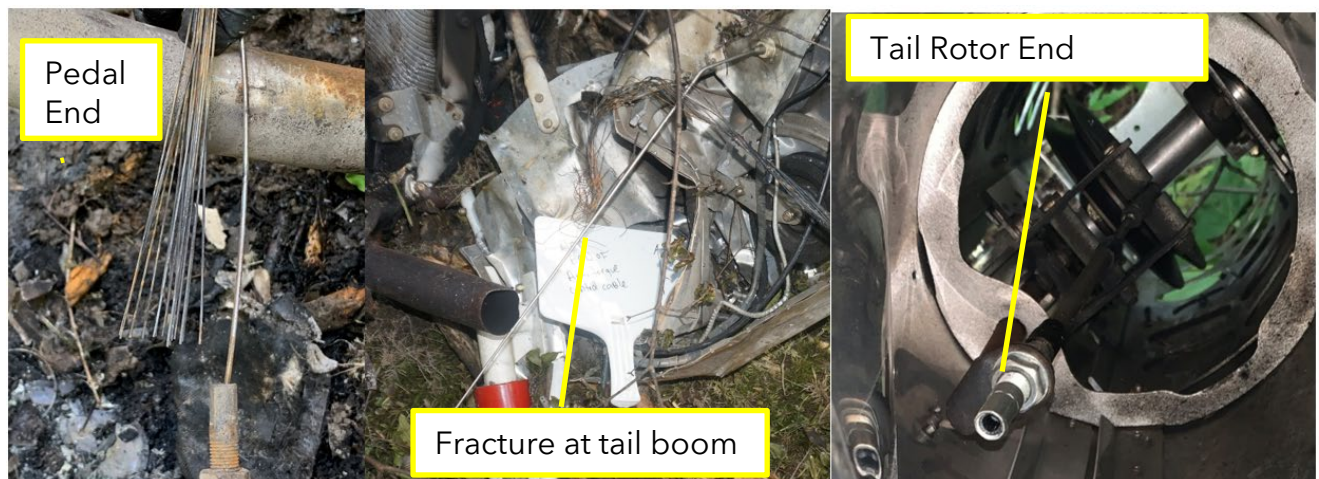
**Figure 23 - Tail Rotor Control Cable**

The single teleflex control cable between the left seat anti-torque pedal set and the tail rotor, was continuous from the pedal set to a fracture near the tail boom separation location. All the small diameter wires in the cable were separated at the pedal end fitting, the large diameter core wire remained attached. The left seat and right seat pedal sets remained attached to the fuselage tube and linked to each other. No wires remained attached at the teleflex fitting in the rear of the tail boom.

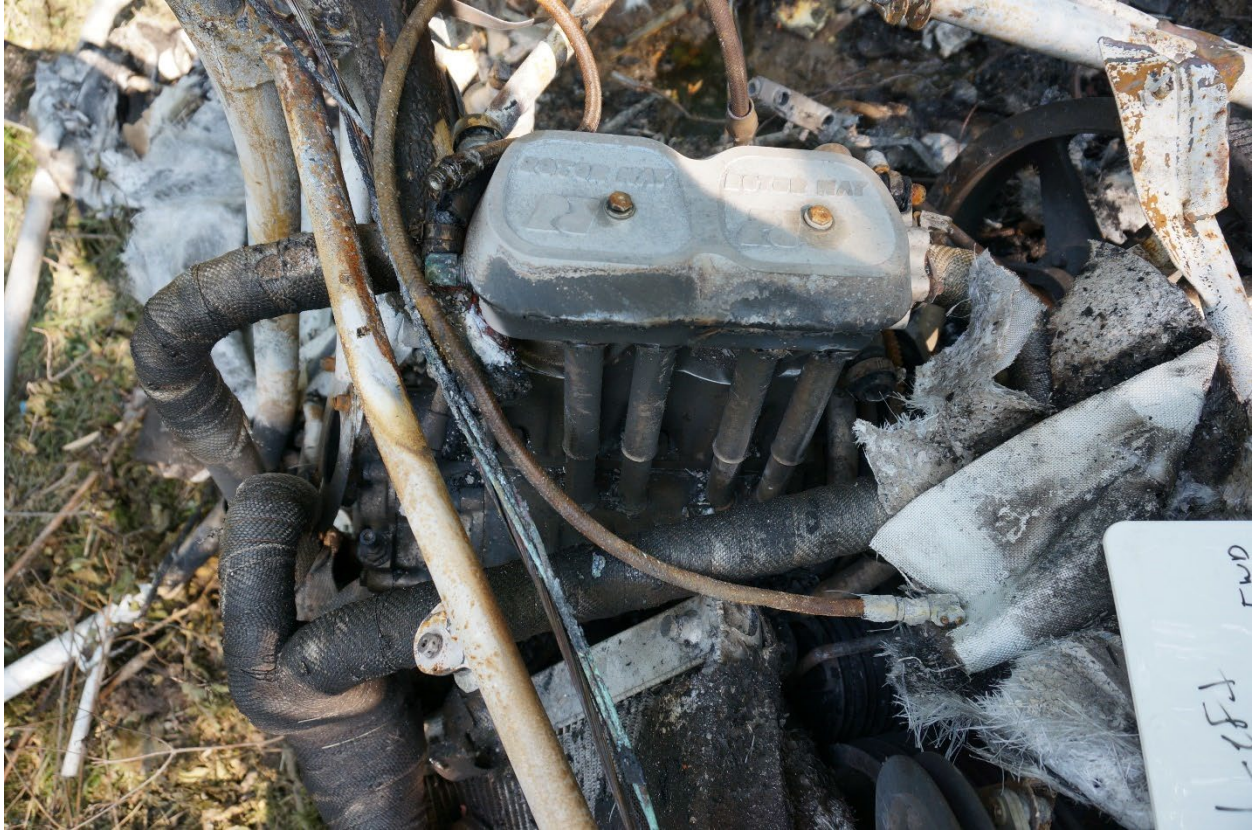
**Figure 24 - Engine**

The engine sustained thermal damage, some components were found melted.

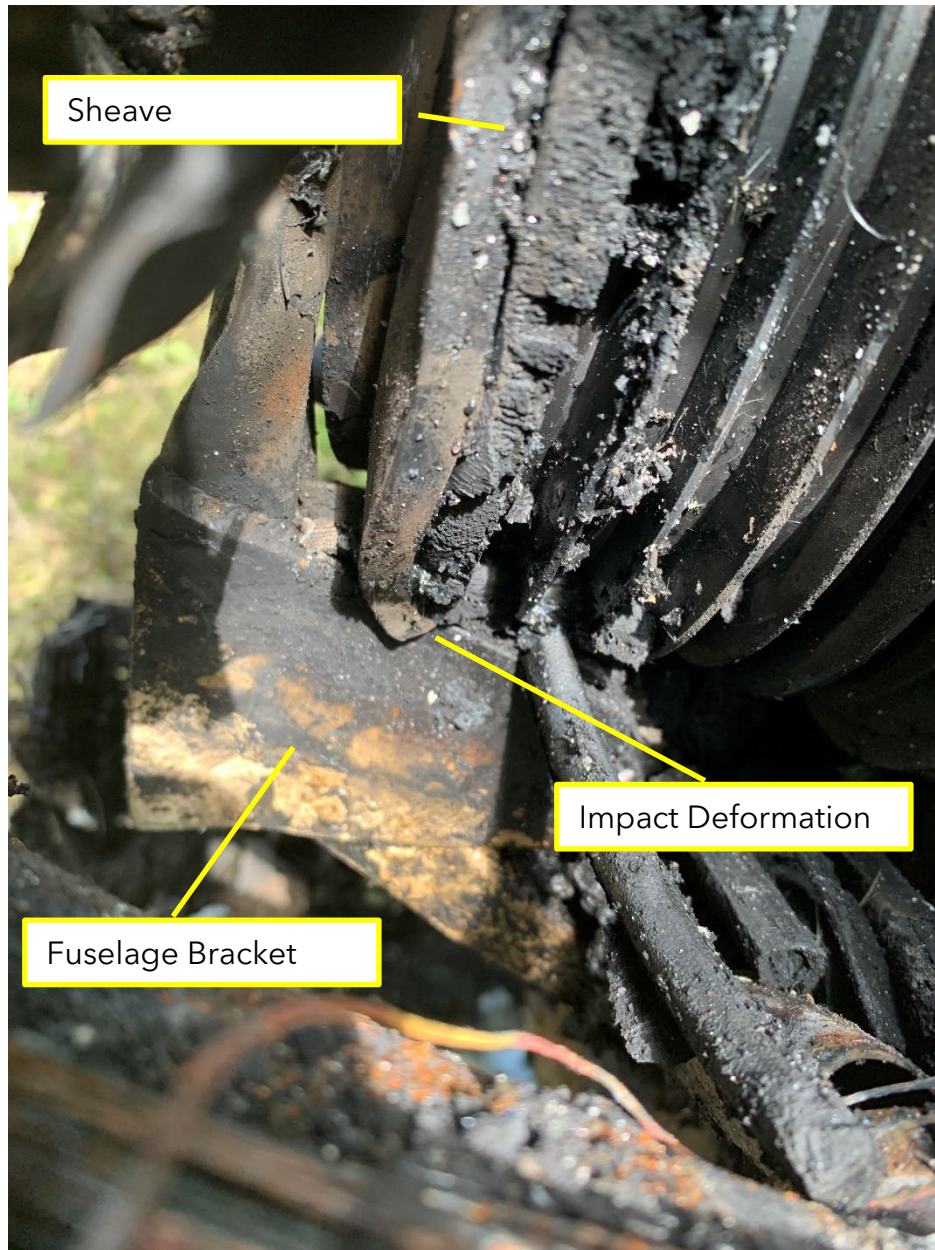
**Figure 25 - Crankshaft Sheave**

A section of fuselage was found impinged on the crankshaft sheave, which left the sheave damaged. No rotational scoring marks were found on the sheave. The crankshaft could not be rotated using hand tools. After cutting away the impinging fuselage structure, the crankshaft still would not rotate.

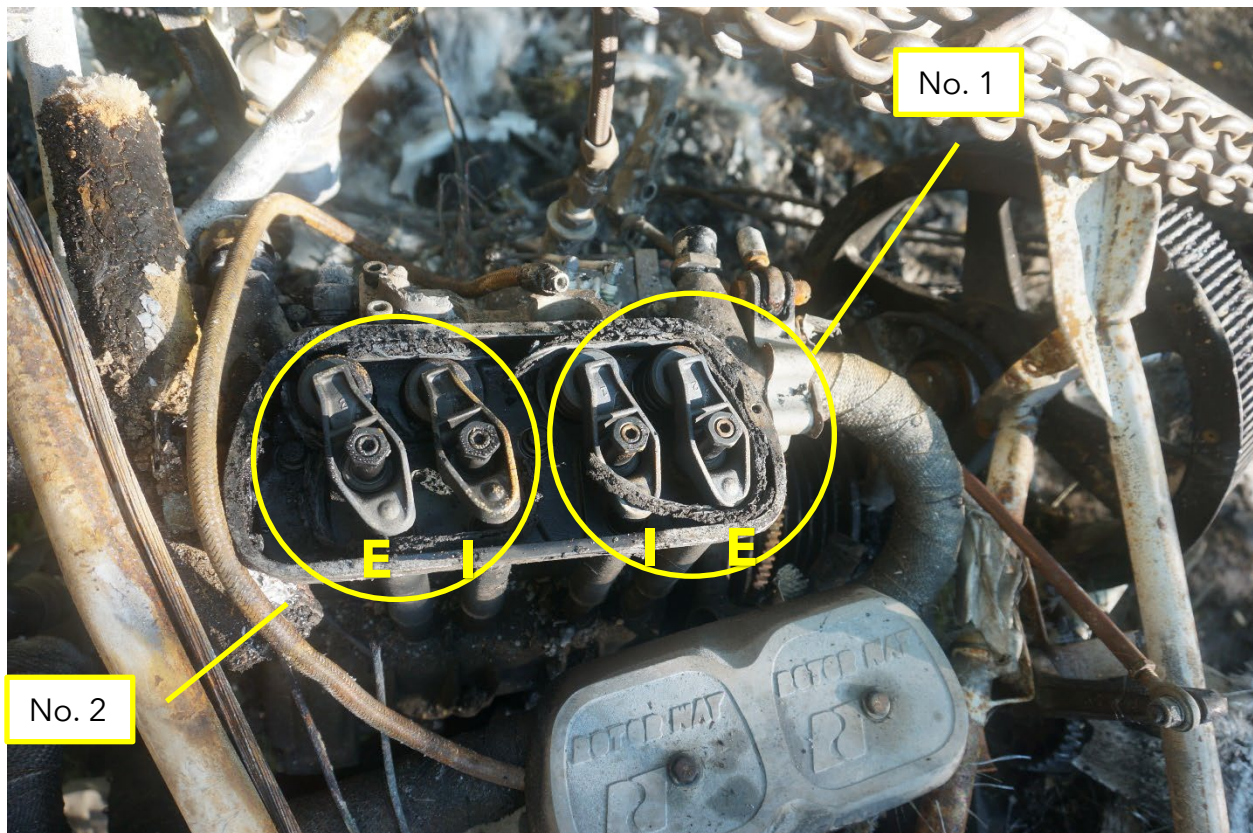
A borescope examination of all four cylinders revealed no anomalies with the cylinder walls, position tops or valves. The Nos. 1 and 2 valve rocker arms, springs and pushrods were in place and undamaged, with some discoloration and consistent with heat from the post crash fire.

**Figure 26 Valvetrain - Cylinders Nos. 1 and 2 ("Right" Engine bank, Left Side of Helicopter)**

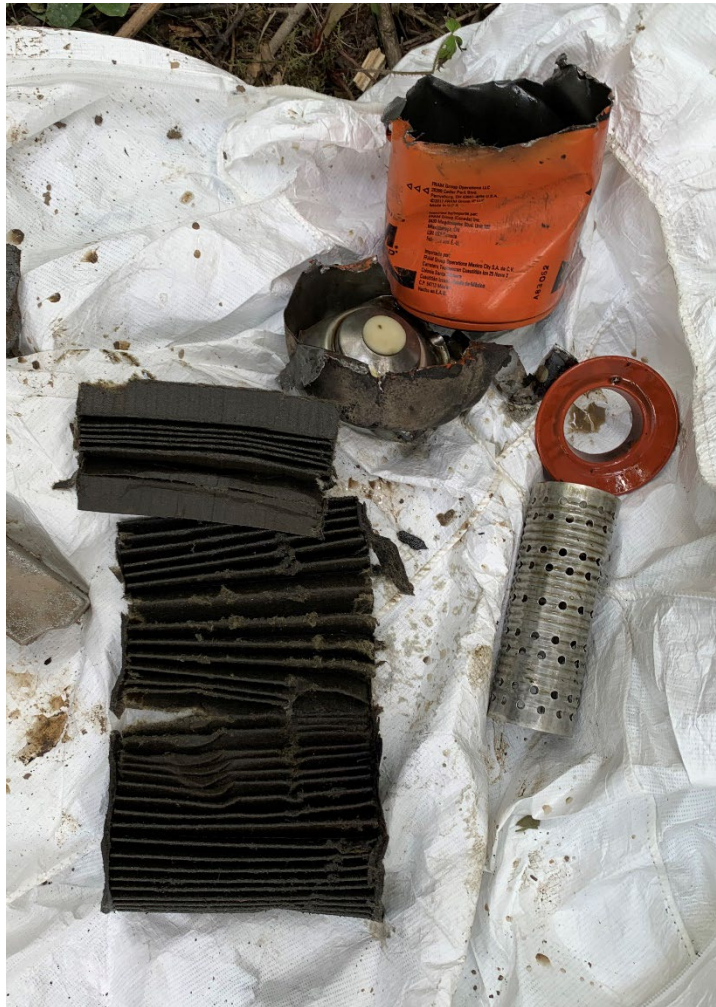
**Figure 27 - Oil Filter**

The spin-on type oil filter element was absent of debris.

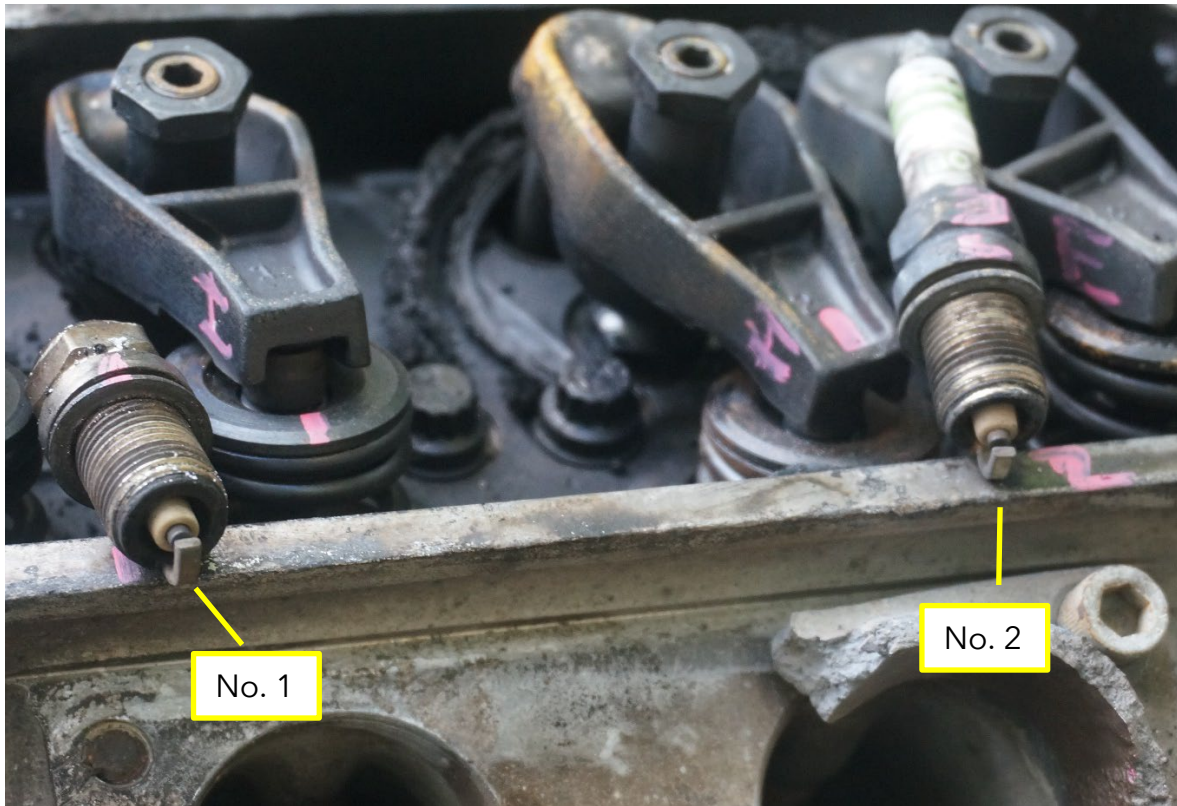
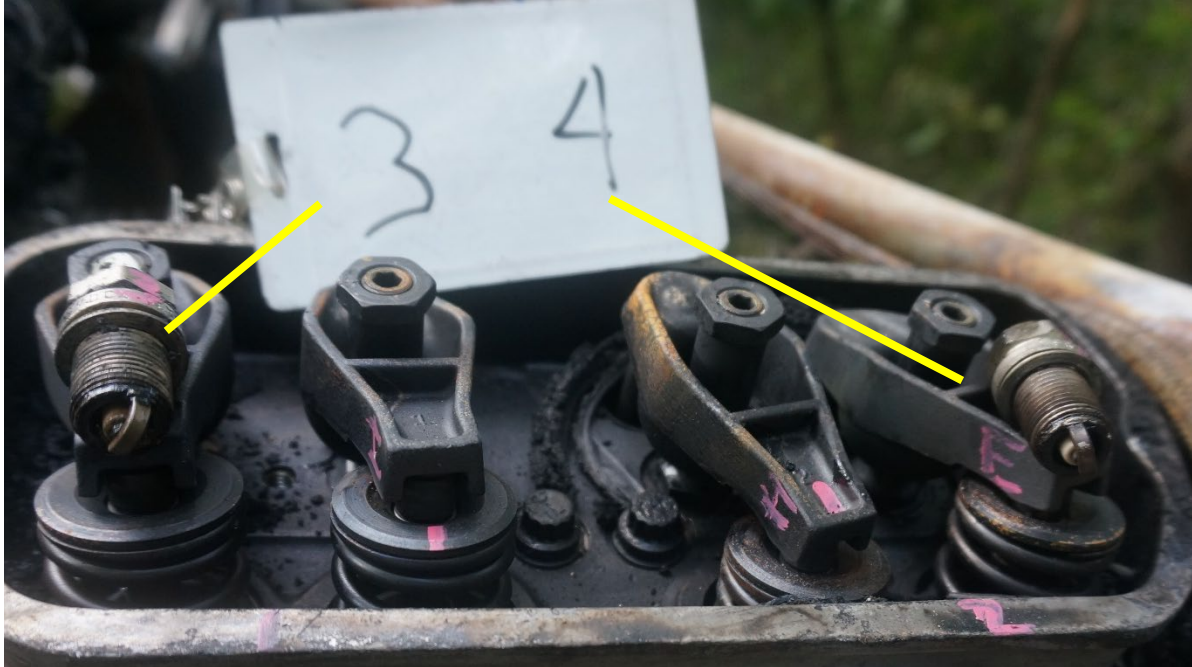
The ignitions leads to all 4 cylinders were thermally damaged and partially or completely melted at the spark plug ends. Only 1 spark plug from each cylinder could be removed due to impact damage. Each was generally clean with tan colored electrodes and white insulators. The No. 3 plug was slightly oil soaked.

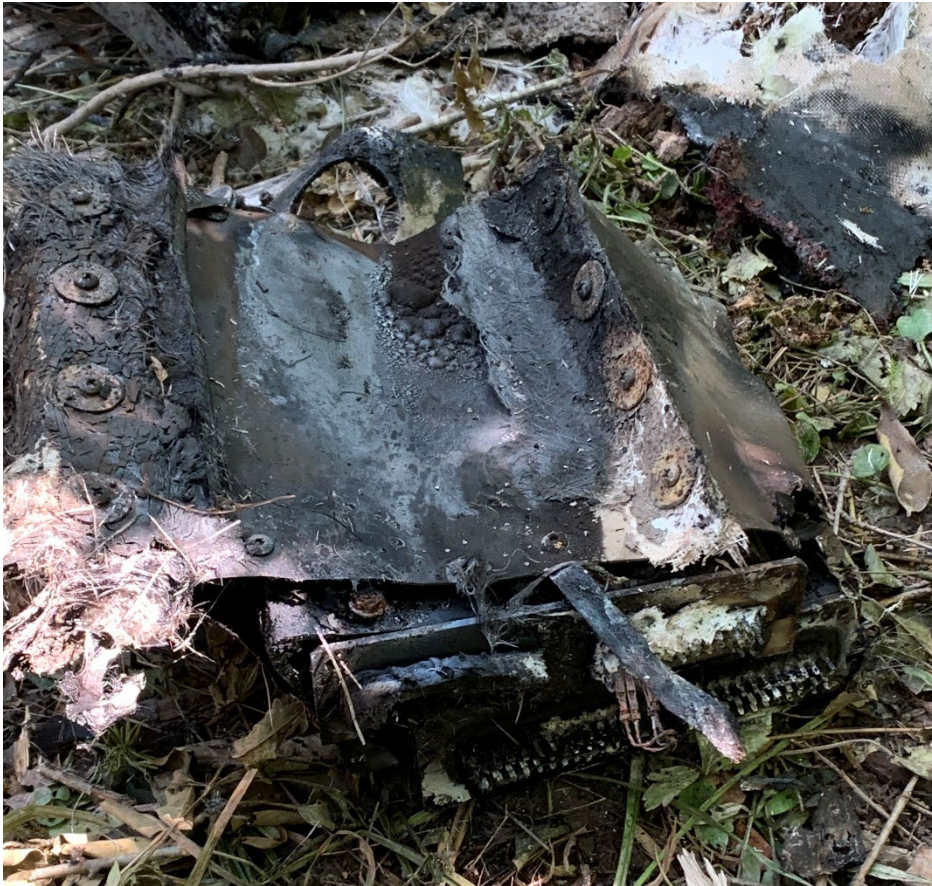
**Figure 30 - Electronic Engine Control Unit**

The electronic engine control unit was impact and thermally damaged.

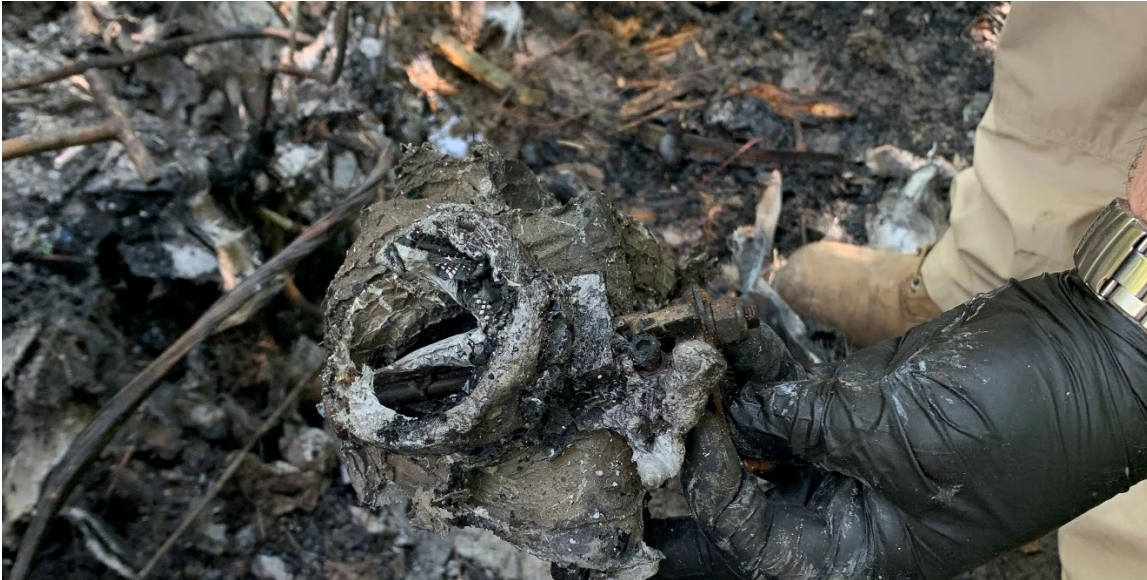
**Figure 31 - Throttle Body**

The throttle body was separated from the engine, it was impact and thermally damaged.

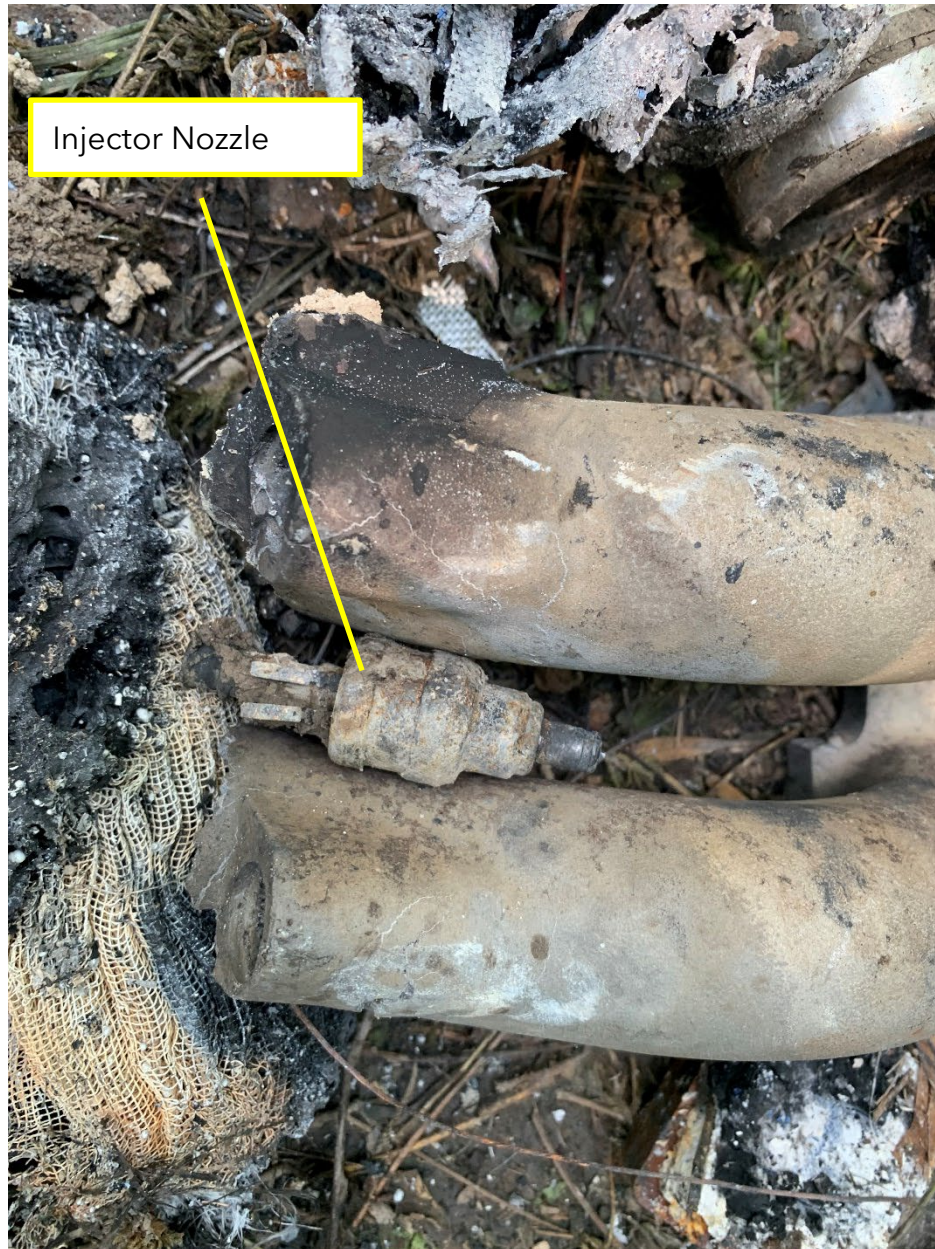
**Figure 32 - Intake Manifold, Unknown Side**

Two fuel manifolds were found, both damaged and fractured, separated from cylinder heads. One had fuel injector nozzles that remained installed, The had no nozzles attached. Some nozzles were found loose on ground. Neither manifold had any fuel lines attached.

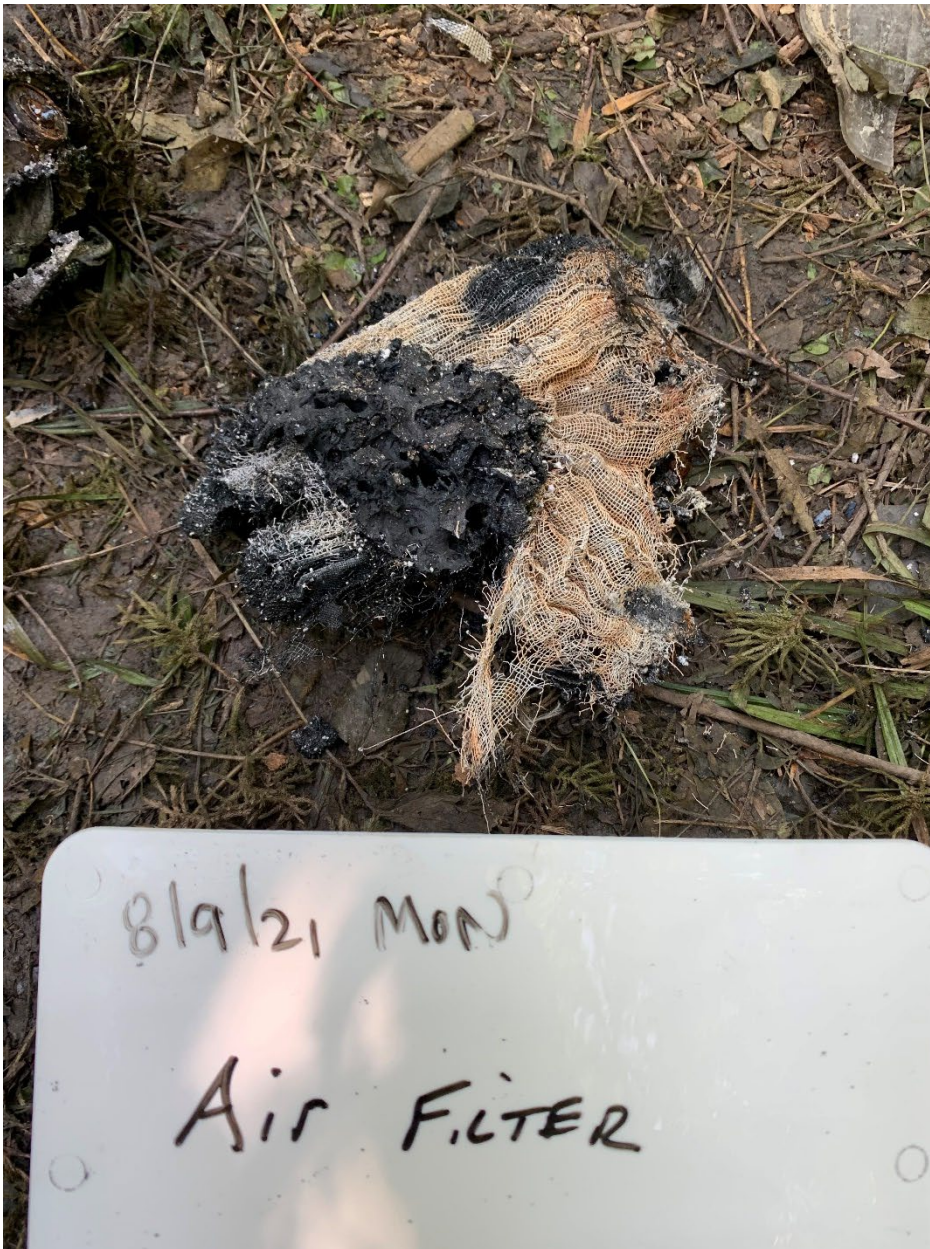
**Figure 33 - Air Filter Element**

The air filter element was impact and thermally damaged.

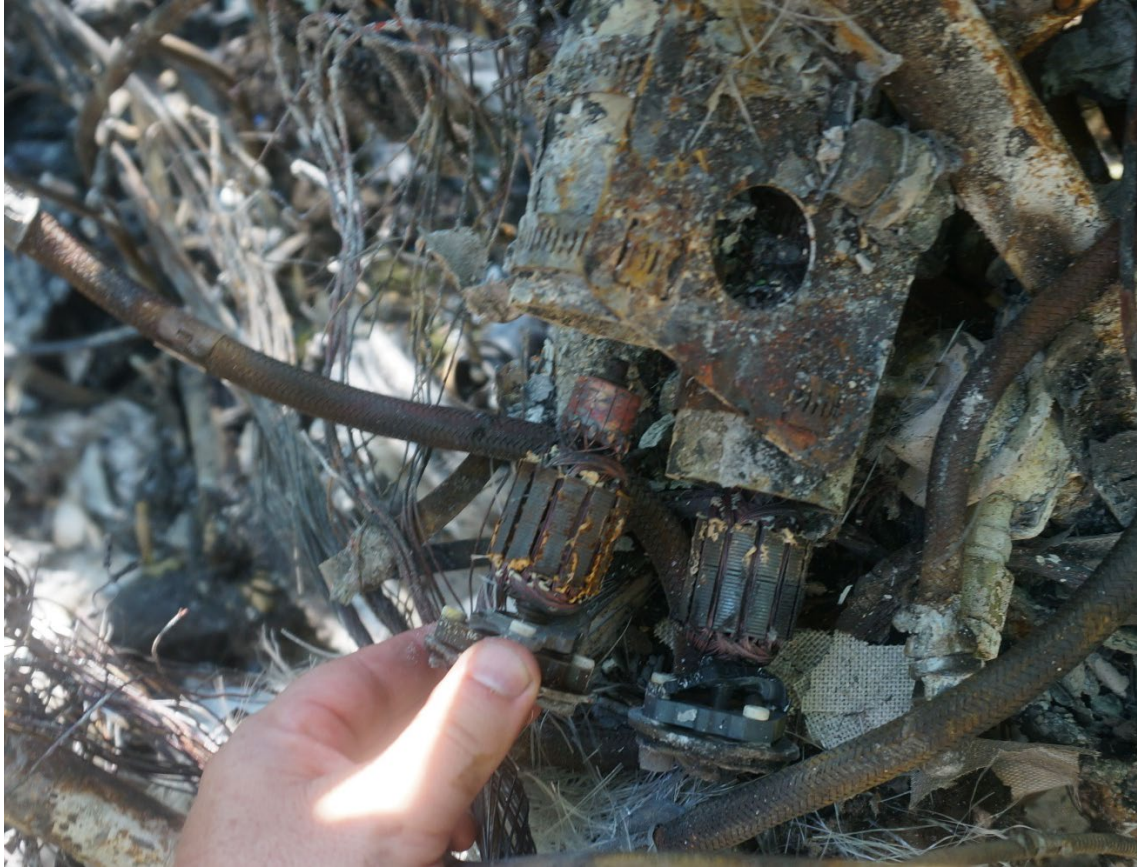
**Figure 34 - Fuel Pumps**

The fuel pumps remained attached to their mount, no fuel lines remained connected, and were thermally damaged. The rotors fell out of their case when pulled and appeared relatively intact.

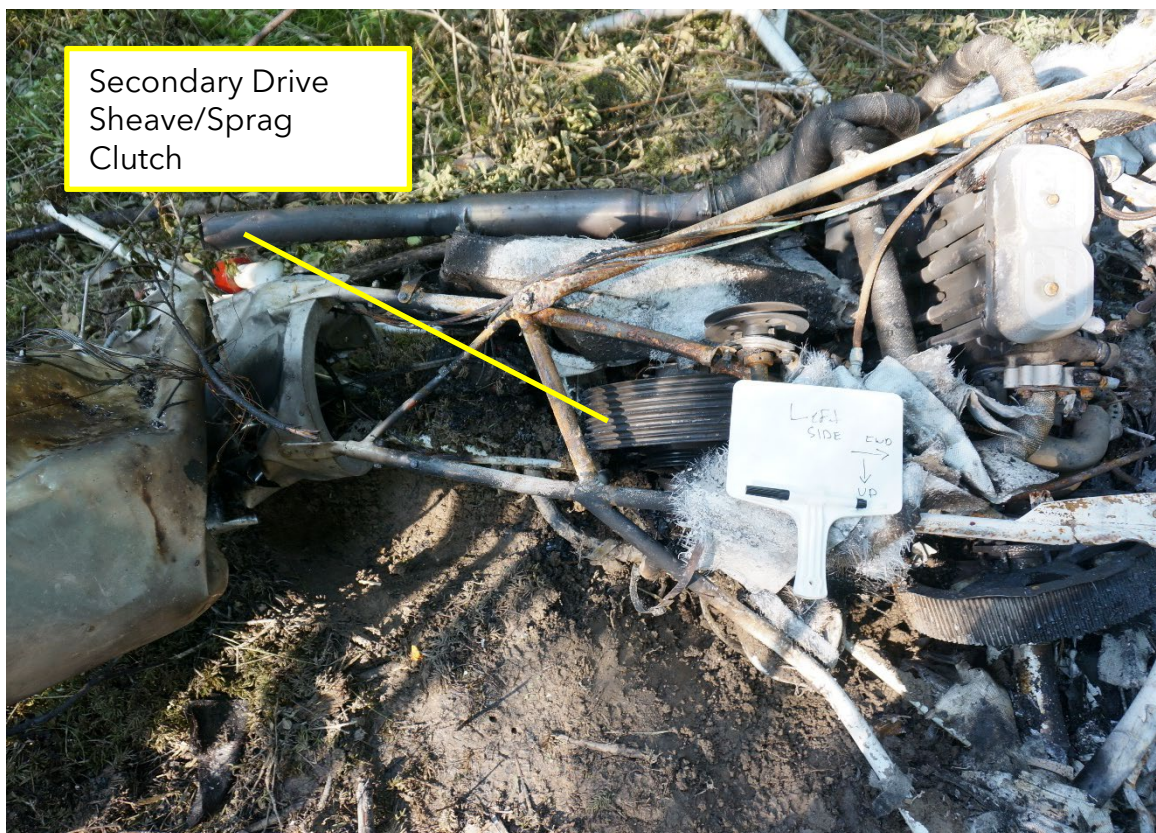
**Figure 35 - Secondary Drive Sheave**

V-belt remnants were found near the crankshaft sheave and the secondary drive sheave, which contains the autorotation or sprag type clutch. The remnants were mostly consumed by fire and none remained around the secondary drive sheave. The secondary sheave could not be rotated by hand in either direction.

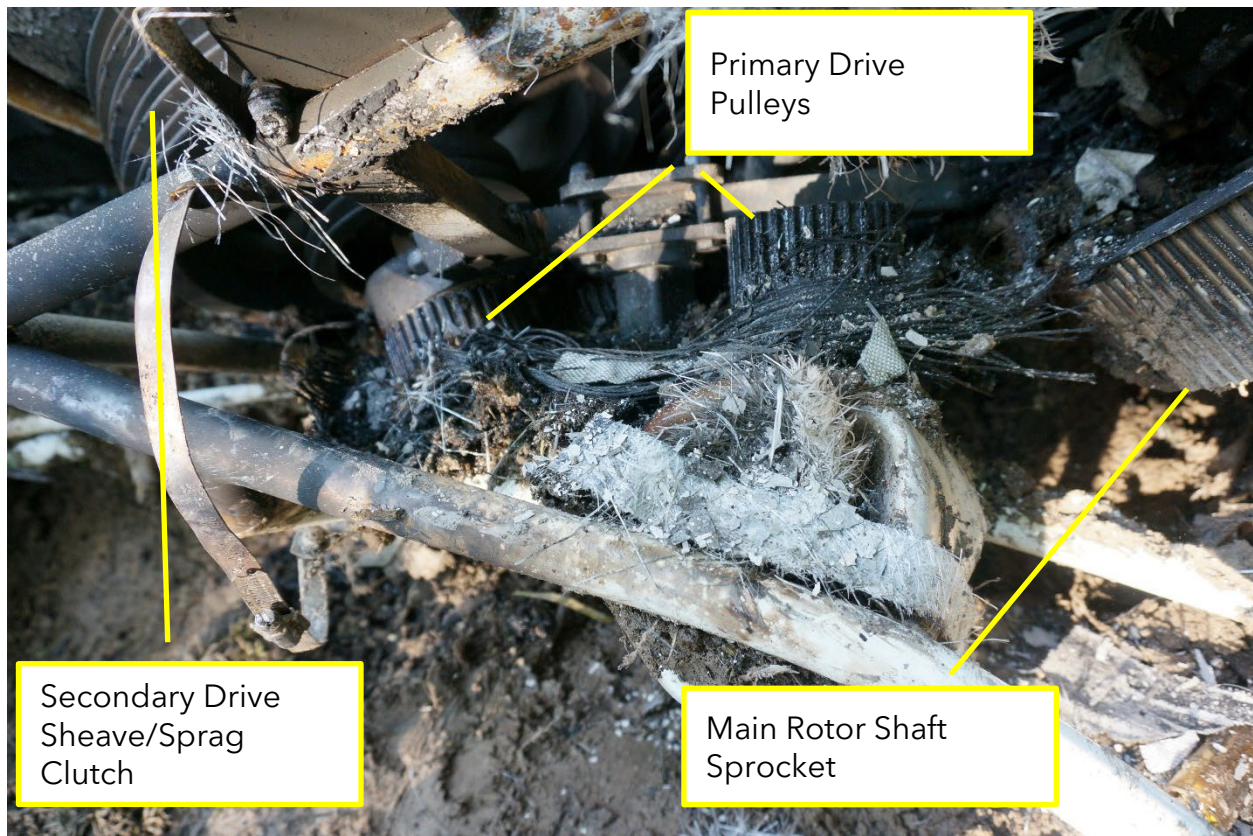
**Figure 36 - Primary Drive Pulleys, Sprocket, and Belt Remnants**

Remnants of the primary drive toothed belt, which drives the main rotor shaft through a series of pulleys from the secondary sheave to the main rotor shaft sprocket, were found along the belt path. No rotational scars were found on the main rotor shaft sprocket.
