**Wreckage Examination  
NTSB Accident Number  
ERA21FA333**

| Location: | Wadesboro, NC (AFP) |
| Date: | August 20, 2021 |
| Aircraft: | Piper PA-24-250 |

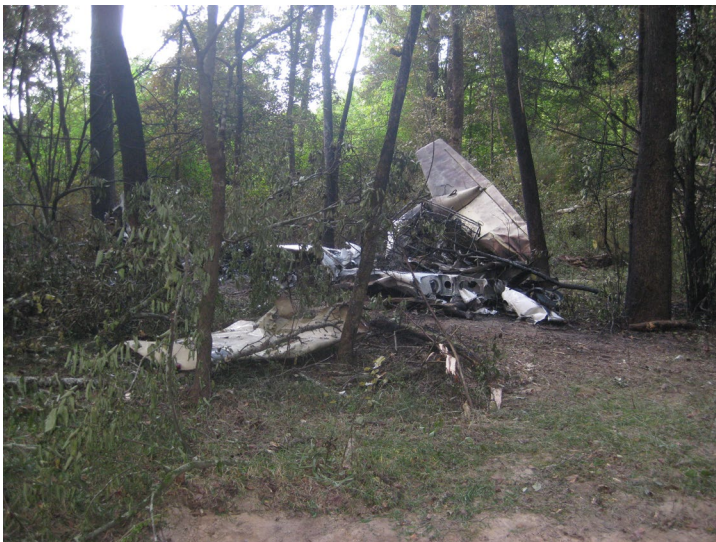
The wreckage came to rest inverted, oriented east, about 1/2 mile north-northwest of the runway 34 departure end. The cockpit and cabin were partially consumed by fire. The throttle, mixture and propeller levers were observed in the full forward position. The magnetos were selected to both and the electric fuel pump switch was in the on position. The fuel selector valve was separated, exhibited thermal damage and was positioned to the left main fuel tank. The gascolator bowl was partially consumed by fire and its fuel screen was absent of debris. The propeller spinner remained attached to the mounts and exhibited torsional deformation. The nose landing had separated and was fire damaged. The two electric fuel pumps were thermally damaged and their internal fuel filters were destroyed.

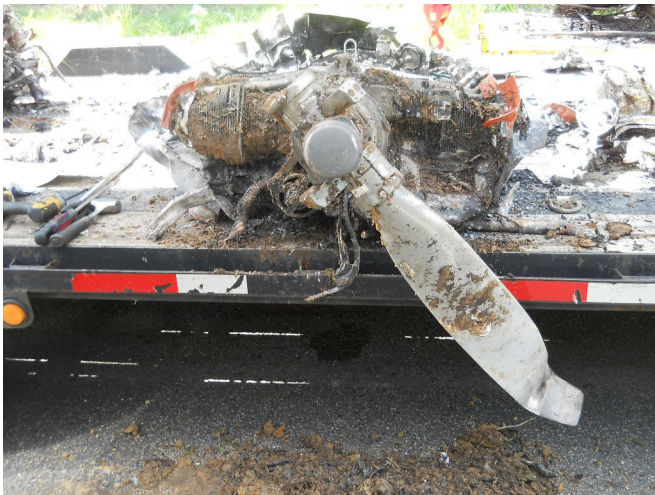
The engine came to rest inverted, nose down. One propeller blade remained attached to the propeller hub and the other blade had separated and was located underneath the engine. Both blades exhibited tip curling and the attached blade exhibited leading edge damage. The top spark plugs were removed. Their electrodes were intact, and the No. 1 electrode was oil soaked. The engine sustained front impact damage and the crankshaft could only be rotated about 90°. Camshaft and crankshaft continuity were confirmed to the rear accessory section and the rear accessory section was then removed. Holes were drilled into the top of the engine crankcase to facilitate borescope examination. Additionally, fire consumed the oil sump and a portion of the lower crankcase, which allowed visual and borescope examination from the underside of the engine. Visual and borescope examination of the cylinders, and through the top and bottom crankcase did not reveal any preimpact mechanical malfunctions.
