**NATIONAL TRANSPORTATION SAFETY BOARD**

**Computed Tomography Specialist's Factual Report**

ERA21FA346

Location: Farmington, Connecticut  
Date: September 2, 2021  
Time: 0951 eastern daylight time  
Airplane: Cessna 560XL airplane, N560AR

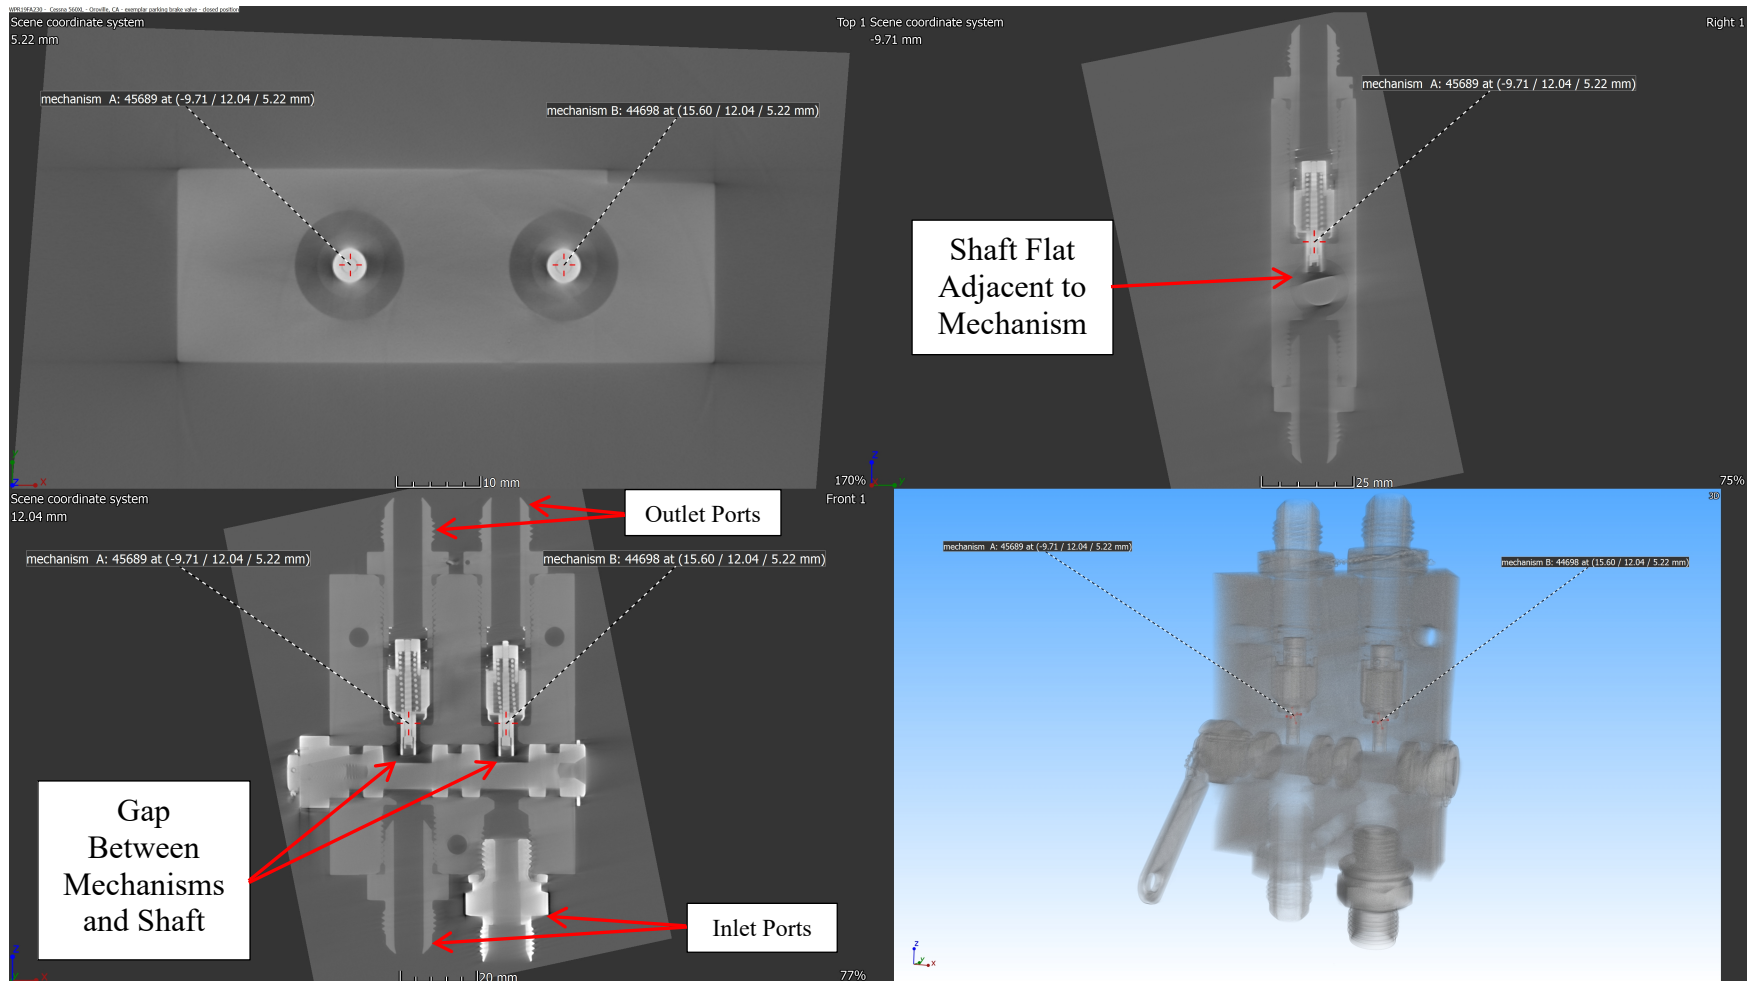
Figure 1  
Exemplar parking brake valve – closed position – mechanism A

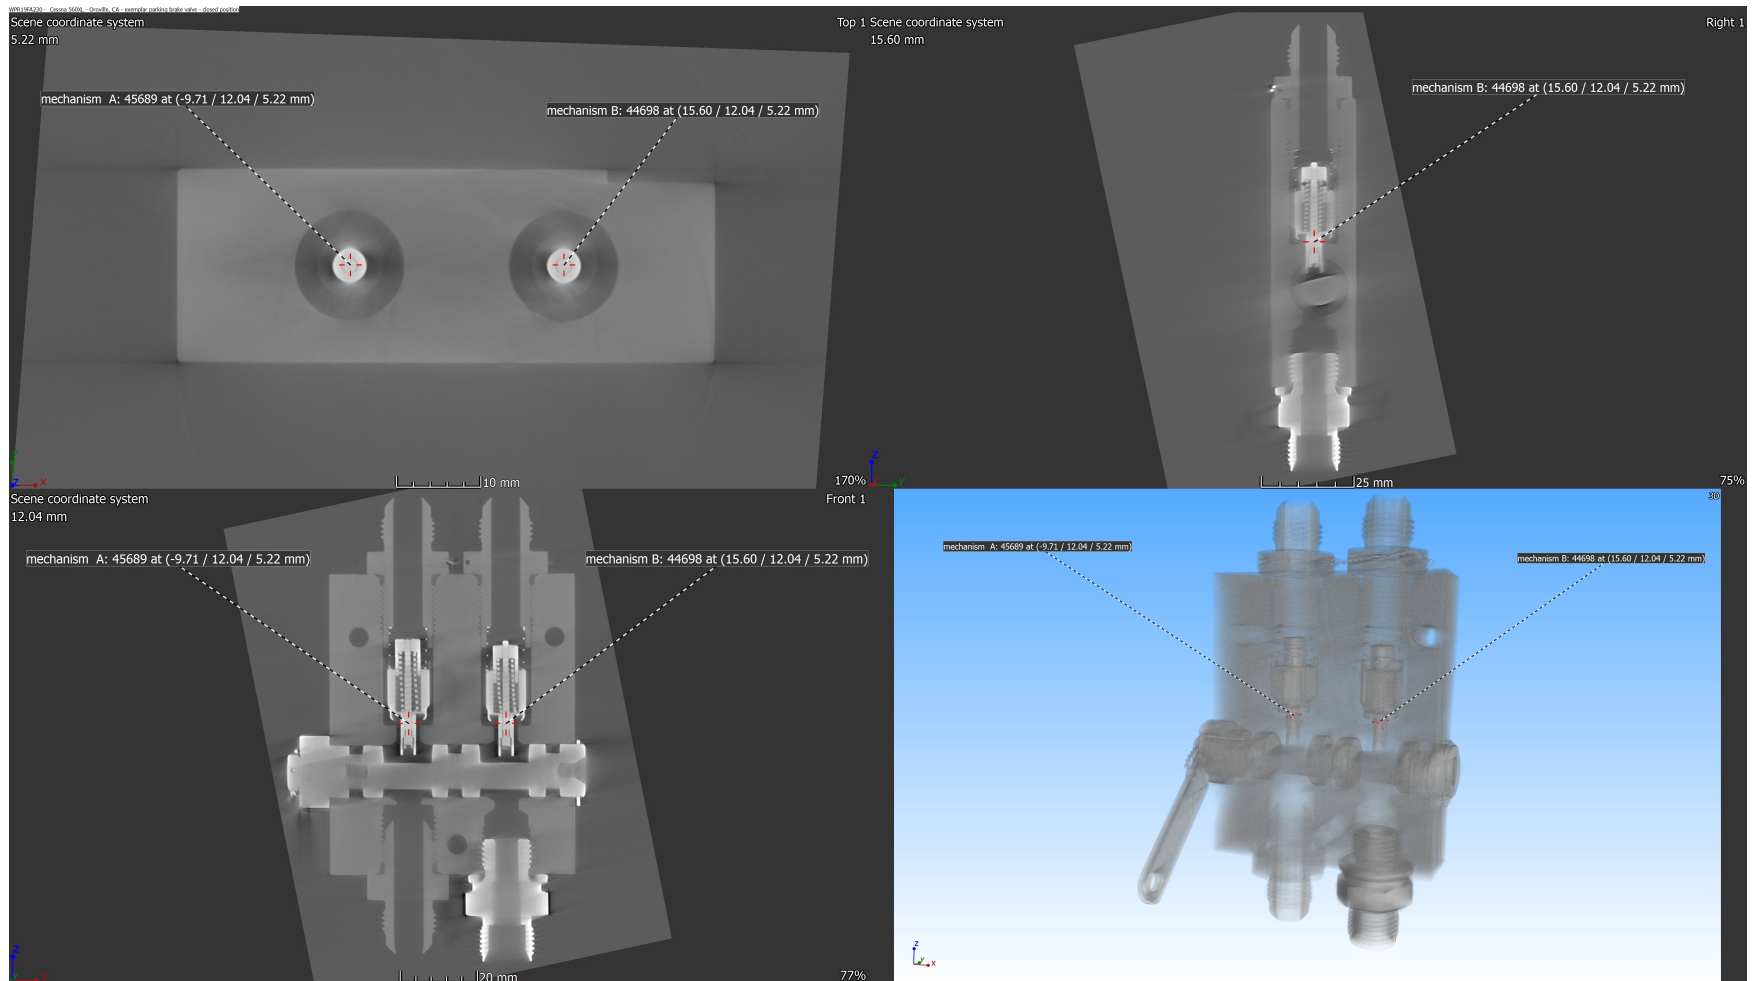
Figure 2  
Exemplar parking brake valve – closed position – mechanism B

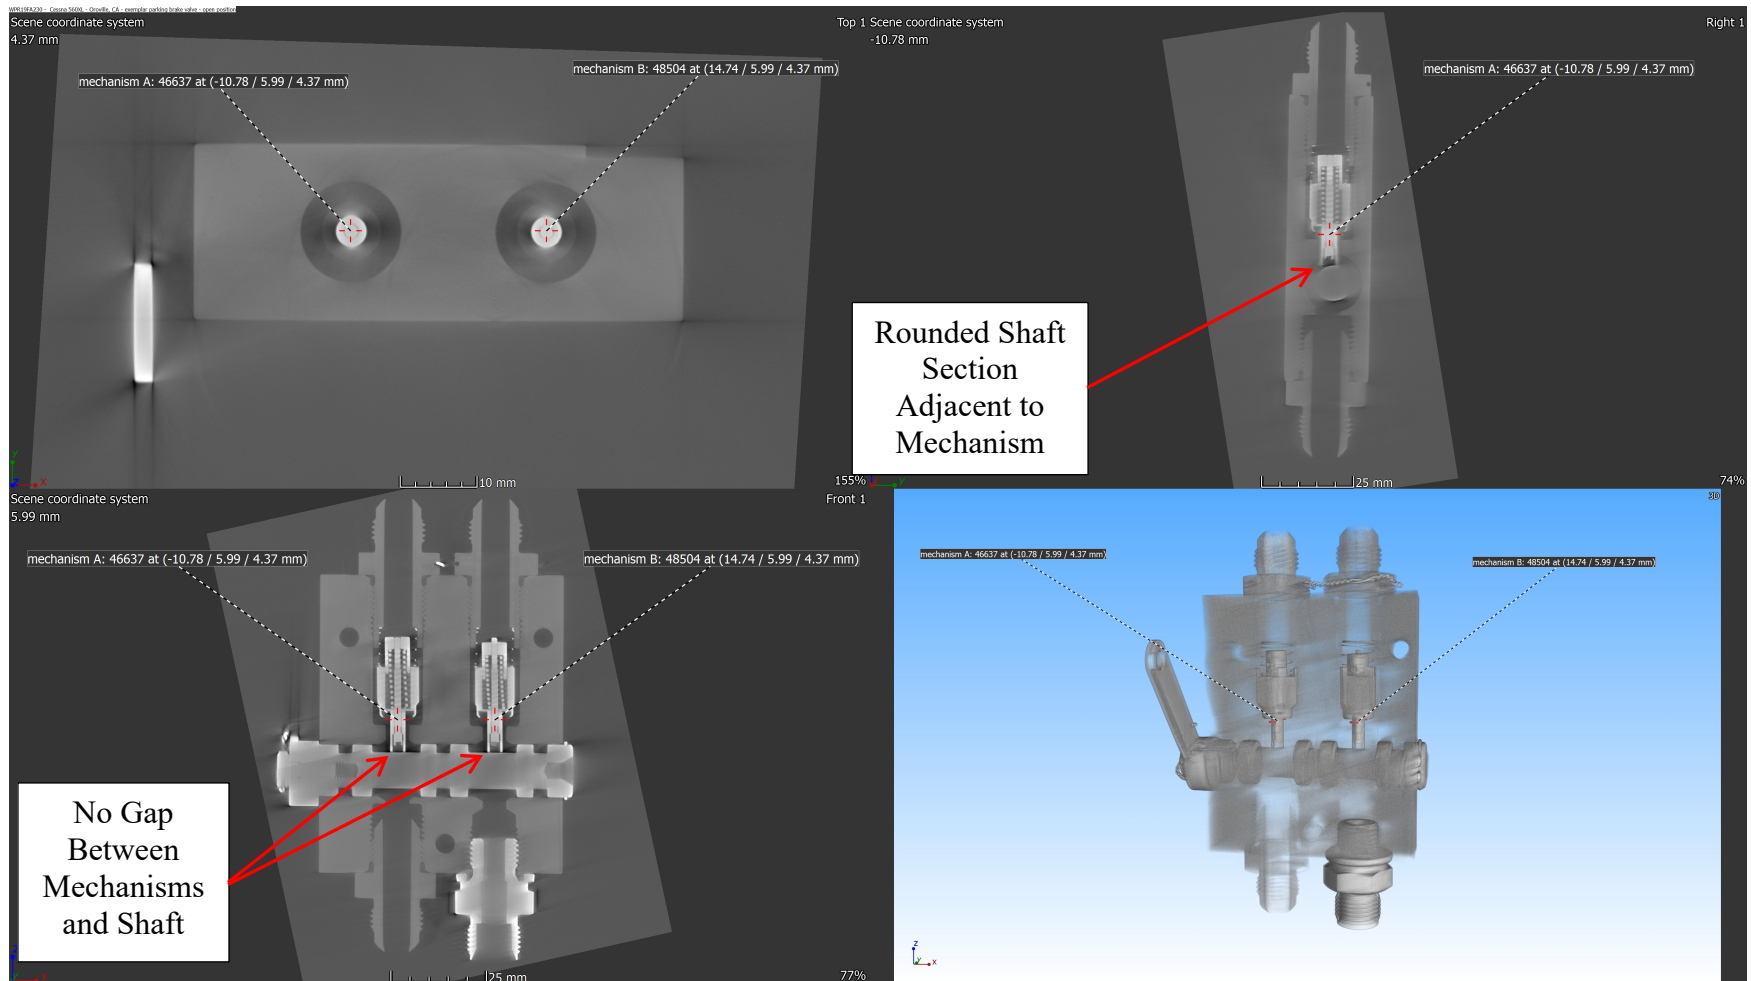
Figure 3  
Exemplar parking brake valve – open position – mechanism A

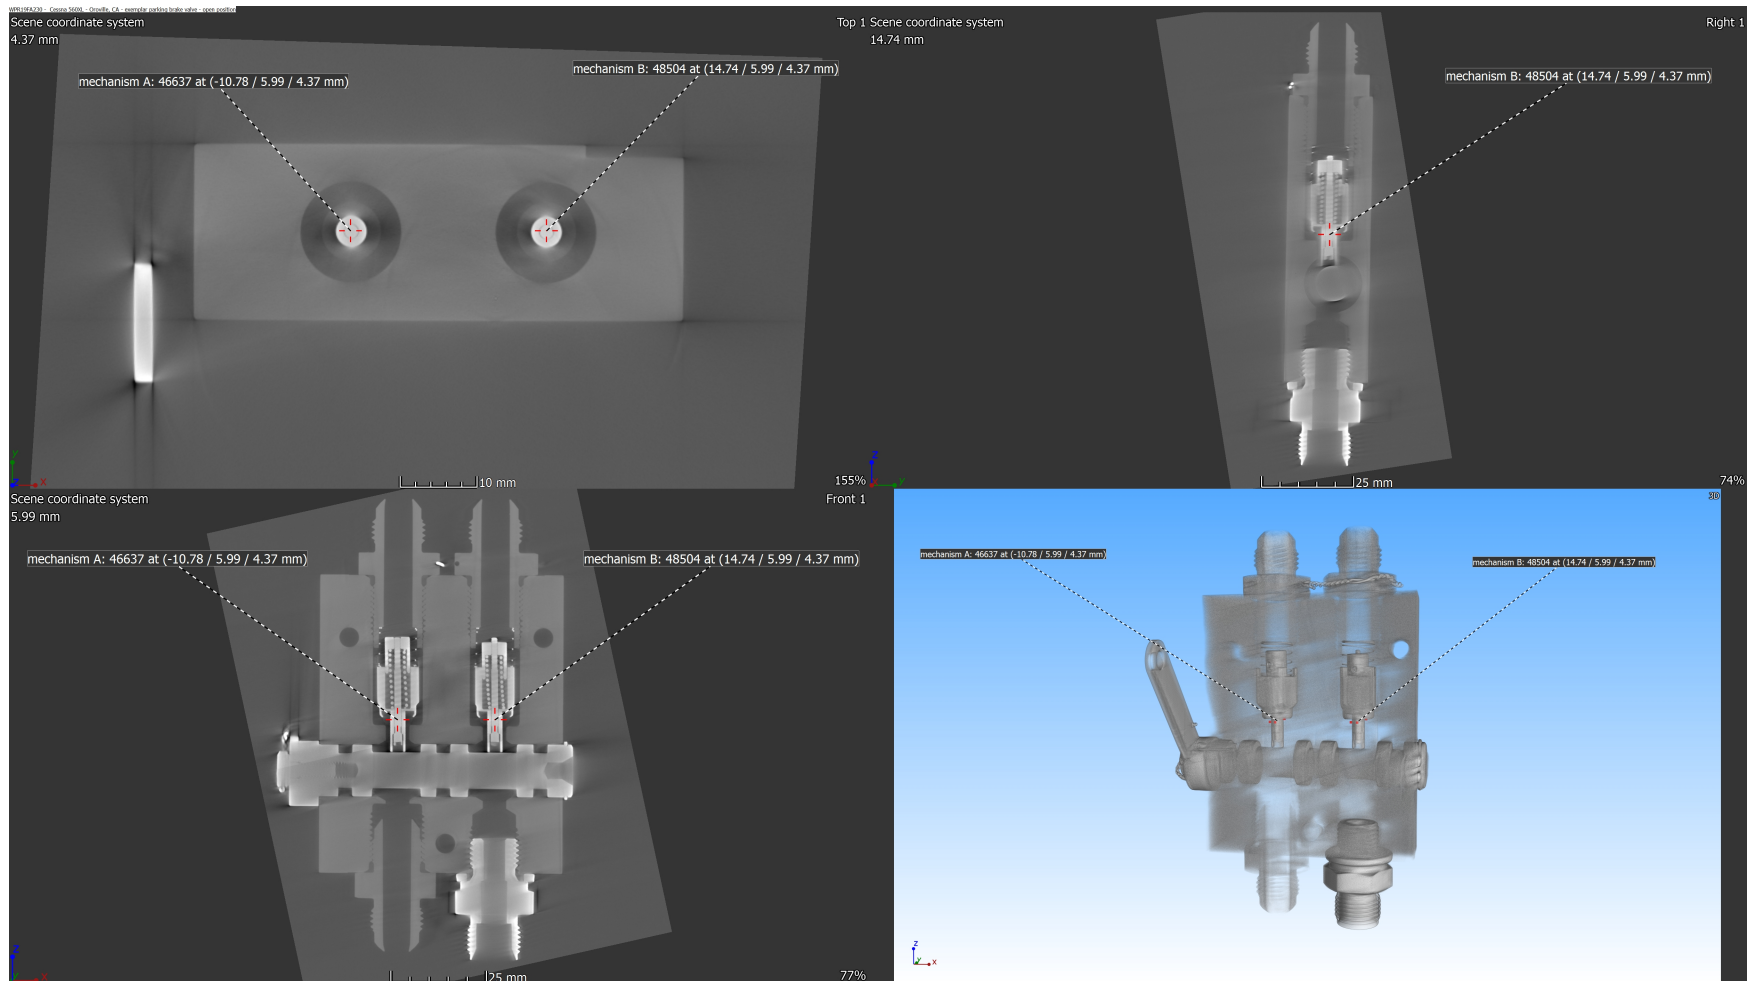
Figure 4  
Exemplar parking brake valve – open position – mechanism B

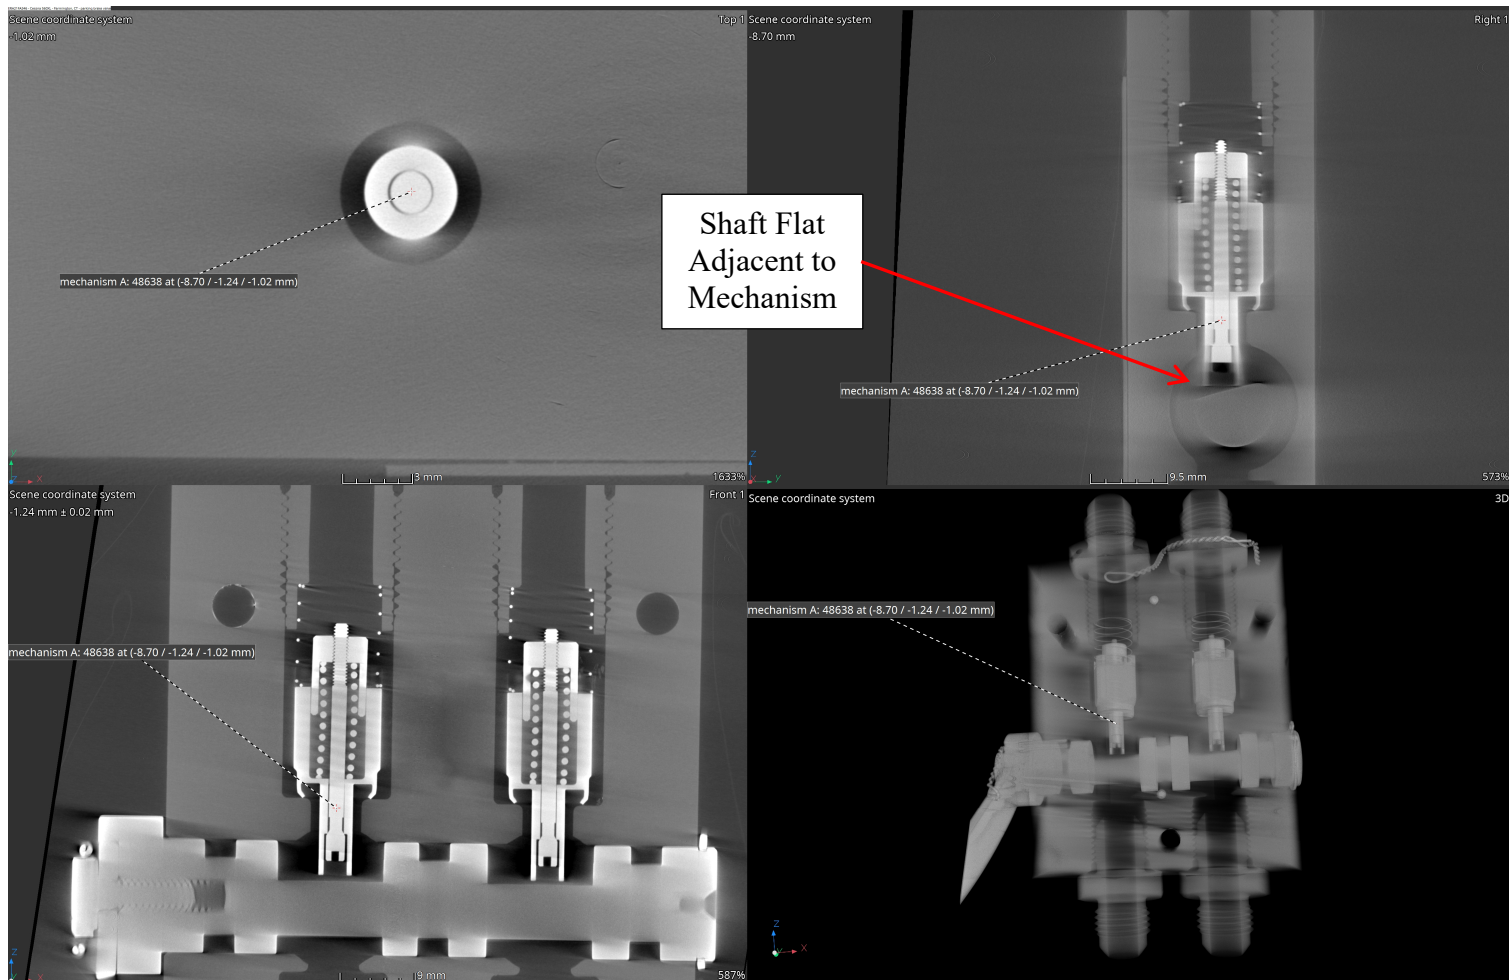
Figure 5  
Accident parking brake valve – mechanism A

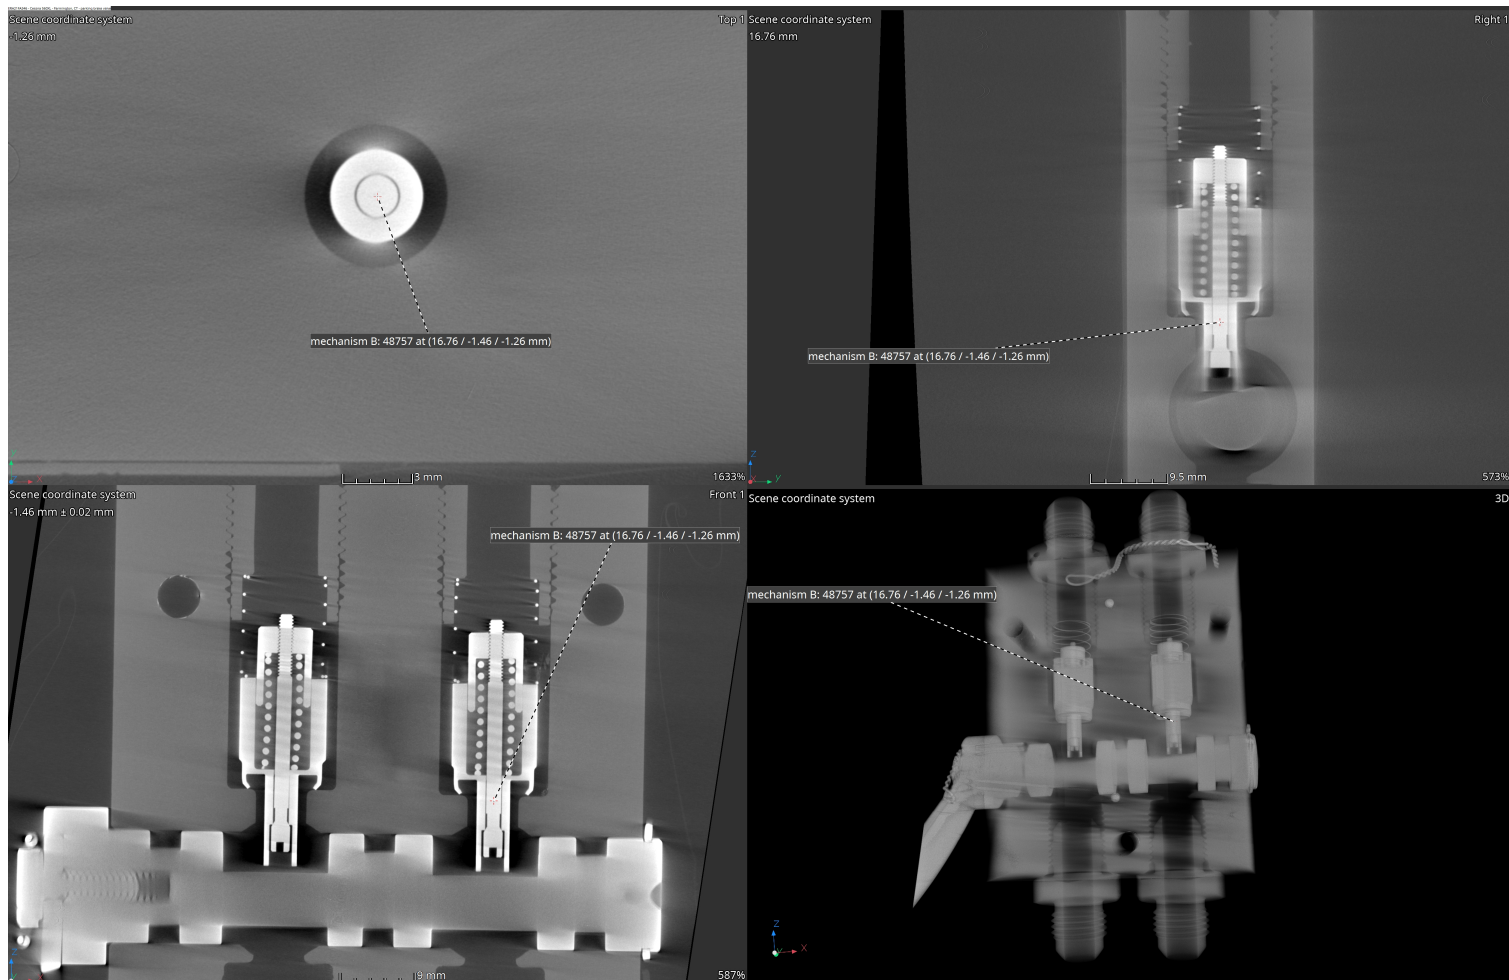
Figure 6  
Accident parking brake valve – mechanism B

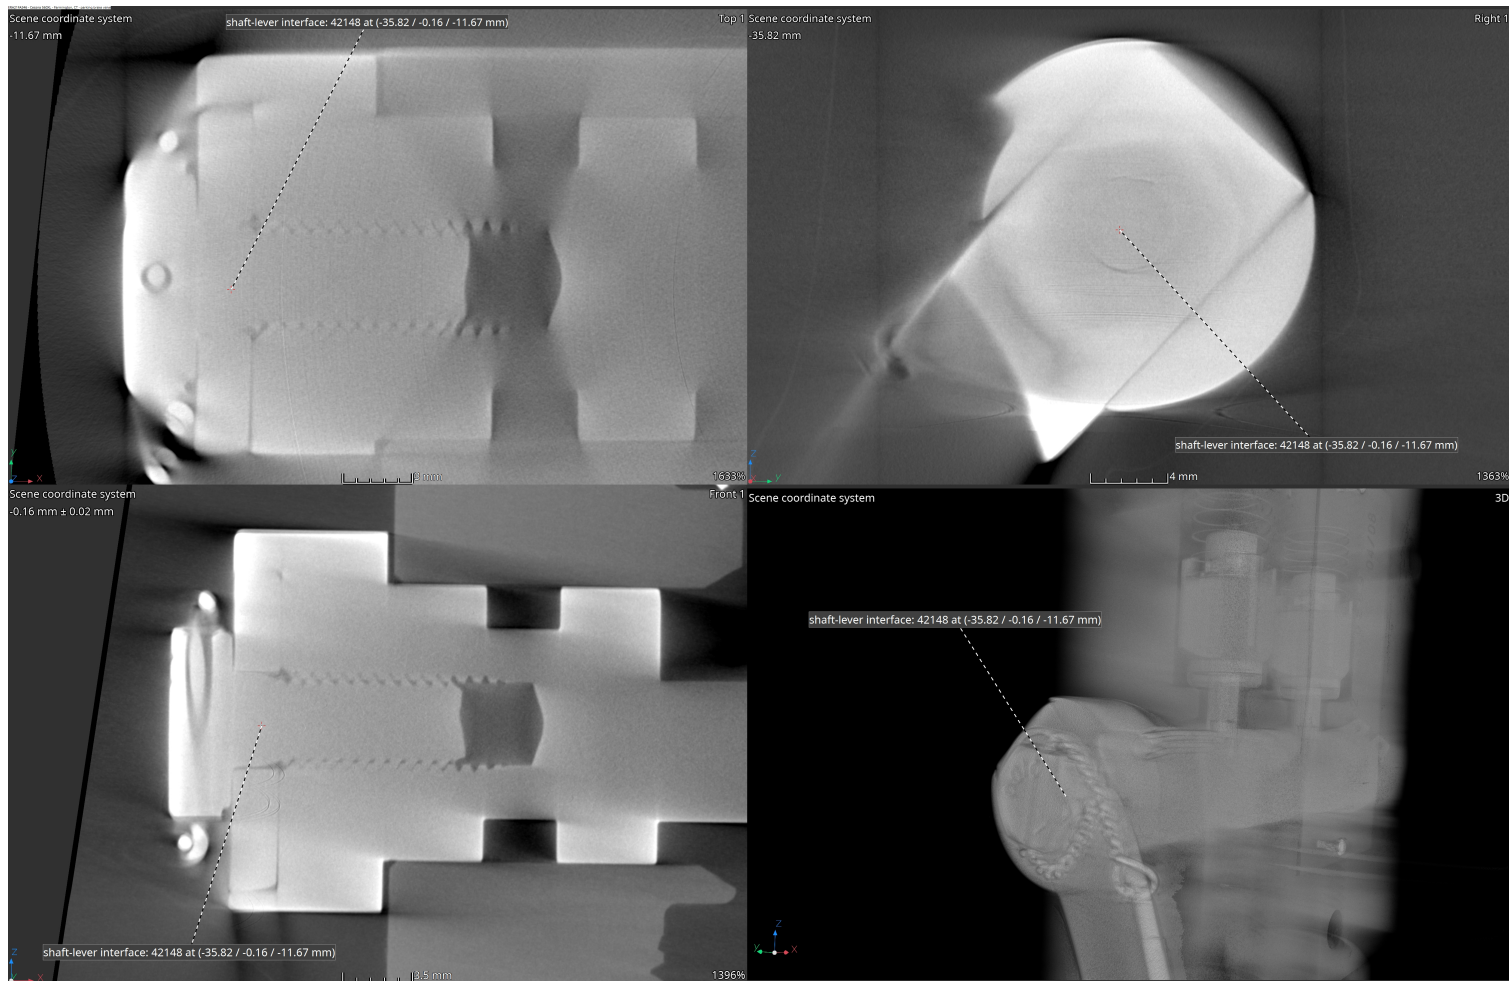
Figure 7  
Accident parking brake valve – lever to shaft interface

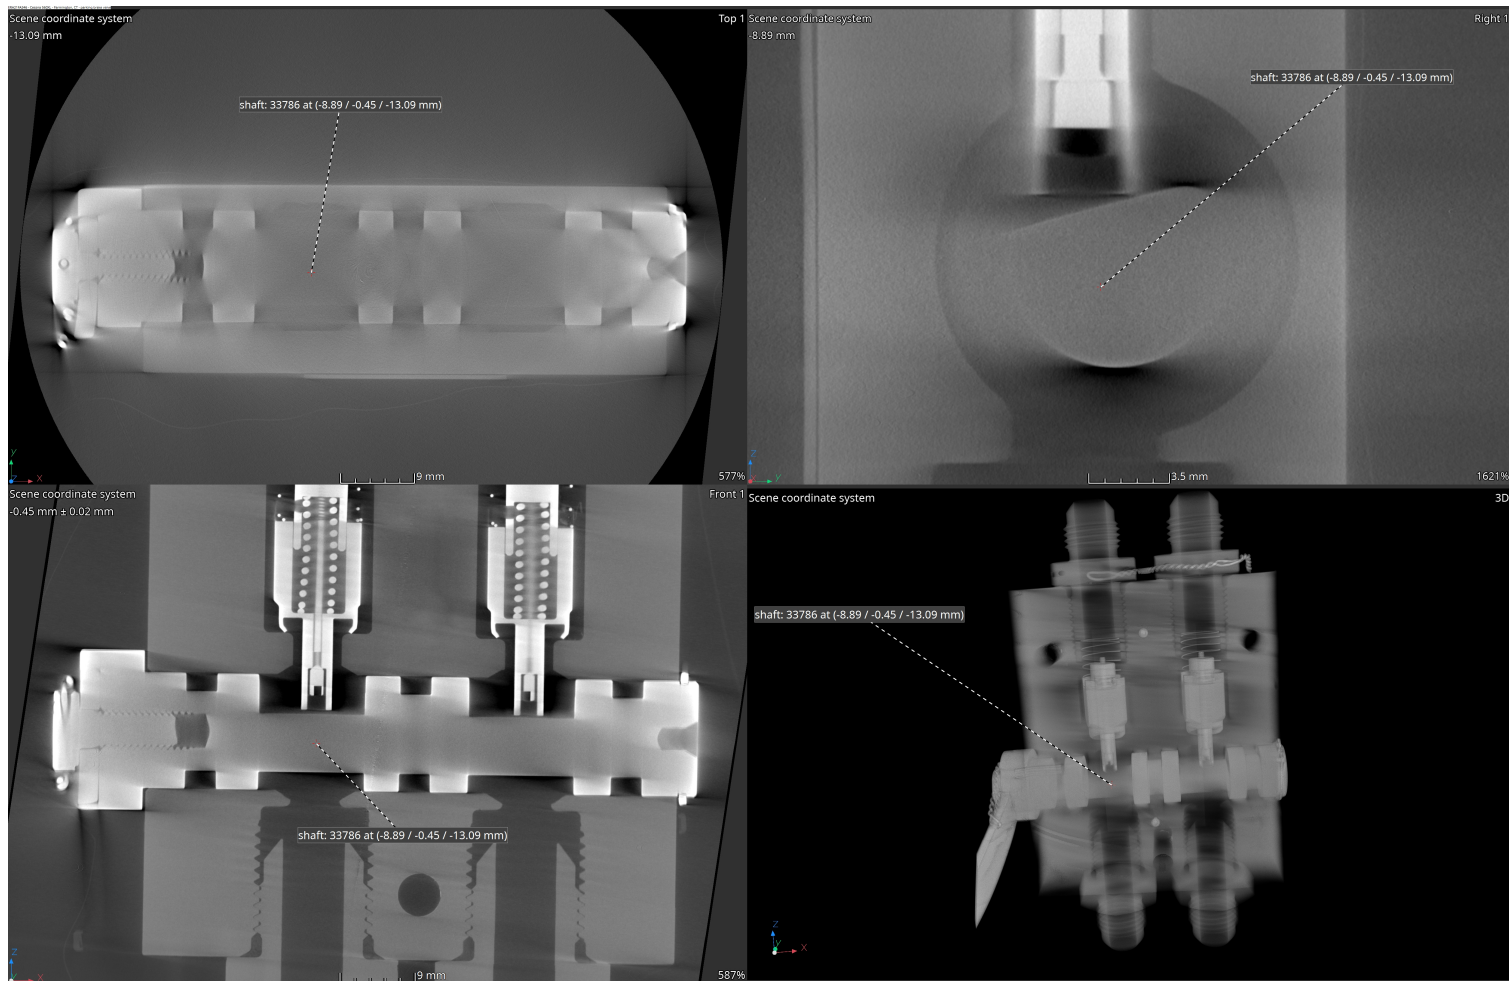
Figure 8  
Accident parking brake valve – shaft

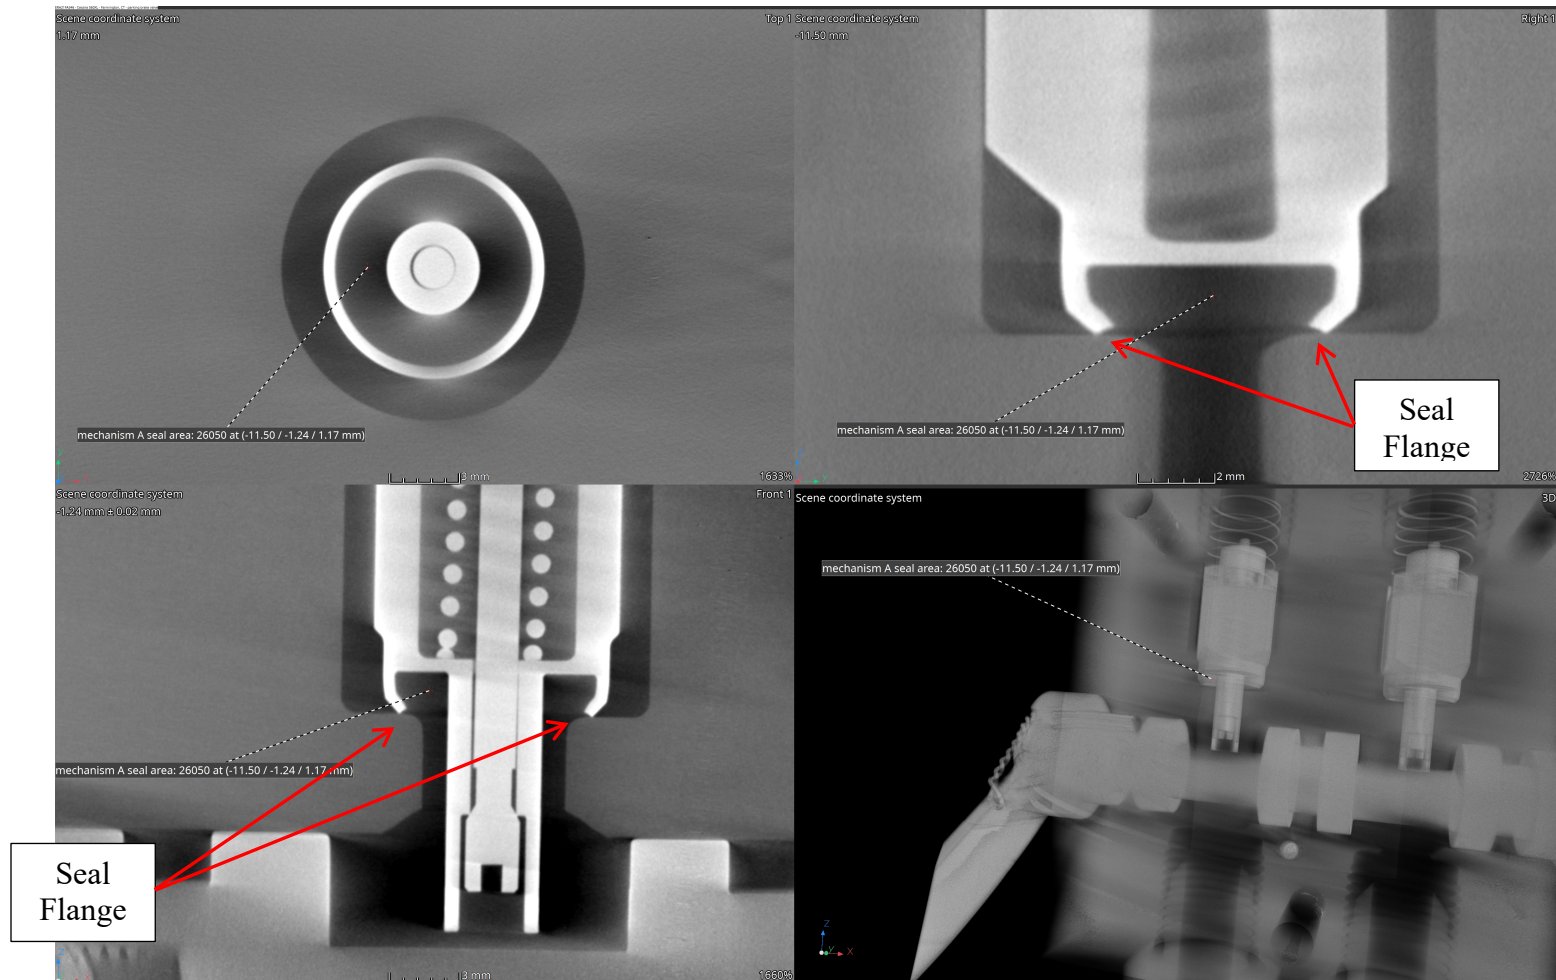
Figure 9  
Accident parking brake valve – mechanism A – seal flange

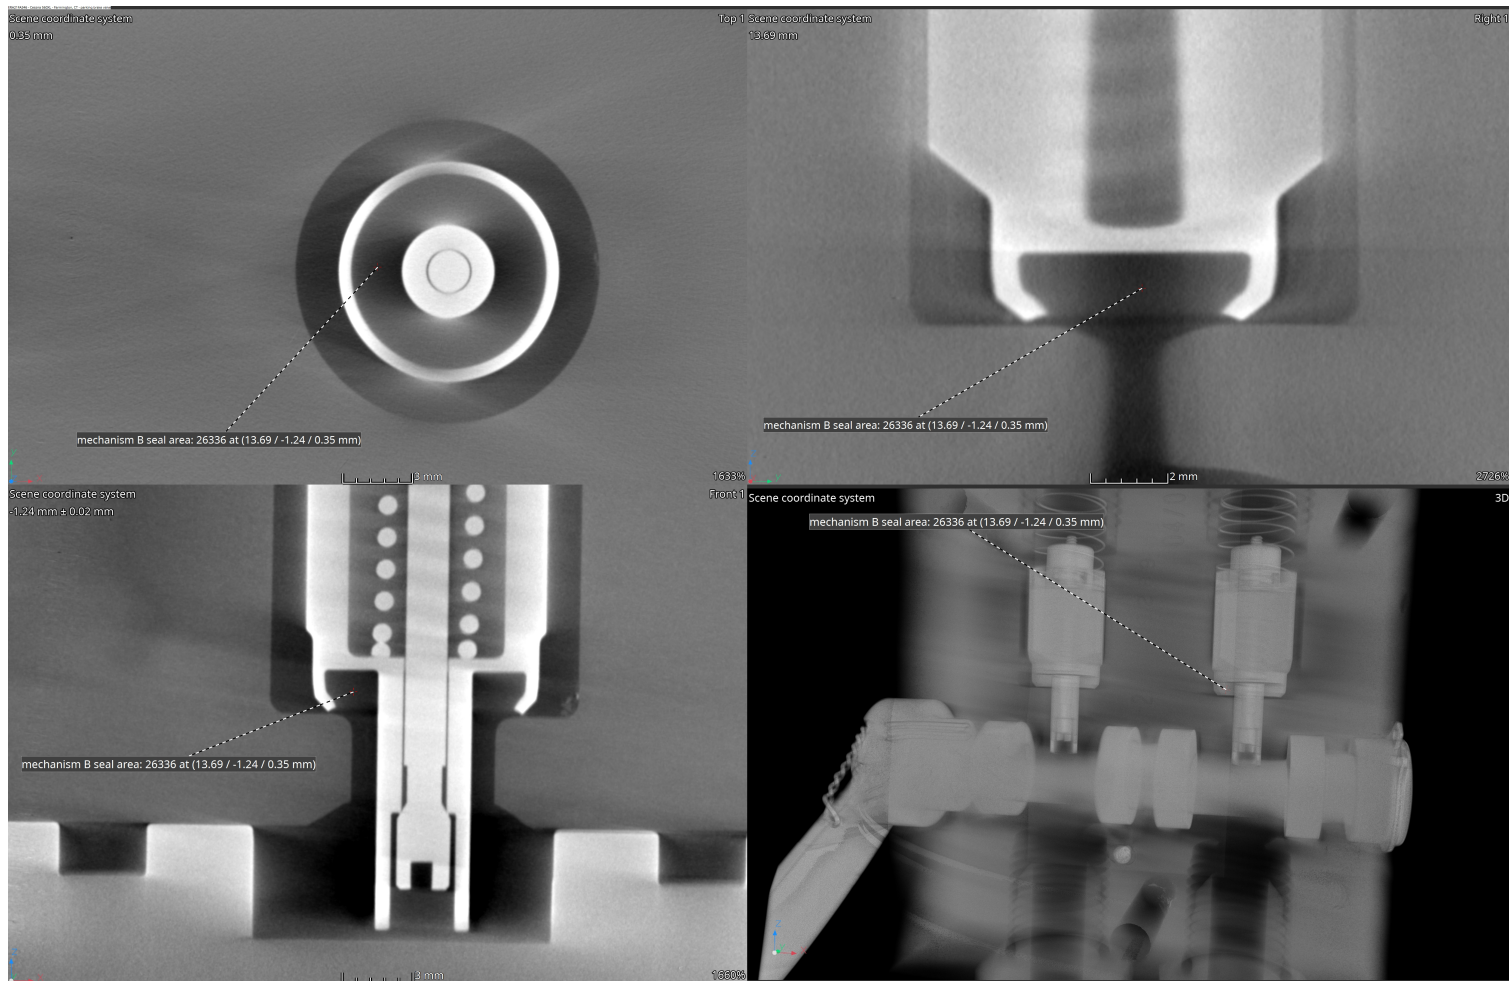
Figure 10  
Accident parking brake valve – mechanism B – seal flange

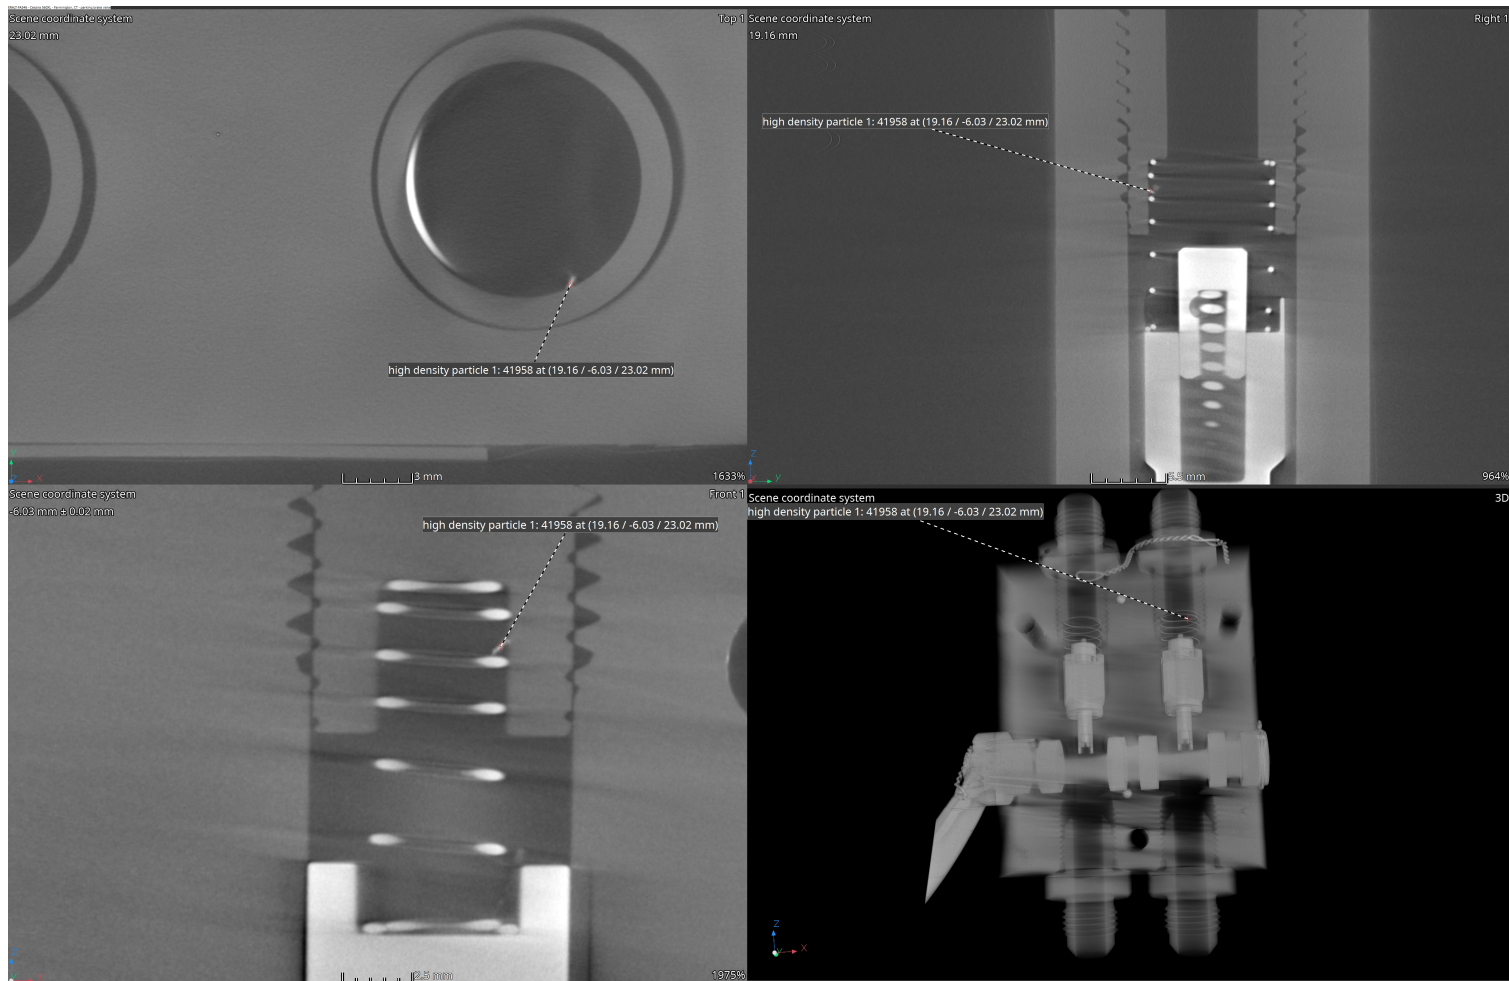
Figure 11  
Accident parking brake valve – high density particle 1

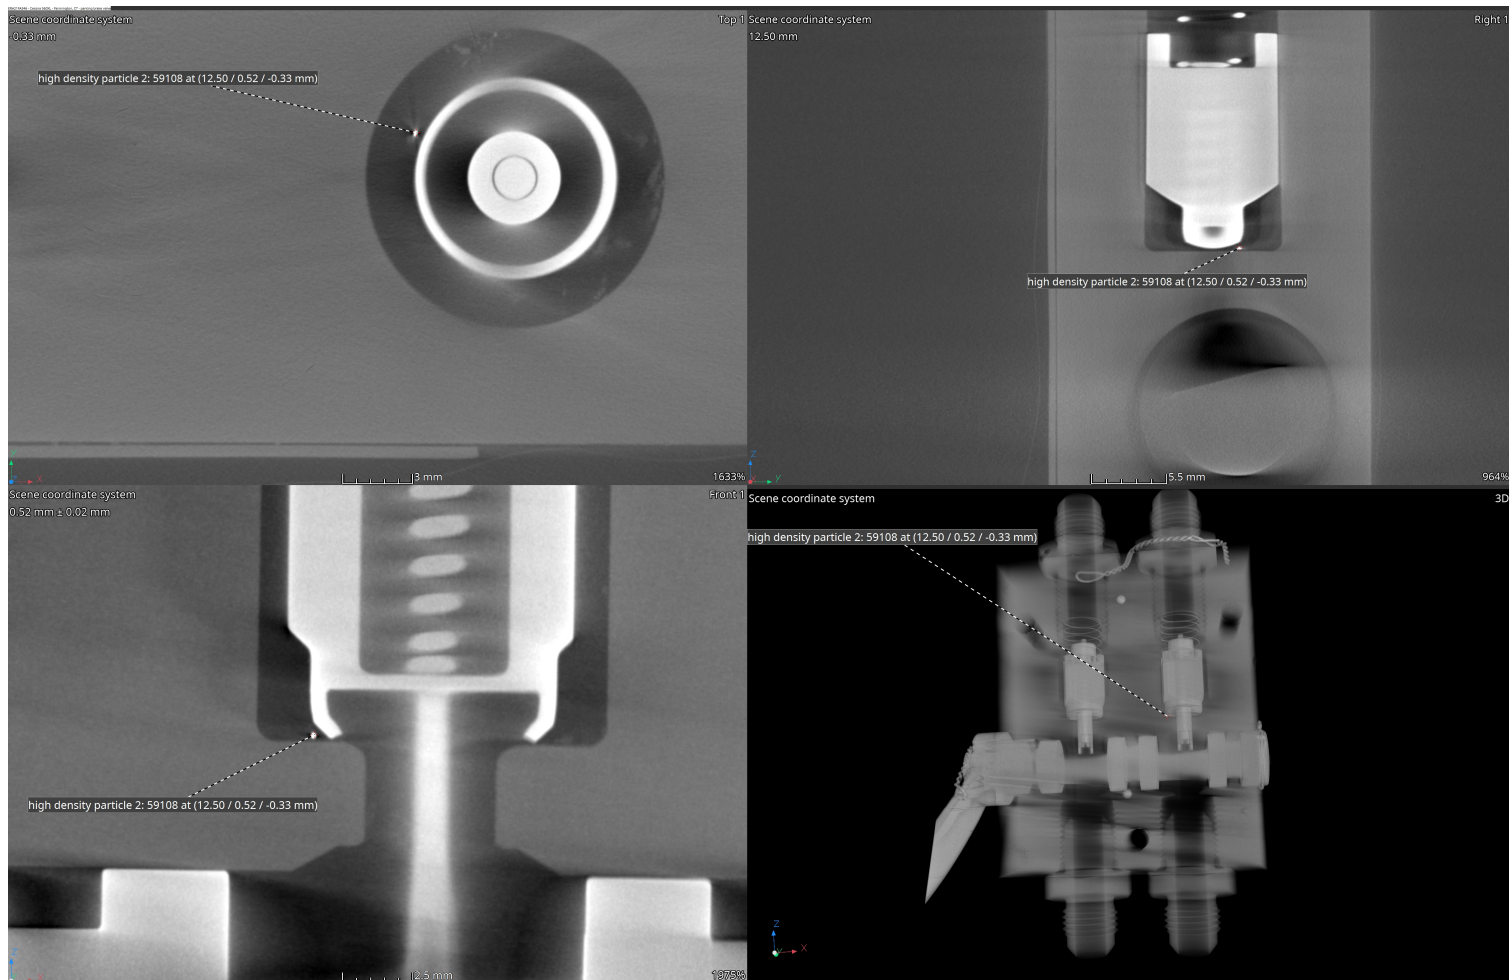
Figure 12  
Accident parking brake valve – high density particle 2

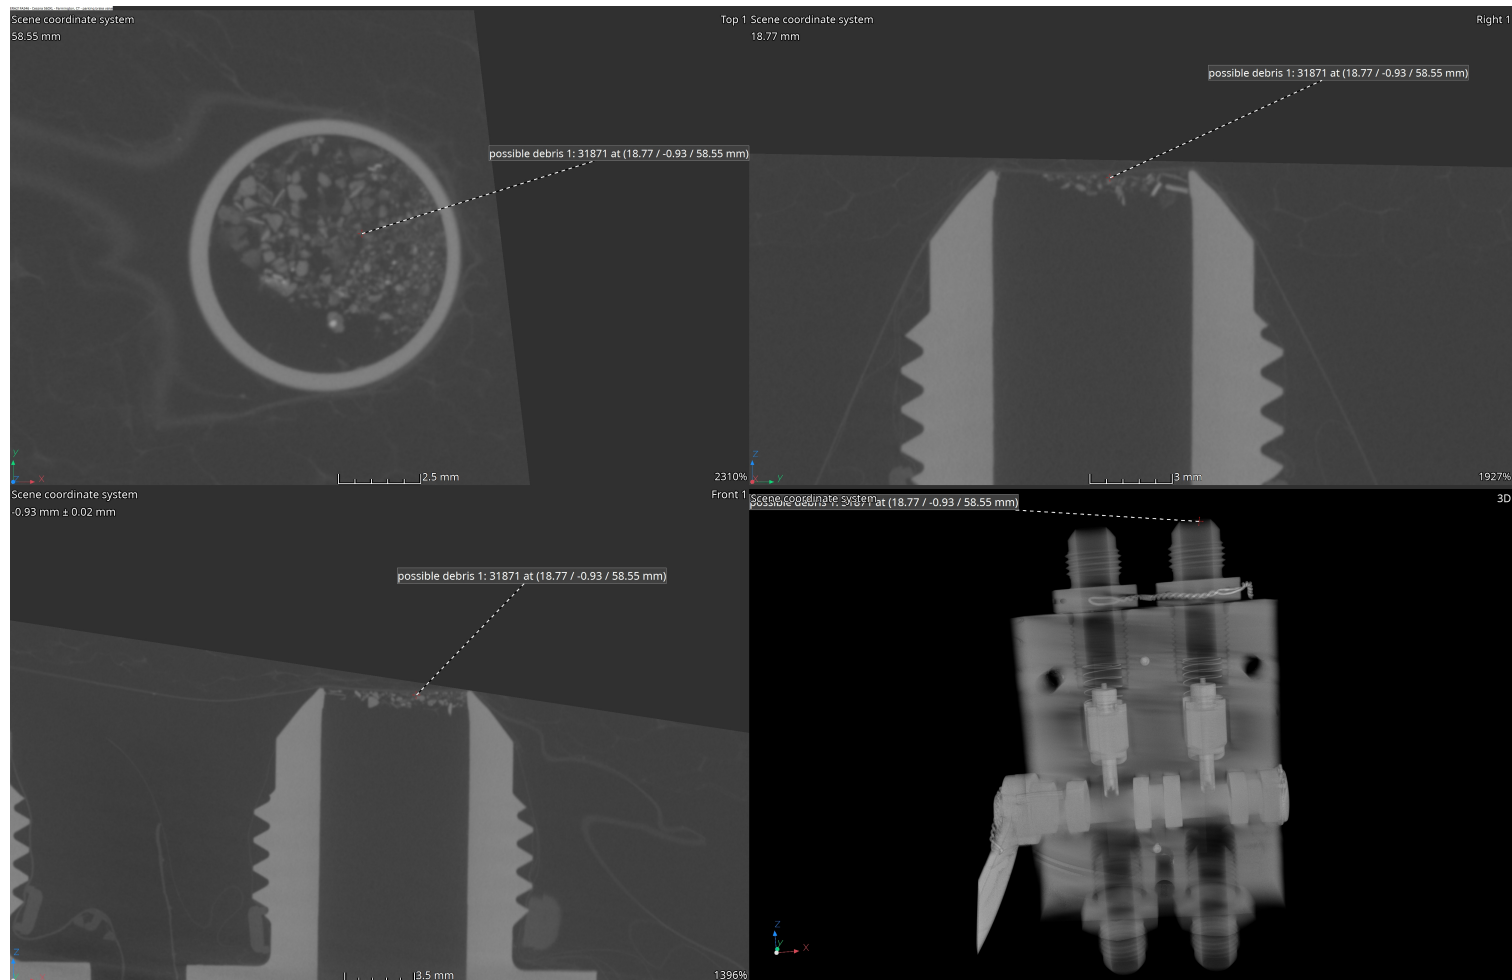
Figure 13  
Accident parking brake valve – possible debris 1

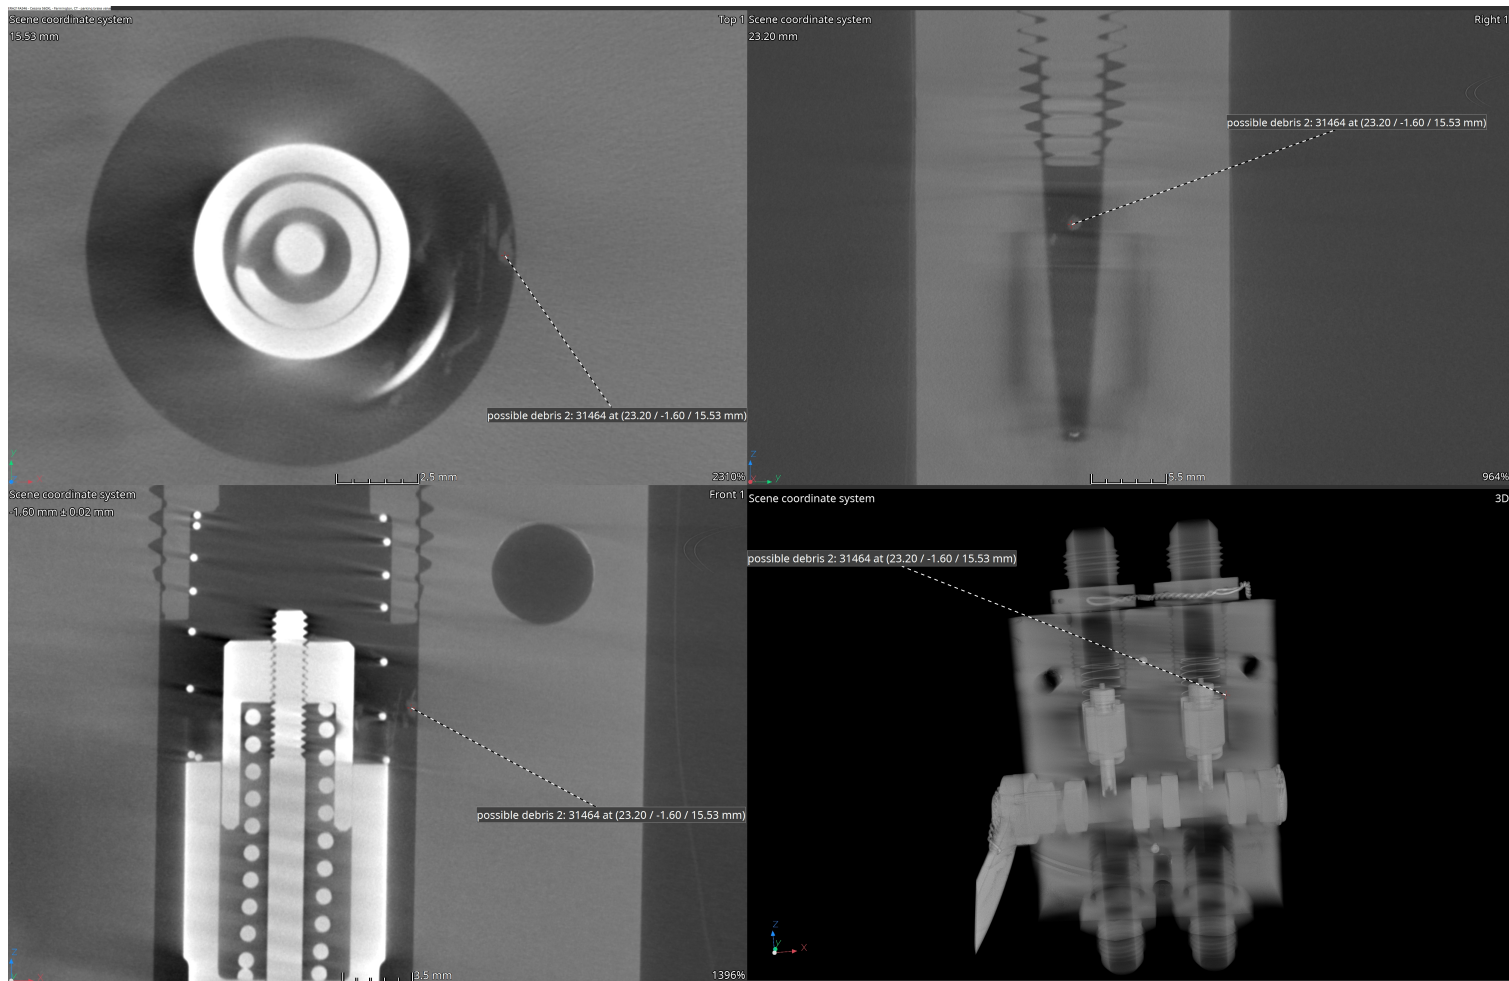
Figure 14  
Accident parking brake valve – possible debris 2
