**NATIONAL TRANSPORTATION SAFETY BOARD**

**Computed Tomography Specialist's Factual Report**

ERA21FA346

Location: Farmington, Connecticut  
Date: September 2, 2021  
Time: 0951 eastern daylight time  
Airplane: Cessna 560XL airplane, N560AR

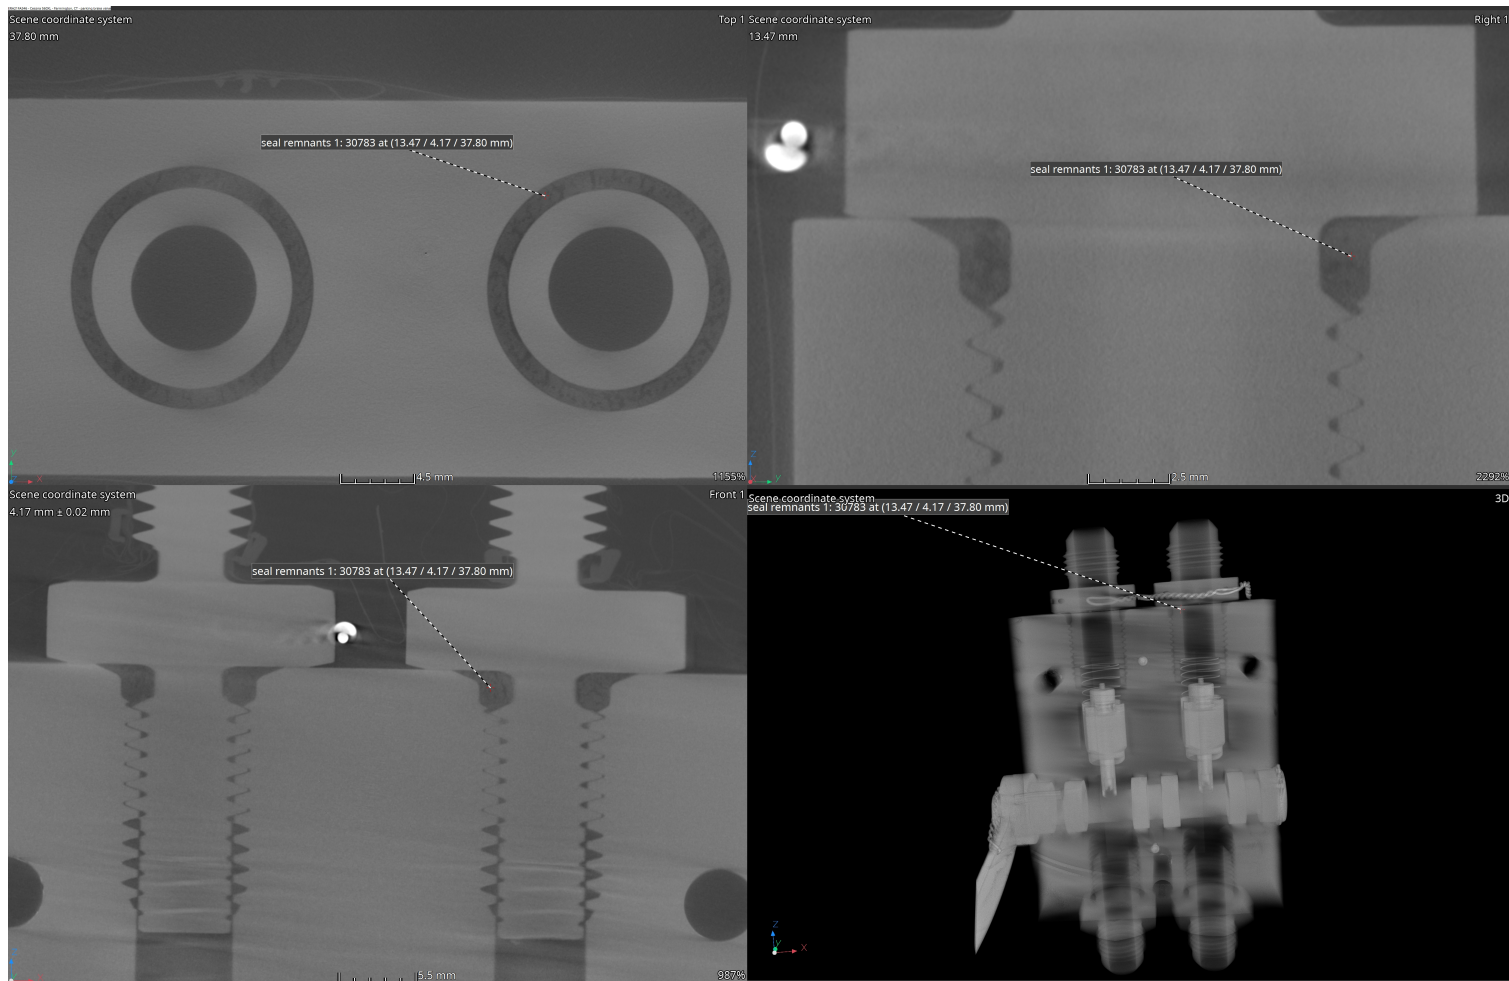
Figure 15  
Accident parking brake valve – seal remnants 1

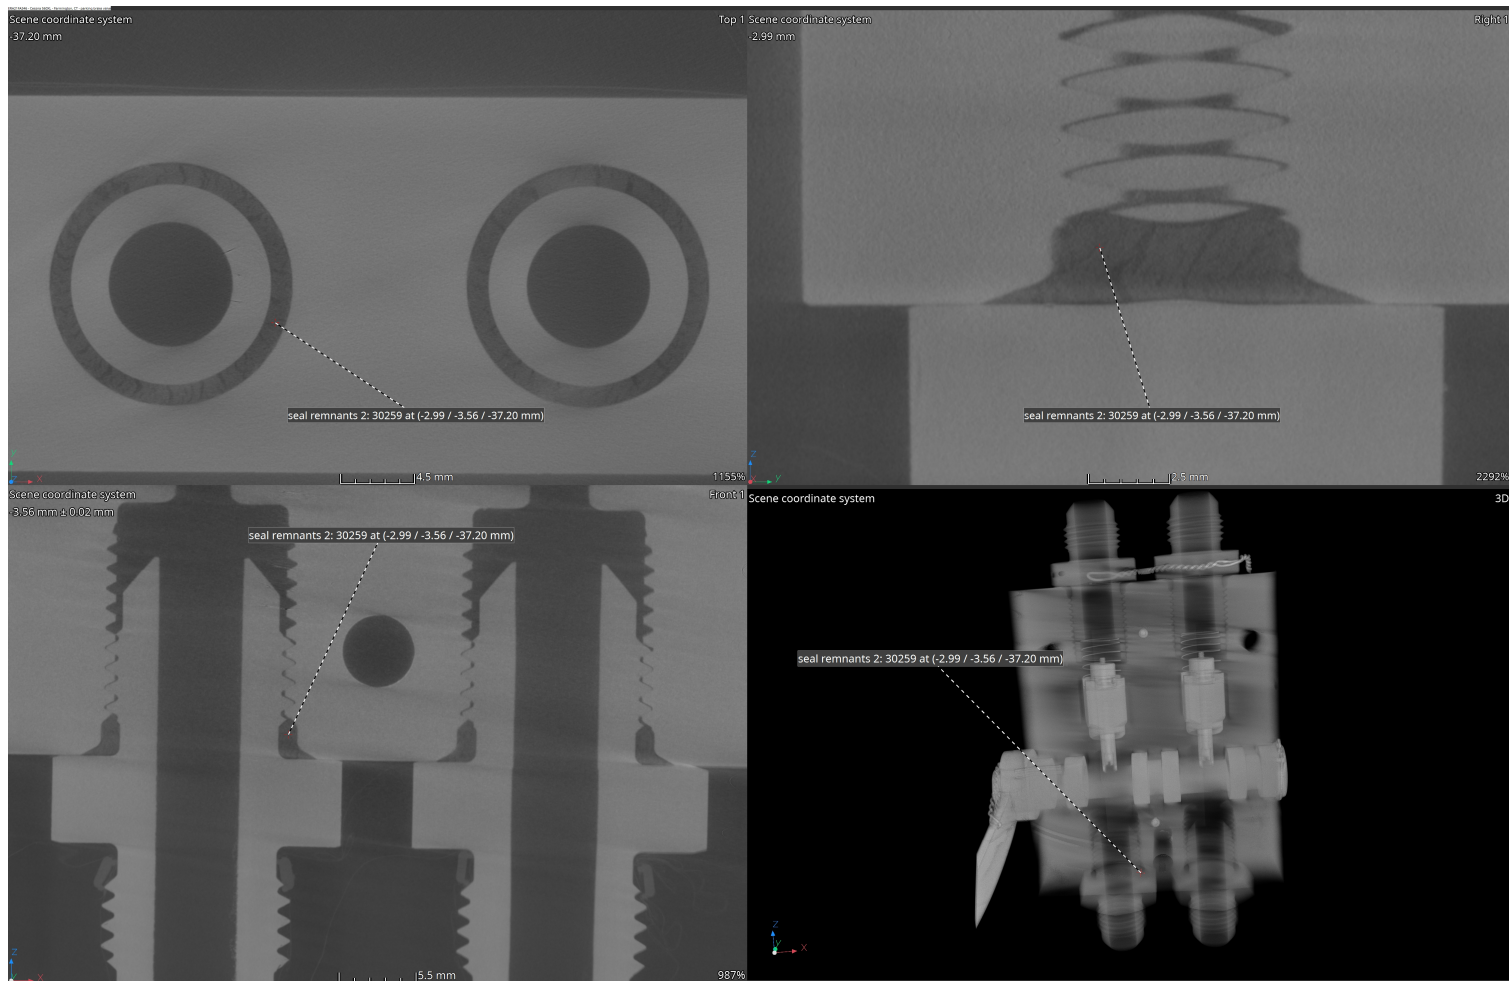
Figure 16  
Accident parking brake valve – seal remnants 2

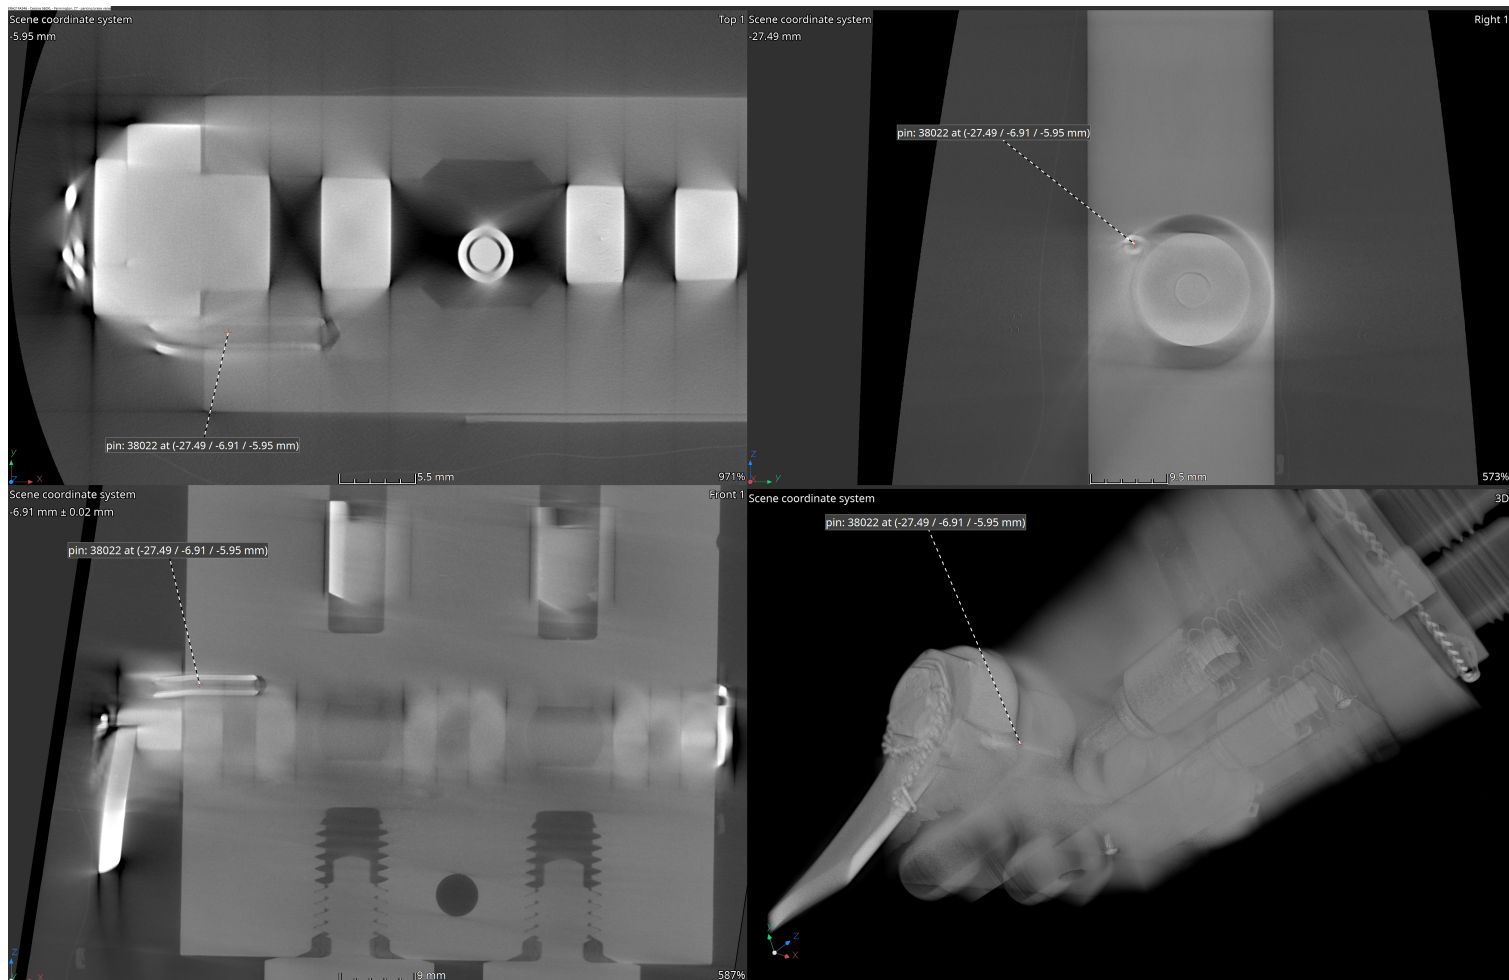
Figure 17  
Accident parking brake valve – pin

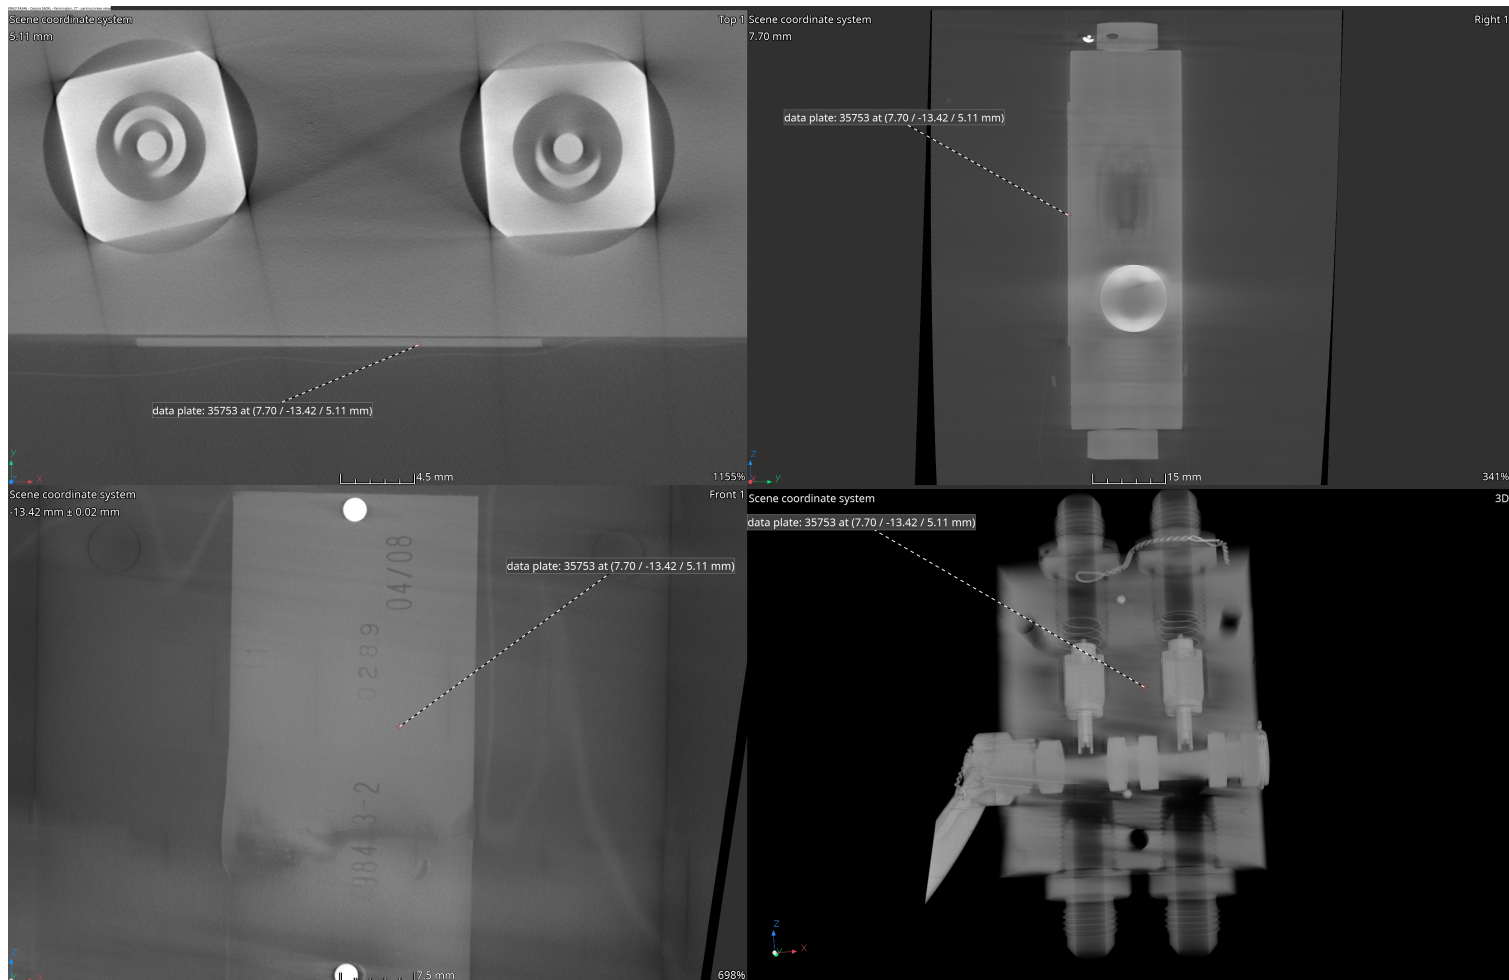
Figure 18  
Accident parking brake valve – data plate
