## Memorandum For Record

**Date: January 19, 2022**  
**NTSB Accident Number: ERA21FA346**

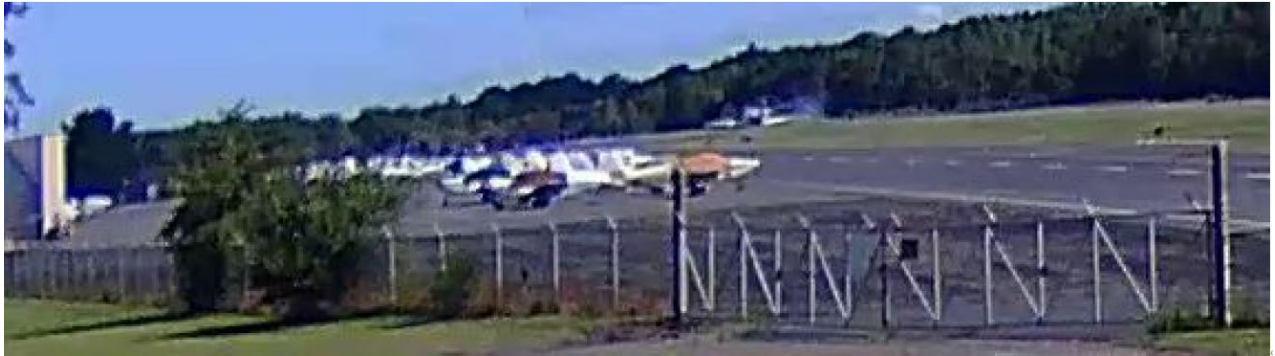
**Figure 1: Screen shot from Video Depicting Gray Colored Smoke Trailing the Airplane.**

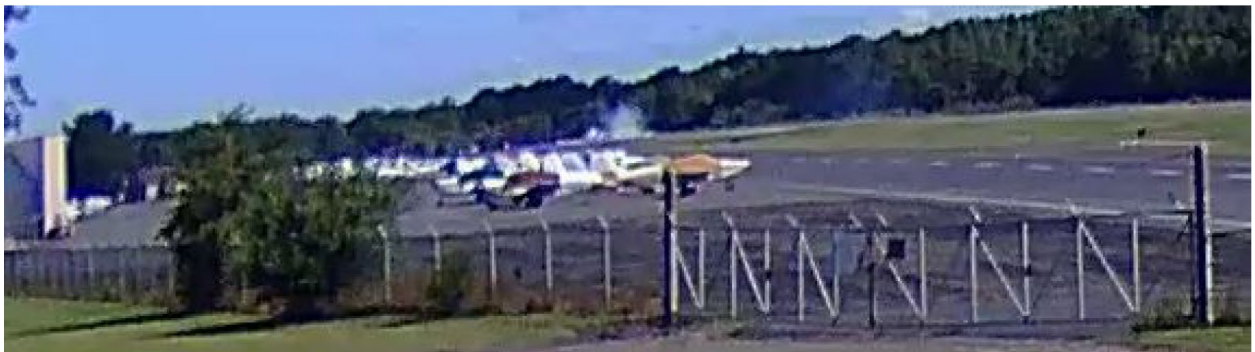
**Figure 2: Screen shot from Video Depicting White Colored Smoke Trailing the Airplane.**

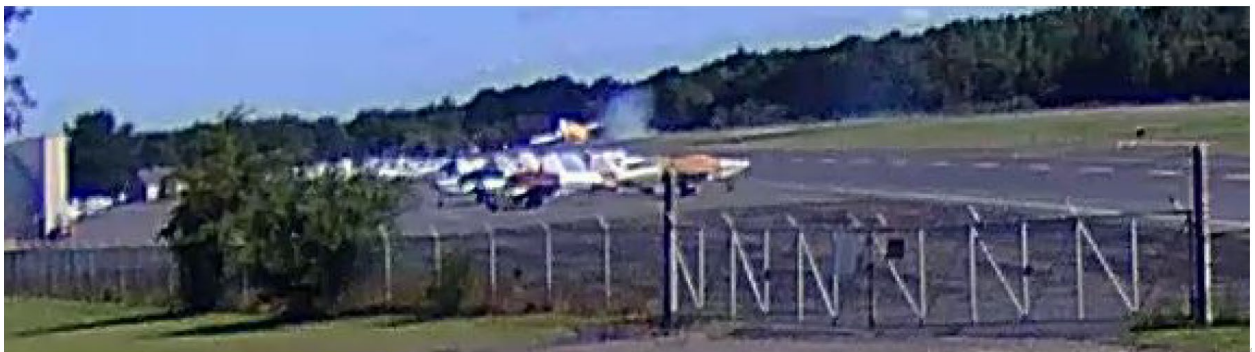
**Figure 3: Screen shot from Video Depicting Slight Left Roll and Fire Trailing the Airplane.**

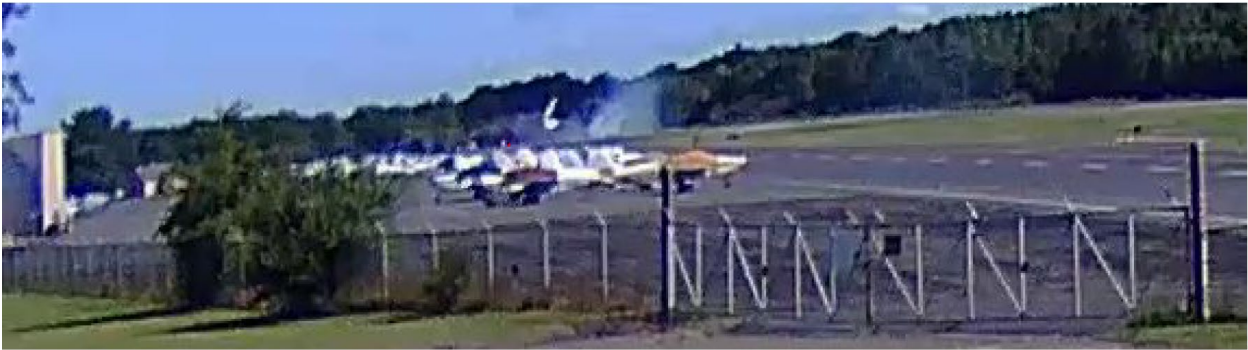
**Figure 4: Screen shot from Video Depicting Airplane Rolling Right to Inverted Attitude.**

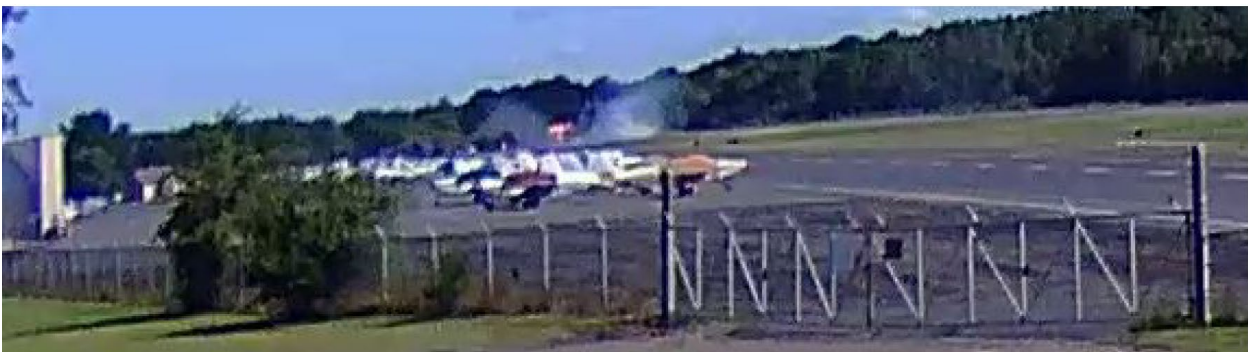
A camera which recorded video file titled, “01\_20210902085957\_part2” was located near the approach end of runway 2. It was mounted on the wall of a building west of taxiway “B” and was about 12 ft above ground level. A review of the 21 minute 32 second video revealed the airplane came into view from behind a hangar at 9 minutes 52 seconds elapsed time and taxied from the ramp to the taxiway, then on the taxiway towards the approach end of runway 2. The airplane went out of view of the camera near the approach end of runway 2 at 12 minutes 31 seconds elapsed time then came back into view during the takeoff roll from runway 2 about 13 minutes 54 seconds elapsed time. The video recorded the takeoff roll and about 14 minutes 6 seconds elapsed time, a puff of gray colored smoke was noted from behind the airplane (Figure 1). At 14 minutes 11 seconds elapsed time a puff of white colored smoke was noted trailing the airplane (Figure 2). The location at that time was consistent with being at the departure end of the runway. At about 14 minutes 13 seconds elapsed time a slight left roll and a spark was noted trailing the airplane (Figure 3). The video depicted the airplane rolling to the right to an inverted attitude (Figure 4) and was lost from view at 14 minutes 18 seconds elapsed time. A fireball was noted at 14 minutes 19 seconds elapsed time (Figure 5), and a tall fireball was noted 2 seconds later.

**Figure 5: Screen shot from Video Depicting Fireball.**

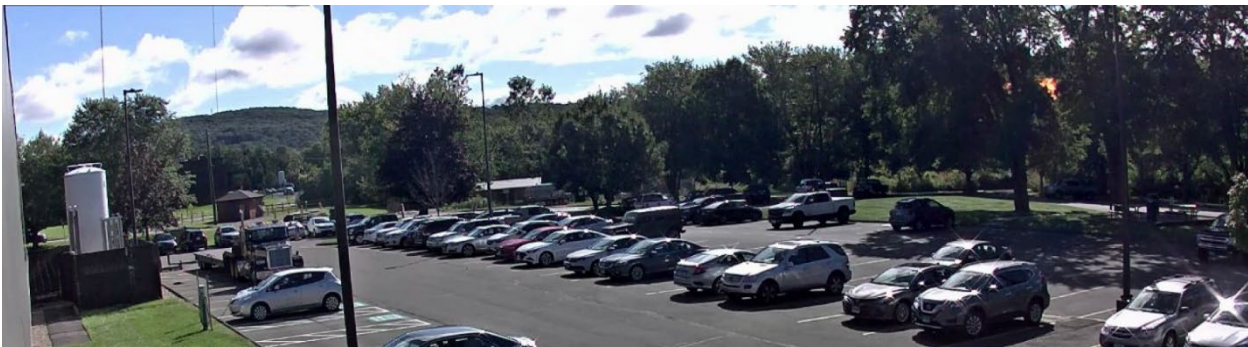
A camera which recorded video file titled, “Bldg1\_FX\_Plot1 - Camera - 01-2021-09-02\_09h50min49s221ms” was located on a building west of the accident site. A review of the 31 second video revealed that at 11 seconds elapsed time, a view of fire was noted off the ground through the trees in the right side of the frame (Figure 6). The fire increased in intensity among the trees above the ground and the airplane came into view while in a steep right bank and slight nose-up attitude with a view of the bottom of the airplane (Figure 7). The airplane rolled to an inverted position with a fire on the right side of the airplane (Figure 8). The airplane went out of view at about 13 seconds elapsed time and a large fireball with black smoke was noted at 19 seconds elapsed time.

**Figure 6: Screen shot from Video Depicting Fire Above Ground Level Through Trees.**

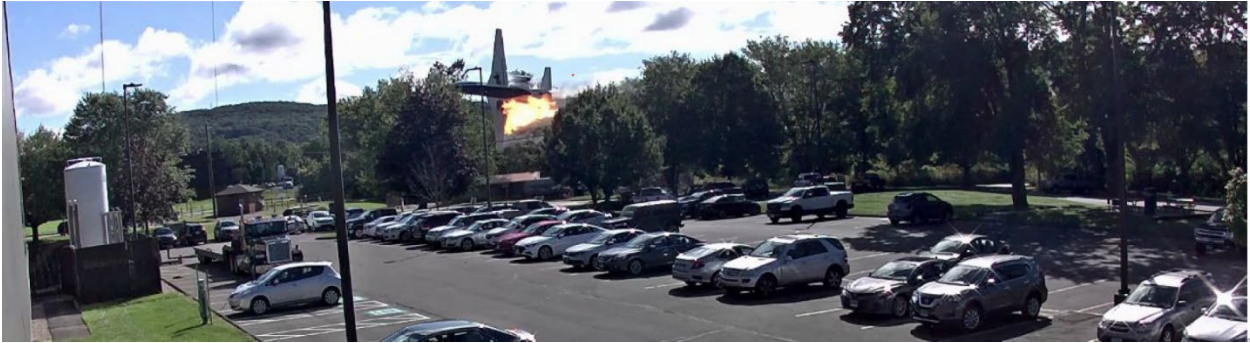
**Figure 7: Screen shot from Video Depicting in Steep Right Bank and Nose-Up Attitude. Note Fire Trailing the Airplane.**

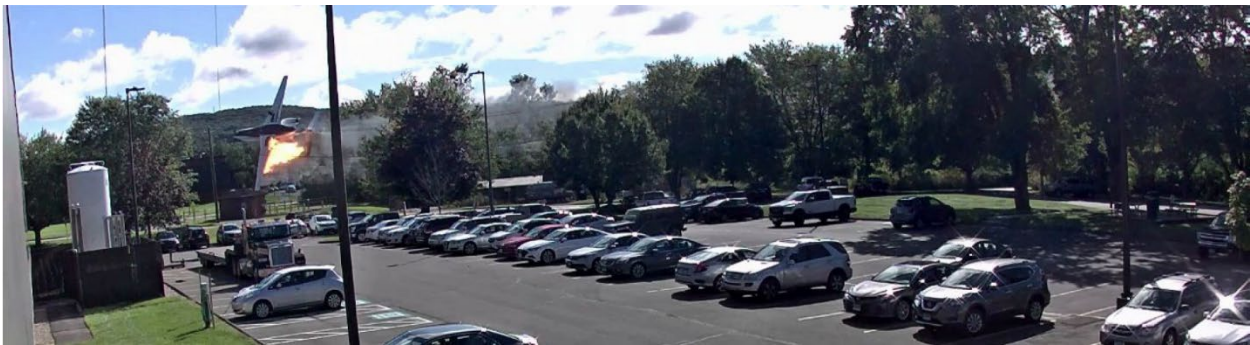
**Figure 8: Screen shot from Video Depicting Airplane in Inverted Position With Fire on Right Side of the Airplane.**
