## RECORD OF CONVERSATION

**Date: January 21, 2022**  
**Person Contacted: Garrison Leykam**  
**NTSB Accident Number: ERA21FA346**

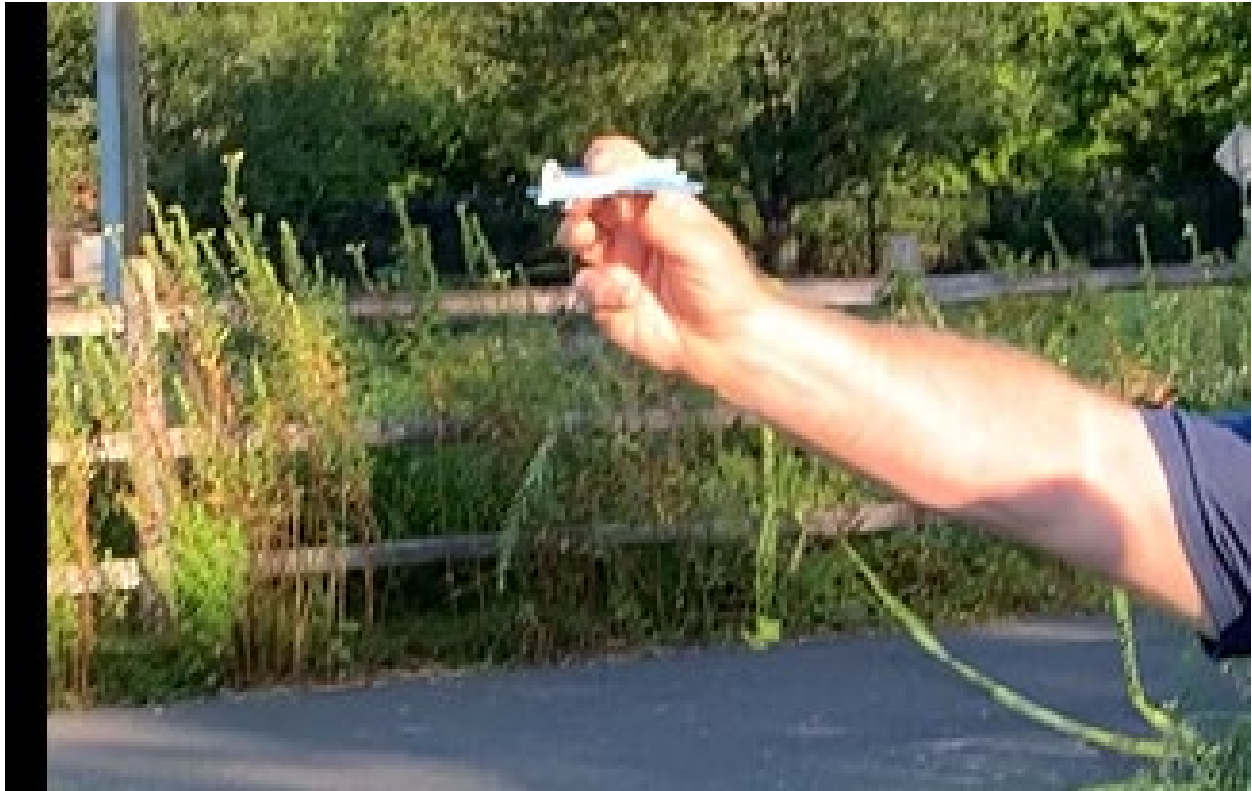
At the start of the video, he was holding the model airplane in front of him (figure 1) depicting the attitude the airplane departed the runway, then indicating, “you could notice the change that way and this part (pointing to the tail) was more down that I should (Figure 2), I thought it would be. To the point where it traveled this way (the direction of flight), and there was a motor up I guess about here (Figure 3) (pointing to the right side of the airplane) that looked like that is what struck the pole (pointing in the direction of the impacted pole). And then the shower, the shower of<sup>3</sup> sparks just went up that way, and some of it was right there (again pointing to the area of the pole). But, but again it was, it came across, it seemed to leave the runway at an ok but instantly changed toward that (Figure 4) (depicting a nose-up attitude) and then flew like that (maintaining the nose-up pitch attitude depicted in Figure 5). As if, the first thing in my mind is, is ultimately what this pilot going to do is go like that (Figure 6) (depicting the airplane pitching up abruptly to an inverted position. Because the ratio of that (pointing to the tail) to that (pointing to the nose) changed significantly in that short distance. Once it hit the pole, it seemed to be more trying to do that (describing the wings rocking). And it was about where the trees are that I heard the motor ‘gunning’. And almost revving with the clutch down. I, I don’t know how else to, to put it.”

Figure 1: Still image extracted from Video Recording Depicting Witness Recounting with Airplane Model the Attitude the Airplane departed the Runway.

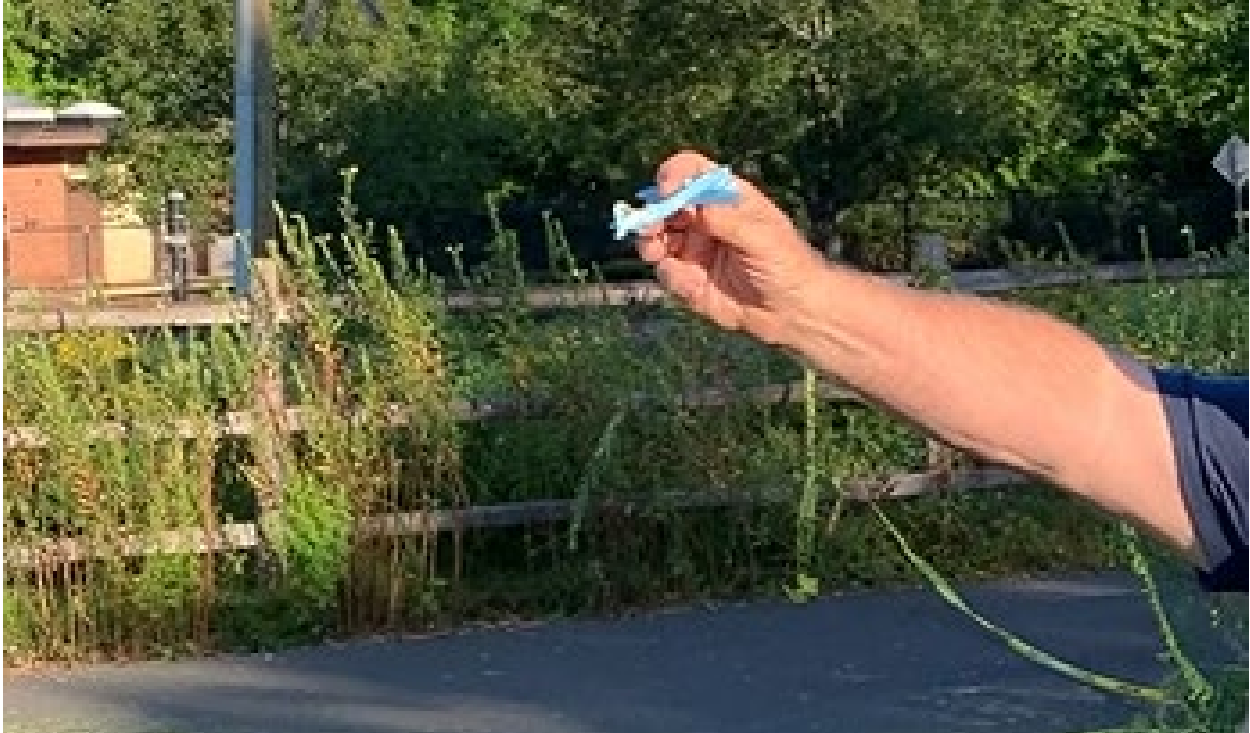
Figure 2: Still image extracted from Video Recording Depicting Witness Recounting with Airplane Model the Attitude the Airplane Was In After Departing the Runway.

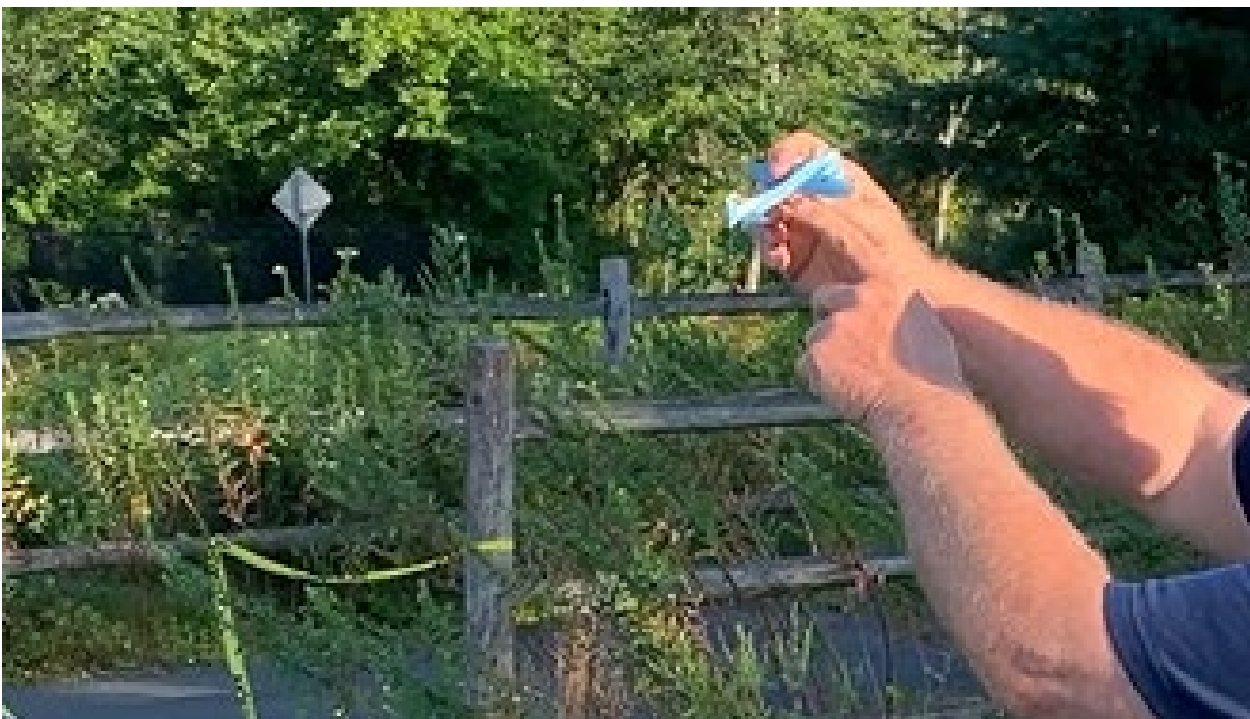
Figure 3: Still image extracted from Video Recording Depicting Witness Recounting with Airplane Model the Attitude and Location of the Right Engine That Impacted the Power Pole.

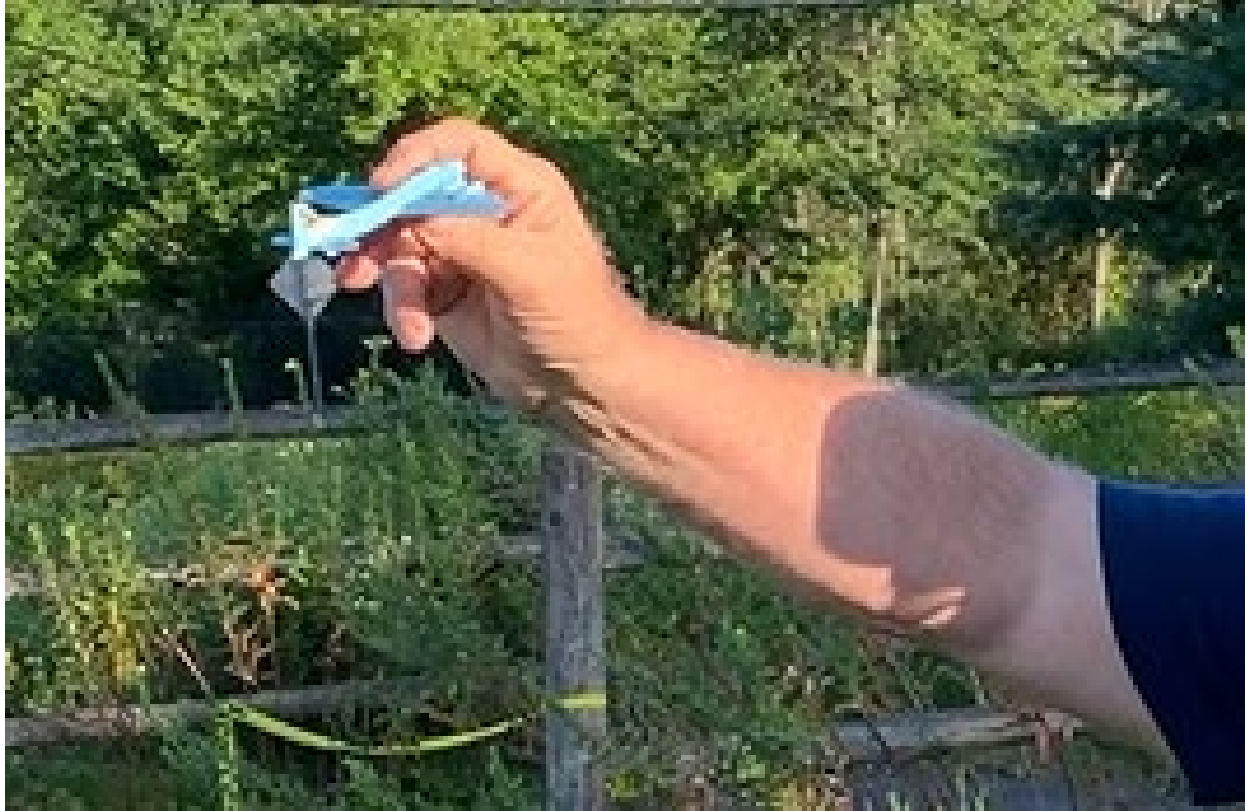
Figure 4: Still image extracted from Video Recording Depicting Witness Recounting with Airplane Model the Nose-Up Attitude the Airplane was in After Departing the Runway.

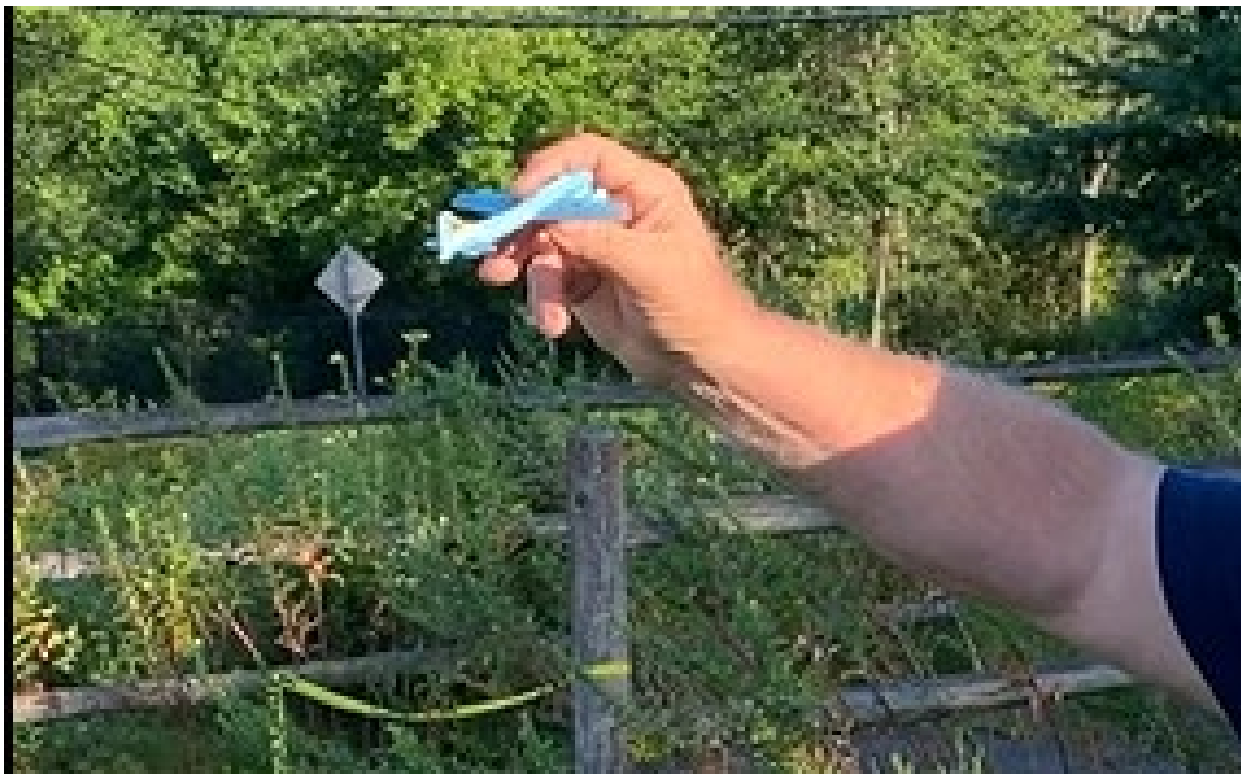
Figure 5: Still image extracted from Video Recording Depicting Witness Recounting with Airplane Model How the Flight Proceeded After Departing the Runway.

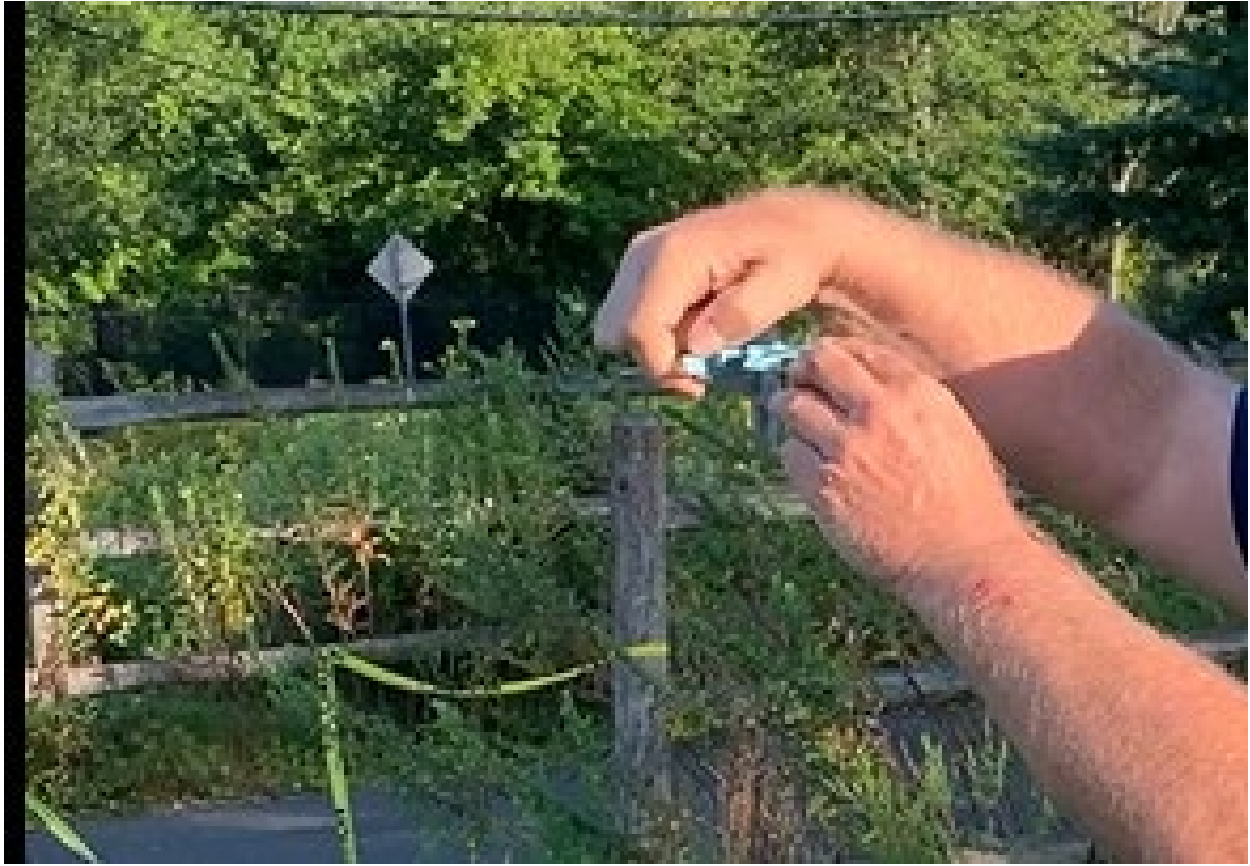
Figure 6: Still image extracted from Video Recording Depicting Witness Recounting with Airplane Model How He Thought the Airplane went From a Nose-Up Attitude to Inverted Attitude.
