# NATIONAL TRANSPORTATION SAFETY BOARD

MATERIALS LABORATORY FACTUAL REPORT

Report No. 22-060

Place : Farmington, Connecticut  
Date : September 2, 2021  
Vehicle : Cessna 560XL, N560AR  
NTSB No. : ERA21FA346  
Investigator : Thomas Jacky, AS-40

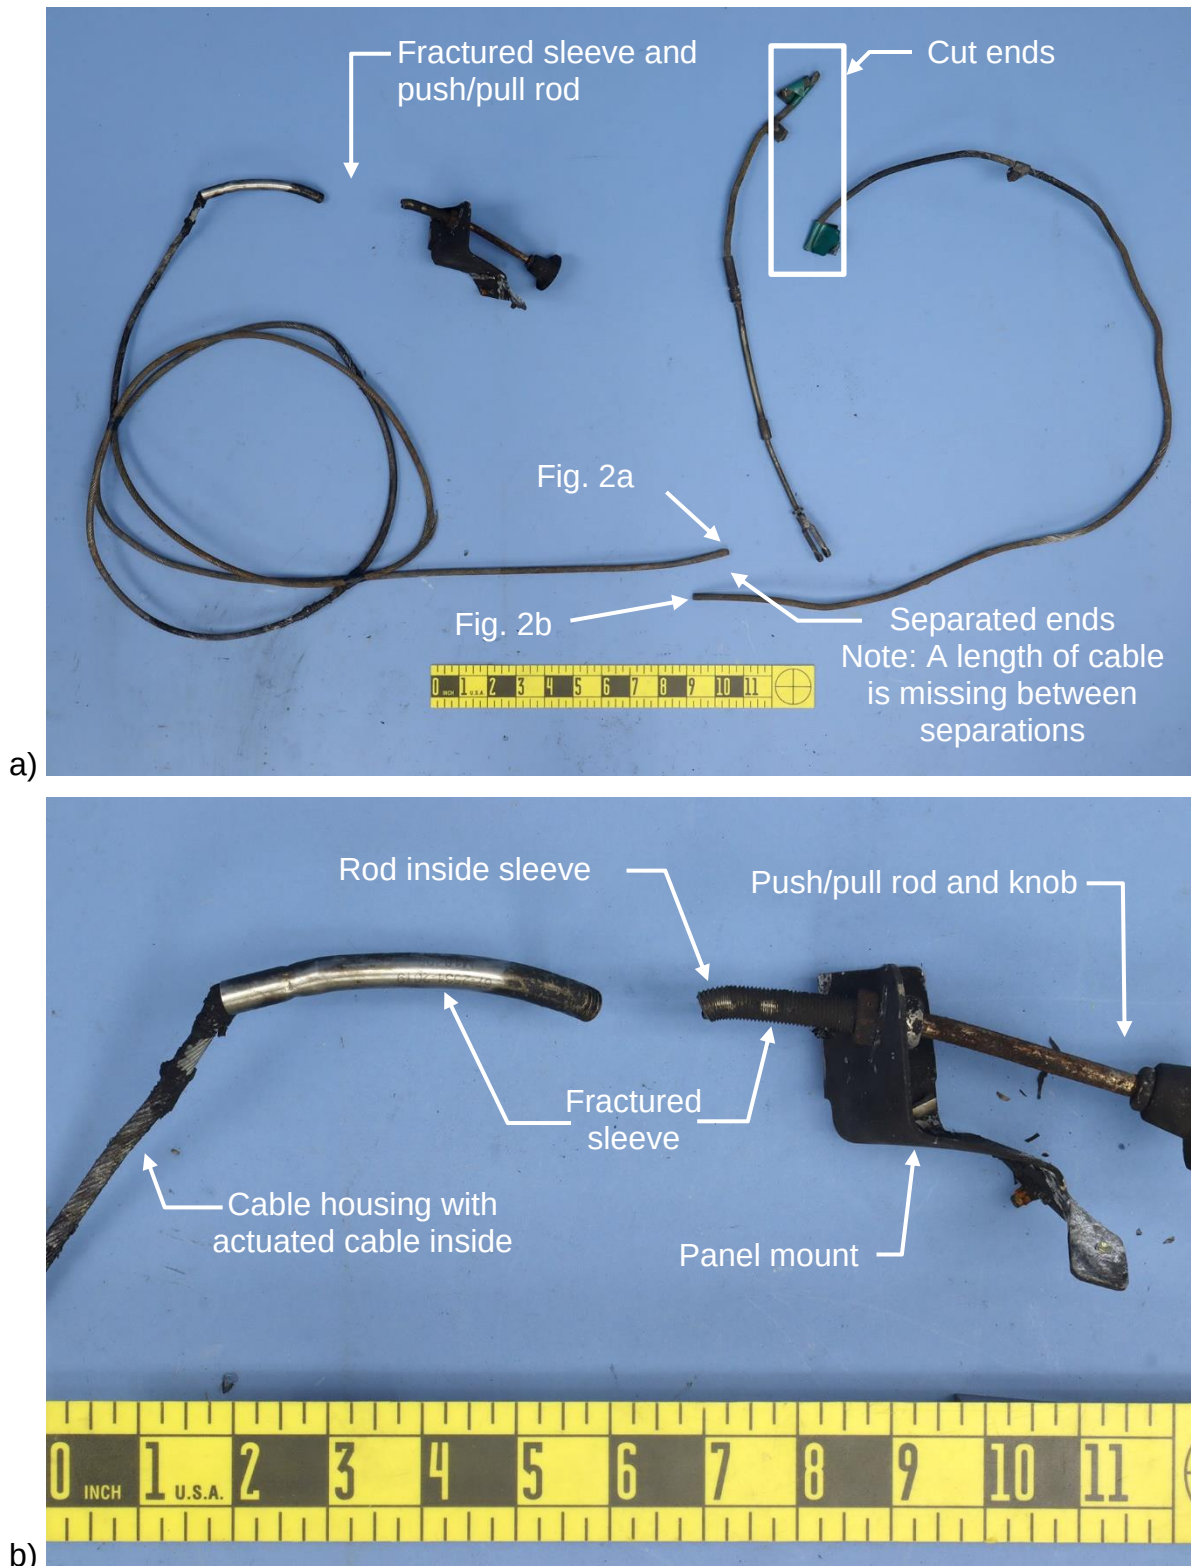
Pieces of a parking brake cable assembly were submitted to the NTSB Materials Laboratory for examination as shown in figure 1a. The assembly was a Bowden cable-type design with an outer housing and an inner actuated cable. The inner cable was actuated by a panel-mounted and crew-operated push/pull rod. The rod was equipped with a knob at one end and was connected to a swivel seal at the other end. The swivel seal was joined to the inner cable and a clevis fitting was joined to the cable at its opposite end. Most of the cable housing consisted of wires laid helically over a cylindrical core. Near the push/pull rod, the housing transitioned to a solid sleeve. The sleeve guided and centered the rod at the rod-to-cable transition. The sleeve was threaded at one end so that it could be attached to a sheet metal panel by sandwiching the panel between two nuts threaded onto the sleeve.

The sleeve had fractured in the threaded region as shown in figure 1b. The sleeve was bent, as was the wire cable housing where it met the sleeve. The push/pull rod was bent at the point where it entered the sleeve and otherwise exhibited no additional notable bends or nicks. The cable assembly had been cut in the field at one location and was separated at two additional locations, as indicated in figure 1a. The cable assembly between the two separated ends was not recovered and therefore was not examined. One separated end, shown in figure 2a, exhibited plastic crushing of the housing's cylindrical core, bending of the housing's wires adjacent to the fractured ends, transverse rub marks on several inner cable wires, and transverse elongation of several inner wires, all in the same direction (nominally top to bottom in figure 2a). The other separation, shown in figure 2b, exhibited transverse rub marks on the inner and outer fractured wire ends. The features were consistent with shear overstress fractures for both separations.

**Figure 1:** a) Pieces of the parking brake cable assembly as received and b) closer view of the fracture through the sleeve and the cable assembly adjacent to the push/pull rod and panel mount.

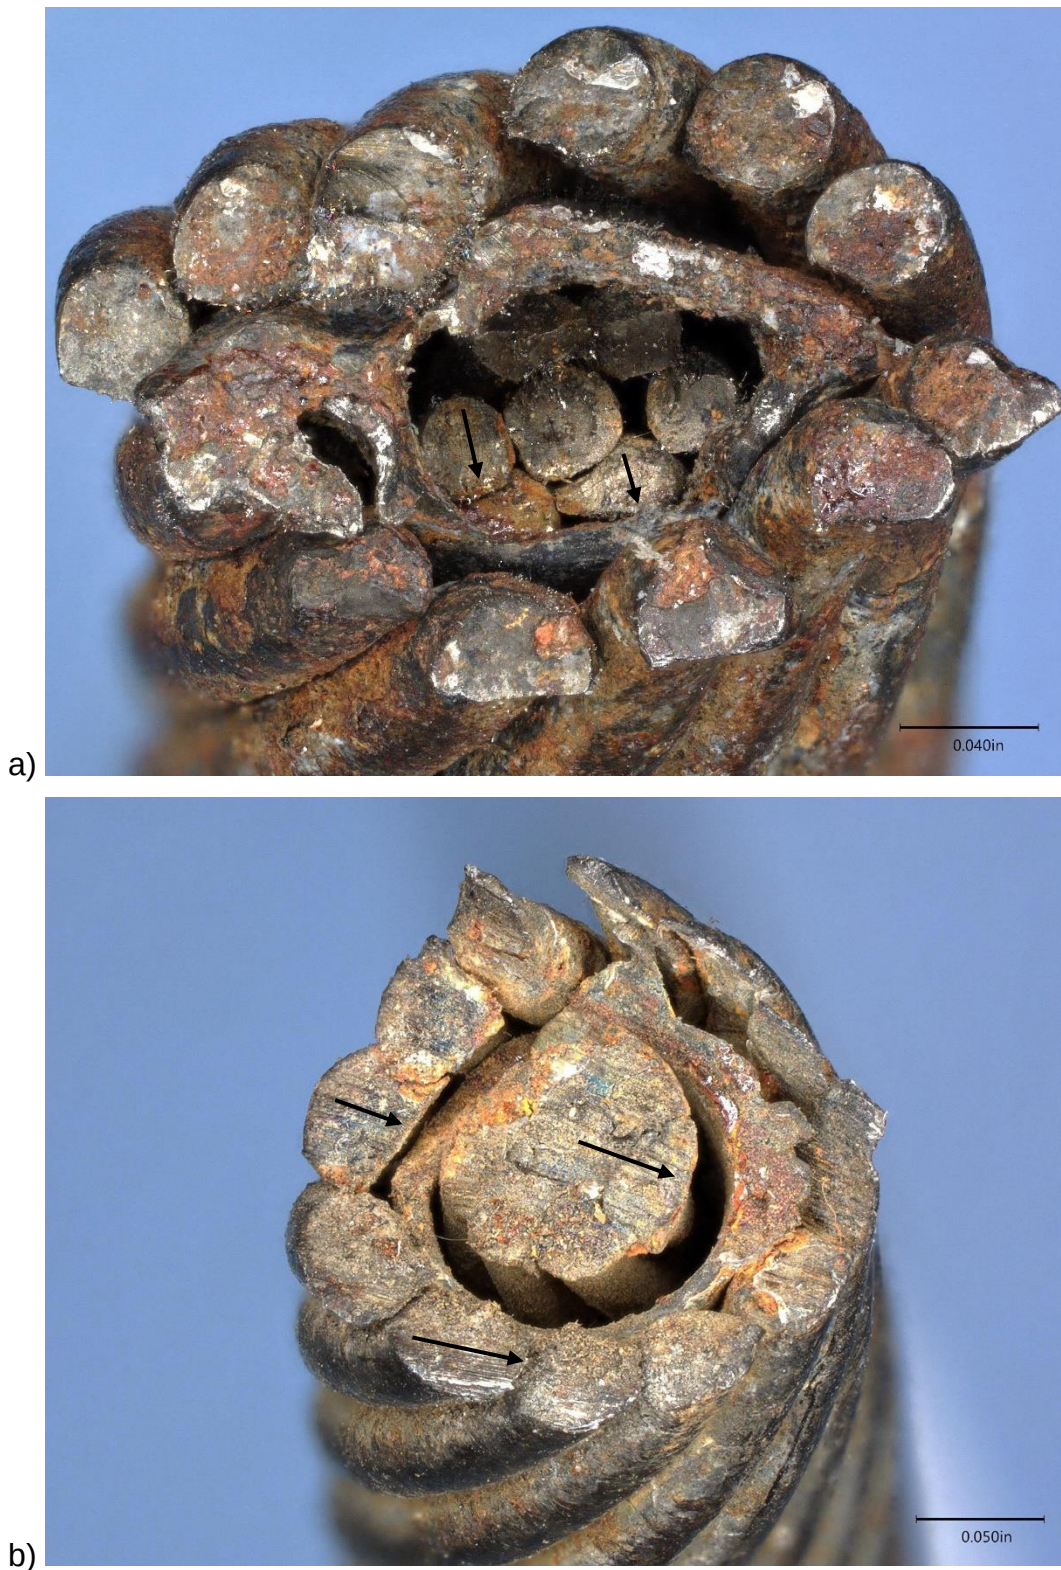
**Figure 2:** a) and b) Images of individual Bowden cable separations as indicated in figure 1a. Black arrows indicated directions of rub marks on the wire ends.

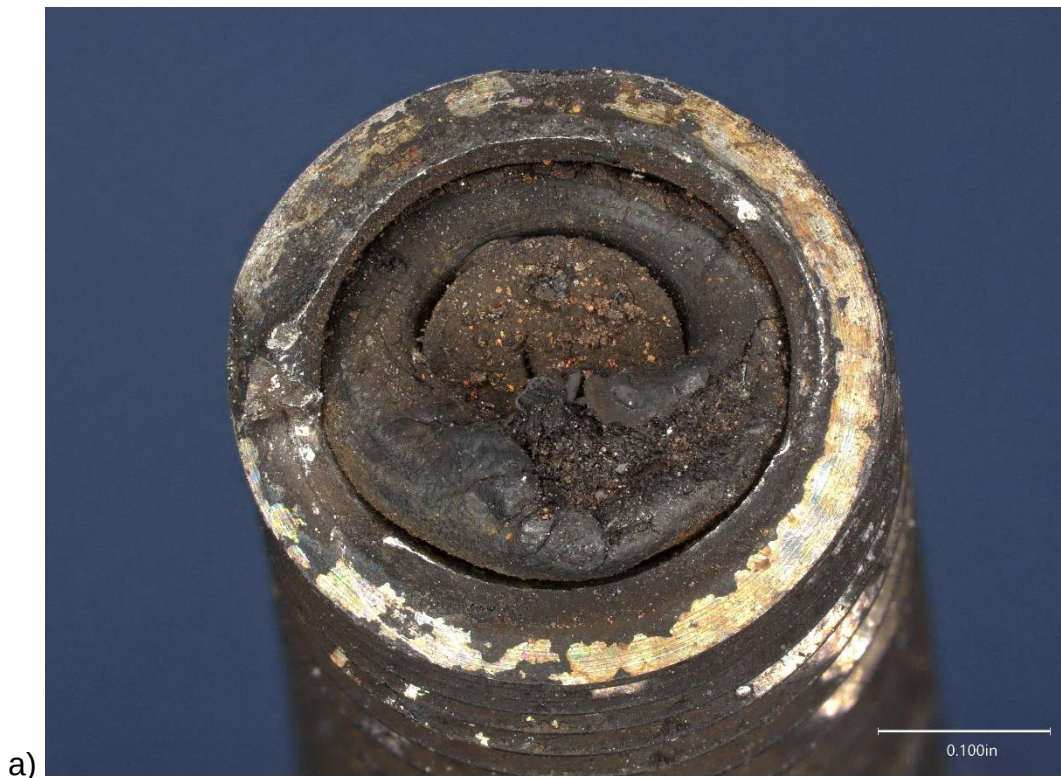
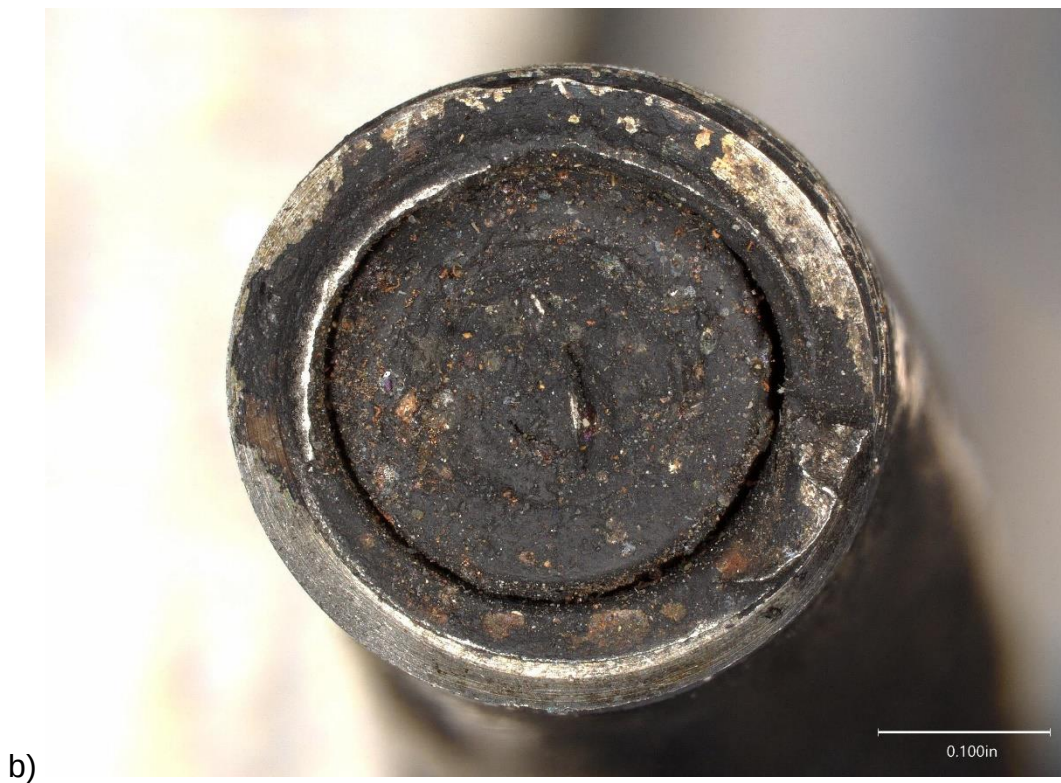
The fractured sleeve is shown in figures 3a and 3b prior to cleaning. The fracture through the sleeve initiated at thread roots and exhibited a rough appearance at an inclined angle, consistent with an overstress fracture. Inside the sleeve, the side leading to the push/pull rod and knob, shown in figure 3a, contained a rubber O-ring surrounding a fractured stub (part of the swivel seal). The other end, connected to the inner cable as shown in figure 3b, contained a flat disk of material (also part of the swivel seal as indicated below).

**Figure 3:** Images of the fracture through the sleeve and the inner cable assembly, as received; a) side connected to the pull rod and knob and b) side connected to the cable.

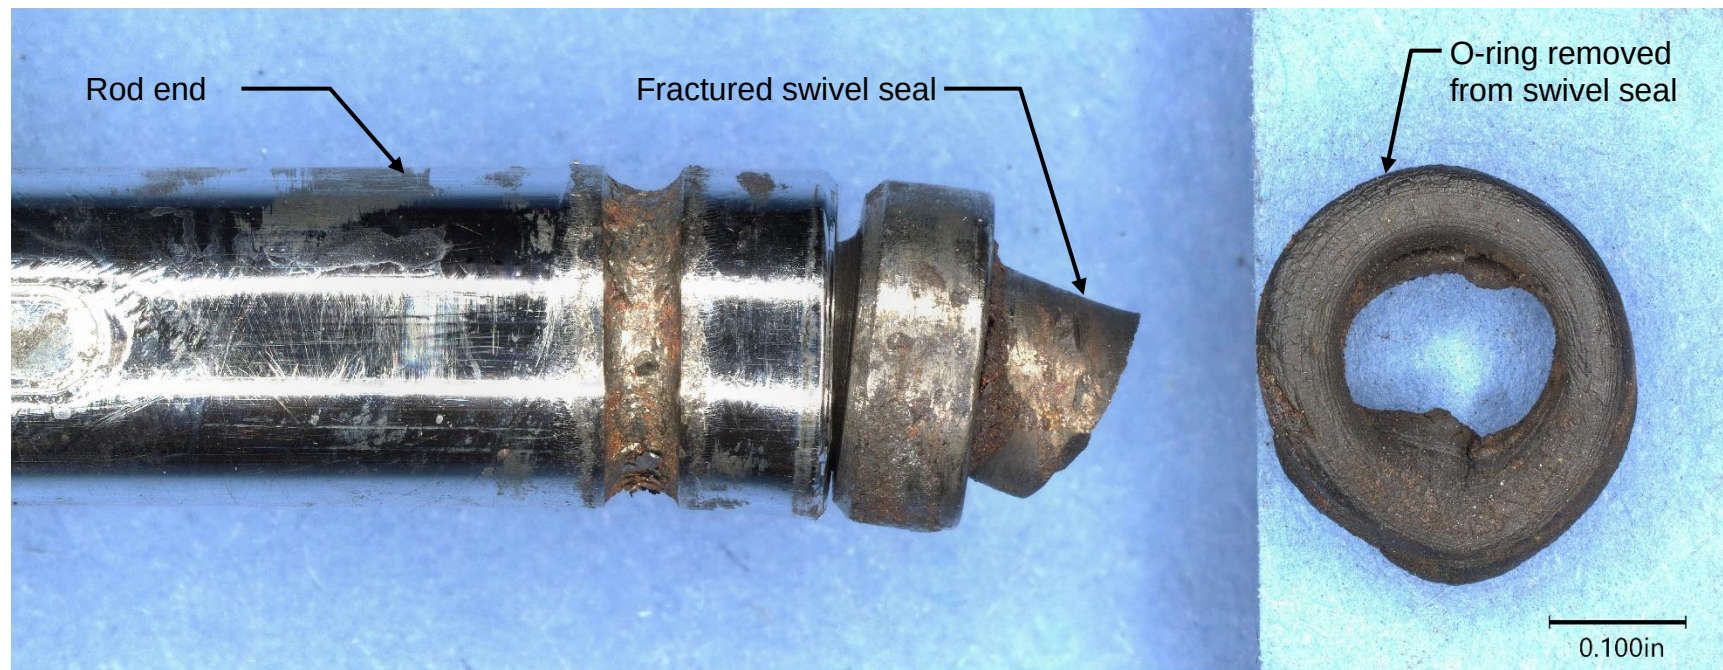
The fracture surfaces were cleaned with an alkaline detergent, a nylon brush, and a sonicating bath, in accordance with standard laboratory procedures. The rubber O-ring was removed with a pair of tweezers and the knob was pulled to try and remove the rod assembly from the sleeve, but it jammed before clearing the opening. With the rod pulled out as far as possible, the bent section of the sleeve (approximately 5/8" from the fractured end) was cut using a thin-kerf abrasive blade and the rod was pushed forward revealing the rod end and the fractured swivel link, as shown in figure 4. The swivel link consisted of two large-diameter sections separated by a small-diameter section within which the O-ring had been situated. The link had fractured at the transition from the small-diameter section to one of the large-diameter sections. The end of the rod and the swivel link were bent. The swivel link fracture surfaces, shown in figures 5a and 5b, exhibited radial lines emanating from an origin area along the outer bend and ending in a shear lip at the inner bend. The deformation and fracture features exhibited by the sleeve, the rod, and the swivel link were consistent with a bending overstress fracture.

**Figure 4:** Image showing the push/pull rod, swivel seal, and rubber O-ring after sectioning the bent section of the sleeve.

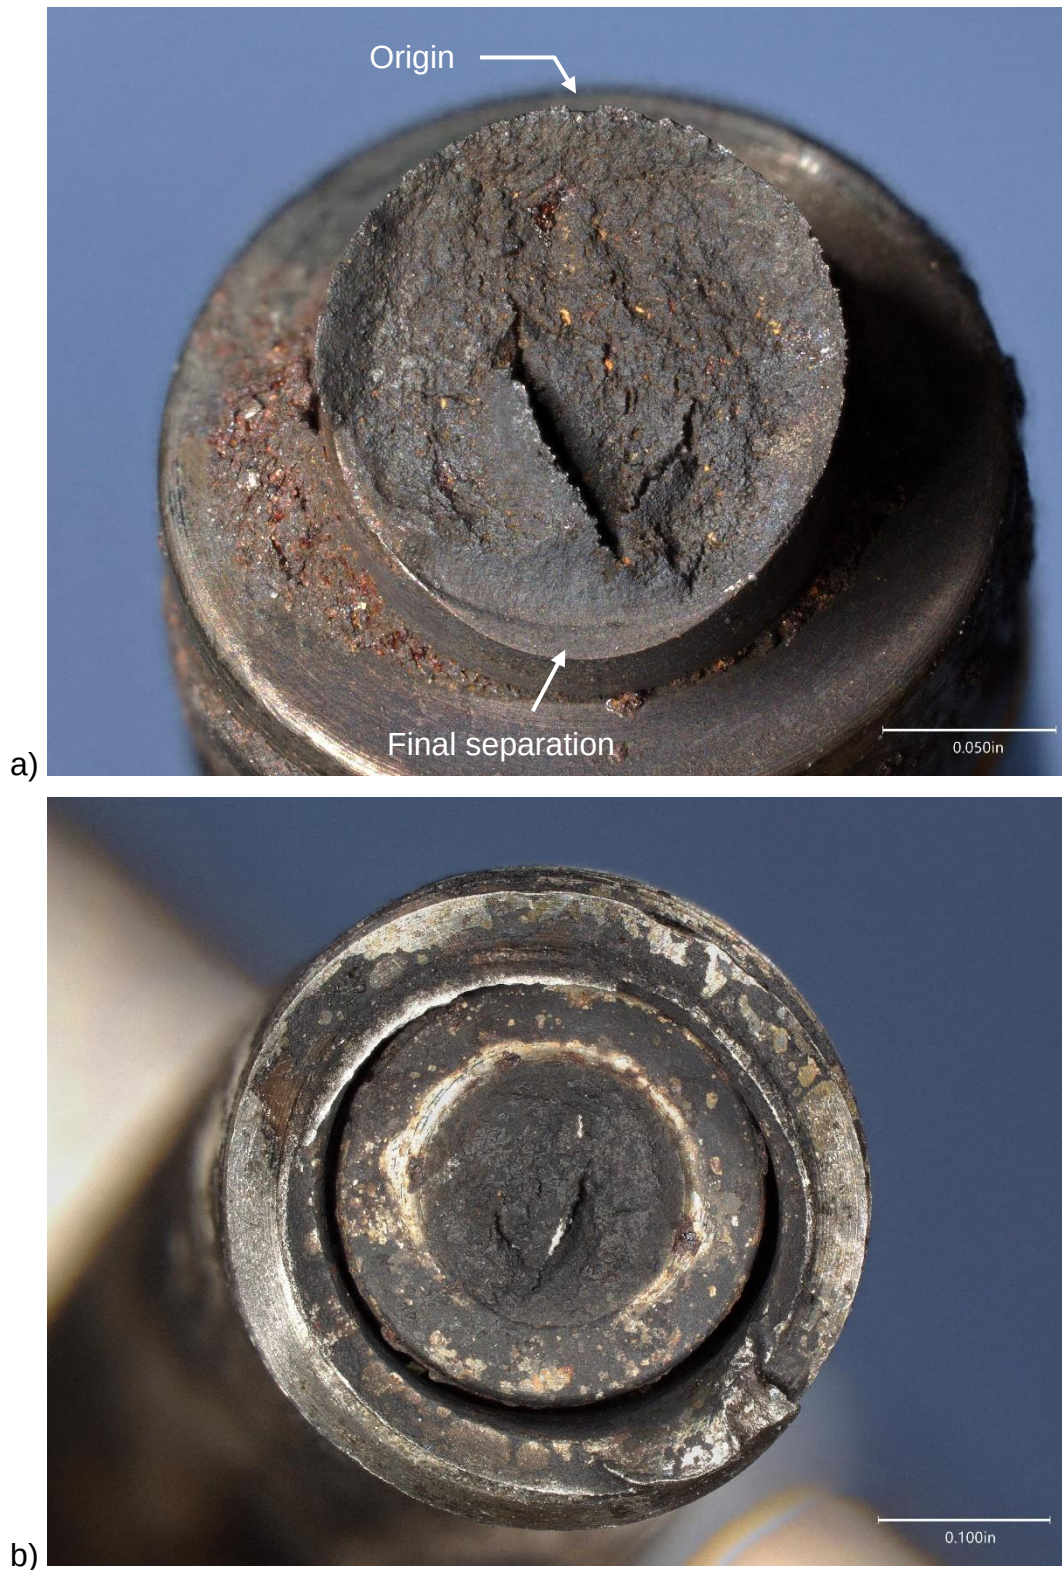
**Figure 5:** Images of the fracture through the swivel seal after disassembly and cleaning; a) push/pull rod and knob side and b) smooth-barrel sleeve and cable side.
